Sequoyah Nuclear Plant

1B Emergency Diesel Generator Regulatory Conference May 02, 2024

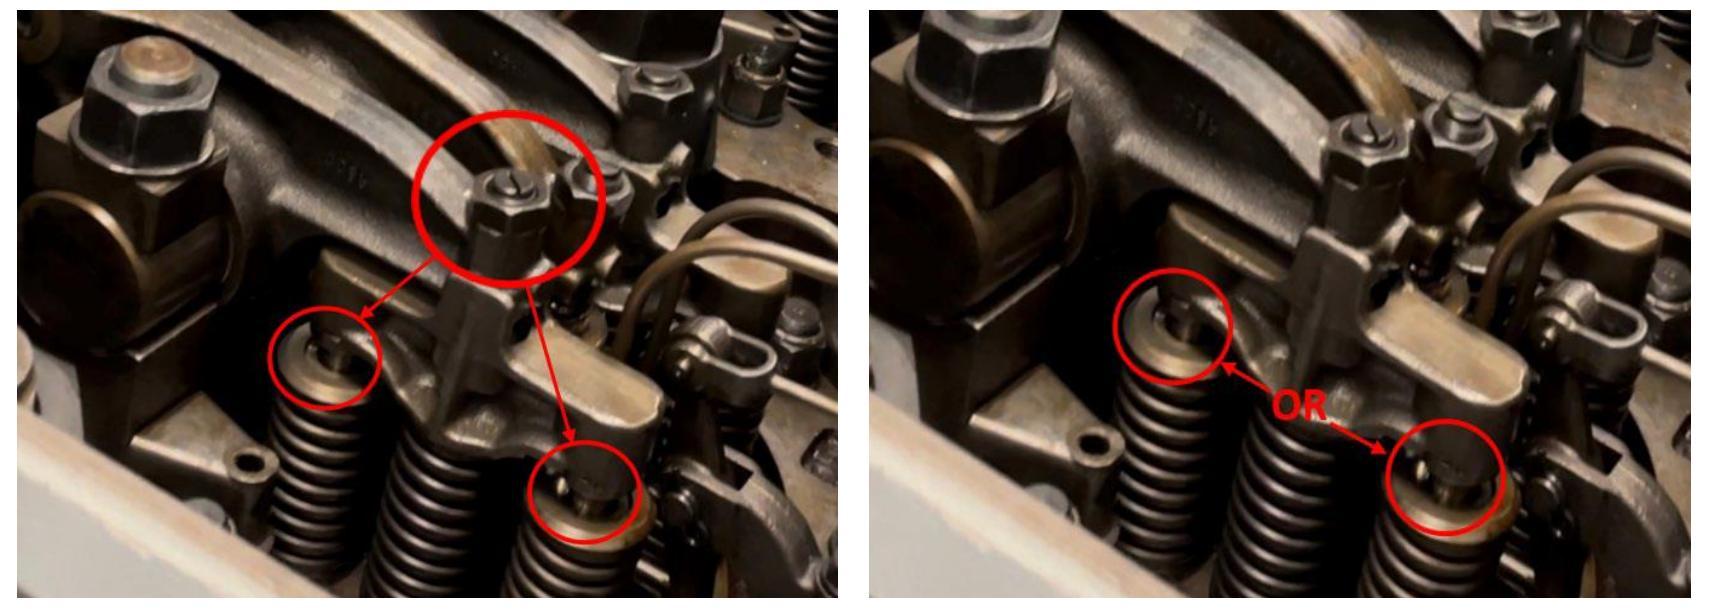
• Fig. 1 Global lash - Involves both inboard and outboard exhaust valves, their respective hydraulic lash adjuster assemblies, and is ultimately impacting the whole valve bridge assembly. • Fig. 2 Local lash - Is concentrated on either the inboard or outboard exhaust valves and the respective hydraulic lash adjuster.

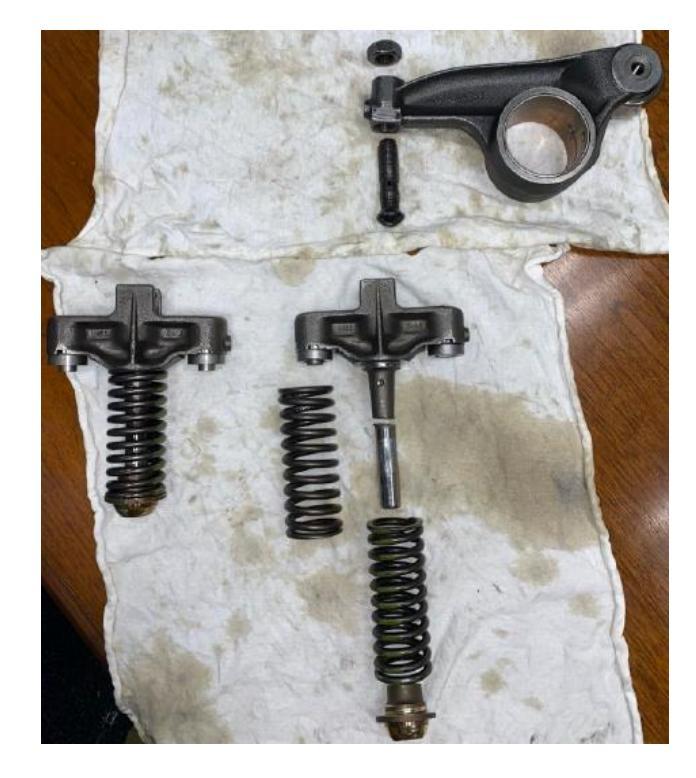
- Failure Scenarios examined as correlated to similar industry Operating Experience:
 - Exhaust valve spring retaining ring failure
 - ANO cracked retaining rings
 - Turkey Point cracked retaining rings
 - Rocker arm set screw loose locknut
 - Davis Besse loose locknut
 - Hydraulic lash adjuster failure
 - Turkey Point lash adjuster failure
- We specifically mapped the loose locknut failure scenario using Industry precedent root cause findings based on the similarity of the ESI conclusion.

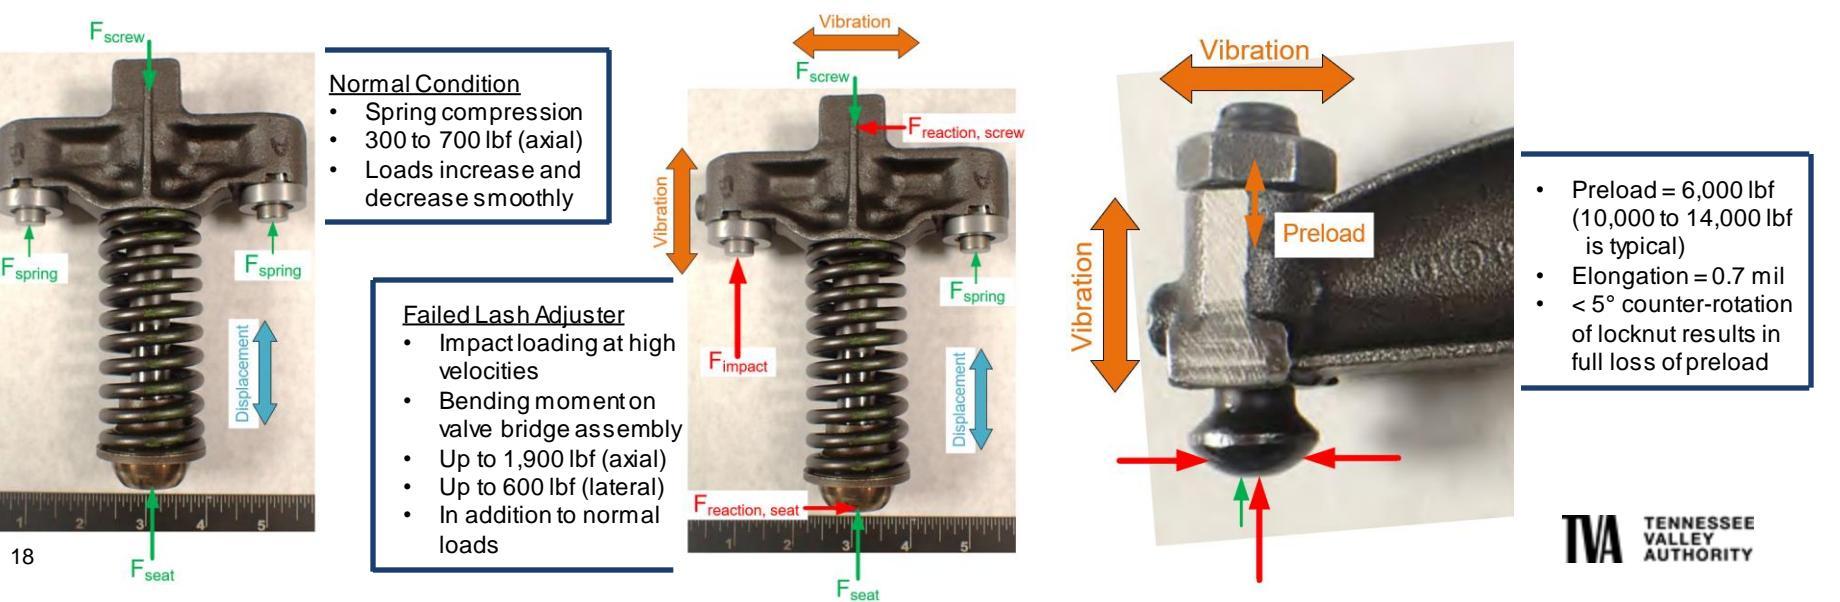
- · Lash adjuster failure results in significant vibrational loading of valvetrain components
 - · Lash adjustment screw and locknut subjected to increased axial loading and additional lateral loading
 - Loads are significant in magnitude and occur at relatively high frequency (900 rpm or 15 Hz)
- Threaded fasteners are susceptible to self-loosening due to vibration, in particular from lateral loading
- Locknut @ 80 ft-lbf adequate adjustment screw preload (normal conditions); marginal preload (w/ failed lash adjuster)
- · Locknut loosening as a consequence of a lash adjuster failure is plausible and should be expected
