- Automated phased array UT of weld fabrication indication in DMW at U.S. BWR/4

# **Automated Phased Array UT of Transverse Weld Fabrication Indication in DMW**

Component ID: N-2F-SE

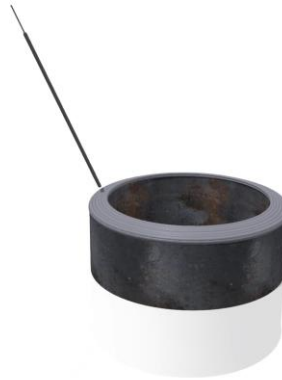
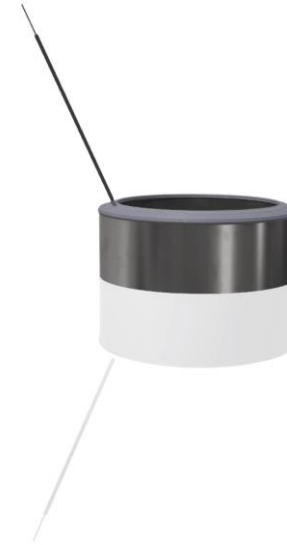
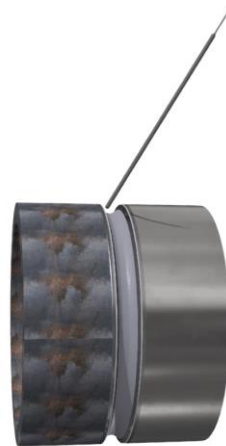
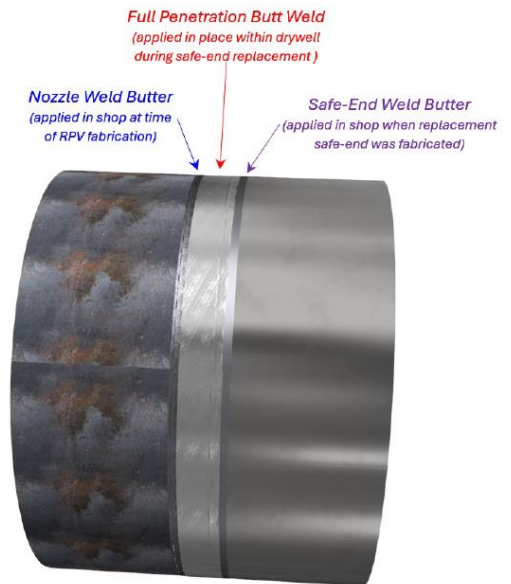
1. Nozzle buttering welded to RPV in the RPV fabrication facility
  - 1G (laying flat) position
2. Safe-end removed at some point
3. Safe-end weld buttering applied long after RPV fabrication
  - 1G (laying flat) position
4. New safe-end mated to RPV nozzle inside drywell
5. New DMW completed inside drywell
  - 5G (fixed horizontal pipe) position

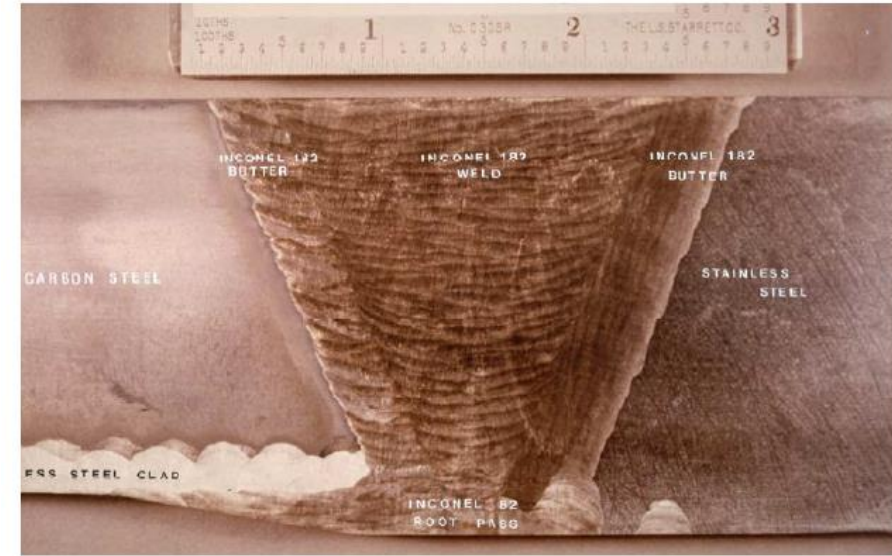
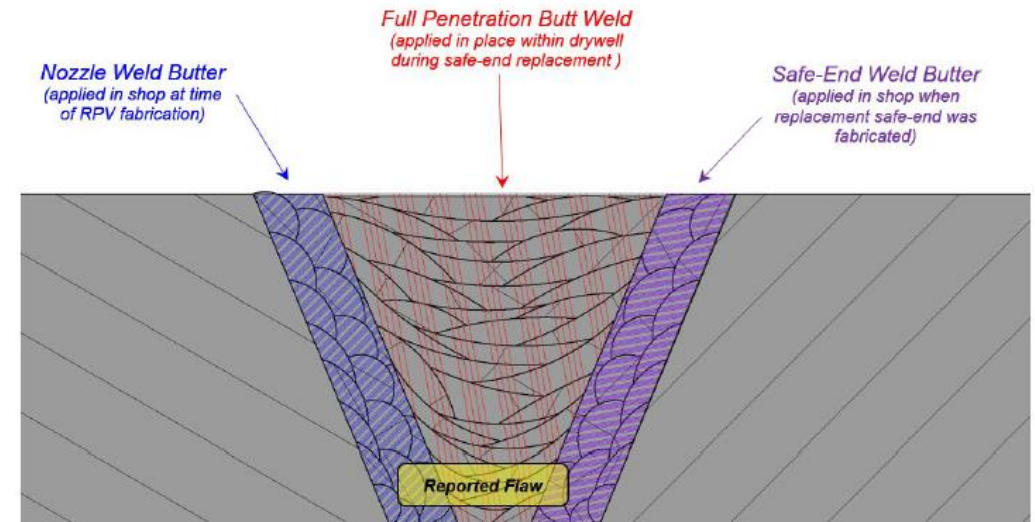
- As recorded, the “weld fabrication flaw” would have to:
  - be oriented transverse to the direction in which welding was performed
    - This is a possible, but unlikely orientation for weld fabrication flaws
  - extend through the RPV butter, across several DMW weld beads, and into the safe-end butter...all of which were applied at different times, at different locations, and using different weld orientations
- A common attribute of transverse SCC flaws within DMWs is they tend to span across the entire width of SC- susceptible Alloy 82/182 weld and butter material

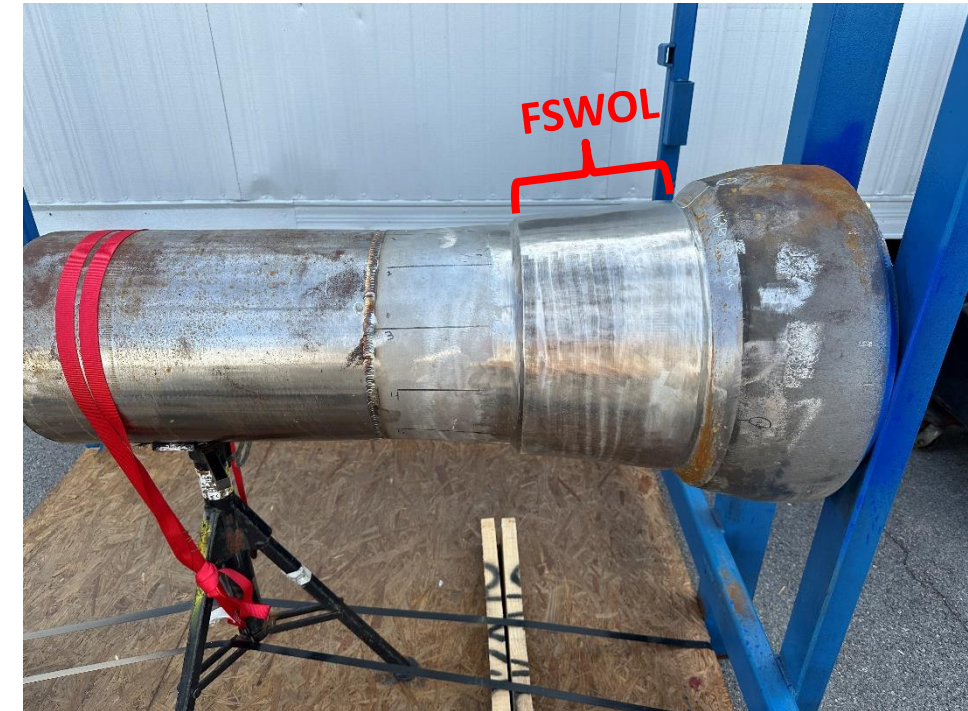
- Long before the 2024 outage, the 2017 indication was evaluated as an inside surface connected planar flaw in accordance with IWB-3600
  - Determined the scheduled 2024 automated UT would be performed before the flaw grew to rejectable size
- Contingency plans to apply full-structural weld overlay during RFO
  - Automated phased array UT of weld overlay mockup performed pre-outage to verify weld parameters capable of welding an acceptable FSWOL
- Scope expansion pre-selected with necessary resources in place
- Experienced manual phased array UT team deployed to take immediate first look at flaw
  - Get in and out quicker than automated UT, use information to initiate scope expansion
- Automated phased array UT mobilized to site to perform definitive characterization of the indication
