October 15, 2024

# **NRC Brief on ANO-2 2R30 Nozzle 71 Half Nozzle Repair**

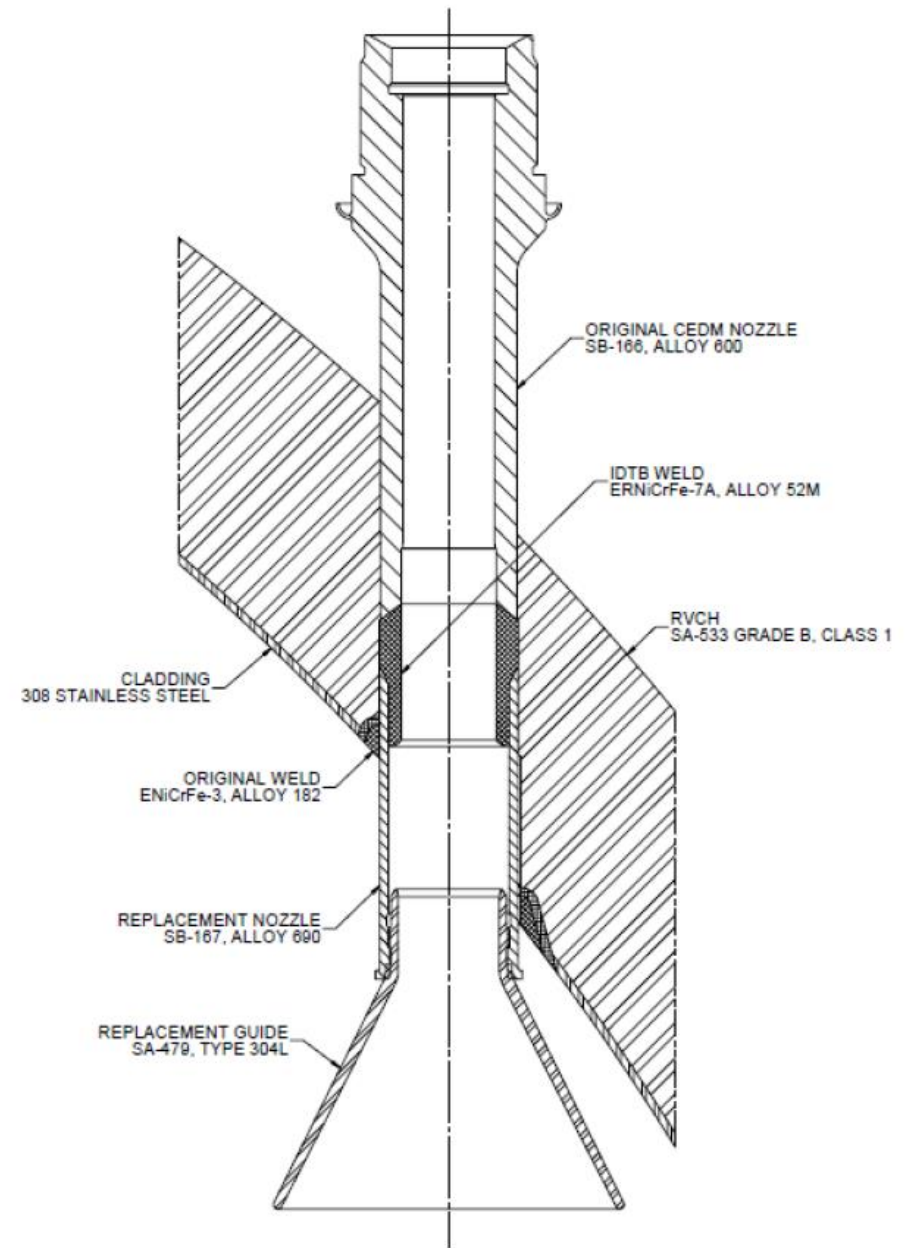
**Penetration Tube/J-weld Repair Diagram**

- Bare metal visual on top of head – No visible leakage
- Clean UT leak path assessment
- Clean Eddy Current from tube ID
- UT indication 0.44" long by 0.195" deep in tube on downhill side located along the top of the J weld
- \*Clean Eddy current on J weld surface and tube OD (augmented exam)

**INDICATION SKETCH – NOT TO SCALE**

Indication Axial Start (L1)	Indication Axial End (L2)	J-Weld Start (L3)	J-Weld End (L4)	Indication Degree Location*	Depth of Indication into Tube Wall (from tube OD)	Comments
2.58"	3.02"	1.31"	2.78"	2°	0.195"*** in the tube wall	Axial Indication on Downhill Side

- Rapid appearance and growth suggested PWSCC
- Fatigue crack considered but concluded to be unsupported
- Potential surface connection using PT
- Undetected growth of cracks thru welds supported by internal OE at Indian Point 2 in 2018

Decision made to proceed with half nozzle repair with Framatome
