# Comanche Peak Moisture Barrier

June 17, 2025

## Moisture Barrier Cap- As-Found Condition Unit 1

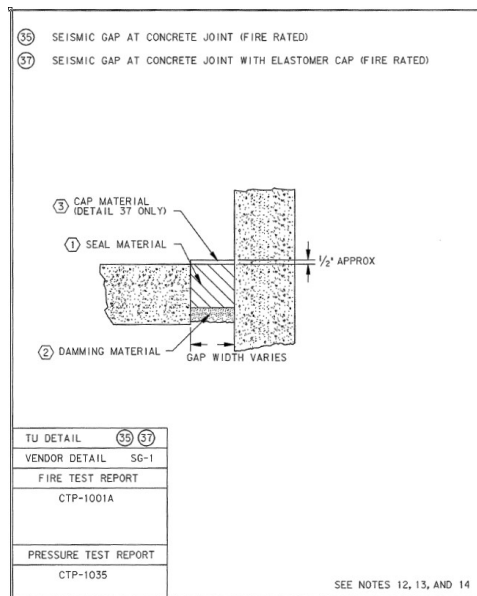
Excerpt from M1-1901-003, Rev CP5

- The Cap is a Promatec 45B ( or equivalent) which is a medium density silicone elastomer.
