Docket: FirstEnergy Nuclear Operating Company, Davis-Besse Nuclear Power Station, Unit 1,
 Docket No. 50-346-LR

SUBJECT:
Davis-Besse Nuclear Power Station, Unit 1
Docket Number 50-346, License Number NPF-3
Submittal of Shield Building Root Cause Evaluation

Root Cause Analysis Report

Concrete Crack within Shield Building
Temporary Access Opening

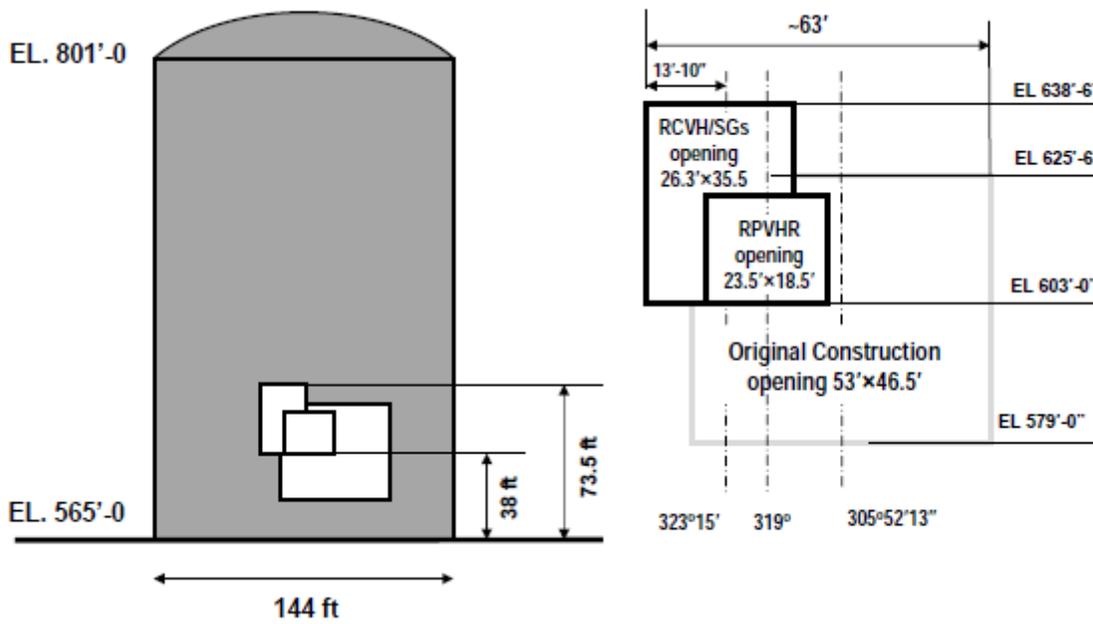
Elevation View of Shield Building / Construction Opening & Temporary Access Openings

American Hydro personnel performing the hydrodemolition of the shield building temporary access opening noted that towards the left side, between the architectural flute reinforcing steel and the outer face of structural reinforcing steel, the concrete removed consisted of larger chunks that sheared through the aggregate leaving a smooth flat surface. The concrete past (inward of) the outer face of structural reinforcing steel, and also on the right side of the temporary access opening placed during the 2002, was more difficult to remove and the larger chunks were not present [Reference 10.1.6]. The American Hydro personnel observed these conditions while using consistent parameters for the hydrodemolition equipment (water pressure, cut angle, nozzle stand-off, traverse speed, step distance). Therefore, the only variable was determined to be the condition of the shield building concrete.

The known extent of condition at the time of problem discovery was a concrete crack in the shield building wall that was visible on the entire 35 feet height of the temporary access opening left face. The crack was adjacent to the outer face of structural reinforcing steel, and it extended approximately eight feet into the left-top and approximately four feet into the left-bottom region of the temporary access opening progressing from the outer face of structural reinforcing steel towards the architectural flute reinforcing steel. The crack at the left-top of the temporary access opening continued to the exterior surface at the edge of the opening and extended about two and a half feet vertically upwards on the exterior surface of the shield building concrete [Reference 10.1.7]. The crack width was initially indeterminate, due to the effect of the hydrodemolition process, resulting in disintegrating the concrete aggregate and cement paste at the crack location. The hydrodemolition process was incomplete at the time of crack discovery and had been stopped to allow removal of the outer face of structural reinforcing steel.
