POST REMEDIATION
URANIUM CONTAMINATION CONCENTRATION CONTOUR PLOT

TEXAS INSTRUMENTS INCORPORATED

Attleboro, Massachusetts

CONFIRMATORY SURVEY OF THE TEXAS INSTRUMENTS, INC. FORMER BURIAL SITE ATTLEBORO, MASSACHUSETTS

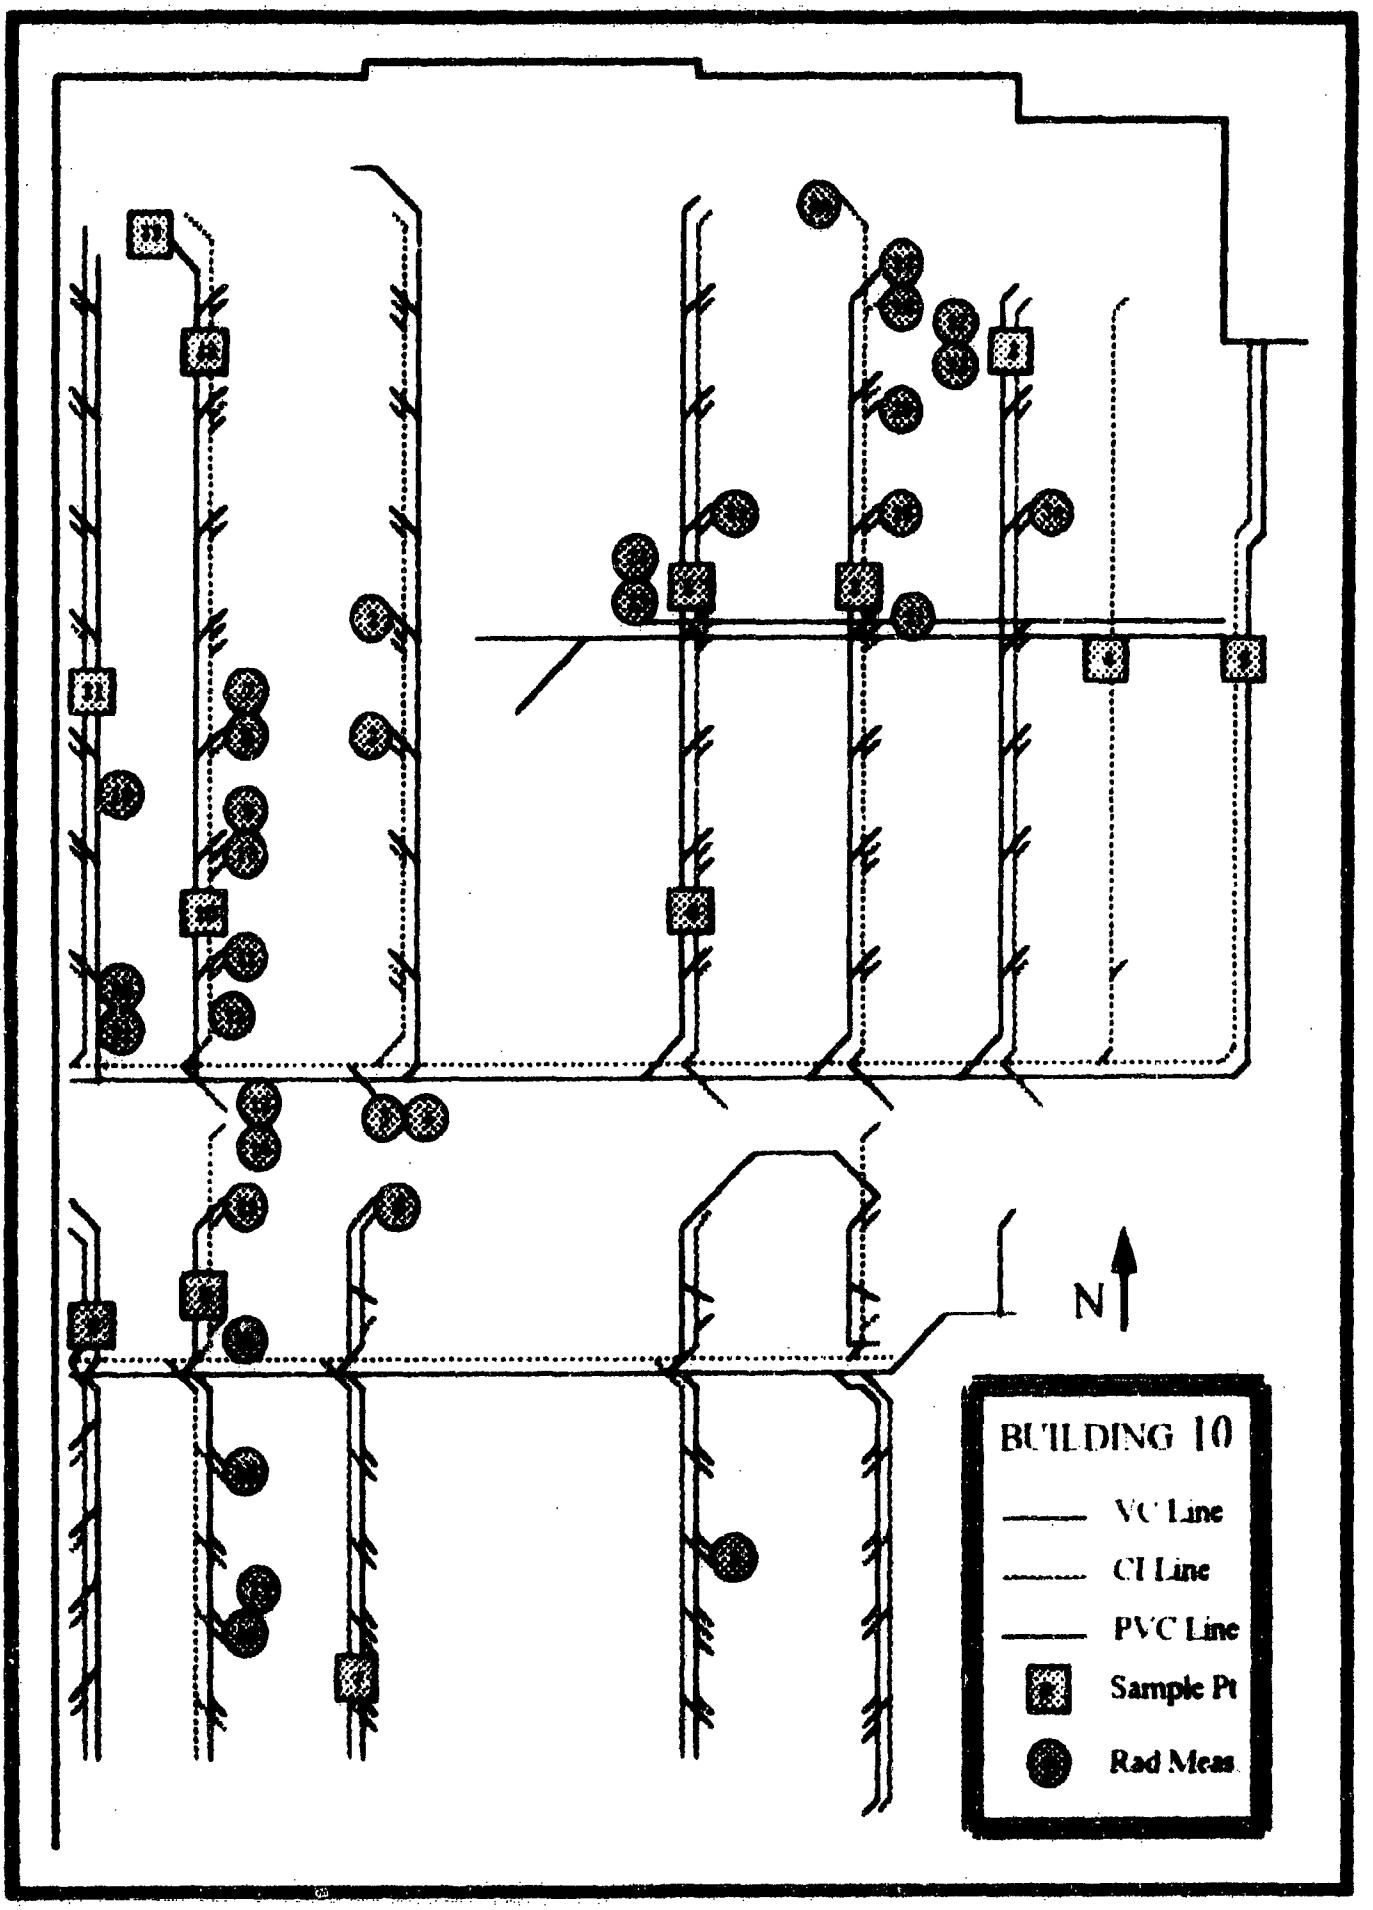
Figure 4. Building 10 Intrusive Sampling and Pipe Line Identification Locations

Location 1 - Two pipes were identified and sampled at this location during the Pilot-Scale Interiors Remediation Project. The pipes are identified as 0815-04-4C-BSS-00-CI Pipe Inside and 0815-04-4C-BSS-00-VC Pipe Inside. During pilot investigations, high readings from the pipe feed line were noted and the pipe was excavated and removed to the main lines. The 4-inch CI and 4-inch VC pipes were opened; a small rod (5 inches long and 1/2-inch in diameter) was removed. Significant sediment buildup was identified. The sediment blocked at least 90 percent of the CI pipe and 50 percent of the VC pipe. This sediment was sampled and shipped for isotopic uranium analysis. It should be noted that these findings were the basis for the WESTON recommendation to perform drain line characterization prior to full -scale remediation activities.

Location 2 - Pipe location 2 includes a 4-inch CI pipe and 5-inch VC pipe. The CI pipe is identified as 0830-04-3D-BSS-CI Pipe Inside. There was very little buildup other than pipe scale, but a sample was collected and submitted for isotopic uranium analysis. The VC pipe was not sampled due to water flow and leakage in the area.

Location 3 - Pipe location 3 includes one 4-inch CI pipe identified as 0830-01-3B-BSS-00-CI Pipe Inside, and a 5-inch VC line. Very little residue was noted, but a scale sample was collected and submitted for isotopic uranium analysis. The VC line had no residue to sample.

Location 5 - Pipe location 5 includes an 8-inch CI pipe identified as 0916-02-2D-BSS-00-East Iron Pipe. This pipe is an arterial line for a large number of roof drains on the northeast part of Building 10. The VC line at this location was leaking water and could not be opened. A sample from the CI line was collected and submitted for isotopic uranium analysis.

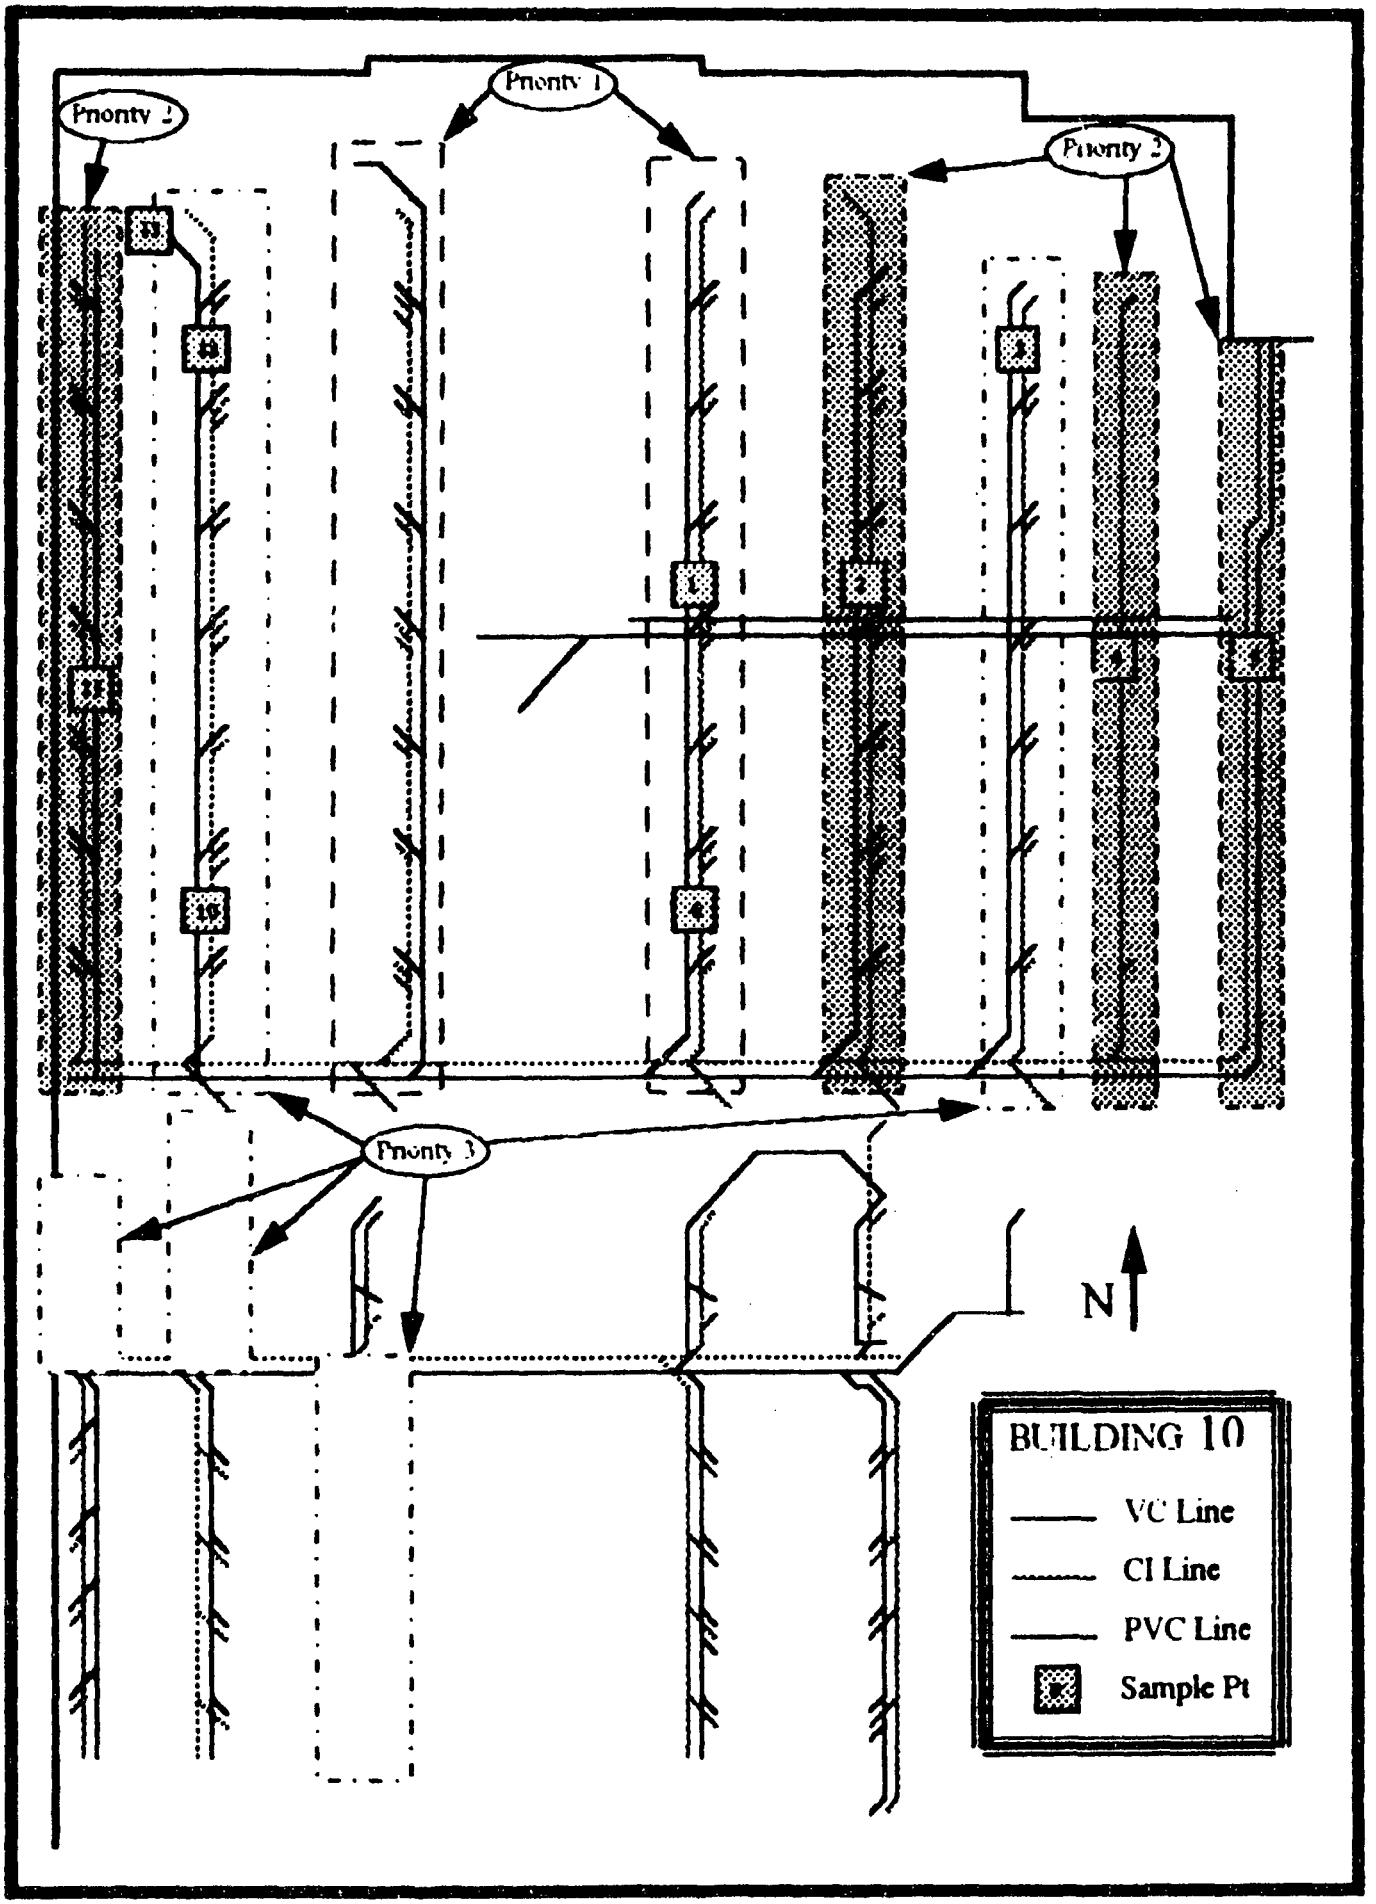
Figure 6. Building 10 Pipe Grouping for Uranium-233 Inventory Developm...

PRIORITY 1 - Priority 1 lines require complete removal due to significant uranium concentrations in or around sections of the line. Potential hazards to untrained workers performing routine maintenance warrant the removal of this material by decontamination workers operating under the protocol of the current building decommissioning effort. The total uranium concentration of material in these lines ranges from 10,000 to 50,000 pCi/g. Priority 1 lines are encountered in Building 10 only, and are designated on Figure 6. Both "sets" of priority 1 lines include a 4-inch VC and 5-inch CI, and are routed from a north to south direction on either side of the former Health and Safety and 509 Departments. These lines bound Areas 5, 6, and 12. The set of lines bounding this area to the west terminate at the Beckhart wire drawing machine, while the set of lines to the east feeds into 8-12" main lines servicing other areas of Building 10.

PRIORITY 2 - Priority 2 lines require a cleaning effort to remove pipe scale and some sediment, typically exhibiting total uranium concentrations of 500 to 1000 pCi/g. These lines could pose a minor hazard to untrained workers performing routine maintenance operations; any intrusive actions should be performed with qualified radiological protection oversight. Priority 2 lines are encountered in Building 10 only, and appear to have serviced the laboratory wing and eastern sections of the former HFIR project. These lines are comprised of both CI and VC of varying diameter and are located in and around decontamination areas 2, 3, 7, 9, and 10 of Building 10.

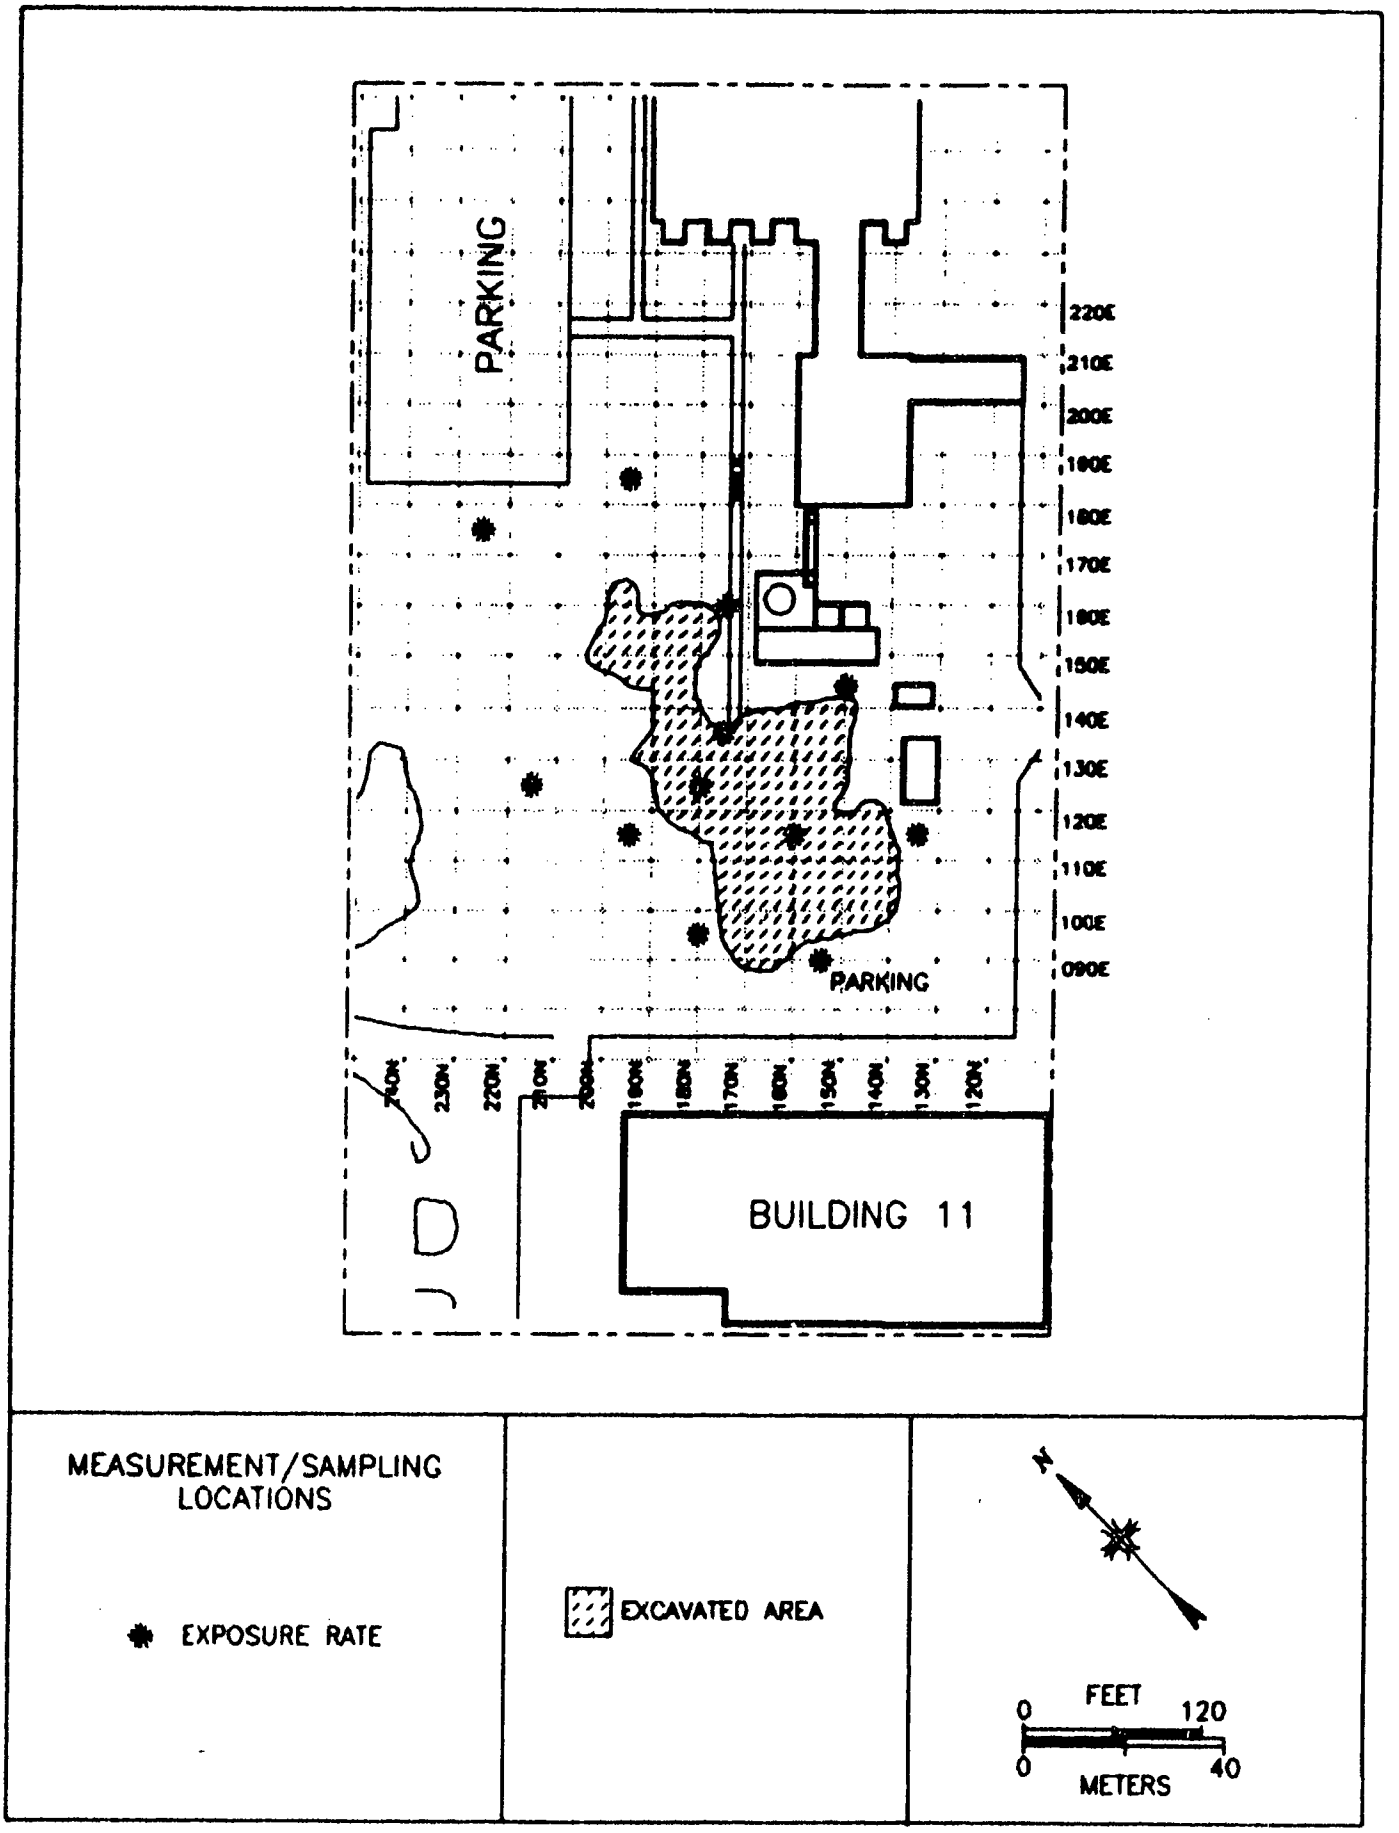
FIGURE 3: The Former Burial Site – Exposure Rate Measurement Locations

Exposure rates were all within the 10 μR/h above background criterion. The radionuclide concentrations in surface and subsurface soil samples were less than the applicable guidelines for release for unrestricted use. In ESSAP's opinion, the licensee documents provide an adequate description of the radiological condition of the facility.

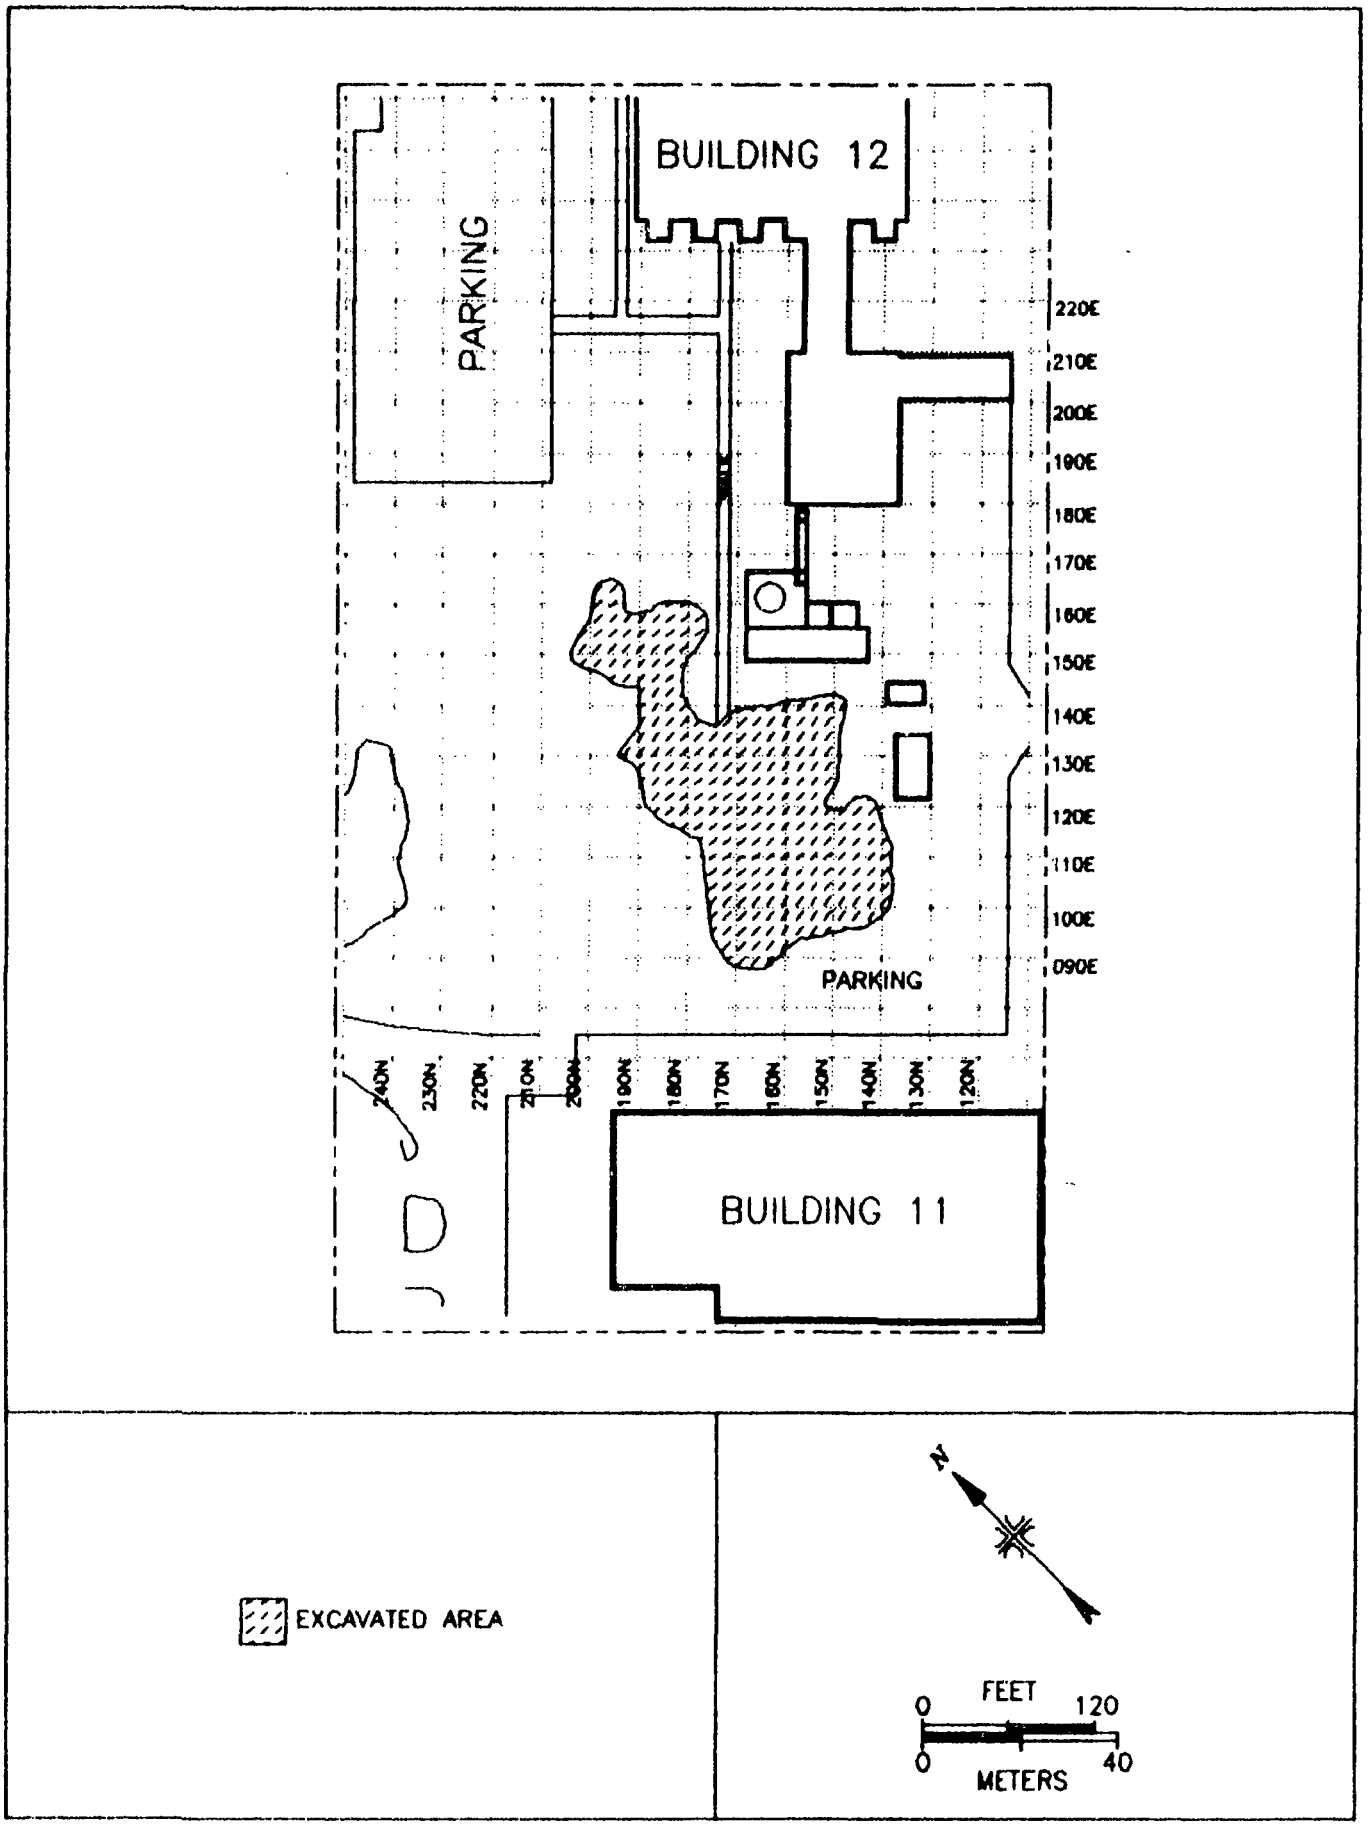
FIGURE 2: The Former Burial Site – Extent of Excavation

The Texas Instruments Inc. Facility, Attleboro, MA is located in North Attleboro, approximately 48 kilometers south of Boston on Route 123 (Figure 1). The former burial site is located between Buildings 11 and 12 (Figure 2). The area of concern for remediation activities was approximately 10,000 m^2. The excavated area at the burial site was approximately 2,500 m^2 and the average depth of the excavated area was approximately 1.5 meters. The west end of the excavation extended into the parking lot, adjacent to Building 11. The excavated area has been backfilled and landscaped. The area which extended into the parking lot has been repaved.

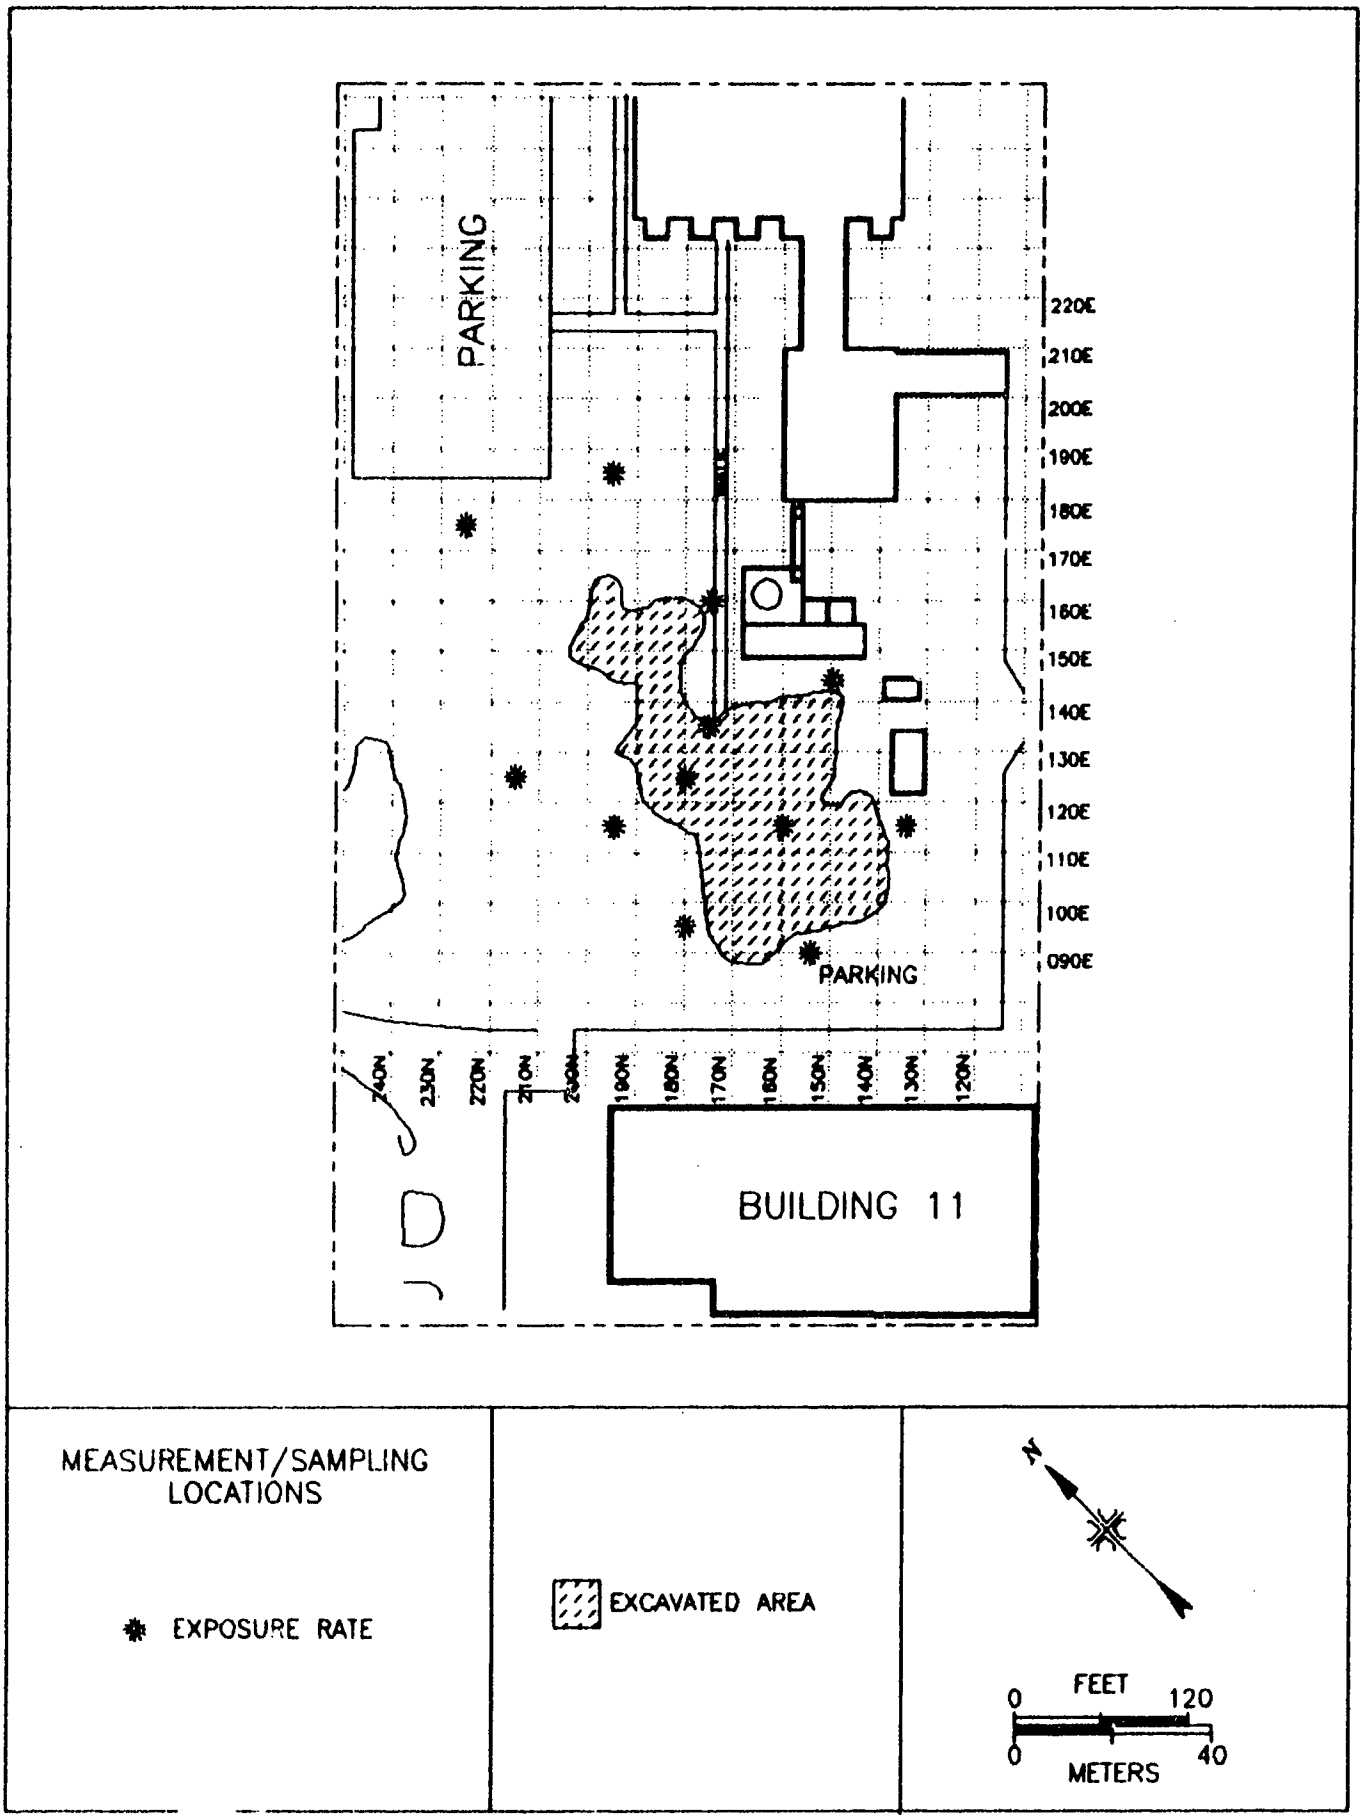
FIGURE 3: The Former Burial Site – Exposure Rate Measurement Locations

Exposure rate measurements were performed at 1 m above the surface at 12 locations, using a pressurized ionization chamber (PIC). Measurement locations are illustrated in Figure 3.

Exposure rates were all within the 10 μR/h above background criterion. The radionuclide concentrations in surface and subsurface soil samples were less than the applicable guidelines for release for unrestricted use. In ESSAP's opinion, the licensee documents provide an adequate description of the radiological condition of the facility.

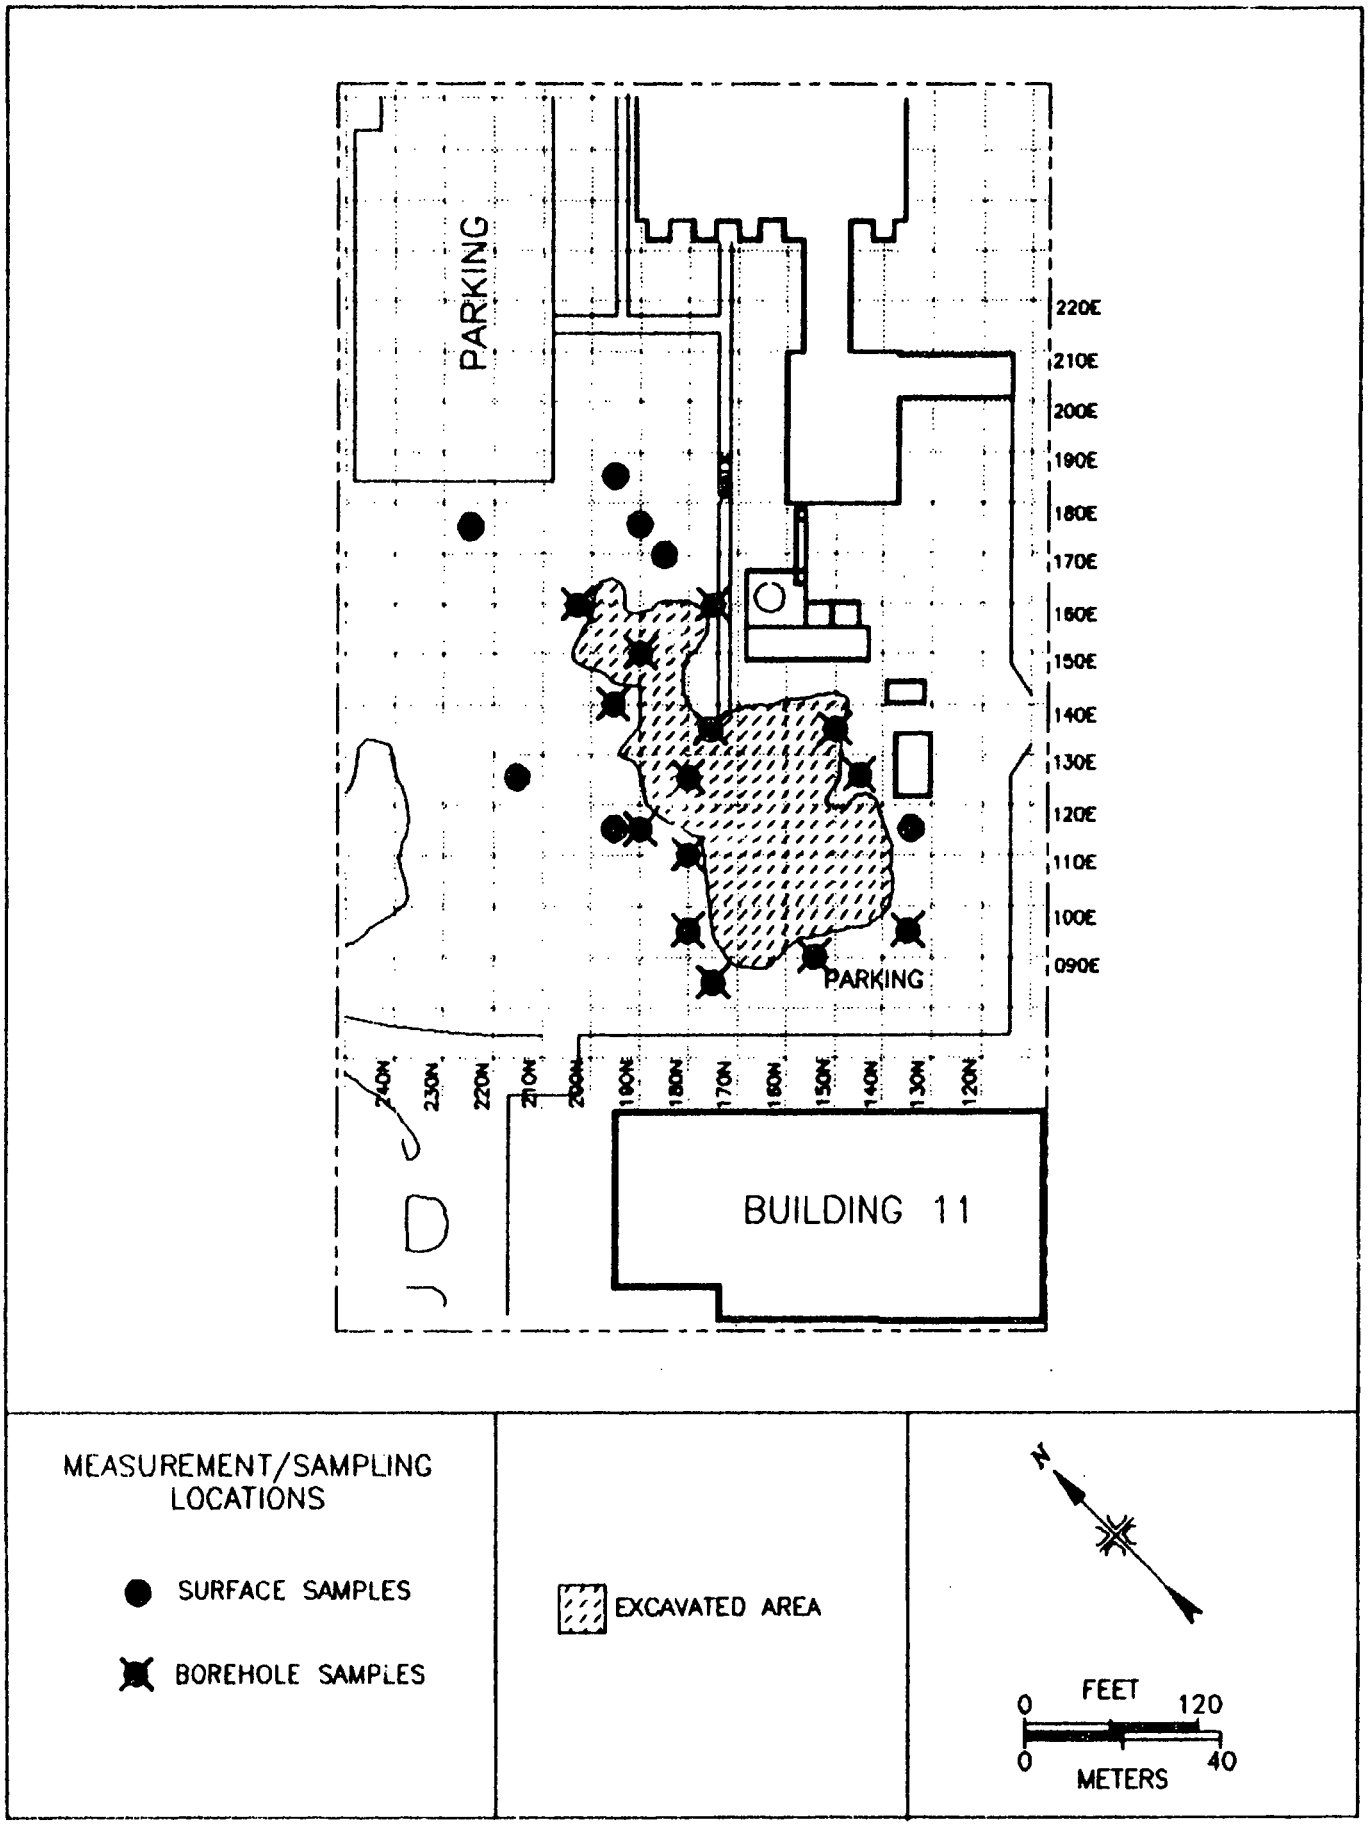
FIGURE 4: The Former Burial Site – Soil Sampling Locations

Five surface soil samples were obtained at the center of randomly selected grid blocks. In addition, two surface soil samples were collected from the area between grid coordinates 185N, 170E and 195N, 180E where the licensee had reported slightly elevated gamma radiation.[4] Sampling locations are illustrated in Figure 4.

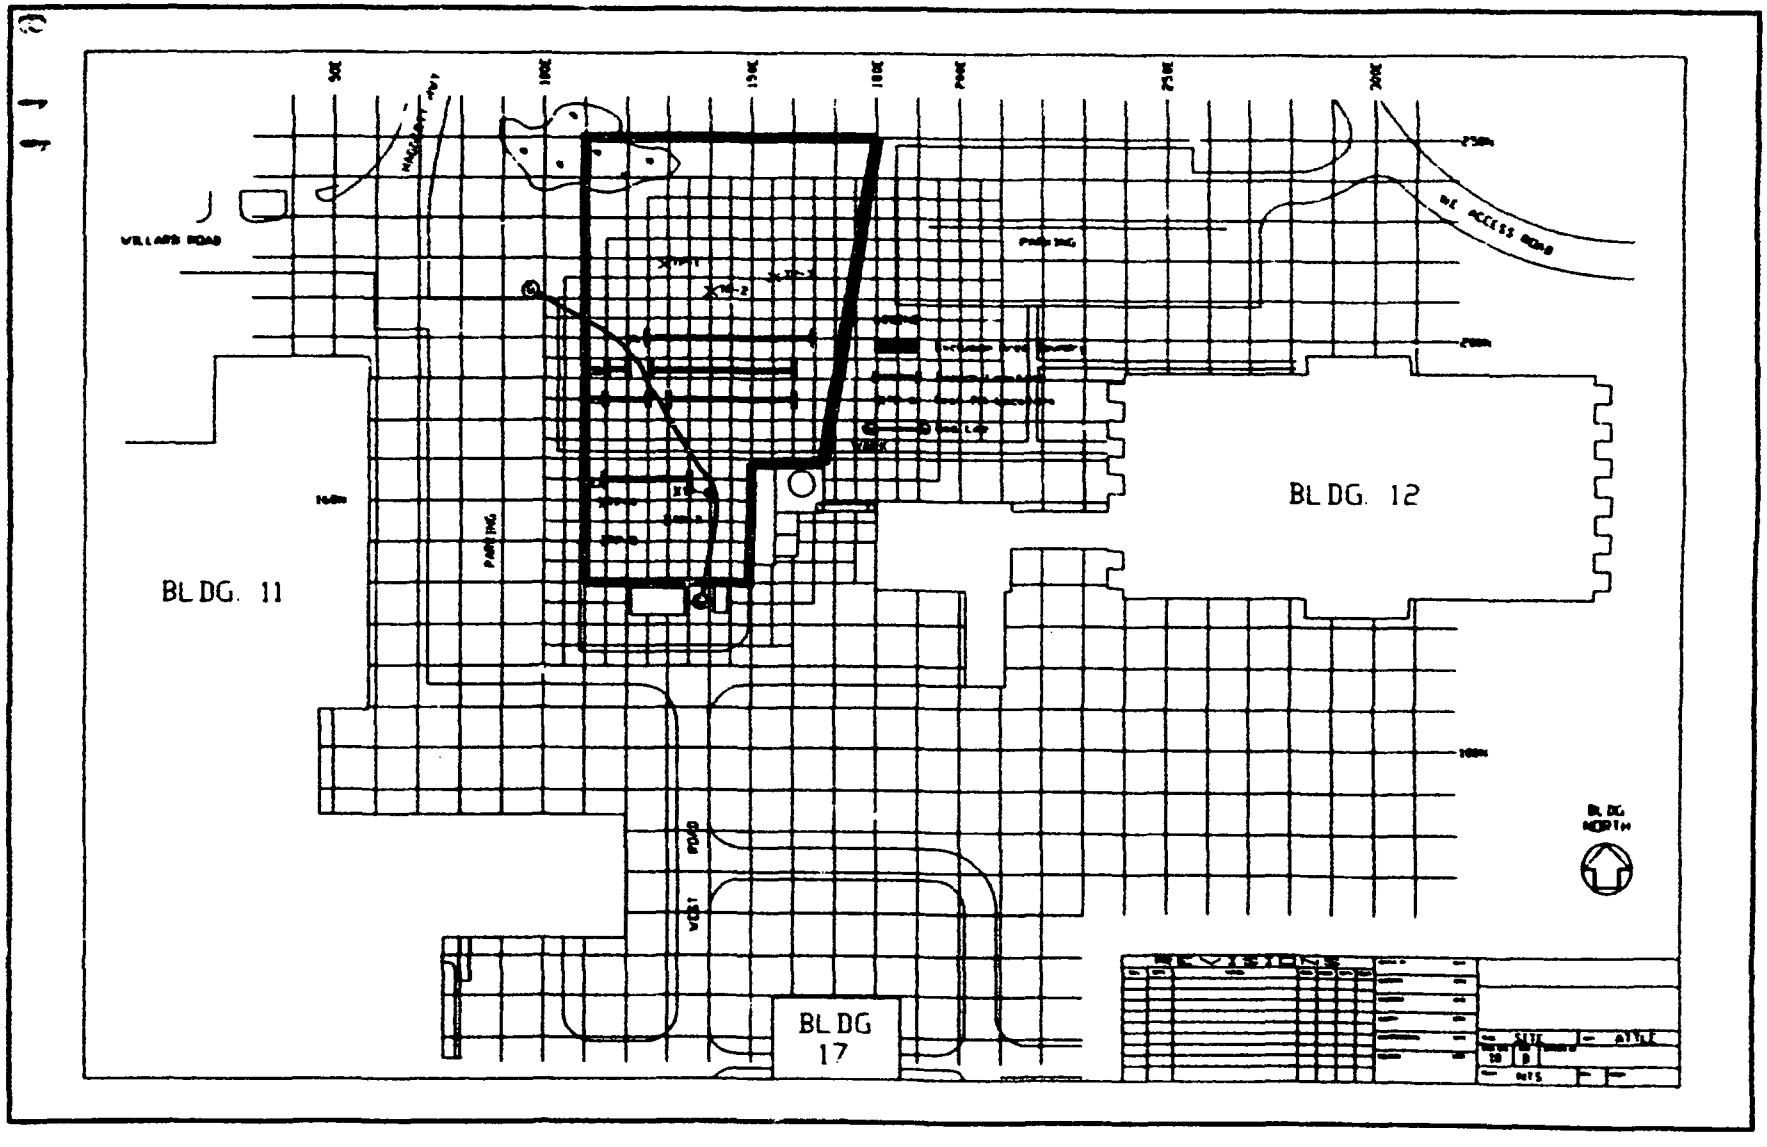
Figure 2.4
Pilot Survey Site Layout

In the pilot study a trenching scheme was used in an attempt to better determine the extent and depth of contamination. The trenches along with a few test pits were excavated in the areas shown in Figure 2.4. The concentration of total uranium in soil samples obtained during the pilot study, based on alpha screening results, ranged from 8.22 to 3349 pCi/g total uranium. Specifically the concentrations of total uranium in samples from trench A, B, C and D ranged from 9.06 to 44.88 pCi/g , 8.22 to 27.99 pCi/g , 20.34 to 84.66 pCi/g , and 14.18 to 3349 pCi/g respectively. The concentrations in samples from the test pits ranged from 11.24 to 117.63 pCi/g total uranium. The highest concentration identified was found in the "D trench" at 170N x 130E. This sample was found at approximately 3 - 4 feet depth. The high end concentrations were found in only a few samples.

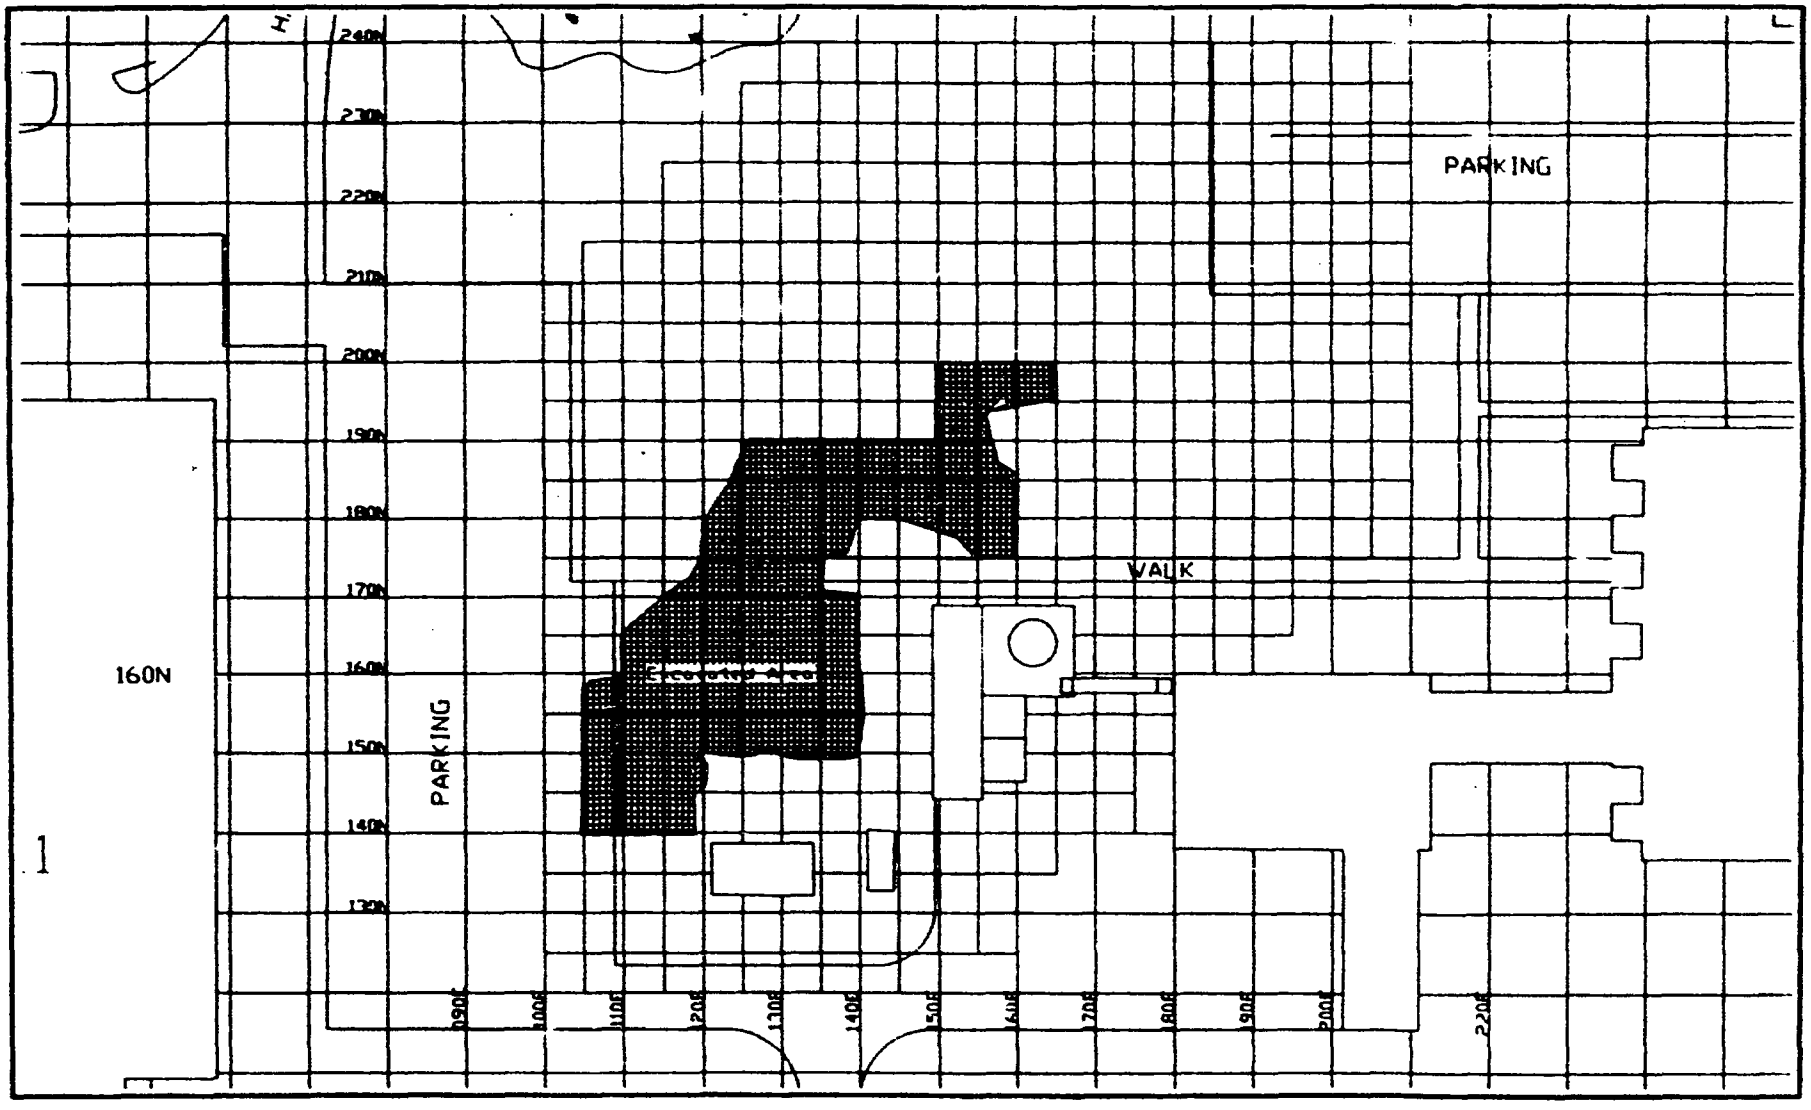
Figure 4.3
Extent of Excavation as of November 28, 1992.

On November 28, 1992, TI submitted a survey of the burial area to the NRC. This survey consisted of alpha screening results for soil samples from the floor of the excavated area and a gamma exposure rate walkover survey for the remaining areas within the defined burial area. Figure 4.3 shows the extent of the excavated area at this point.
