Causes and Significance of Design-Basis Issues at U.S. Nuclear Power Plants

U.S. Nuclear Regulatory Commission
Office Nuclear Regulatory Research
Washington, DC 20555-0001

Prepared by:
R.L. Lloyd, J.R. Boardman, S.V. Pullani

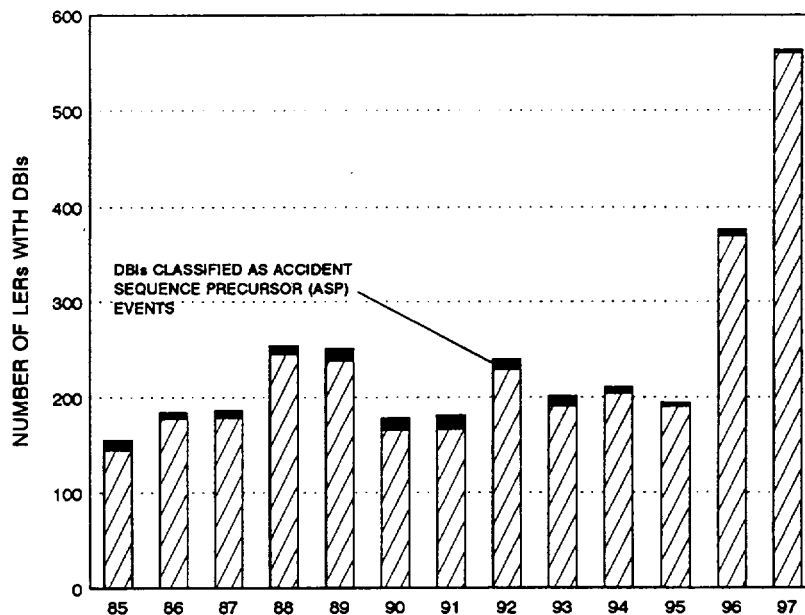
U.S. operating plants reported over 3100 LERs with DBIs during the period 1985–1997, or about 240 per year. The number of DBIs on a year-to-year basis for 1985–1997 is shown in Figure 1. The portion of DBIs that

met the ASP CCDP of at least 1×10^{-6} is shown in black for each year. From 1985–1997, LERs have identified increasing numbers of DBIs involving both trains and systems, however the majority of these DBIs have been of low safety significance from an ASP perspective.

Figure 1 Trend of design basis issues reported for 1985–1997

For 1985–1987 the number of DBIs ranged from 155–184 per year. For 1988 and 1989, the number significantly increased to 254 and 251, respectively. This increase coincided with the broad implementation, beginning in 1987, of NRC safety systems functional inspections and safety systems outage modification inspections. For 1985–1995, the number of DBIs varied between 155 and 194. There was a significant increase in DBIs in 1996 (from 194 to 377) and again in 1997 (from 377 to 563). This increase appeared to coincide with certain NRC initiatives including: NRC team

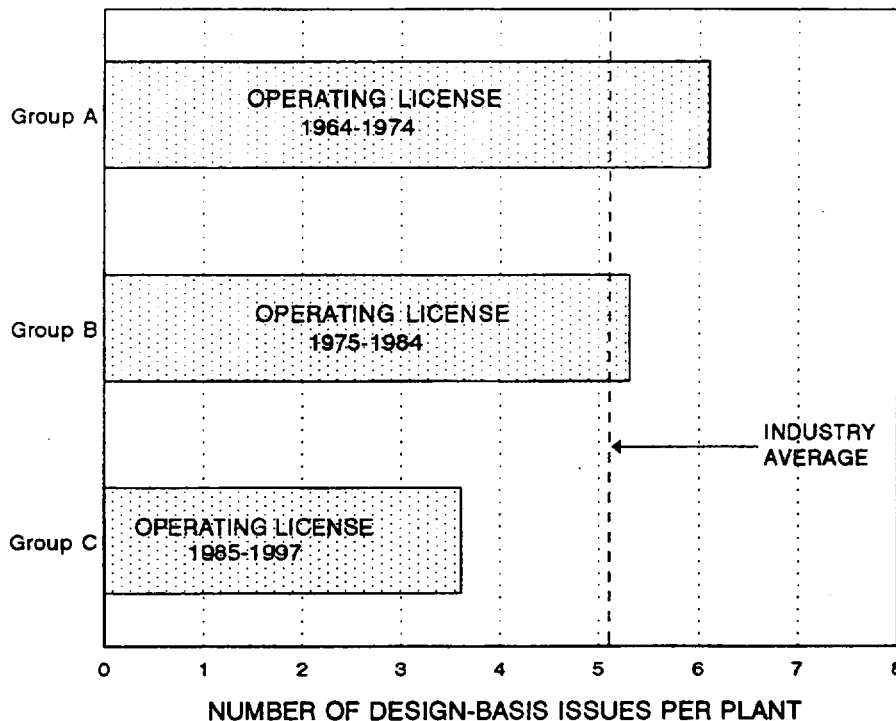
Figure 2 shows the average number of DBIs per plant for 1997 for the three age groups. Group A, B, and C plants had 6.1, 5.3, and 3.6 DBIs per plant, respectively. Older plants (group A) had significantly more DBIs per plant than the newer plants (groups B and C). The industry average was found to be 5.1 DBIs per plant.

Figure 2 Plant age and design-basis issues per plant

Analysis identified several apparent reasons for the higher number of DBIs for older plants. Apparent reasons included less rigorous design-basis information, missing design information, and differences in both computational methodologies and applicable design code criteria.

Figure 2, older plants reported significantly more DBIs than new plants during 1997. Since plants in Regions I and III include a disproportionately higher percentage of older plants, plant age appears to be a factor for the larger number of DBIs in these regions. However, another possible reason was the higher level of engineering inspection effort in these regions. The hypothesis that NRC engineering inspection effort had a direct and indirect effect on the number of DBIs reported by licensees is evaluated in Section 4.4.

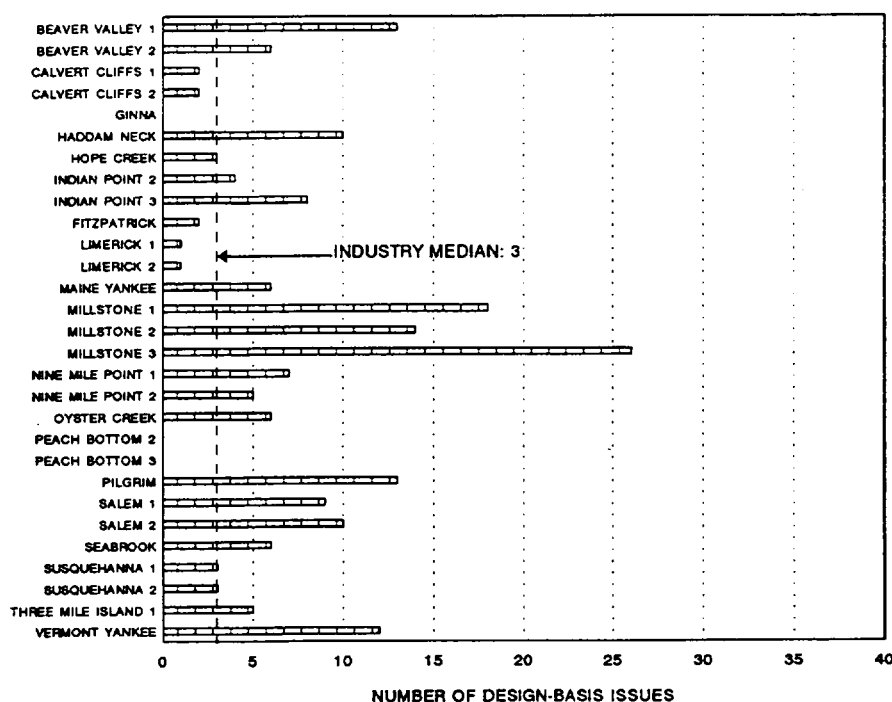
Figure 3 Region I plant distribution of design-basis issues for 1997

The number of DBIs for 1997 varied widely among plants. Figures 3 through 6 show the number of DBIs for 1997 for plants located in each of the four NRC regions. As noted earlier, in 1997 the industry average for all 110 operating plants was 5.1 DBIs per plant. In addition, the industry median was 3 DBIs per plant as shown in Figures 3 through 6. Other observations include:

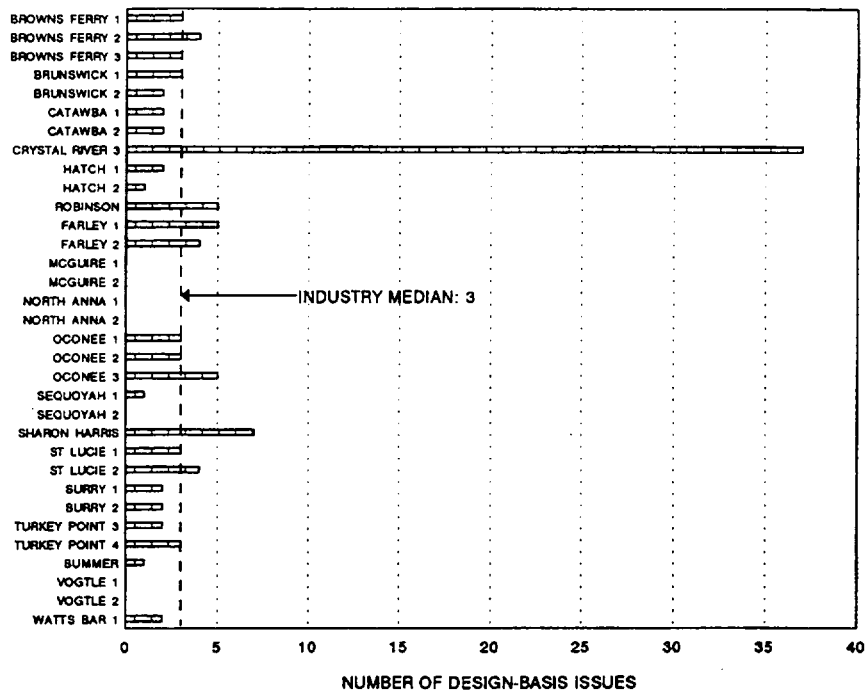
Figure 4 Region II plant distribution of design-basis issues for 1997

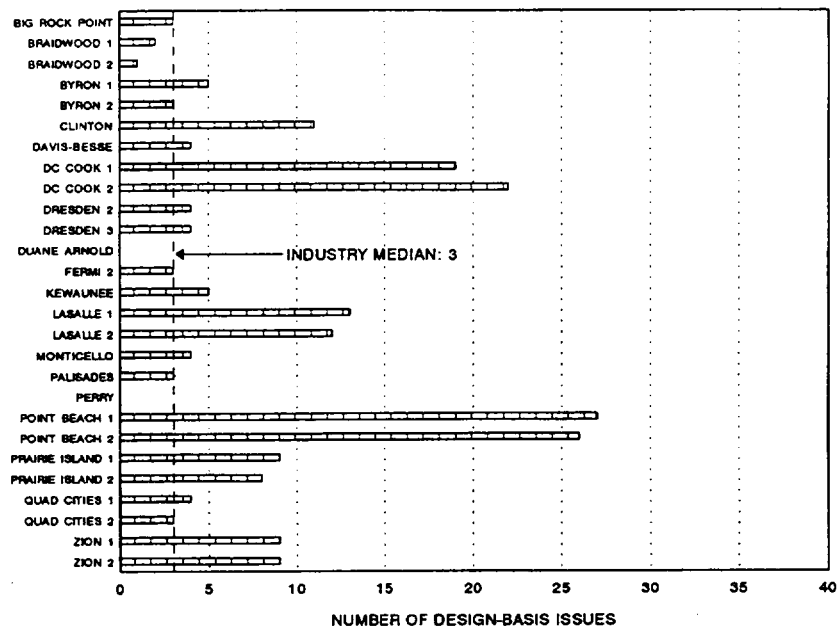
Figure 5 Region III plant distribution of design-basis issues for 1997

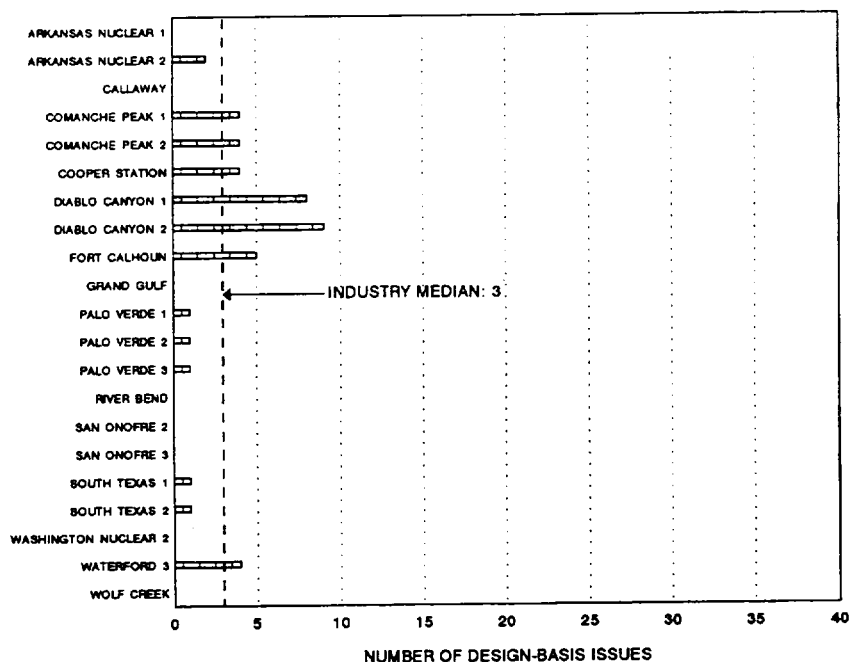
Figure 6 Region IV plant distribution of design-basis issues for 1997

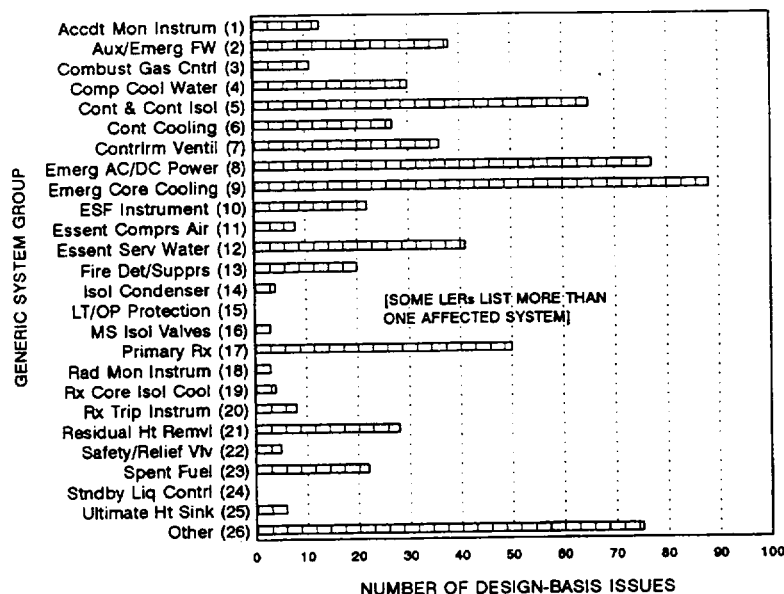
Figure 7 Distribution of design-basis issues by plant system in 1997

The DBIs reported in LERs for 1997 involved plant systems that have deterministic importance with respect to ensuring plant safety. A generic list of 26 plant system groups was used to categorize the system(s) reported in LERs. For a complete listing of systems that are listed under each group, see Appendix E. Some of the LERs reported more than one DBI, resulting in a total of 684 DBI-system counts for the 26 plant systems. Figure 7 shows the DBI count for each plant system. Analysis results (based on the 684 DBI-system counts) included the following observations:

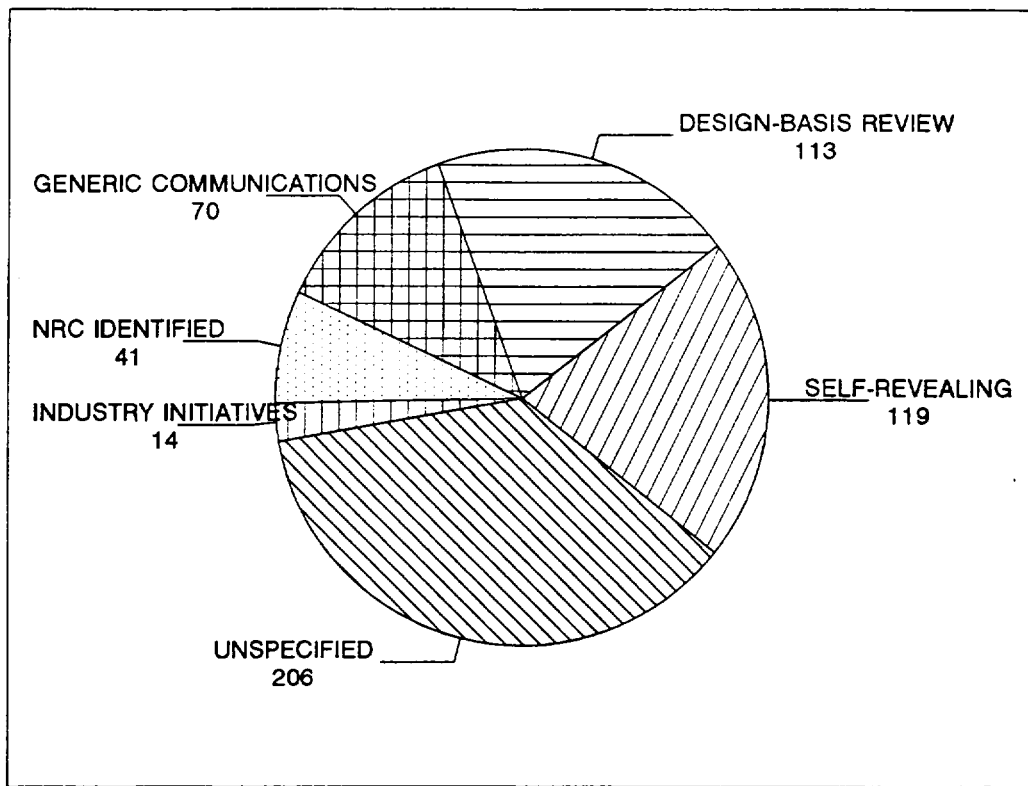
Figure 8 Activity that initiated licensee event reports with design-basis issues for 1997

A review of the 563 DBIs for 1997 identified the following six predominant initiator categories (identifying activities) as shown in Figure 8:

As shown in Figure 8, there are several initiators for DBIs, the largest category being

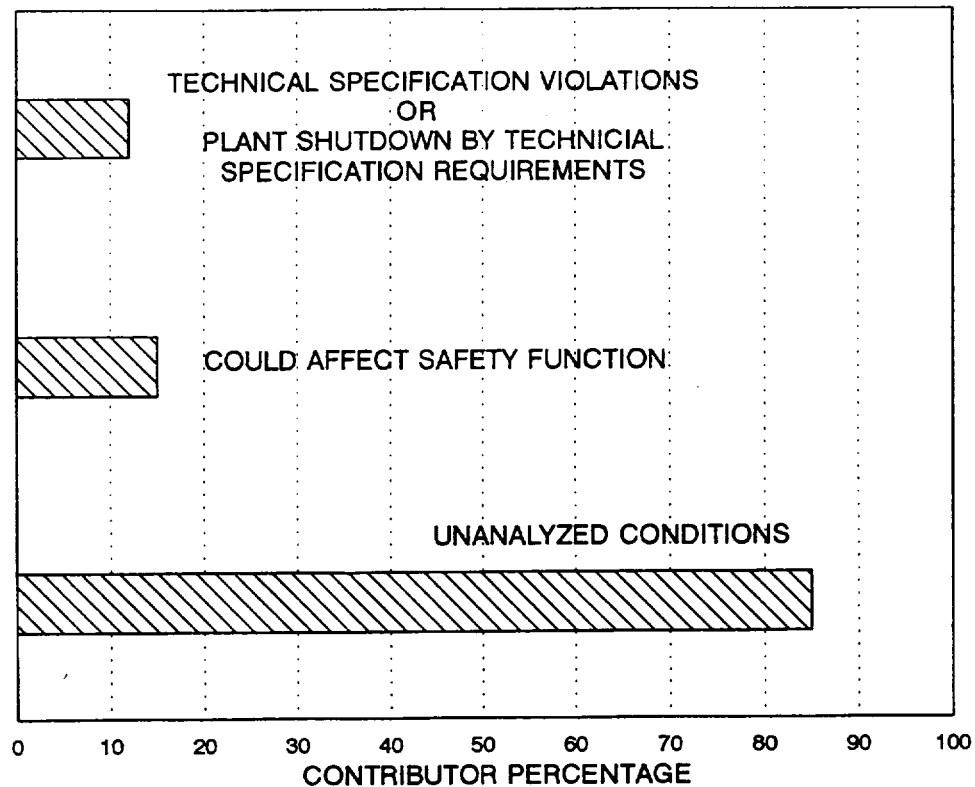
As shown in Figure 9, the most frequent reportability reason (85 percent of DBIs) was “Unanalyzed Conditions,” as required by 10 CFR 50.73(a)(2)(ii). Other significant reportability reasons were “Could Affect Safety Function” (15 percent of DBIs) [10 CFR 50.73(a)(2)(v)], and “Technical Specification Violations or Plant Shutdown by Technical Specification Requirements” (12 percent of DBIs) [10 CFR 50.73(a)(2)(v)].

Figure 9 Reportability reasons for design-basis issues for 1997

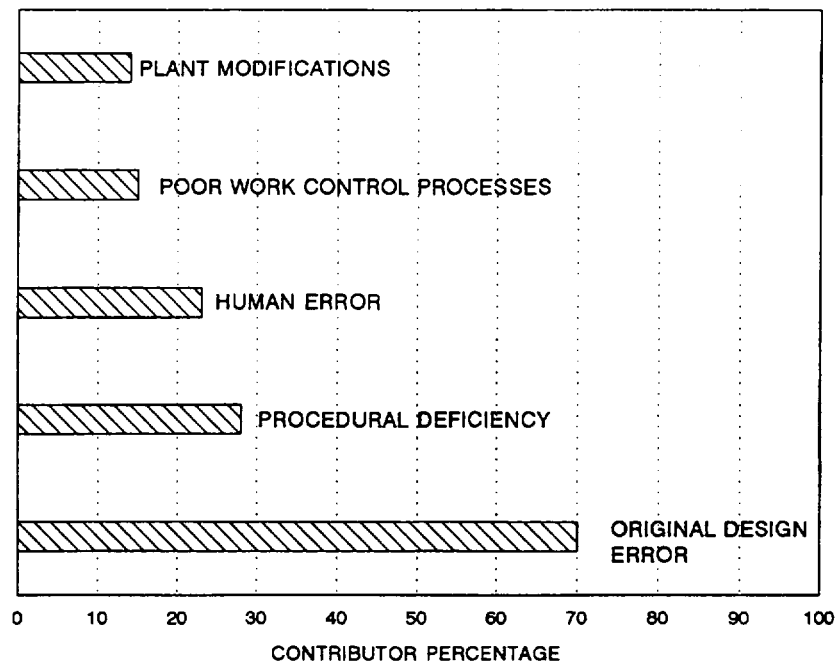
Licensees often cited multiple causes for DBIs as shown in Figure 10. As such, individual LERs with DBIs can contribute to more than one cause category. Of the 563 LERs with DBIs reported for 1997, the most frequent contributing causes included design errors dating back to the time of original licensing (70 percent), procedural deficiencies (28 percent),

human error (23 percent), poor work control practices (15 percent), and plant modifications (14 percent). Because most DBIs were reported while the plants were shut down, licensees typically stated that the risk associated with the DBI was minimal, even though in some instances, multiple trains or systems had been outside their respective design basis over several operating cycles.

Figure 10 Causes of design-basis issues for 1997

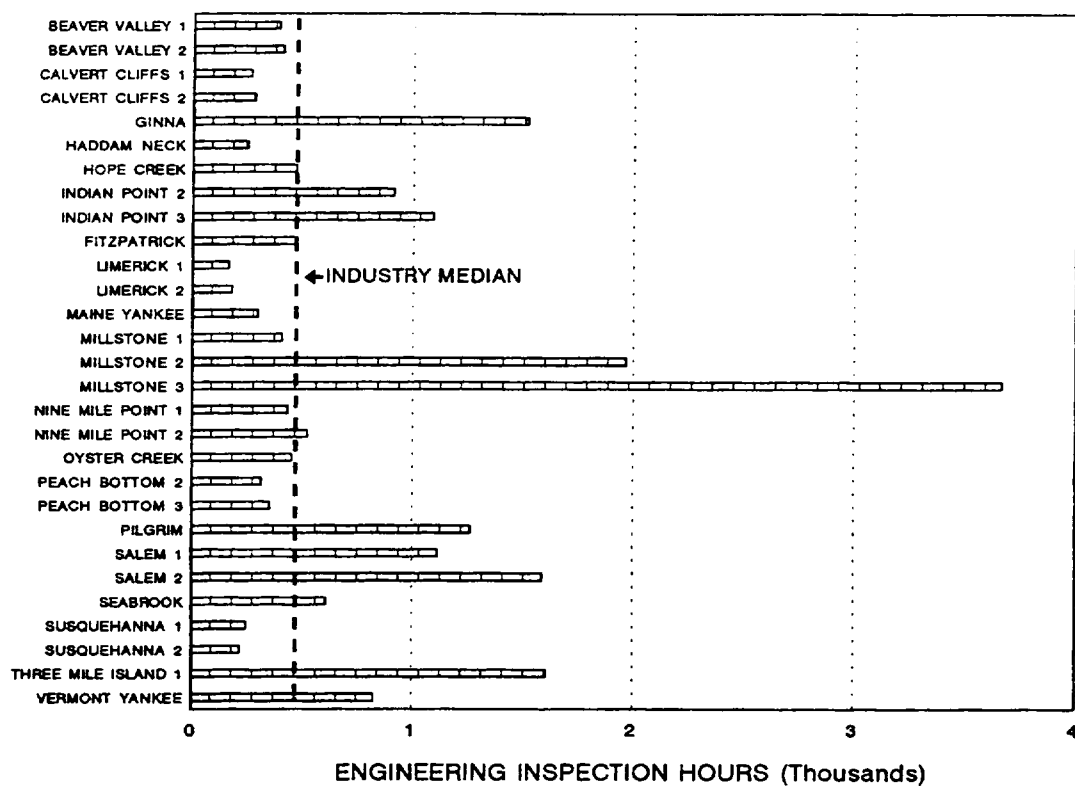
Figure 11 Engineering inspection hours vs. total inspection hours

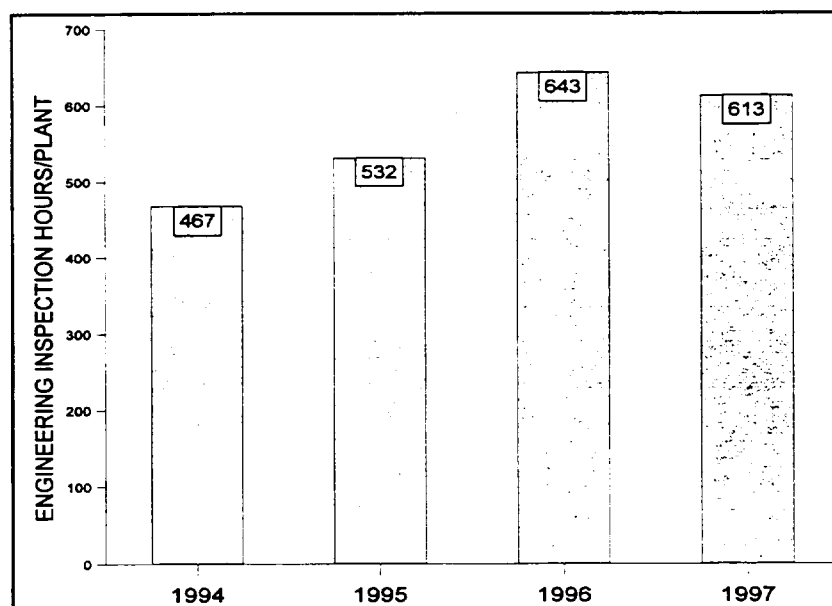
Figure 12 Trend in NRC engineering inspection hours per plants

The total number of engineering inspection hours increased from 1994 through 1996 and then decreased in 1997, largely as a result of the changes in inspection effort by Regions I and III during this period (see Figure 12). For example, Table 1 provides a listing of plants that averaged more than 1000 hours of engineering inspection effort annually for the period 1994 through 1997.

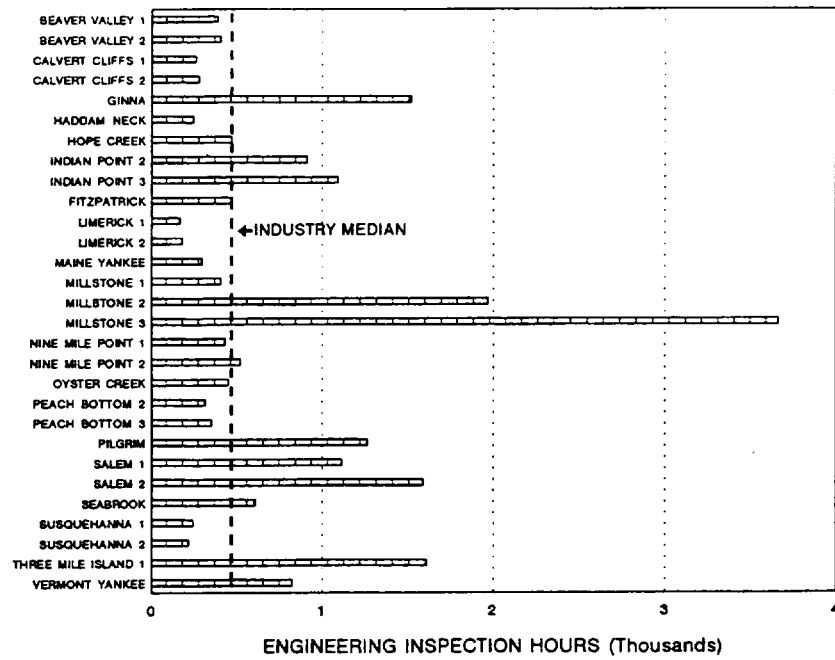
Figure 13 Region I plant engineering inspection hours for 1997

Figures 13–16 show the engineering inspection hours for each plant in Regions I–IV for 1997, respectively. The 1997 industry median and average for NRC engineering inspection hours per plant were 452 hours and 613 hours, respectively. Browns Ferry 1 (Region II) had a low of approximately 90 engineering inspection hours, while Millstone 3 (Region I) had a high of almost 3700 engineering inspection hours. As shown in

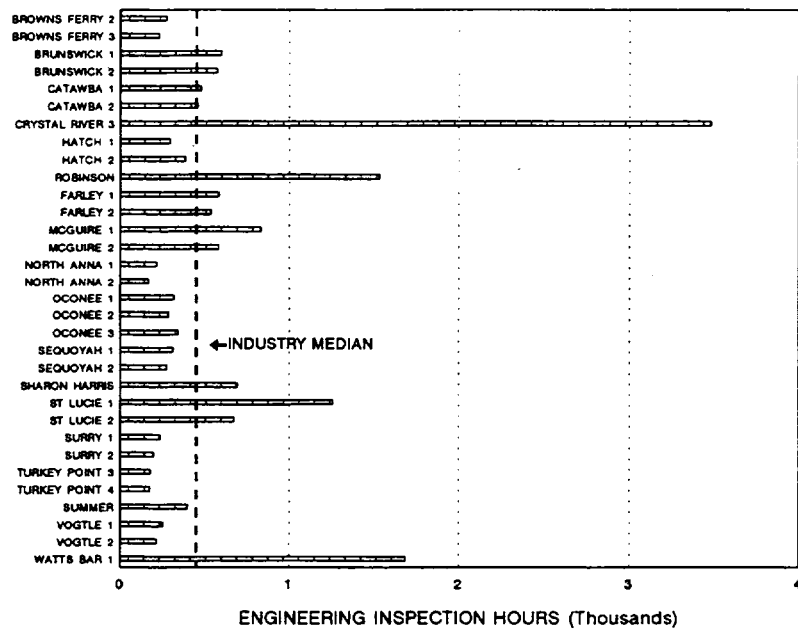
Figure 14 Region II plant engineering inspection hours for 1997

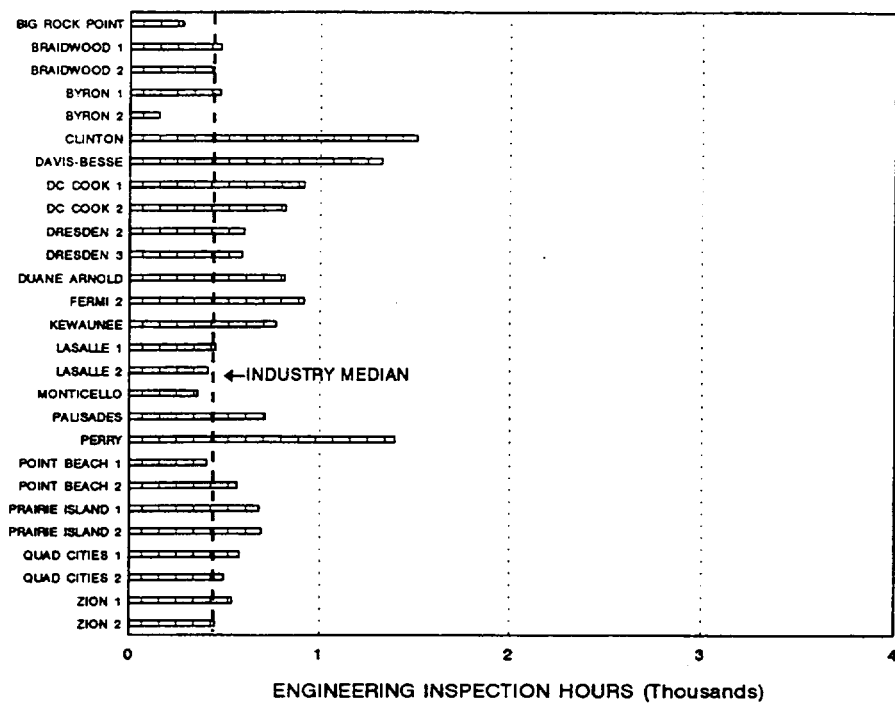
Figure 15 Region III plant engineering inspection hours for 1997

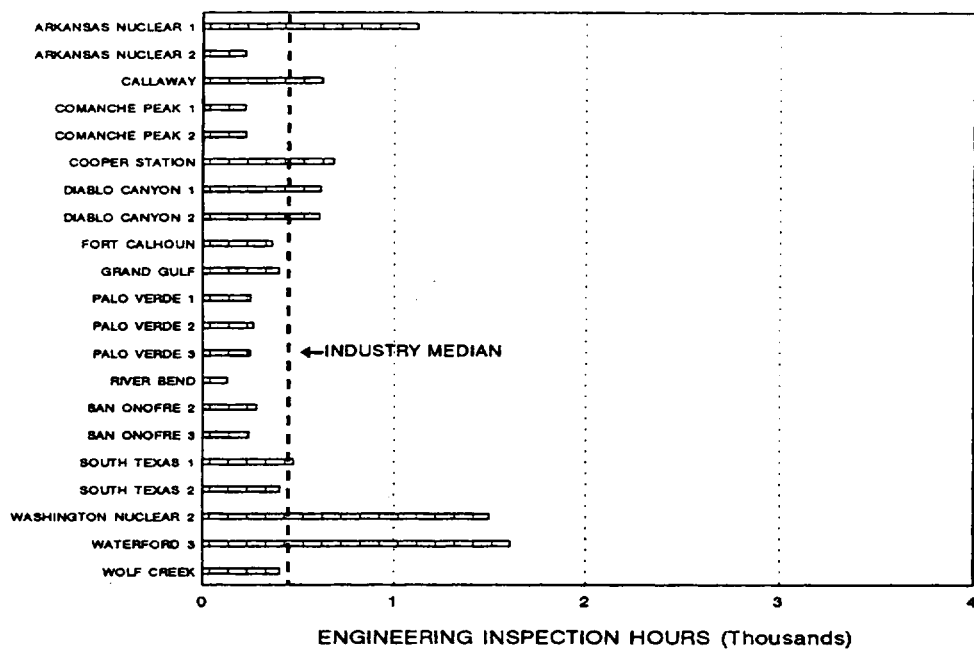
Figure 16 Region IV plant engineering inspection hours for 1997

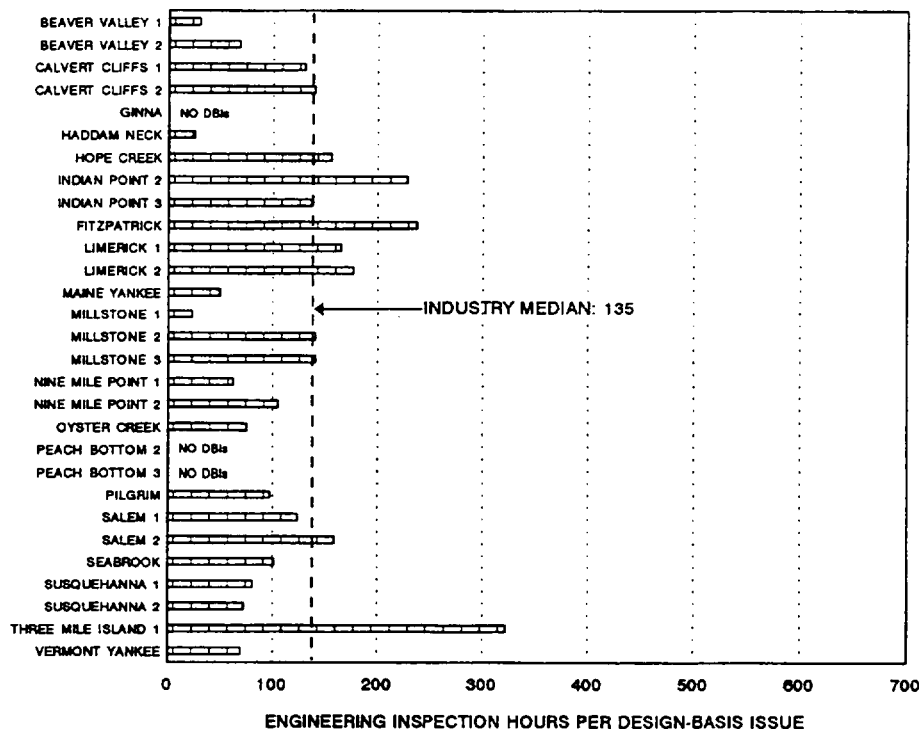
Figure 17 Region I plant engineering inspection hours per design-basis issue for 1997

Figures 17–20 show the number of engineering inspection hours per DBI for each plant during 1997 for Regions I–IV, respectively. These figures were produced using the information shown in Figures 13–16 which shows the plant-by-plant distribution of NRC engineering inspection effort (in hours) for 1997, and Figures 3–6, which shows the plant-by-plant distribution of DBIs for 1997. Dividing the inspection hours for each plant by the total number of DBIs (found from all initiators), provides the number of engineering inspection hours per DBI for each plant. The 1997 industry median for engineering inspection hours per DBI was 135.

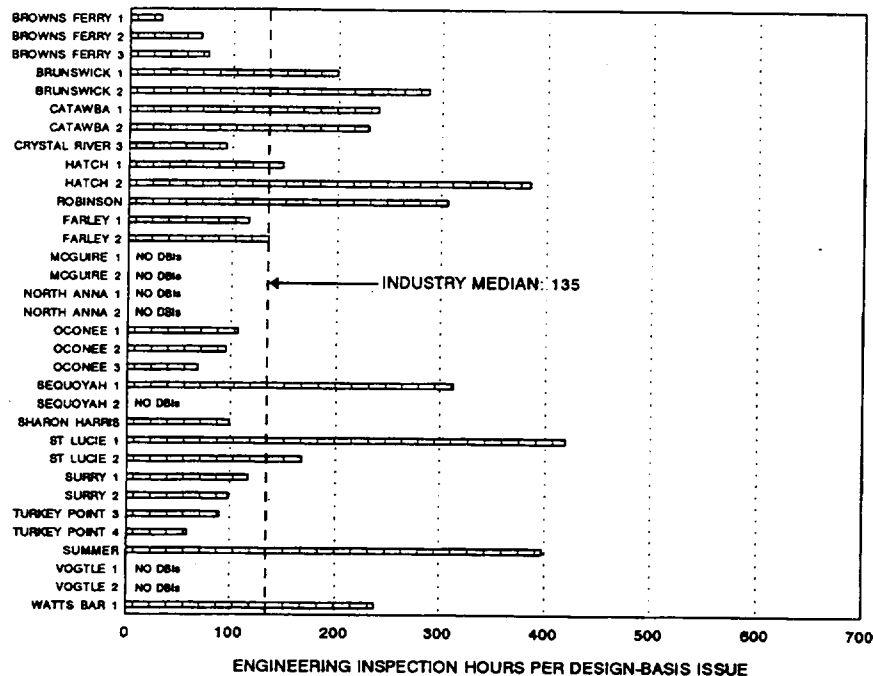
Figure 18 Region II plant engineering inspection hours per design-basis issue for 1997

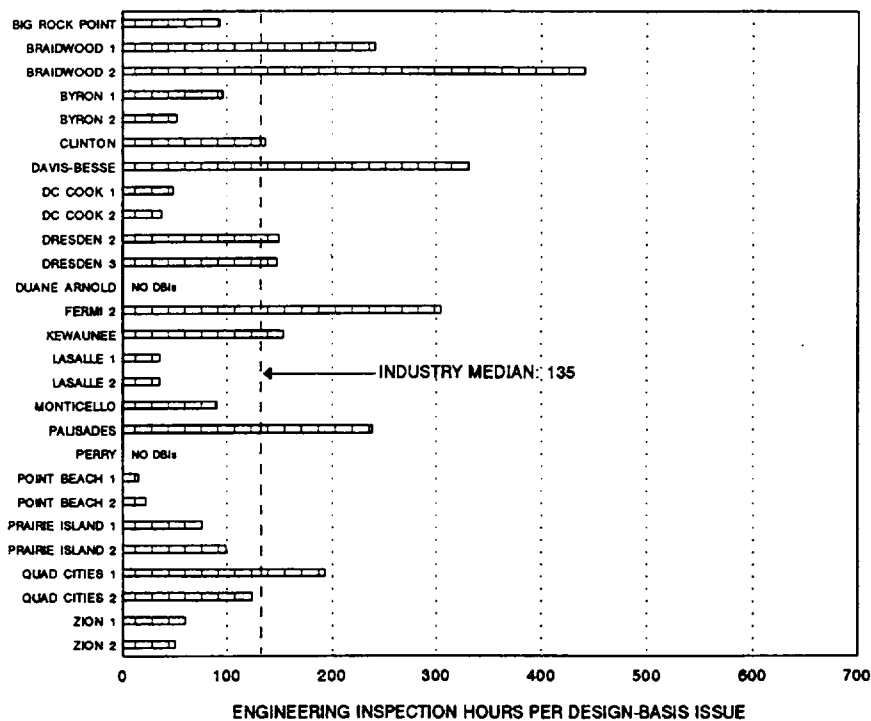
Figure 19 Region III plant engineering inspection hours per design-basis issue for 1997

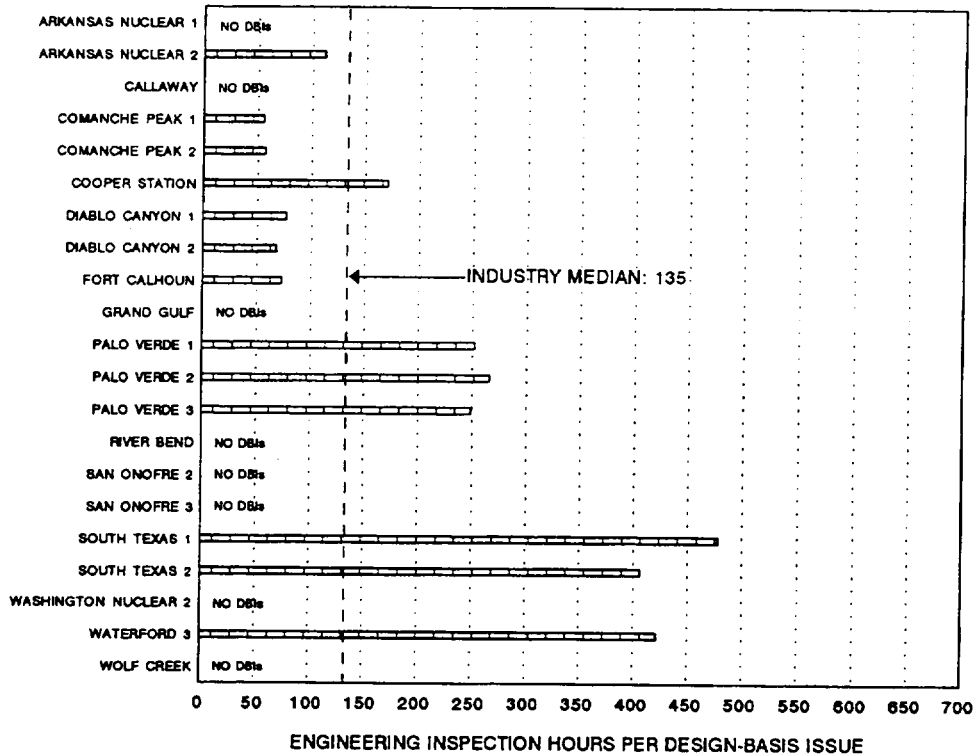
Figure 20 Region IV plant engineering inspection hours per design-basis issue for 1997

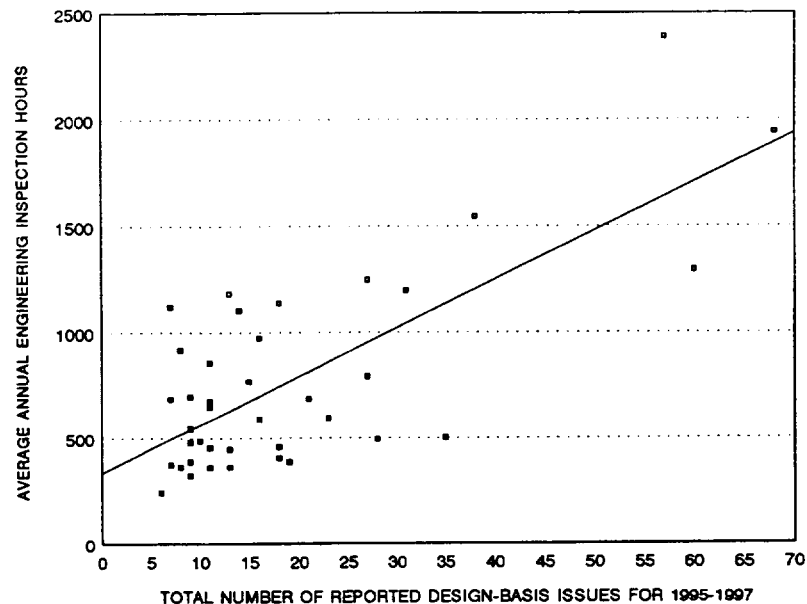
model was the value reported by the lead unit only. The data set was also truncated to remove the facilities that reported five or fewer DBIs over the three year period. The result of the regression analysis is shown in Figure 21.

Figure 21 Engineering inspection hours and design-basis issue relationship (1995–1997)

The statistical analysis results indicated that the linear relationship between the two variables had a correlation coefficient of 0.73, indicating a moderately strong relationship between the variables. The “P” value was less than 0.01, indicating a statistically significant relationship between the two variables at the 99 percent confidence level. The “R-Squared” statistic indicates that the linear model as fitted explains approximately 54 percent of the variability in the dependent variable (engineering hours expended). A “Lack-of-Fit” test was performed to determine whether the linear regression model was adequate to describe the observed data. This test indicated that the linear regression model was adequate for the observed data.

During 1995–1997, the NRC average annual number of engineering inspection hours for a plant correlated with the total number of DBIs for the plant as shown in Figure 21. Consequently, an increase in the number of

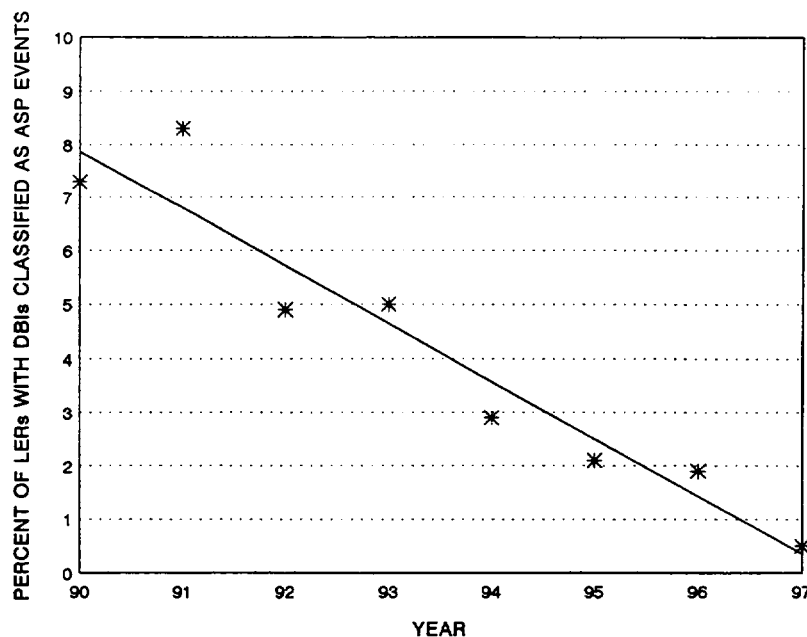
peaked at approximately 8 percent of reported DBIs, by 1997, this percentage had dropped to approximately 0.5 percent (See Figure 22). The reduction in the percentage of DBIs that are classified as ASP events may indicate that many of the most significant DBIs have been discovered through many years of design reviews and inspections. Caution should be used in extrapolating the line shown in Figure 22, since it is expected that DBIs will continue to be reported by licensees, and that some of them will be potentially safety significant.

Figure 22 Percent of licensee event reports with design-basis issues classified as accident sequence precursor events

A similar reduction in the number of ASP events can be seen when considering only LERs with DBIs. From 1992 to 1997 there was an increasing trend in the number DBIs reported in LERs, but the number which were ASP events (CCDP of at least 1×10^{-6}) generally decreased during the period. In 1991, DBIs that were classified as ASP events

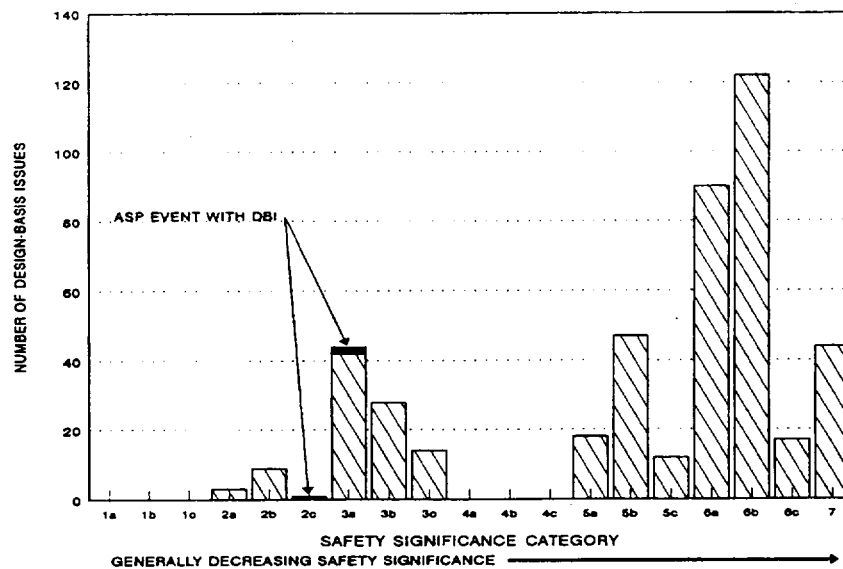
The overall results of the detailed sorting of the 449 DBIs into the 19 DBI safety significance categories is shown in Figure 23. As seen in Figure 23, during 1997 there were no Group I DBIs involving a safety demand (Category 1) for an SSC whose function was adversely impacted by the DBIs. Consequently, there were no DBIs in the category of highest safety significance. As shown in the figure, the DBIs which were ASP events in 1997 were in either Category 2 or 3. Category 2 had 13 DBIs and Category 3 had 86 DBIs. Most of the DBIs (78percent) were in Group II (Categories 4, 5, 6, and 7) where their risk significance was classified as either minimal or none.

Figure 23 Distribution of design-basis issues by safety significant category

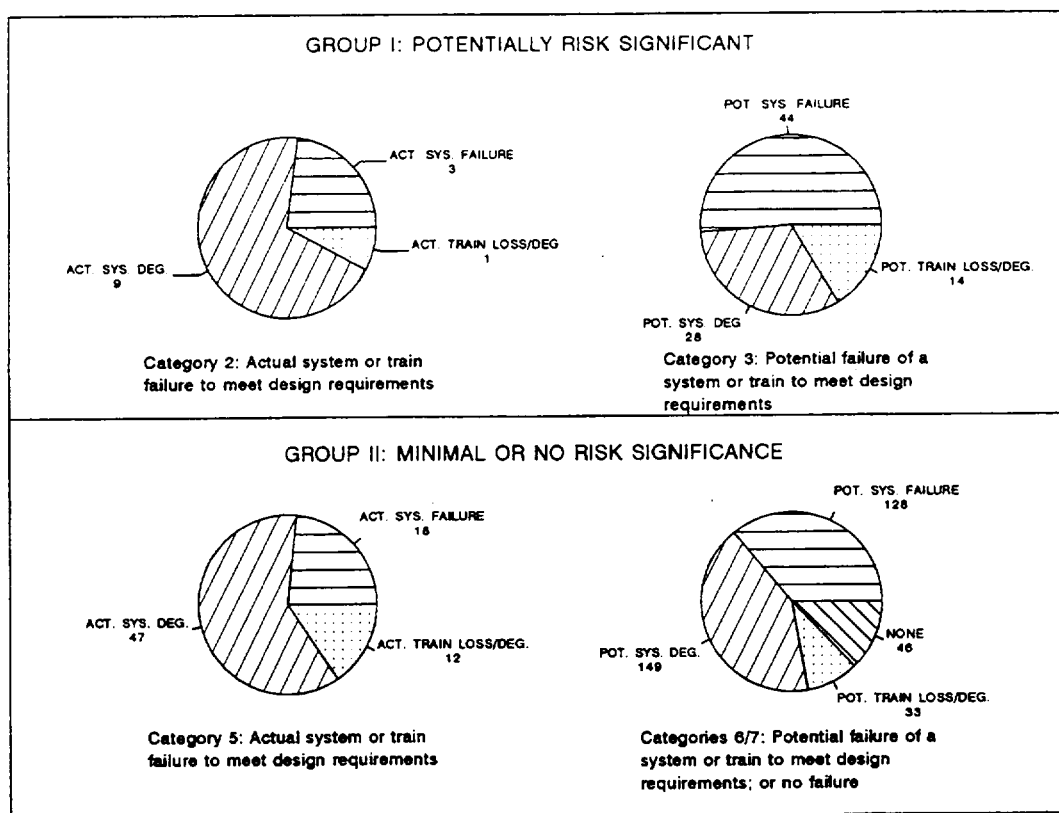
The distribution of DBIs across the safety significance categories of the simplified framework (i.e., Categories 2 and 3 in Group I;

Categories 5 and 6/7 in Group II) are shown in Figure 24.

Figure 24 Distribution of Group I and Group II design basis issues

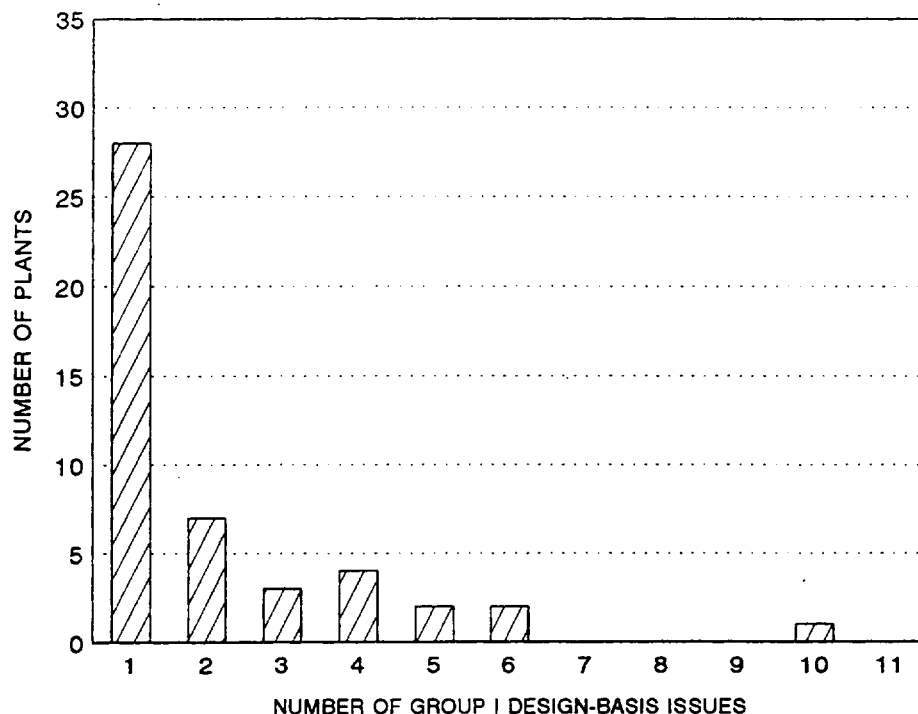
number of Group I DBIs for 1997 is shown in Figure 25. About 57 percent of the plants (63) had no Group I DBIs while about 28 percent had only one Group I DBI (28 plants). Crystal River 3 had the greatest number of Group I DBIs at 10.

Figure 25 Plant distribution of Group I design-basis issues

As noted in Section 6.2, there were 99 Group I DBIs. These DBIs were reported at 47 of the 110 licensed operating nuclear power plants. The distribution of number of plants vs the

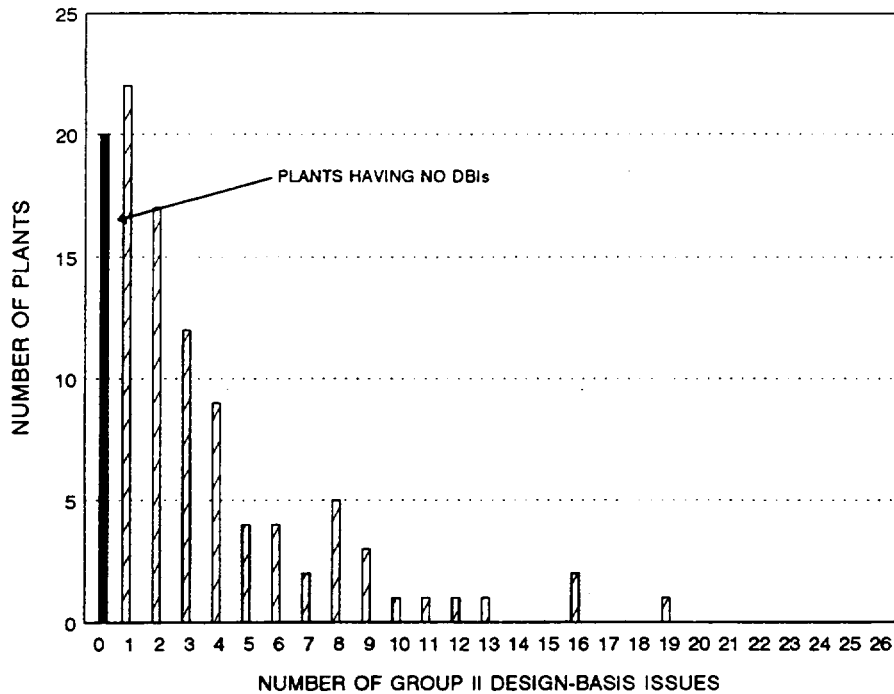
Figure 26 shows the distribution of the number of plants with varying numbers of Group II DBIs. For 1997, out of the 449 DBIs analyzed, 350 DBIs were of minimal risk or no risk significance (Group II). These 350 Group II DBIs involved 85 different plants. A total of 20 plants had no DBIs during 1997. The most frequent number of Group II DBIs submitted by a plant was one, which occurred at 22 plants.

However, in 1997, 17 plants submitted from 7 to 19 Group II DBIs involving minimal risk or no risk significance - an average of about 10 LERs with minimal or no risk significant DBIs per plant. As shown in Figure 26, a significant number of plants reported a relatively large number of LERs with DBIs having minimal or no risk significance, indicating that the LER rule in effect at the time was not effective in discriminating (screening out) the reporting of DBIs having minimal or no risk significance.

Figure 26 Plant distribution Group II design-basis issues

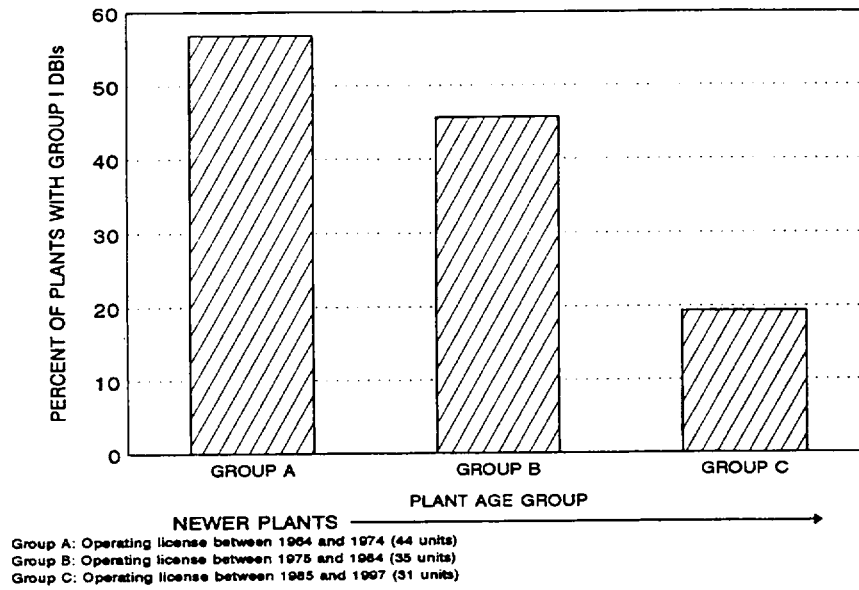
For 1997, as shown in Figure 27, “older” plants generally had a higher percentage of Group I DBIs than plants of “medium” age or the “newer” plants. This result is similar to the relative distribution shown in Figure 2 which shows that plants in Group C (operating license between 1985 and 1997) had much fewer DBIs per plant than plants in Group A (operating license between 1964 and 1974). For example, for 1997, the approximate percentage of plants with Group I DBIs for plants in plant age Groups A, B, and C was 57 percent, 46, percent and 19 percent. The apparent reasons for the difference included: generally lower quality, completeness and accessibility of plant design basis information at older plants. The impact of NRC engineering inspection in Regions I and III (which have more older plants) compared to Region II and IV plants was also considered a factor.

Figure 27 Group I design-basis issues by plant age

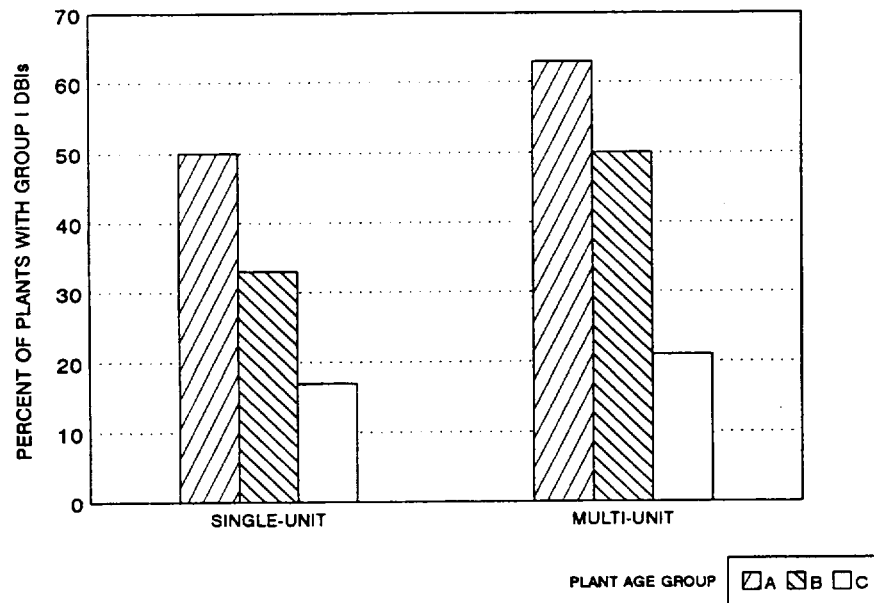
As shown in Figure 28, for 1997, plants associated with multi-unit sites had a higher percentage of Group I DBIs than did single-unit sites. Shared systems was believed to be the major reason for the higher percentage of Group I DBIs for these sites. In addition, plant age was also a factor for both single and multi-unit sites, in that older plants, whether single or multi-unit had a greater percentage of Group I DBIs than did newer plants. The percentage of plants associated with single-unit sites that had at least one Group I DBI was 50, 33, and 17 for plant age groups A, B, and C respectively, whereas, for multi-unit sites that had at least one Group I DBI, the percentage was 63, 50, and 21 for plant age groups A, B, and C respectively. Plant age group A represents older licensing dates (plant licensed before 1974), and group C represents the newer licensing dates (plants licensed after 1984). See Section 3.2.1 for plant age group definition.

Figure 28 Percentage of single-unit and multi-unit plants with Group I design-basis issues

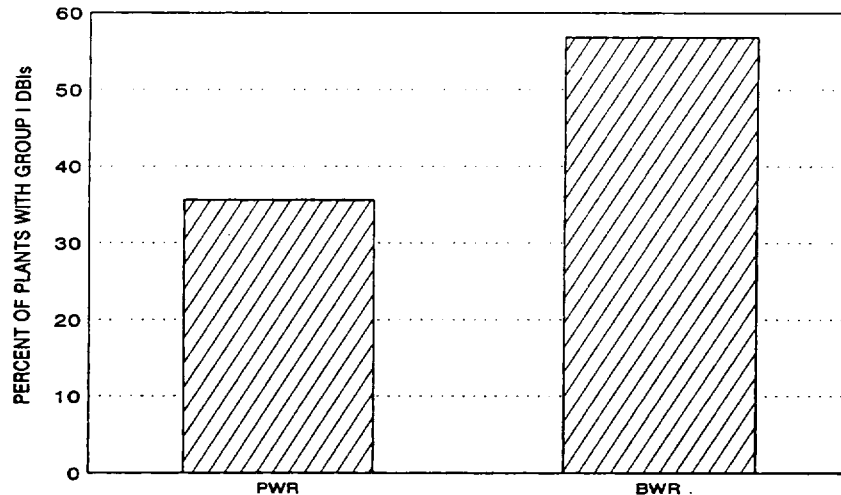
Boiling water reactors had a higher percentage of Group I DBI than PWRs as shown in Figure 29. For BWRs, about 57 percent had at least one

Group I DBI, while for PWRs, about 36 percent had at least one Group I DBI. Although for 1997, BWRs had a higher percentage of Group I DBIs than PWRs, from an ASP perspective, all of the ASP events in 1997 involving DBIs occurred at PWRs.

Figure 29 Group I design-basis issues for boiling-water reactors and pressurized water reactors

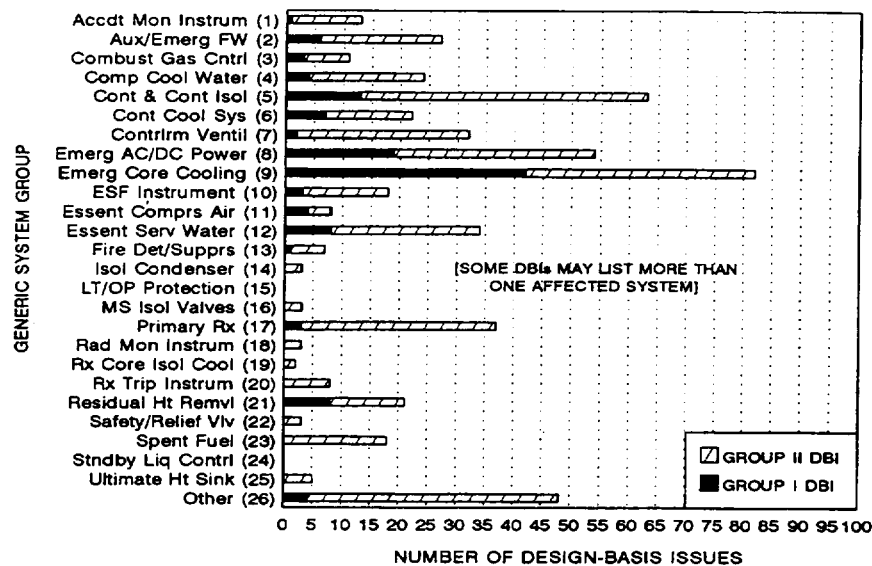
Figure 30 Group I and Group II design-basis issues by plant system

For 1997, each Group I DBI (99 total) and Group II DBI (350 total) was sorted into the generic plant systems listed in Appendix E*. For each Group I DBI, only the system that was determined to be important to risk as discussed in the LER was included, resulting in 99 DBI-systems affected. For Group II DBIs, up to two systems may have been associated with each DBIs, which resulted in 418 DBI-systems. The analysis results shown in Figure 30 indicate that relatively few systems disproportionately accounted for the Group I

DBIs. Three plant systems accounted for approximately 58 percent of the Group I DBIs - ECCS (33 percent), and emergency ac/dc power (15 percent), and containment and containment isolation (10 percent). The auxiliary/emergency feedwater system, which is generally considered a very risk significant system, had a total of 27 DBIs, however only six were classified as Group I. This may indicate that many of the risk significant DBIs for this system have been previously discovered and corrected through intensive licensee and NRC design reviews and inspections.

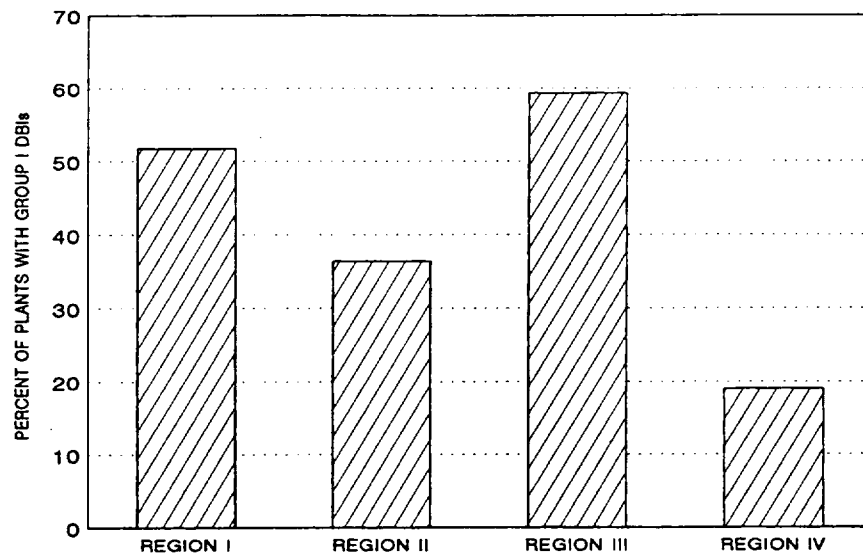
Figure 31 Regional distribution of Group I design-basis issues

For 1997, plants in Regions I and III had reported the largest number of Group I DBIs (35 and 36 respectively), while plants in Regions II and IV reported the fewest number of Group I DBIs (22 and 6 respectively). Figure 31 shows the percentage of plants in each region that had at least one Group I DBI. As shown in the figure, Region III had the highest percentage of plants with at least one Group I
