**DOCKET NUMBER 50-483  
UNION ELECTRIC COMPANY  
CALLAWAY PLANT  
"RESPONSE TO NRC REVIEWER TELECON QUESTIONS  
REGARDING INSTALLATION OF AUTOMATIC LOAD TAP  
CHANGING TRANSFORMERS TO PROVIDE OFFSITE POWER  
TO THE SAFETY RELATED ELECTRICAL BUSSES"**

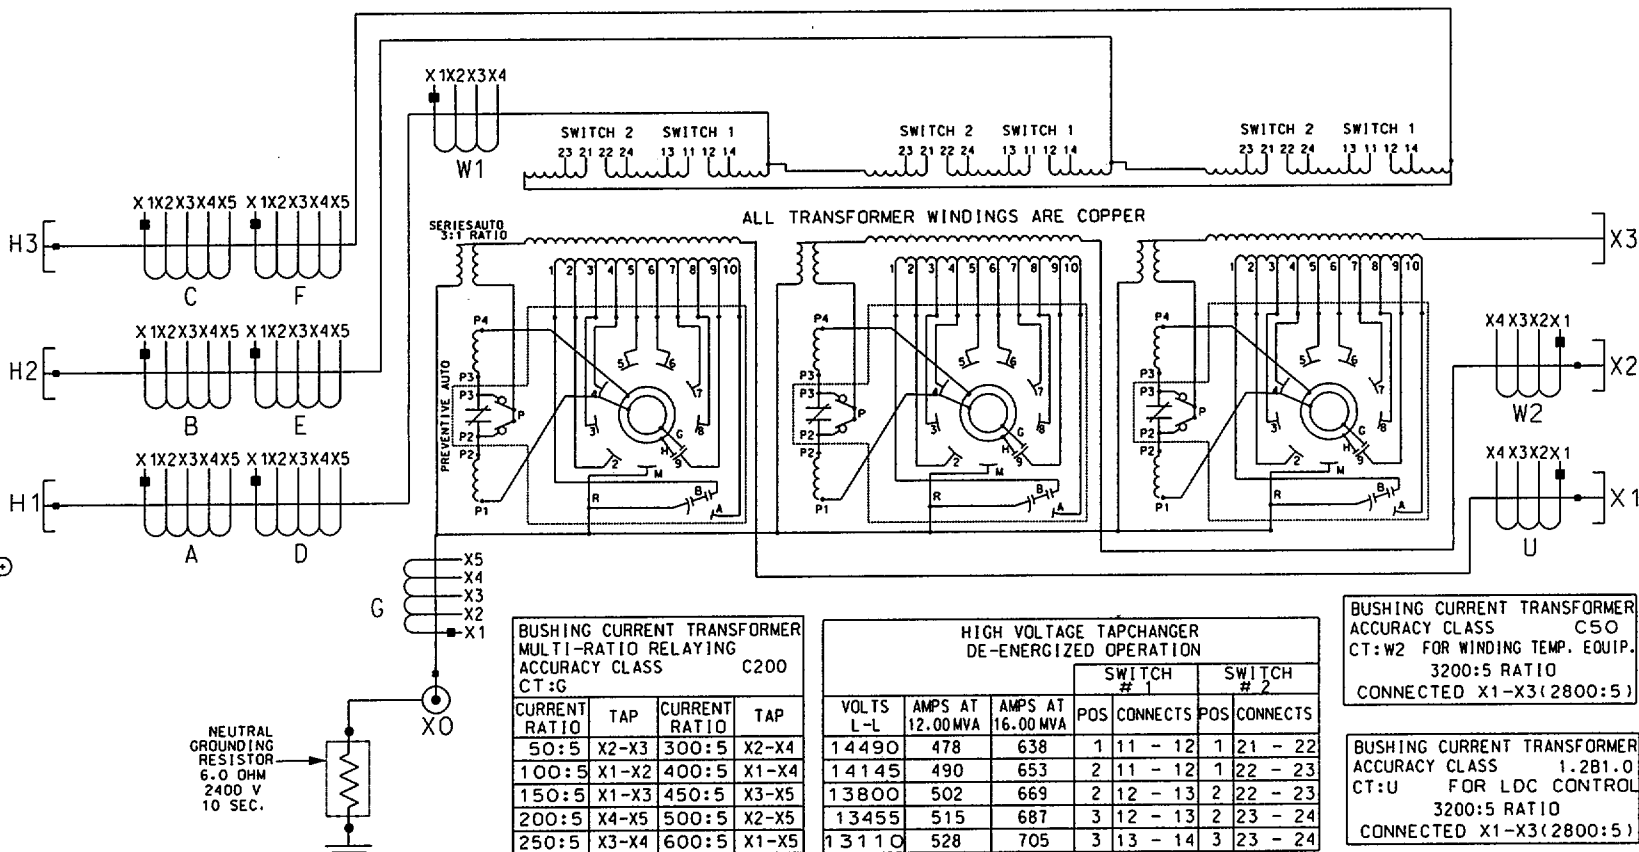
BUSHING CURRENT TRANSFORMER MULTI-RATIO RELAYING ACCURACY CLASS C400 CT: A.B.C.D.E.F			
CURRENT RATIO	TAP	CURRENT RATIO	TAP
100:5	X2-X3	600:5	X2-X4
200:5	X1-X2	800:5	X1-X4
300:5	X1-X3	900:5	X3-X5
400:5	X4-X5	1000:5	X2-X5
500:5	X3-X4	1200:5	X1-X5

BUSHING CURRENT TRANSFORMER  
ACCURACY CLASS C50  
CT: W1 FOR WINDING TEMP. EQUIP.  
1300:5 RATIO  
CONNECTED X2-X3 (1000:5)

BUSHING CURRENT TRANSFORMER MULTI-RATIO RELAYING ACCURACY CLASS C200 CT: G			
CURRENT RATIO	TAP	CURRENT RATIO	TAP
50:5	X2-X3	300:5	X2-X4
100:5	X1-X2	400:5	X1-X4
150:5	X1-X3	450:5	X3-X5
200:5	X4-X5	500:5	X2-X5
250:5	X3-X4	600:5	X1-X5

HIGH VOLTAGE TAPCHANGER DE-ENERGIZED OPERATION			
VOLTS L-L	AMPS AT 12.00 MVA	AMPS AT 16.00 MVA	SWITCH #1 POS CONNECTS
14490	478	638	1 11 - 12
14145	490	653	2 11 - 12
13800	502	669	2 12 - 13
13455	515	687	3 12 - 13
13110	528	705	3 13 - 14
