POST REMEDIATION
URANIUM CONTAMINATION CONCENTRATION CONTOUR PLOT

TEXAS INSTRUMENTS INCORPORATED

Attleboro, Massachusetts

CONFIRMATORY SURVEY OF THE TEXAS INSTRUMENTS, INC. FORMER BURIAL SITE ATTLEBORO, MASSACHUSETTS

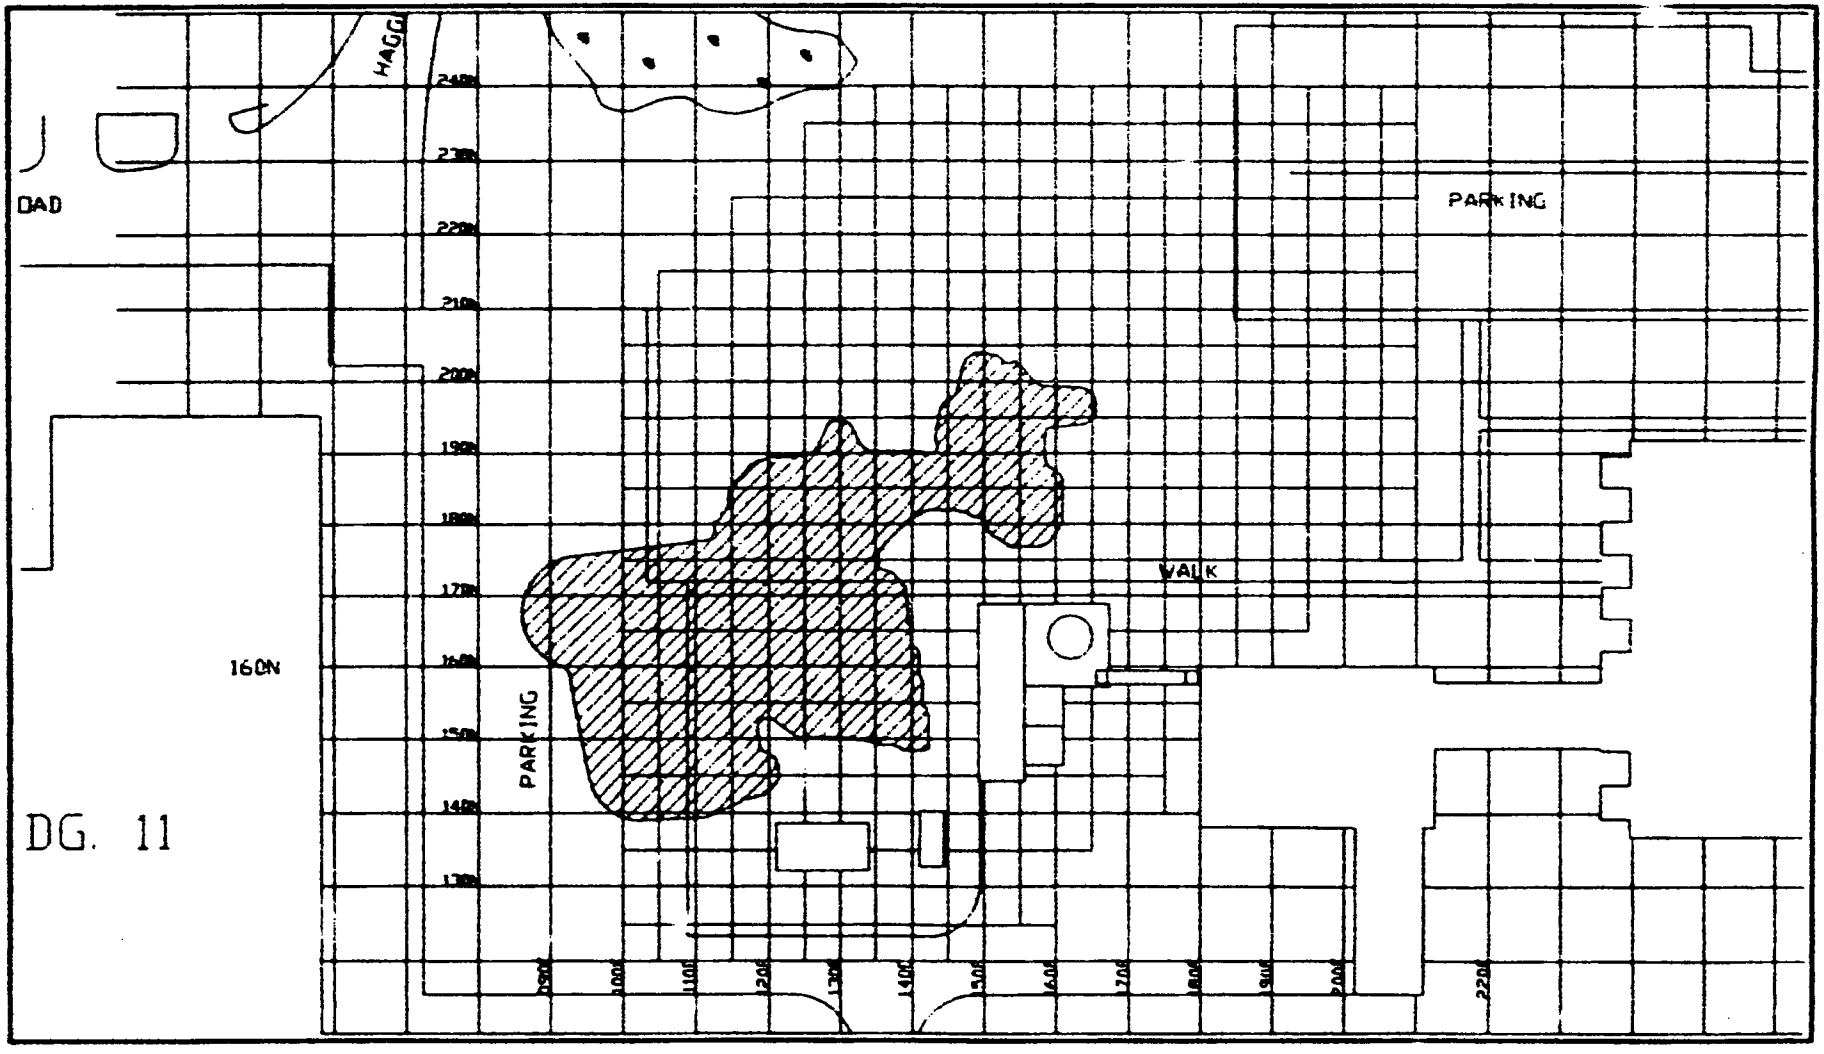
Figure 4.4
Final Site Excavation

From December 15, 1992 to January 5, 1993, the bounds of the excavation were extended in accordance with the NRC recommendations. The bounds of the excavation were extended in locations where the NaI readings, on the accessible portion of the wall, were greater than two times background. Subsurface split spoon soil samples were taken to demonstrate that the excavation had been appropriately extended. As shown in Figure 4.4, the excavation extended beyond the original exclusion zone and into the building 11 parking lot.

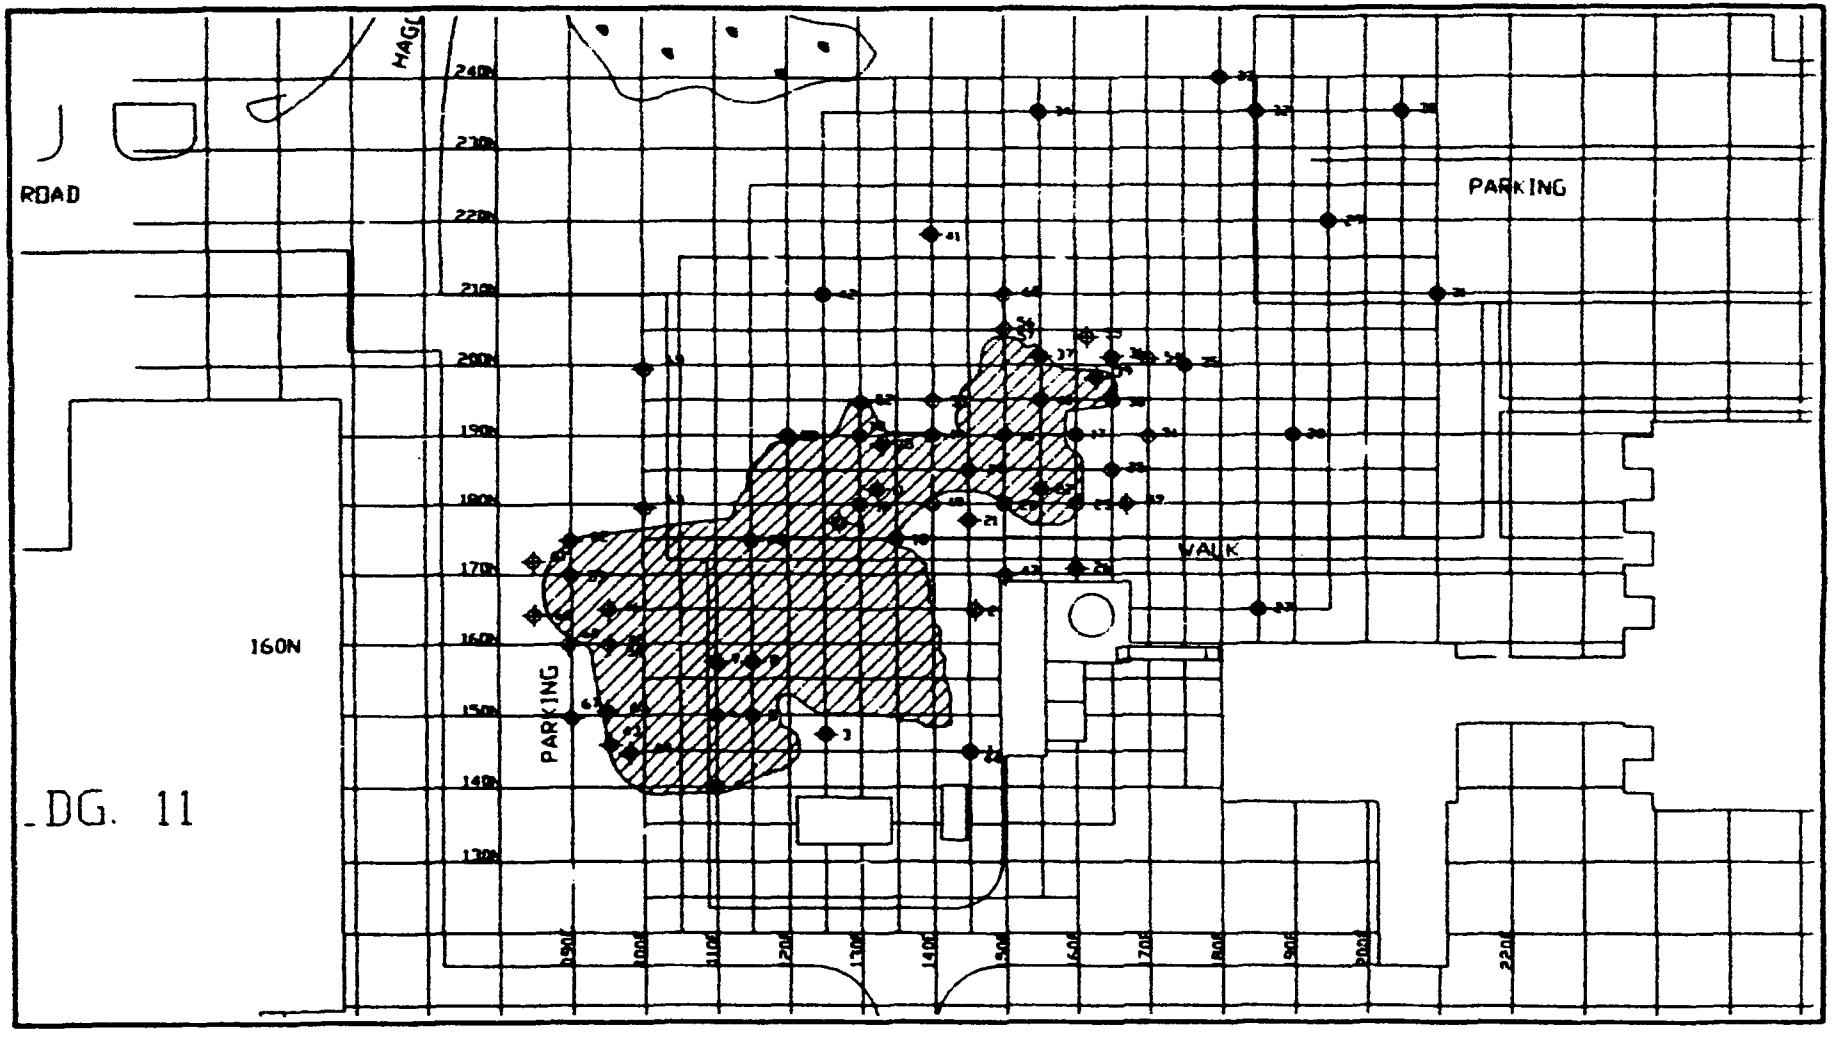
Figure 5.1
Split Spoon Sample Locations

1. Figure 5.1. The two different symbols (closed and open circles) are not defined.

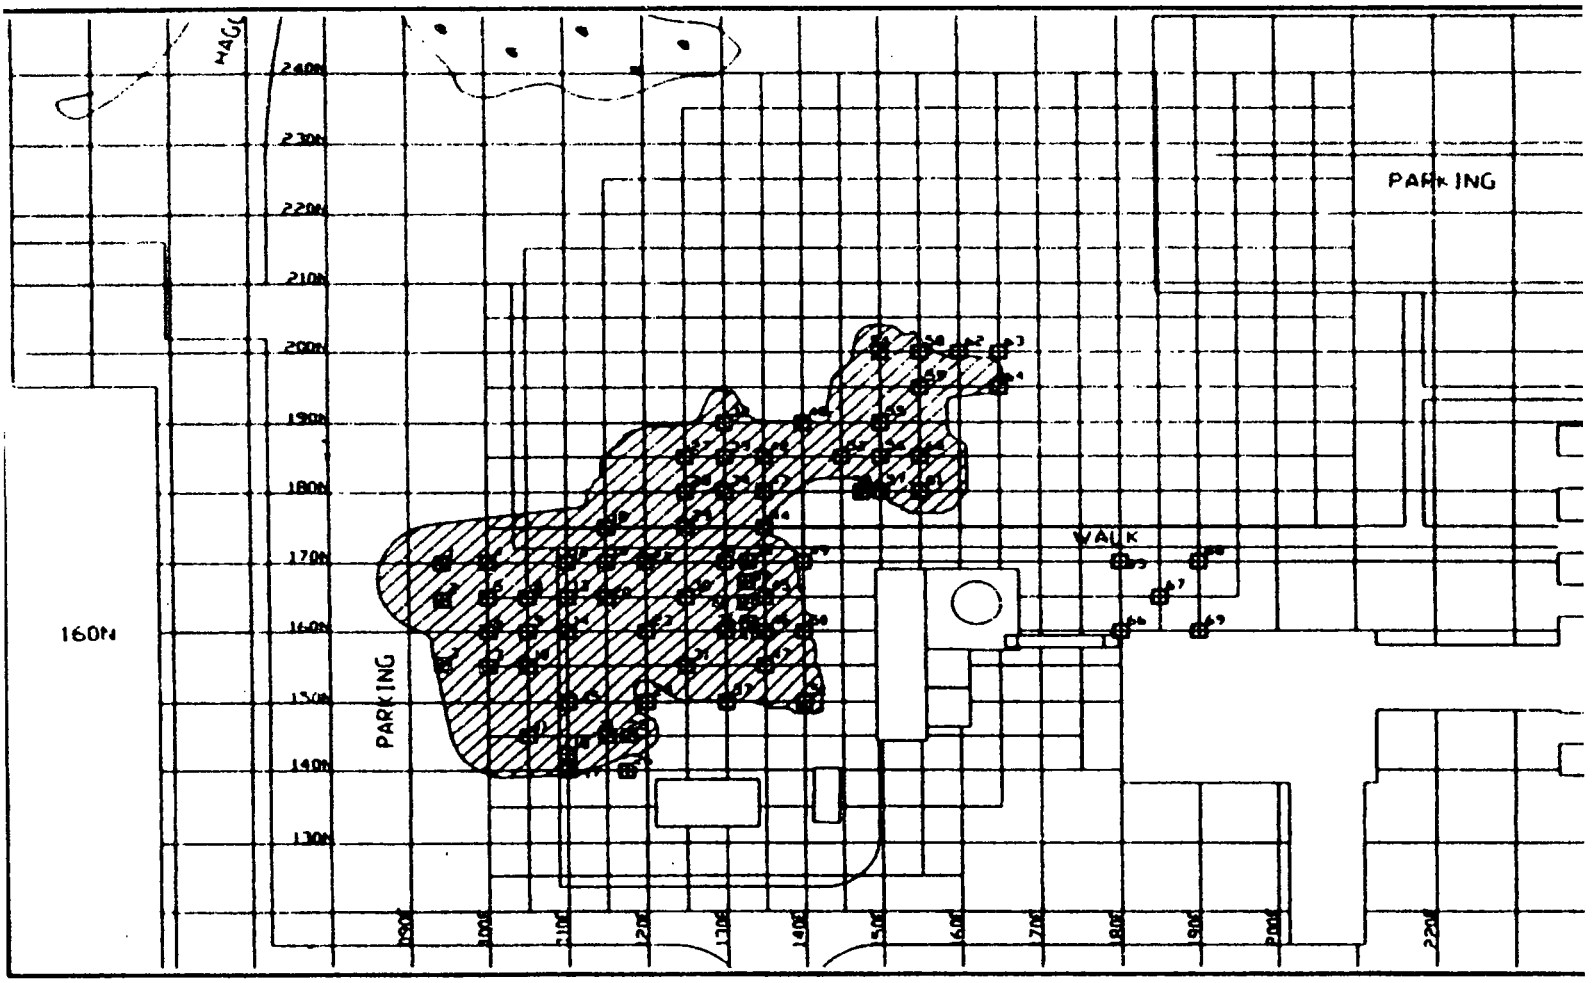
Figure 1
Surface Soil Sample Locations Within Excavated Area

The conclusion of the survey conducted by ORISE for the NRC, on December 14-16 1992, was that the bottom of the excavation was at acceptable levels, however, there was some question on areas around the wall of the excavation. NRC requested that Texas Instruments continue to excavate in certain areas and that Texas Instruments demonstrate that the extent of the excavation is appropriate.
