Three Mile Island Unit 2 Case Study Overview

IAEA International Project on Managing the Decommissioning and Remediation of Damaged Nuclear Facilities (DAROD)

31 August – 4 September, 2015

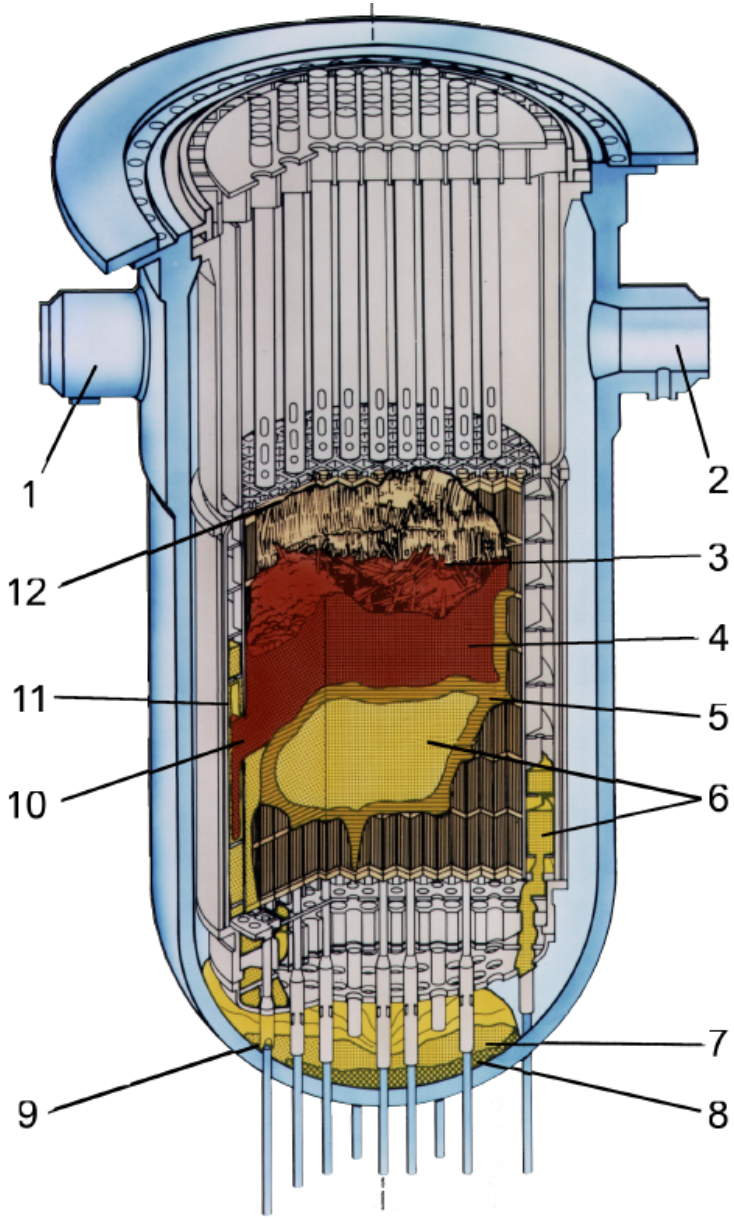
Technical Issues – Post Emergency State of the Core

- Fuel melting and reactor core damage had occurred
- Contaminated coolant water remained in the basement of the containment building
- The containment building was contaminated but remained in-tact and functional
- First entry into the reactor building containment was conducted by two utility staff on July 23, 1980 (image to the right)

1. Cold leg Loop 2B inlet
2. Cold leg Loop 1A inlet
3. Cavity
4. Loose core debris
5. Crust
6. Previously molten material
7. Lower plenum debris
8. Hard layer debris
9. Damaged in-core instrument guide
10. Hole in baffle plate
11. Coating of previously molten material on bypass region interior surfaces
12. Upper grid damage

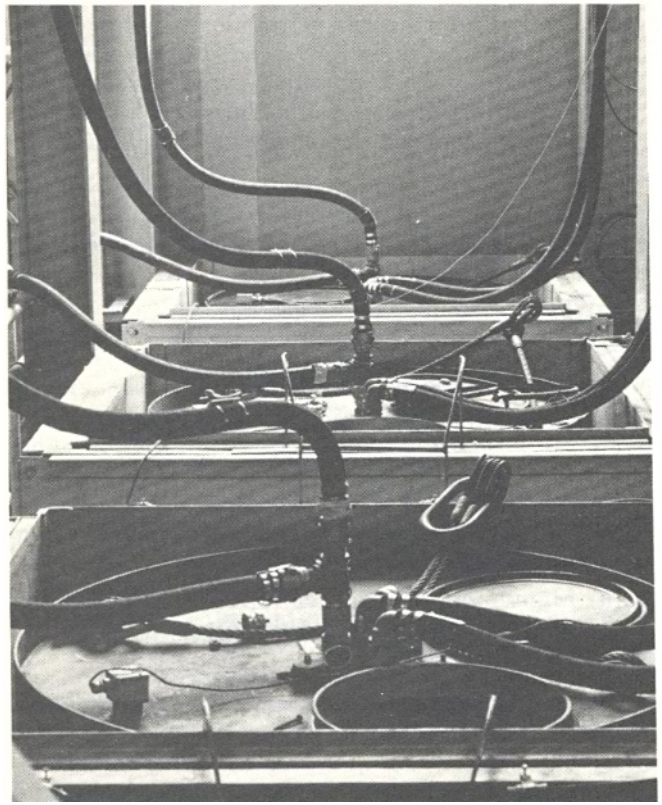
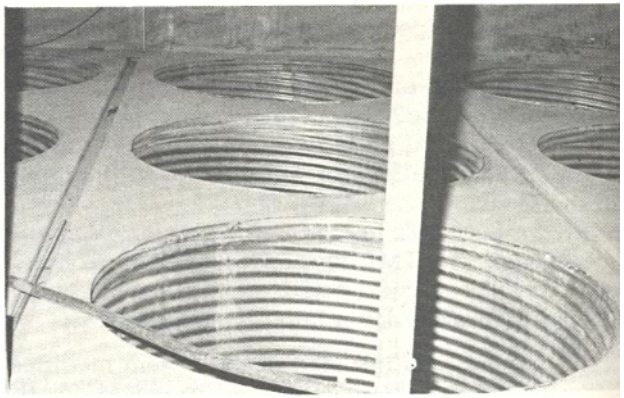
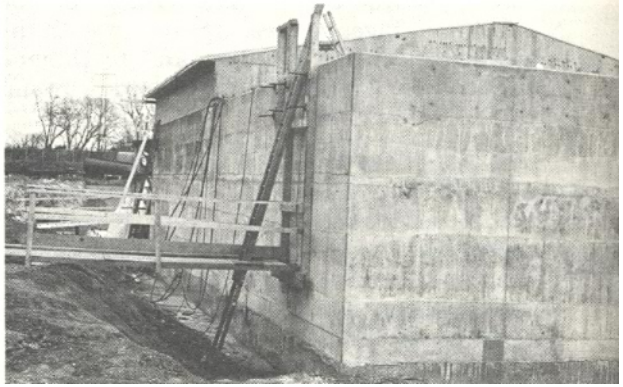
EPICOR-II System

- Decontamination of intermediate-level contaminated water (defined as less than 3.7 MBq/mL [100 µCi/mL]) in the auxiliary building
  - Environmental Assessment issued and approval granted to use the Epicor-II filtration system

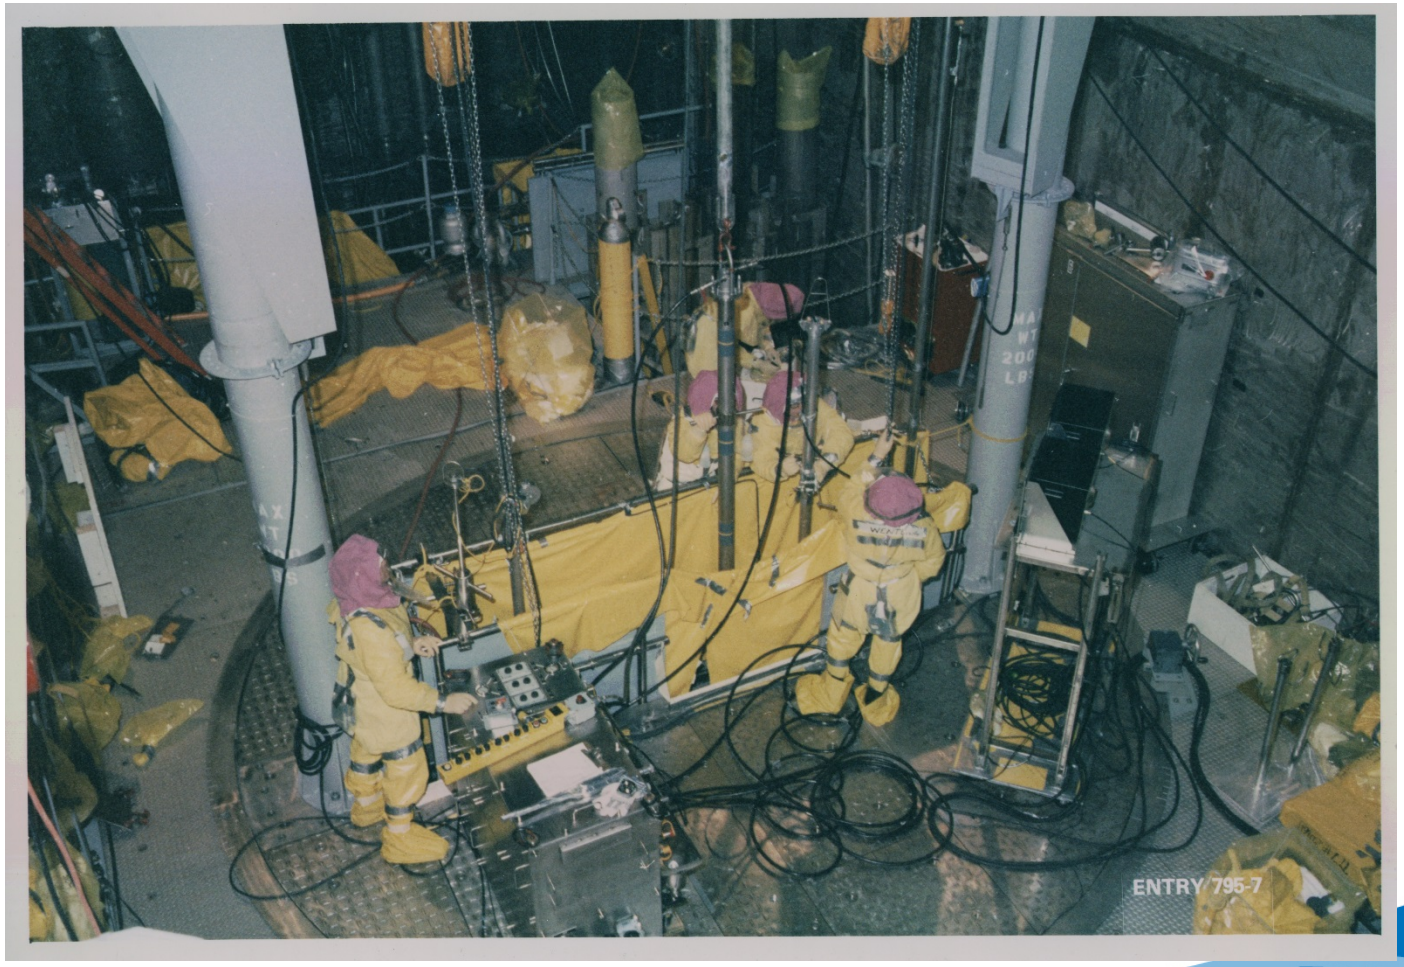
Shielded defueling work platform (DWP)

- Removal of fuel debris from the reactor
  - Operators removed damaged fuel and structural debris from the reactor vessel by “pick and place” defueling of loose core debris
  - Workers performed defueling operations from a shielded defueling work platform (DWP) located nine feet above the reactor vessel flange
  - The DWP had a rotating 17-foot diameter surface with six-inch steel shield plates, and was designed to provide access for defueling tools and equipment into the reactor vessel

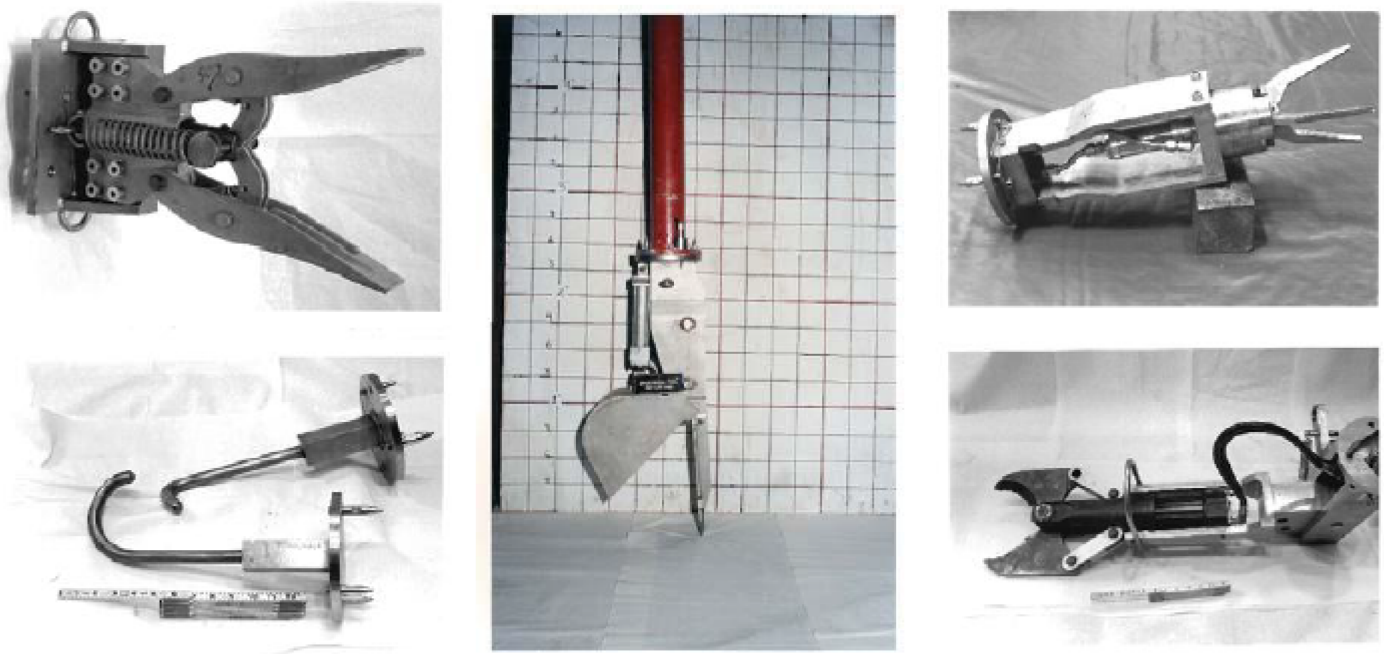
Numerous manual and hydraulically powered long-handled tools were used to perform a variety of functions, such as pulling, grappling, cutting, scooping, and breaking up the core debris. These tools were used to load debris into defueling canisters positioned underwater in the reactor vessel.
