South Texas Project Electric Generating Station P.O. Box 289 Wadsworth, Texas 77483

South Texas Project  
Unit 2  
Docket No. STN 50-499  
Licensee Event Report 2-01-003  
Steam Generator 2C Classified as Category C-3

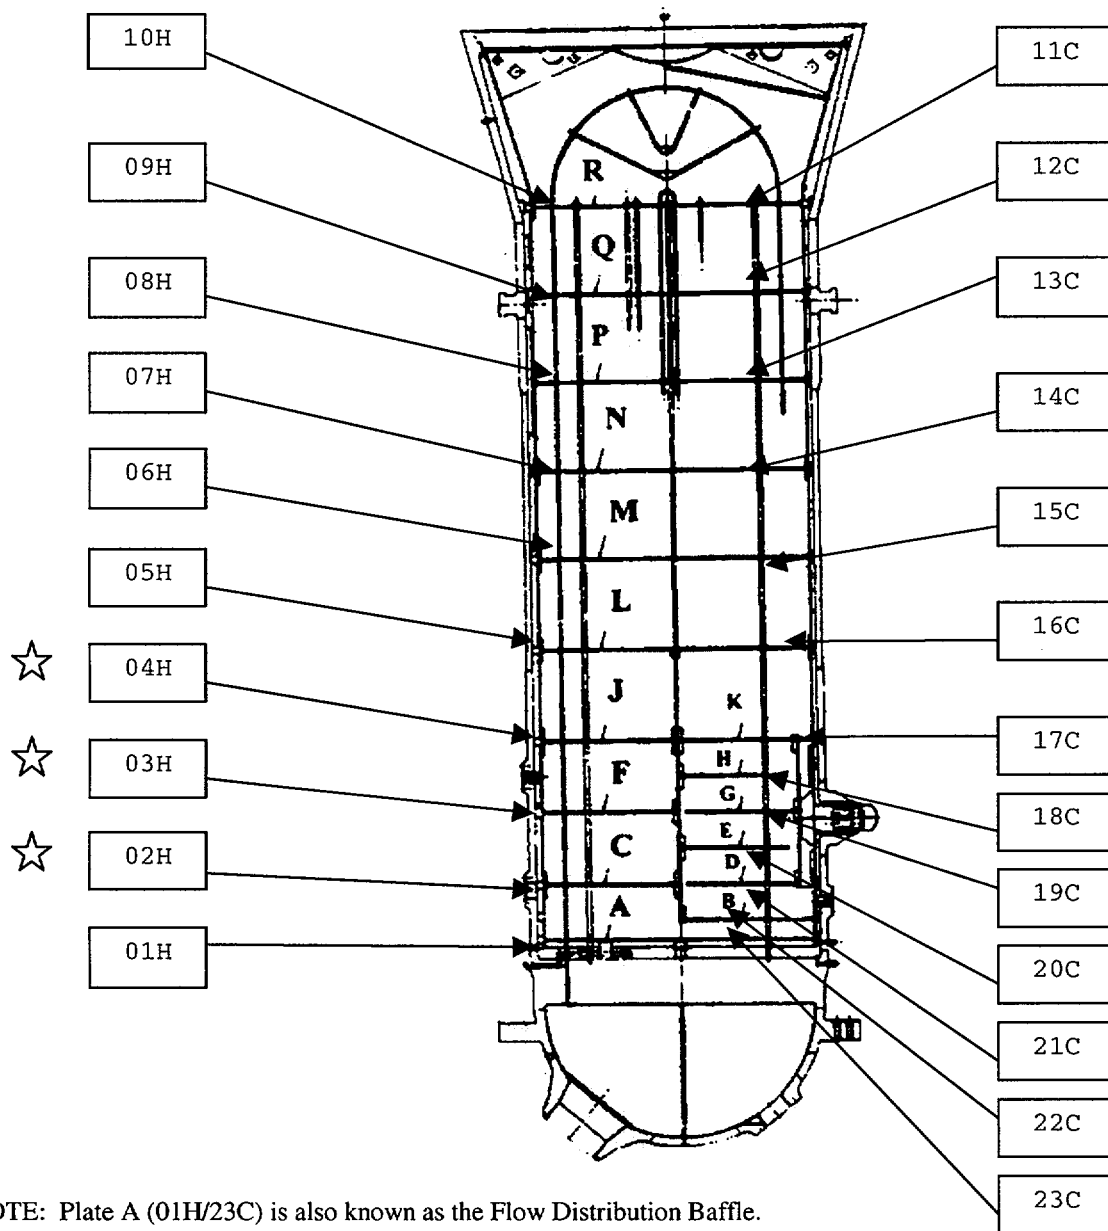
**FIGURE 1**  
**TUBE SUPPORT PLATE IDENTIFICATION IN MODEL E SGs**

NOTE: Plate A (01H/23C) is also known as the Flow Distribution Baffle.

☆ Three Volt ARC applies at these plates only.

The inspection results are discussed below by degradation mechanism. A summary of how many defective tubes were attributed to each of these damage mechanisms is provided in Table 1. As discussed below, many tubes were also preventively plugged. A summary of all tube plugging is given in Table 2. Figure 1 provides identification of the tube support plates in the Model E steam generators.
