SUBJECT: DRAFT NUREG-XXXX, TECHNICAL ASSESSMENT, GENERIC
ISSUE 186: POTENTIAL RISK AND CONSEQUENCES OF HEAVY
LOAD DROPS IN NUCLEAR POWER PLANTS

This study was initiated in response to candidate generic issue 186, *"Potential Risk and Consequences of Heavy Load Drops in Nuclear Power Plants."* The attached report documents the results of a systematic and comprehensive study of crane operating experience at U.S. nuclear power plants.

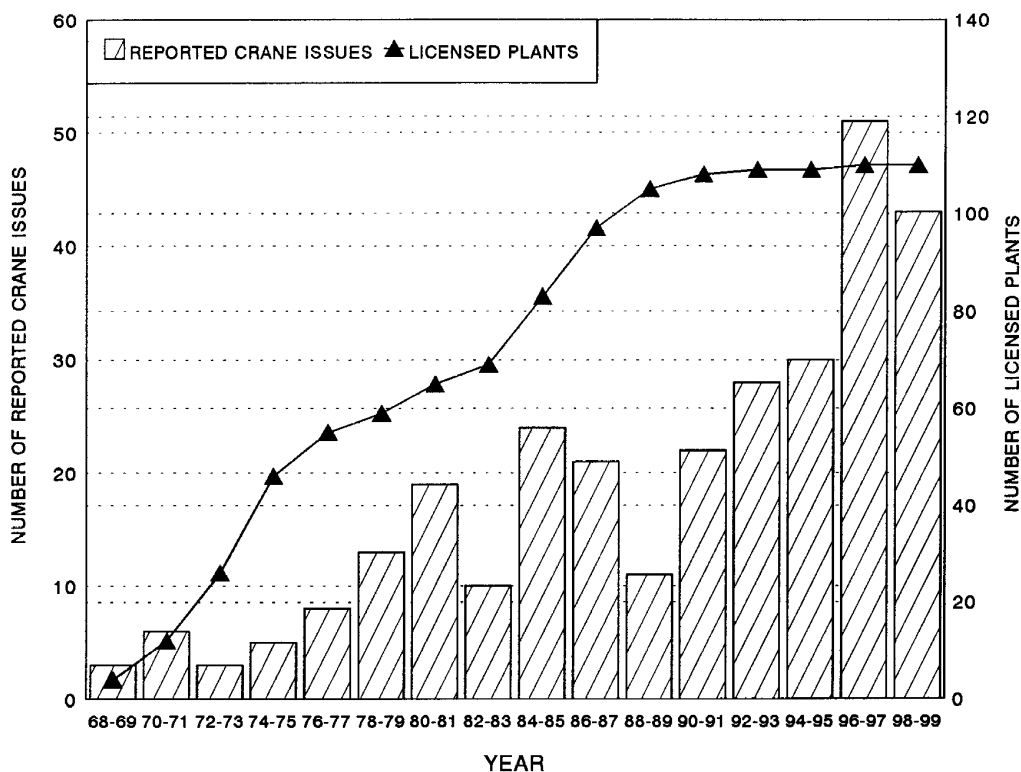
Figure 1, *Documented crane issues at U.S. nuclear power plants (1968-1999)*, shows the total number of reported crane issues in two year increments. Crane issues were reported by individual licensees, through NRC documents and inspection reports, by vendors, and the public. The crane issues shown occurred during both construction and operation. Issues involving small hoists, light loads, or rigging issues are generally not included. Figure 1 also shows the total number of nuclear power plants that were licensed to operate during each of the two-year time periods.

As shown by the figure, there has been an increase in the number of issues over the last decade when compared to the first two decades. For example, the average number of issues per licensed plant per calendar year [i.e., (number of issues)/(average number of operating plants) divided by the number of calendar years in the sample] was (1) 0.10 for the period 1968 through 1979, (2) 0.10 for the period 1980 through 1989, and (3) 0.15 for the period 1990 through 1999. Although there was an increase in the number of reported crane issues in the last decade, the severity of crane issues as measured by the number of drops, slips, deaths or injuries was not proportional to the increase in the number of operating nuclear power plants (see figures 8 and 10).

Figure 1: Documented crane issues at U.S. nuclear power plants (1968-1999)

To reverse the increase in the number of crane issues noted in Figures 1 and 8 in the last decade (1990 through 1999), and to prepare for an increase in the number of very heavy load lifts, it may be beneficial to revisit the guidelines presented above, and in NUREG-0612 in general. Many older nuclear facilities will reach the maximum capacity of their spent fuel pools, and are beginning to transfer, or will soon transfer, spent fuel to an independent spent fuel storage installation (ISFSI). Transfer of spent fuel to an ISFSI will increase the number of very heavy load lifts. In addition, as nuclear facilities are decommissioned, and spent fuel casks and other very heavy nuclear components are removed, a significant increase in the number of very heavy loads may also occur.

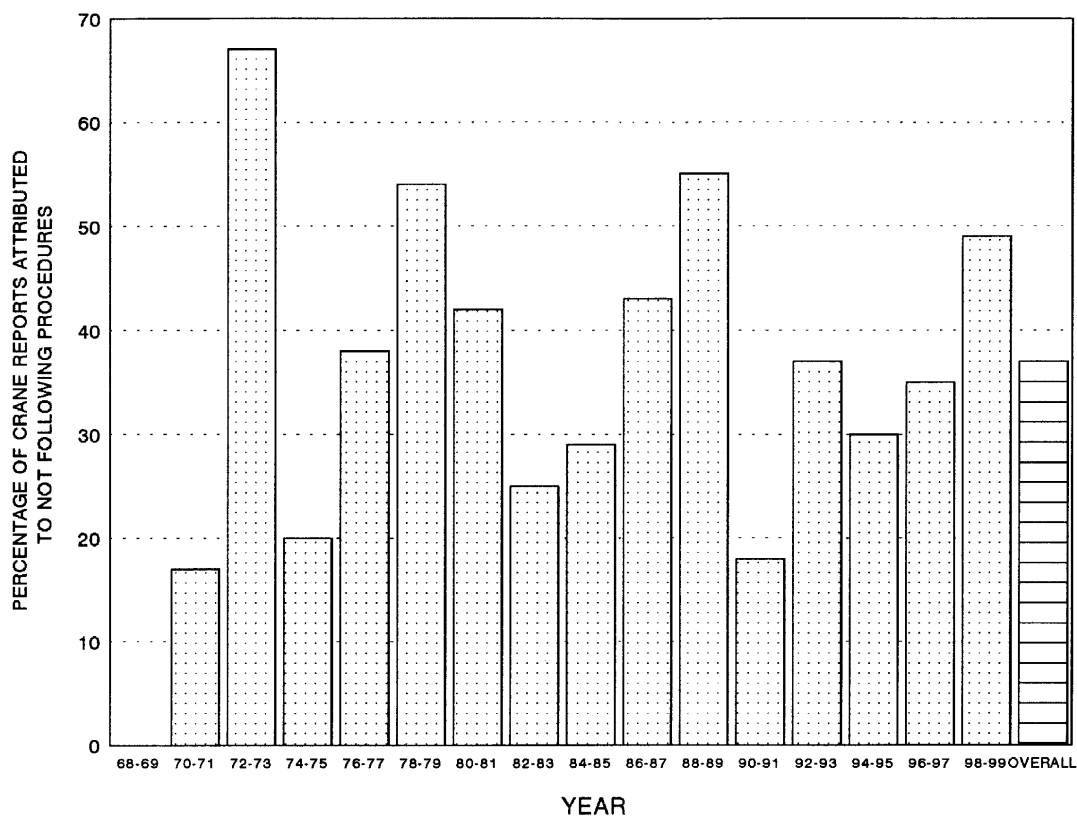
Figure 2, *Crane issues caused by not following procedures (1968-1999)*, shows the percentage of crane issue reports that were caused by not following specific crane operating procedures. As shown in the figure, the percentage of crane issue reports caused by not following specific crane operating procedures has been cyclic, with an overall average of approximately 36 percent. Section 2.2.5 also discusses other forms of “not following procedures” such as not maintaining proper system alignment, room ventilation issues, load path requirements, poor procedures, etc.

Figure 2: Crane issues caused by not following procedures (1968-1999)

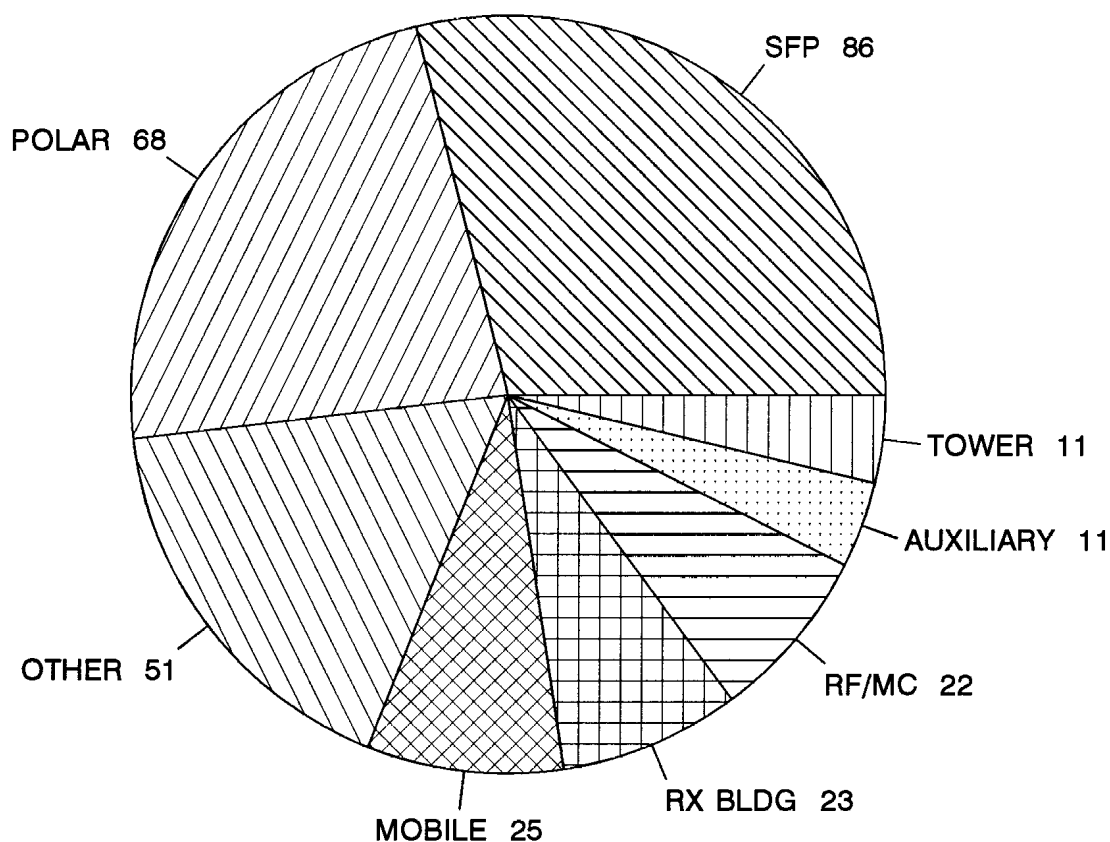
For the 297 reported crane issues during the period 1968 through 1999, Figure 3, *Crane issue distribution by crane type (1968-1999)*, shows the distribution by crane type. The number of crane issues for each crane type was not broken down by reactor type, operational phase, or weight of load at the time of the event. Crane types include polar, spent fuel pool (SFP), tower, auxiliary, refueling/manipulator (RF/MC), reactor (RX) building, mobile, and other. The category “other” refers to cranes which do not specifically fit into one of the previous categories, and could include turbine building cranes, special cask handling cranes, unspecified cranes, or miscellaneous cranes used inside or outside of areas containing safety-related components. The figure does not represent failure rates of different types of cranes, only the total number of documented crane issues. For example, in general, there would be many more lifts performed using the spent fuel pool or refueling cranes than mobile cranes, so a greater number of issues would be expected for spent fuel pool cranes. In addition, there are approximately twice as many PWRs (generally have polar cranes) than BWRs (generally having reactor building cranes, which are parallel track overhead bridge cranes), consequently, a greater number of issues would be expected for polar cranes than for reactor building cranes.

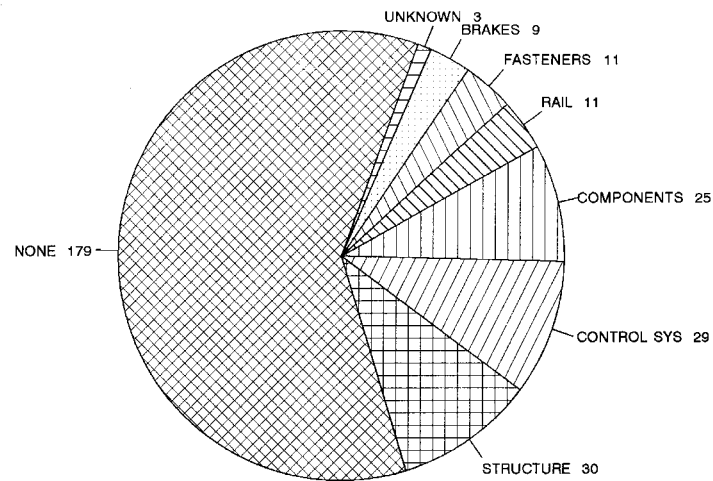
As shown in Figure 4, *Crane issues due to hardware deficiencies (1968-1999)*, of the 297 crane issues, 118 involved actual equipment or hardware problems. The remainder (179), did not involve hardware deficiencies and were categorized as “None.”

Figure 4: Crane hardware

issues due to deficiencies

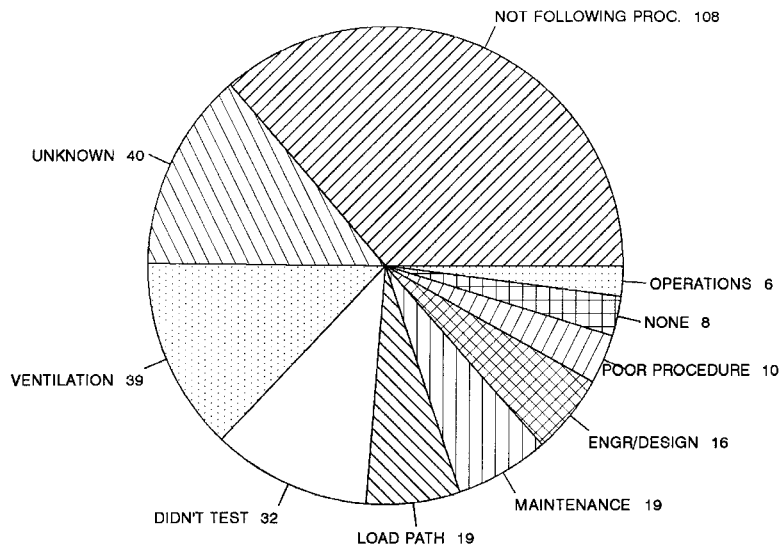
Figure 5, *Crane Program Implementation issues (1968-1999)*, shows the distribution of causes for the documented crane issues.

Figure 5: Implementation (1968-1999)

Crane Program on issues

The probability of a drop over Safe Shutdown Equipment (SSE) would be related to the probability of the failure to follow procedures. As shown in Figure 5, a large percentage of crane issues are either related to not following procedures, or not properly implementing procedures. For the purposes of this assessment, it was conservatively assumed that all crane issues were the result of the failure to follow procedures and could have caused a drop over an SSE. This would result in a probability of approximately $2\text{E-}03$ failures per lift. Wash-1400 provides a human reliability estimated failure rate of $1\text{E-}02$ (based on data from the United Kingdom Atomic Energy Agency and the U.S. military) was used as the upper bound for this study. Both of these values will receive additional analyses.

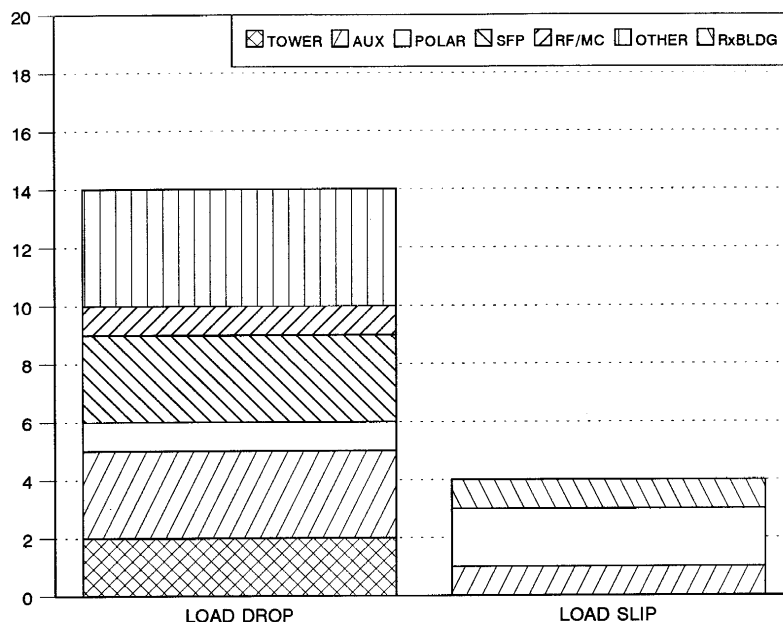
During the period 1968-1999, there were 14 reported events involving a crane load drop, and 4 involving a load slip. Figure 7, *Crane type involved in load slip or drop (1968-1999)*, shows the crane type involved in load slips and load drops. In addition, Table 2, *Reported crane issues involving a load drop or a load slip*, provides description of each event.

Figure 7:
involved in
drop (1968-1999)

**Crane type
load slip or**

As shown in Figure 7 and Table 2, there have been 14 reported load drop events for the period 1968 through 1999. Of these, four involved very heavy loads (greater than approximately 30 tons). Three of the four very heavy load drop events occurred during construction, while the fourth event occurred at an operating facility. The operating event was minor and resulted in the bending of two reactor head alignment pins when the crane operator inadvertently lowered the head too far (i.e., crane control functions were not lost).

As shown in Figure 7 and Table 2, there have been four reported load slip events for the period 1968 through 1999. Three of these load slips involved very heavy loads at operating facilities. The Dresden event was not risk significant, since no equipment was impacted when the reactor vessel head slipped lower when attempting to raise the head. The Comanche Peak event could have caused significant damage had the reactor coolant pump motor continued in its descent, impacting the reactor coolant piping. The Arkansas event was similar to the Dresden event and was not risk significant.

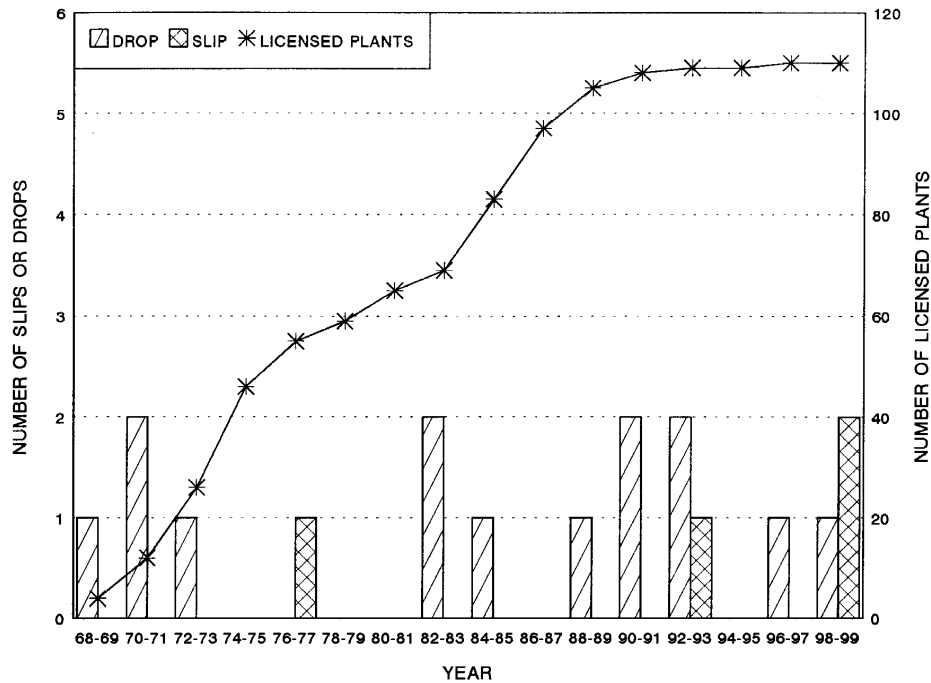
Figure 8, *Distribution of load slips and drops* (1968-1999), shows both the number of documented load slips and load drops, and a plot showing the number of licensed power plants for the period 1968 through 1999. The crane events shown occurred during both construction and operation. Events involving small hoists, light loads, or rigging issues are generally not included. As shown by the figure, there has been a slight increase in the combined number of both load slips and load drops over the last decade when compared to the first two decades, however, this increase is substantially offset by the increase in the number of licensed nuclear power plants from 1968 to 1999.

For example, the average combined number of drop and slip events per licensed plant per calendar year [i.e., (number of events)/(average number of operating plants) divided by the number of calendar years in the sample] was (1) 0.014 for the period 1968 through 1979 (11 years), (2) 0.005 for the period 1980 through 1989 (10 years), and (3) 0.008 for the period 1990 through 1999 (10 years).

Figure 8: Distribution of load slips and drops (1968-1999)

Potential reasons for the crane performance improvement shown in Figure 8 could include; (1) general implementation of lessons learned, (2) a heightened awareness of safety at operating plants as opposed to construction sites, (3) implementation of NUREG-0612 Section 5.1.1 guidelines for control of heavy loads which was issued in 1980, and (4) crane upgrades performed since initial plant licensing. Figure 8 shows a slight increase in the number of crane events is evident during the mid-1990s. Similarly, Figure 10, *Distribution of crane related deaths and injuries* (1968-1999) shows a comparable trend, with a concentration of nuclear crane related deaths and injuries between 1976 and 1981, with no deaths reported since 1985. In addition, Figure 1 in Appendix C, *Independent Oversight Special Study of Hoisting and Rigging Incidents Within the Department of Energy*, shows an increase in the frequency of hoisting and rigging events beginning in the second quarter of 1994, although improvements were realized in the latter part of 1995.

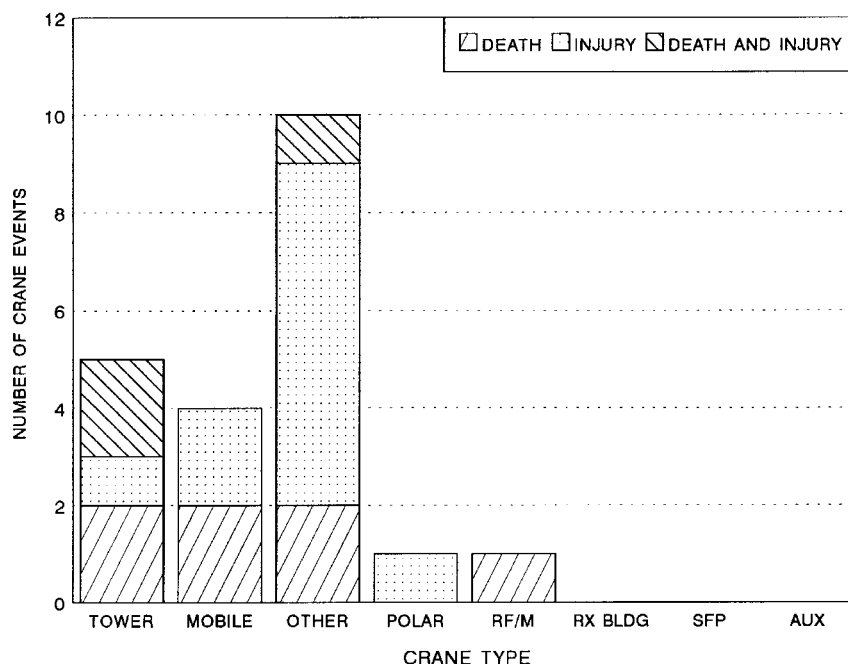
Figure 9, *Crane types involved in deaths or injuries (1968-1999)*, shows the number of events that led to either a death, an injury, or both a death and an injury. In reviewing deaths and injuries caused by crane operation, each event was sorted by crane type. Crane types were put into eight different categories.

Figure 9: Crane types involved in deaths or injuries (1968-1999)

As shown by Figure 9, most deaths and injuries occurred while using cranes that don't lift heavy loads near safety-related equipment (i.e., tower, mobile, or other categories). These types of cranes have typically not been as well controlled and maintained in the past as are polar, reactor building, or spent fuel pool cranes.

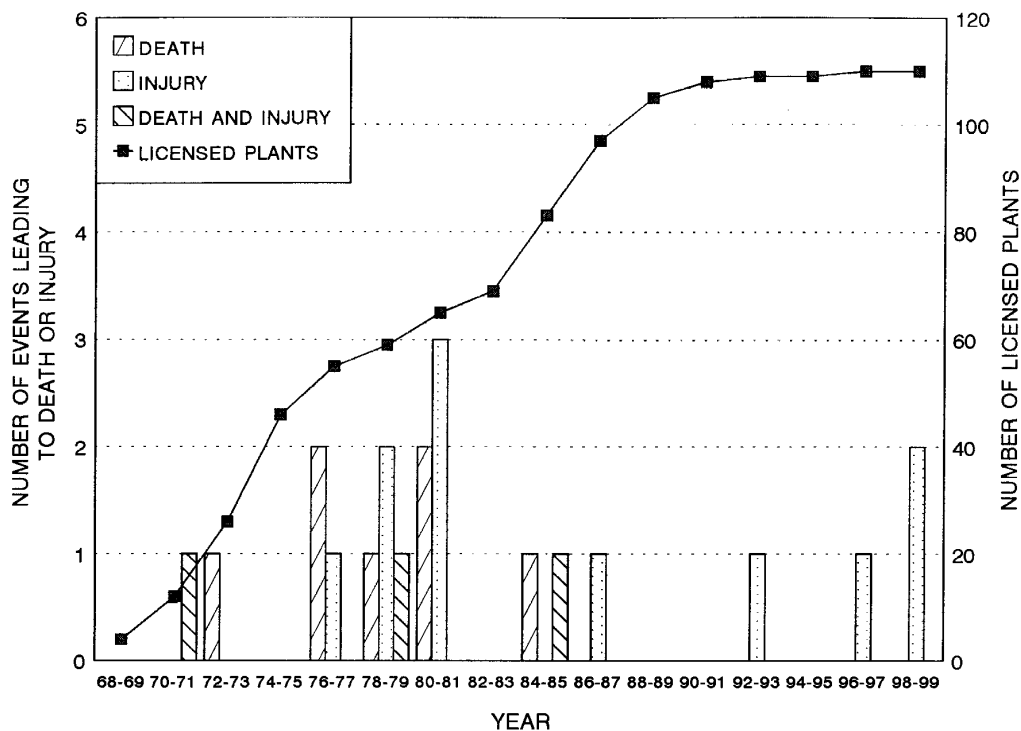
Figure 10, *Distribution of crane related deaths and injuries (1968-1999)*, shows the number of crane related events resulting in a death, an injury, or both a death and an injury. In some instances, more than one death or injury occurred as a result of an event. During this time period, there have been seven reported crane events that have resulted in deaths, three that have involved both deaths and injuries, and 11 events that have resulted in injuries. The highest concentration of crane related deaths and injuries at nuclear power plants occurred between 1976 and 1981. The last death in a crane related accident at a U.S. nuclear power plant occurred in 1985. For comparative purposes, Figure 10 also shows the cumulative number of nuclear power plants that had an operating license during the period from 1968 through 1999.

Figure 10: Distribution of crane related deaths and injuries (1968-1999)

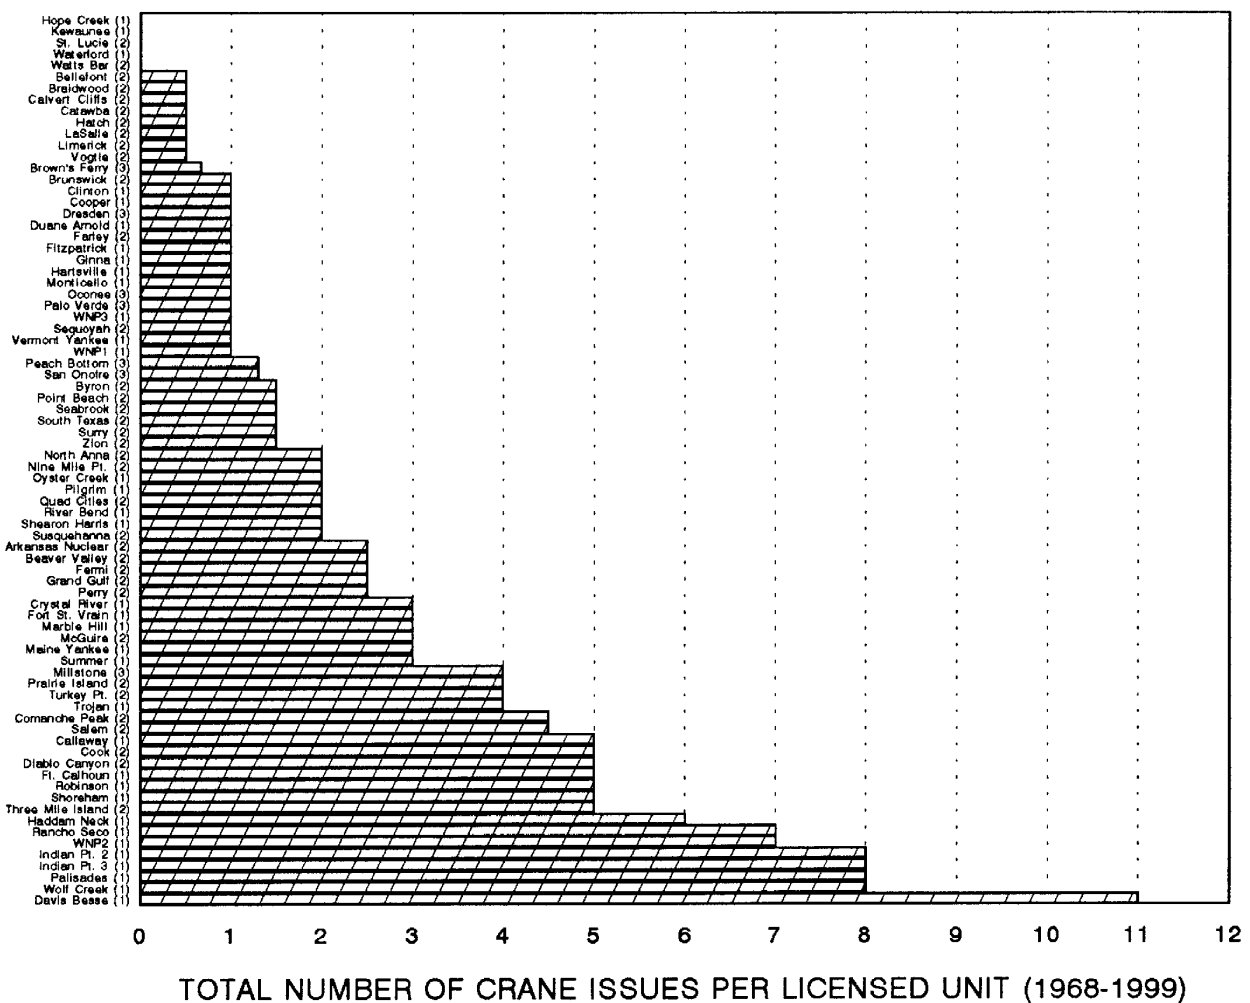
Figure 11, *Distribution of crane issues by facility, on a per unit basis (1968-1999)*, shows the number of crane issues documented against each nuclear power plant facility, divided by the number of units (i.e., units that received an operating license, or were substantially completed) at that facility. Since there are many facilities that had units canceled, judgement was used in determining how many plants were “substantially” completed, but did not receive an operating license. Four nuclear facilities reported no crane events; Hope Creek, Kewaunee, St. Lucie, and Watts Bar. Hope Creek, Kewaunee, Waterford, and Watts Bar.

Figure 11: Distribution of crane issues by facility, on a per unit basis (1968-1999)
