Subject: Westinghouse Hematite Decommissioning Project - Request for NRC Review of Final Status Survey Final Report Volume 3, Chapter 4, Survey Area Release Record for Land Survey Area 10, Survey Unit 12 (License No. SNM-00033, Docket No. 070-00036)

Survey Area Release Record for Land Survey Area 10, Survey Unit 12

Hematite Decommissioning Project

TITLE: **Survey Area Release Record for Land Survey Area 10, Survey Unit 12 (LSA 10-12)**

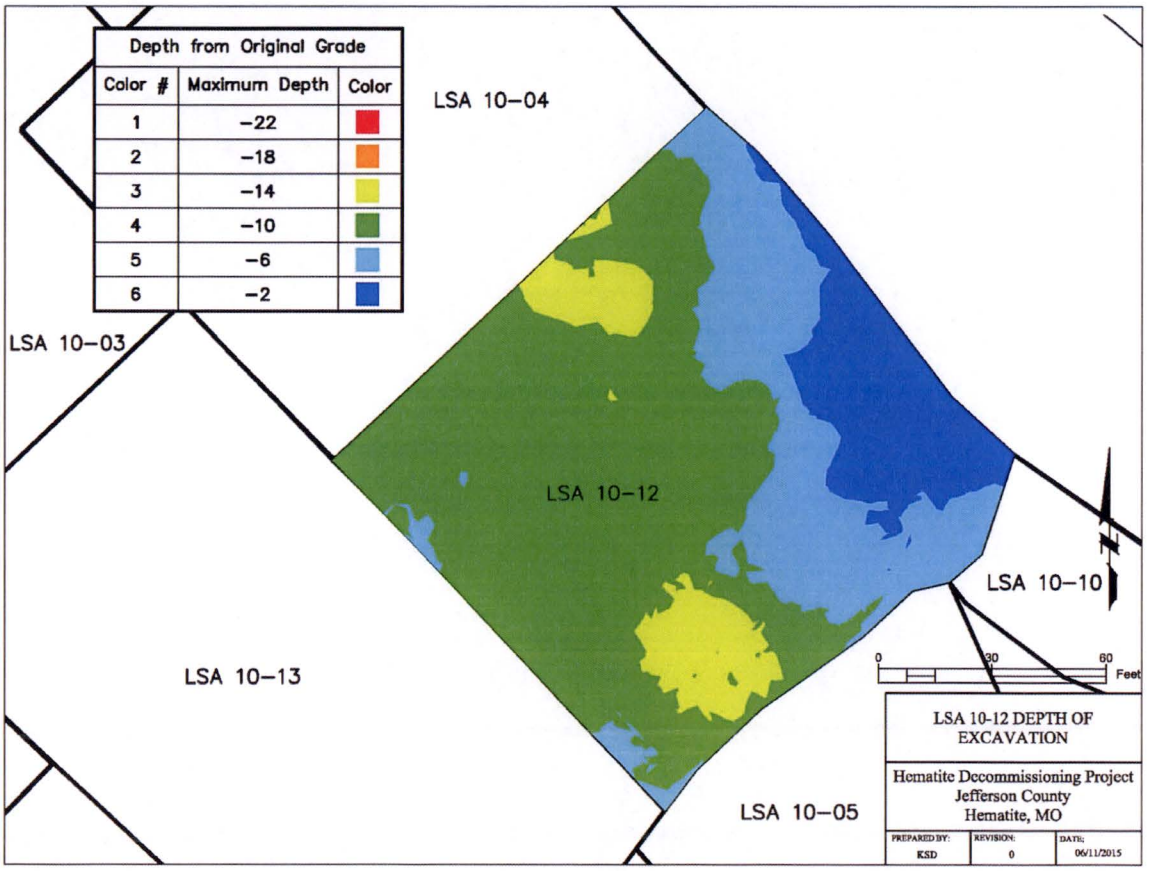
Figure 3-5
LSA 10-12 Depth of Excavation Map (Depths in Feet)*

The maximum depth of remedial excavation necessary in portions of LSA 10-12 to ensure all areas identified during site characterization and remedial action survey efforts were adequately remediated relative to the original grade was 14 ft. The estimated volume of excavated waste materials from LSA 10-12 was 3,991 cubic yards. Figure 3-5 provides the depth of excavations for LSA 10-12. The areas of the LSA 10-12 indicated in Figure 3-5 in the blue and light blue shaded areas indicate the excavation from the original downward sloped terrain surface to the lower elevation of the Northeast Site Creek. The final elevation of the excavation floor was relatively the same across the SU.

*Depth of Excavation Map presented in colored bands of feet. Maximum depth is 14ft.

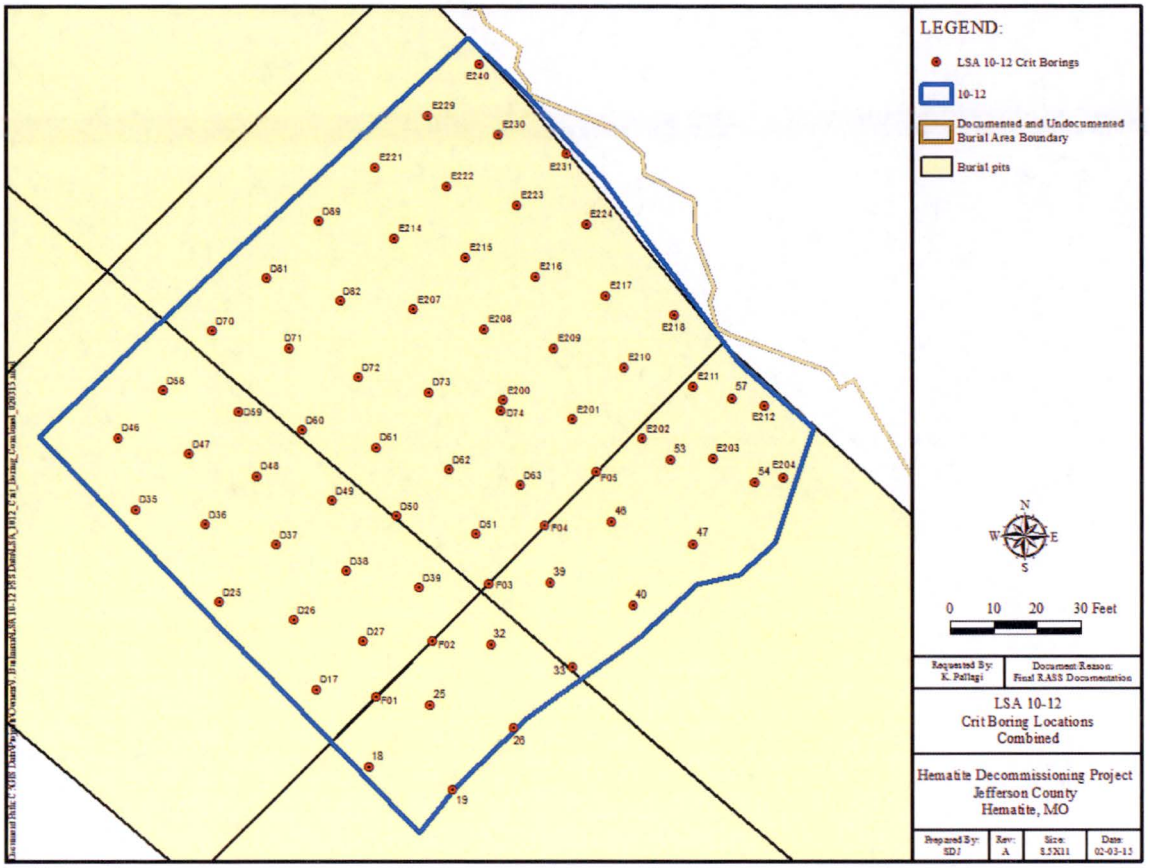
Figure 3-6
NCS Core Bore Locations in LSA 10-12

The survey measurements from the spoils material and boreholes for LSA 10-12, along with the results of the visual inspection, were then reviewed by the NCS Specialist and the area released from NCS controls. The visual inspection of the cores provided evidence that no materials indicative of burial pit waste were encountered below the excavation surface within LSA 10-12. Once the area was released from NCS controls, excavation continued, as necessary, for additional remediation of radiological and/or VOC contamination.

No materials indicative of burial pit waste were encountered below the excavation surface within LSA 10-12.

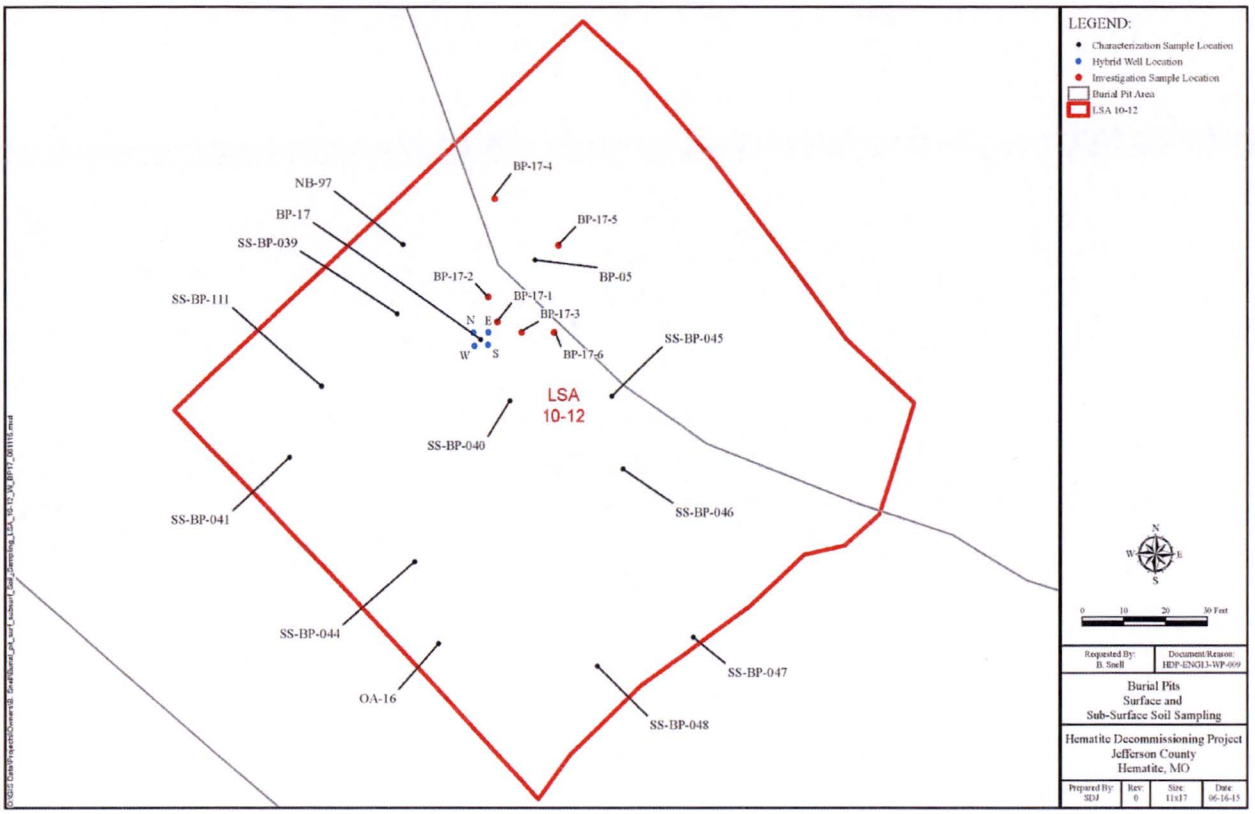
Figure 3-7
Site Characterization Borings within LSA 10-12

No sample collected during the characterization effort exceeded an SOF of 1 as compared to the Uniform Stratum DCGLs; accordingly no characterization sample collected within LSA 10-12 exceeded an SOF of 1 as compared to the Three-Layer DCGLs.

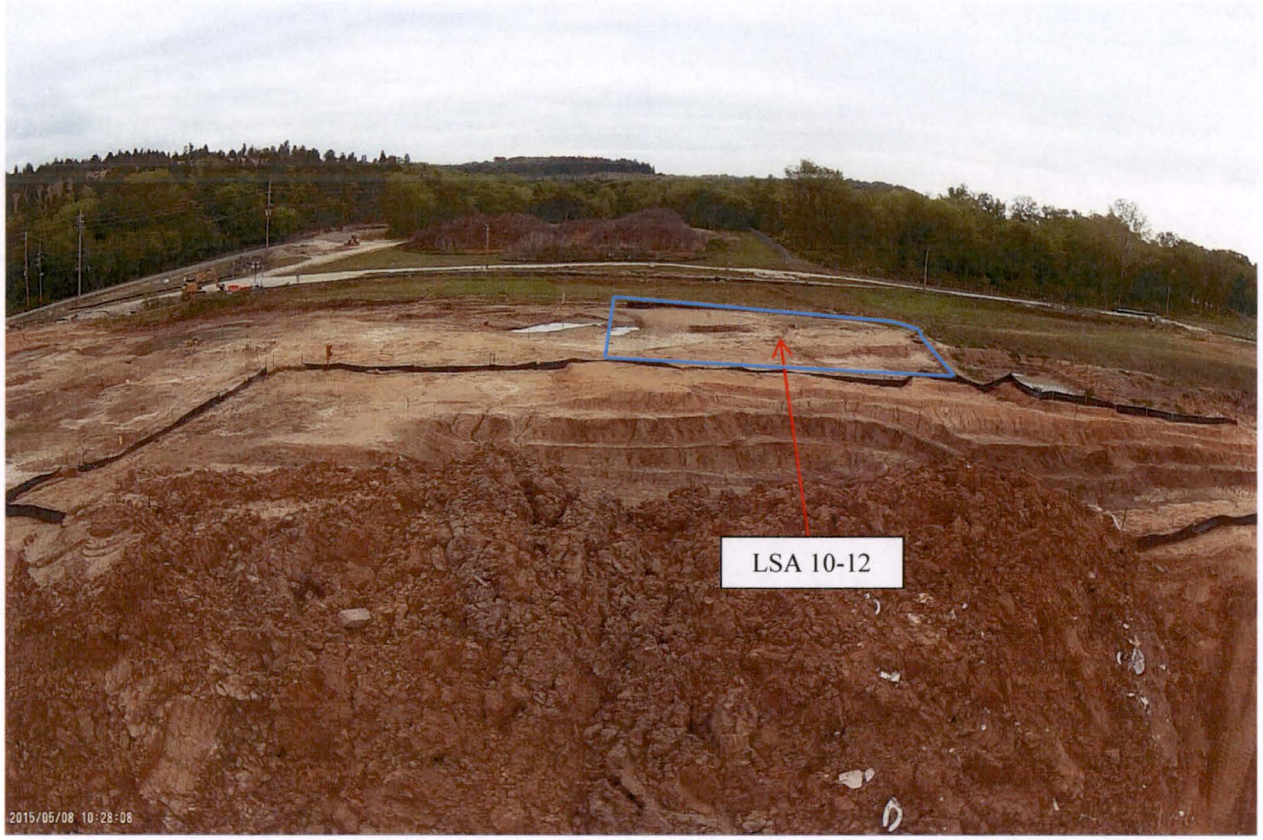
Figure 3-8
LSA 10-12 Prepared for RASS FSS Design

The RASS was conducted 1) to guide remediation activities, 2) to determine when an area or survey unit had been adequately prepared for FSS, and 3) to provide updated estimates of the parameters to be used for planning the FSS. Upon completion of remediation within the SU and prior to implementation of FSS activities, a final RASS was performed to validate the status of the SU prior to implementing Isolation and Control (I & C) postings. The I & C posting for LSA 10-12 was completed on December 12, 2014. Figure 3-8 is a photograph which shows LSA 10-12 ready for the final RASS prior to final storm water removal.

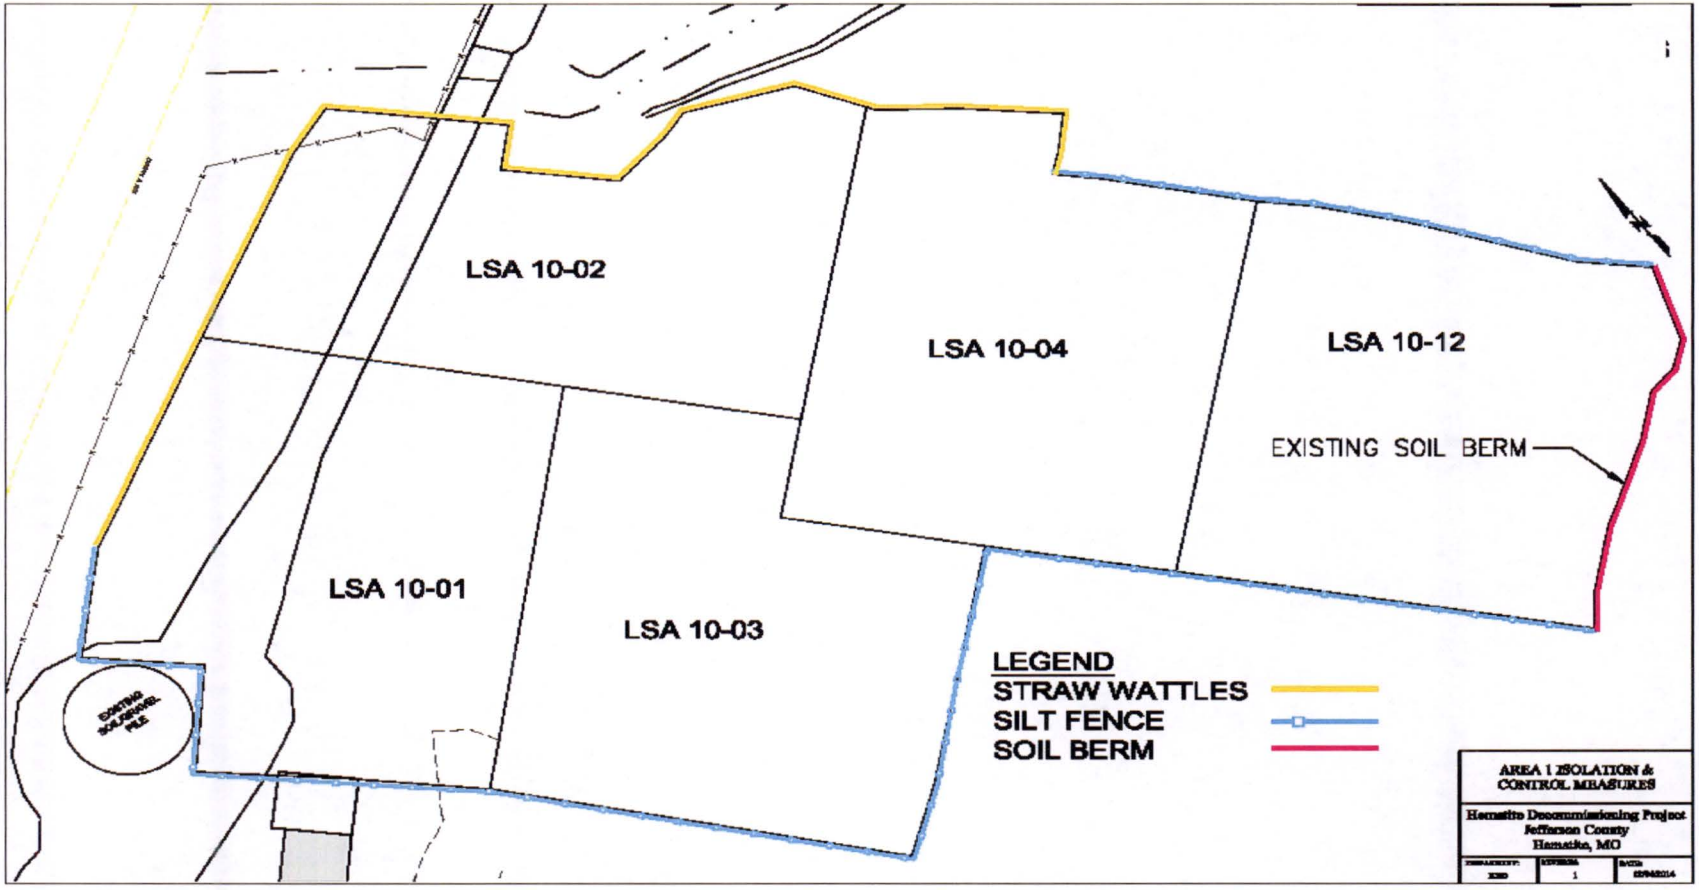
Figure 3-9
Isolation and Control of Area Containing LSA 10-12

As directed by HDP-PR-HP-602, *Data Package Development and Isolation and Control Measures to Support Final Status Survey,* on December 12, 2014, LSA 10-01, LSA 10-02, LSA 10-03, LSA 10-04, and LSA 10-12 were isolated and controlled in accordance with Work Package HDP-WP-ENG-803, *Isolation and Control Measures,* (See Figure 3-9) Isolation and control measures included silt fencing, straw wattles, and soil berms between these SUs and the adjacent remediation area to ensure that cross-contamination of these LSAs undergoing FSS did not occur.

The administrative control of distinctive green and white rope with multiple postings labeled "Contact Health Physics Prior to Entry" was installed around the entire perimeter of the SUs prior to FSS field activities to prevent inadvertent entry by site personnel. LSA 10-12 is located within the fenced security perimeter of the HDP which therefore prevents access by the general public.

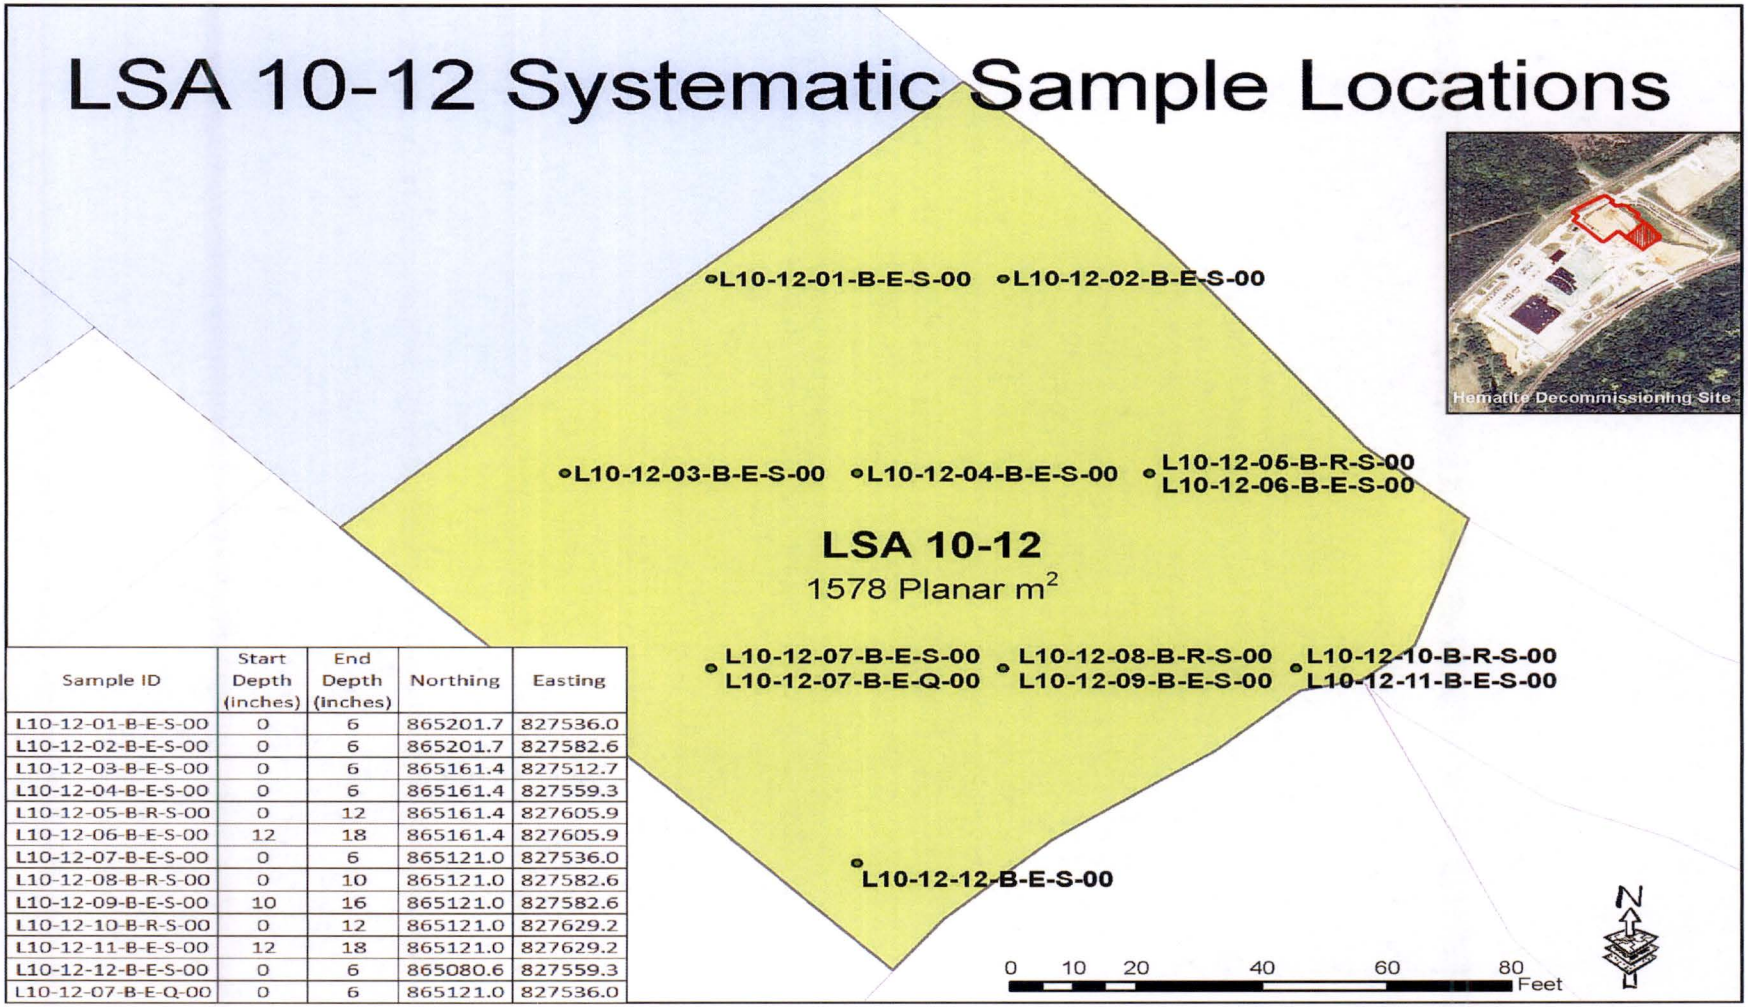
Figure 6-1
LSA 10-12 Systematic Soil Sample Locations

Figure 6-1 presents the map of the nine systematic sample locations which were sampled within LSA 10-12. The inset table notes the location coordinates (Missouri East, North American Datum (NAD) 1983) and collection intervals for each systematic location.

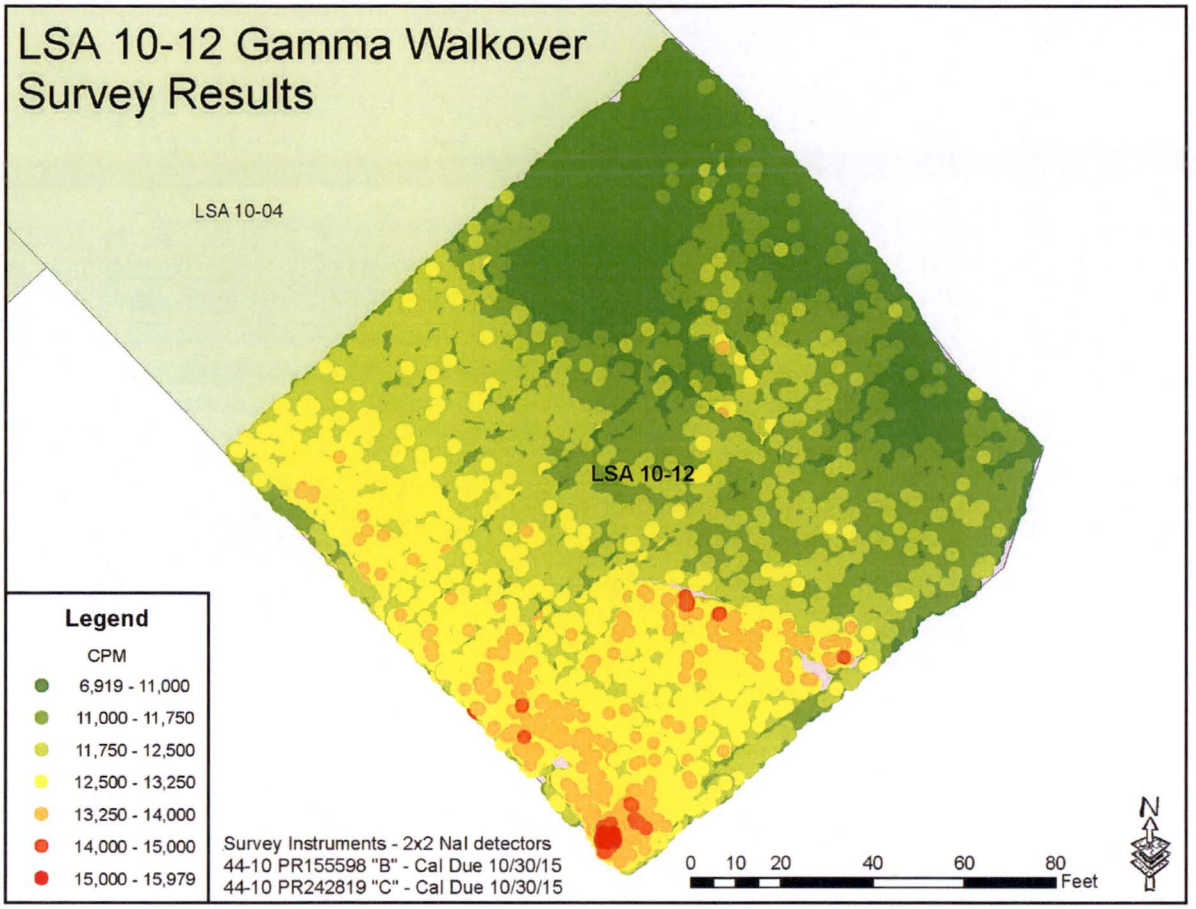
Figure 7-1
Colorimetric GWS Plot for LSA 10-12

For LSA 10-12, GWS count rates ranged between 6,919 gcpm and 15,979 gcpm, with a mean count rate of 11,229 gcpm. The median count rate was 11,356 gcpm and the standard deviation was 1,117 cpm. Figure 7-1 below presents a map of the complete GWS data set.

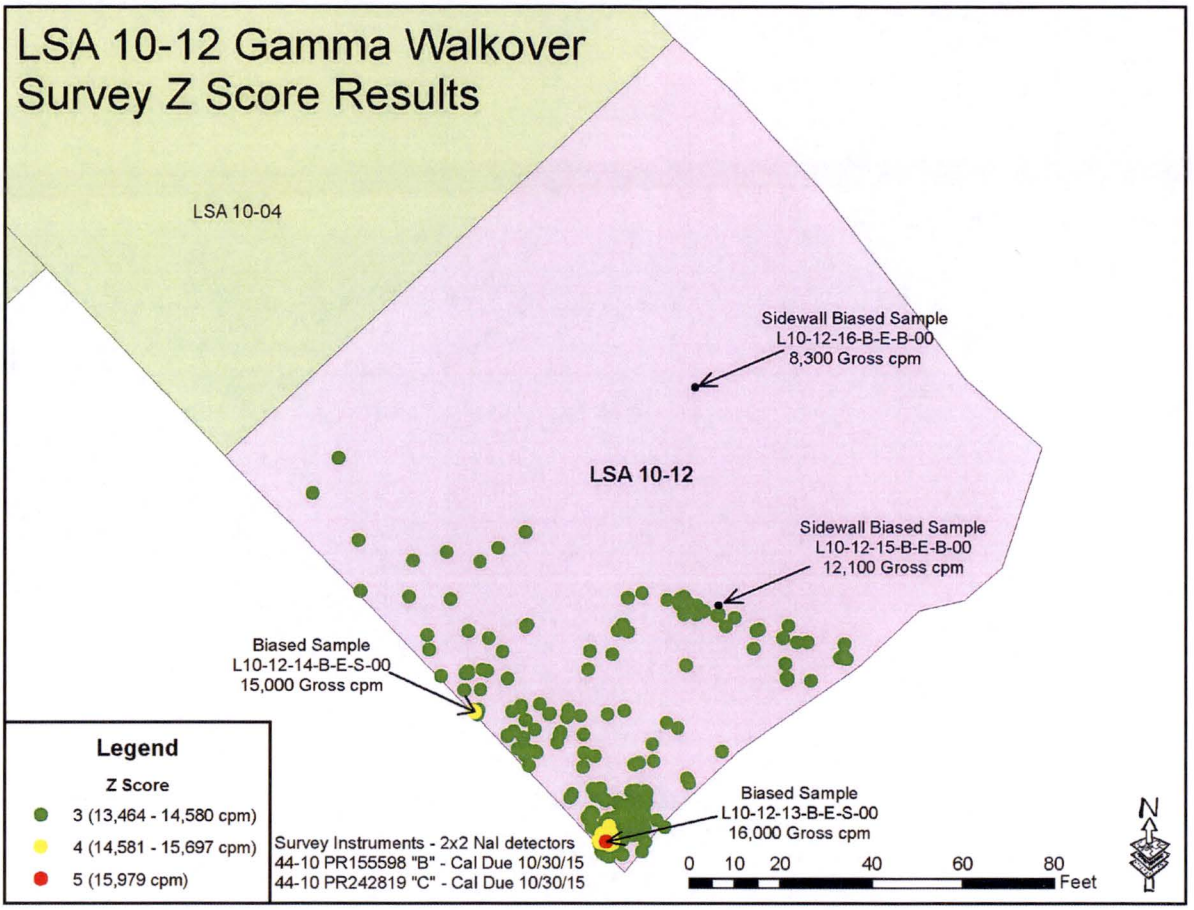
Figure 7-2
Colorimetric GWS Plot for LSA 10-12 (Measurements > Z-score of 3)

An evaluation of the entire GWS data set was performed to evaluate those small areas of elevated activity which exceeded three (3) standard deviations above the GWS mean measurement, (i.e., "+3 Z-score"). Two locations, L10-12-13 and L10-12-14, were selected for biased sample collections. Location L10-12-13 represented the maximum GWS measurement encountered within the survey unit.

Figure 7-2 below presents a map of the +3 Z-score GWS measurements within LSA 10-12, including the selected biased sampling locations (ID: L10-12-13-B-E-S-00, L10-12-14-B-E-S-00).

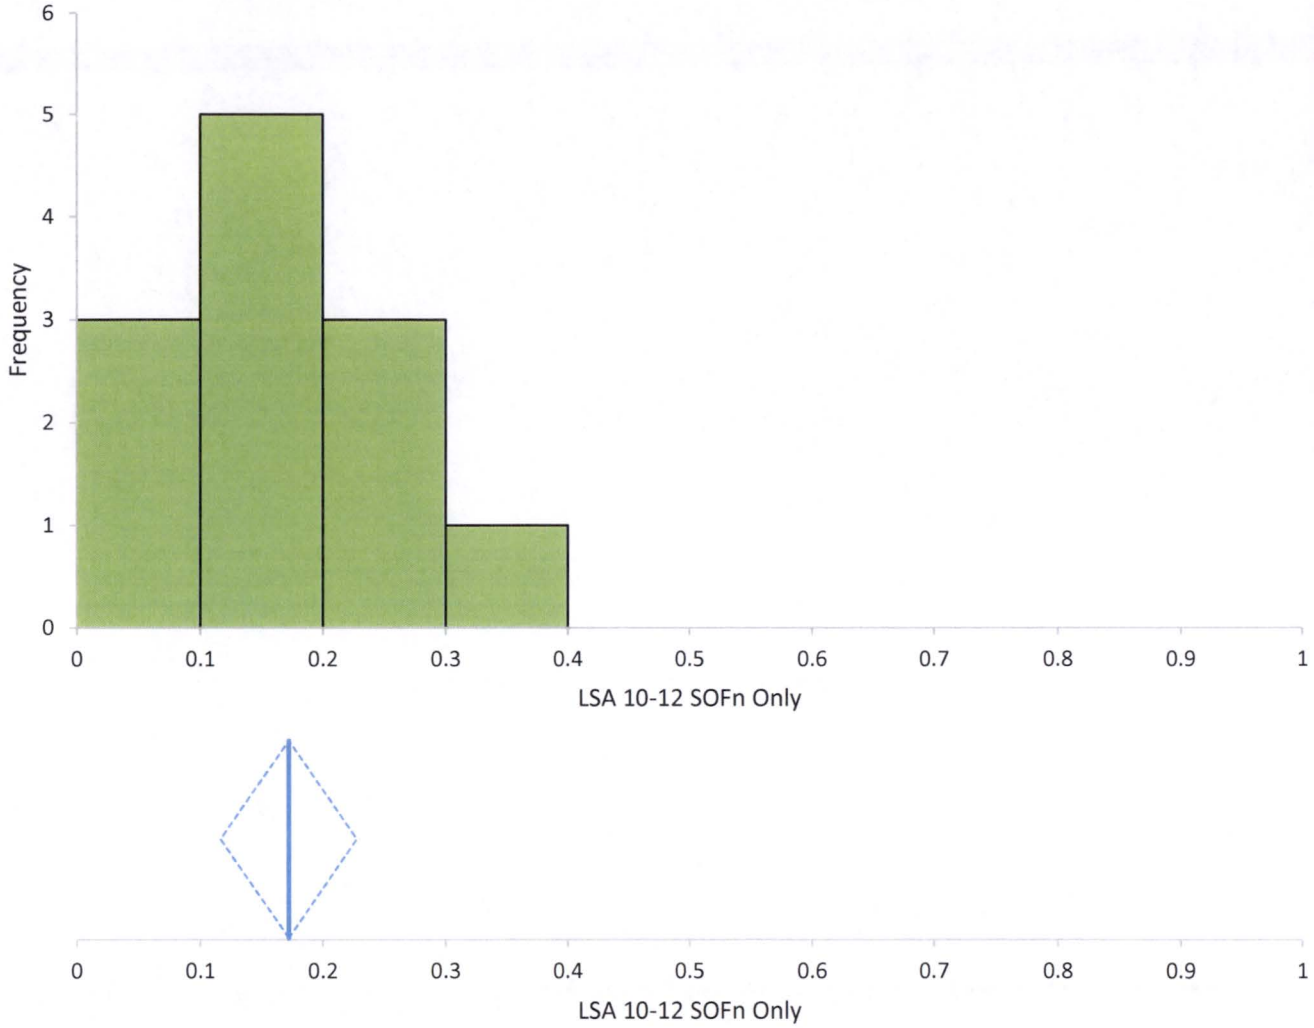
Figure 7-3
Graphic Statistical Summary for LSA 10-12 (SOF parameter)

Figure 7-3 exhibits no unusual symmetry or bimodality concerns for the LSA 10-12 data associated with the systematically collected measurement locations.

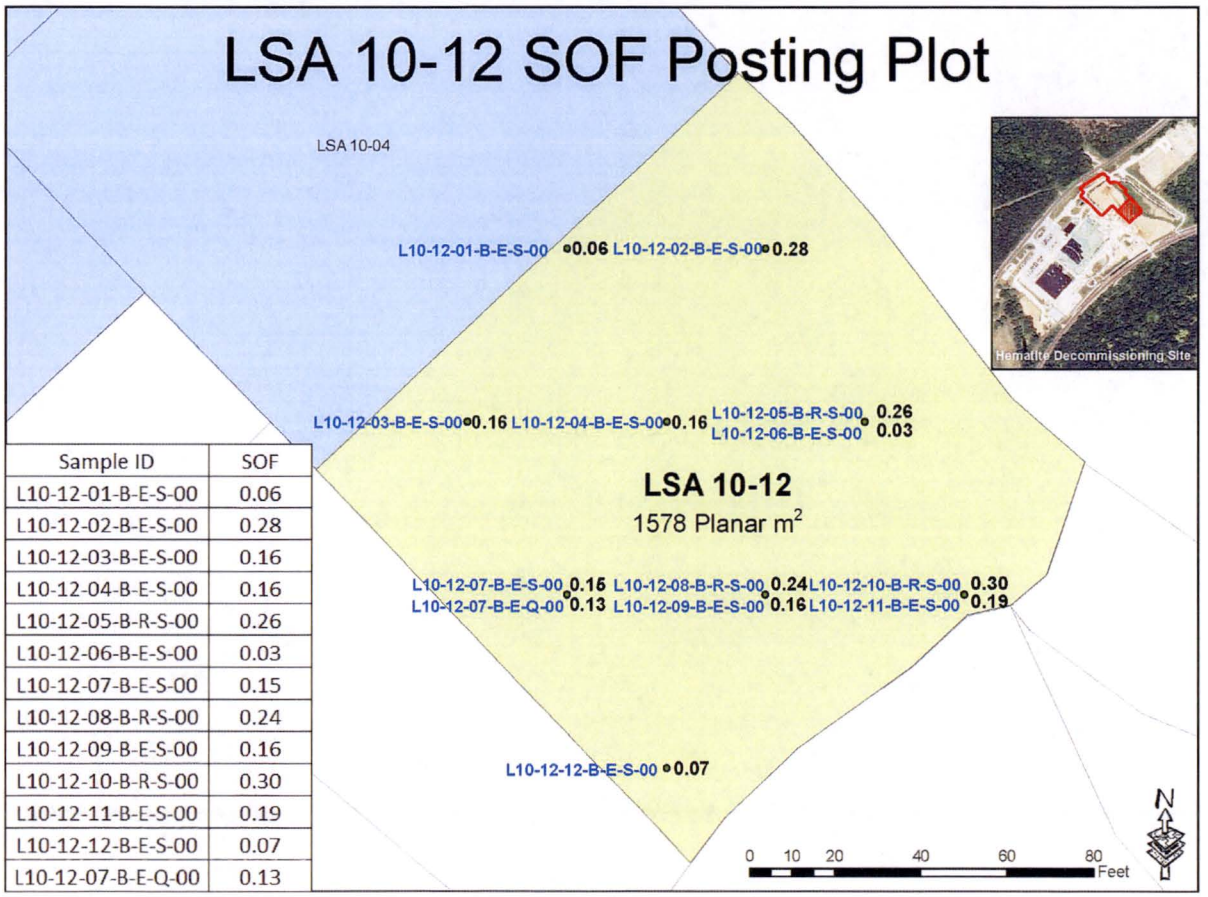
Figure 7-4
Posting Plot for LSA 10-12 Systematic Measurement Locations

A posting plot is simply a map of the survey unit with the data values (in this case the SOF values for each systematically collected sample) entered at the measurement locations. This potentially reveals heterogeneities in the data – especially possible patches of elevated residual radioactivity. The posting plot for LSA 10-12 is presented below in Figure 7-4. Figure 7-4 shows no unusual patterns in the data.
