SEISMIC SIMULATION AND RADIATION TEST PROGRAM

SEVEN PRESSURE SWITCHES

REPORT NO. 44285-1

Test Report No. 16013-2

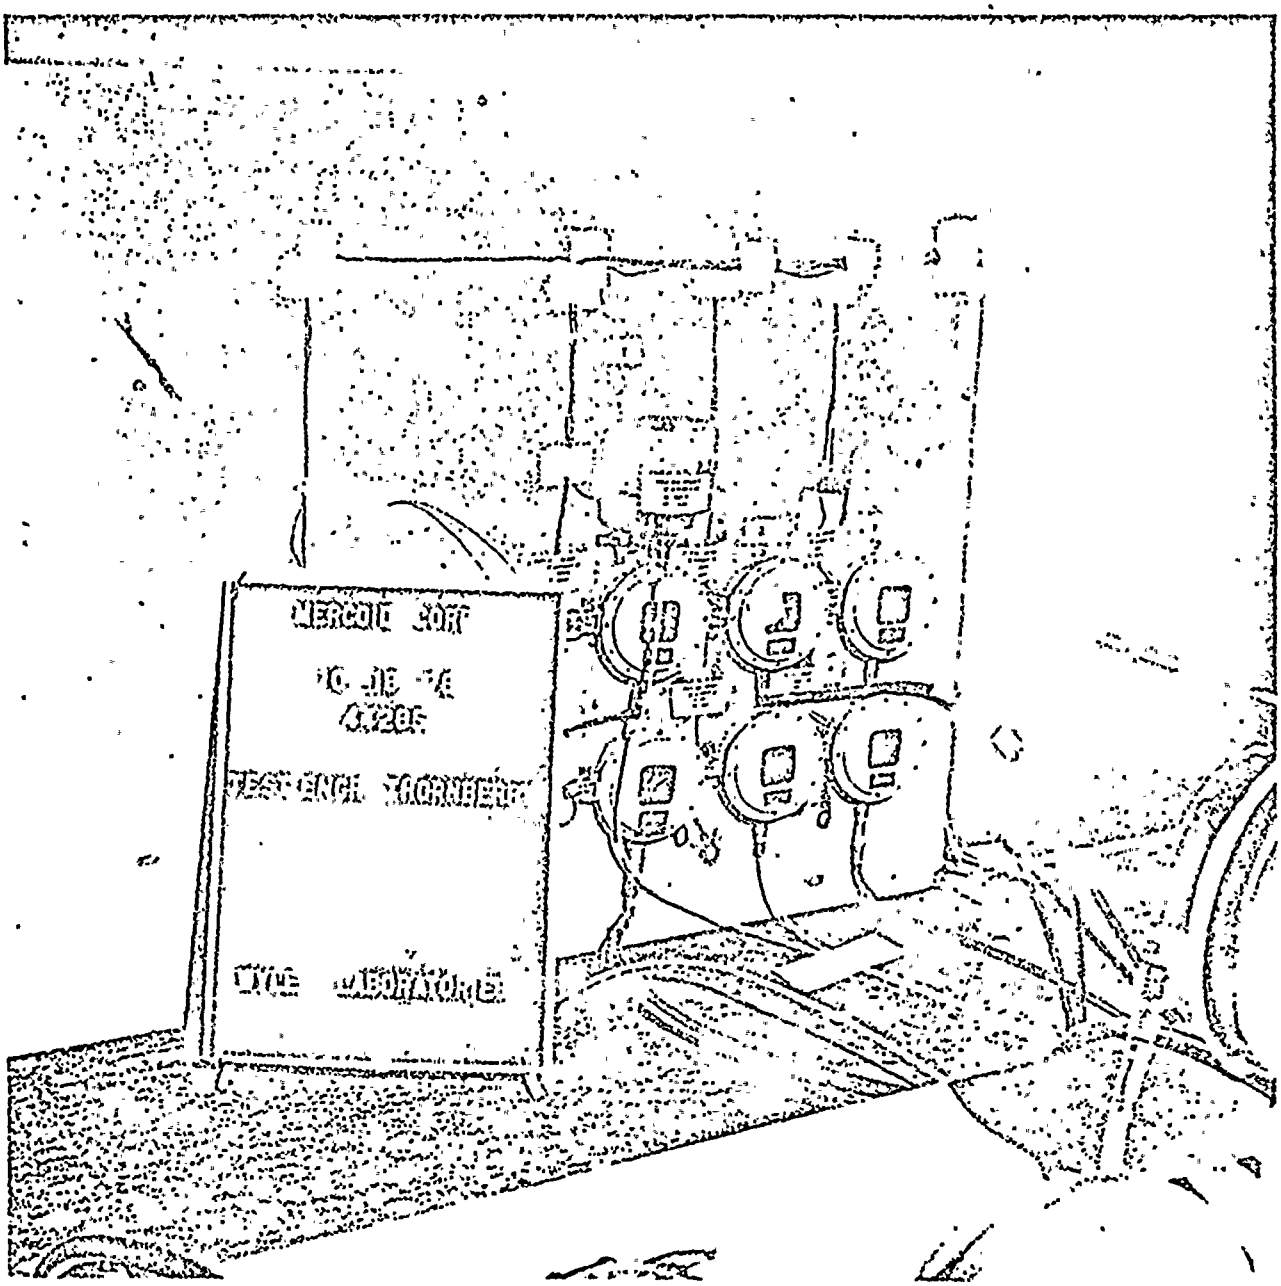
PHOTOGRAPH 1

Photograph 1 shows the specimens installed in the side-to-side and vertical orientation for biaxial testing on the Wyle Multiaxis Seismic Simulator Table.

The specimens were initially installed on the Seismic Simulator Table in the SS/V test orientations, as shown in Photograph 1. For the second orientation of tests, the specimens were rotated 90 degrees in the horizontal plane to the FB/V test orientation.

TEST SETUP
SIDE-TO-SIDE/VERTICAL ORIENTATION

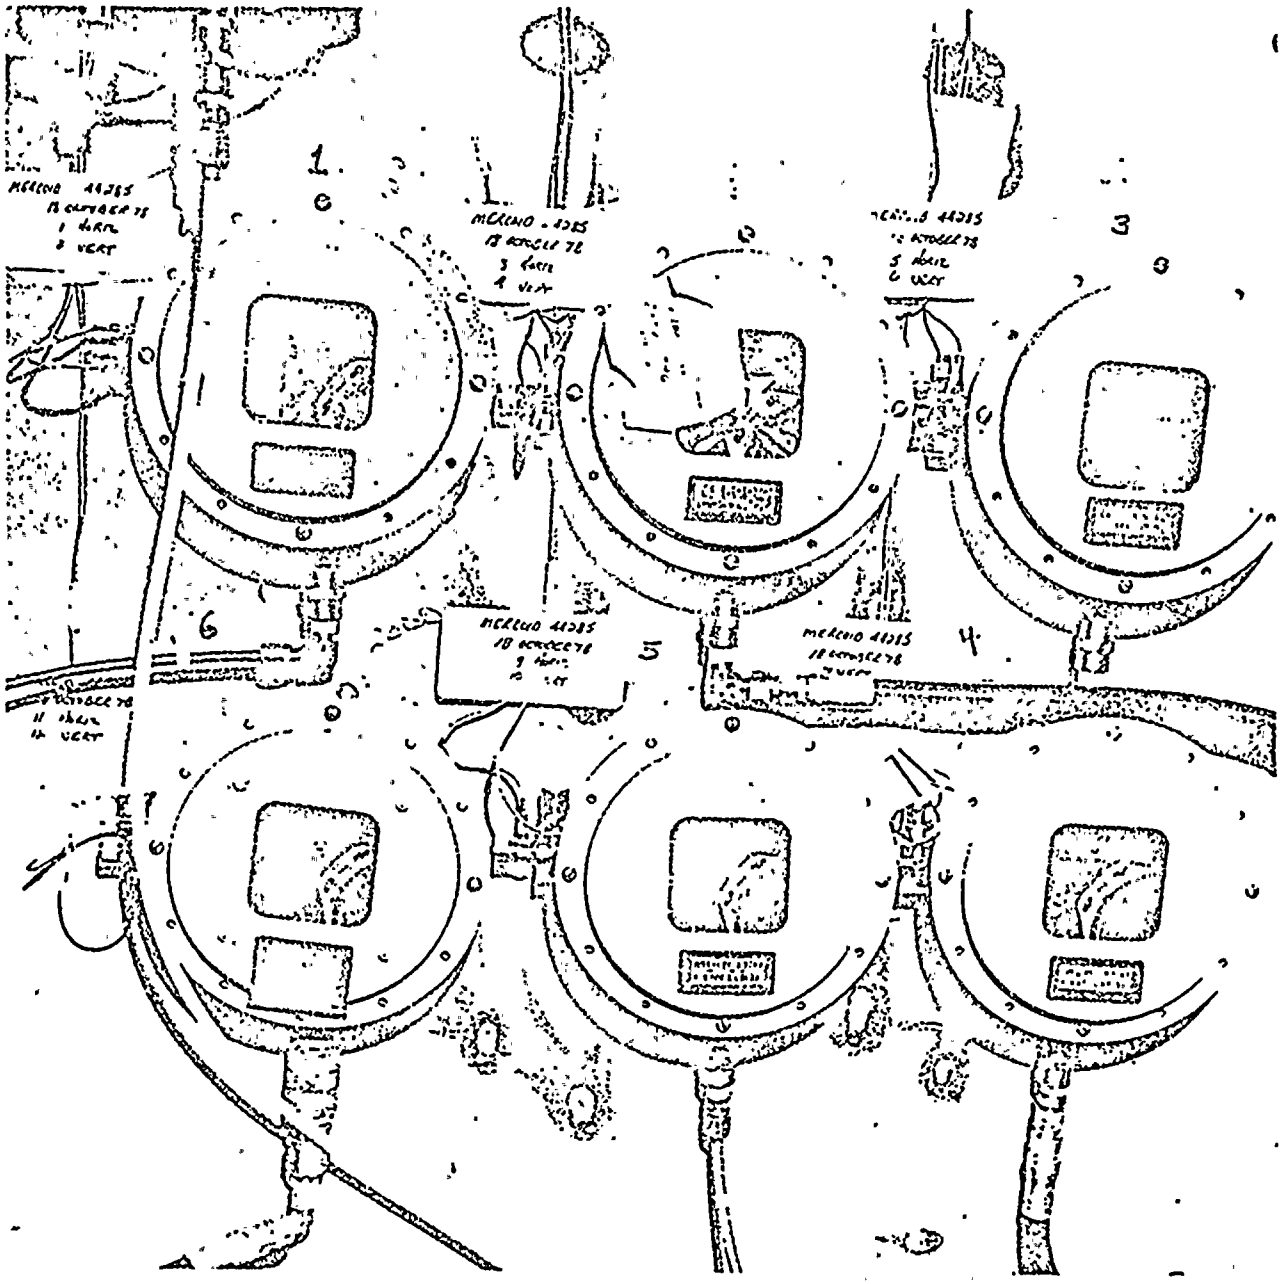
PHOTOGRAPH 2

Photographs 2 and 3 show the specimen response accelerometer mounting locations.

A total of fourteen (14) uniaxial piezo-electric accelerometers were located on the specimens as shown in Photographs 2 and 3. The placement of the accelerometers was at the discretion of the Mercoid Technical Representative. FM tape and oscillograph recorders provided a record of each accelerometer response. The horizontal accelerometers were oriented in the side-to-side direction during the SS/V testing and re-oriented to the front-to-back direction during the FB/V testing.

ACCELEROMETER LOCATIONS
ITEM 1 - 1H, 2V; ITEM 2 - 3H, 4V;
ITEM 3 - 5H, 6V; ITEM 4 - 7V, 8H;
ITEM 5 - 9H, 10V; ITEM 6 - 11H, 12V

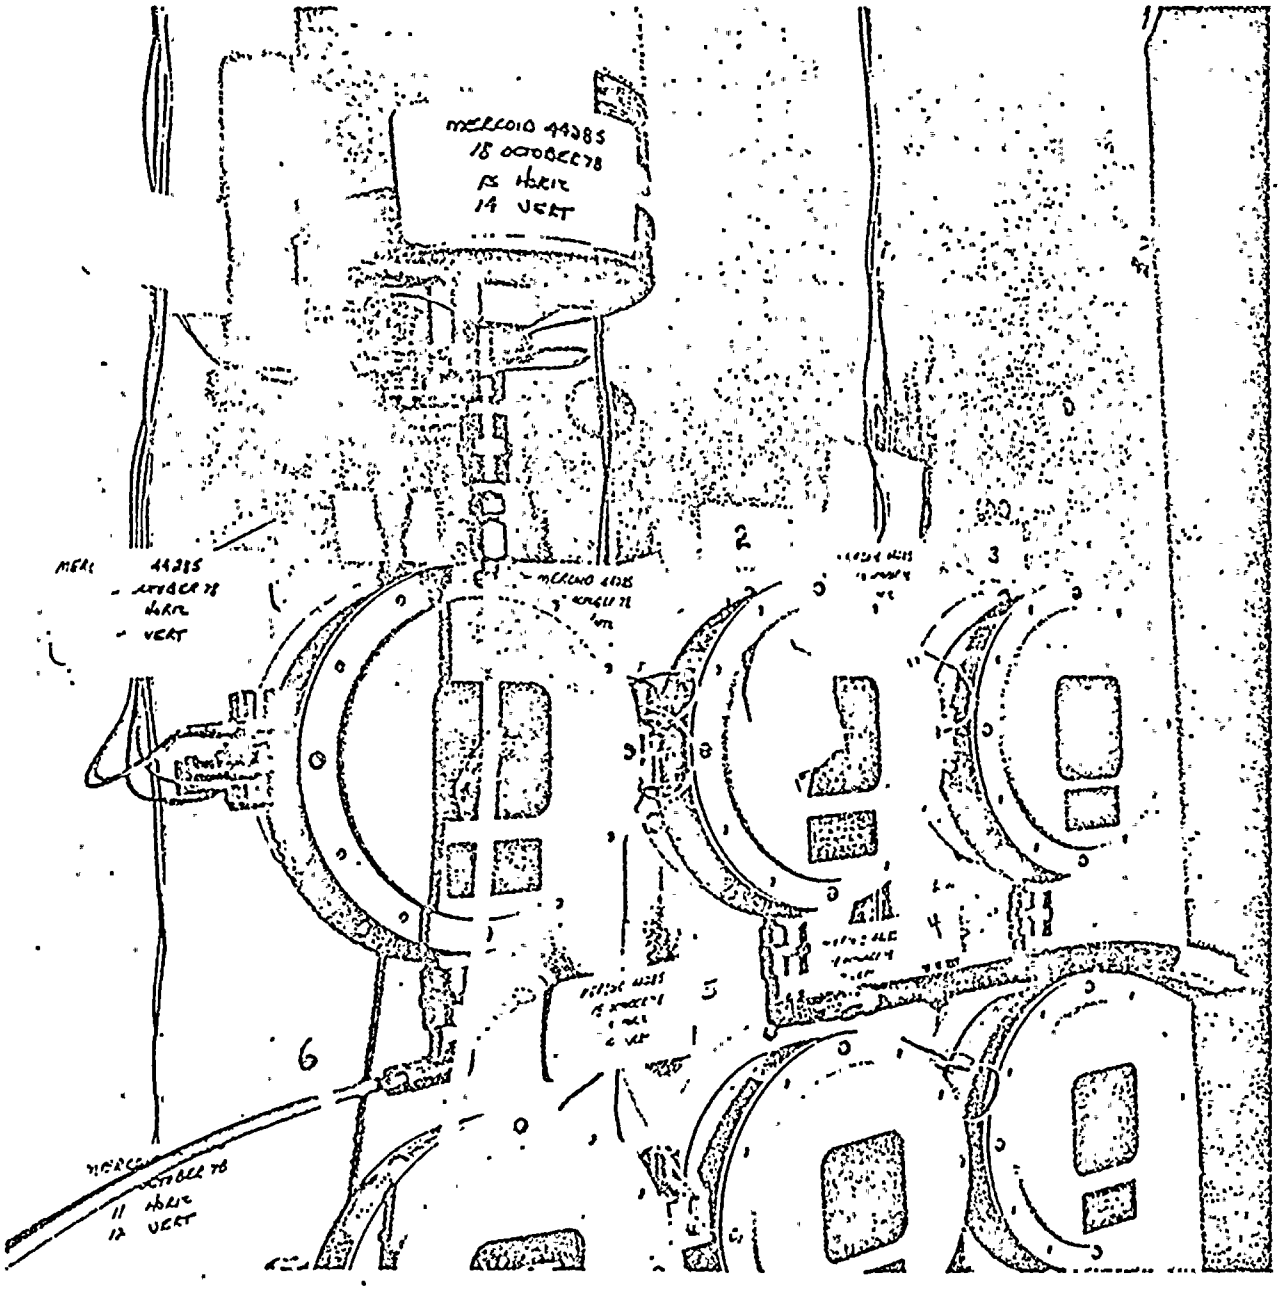
PHOTOGRAPH 3

ACCELEROMETER LOCATION
ITEM 7 - 13H, 14V

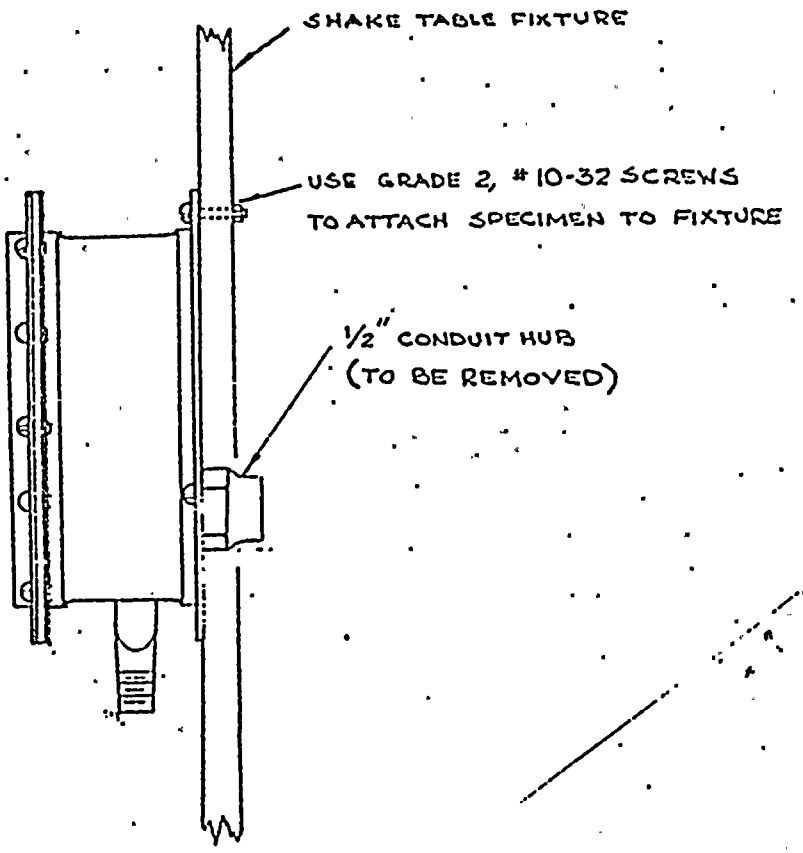
FIGURE 1
TEST MOUNTING

Each Mercoid pressure switch was mounted on the vertical surface of a steel plate vibration test fixture in the manner shown in Figures 1 and 2. After each Mercoid pressure switch was plumbed and mounted, the test fixture/test item assembly was securely attached to the 45° biaxial table of the AETC seismic test facility. The use of the 45° biaxial table results in equal horizontal and vertical input components.

Following the completion of the multiple frequency vibration test, items 82079 and 82084 were subjected to the following environmental test. The test items, mounted vertically as shown in Figure 1, were placed inside an AETC high pressure test chamber. The pressure switches were plumbed and wired through the chamber wall such that the switches could be pressurized and electrically monitored during the elevated temperature and pressure test.

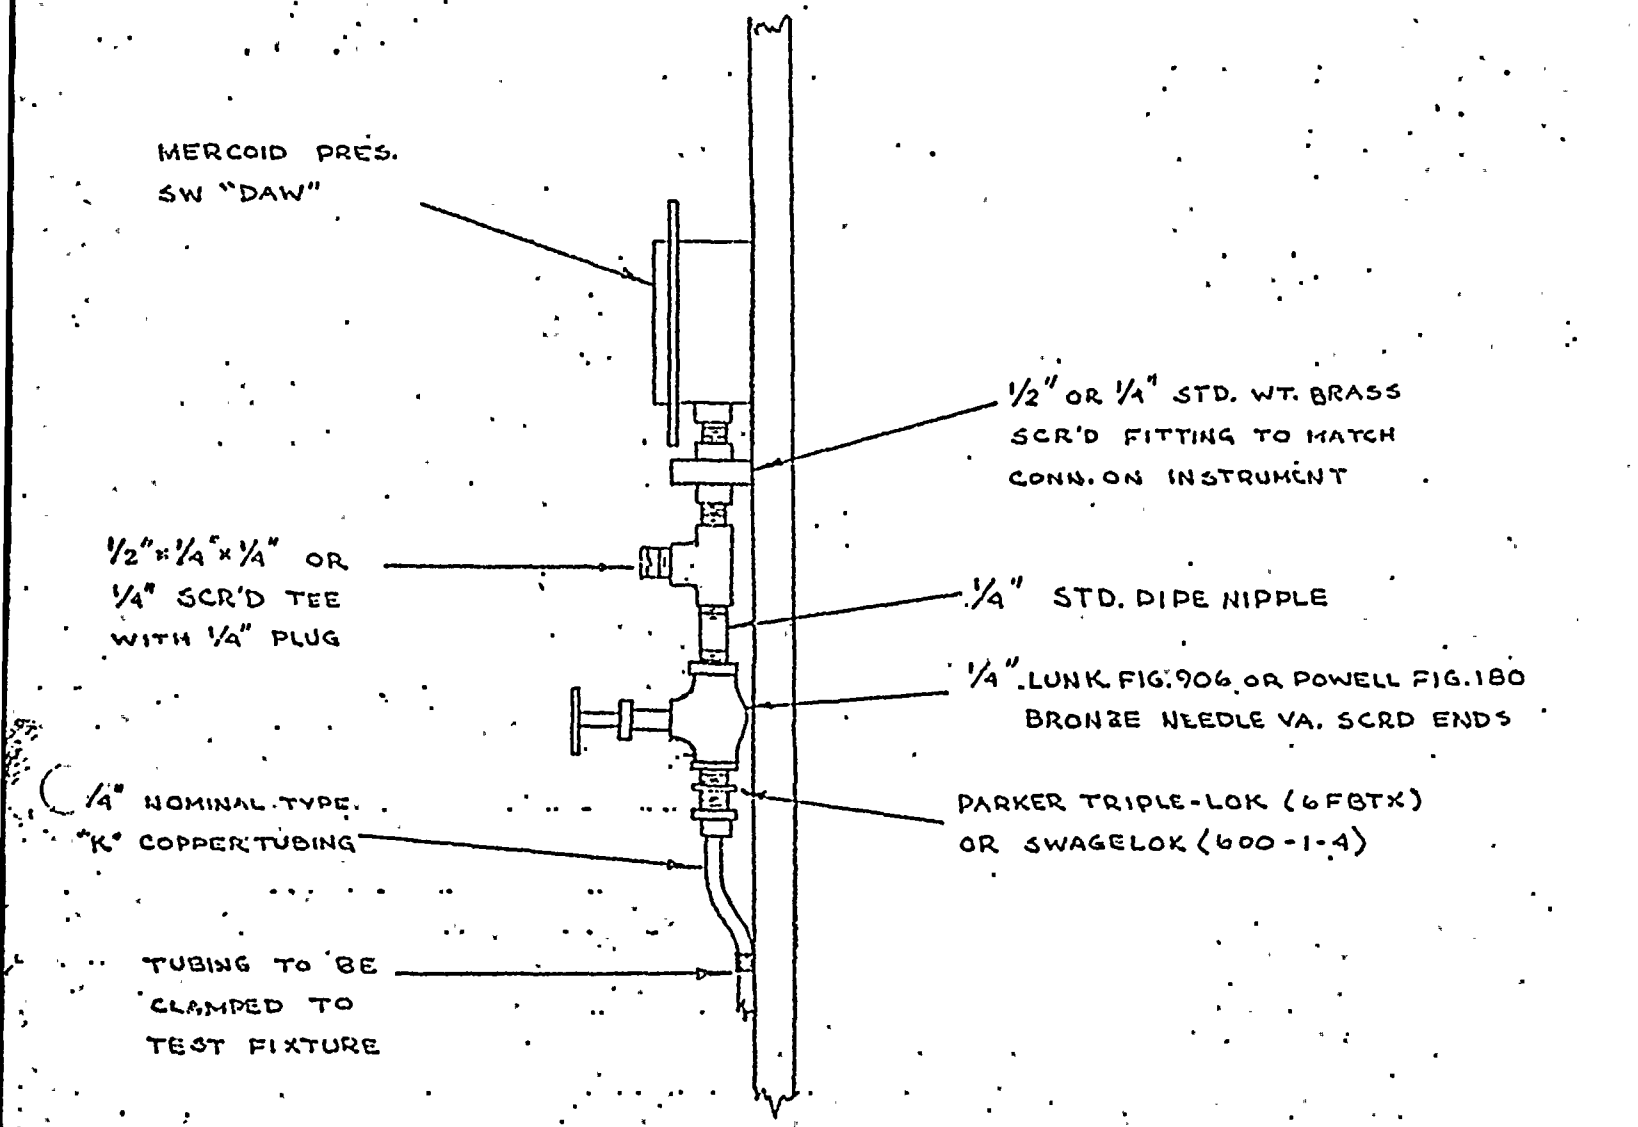
FIGURE 2

TEST MOUNTING

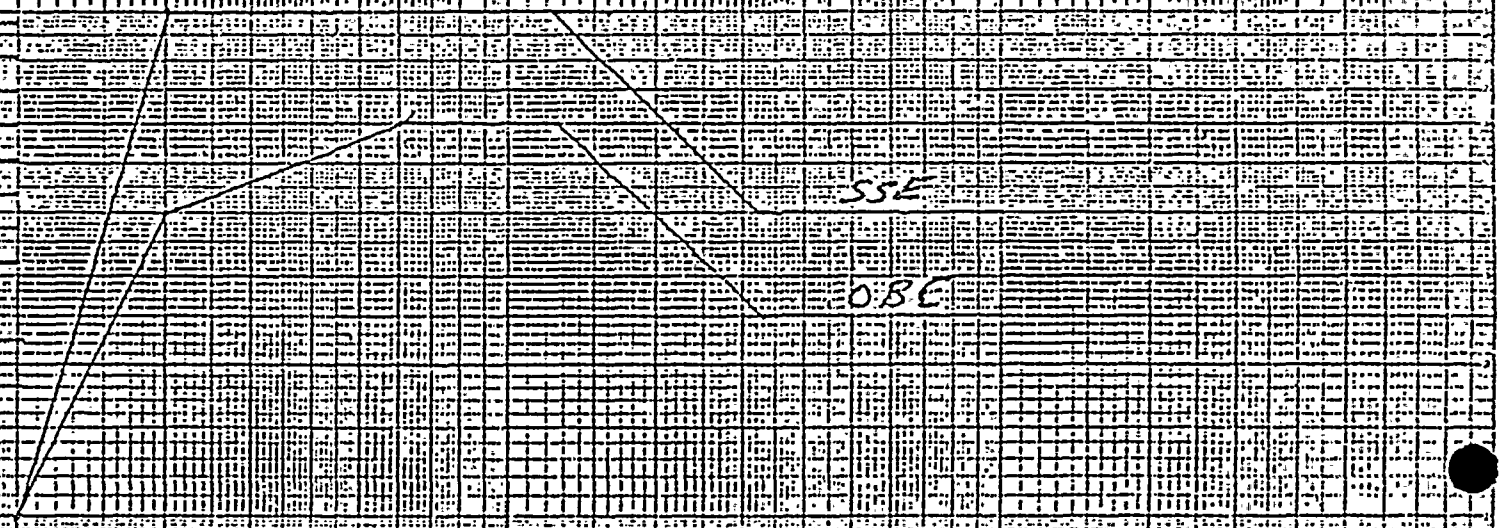
FIGURE 10

For test items 82075-82083, 82085 and 82086, there was no evidence of mechanical damage, deterioration, false closure of open contacts for longer than 3 milliseconds or false opening of closed contacts for longer than 10 milliseconds, or interference with proper operation detected during or as a result of the multiple frequency test performed at the full SSE shown in Figure 10.

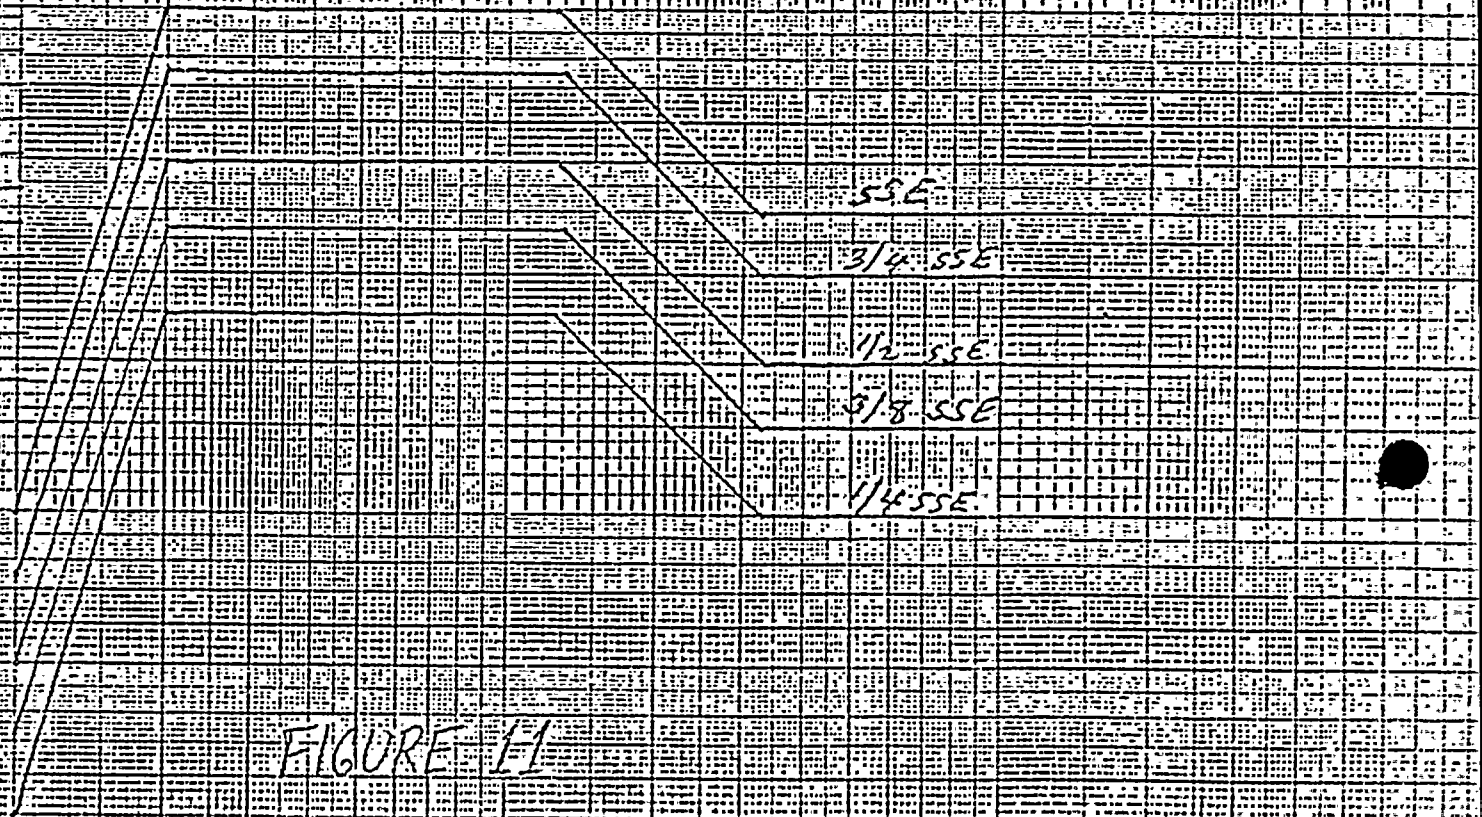
FIGURE 11

For those test items which failed to fulfill the qualification acceptance criteria during the SSE levels of multiple frequency testing (test runs #6 & #7), additional testing was done at lower vibration input levels until a maximum level was determined at which the unit would qualify. The additional multiple frequency testing was conducted using RRS curves of 3/4 SSE, 1/2 SSE, and 1/4 SSE as shown in Figure 11. The additional test runs were each 30 seconds in duration.

For test items 82084 and 82087-82089, there was no evidence of mechanical damage, deterioration, false closure of open contacts for longer than 3 milliseconds or false opening of closed contacts for longer than 10 milliseconds, or interference with proper operation detected during or as a result of the multiple frequency test performed at the following levels, shown in Figure 11.

ITEM NO.	QUALIFICATION LEVELS TEST CONDITION #1	TEST CONDITION #2
82084	SSE	3/8 SSE
82087	3/4 SSE	1/2 SSE
82088	SSE	1/2 SSE
82089	3/4 SSE	3/4 SSE
