BRUNSWICK STEAM ELECTRIC PLANT, UNIT NOS. 1 AND 2
DOCKET NOS. 50-325 AND 50-324/LICENSE NOS. DPR-71 AND DPR-62
RESPONSE TO REQUEST FOR ADDITIONAL INFORMATION REGARDING
REQUEST FOR LICENSE AMENDMENTS - FREQUENCY OF PERFORMANCE-
BASED LEAKAGE RATE TESTING
(NRC TAC NOS. MB3470 AND MB3471)

BRUNSWICK STEAM ELECTRIC PLANT, UNIT NOS. 1 AND 2
DOCKET NOS. 50-325 AND 50-324/LICENSE NOS. DPR-71 AND DPR-62
RESPONSE TO REQUEST FOR ADDITIONAL INFORMATION REGARDING
REQUEST FOR LICENSE AMENDMENTS - FREQUENCY OF
PERFORMANCE-BASED LEAKAGE RATE TESTING
(NRC TAC NOS. MB3470 AND MB3471)

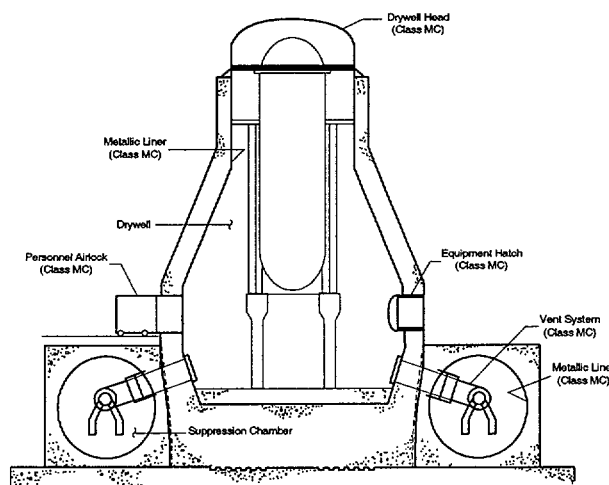
Figure 1

BSEP Units 1 and 2 are BWR-4s with Mark I steel-lined, reinforced concrete primary containments (i.e., refer to Figure 1). The concrete primary containment is comprised of three major components: (1) Drywell, (2) Suppression Chamber, and (3) Vent System.

The Drywell is composed of a series of vertical right cylinders and truncated cones with inside diameters between approximately 65 feet to 36 feet. The overall height from the top of the foundation mat to the Drywell head flange is approximately 111 feet. The Drywell is sealed at the top with a steel pressure vessel head bolted to the reinforced liner plate extension that is in turn anchored to the reinforced concrete.

The Suppression Chamber (i.e., also referred to as the Torus) is a 16-sided steel liner, reinforced concrete pressure vessel in a shape of a torus. The Suppression Chamber is approximately 40 percent filled with water and encircles the lower portion of the Drywell structure.

The Vent System connects the Drywell and the Suppression Chamber. Eight circular vent lines (i.e., approximately 76 inches in diameter), equally spaced around the periphery of the Drywell, connect the Drywell to a vent ring header contained within the air space of the Suppression Chamber. Projecting downward from the vent ring header are 96 downcomer pipes that terminate below the water level in the Suppression Chamber. For clarification, only the eight vent lines are part of the primary containment leakage boundary.
