DNC is Committed to Assuring Our Reactor Heads Perform Safely

Millstone 2 Features and Inspection Considerations

Reactor Head Nozzle Configuration

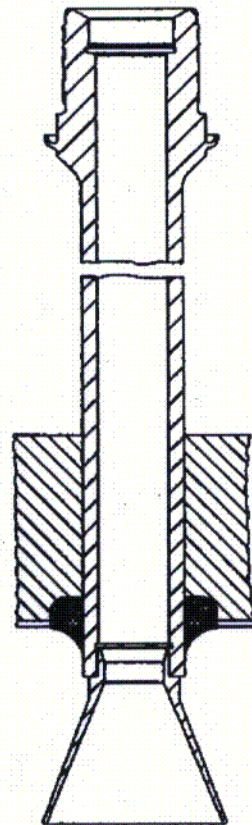
Nozzle Sketch

- ◆ *Ranked 29th in the susceptibility out of 69 PWRs*
- ◆ *CE designed and fabricated head using Huntington Alloys penetration tubes.*
- ◆ *Penetrations do not contain thermal sleeves*
- ◆ *Asbestos insulation of vessel head is contoured and close fitting to the head surface.*

TYPICAL CEDM NOZZLE

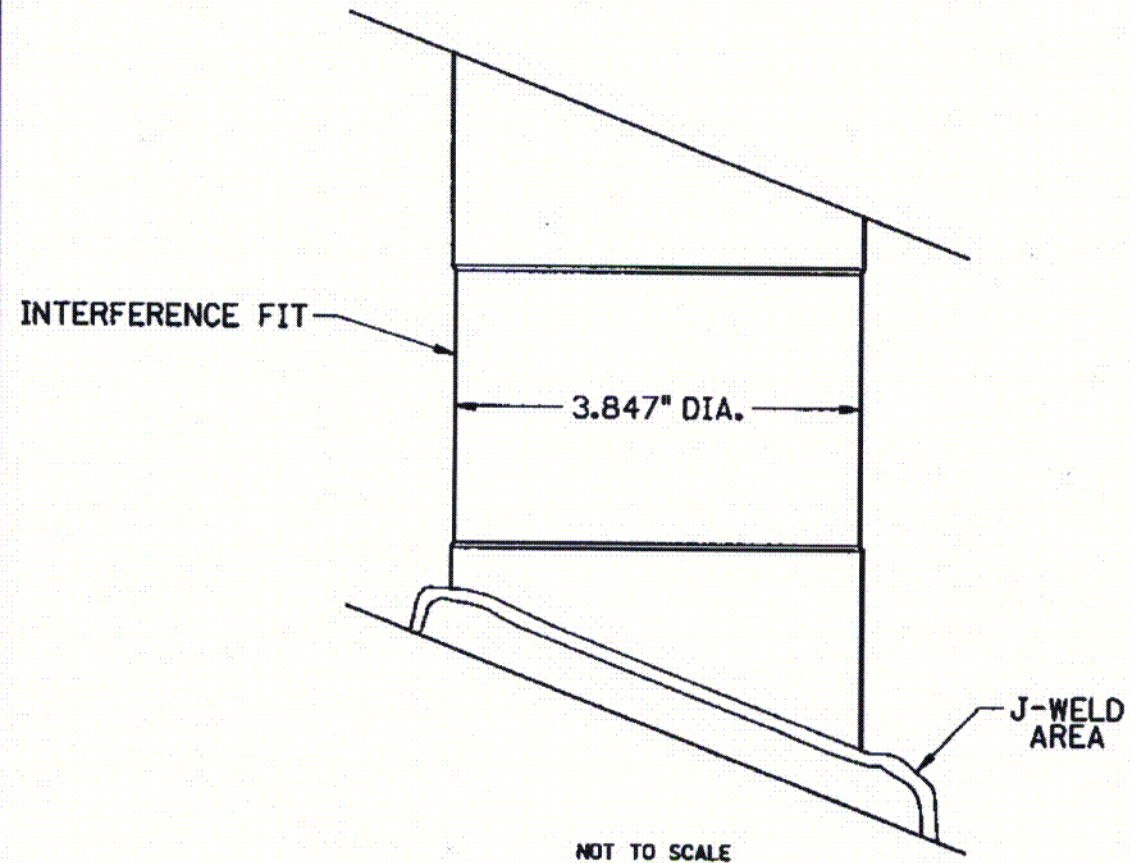
- ◆ *Methods - UT of the Interference Fit Region*
 - *Demonstrated to Millstone NDE personnel that data taken at various sites can reliably detect the leak path through the interference fit region.*
 - *The ability to review this region ultrasonically enhances our leak detection capabilities before a leak would be detected by a bare head visual examination.*

- The ultrasonic inspection technique, capturing reflected energy on computerized C-scan displays, can accurately detect a leak path emanating either from the weld to tube interface or above the weld through the interference fit region.*

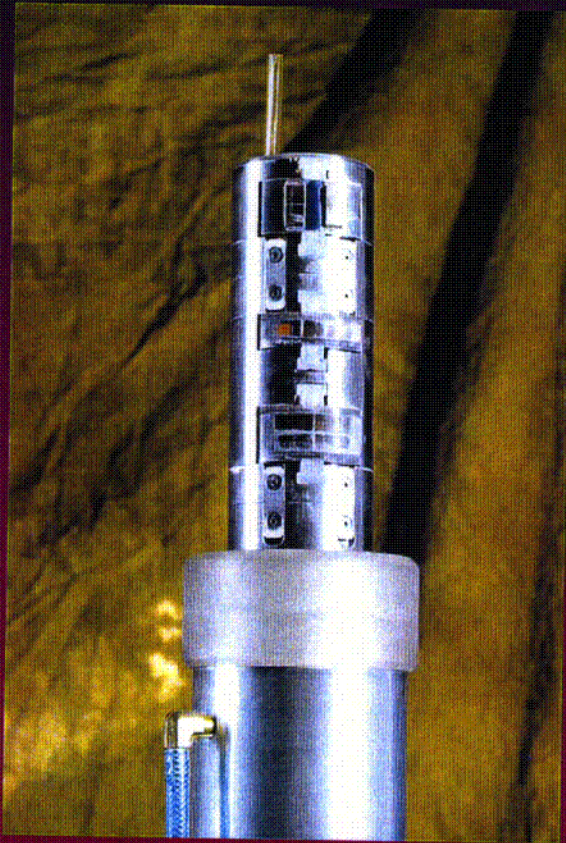
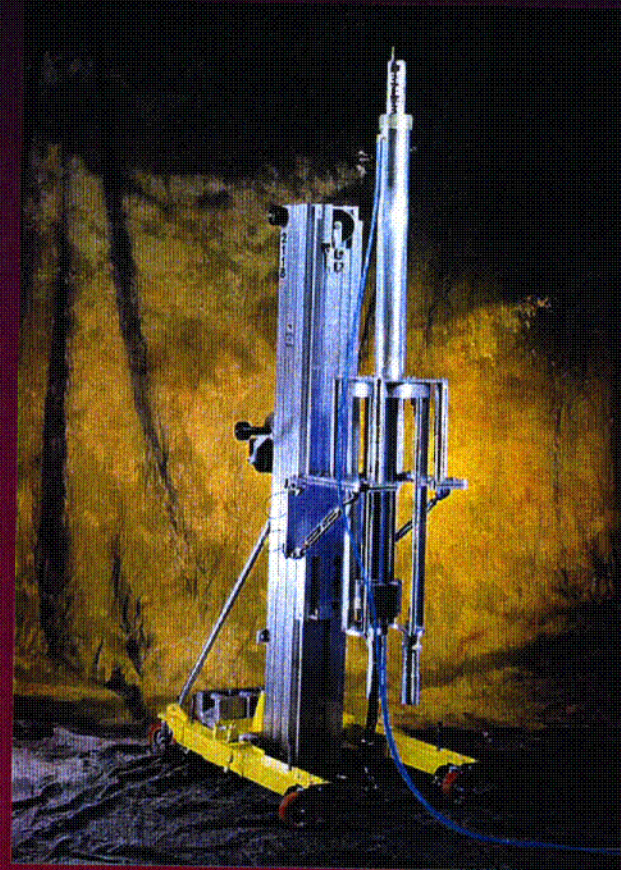
Bottom up Rotating UT Inspection Head and Delivery Tool

- ◆ *In Progress NDE Development*
 - *FTI is continuing to make advances in ultrasonic examination techniques that can assess cracks initiating in the weld region.*

- Continuous improvement in examination technique increasing their ability to detect all the flaws anticipated in the tube.*
- Continuous improvement in equipment enabling additional data to be obtained by incorporating multiple probe rotating head design.*
- Continuous improvement in examination technique to investigate interference fit region for evidence of a leak path.*

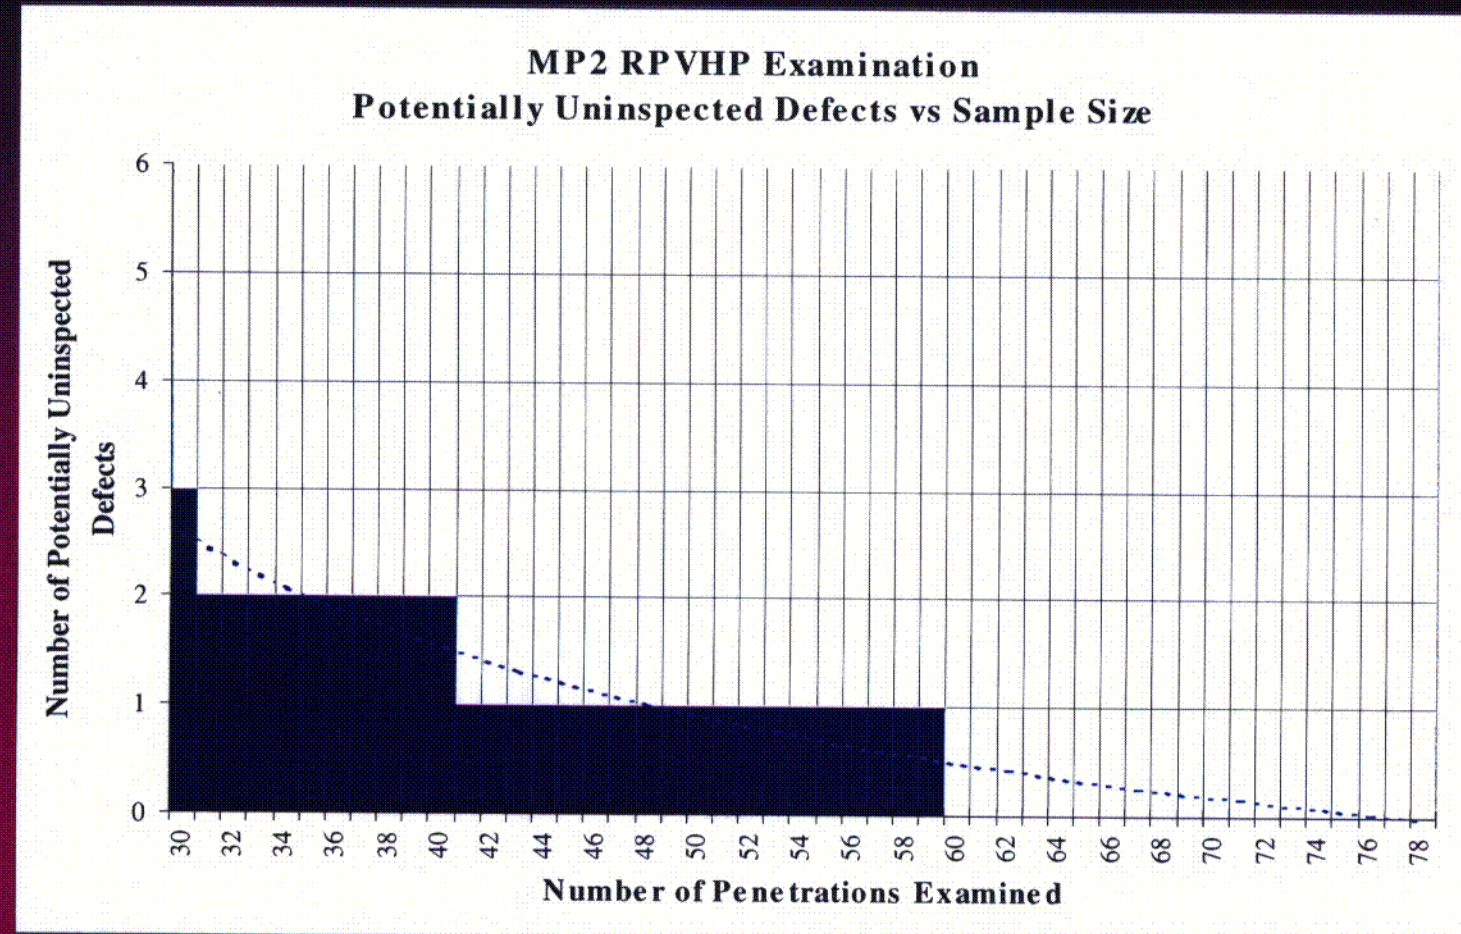
Figure 1
Defect Probability vs. Sample Size

where: r is the number of RPVHPs with unacceptable flaws (in our case we require that $r = 0$), $Z^2_{\alpha/2}$ is the normal variate exceeded with probability $\alpha/2$, and P is the probability of finding a RVHP nozzle with unacceptable flaws . Note that the equation above is for double-sided distribution.

Since we have a finite population with size $N = 78$, we replace $Z^2_{\alpha/2}$ by

$Z^2_{\alpha/2} (N-n)/(N-1)$ Note: for single-sided distribution replace $Z^2_{\alpha/2}$ with Z^2_{α}

- ◆ *Assumes that the UT inspection has identified no unacceptable flaws in “n” RPVHPs*
- ◆ *Calculates the upper 90% confidence limit on the number of RPVHPs with potentially unacceptable flaws as a function of “n”*
- ◆ *This method is appropriate for the RPVHP inspection since the population size is finite*
- ◆ *A random sampling that is consistent with SG Tube inspection will be employed*

- ◆ *For a large sample ($n > 30$), 100 (1- α) % confidence limit for P is given by:*

$$\begin{aligned} & [r + 0.5 \cdot Z_{\alpha/2}^2 \pm \{(r + 0.5 Z_{\alpha/2}^2)^2 - (n + Z_{\alpha/2}^2) r^2 / n\}^{1/2}] \\ & \text{divided by } (n + Z_{\alpha/2}^2) \end{aligned}$$
