Site Observational Work Plan for the Durango, Colorado, UMTRA Project Site

January 2002

Prepared by the
U.S. Department of Energy
Grand Junction Office

Project Number UGW-511-0006-10-000
Document Number U0143200

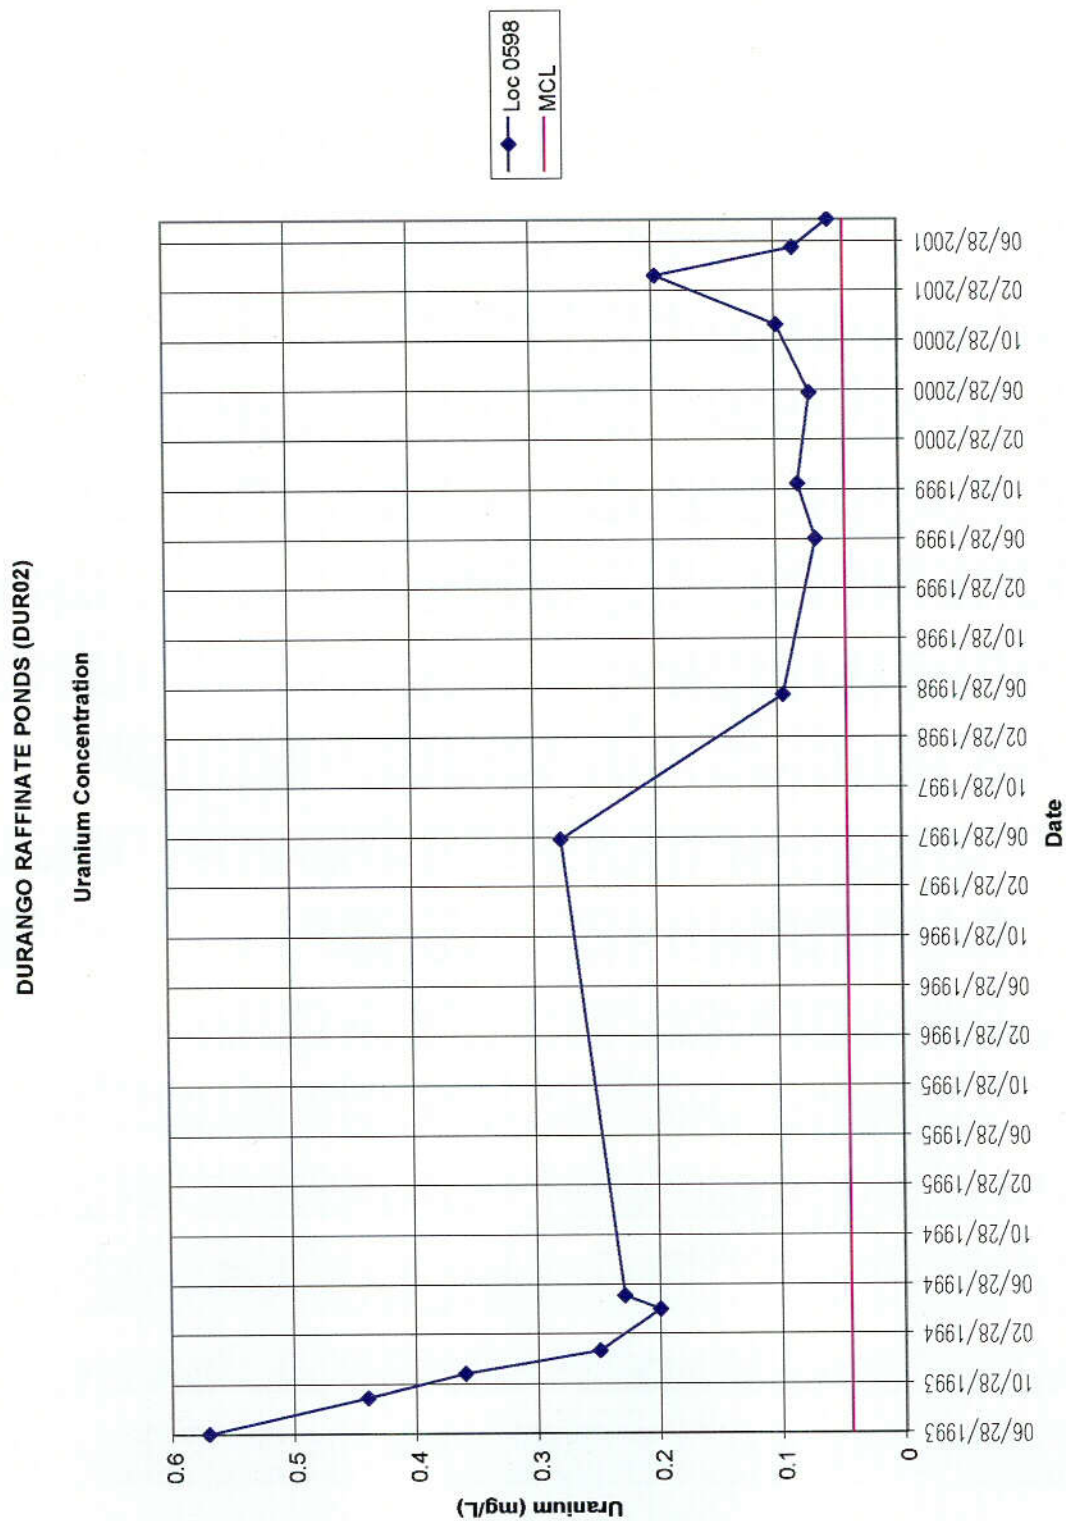
Figure 4-23. Uranium Concentration in Fault Well 598 at the Durango Raffinate Ponds Area

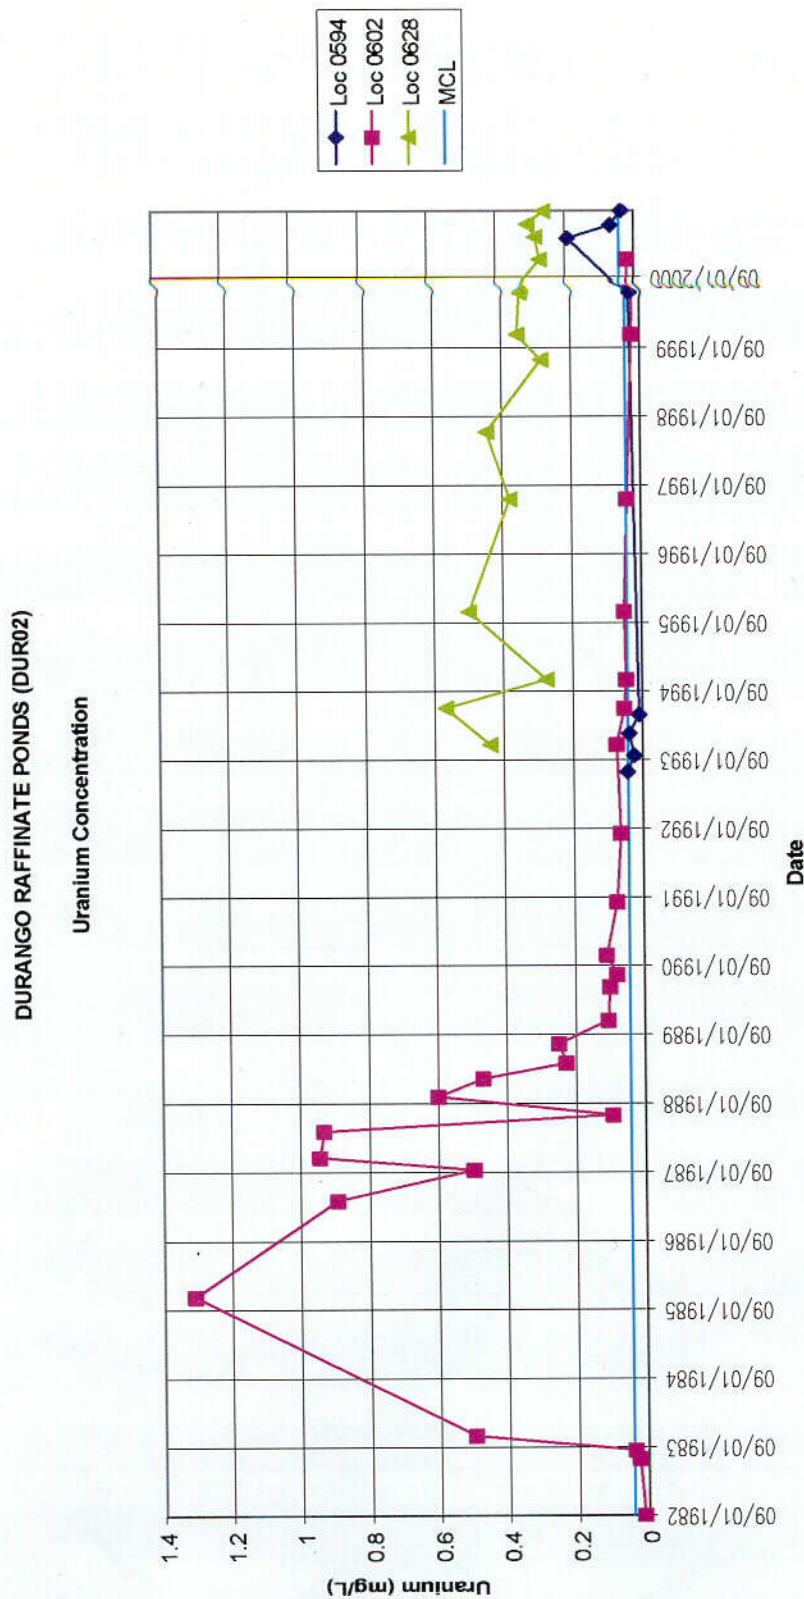
Figure 4-24. Uranium Concentration at the Durango Raffinate Ponds (DUR02)

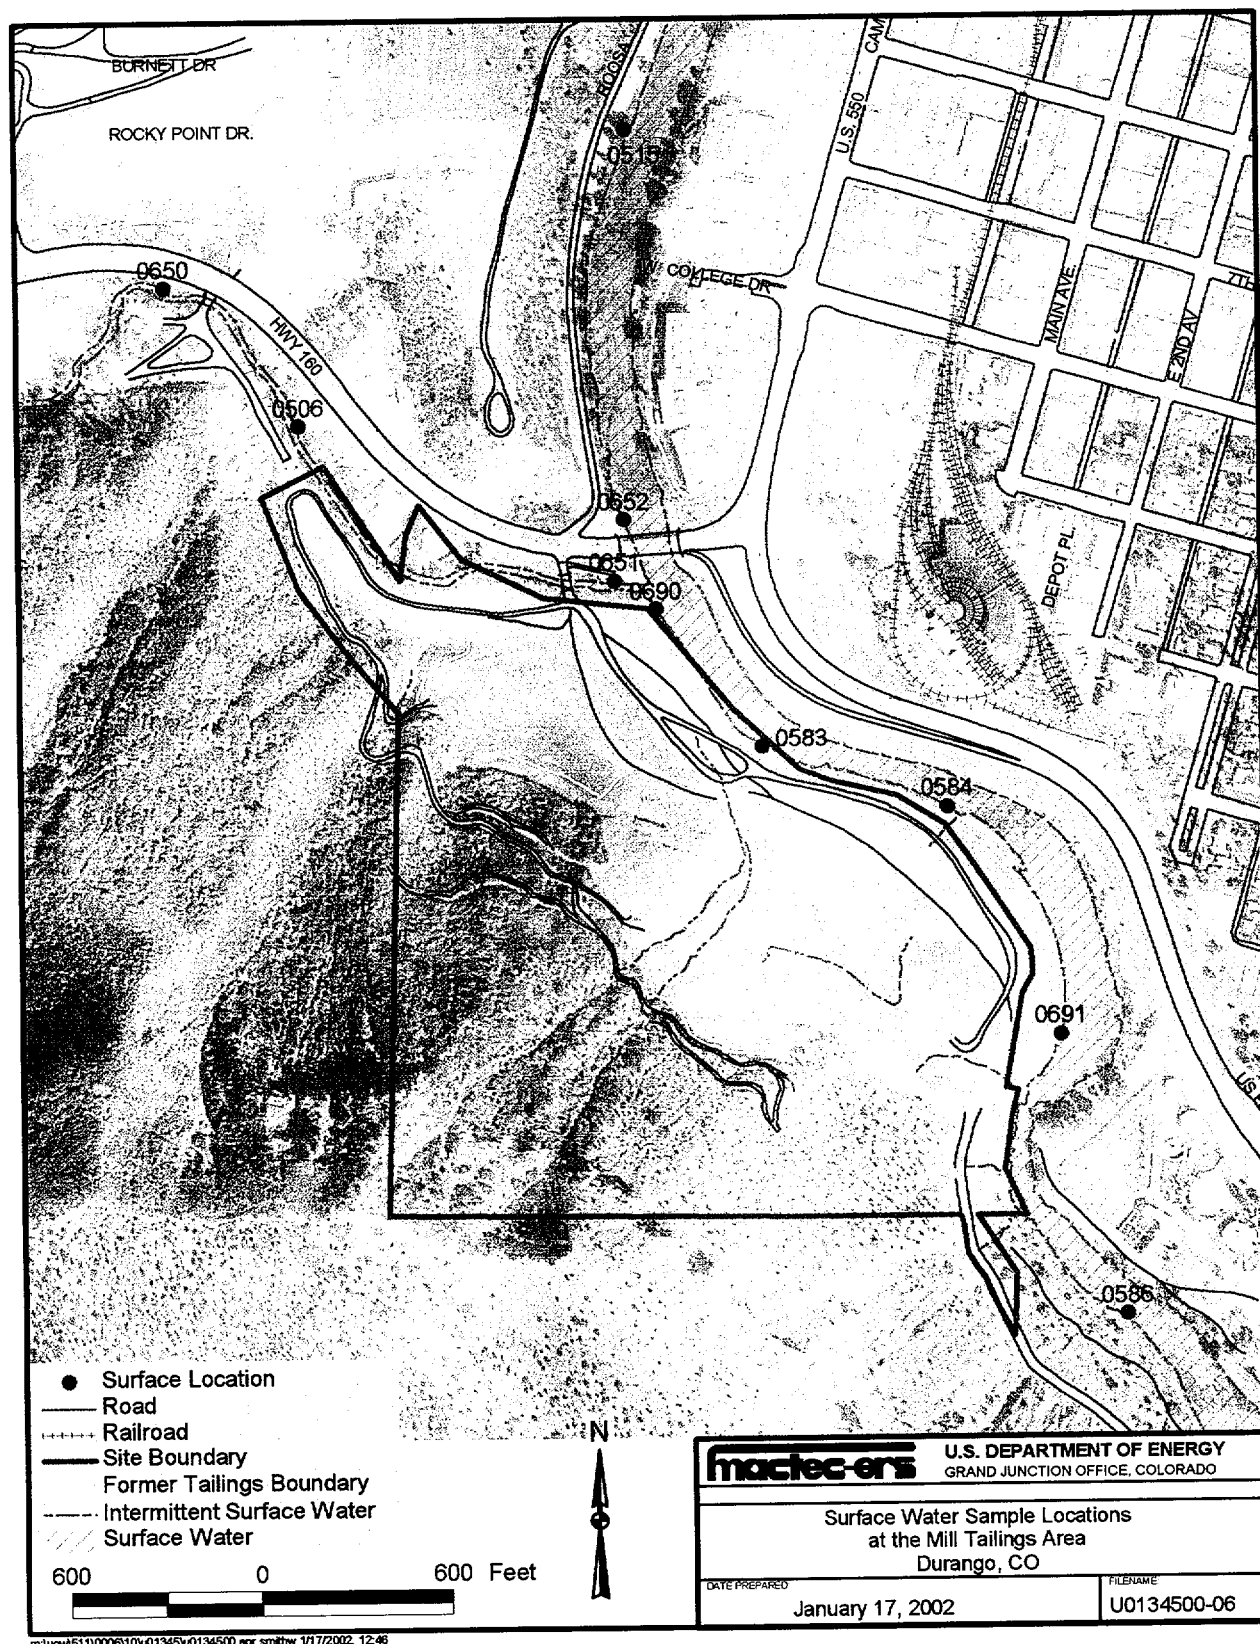
Figure 4-25. Surface Sample Locations at the Mill Tailings Area

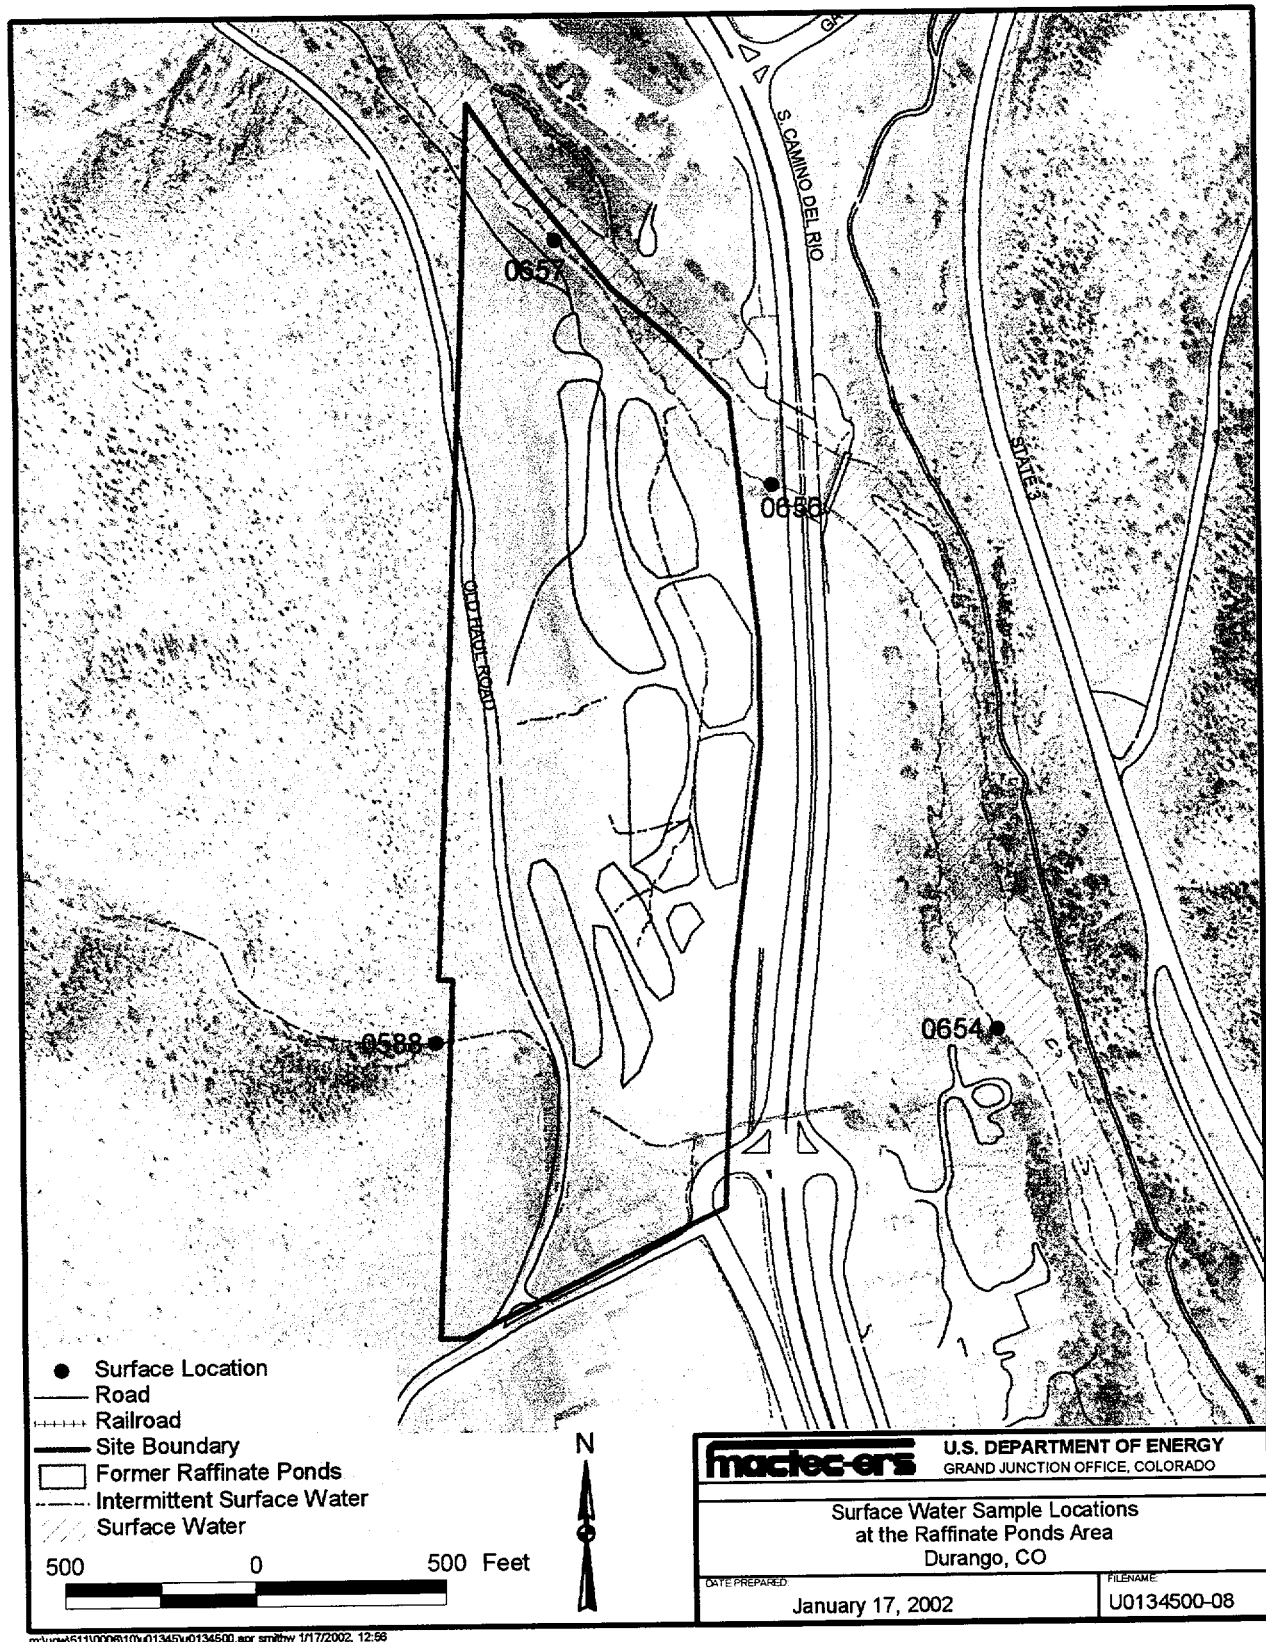
Figure 4-26. Surface Locations at the Raffinate Ponds Area

At the raffinate ponds area, surface water was sampled along South Creek, from one location upgradient of the site (0588). The Animas River was sampled at two locations adjacent to the site (0656 and 0657), and at one downgradient location (0654). Because of the proximity of the mill tailings area to the raffinate ponds area, the Animas River sample locations 0515 and 0652 were used to establish background for both sites. Raffinate ponds area surface water sample locations are shown in Figure 4–26.

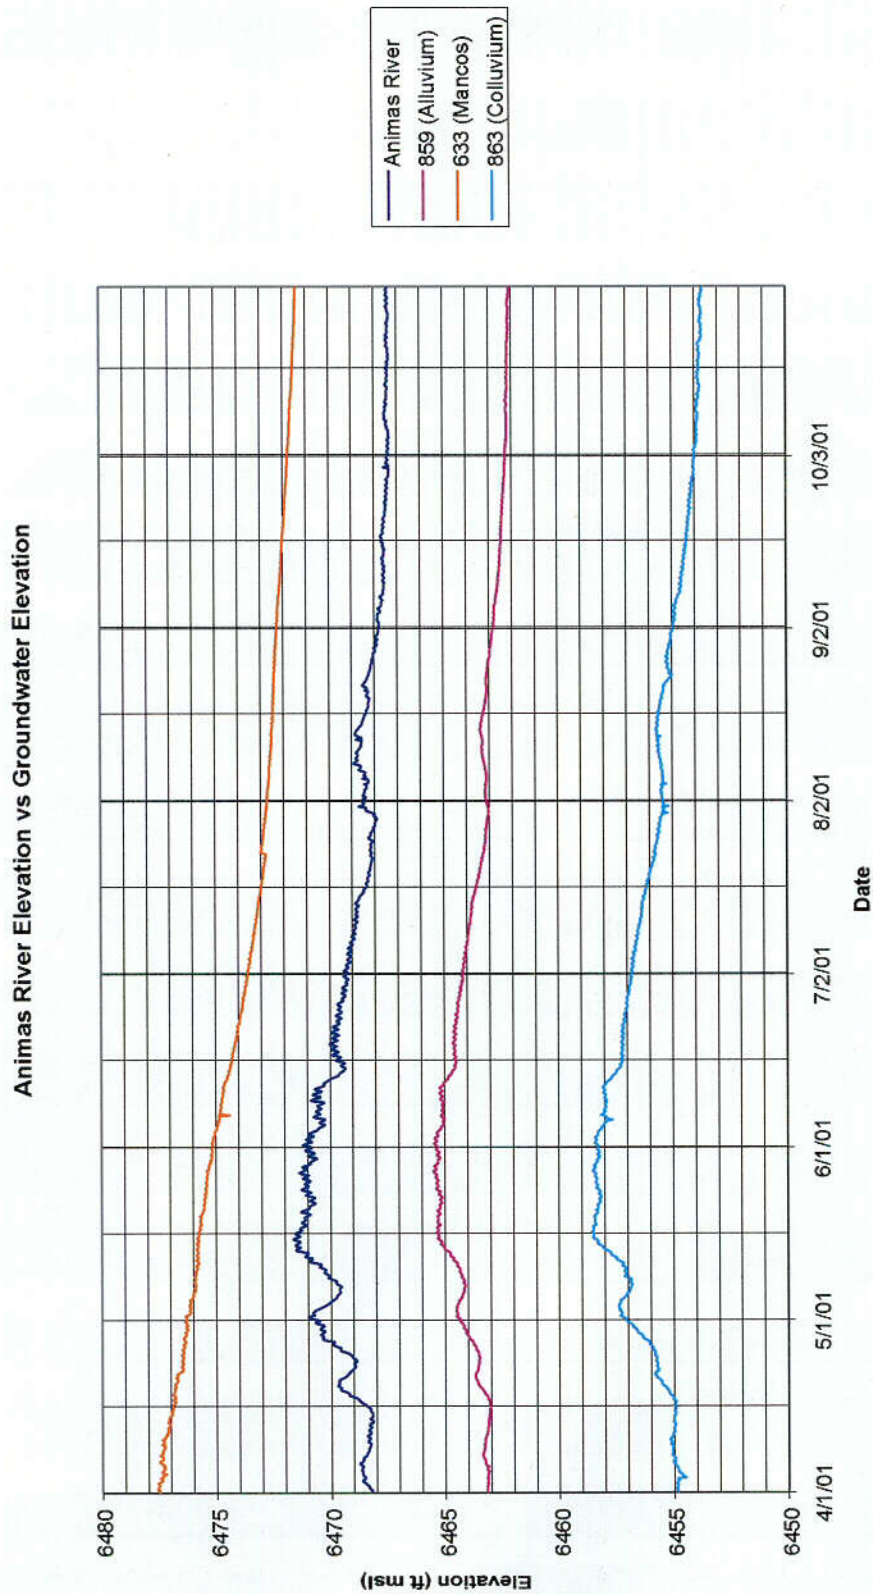
Figure 5-2. Animas River Elevation versus Ground Water Elevation

Wells 0863, 0859, and 0633 (completed in the colluvium, alluvium, and Mancos Shale, respectively) were equipped with dataloggers to monitor groundwater fluctuations between April and November, 2001. This data set is compared to the fluctuations of the Animas River stage in Figure 5-2. For comparison, the actual river elevation shown in Figure 5-2 is not as important as the fluctuation pattern shown, since the elevation is representative at only one point (stilling well 0876) along the Animas River.

Ground water in the colluvium and alluvium exhibit the same fluctuation pattern as displayed by the Animas River stage, confirming that water in these two units are hydraulically connected to the river. Ground water in the Mancos Shale onsite does not exhibit the same pattern. As shown in Figure 5-2, the Mancos Shale ground water surface does not show a definite peak in mid-May like the colluvium and alluvium units, suggesting the Mancos shale ground water flow system is impacted by a source other than the Animas River.

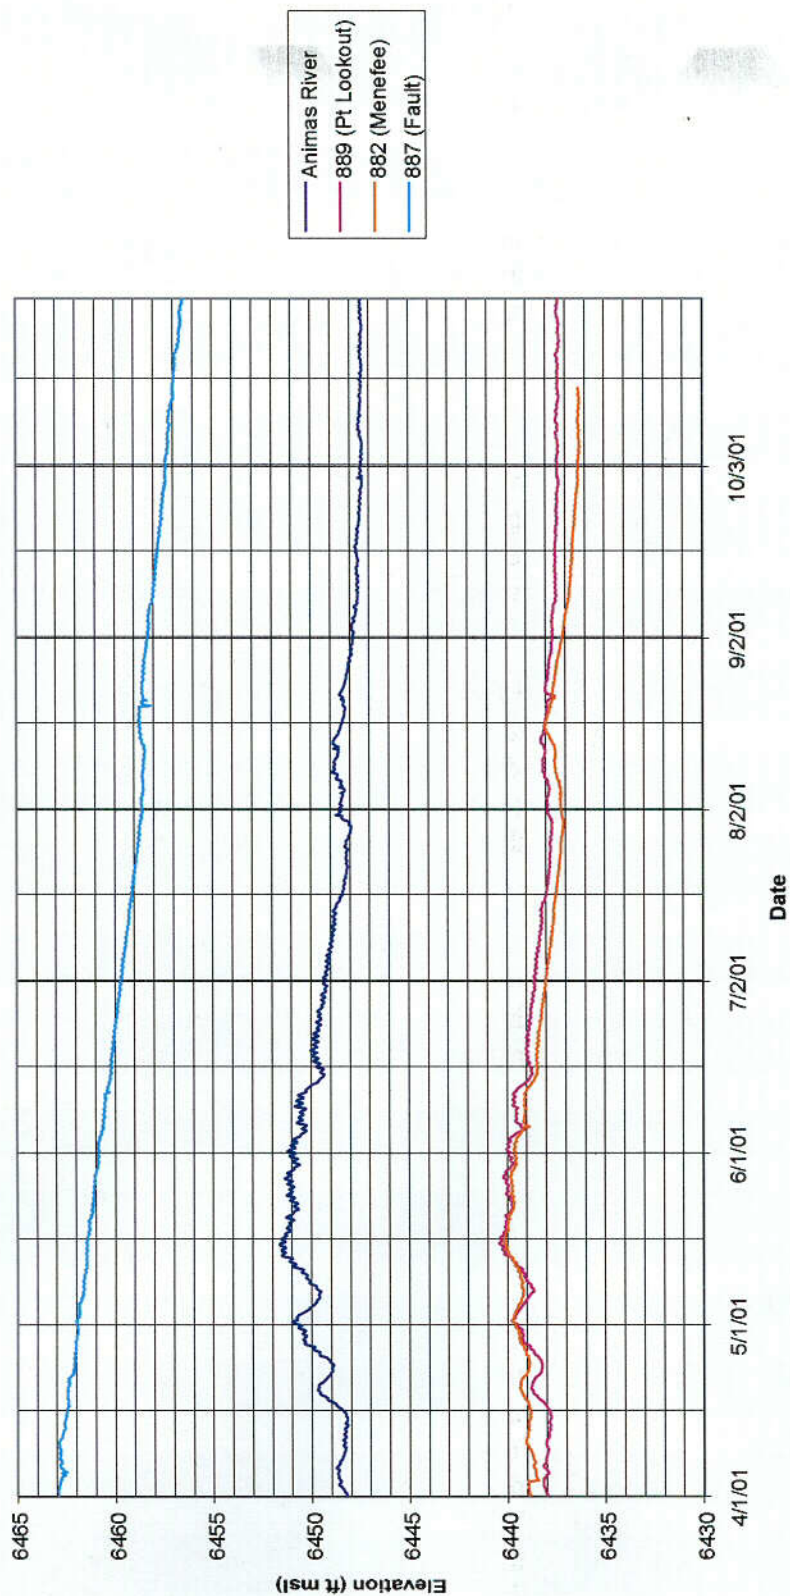
Figure 5-4. Animas River Elevation versus Ground Water Elevation

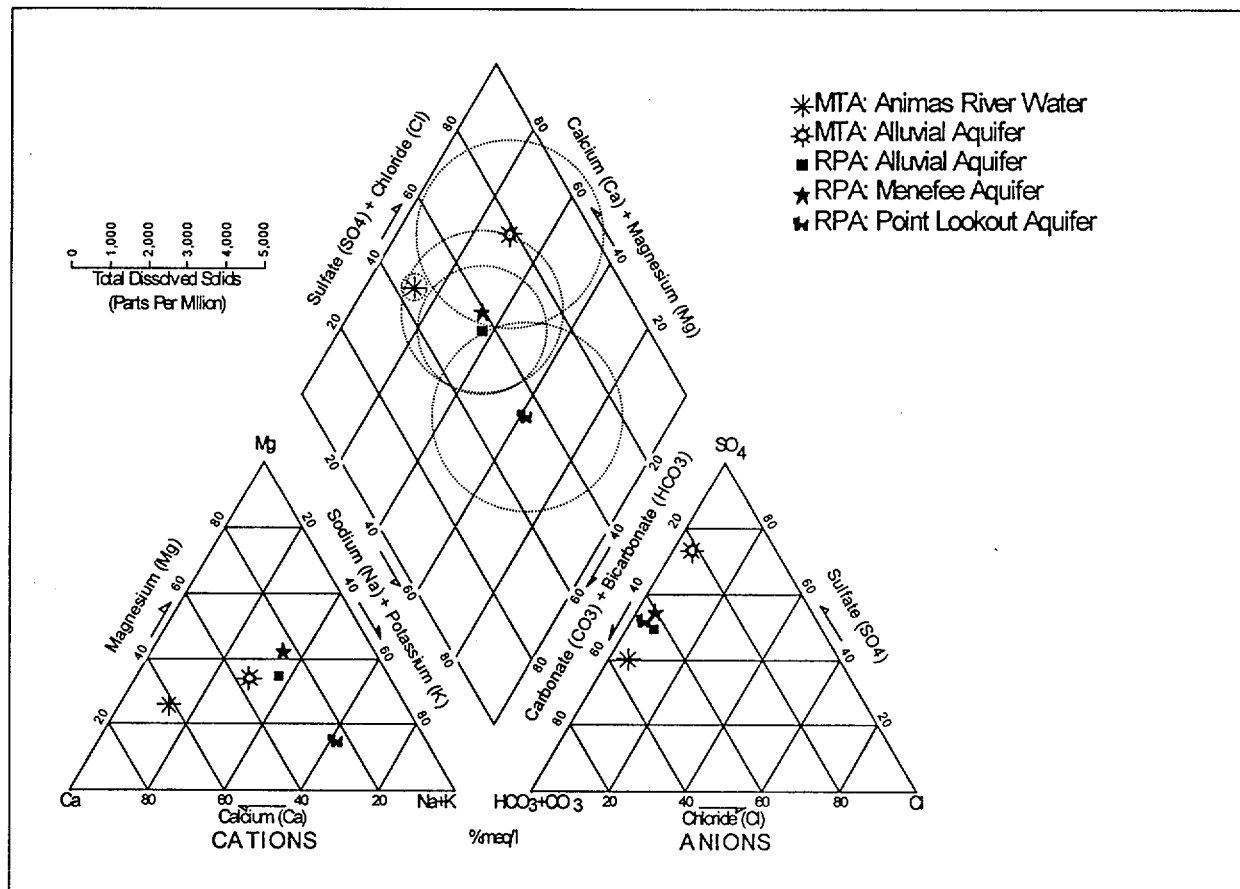
Figure 5-5. Piper Diagram for Mill Tailings Area (MTA) and Raffinate Ponds Area (RDA) Background Ground Water and Animas River Water using Mean Concentrations

The average major ion concentrations of Animas River water are plotted on the Piper diagram presented in Figure 5-5. Surface water samples were collected from locations 0506, 0515, 0652, and 0650. Surface water is a calcium-bicarbonate type with concentrations ranging from 93 to 440 mg/L. The mean pH is 7.96 and the water has a mean iron concentration of 0.0486 mg/L, which indicates the water is oxidizing. Concentrations of the following 13 analytes were less than or equal to the detection limit: ammonium, antimony, arsenic, cadmium, copper, lead, molybdenum, selenium, thallium, vanadium, lead-210, radium-228, and thorium-230 (Table 5-5).

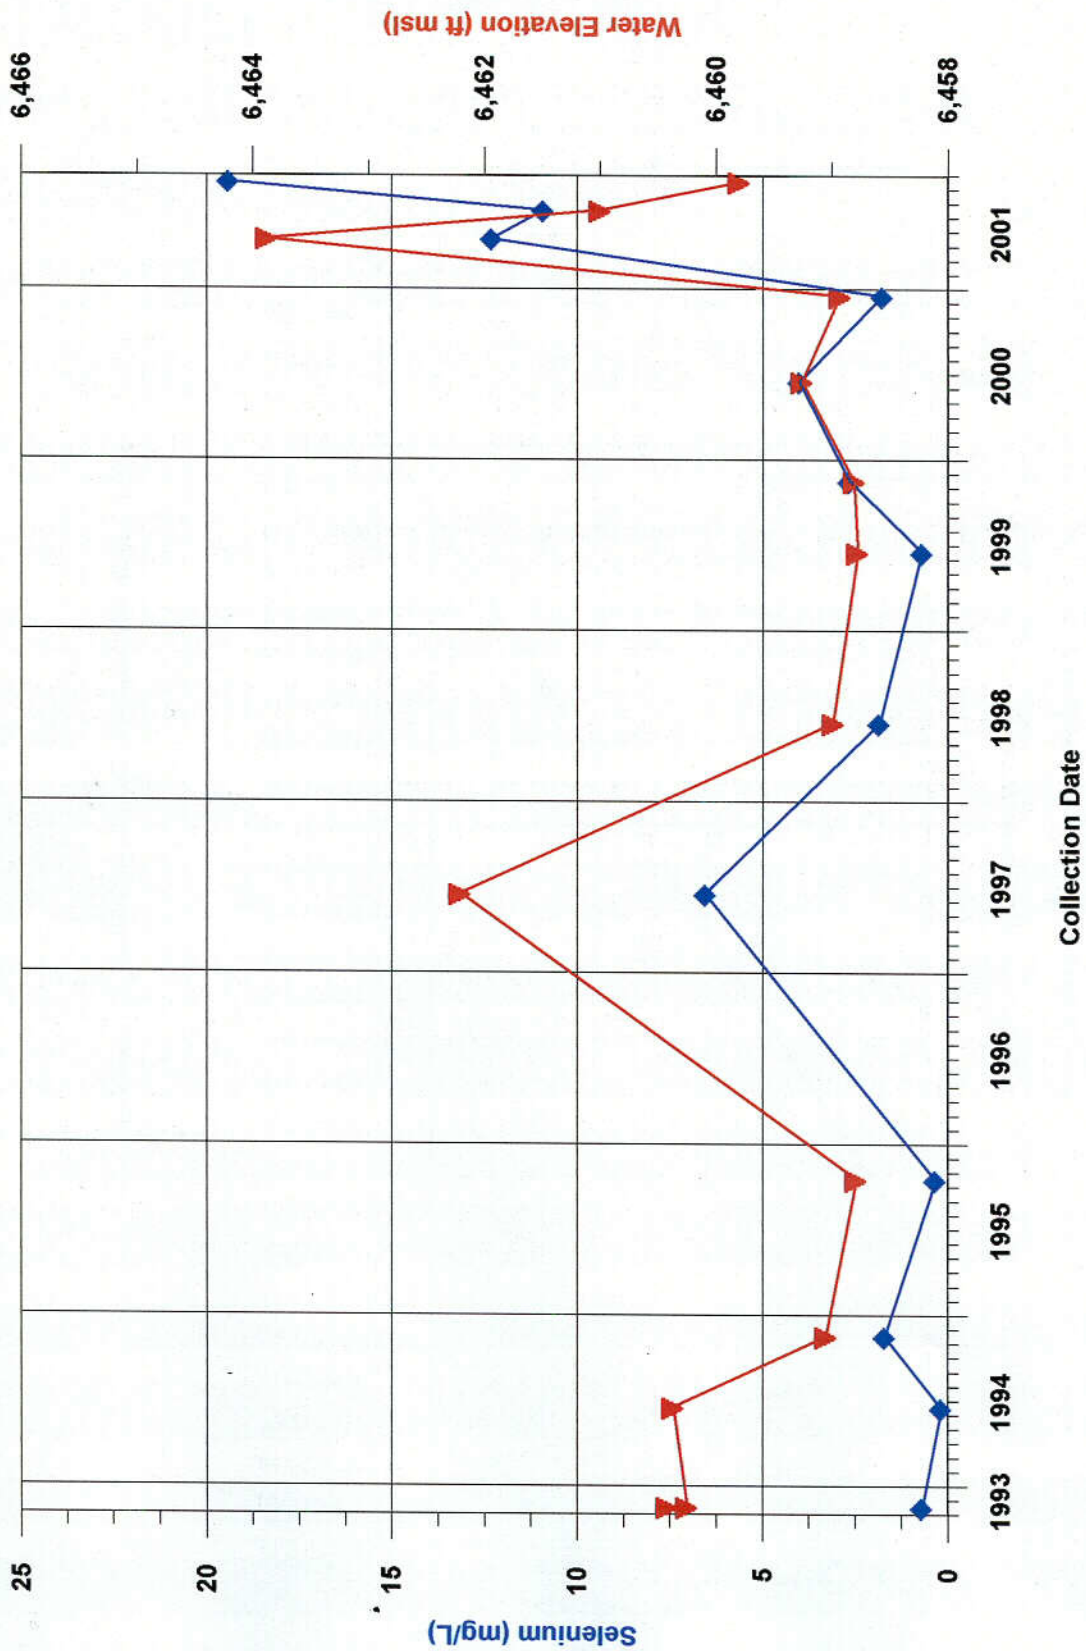
DUR02-0628

◆ Selenium
▼ Water Elevation
 Figure 5-21. Selenium Concentrations and Ground Water Elevations at Well 0628

As shown in Plate 3, the screened interval nearly to the surface in well 0628 is near a subcropping zone of coal beds in the Menefee Formation. The screened interval is not shown at the ground surface in the cross section because it was projected to identify lithology. These nearby subcropping coal beds are a likely source for selenium to be mobilized by increasing contact with oxidizing water. This interpretation is supported by the correlation between water levels and selenium concentrations in this well. As shown in Figure 5-21, with the exception of the most recent value, there is a direct correlation between water levels and selenium concentrations.

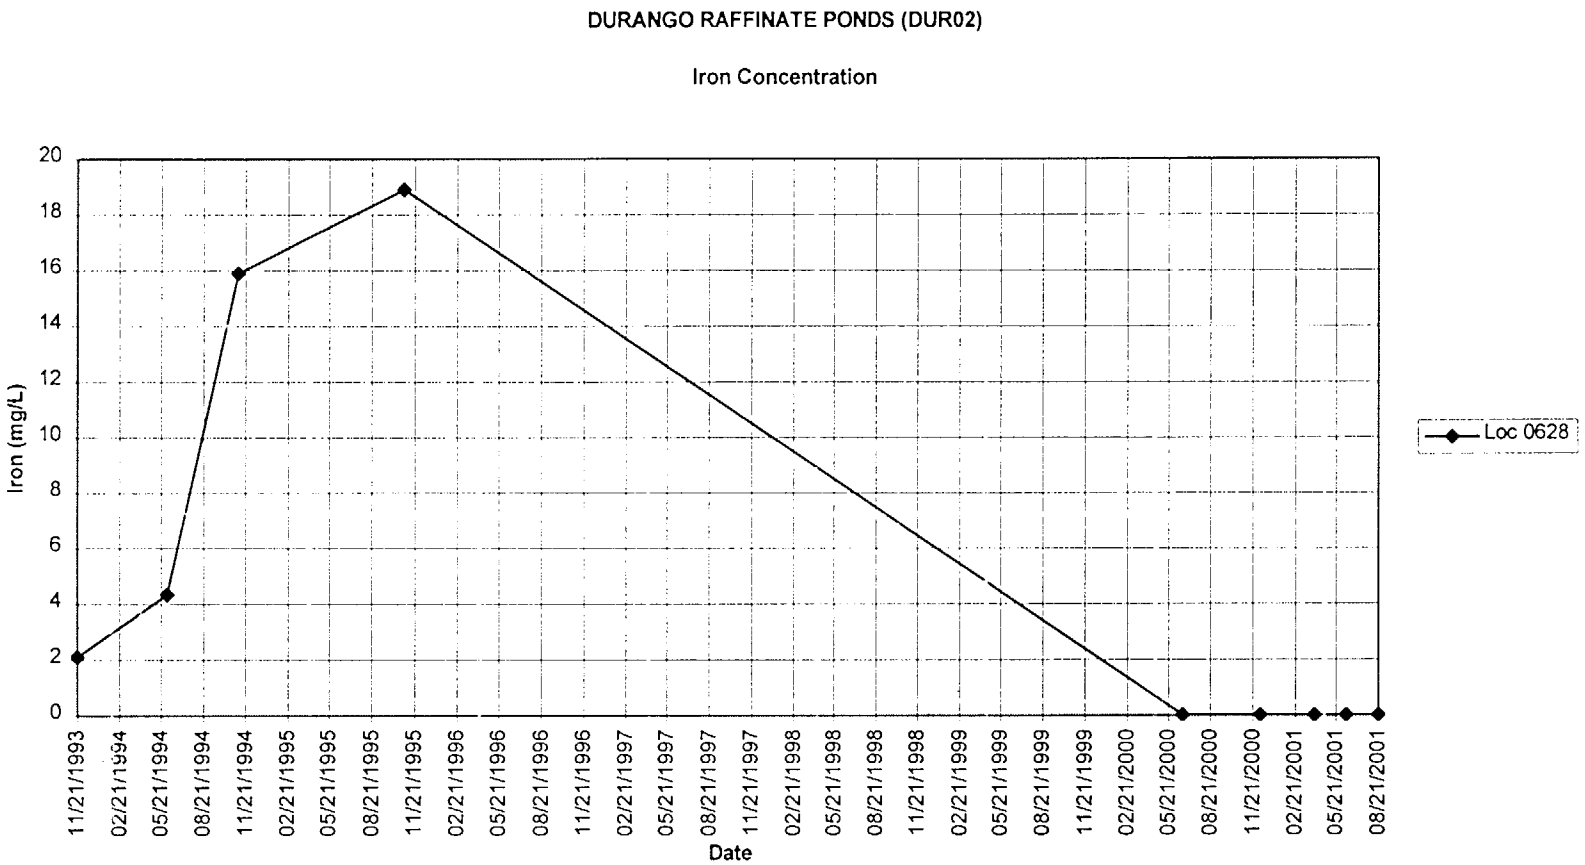
Figure 5-22. Time-Concentration Plot of Iron in Well 0628

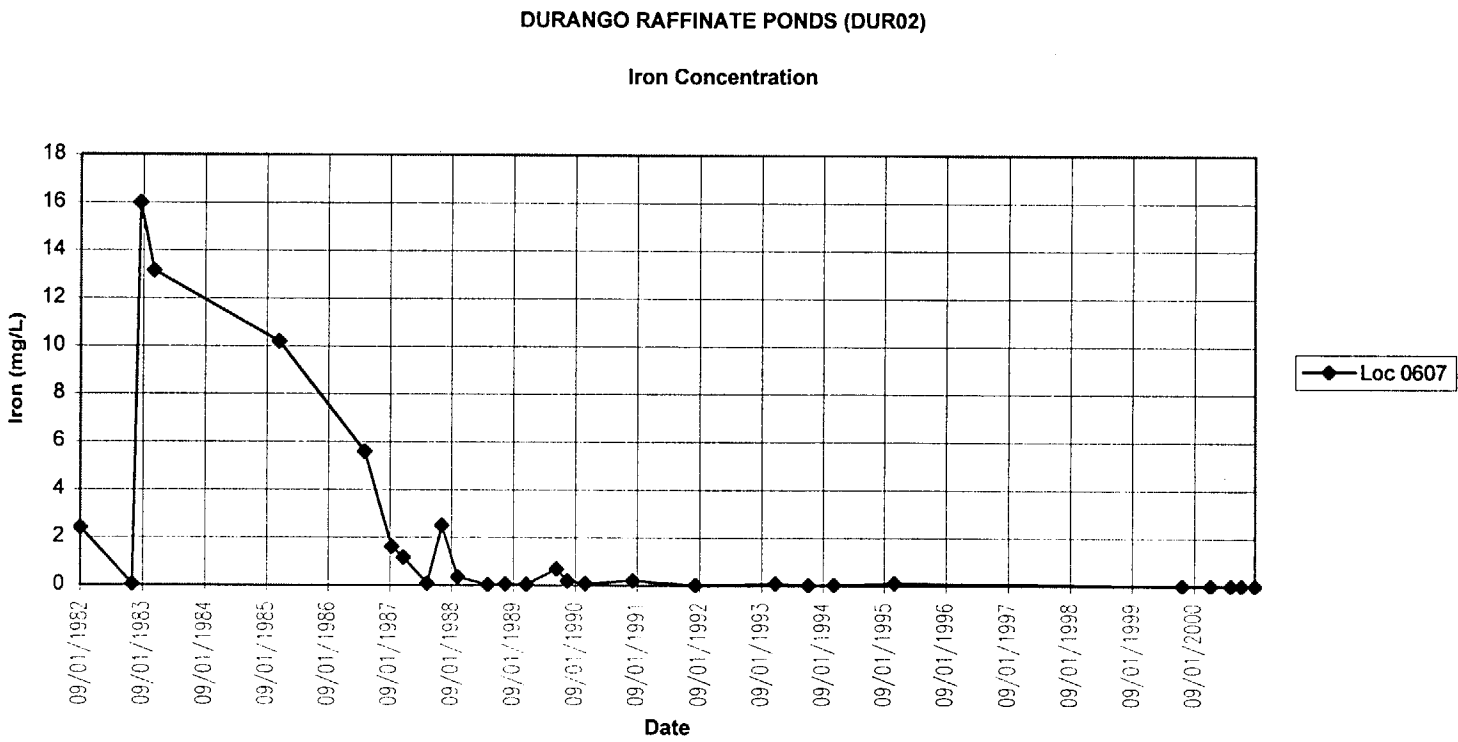
Figure 5-23. Time-Concentration Plot of Iron in Well 0607

Figure 5-23 shows all historical iron concentrations for well 0607, and Figure 5-24 shows more recent concentrations in detail. The results are notable because of the time frame when redox conditions began to change. As shown in the figures, the increase of ORP and the resulting decrease in iron concentrations began in 1983, approximately 4 years before surface remediation began. This indicates surface remediation activities were not a factor in changing the oxidizing conditions at this location.

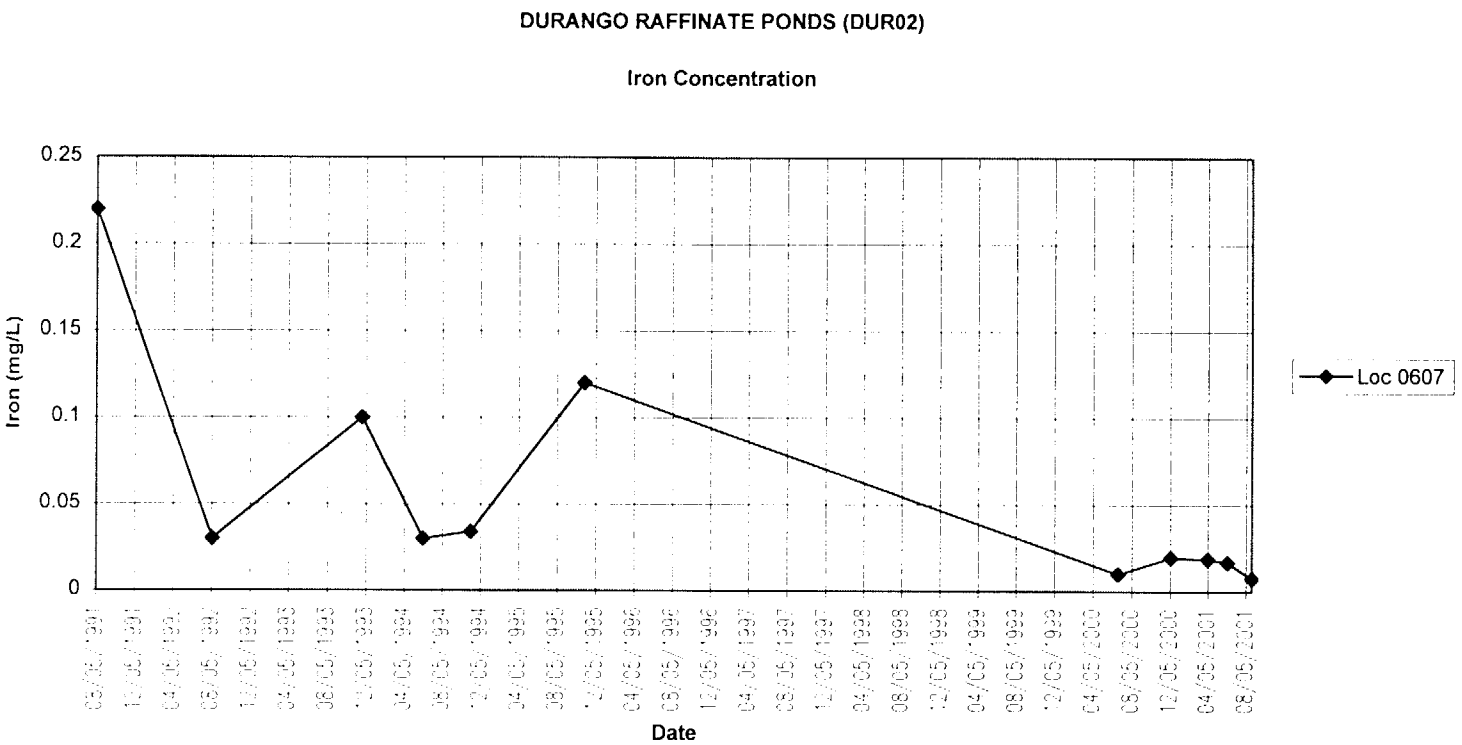
Figure 5-24. Time-Concentration Plot Detail of Iron in Well 0607

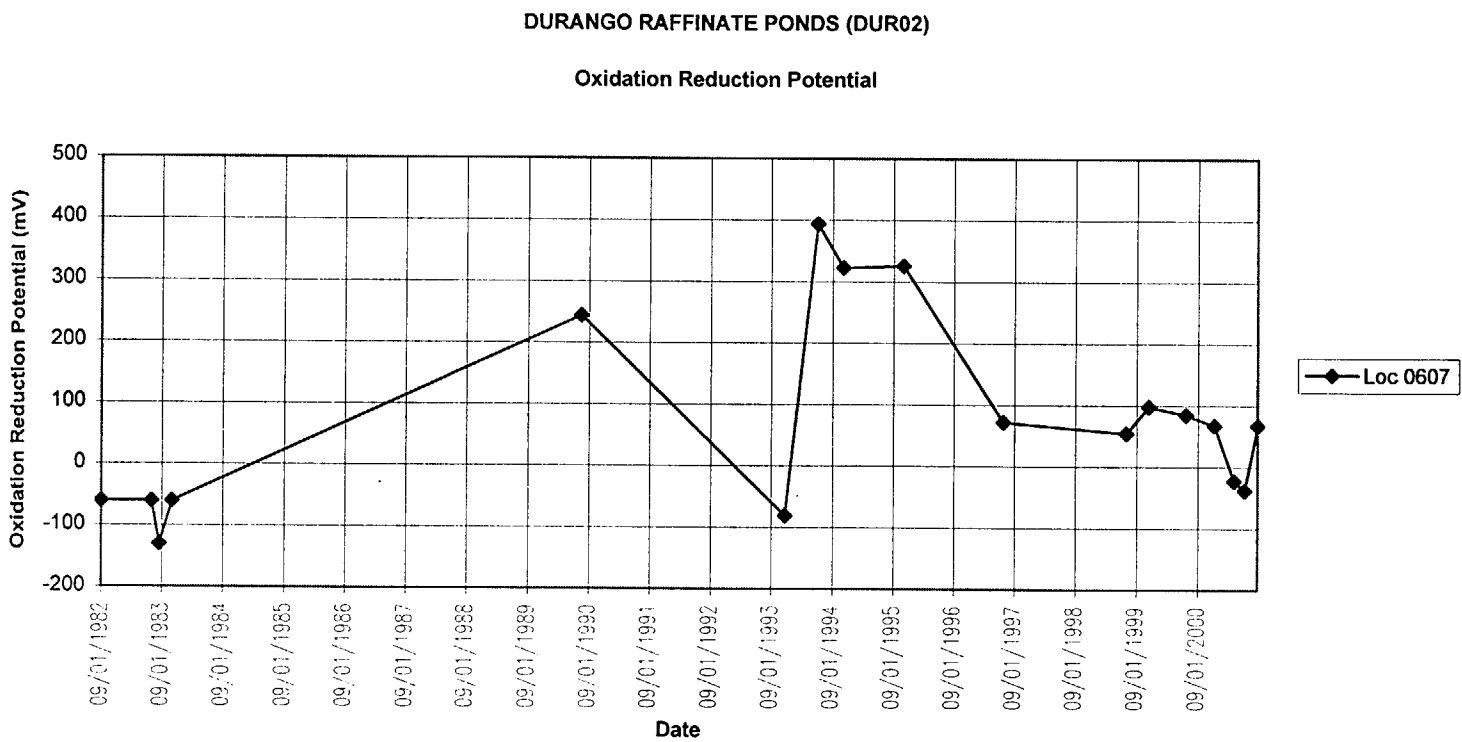
Figure 5-25. Oxidation Reduction Potential Measurements in Well 0607

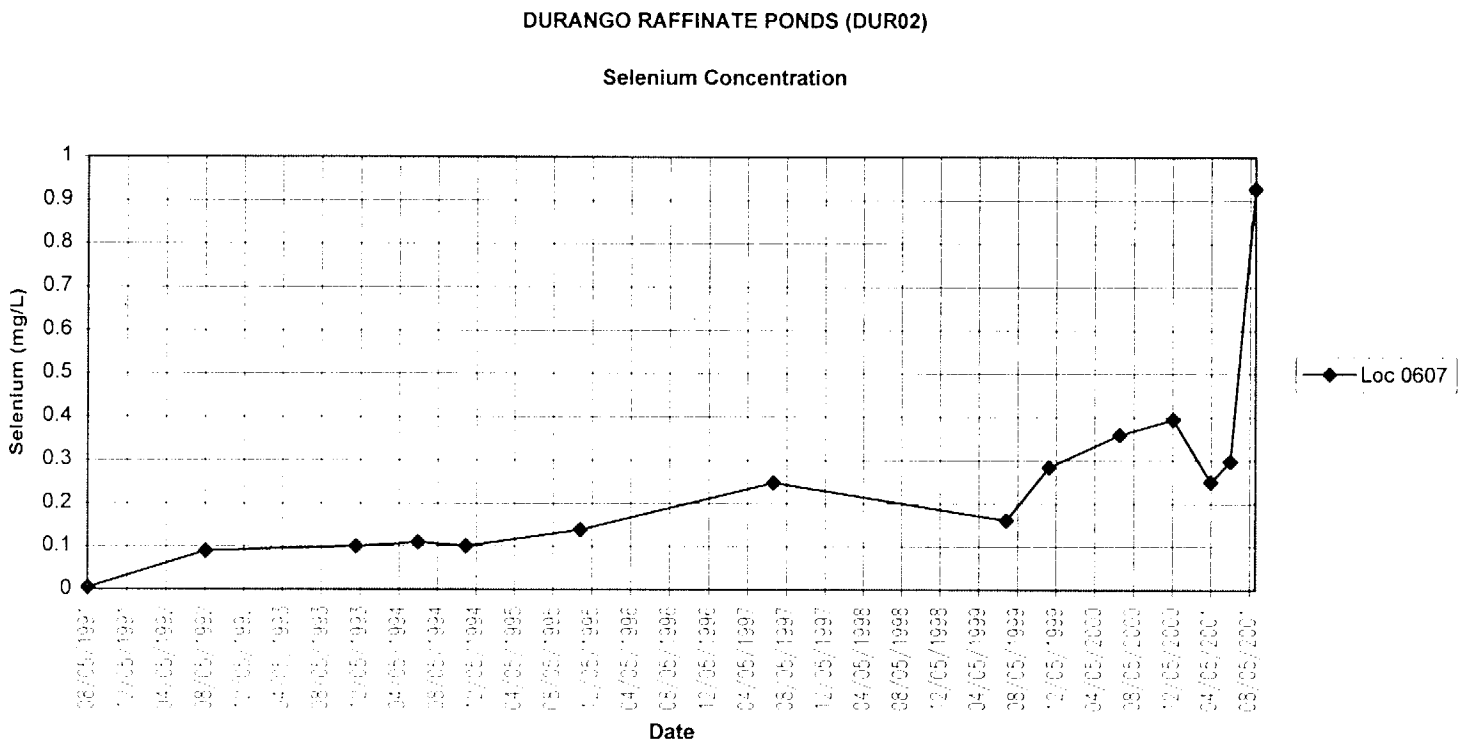
Figure 5-26. Time-Concentration Plot of Selenium in Well 0607

- Except for the levels of selenium (Figure 5-26), ground water quality has improved. For the selenium increase to be caused by site-related activities, the overall water quality of the aquifer should be degraded further as well. At other millsites, water contaminated by past uranium-ore processing activities has high a concentration of dissolved solids, a high alkalinity, and a high conductance. The ions chiefly responsible for TDS, alkalinity, and conductance (e.g., sodium, calcium, sulfate, carbonate) are highly mobile in ground water. There is no explanation for how these could decrease while an associated contaminant could increase. As shown in Figure 5-27 through Figure 5-29, TDS, alkalinity, and conductance have all decreased since remediation. In other words, with respect to general water quality, the water in well 0607 has been diluted with cleaner water since remediation. Hence, the only explanation for the increase in selenium is that an influx of water with greater oxidation potential is causing the release of naturally occurring selenium from the aquifer solids.

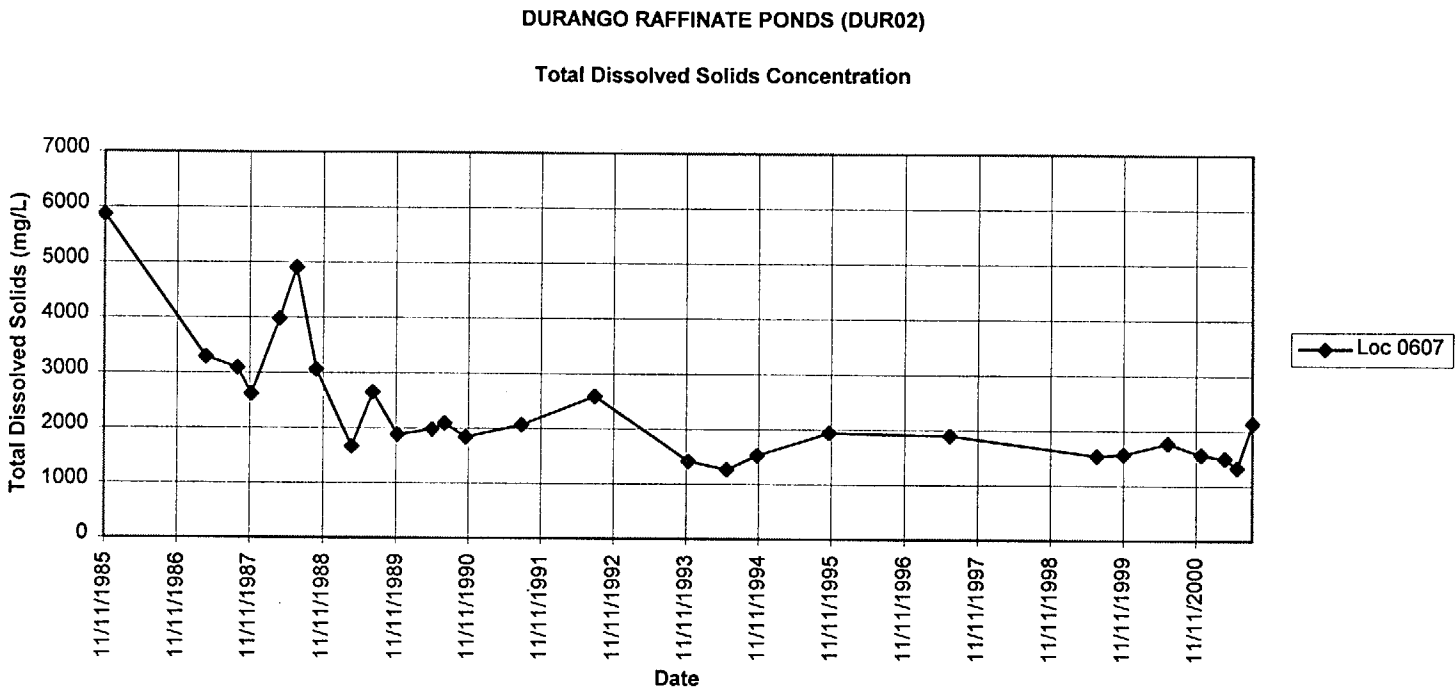
Figure 5-27. Time-Concentration Plot of TDS in Well 0607

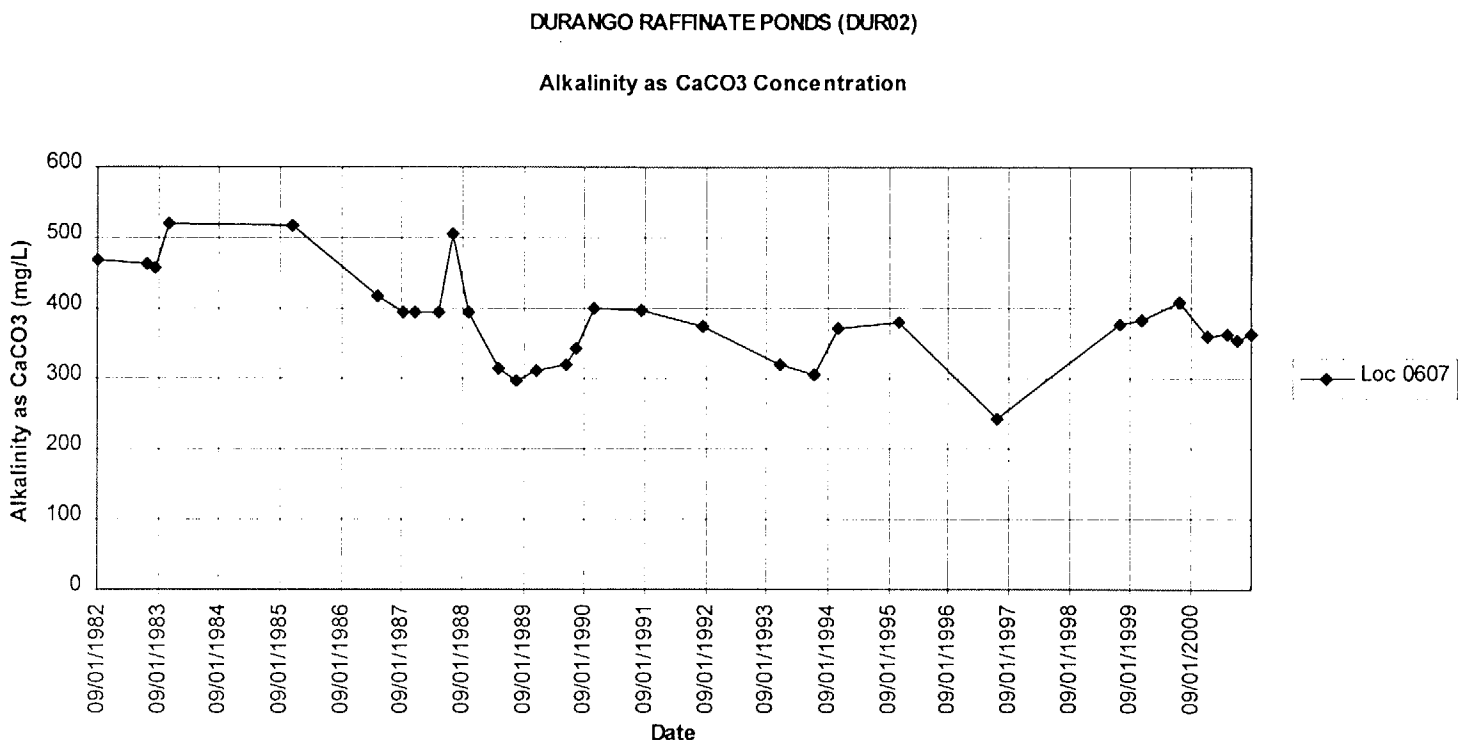
Figure 5-28. Time-Concentration Plot of Alkalinity as CaCO₃ in Well 0607

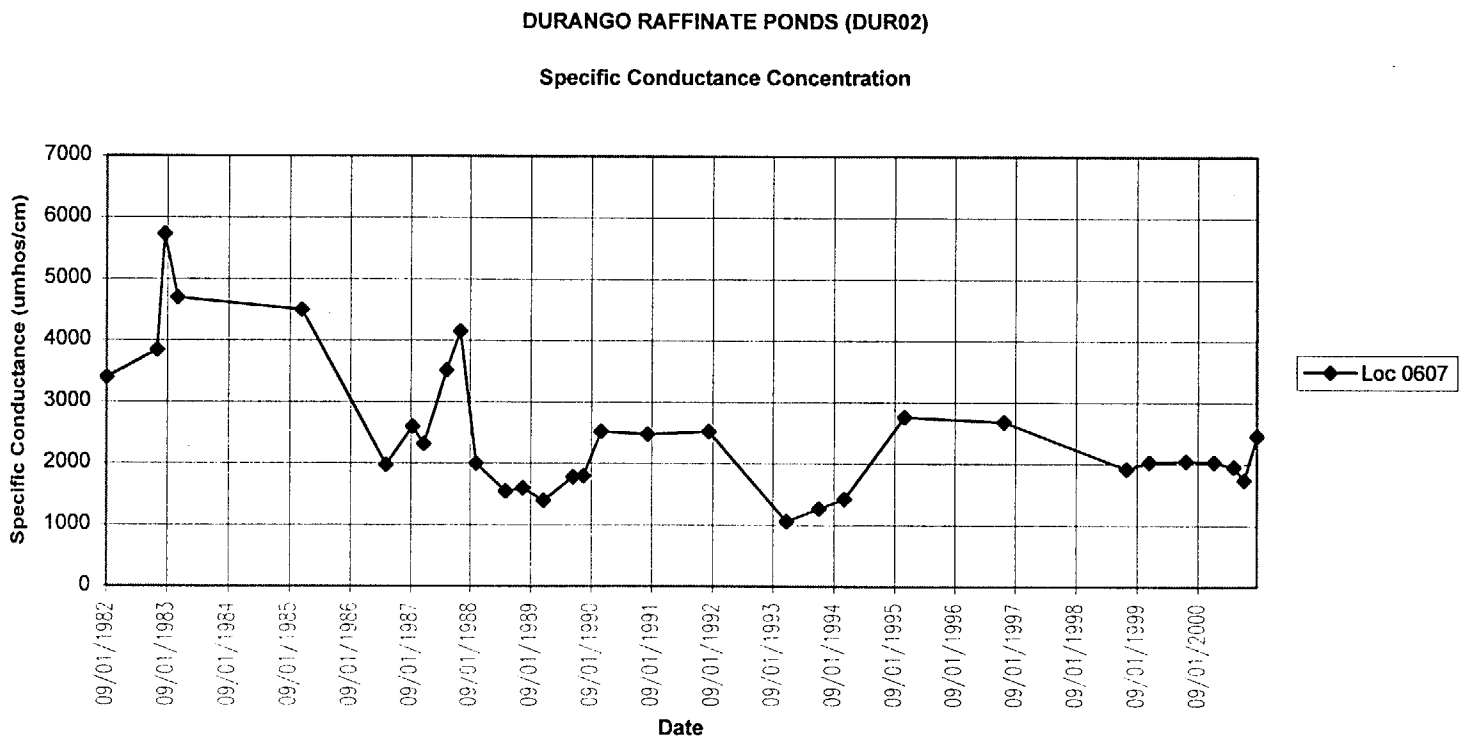
Figure 5-29. Specific Conductance in Well 0607
