UNITED STATES OF AMERICA
NUCLEAR REGULATORY COMMISSION
ATOMIC SAFETY AND LICENSING BOARD PANEL

IN THE MATTER OF:)	
)	
INTERNATIONAL URANIUM (USA))	Docket No. 40-8681-MLA-11
CORPORATION)	
)	ASLBP NO. 02-795-02-MLA
(Source Material License Amendment,)	
License No. SUA-1358))	July 29, 2002
_____)

SIERRA CLUB COMMENTS ON IUSA’S RESPONSE TO PRESIDING OFFICER’S
REQUEST FOR ADDITIONAL INFORMATION

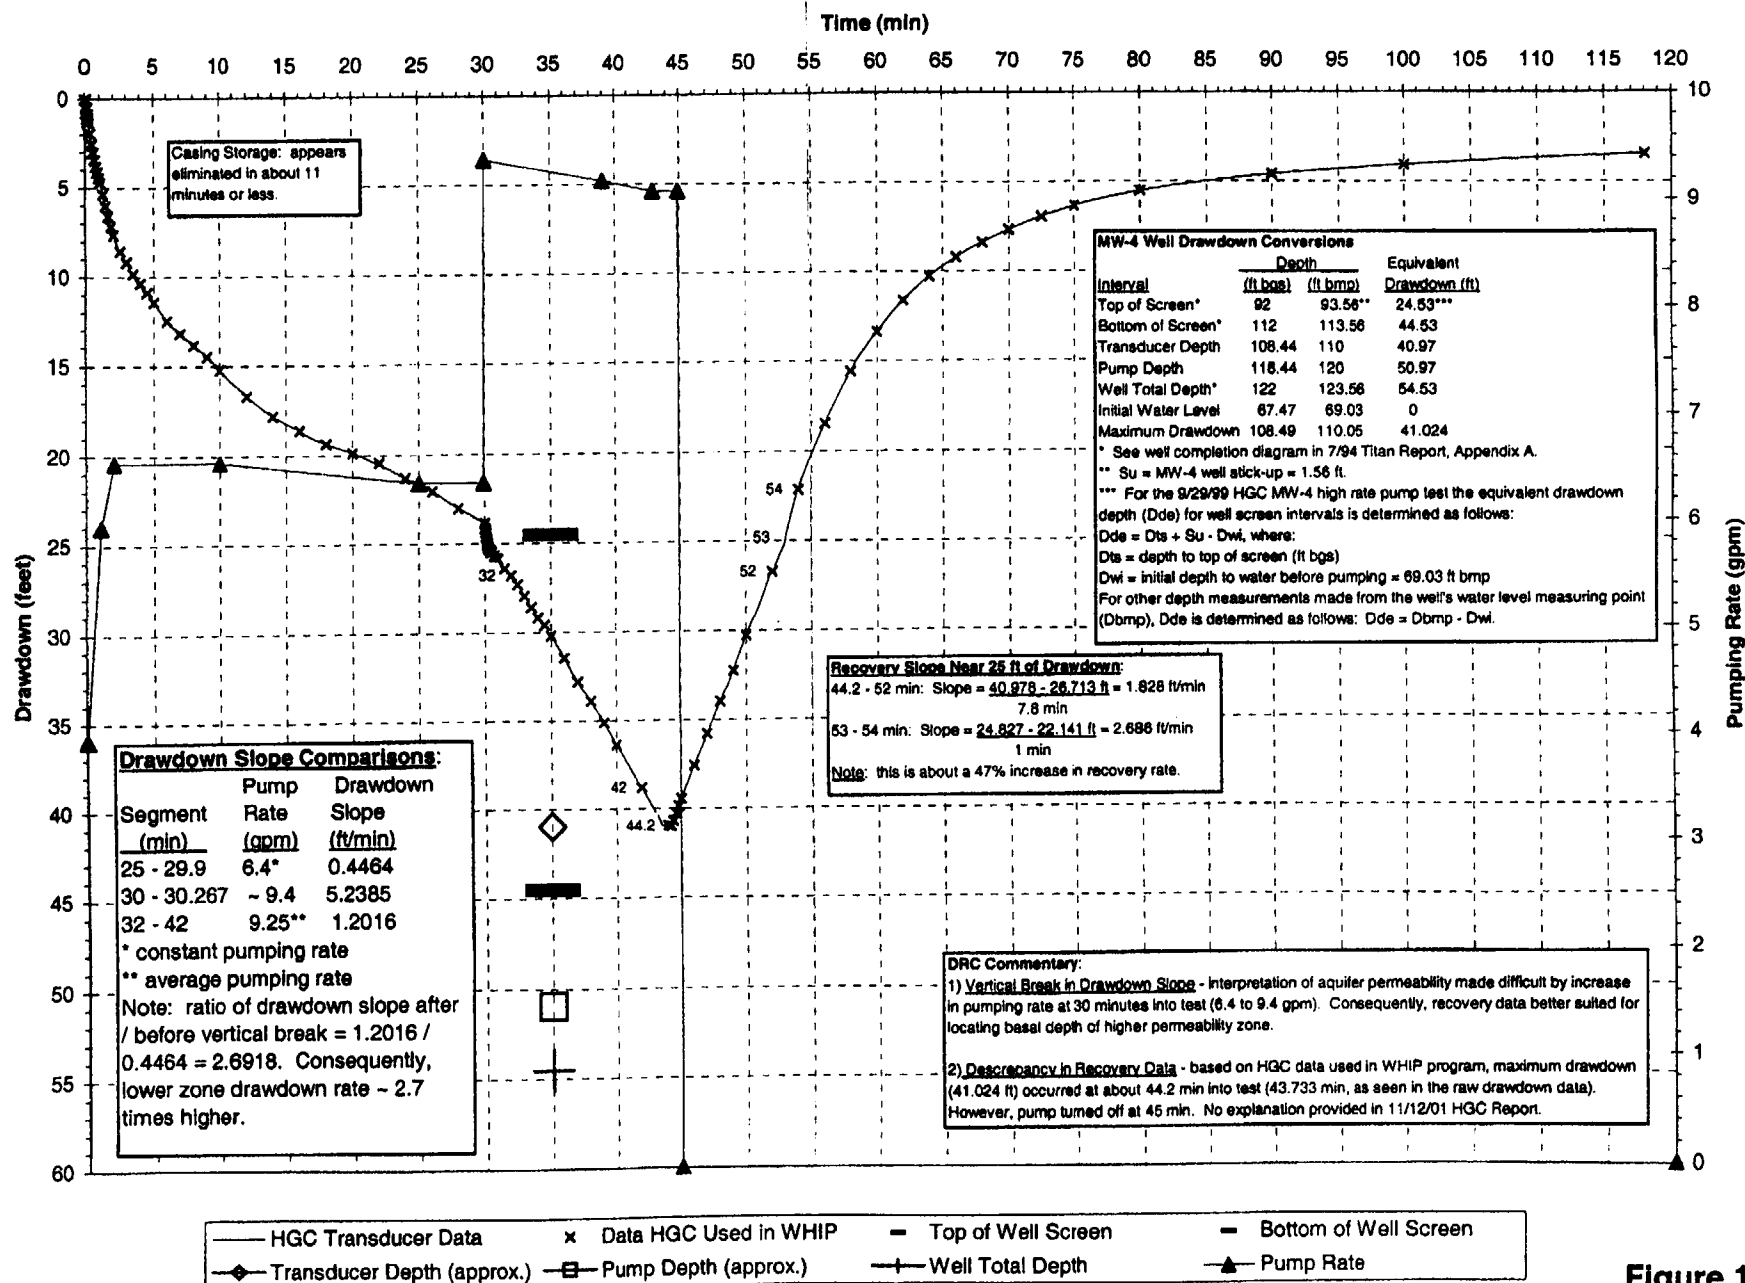
IUC Well MW-4 Pump Test: HGC 1999 Data, Test 2 (high pumping rate)

high rate test of MW-4 (see Table 1, above). Arguments could be made that IUC could have placed the pressure transducer at a greater depth to better test the location of the Jmb contact in well MW-4 (see Figure 1, below). As reported, the transducer was not set lower than 110 ft bmp at the time of the high rate pump test due to the limited length of the transducer cable (12/21/01 HGC facsimile). Despite this constraint, DRC staff have concluded that a pumping water level below the 108 ft bgs interval combined with a sustained well yield during this portion of the pump test both suggest the Jmb contact is deeper than 108 ft bgs.

- A. High Initial Water Level in Well – review shows that before pumping commenced the initial water level in the well was 24.53 feet above the screened interval (see Figure 1 below). As a result, well MW-4 was screened across only a portion of the shallow aquifer, and

- A. Apparent Lack of Unique Solution: 1999 Drawdown Response High Rate Data – review of the November 12, 2001 HGC Report shows that at the same time that the vertical break occurred in the drawdown response data, at about 30 minutes into the test, HGC suddenly increased the pumping rate from 6.4 to 9.4 gpm (see Figure 1 below). As a result, the near vertical response in the drawdown curve is a product of both the pump rate increase and possible changes in aquifer characteristics.

- B. Apparent Lack of Unique Solution: 1999 Recovery Response High Rate Data – the water level recovery portion of the 1999 high rate test shows two different recovery slopes are apparent in the MW-4 recovery response (see Figure 1 below). The transition of these two different recovery slopes occurs at about 53 minutes into the test (which corresponds to a drawdown equivalent interval of about 25 feet). Prior to 53 minutes, well MW-4 exhibited a recovery rate of about 1.83 ft/min. After this point, the well recovered at a 47% higher rate, 2.69 ft/min. However, it is important to note that at this same 53 minute time interval, the water level in well MW-4 rose above the top of the well screen located at a depth of 92 ft bgs. Consequently, it appears that the increase in the well recovery rate above and beyond this point is the product of partial penetration effects in well MW-4.
