Plant/Facility Name Arkansas Nuclear One, Unit 2 (ANO-2)

ANO-2 Bare Metal Visual Relaxation Request

ANO-2 Relaxation Request

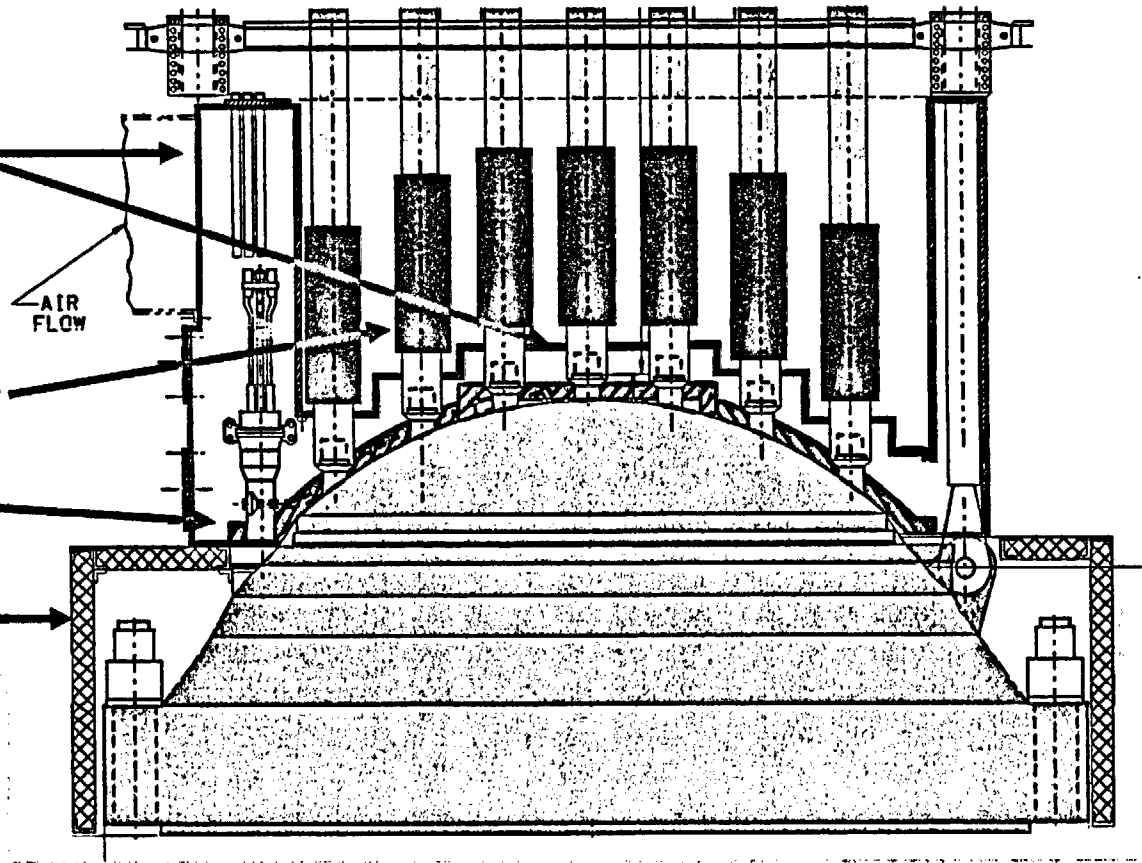
RVH Cooling Shroud and Insulation

- ▶ **Cooling Shroud**
- ▶ **ICI Access Doors**
- ▶ **CEDM Coil Stacks**
- ▶ **Panel Insulation**
- ▶ **Removable Insulation**

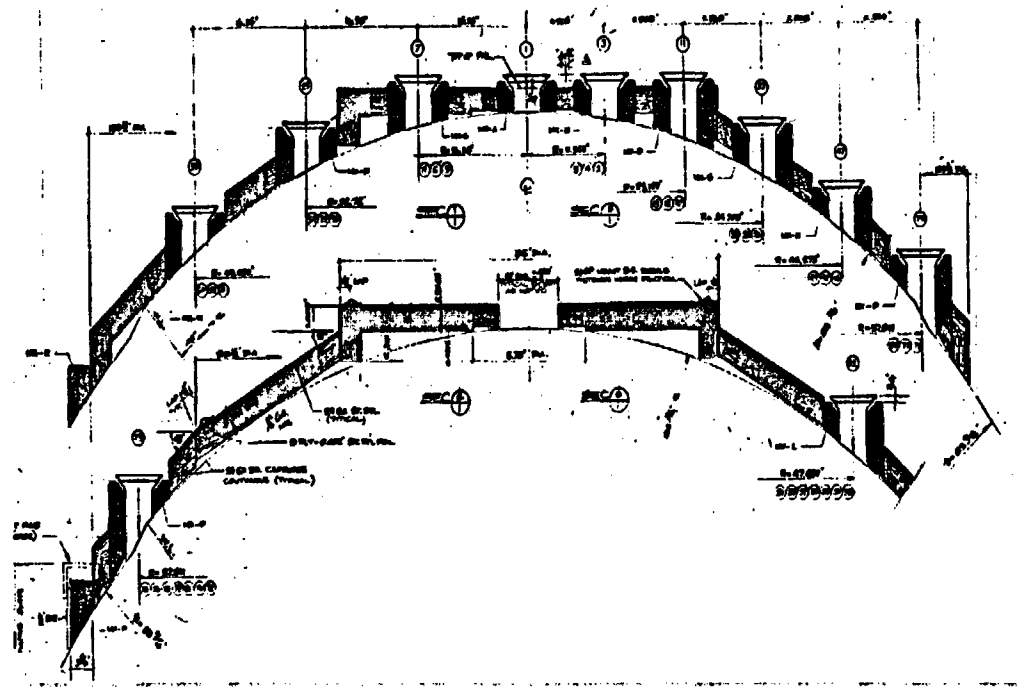
Panel Insulation

- ▶ Collars are enclosed by prefabricated Stainless Steel reflective insulation panels
- ▶ Panels are sized to closely fit around the collars
- ▶ 56" diameter dome panel and 16 panels around the radius

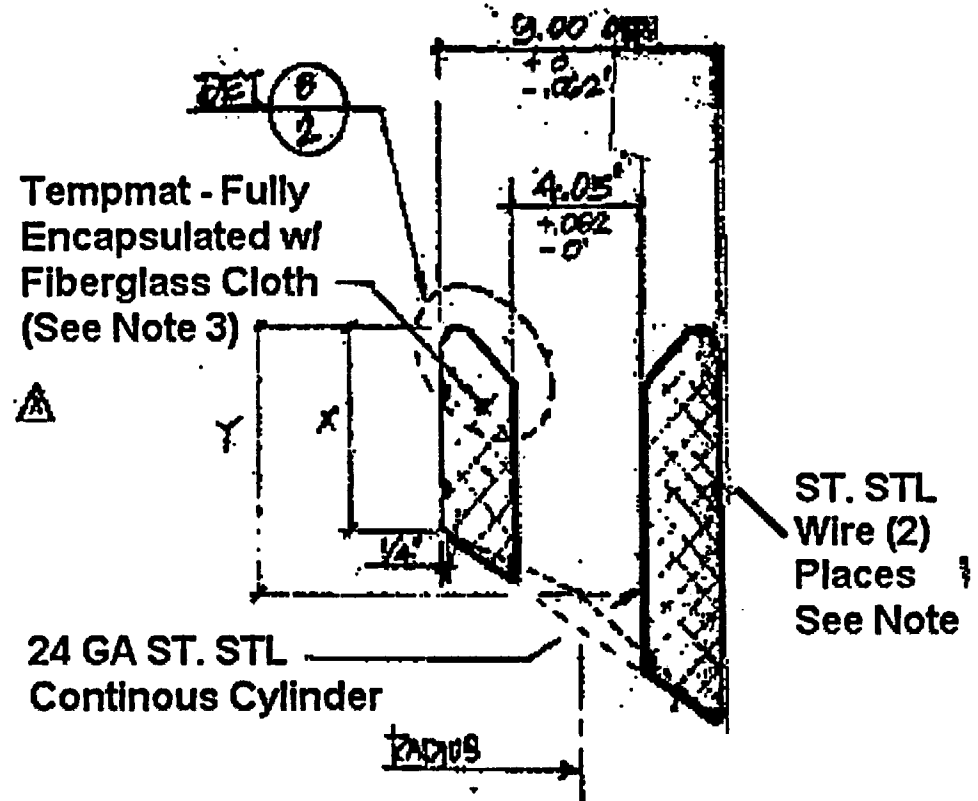
Nozzle Insulation Collars

- ▶ 81 CEDM and 8 ICI collars
- ▶ Collars are custom fit to vessel contour
- ▶ Collars are Pittsburgh Corning TempMat insulation covered with fiberglass cloth lagging and held in place by stainless steel (SS) wire.
- ▶ Each collar contains a 24 GA SS Continuous Cylinder

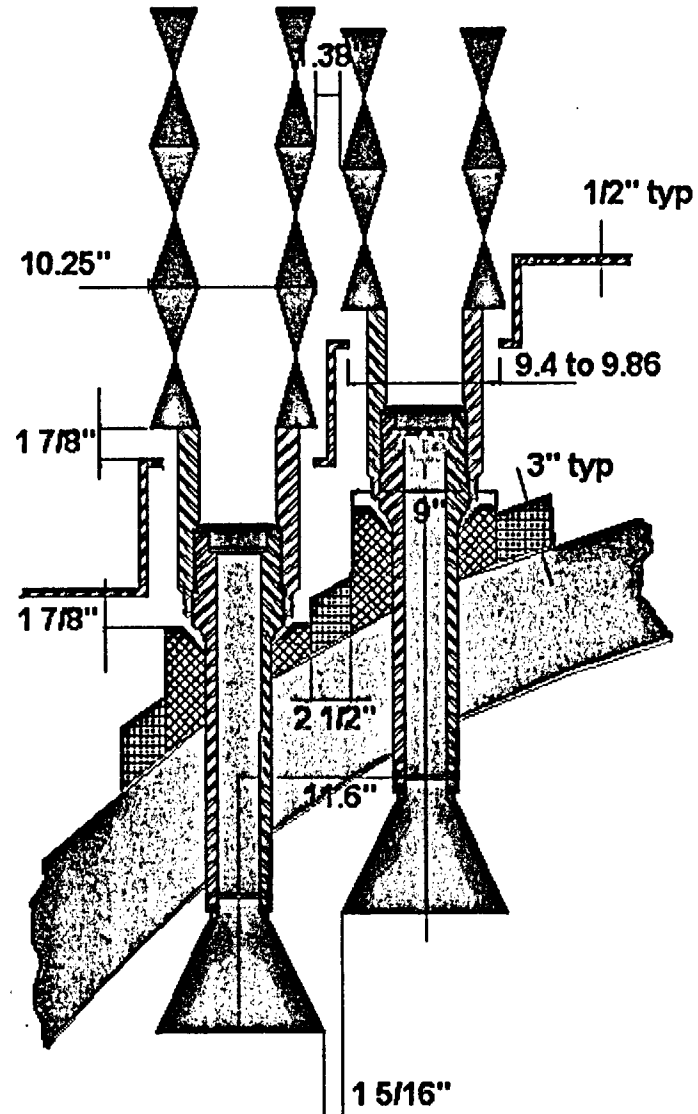
Interferences to BMV

- ▶ CEDM collars cannot be removed with panels installed
- ▶ Cooling Shroud to Coil Stack Interference
- ▶ Openings in Cooling Shroud are part of the cooling system design
- ▶ Nozzle spacing limits access
- ▶ Limited access between cooling shroud and insulation

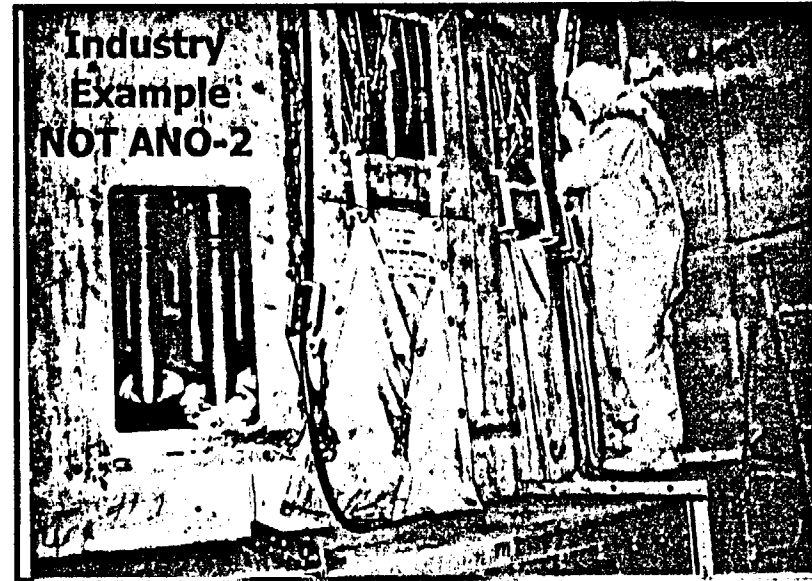
What's Unique About ANO-2

- ▶ **CEDM Motor Housings follows the RVH contour**
- ▶ **Stepped shroud design severely limits access for BMV**
- ▶ **All Coil Stack/RSPTs must be removed to support a BMV**

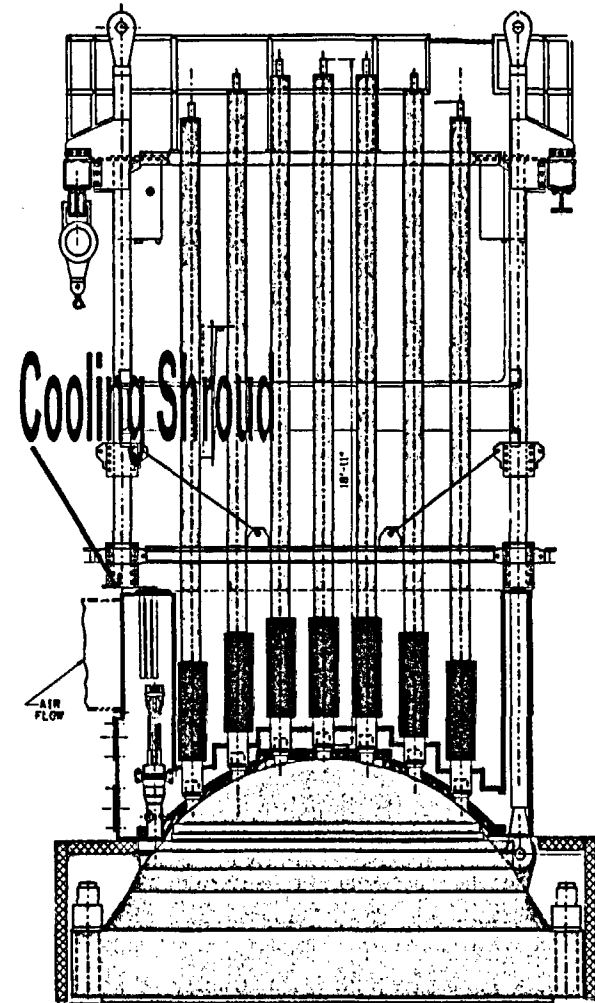
Disassembly Sequence

- ▶ **Remove & Store 162 RSPTs**
- ▶ **Remove & Store 81 CEDM Coil Stacks**
- ▶ **Disconnect, Rig and Store Superstructure**
- ▶ **Remove 17 Insulation Panels**
- ▶ **Remove 81 CEDM Insulation Collars**

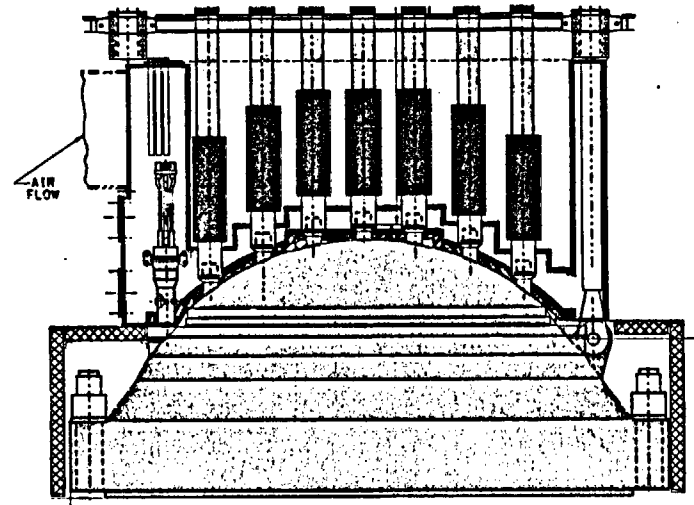
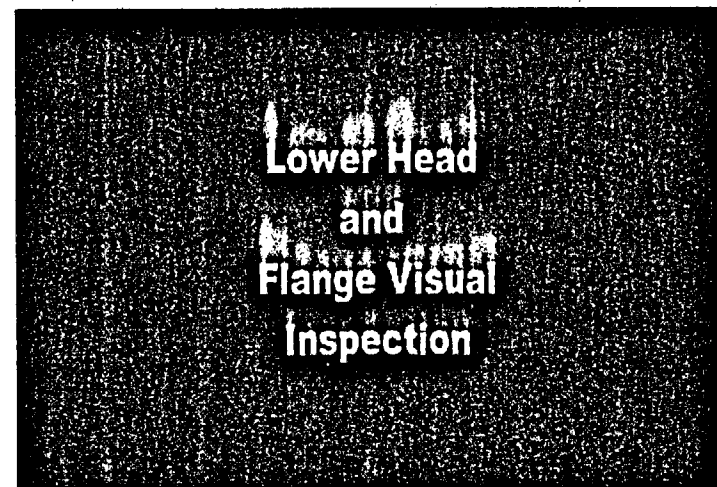
2R15 - Supplemental Visual Inspection Above Insulation

- ▶ Performed visual exam above shroud, around all ICI nozzles, and some outboard CEDM nozzles
- ▶ No boron found

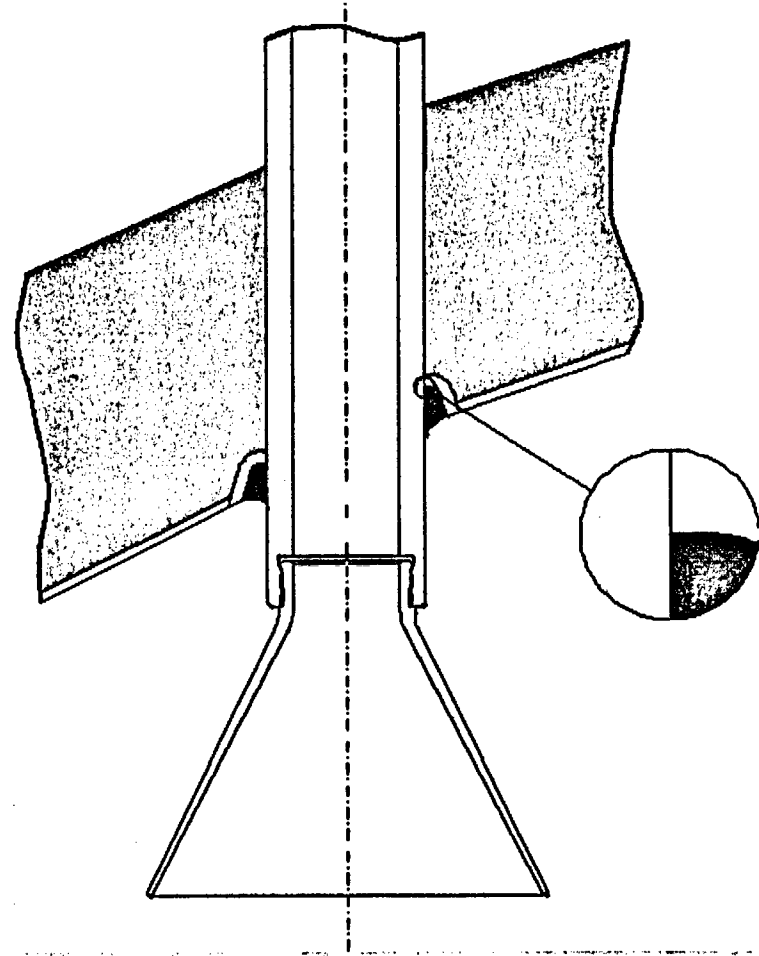
Demonstration of Triple Point

- ▶ Demonstrated detection of flat-bottomed holes up to 0.200" in depth, on Entergy/MRP Mock-up in 2002.
- ▶ Detected Circ Flaws extending to approximately 0.050" deep in Entergy/MRP Mock-up in 2002.

- ▶ Detected a pure axial/radial squeezed notch that extended thru-weld to the Triple Point (0.060").

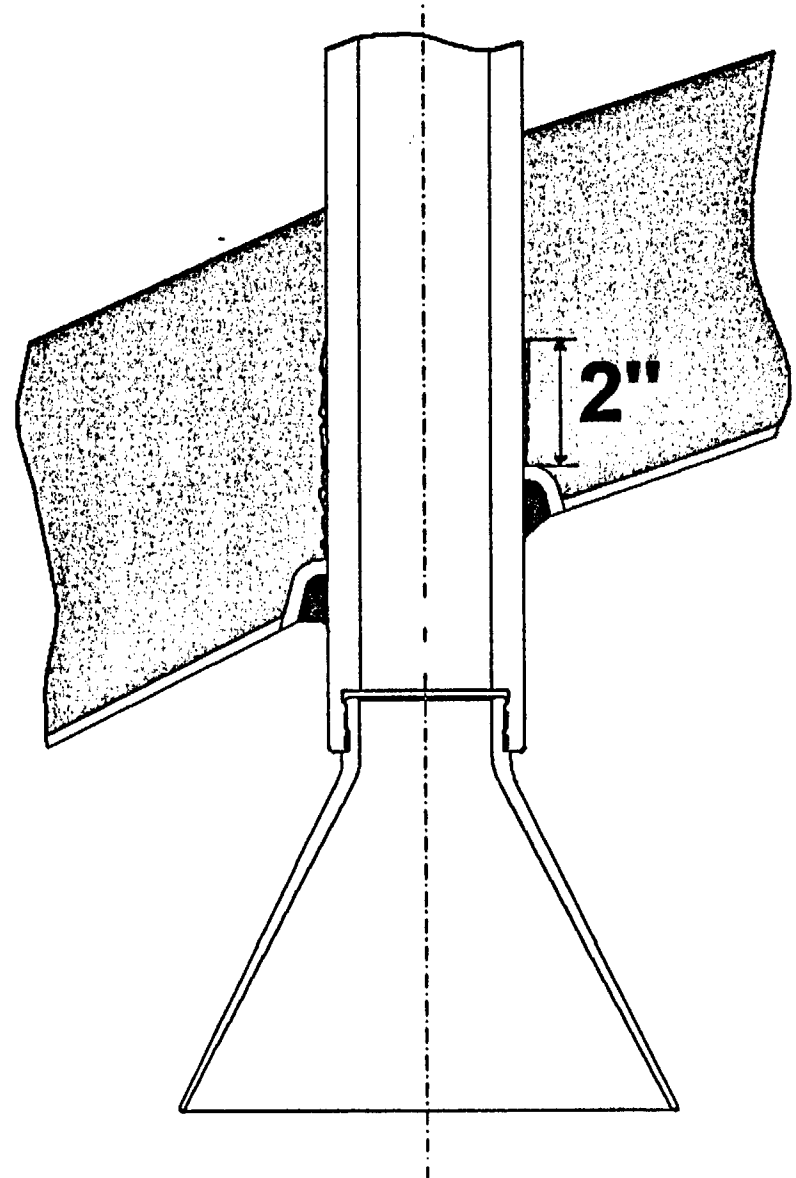
Riverbed Exam

- ▶ Proceduralized process
- ▶ Performed with 2.25 MHz, 0 degree Transducer
- ▶ Highly sensitive to amplitude changes in tube backwall signal
- ▶ Effective for detection of leakage in annulus

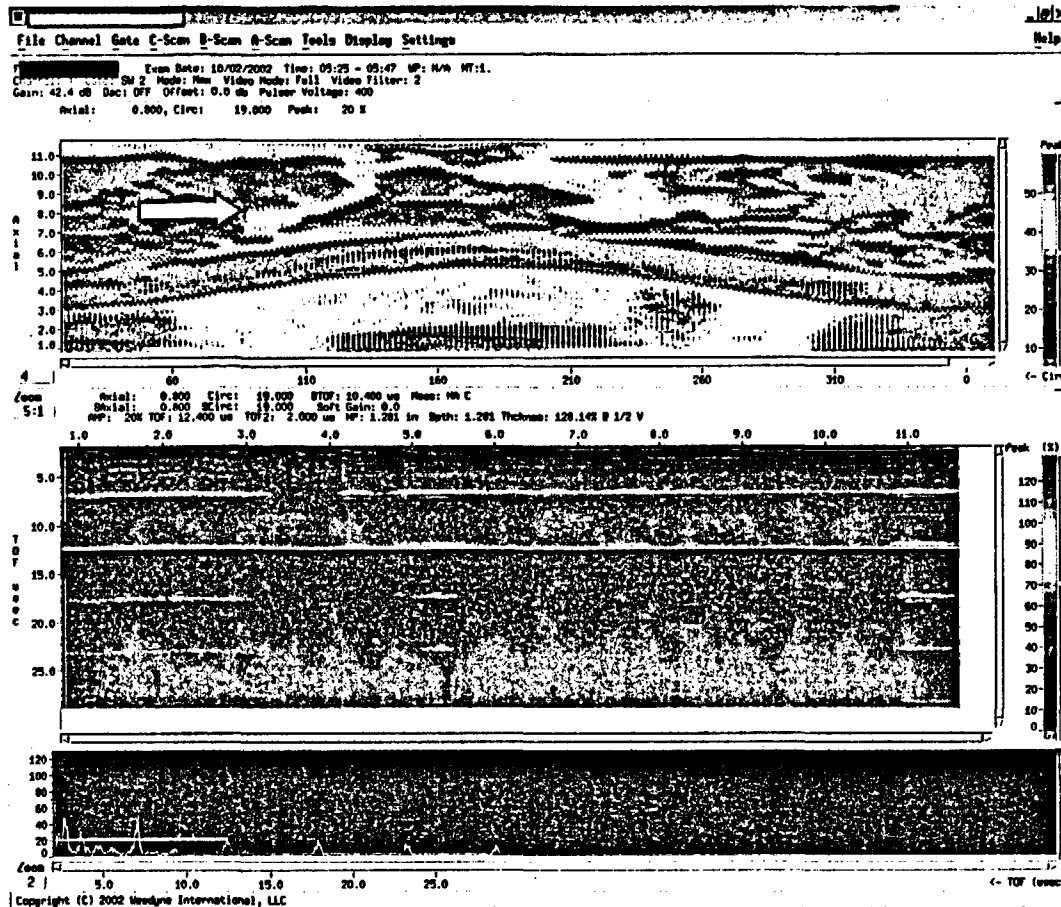
Riverbed Identification

- ▶ Leak path identified with straight beam ultrasonics
- ▶ Leak path leads to loss of shrink fit integrity and a resulting increase in reflectivity

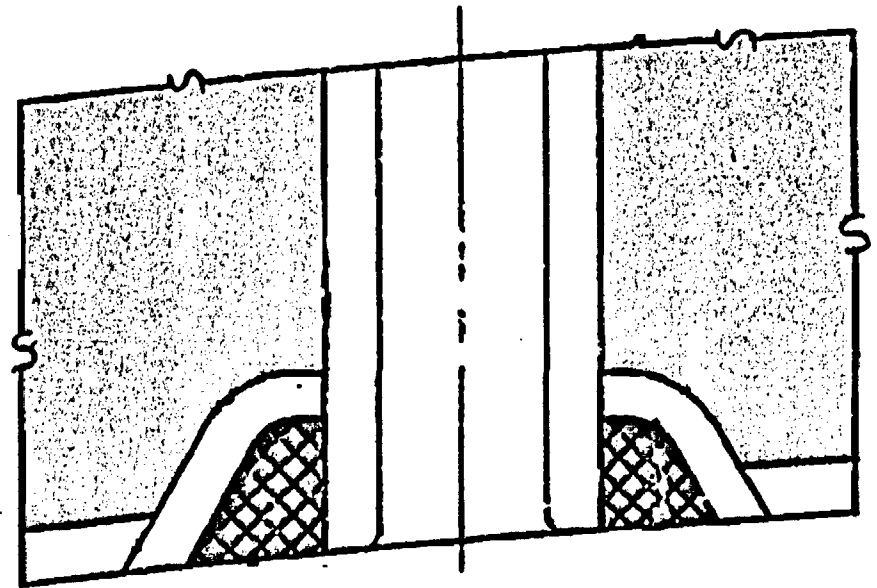
Vent Line Wetted Surface Exam

- ▶ Complete wetted surfaces examination
 - ECT examination at tube ID surface
 - ECT array examination of J-weld surface

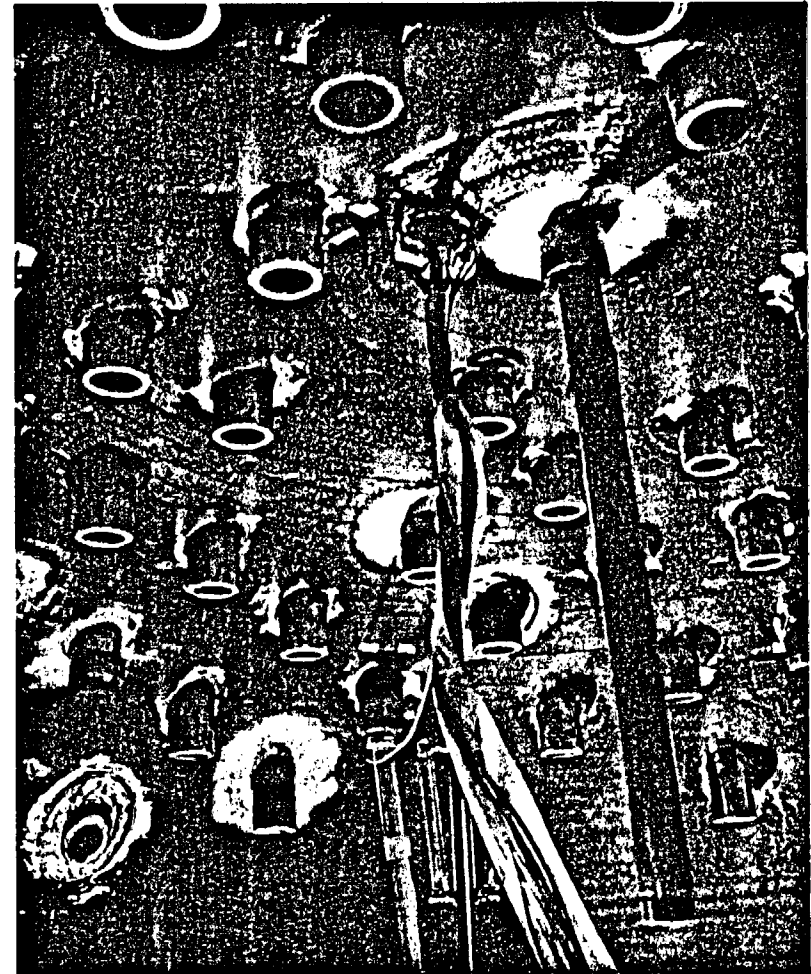
Reactor Vessel Vent Line J-Groove Weld ECT Examination

- ▶ Manual delivery, low dose
- ▶ 12-coil array
 - 100, 250 and 600 kHz
- ▶ Coils offset to provide coverage in one rotation

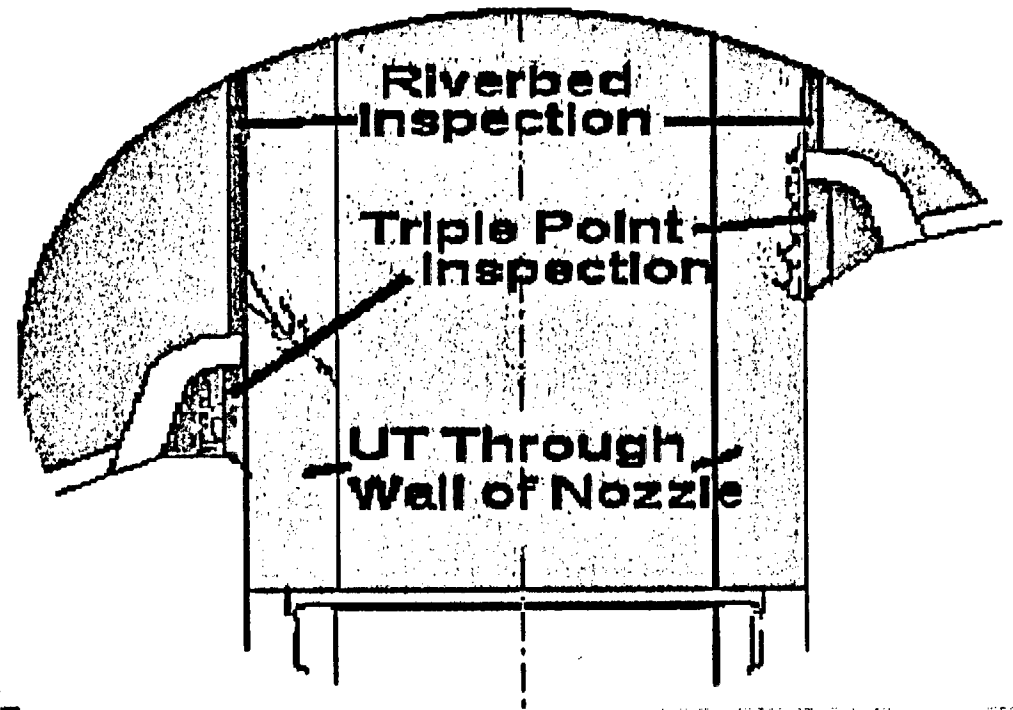
CEDM/ICI Volumetric Summary

- ▶ Axial and Circ TOFD
- ▶ 0 degree UT
- ▶ Triple Point
- ▶ 0 degree "Riverbed" examination for leakage assessment

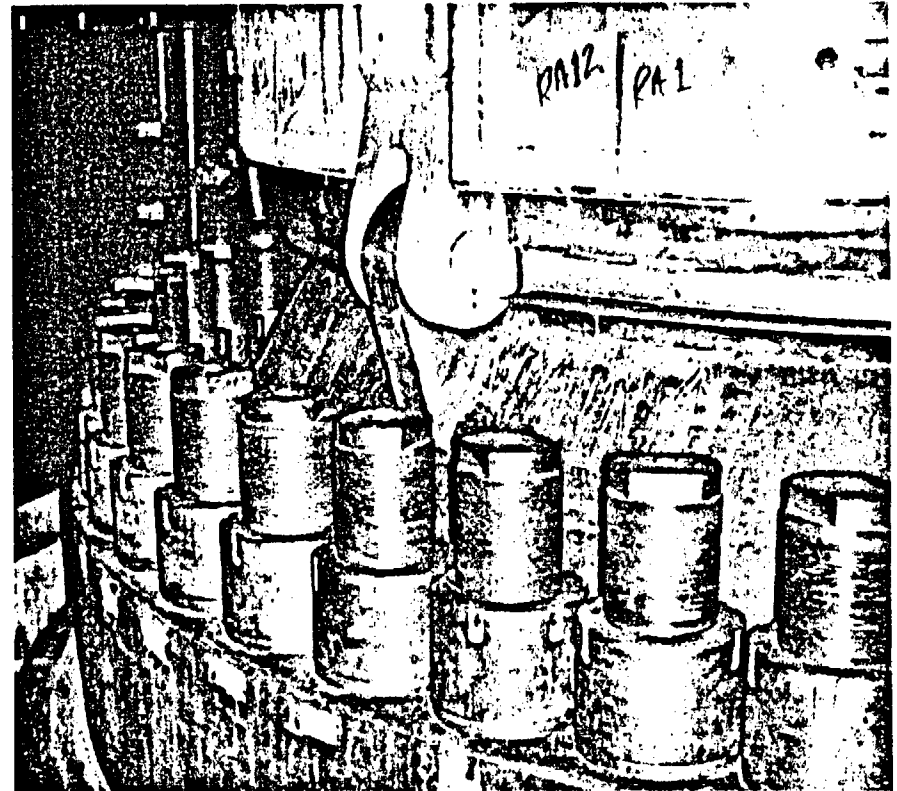
Supplemental Visual

- ▶ Above shroud
- ▶ Around flange
- ▶ Through doorways

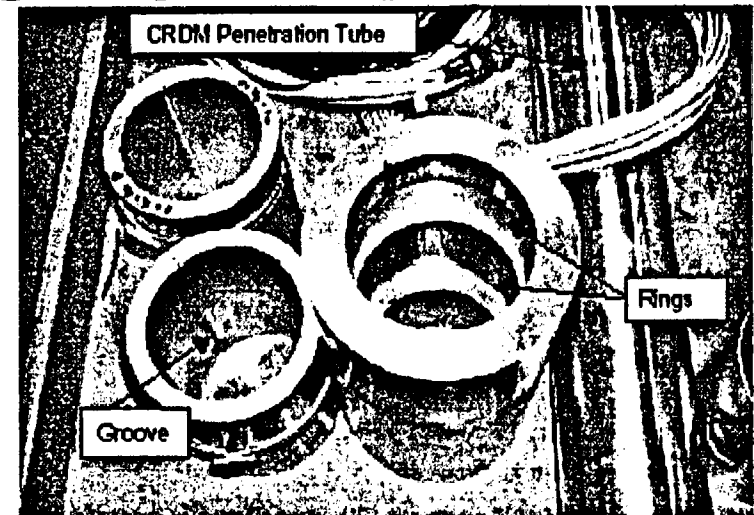
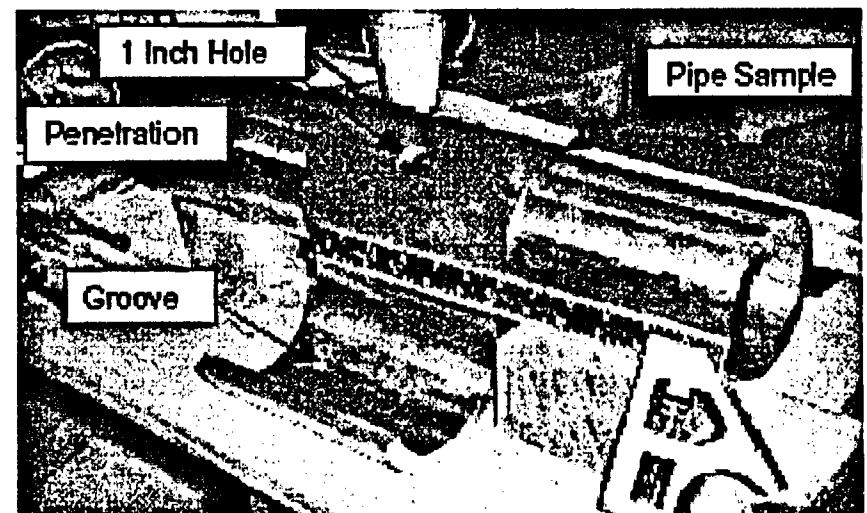
Development of Low Frequency Vessel Leakage/Integrity Inspection

- ▶ Evaluated using machined samples, representing various degradation morphologies (rings, grooves, drilled holes)
- ▶ Tests performed both on a test stand, and on an actual reactor vessel head at the Waltz Mill facility

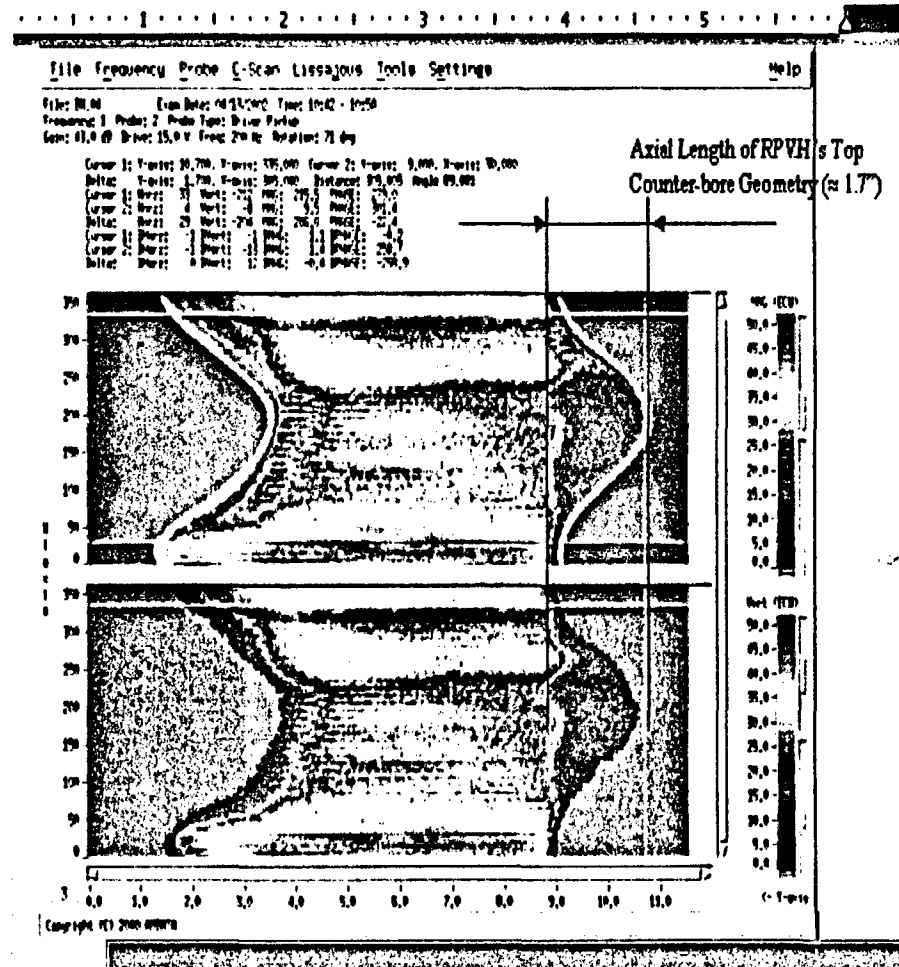
Development of Low Frequency Vessel Leakage/Integrity Inspection

- Inspections were performed on six penetrations on the Jamesport reactor head
- Results showed this tool's ability to map the counter bore region near the OD of the head (0.015" change)

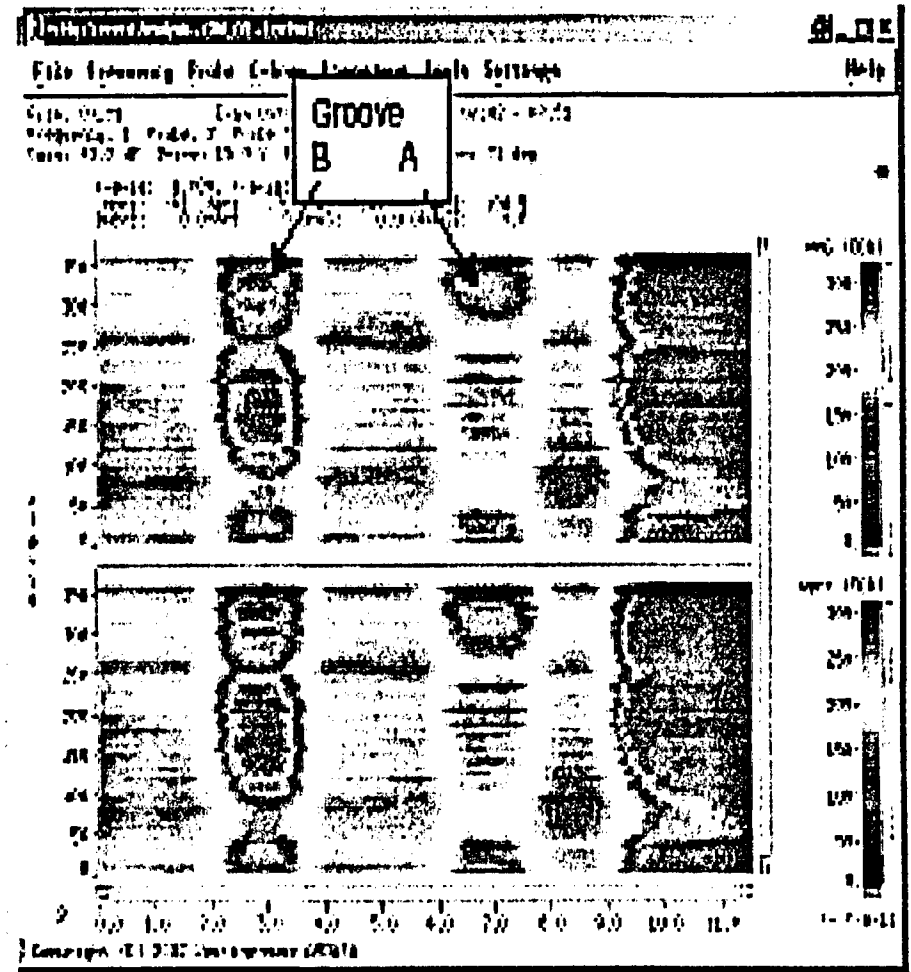
Development of Low Frequency Vessel Leakage/Integrity Inspection

- ▶ Picture shows machined grooves of 0.250" depth (A) and 0.500" depth (B).
- ▶ Both grooves are 2" in axial length and 360 degrees around the sample.

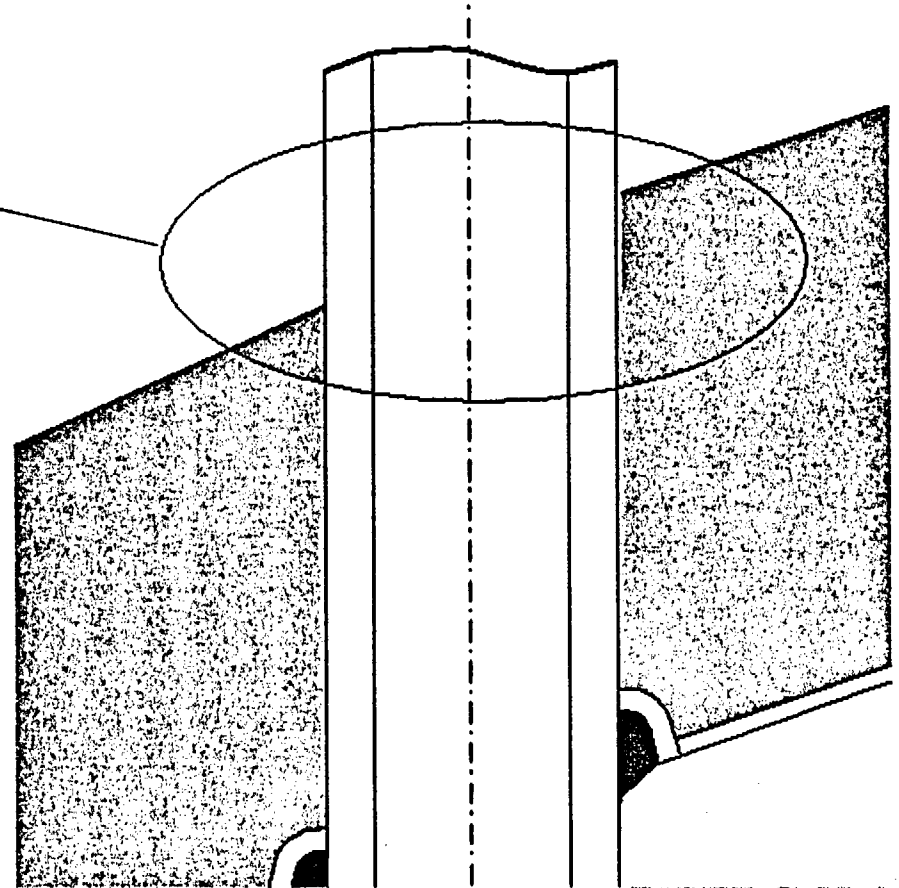
Low Frequency Vessel Inspection

- ▶ OD of Vessel and counter bore inspection area
- ▶ Measures degradation
- ▶ Diverse and complementary to UT (triple point and riverbed)
- ▶ Assures integrity of OD of Vessel

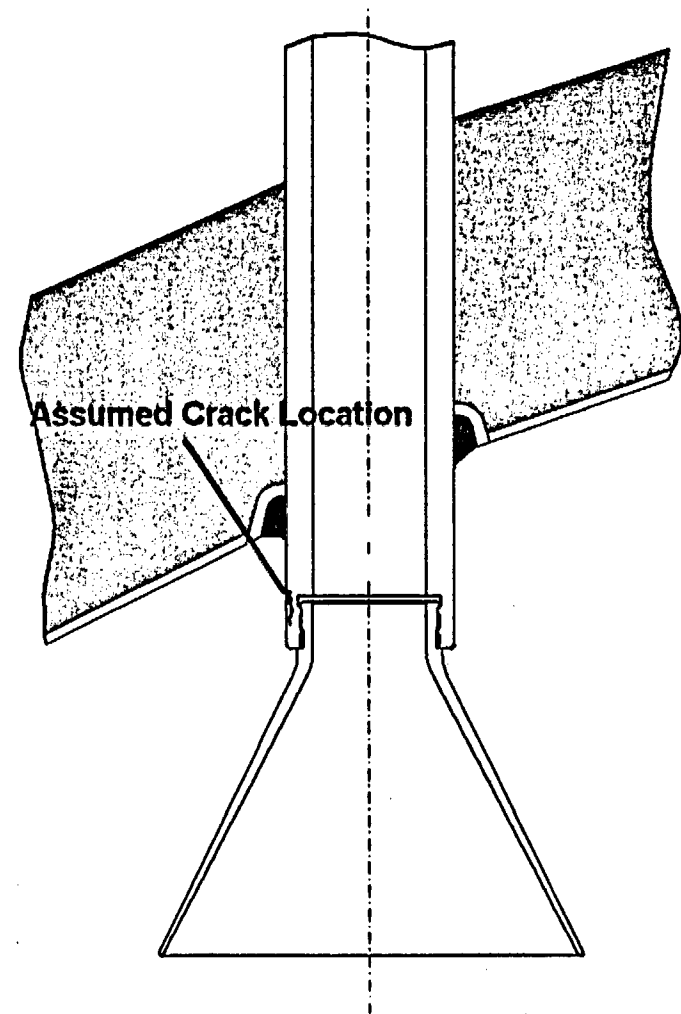
ORDER Relaxation - Inspection of Threaded Nozzle Cone Area

- ▶ Threaded length 1.34" not inspected
- ▶ Dead Zone ~0.2 inches
- ▶ Crack Growth Analysis from dead zone area to J-weld interface
 - Finite element analysis for residual operating and weld stresses
 - Elastic/plastic fracture mechanics analysis
- ▶ All nozzles acceptable for greater than one cycle

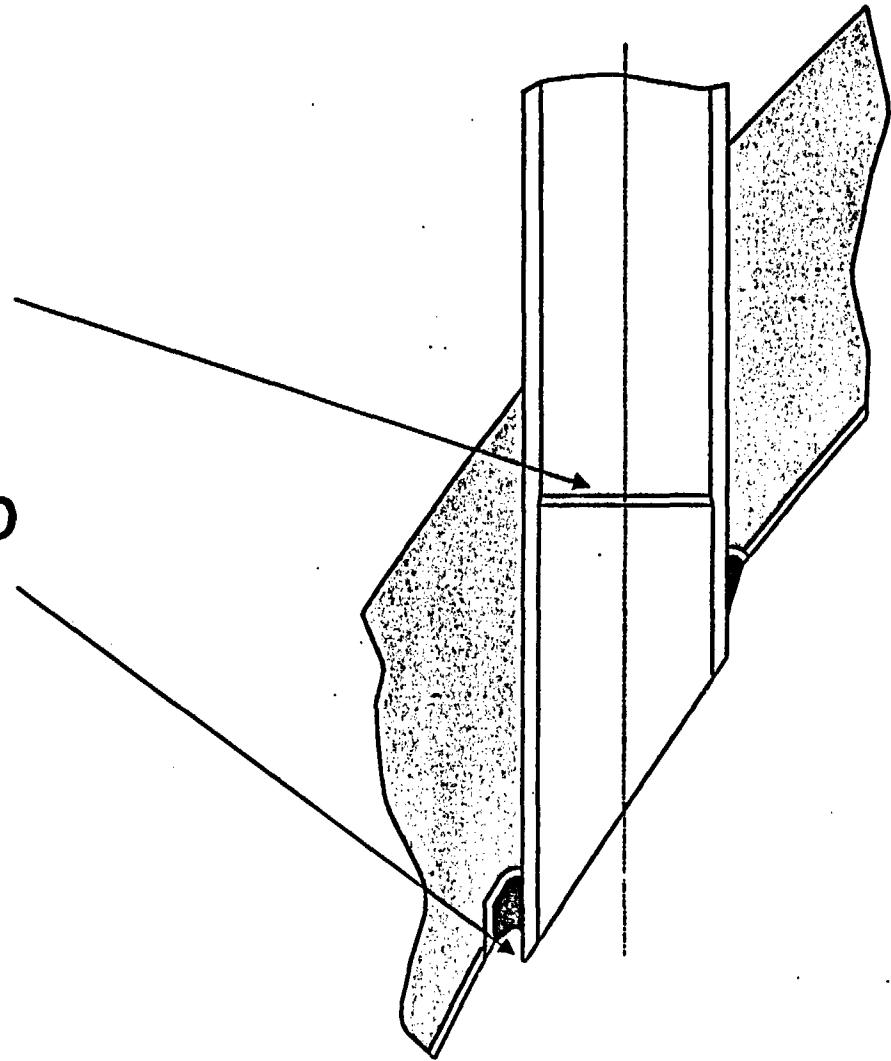
ORDER Relaxation - Inspection of ICI Nozzle Ends

- ▶ Counter Bore affects the 2" criteria above the weld
- ▶ Cannot see to the tip of nozzle
