# **Common-Cause Failure Event Insights**

## **Circuit Breakers**

**Idaho National Engineering and Environmental Laboratory**

**U.S. Nuclear Regulatory Commission  
Office of Nuclear Regulatory Research  
Washington, DC 20555-0001**

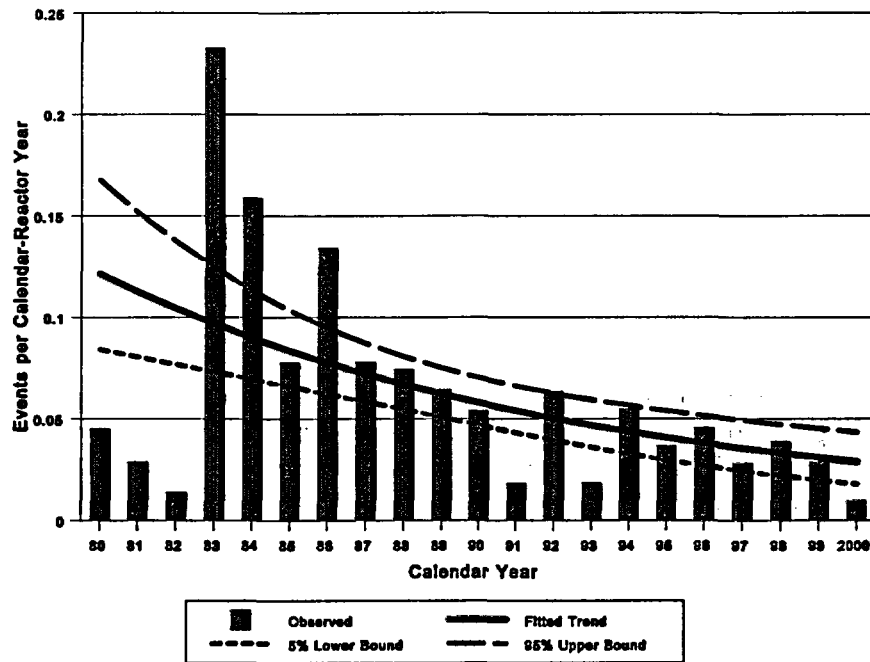
Figure ES-1. Trend for all circuit breaker CCF events. The decreasing trend is statistically significant with a p-value = 0.0001.

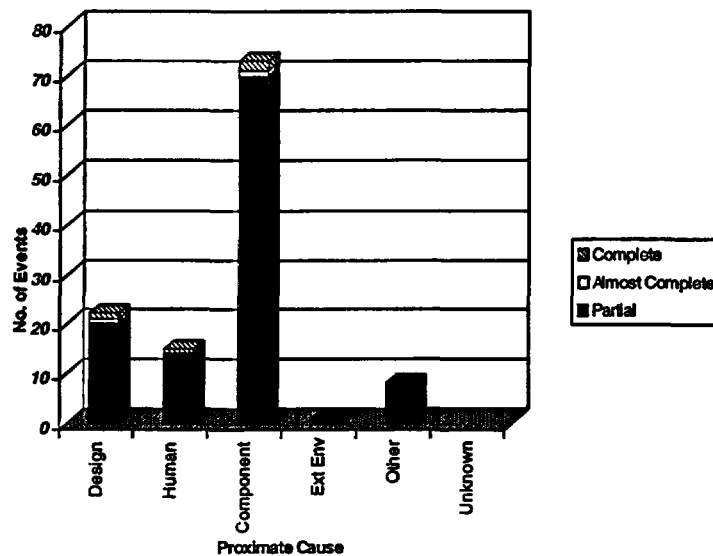
**Proximate Cause.** As shown in Figure ES-2, the leading proximate cause group was Internal to Component and accounted for 61 percent of the total. Design/Construction/Installation/Manufacture Inadequacy accounted for about 18 percent of the total events. The Operational/Human error cause group accounted for 13 percent of the total events. There were eight events attributed to the Other cause category. Although the Internal to Component cause group had the largest fraction of the events, only three percent were Complete failures.

Figure ES-2. Proximate cause distribution for all circuit breaker CCF events.

The Internal to Component proximate cause category is the most likely for the circuit breakers and encompasses the malfunctioning of hardware internal to the component. Circuit breaker failure due

to internal causes are most likely the result of phenomena such as dirt and dust, hardening of lubricants, aging, normal wear, and binding. Generally, these failures are thought of as being preventable by more frequent maintenance.

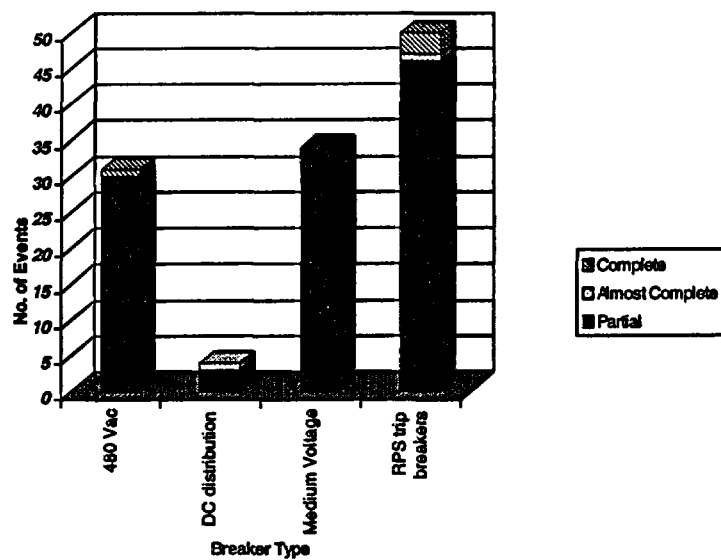
Figure ES-3. Circuit breaker type distribution for all circuit breaker CCF events.

**Piece Parts.** For all breaker types, the mechanical assembly had the most events, 31 (26 percent). The mechanical assembly was identified for all breaker types. Most of these events were coupled by inadequate maintenance. The undervoltage (UV) trip assembly had the second most events, 28 (24 percent). The UV trip assembly was identified mostly for the RTBs.

The most likely piece part involved in a reactor trip breaker CCF event was the UV trip assembly. The most likely piece part involved in both medium voltage and 480 Vac breaker CCF events was the mechanical operating assembly.

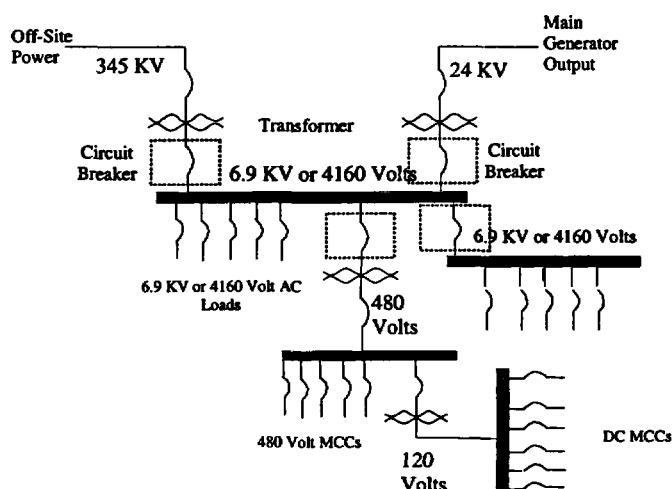
Included within the 480 Vac circuit breaker type are the circuit breakers located at the motor control centers (MCC) and the associated power boards that supply power specifically to any 480-volt equipment. The MCCs and the power boards are not included except for the load shedding and load sequencing circuitry/devices, which are, in some cases, physically located within the MCCs. Load shedding of the safety bus and subsequent load sequencing onto the bus of vital electrical loads is considered integral to the 480 Vac circuit breakers function and is therefore considered within the bounds of this study. All instrumentation, control logic, and the attendant process detectors for system initiations, trips, and operational control are included. Batteries were included if failures impacted 480 Vac circuit breakers functional operability. Figure 2-1 shows a typical 480 Vac circuit breaker arrangement.

Figure 2-1. Generic distribution system.

The Medium Voltage circuit breakers considered here are feeder circuit breakers to smaller electrical distribution centers (480 Vac motor control centers), circuit breakers between two 4160 volts-ac (Vac) busses, and the feeder circuit breakers from off-site power. Circuit breakers, which supply power to 4160 Vac and 6.9 kVac busses, as well as circuit breakers supplying loads from the 4160 Vac and 6.9 kVac busses, were also considered. Circuit breakers that supply individual components (e.g., safety injection pumps) are not included in this study, but are included in the component studies as a part of the individual component. Circuit breakers used to supply power from an emergency diesel generator to a 4160-volt bus are specifically excluded and are considered under the separate study of emergency diesel generators. Figure 2-1 shows a typical simplified ac power distribution system. The circuit breakers considered in this study are shown in boxes.

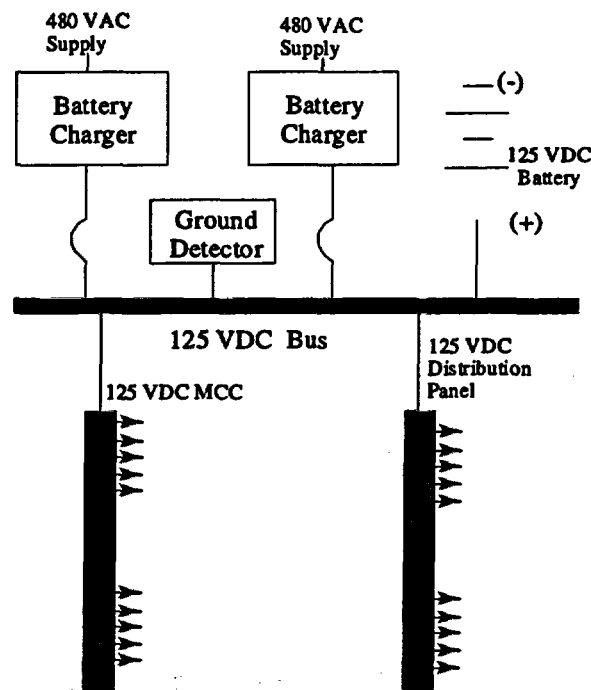
Most dc loads are supplied from 125 volt-dc (Vdc) panels through individual distribution circuit breakers, though some plants may have 250 Vdc distribution systems to support dc-powered motor-operated valves or other relatively large dc-powered loads. Multiple trains or divisions are available to ensure dc power is supplied to redundant components. These dc distribution divisions typically number from as few as two to as many as eight depending on the design of the plant. The dc power is normally distributed to the loads from a battery charger in parallel with a battery. The battery charger is usually powered from a Class 1E 480 Vac bus, supplied from off-site power or the emergency diesel generators. In the event power is not available from the normal source, dedicated station batteries supply dc power to the distribution system. A simplified schematic for a typical train or division of dc-power distribution is presented in Figure 2-2.

Figure 2-2. Dc power distribution configuration.

The dc distribution circuit breakers are normally in the closed position regardless of whether the plant is at power or shutdown. Most of the dc distribution circuit breakers are manipulated locally with only instrumentation available to the control room operator.

The dc circuit breakers have overcurrent protection that is a built-in part of a circuit breaker unit. Most circuit breakers, especially for safety-related equipment applications, provide additional protection by monitoring parameters such as undervoltage, ground faults, and other protection schemes as required for circuit breaker/system protection or the specific safety application. This additional application hardware is generally located external to the circuit breaker and merely utilizes the remote operating features of the circuit breaker. This hardware, as well as the remote operating hardware, is considered integral to the function of the circuit breaker and part of the breaker for failure analysis. It includes all sensing devices, cabling, and components necessary to process the signals and provide control signals to the individual circuit breaker.

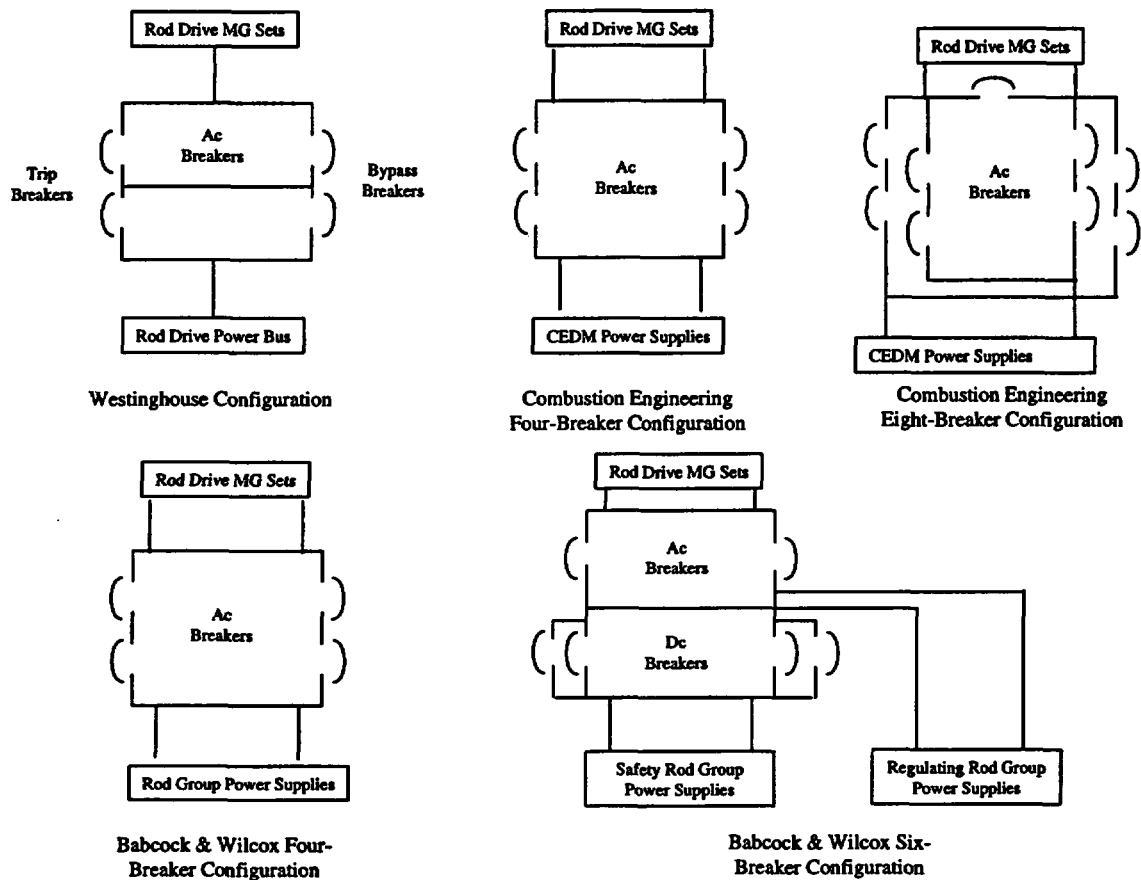
The reactor trip breakers (RTBs) are part of the pressurized water reactor (PWR) reactor protection system (RPS), and supply power to the control rod drive mechanisms. Both ac and dc circuit breakers are used for the RTBs depending on the RPS design. On a reactor trip signal, the circuit breakers will open, removing power from the control rod drive mechanisms. The control rods will then unlatch and drop into the reactor core due to gravity. Figure 2-3 shows typical RTB arrangements.

Figure 2-3. Reactor trip breaker configurations.

The RTB component is defined as the circuit breaker itself, as well the hardware and controls for the individual breakers that enable them to close and remain closed. The rod drive power supplies and RPS system components are not considered part of the RTB.

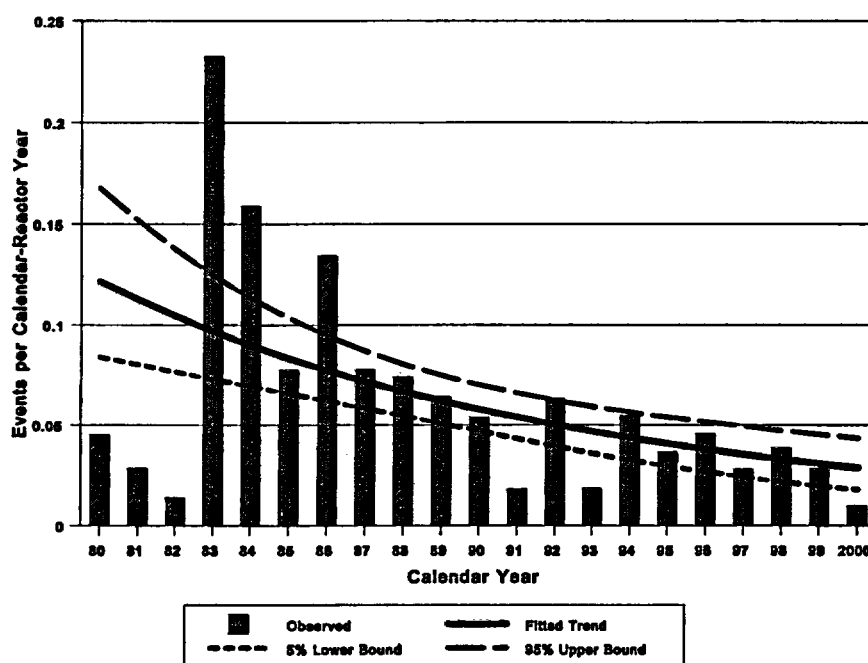
Figure 3-1 shows the yearly occurrence rate, the fitted trend, and its 90 percent uncertainty bounds for all circuit breaker CCF events over the time span of this study. The decreasing trend is statistically significant<sup>a</sup> with a p-value<sup>b</sup> of 0.0001. Based on the review of failure data for this study, the improved maintenance and operating procedures as well as the improved testing and inspection requirements have facilitated the observed reduction of the occurrence of CCF events over the 21 years of experience included in this study.

Figure 3-1. Trend for all circuit breaker CCF events. The decreasing trend is statistically significant with a p-value = 0.0001.

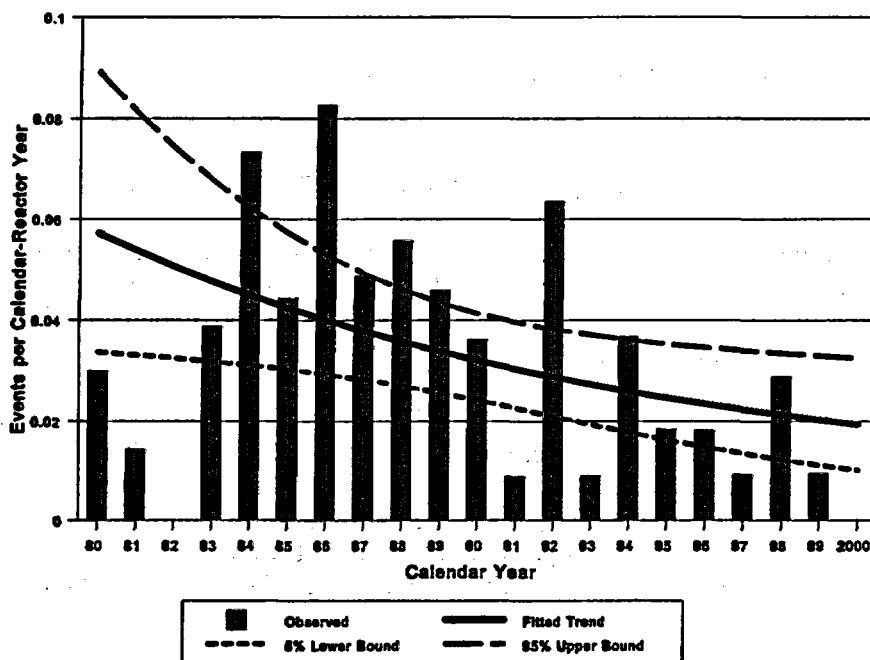
Figure 3-2 and Figure 3-3 show similar statistically significant decreasing trends for both the fail-to-close and the fail-to-open failure modes for all circuit breaker CCF events, with p-values of 0.0099 and 0.0001, respectively. Figure 3-2 shows a significant increase after 1983 followed by a noticeable decrease in the number of total failures beginning in 1990. Figure 3-3 shows a large step increase in 1983, followed by a rapid decrease from 1983 through 1987. The increase in circuit breaker unreliability was noted in a study performed for the NRC's Nuclear Plant Aging Research Program (NPAR)<sup>9</sup>. The study noted that this increase was due to utility response to IE Bulletins (IE 83-01 & IE 83-08) that were issued subsequent to the RTB failures at Salem Unit 1 in February 1983. In addition to more frequent and detailed inspections, the IE Bulletins required independent testing of the operation of the undervoltage

Figure 3-2. Trend for all circuit breaker CCF events for the fail-to-close failure mode. The decreasing trend is statistically significant with a p-value = 0.0099.

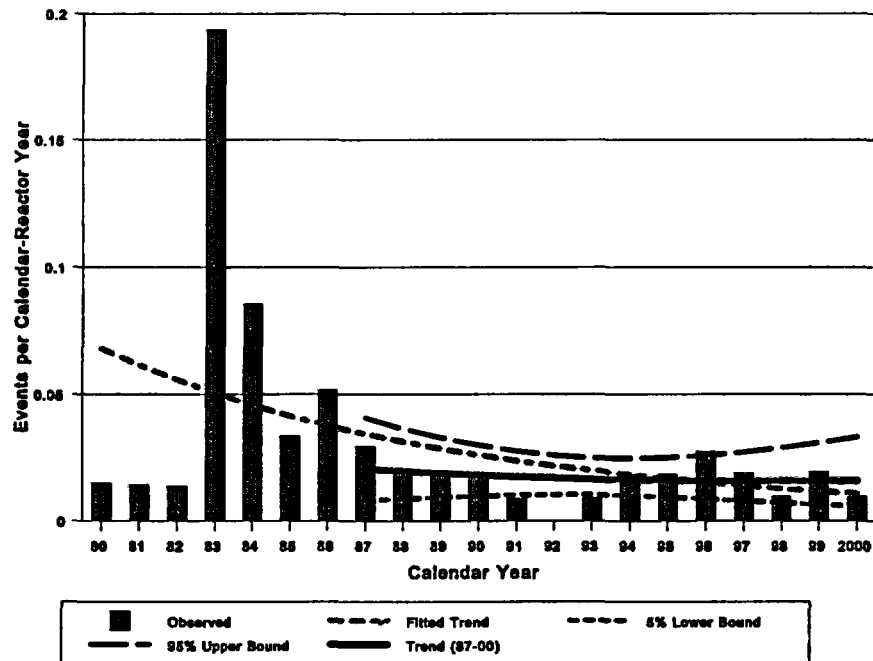
Figure 3-3. Trend for all circuit breaker CCF events for the fail-to-open failure mode. The decreasing trend is statistically significant with a p-value = 0.0001. P-value is 0.6746 for 1987-2000 data.

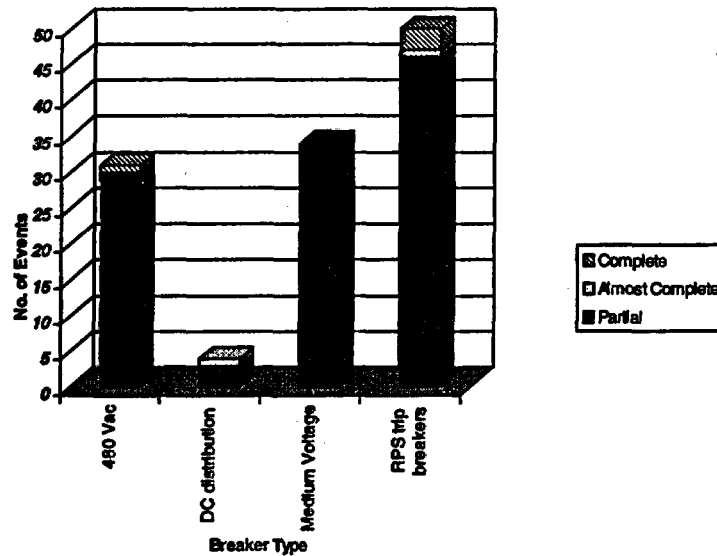
Figure 3-4 shows the distribution of the CCF events by circuit breaker type. The highest number of events occurred in the RPS trip breaker type (50 events or 42 percent). The Complete RTB events are fail-to-open, and all occurred in 1983 at two NPP units. The Medium Voltage (34 events, 29 percent) and 480 Vac circuit breakers (31 events, 26 percent) are also significant contributors. Together, these three circuit breaker types comprise over 97 percent of the circuit breaker CCF events studied. Section 4 of this report provides an in-depth analysis of the CCF events assigned to these circuit breaker types.

Figure 3-4. Circuit breaker type distribution for all circuit breaker CCF events.

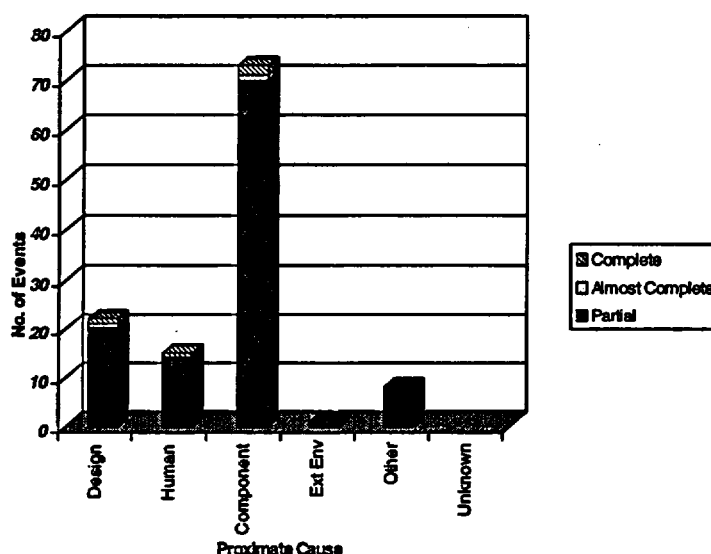
Figure 3-5 shows the distribution of CCF events by proximate cause. The leading proximate cause was Internal to Component and accounted for about 61 percent of the total events. Design/Construction/Installation/Manufacture Inadequacy faults accounted for 18 percent of the total. Human error accounted for 13 percent of the total events. To a lesser degree, External Environment and the Other proximate cause categories were assigned to the circuit breaker component.

Figure 3-5. Proximate cause distribution for all circuit breaker CCF events.

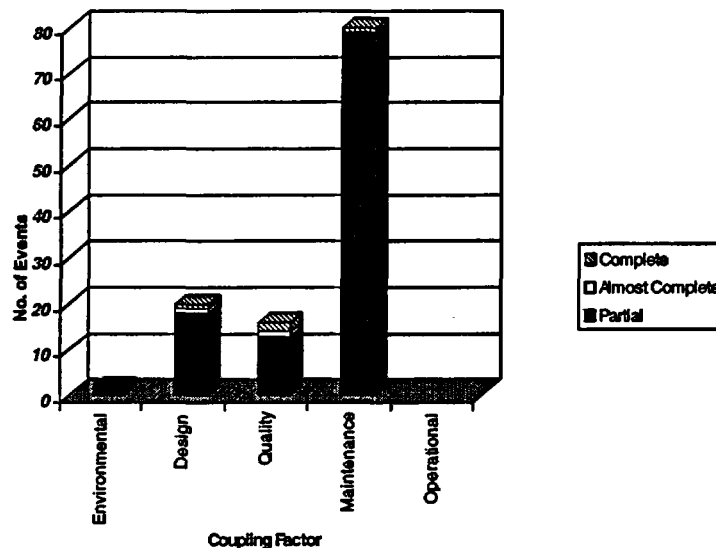
Closely connected to the proximate cause is the concept of **coupling factor**. A coupling factor is a characteristic of a component group or piece parts that links them together so that they are more susceptible to the same causal mechanisms of failure. Such factors include similarity in design, location, environment, mission, and operational, maintenance, design, manufacturer, and test procedures. These factors have also been referred to as examples of coupling mechanisms, but because they really identify a potential for common susceptibility, it is preferable to think of these factors as characteristics of a common-cause component group. Reference 4 contains additional detail about the coupling factors. Figure 3-6 shows the coupling factor distribution for the events.

Figure 3-6. Coupling factor distribution for all circuit breaker CCF events.

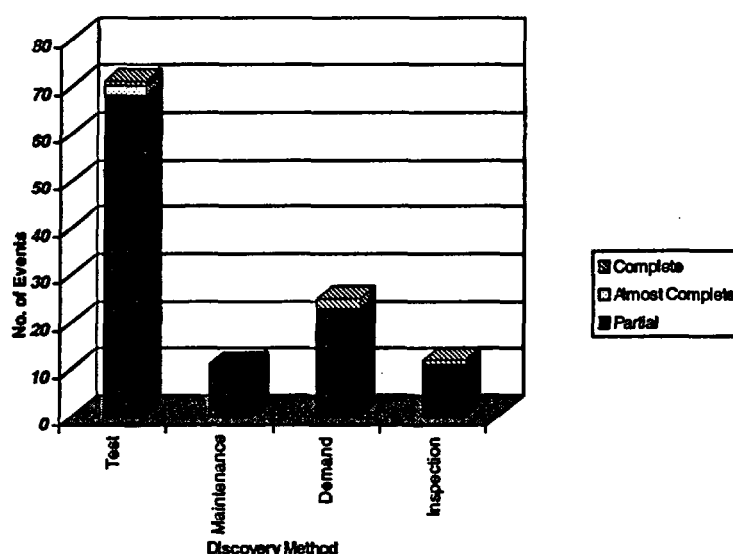
Figure 3-7 shows the distribution of how the events were discovered or detected. Testing accounts for 71 events, (60 percent), Demand for 25 events (21 percent), Maintenance for 11 events (9 percent), and Inspection for 12 events (10 percent). The importance of Testing indicates the success of testing in detecting common-cause failures. Testing is designed to detect faults before they occur. The testing program has shown that it is successful in accomplishing this goal.

Figure 3-7. Discovery method distribution for all circuit breaker CCF events.

**Method of Discovery.** When the method of discovery was investigated, Testing accounted for 71 events (60 percent), Demand for 25 events (21 percent), Maintenance 11 events (9 percent), and Inspection 12 events (10 percent). The testing program has shown that it is successful in detecting faults.

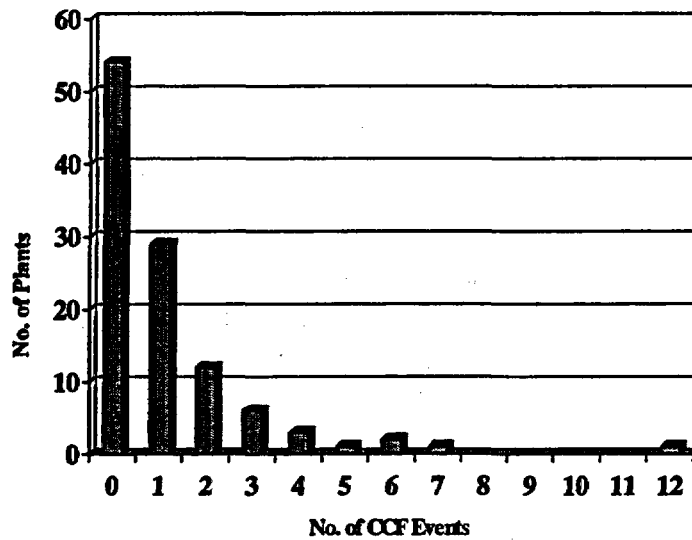
Figure 3-8 shows the distribution of breaker CCF events among the NPP units. The data are based on 109 NPP units represented in the insights CCF studies. The largest contribution (76 percent) consists of NPP units with either zero or one CCF event. This may indicate that the majority of the NPP units have maintenance and testing programs to identify possible circuit breaker CCF events and work towards preventing either the first event or any repeat events. Seventy-four percent of the total circuit breaker CCF events occurred at 51 of the NPP units.

Figure 3-8. Distribution of NPP units experiencing a multiplicity of CCFs for all circuit breaker CCF events.

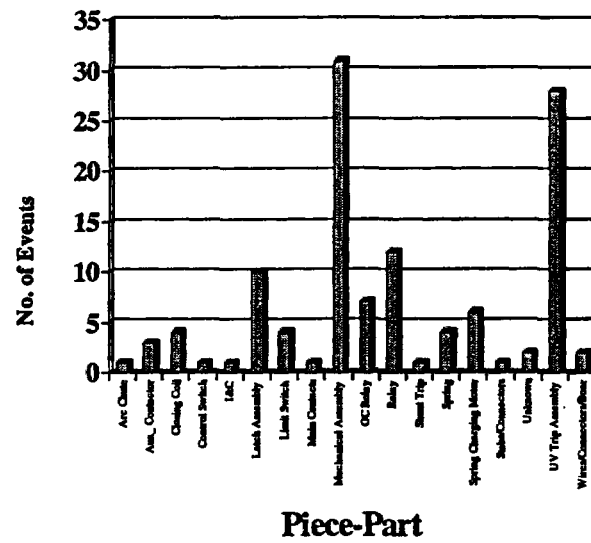
Figure 3-9 shows the distribution of the failed piece-parts for all breaker types. The mechanical assembly had 31 events (26 percent). The mechanical assembly was identified for all breaker types. Most of these events were coupled by inadequate maintenance. The UV trip assembly had 28 events (24 percent). The UV trip assembly was identified mostly for the RPS trip breakers. Table A-4 in Appendix A presents the entire circuit breaker data set, sorted by the piece-part. This table can be referred to when reading the following discussions to see individual events described.

Figure 3-9. Distribution of the failed piece-parts for all circuit breaker CCF events.

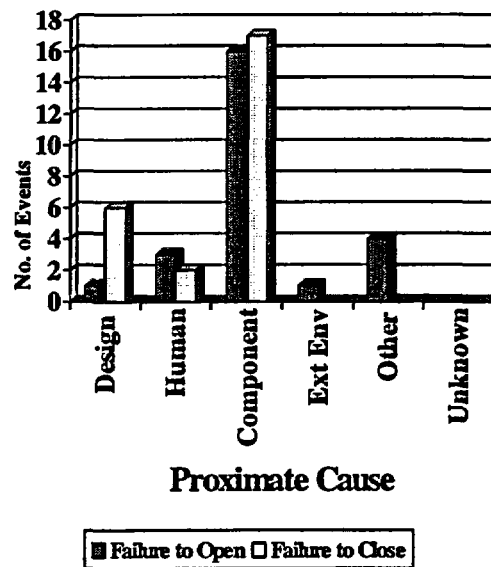
Fifty circuit breaker CCF events affected the RPS Trip type circuit breaker (see Table B-1 in Appendix B, items 70–119). Figure 4-1 through Figure 4-3 show selected distributions graphically. Half of the RTB CCF events (25) were due to problems with the undervoltage (UV) trip assemblies. Table 4-3 contains a summary of these events by proximate cause group and failure. Figure 4-1 shows that the most likely proximate cause group was Internal to the Component.

Figure 4-1. Distribution of proximate causes for the RPS trip breaker type.

The Internal to Component proximate cause group had 33 events (66 percent) of which two were Complete and one was Almost Complete (see Table B-1 in Appendix B, items 78 –110). Affected piece parts included the undervoltage trip assembly, the mechanical operating assembly, and the latch assembly. The vast majority of these events were coupled by inadequate maintenance.

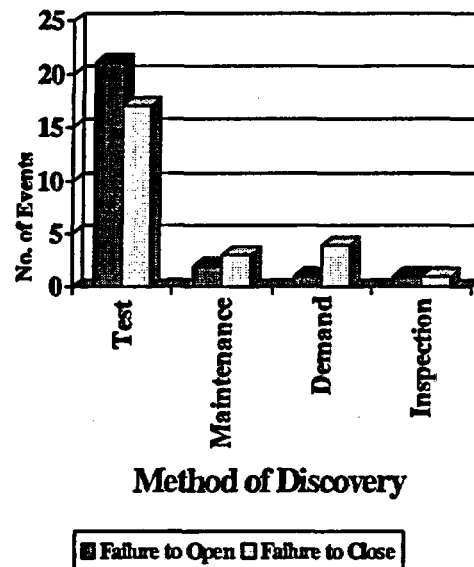
Testing was the most likely method of discovery for instrumentation and control circuit breaker events (38 out of the 50 events, 76 percent) as shown in Figure 4-2. The reactor trip breakers are frequently tested. This tends to make testing the most likely method of discovery. Inspection, Maintenance, and Demand make up the rest of the observed discovery methods. The most likely piece part involved in a RTB CCF event was the undervoltage trip assemblies as shown in Figure 4-3.

Figure 4-2. Distribution of the method of discovery for the RPS trip breaker type.

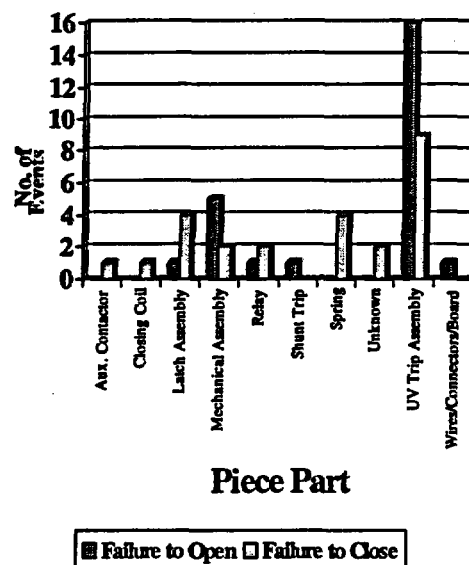
Figure 4-3. Distribution of the affected piece part for the RPS trip circuit breaker type.

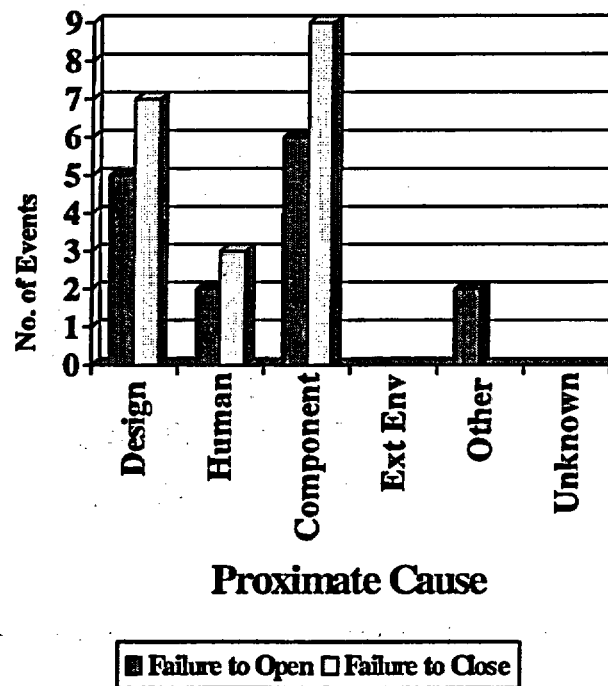
Figure 4-4. Distribution of proximate causes for the Medium Voltage circuit breaker type.

The most likely proximate causes are Internal to Component and Design/Construction/Installation/Manufacture Inadequacy as shown in Figure 4-4. Table 4-5 contains a summary of these events by proximate cause group and degree of failure. None of the Medium Voltage breaker CCF events were complete.

The Internal to Component proximate cause group had 15 events (44 percent) (see Table B-1 in Appendix B, items 48 – 62). Affected piece parts included the mechanical operating assembly, the charging spring motor, the arc chute, auxiliary contactors, latch assemblies, limit switches, over-current relays, stab connectors, and trip coils. Most of these events were coupled by inadequate maintenance and design.

The Design/Construction/Installation/Manufacture Inadequacy proximate cause group had 12 events (35 percent) (see Table B-1 in Appendix B, items 36 – 47). Affected piece parts included relays,

The Operational/Human Error proximate cause group contains five events (15 percent) (see Table B-1 in Appendix B, items 63 – 67). Affected piece parts included the mechanical operating assembly, latch assembly, and relays. Most of these events were coupled by inadequate maintenance and test procedures or maintenance staff errors.

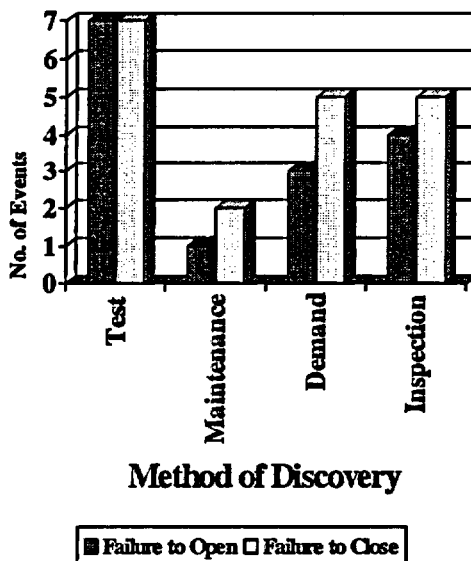
Figure 4-5. Distribution of the method of discovery for the Medium Voltage circuit breaker type.

Testing was the most likely method of discovery for the Medium Voltage circuit breaker events (14 out of the 34 events, 41 percent) as shown in Figure 4-5. The most likely piece parts involved in these CCF events were the mechanical operating assemblies, charging motors, latch assemblies, relays and limit switches as shown in Figure 4-6. The descriptions of all Medium Voltage circuit breaker CCF events can be found in Appendix A.

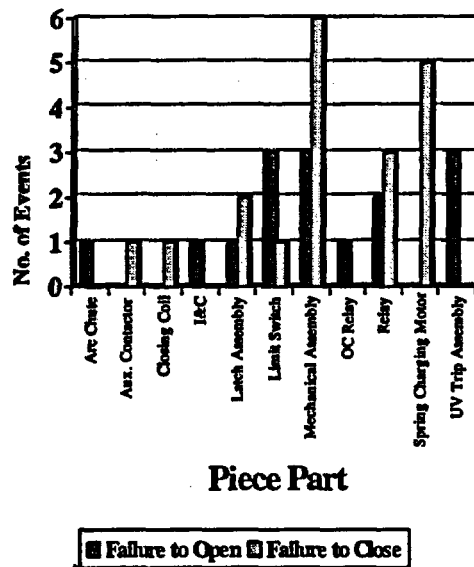
Figure 4-6. Distribution of the affected piece part for the Medium Voltage circuit breaker type.

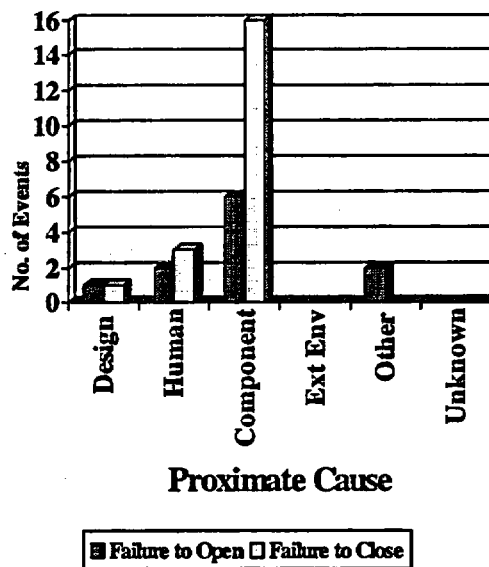
Figure 4-7. Distribution of proximate causes for the 480 Vac circuit breaker type.

Thirty-one circuit breaker CCF events affected the 480 Vac circuit breakers (see Table B-1 in Appendix B, items 1–31). Figure 4-7 through Figure 4-9 show selected distributions graphically. The majority of circuit breaker CCF events involving the 480 Vac circuit breaker type were caused by faults internal to the circuit breakers. Of the 31 events, only one was Complete. The coupling factor for almost all of the events (27) was Maintenance. Table 4-6 contains a summary of these events by proximate cause group and degree of failure.

The Internal to Component proximate cause group had 22 events (71 percent) of which none were Complete (see Table B-1 in Appendix B, items 3 – 24). Affected piece parts included the mechanical operating assembly, relays, closing coils, latch assemblies, auxiliary contactors, and over-current relays. Almost all of these events were coupled by inadequate maintenance and testing schedules.

The Operational/Human Error proximate cause group contained five events (16 percent) of which none were Complete (see Table B-1 in Appendix B, items 25 – 29). Affected piece parts included the mechanical operating assembly, the main contacts, and the over-current relay. These events were all coupled by either inadequate maintenance, test procedures, or by maintenance staff errors.

The Design/Construction/Installation/Manufacture Inadequacy proximate cause group had two events (6 percent) of which one was Complete (see Table B-1 in Appendix B, items 1 – 2). Affected piece parts included fuses, relays, stab connectors, and trip coils. Most of these events were coupled by shared quality issues related to installation or construction.

The Other proximate cause group had two events, neither of which was complete (see Table B-1 in Appendix B, items 30 – 31). Both events involved out-of-tolerance over-current trip relays.

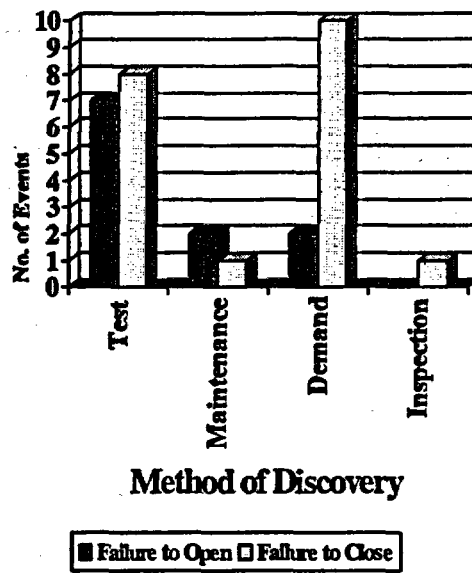
Figure 4-8. Distribution of the method of discovery for the 480 Vac circuit breaker type.

Testing was the most likely method of discovery for 480 Vac circuit breaker events (15 out of the 31 events, 48 percent) as shown in Figure 4-8. A rather large number of these events were discovered by demands (39 percent). Inspection and Maintenance make up the next most likely discovery methods. The most likely piece part involved in 480 Vac circuit breaker CCF events was the mechanical operating assembly as shown in Figure 4-9.

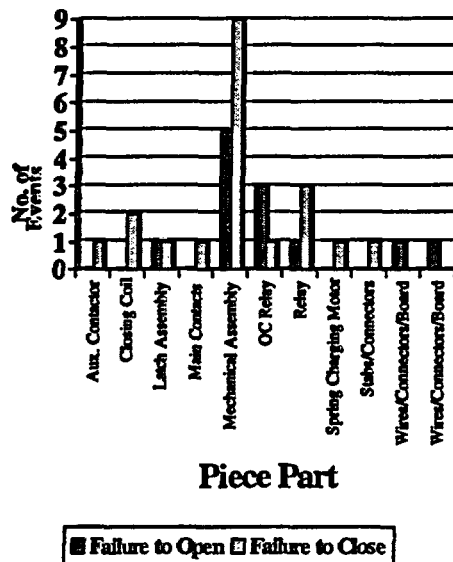
Figure 4-9. Distribution of the affected piece part for the 480 Vac circuit breaker type.
