Braidwood Station, Unit 2
Facility Operating License No. NPF-77
NRC Docket No. STN 50-457

Subject: Braidwood Station, Unit 2 Ninth Refueling Outage Steam Generator Tube Inspection Report, Additional Information Pertaining to Steam Generator Secondary Side Inspections

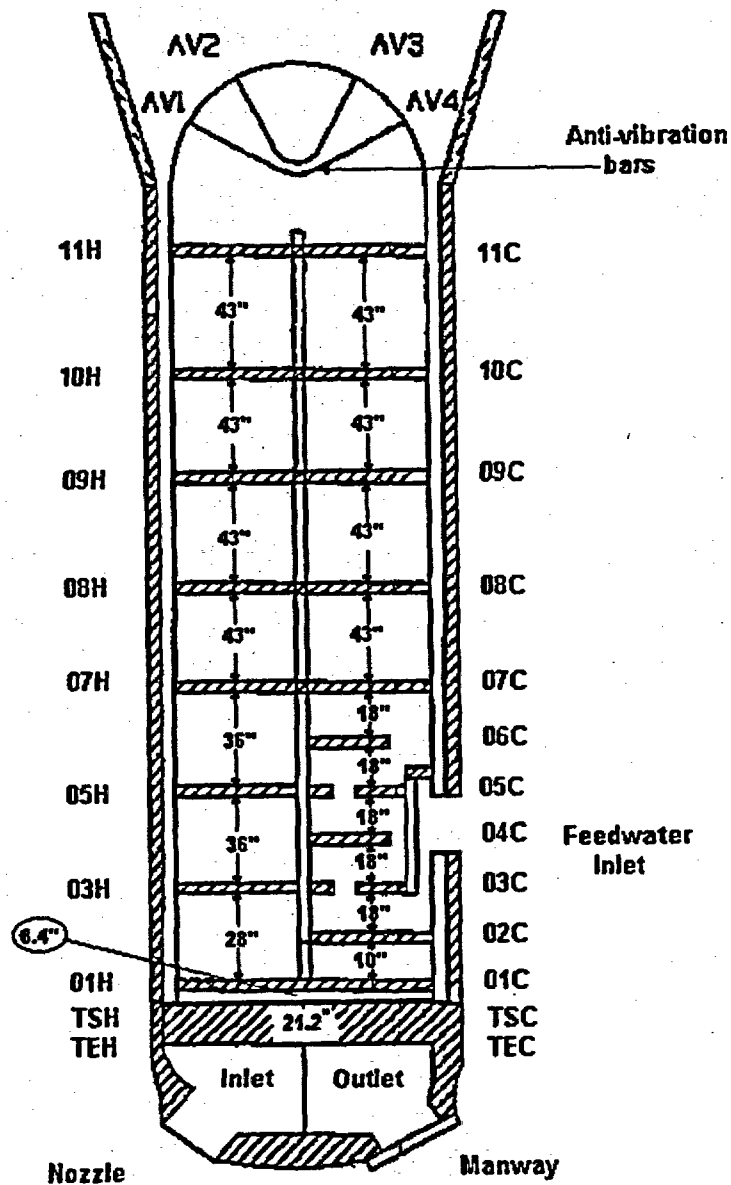
FIGURE A.2
D-5 Support Plate Locations

Note: Tube Support Plate dimensions
are centerline to centerline.
