APPLICANT: Omaha Public Power District

FACILITY: Fort Calhoun Station, Unit 1

SUBJECT: SUMMARY OF MEETING WITH OMAHA PUBLIC POWER DISTRICT (OPPD) TO DISCUSS DRAFT RESPONSES TO REQUESTS FOR ADDITIONAL INFORMATION (RAIs) FOR THE RENEWAL OF THE OPERATING LICENSE FOR FORT CALHOUN STATION, UNIT 1 (FCS)

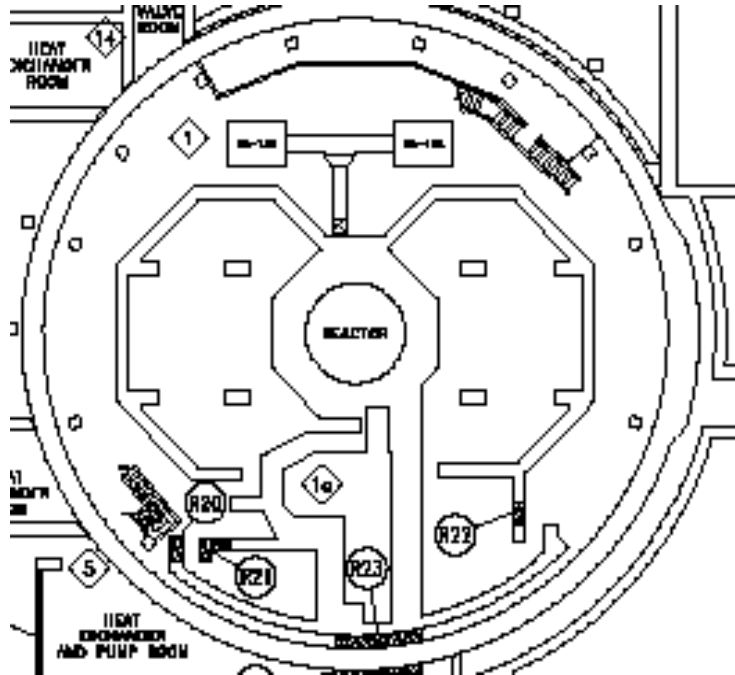
1. The masonry walls in containment are identified as R20, R21, R22, and R23 in the following figure of the 989' elevation level of containment.

2. Temperature – 120°F
Humidity – 20 to 100%
Radiation – 10R/hr averaged over a 40-year life.
3. The masonry walls in containment are inspected during performance of the containment inspection surveillance test which is performed every other refueling outage.
4. Containment inspections performed in 1996, 1999, and 2002 did not identify any degradation of the masonry walls.
