TRANSMITTAL OF MEETING HANDOUT MATERIALS FOR  
IMMEDIATE PLACEMENT IN THE PUBLIC DOMAIN

Meeting with the BWROG  
to discuss steam dryer  
integrity

## BWR Steam Dryer Update

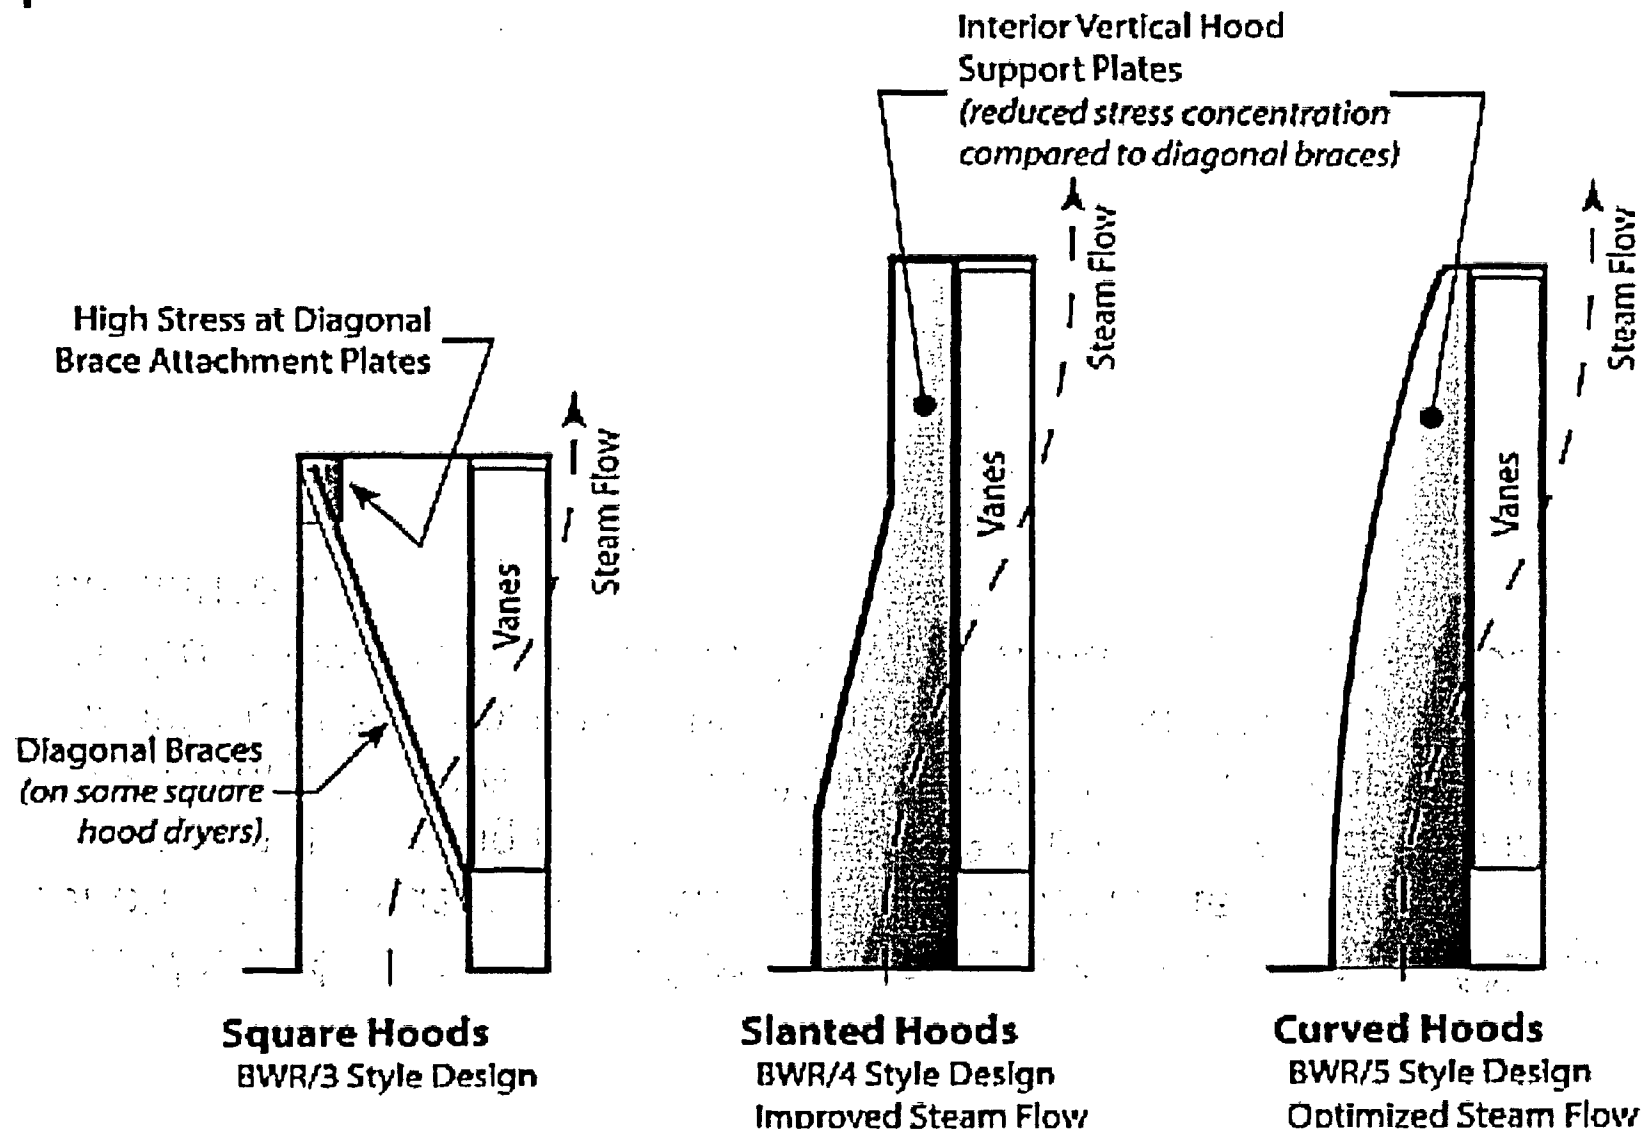
## Basic GE Steam Dryer Hood Types

- Internal inspections recommended only for BWR/3 with internal diagonal braces
  - Interior brace attachment bracket forms localized stress concentration on inside surface of hood
  - Crack initiation observed at this location in two BWR/3s
  - Location predicted by structural analysis
- External inspections recommended for later dryer designs
  - No internal bracket forming stress concentration
  - Single-sided groove or fillet weld specified
  - Full weld penetration or backside welds not required
  - May be difficult to distinguish potential crack from crevice area in weld root

- Overseas BWR/4
  - Power uprate = 110%
  - Square hood design, no internal braces
  - High-stress locations per SIL 644 Supp. 1
    - Accessible areas under the hood also inspected
- Peach Bottom 3
  - Power uprate = 105%
  - Slanted hood design, no internal braces
  - High stress locations per SIL 644 Supp. 1
- Duane Arnold
  - Power uprate = 112%
  - Slanted hood design, no internal braces
  - End panels, cover plates, tie bars, no vertical rib inspection (conducted prior to issuance of but consistent with SIL 644 Supp. 1)
- Results: no indications found in high stress locations

- Dresden 2
  - Power uprate = 117%
  - Square hood design, internal braces
  - dryer outer, interior hood welds per SIL 644 Supp. 1
    - Included interior of inner banks
  - Short fatigue cracks on inner surface of outer vertical hood panels at diagonal brace brackets
    - Location predicted by structural, loads analyses
    - Similar to Quad Cities 2 outer hood on 270° side
    - No cracking on inner banks
