Dresden Nuclear Power Station, Units 2 and 3
Facility Operating License Nos. DPR-19 and DPR-25
NRC Docket No. 50-237 and 50-249

Quad Cities Nuclear Power Station, Units 1 and 2
Facility Operating License Nos. DPR-29 and DPR-30
NRC Docket Nos. 50-254 and 50-265

Subject: Additional Information for the Review of the License Renewal Applications
for Dresden Nuclear Power Station, Units 2 and 3 and Quad Cities
Nuclear Power Station, Units 1 and 2

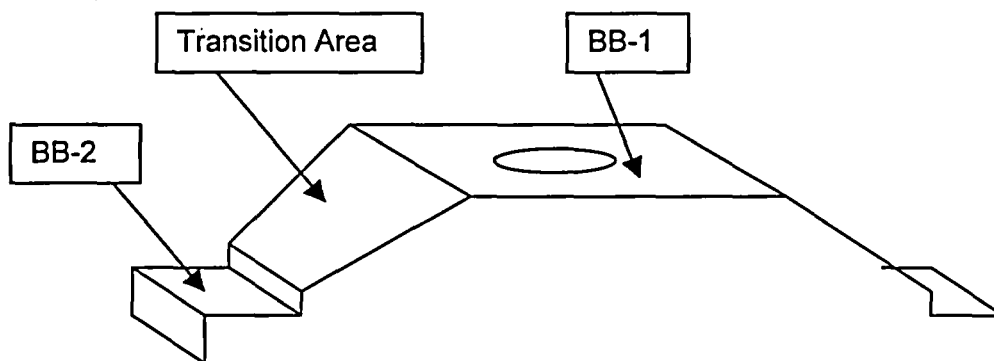
However, the cracking occurred in the transition area, located between BB-1 (the area surrounding the bolt hole) and BB-2 (the machined radius or ear). The transition area is a low stress location, outside the area of interest specified by the BWRVIP-41. (See below sketch.)

The statement is not a contradiction. Inspections recommended in BWRVIP-41 are divided into both baseline and re-inspection recommendations based on an inspection cycle of six years. Baseline inspection required UT or other NDE technique of all beams during the next inspection cycle. Fifty percent of the inspections were to be performed in the next refueling outage. Re-inspection requirements are 50% per inspection cycle for the first 20 years of service and 100% per inspection cycle beyond 20 years of service. Both Dresden and Quad Cities have performed 100 percent UT inspections of the BB-1 and BB-2 each refueling outage since 1995, which exceeds BWRVIP-41 recommendations.

As part of the corrective actions from the LER root cause investigation, Exelon has requested the BWRVIP committee to provide further evaluations of the adequacy of the examinations performed on the hold down beams. Exelon will continue to perform the inspections required by BWRVIP-41 (BB-1 and BB-2) and will incorporate the additional changes in inspection methodology when incorporated into BWRVIP-41.
