FPL

Nuclear Engineering

NRC / FPL Interface Meeting

December 6, 2004

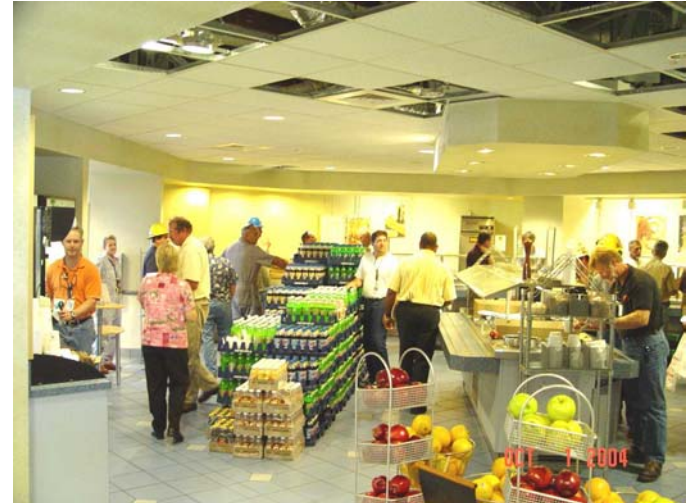
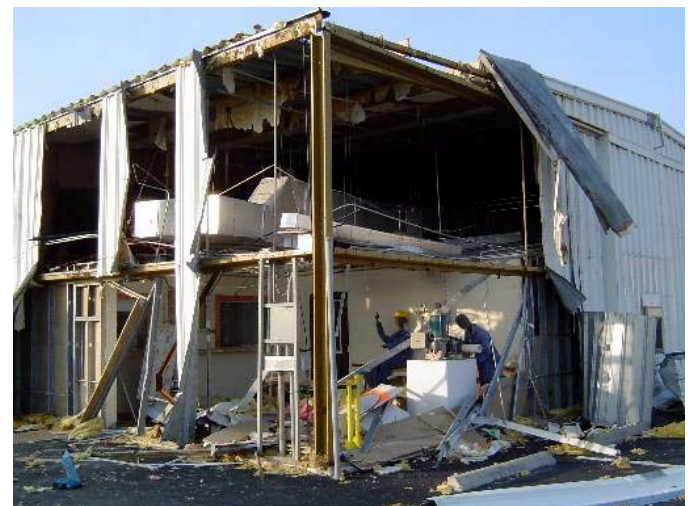
- Extensive Hurricane preparation at both sites
- Dedicated Hurricane / Emergency Plan staffing
- Two dual-unit outages
- Loss of all offsite power at St. Lucie during Jeanne
- St. Lucie outage rescheduled
- Infrastructure damage
