Dominion Nuclear Connecticut, Inc.  
Millstone Power Station  
Rope Ferry Road  
Waterford, CT 06385

**DOMINION NUCLEAR CONNECTICUT, INC. (DNC)**  
**MILLSTONE POWER STATION UNITS 2 AND 3**  
**RESPONSE TO REQUEST FOR ADDITIONAL INFORMATION**  
**LICENSE RENEWAL APPLICATIONS**

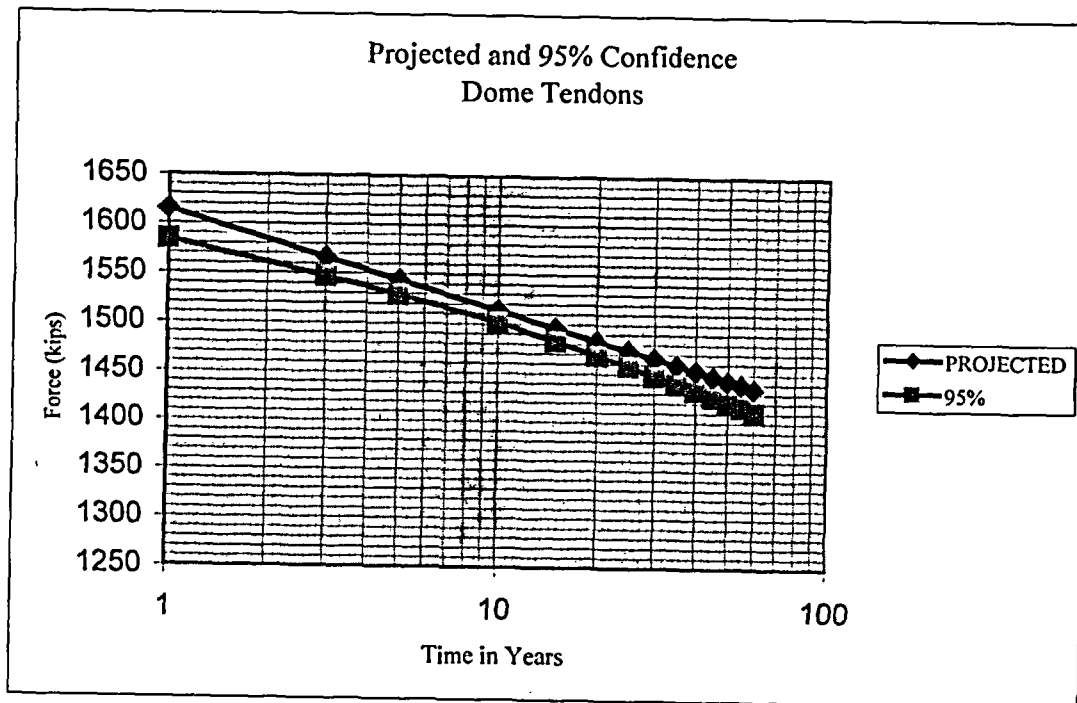
Figure 1  
Millstone Unit 2  
Containment Tendon Prestress  
Dome Tendons

Consistent with Regulatory Guide 1.35.1, the containment dome, horizontal and vertical tendon surveillance results (Millstone Unit 2 LRA, Section 4, Tables 4.5-1, 4.5-2 and 4.5-3) used in the development of LRA Figure 4.5-1 have been plotted in the following Figures 1, 2 and 3, against the logarithm of time using the methodology identified in Attachment 3 of NRC Information Notice 99-10. Prestressing forces for the Millstone Unit 2 containment dome, horizontal and vertical tendon are shown to vary linearly with time. Further discussion and information on the development of these curves can be found in the responses to RAI 4.5-2, RAI 4.5-4 and RAI 4.5-7.
