# **Regulatory Effectiveness Assessment of Generic Issue 43 and Generic Letter 88-14**

**U.S. Nuclear Regulatory Commission  
Office of Nuclear Regulatory Research  
Washington, DC 20555-0001**

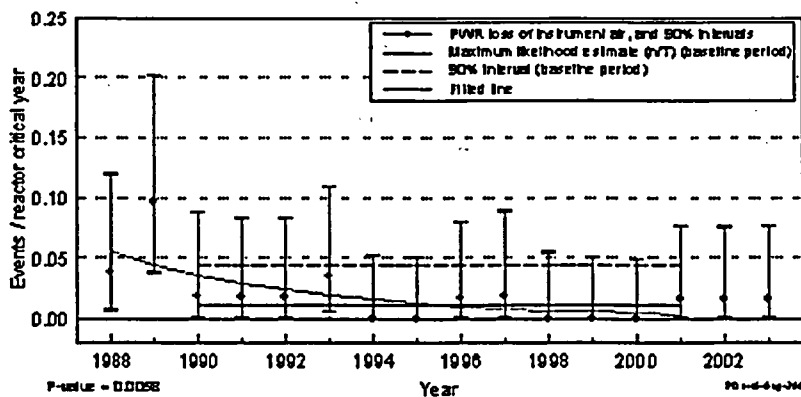
Figure 1. Frequency of PWR initiating events with loss of instrument air

In 2004, Idaho National Engineering and Environment Laboratory (INEEL) analyzed the initiating event frequencies at U.S. nuclear power plants (Ref. 8). As shown in Figures 1 and 2, the historical frequency of initiating events with loss of instrument air has decreased for both boiling-water reactors (BWRs) and pressurized-water reactors (PWRs). INEEL concluded that the long-term trend is likely to represent more than mere random variation. Both BWRs and PWRs showed low baseline initiating event frequencies for loss of instrument air, with mean frequencies of 0.0083 and 0.0115 per reactor critical year for BWRs and PWRs, respectively. These baseline initiating event frequencies are significantly lower than the "pre-baseline" frequencies (before 1994 for BWRs and before 1990 for PWRs); however, the INEEL analysis did not provide reasons for the observed frequency changes.

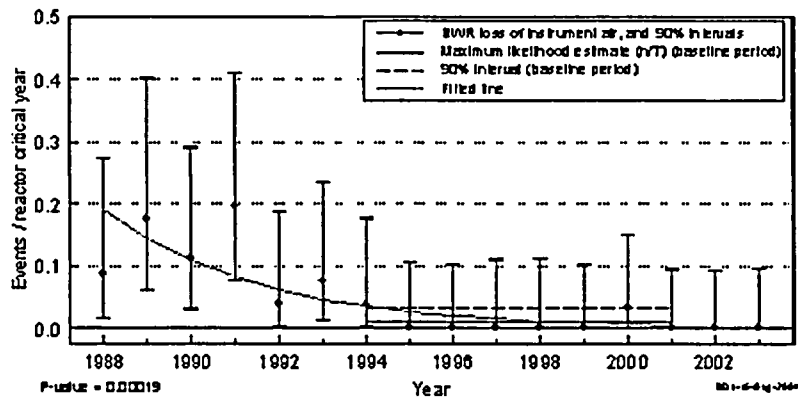
Figure 2. Frequency of BWR initiating events with loss of instrument air

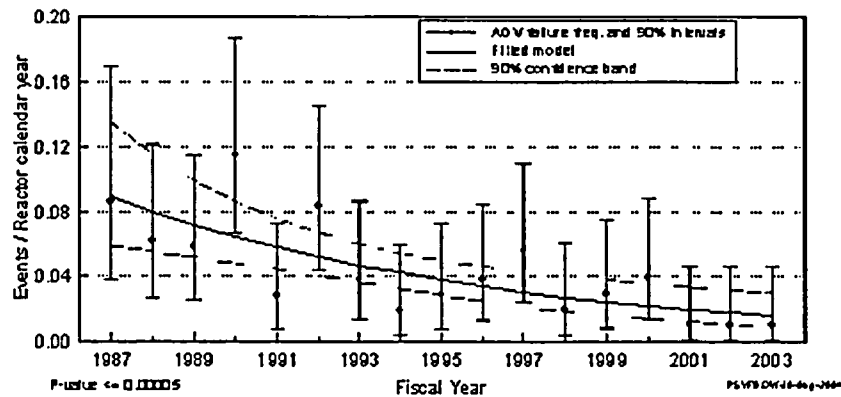
Figure 3. Frequency of failures (events per operating year), as a function of fiscal year

In 2004, INEEL also analyzed the component performance of air-operated valves (AOVs) at U.S. commercial reactors (Ref. 9). That analysis showed statistically significant improving trends for AOV performance in many areas, including overall failure frequency (Fig. 3), frequency of unplanned demands (Fig. 4), and probability of failure on demand (Fig. 5), each of which reduced by a factor of 3 or greater. The INEEL analysis did not provide reasons for the observed performance improvement.

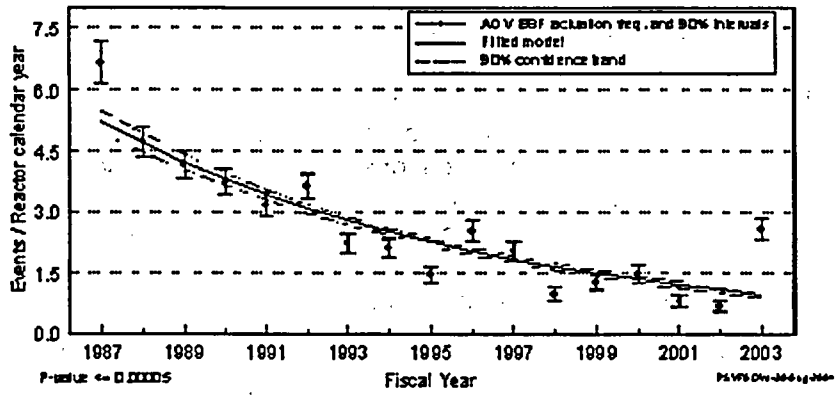
Figure 4. Frequency of unplanned demands (events per operating year), as a function of fiscal year

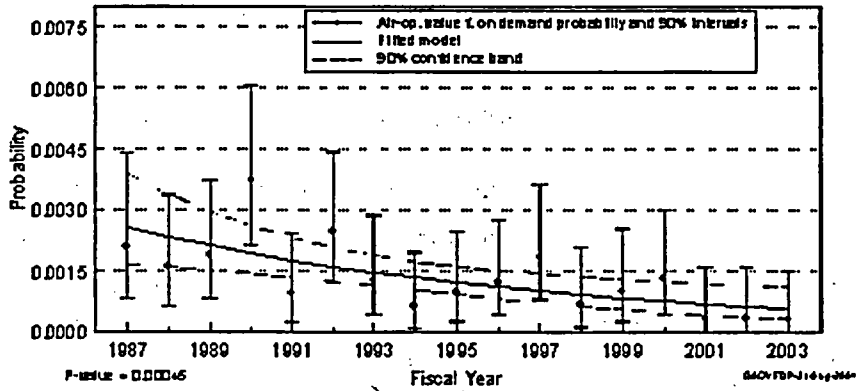
Figure 5. Probability of air-operated valve failures on demand
