Integrated Chemical Effects Test Project: Test #3 Data Report

Los Alamos National Laboratory

**U.S. Nuclear Regulatory Commission
Office of Nuclear Regulatory Research
Washington, DC 20555-0001**

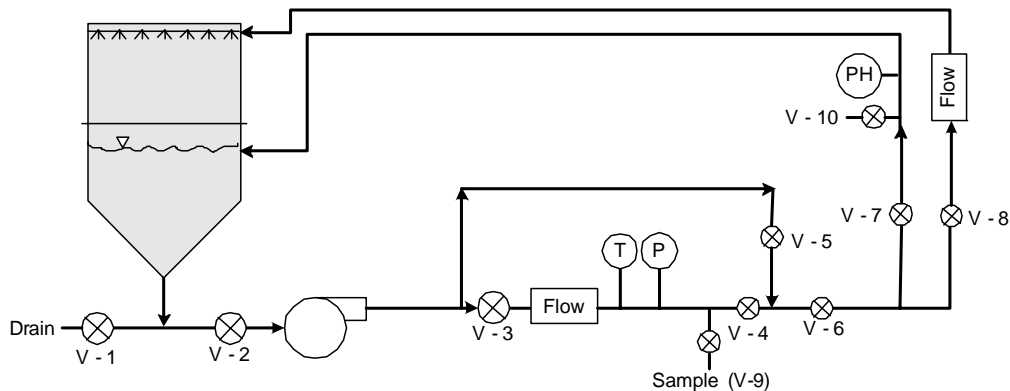
The as-built test loop consists of a test tank, a recirculation pump, 2 flow meters, 10 isolation valves, and pipes that connect the major components, as shown schematically in Figure 2-1. P, T, and pH represent pressure, temperature, and pH probes, respectively.

Figure 2-1. Test loop process flow diagram.

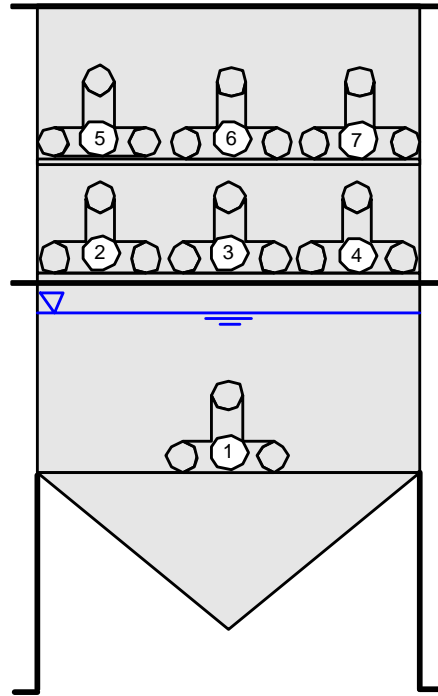
The arrangement of the coupon racks in the test tank is schematically illustrated in Figure 2-2. The figure shows a side view of the ICET tank, with the ends of the seven CPVC racks illustrated. The normal water level is shown with the blue line in the figure. Rack #1 is the only submerged rack, and it sits on angle iron. It is centered in the tank, so that flow from the two headers reaches it equally. Racks #2–#4 are positioned above the water line, supported by angle iron in the tank. Racks #5–#7 are positioned at a higher level, also supported by angle iron. Racks #2–#7 are exposed to spray. In the figure, north is to the right, and south is to the left. Directions are used only to identify such things as rack locations and sediment locations.

Figure 2-2. Coupon rack configuration in the ICET tank. The blue line represents the surface of the test solution.

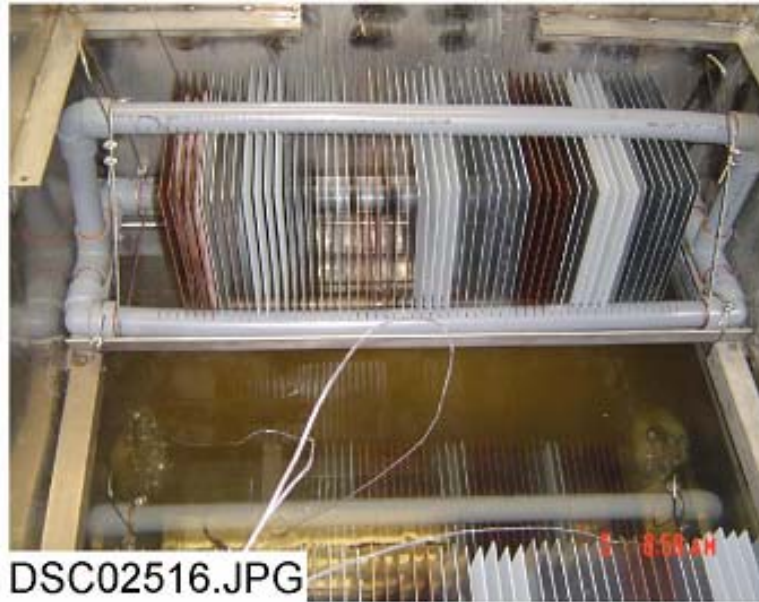
Figure 2-3 shows the configuration of an unsubmerged coupon rack loaded with metal coupons in the ICET tank. The loading pattern of the racks was nearly identical, varying by only one or two coupons. Shown in the figure from left to right, the coupons are arranged as follows: 4 Cu, 4 Al, 4 inorganic zinc (IOZ), 7 GS, 4 Cu, 3 Al, 4 IOZ, 7 GS, 4 Cu, 3 Al, 4 IOZ, and 7 GS.

Figure 2-3. A loaded coupon rack in the ICET tank.

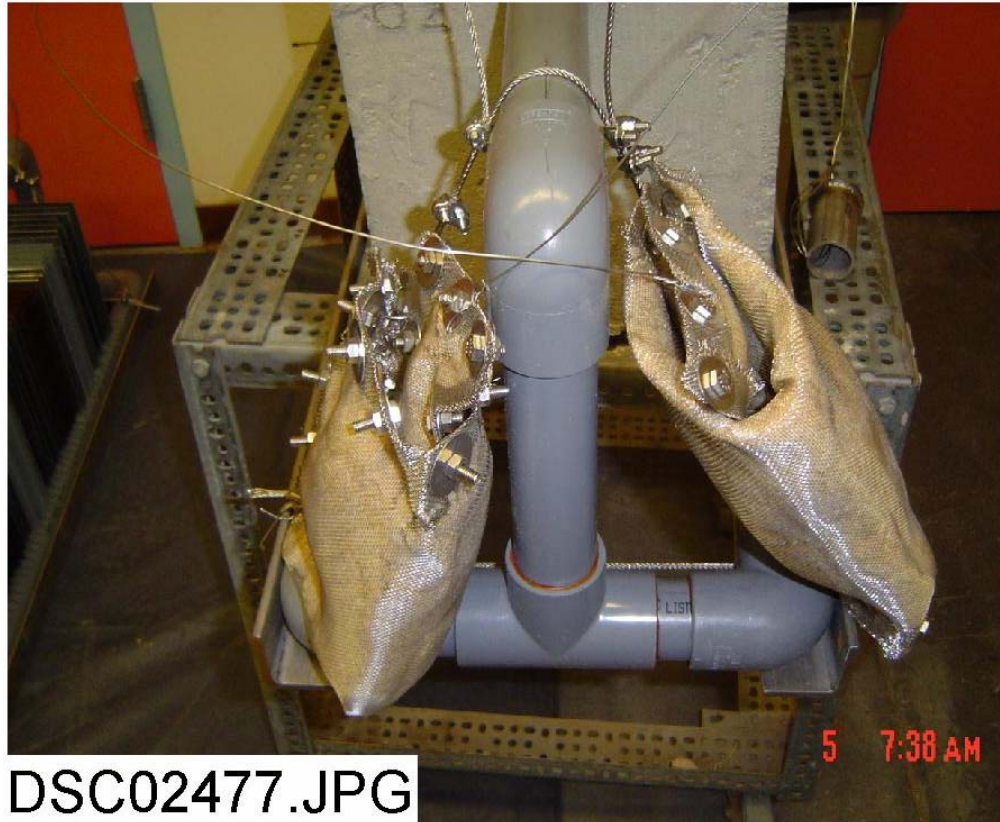
Several fiberglass samples were placed in the ICET tank. Samples were either submerged or held above the water level. The unsubmerged fiberglass samples were positioned so they would be exposed to sprays. The fiberglass samples were contained in SS wire mesh that allowed water flow while confining the fiberglass material. Both loosely-packed and more tightly-packed samples were used. In addition, some submerged fiberglass samples were located where they would be exposed to relatively high-flow conditions, and others were located in quiescent regions of the tank. Figure 2-4 shows the so-called “sacrificial” fiberglass samples in wire mesh pouches attached to the submerged coupon rack (rack 1 in Figure 2-2). Each pouch contains approximately 5 g of fiberglass. Those samples were attached with SS wire and removed from the tank on Days 4, 15, and 30, and examined. As shown in the figure, bigger insulation bags were wrapped around the sacrificial specimens during the test. See Subsection 2.4.1.1 for descriptions of other fiberglass samples.

Figure 2-4. Fiberglass samples attached to coupon rack.

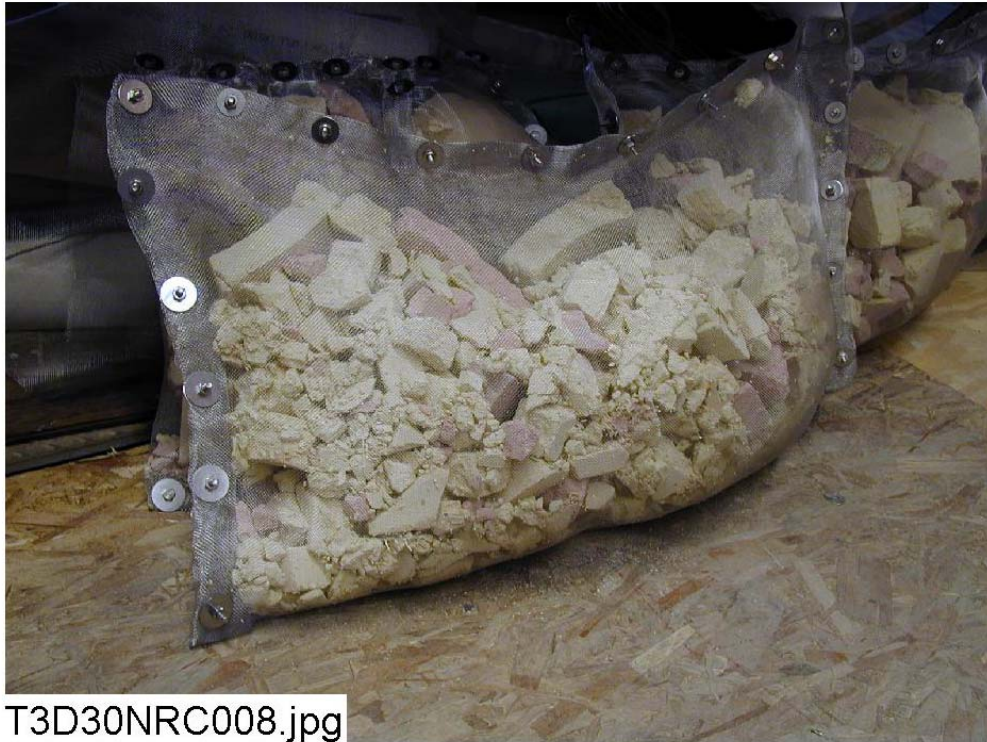
Several cal-sil insulation samples were also placed in the ICET tank. Samples were either submerged or held above the water level. The unsubmerged cal-sil samples were positioned so they would be exposed to sprays. As with the fiberglass samples, all of the cal-sil samples (except for the dust) were contained in SS wire mesh that allowed water flow while confining the cal-sil material. In addition to solid pieces of cal-sil, cal-sil dust (approximately 43.5 lb) was placed in the tank solution before the test began. Both types of samples are shown in Figures 2-5 and 2-6.

Table 2-5. Solid pieces of cal-sil samples in SS mesh.

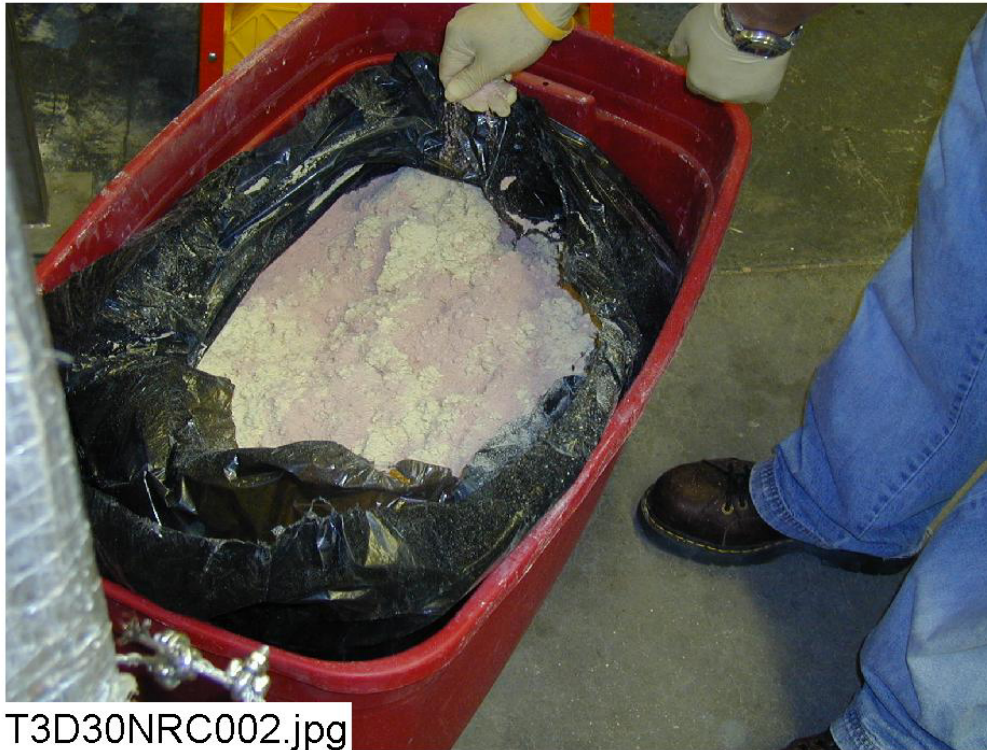
Figure 2-6. Cal-sil dust.

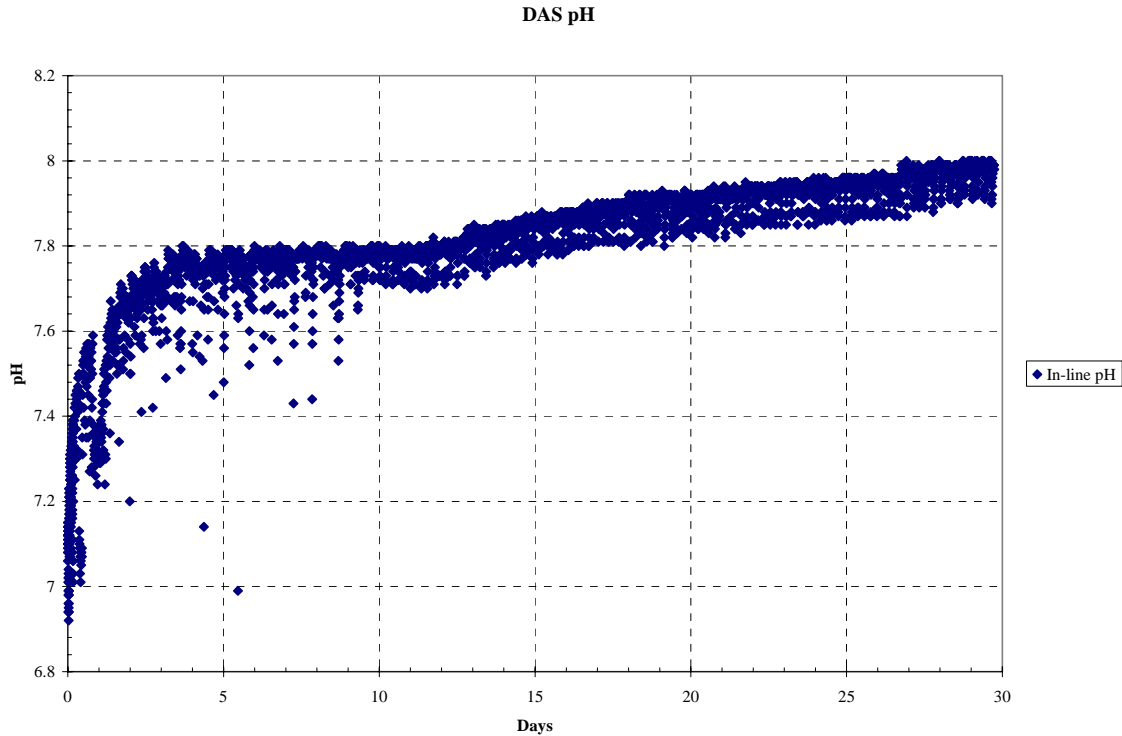
The in-line pH probe tracked the overall bench-top pH readings, but the results have noise and a slight offset. Due to the noise within the raw data, the bench-top pH readings are more reliable. Figure 3-1 shows results from the in-line pH probe.

Figure 3-1. In-line pH measurements.

Four hours into the test, the in-line pH measurement was 7.37, and at Day 30 the pH measurement was 7.92. Figure 3-2 presents the bench-top pH readings. Four hours into the test, the bench-top pH measurement was 7.32, and at Day 30 the pH measurement was 8.05.

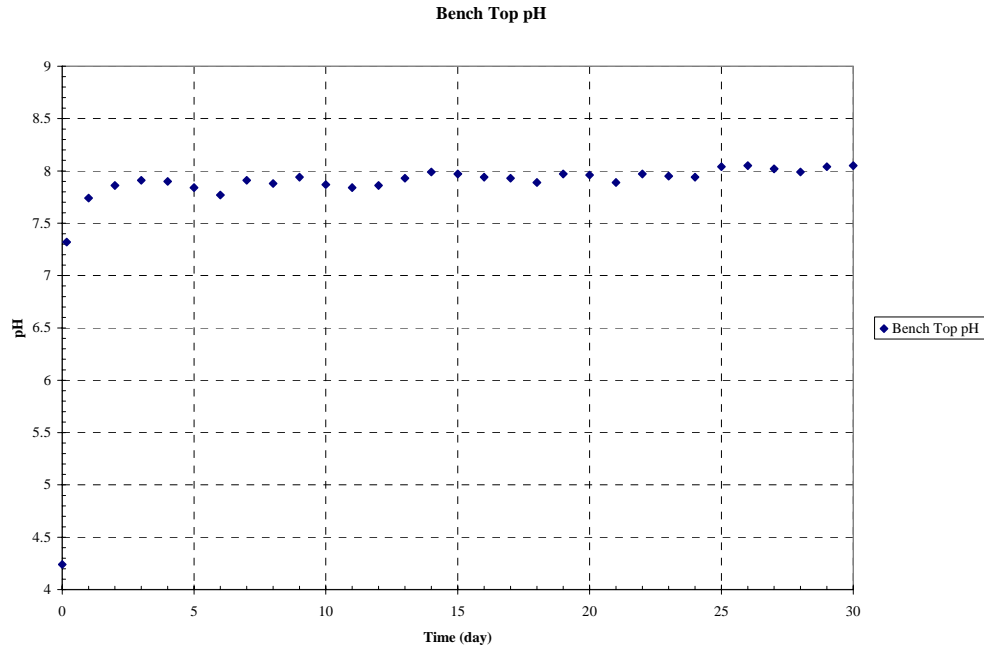
Figure 3-2. Bench-top pH meter results.

pH: Before time zero, 15.45 kg of boric acid and 0.663 g of LiOH were dissolved in the ICET tank. The measured bench-top pH was 4.24, which was similar to the expected value obtained from analytical predictions. Following the addition of the premixed TSP batches, the pH was 7.32. The pH then continued to rise through Day 3 of testing to 7.9. After Day 3, the pH varied in the range of 7.8–8.0.

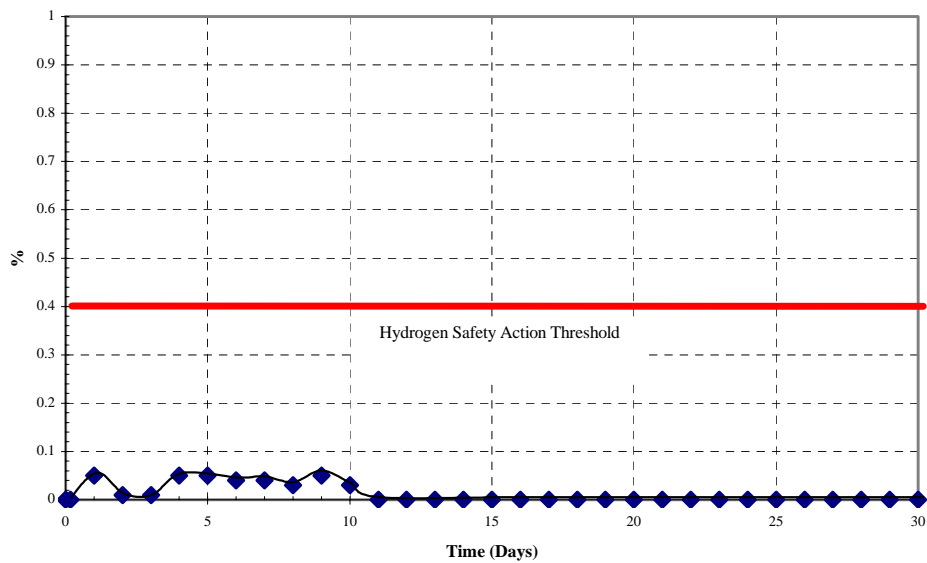
Hydrogen remained at or below 0.05% for Test #3. Figure 3-3 displays the evolution of hydrogen generation throughout the test. A general trend line has been superimposed upon the hydrogen generation data set. Each of the measured values is well below the hydrogen safety action threshold of 0.4%.

Figure 3-3. Hydrogen generation.

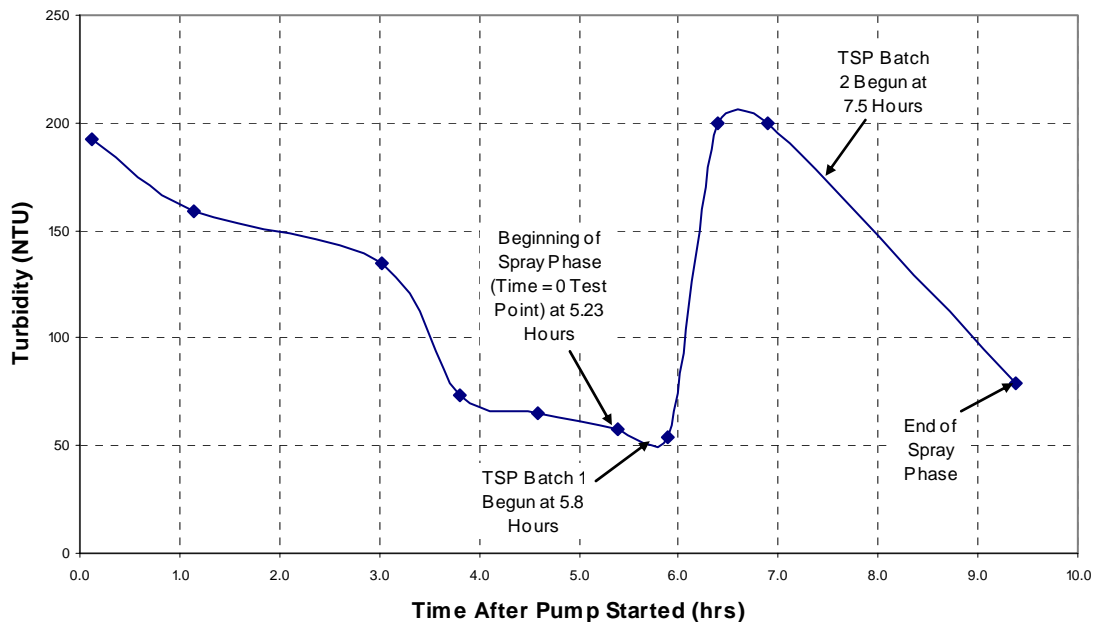
Due to the cloudy nature of the water in the tank after the circulation pump was turned on, additional turbidity values were measured at 60°C over a 9-hour time period, in addition to the regular daily monitoring. Figure 3-4 depicts the evolution of turbidity during that time period. The x-axis on the graph represents the time in hours after the circulation pump was turned on, following cal-sil addition and while the system was heating up. As can be seen, the turbidity gradually decreased from 192 NTU at the 7-minute point to 54 NTU at the 5.9-hour point. Note that the 5.23-hour point on the graph corresponds to the time-zero test point. The spray nozzles were activated at that time. At the 6.4-hour point, the turbidity peaked above 200 NTU. The turbidity decreased to 79 NTU by the end of the spray phase. (Note that the Batch 1 addition began at approximately 5.8 hours on Figure 3-4, and Batch 2 addition began at 7.5 hours.)

Figure 3-4. Day 1 turbidity results.

Turbidity: For the 23°C and 60°C water samples, the baseline turbidity values, which were taken after the latent debris and crushed concrete were added, were 7.3 NTU and 7.5 NTU, respectively. After the addition of cal-sil, the tank solution was observed to become much more turbid. Then with time, the turbidity decreased. Upon the addition of Batch 1 and Batch 2 chemicals, particulates were suspended in solution, and the solution was noticeably cloudier. Figure 3-4 presents the daily turbidity results.

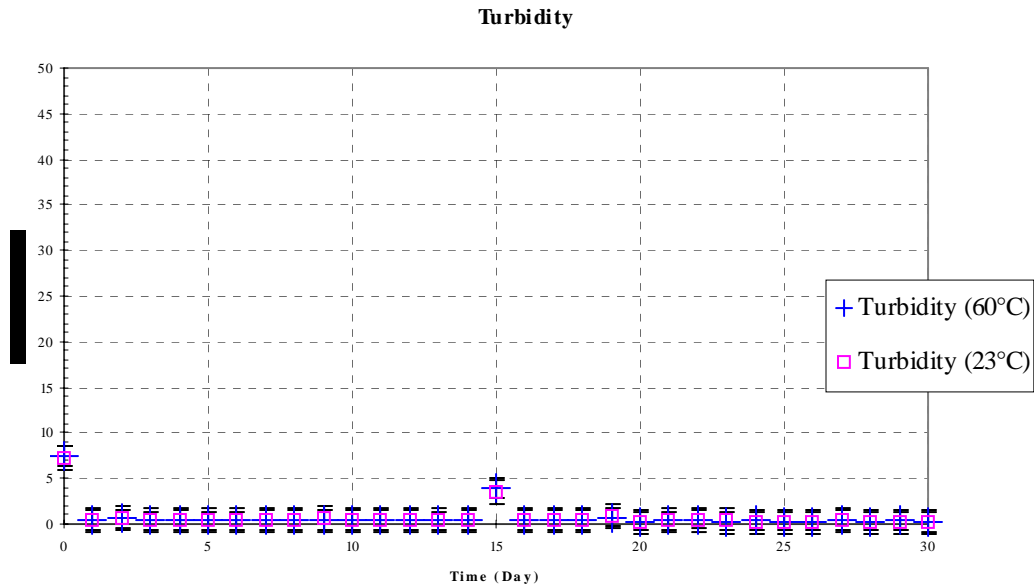
Figure 3-5 depicts the evolution of turbidity at 23°C and 60°C throughout Test #3. The trend of each curve exhibits an initial spike during the addition of Batch 1 chemicals,

followed by a sharp decline to the Day 1 test point and steady behavior from then on. The turbidity values on Day 15 were slightly higher, but no direct cause has been identified. The Day 15 values were 3.9 NTU and 3.5 NTU for the 60°C and 23°C samples, respectively. Thereafter, the turbidity values decreased and remained steady.

Figure 3-5. Daily turbidity results.

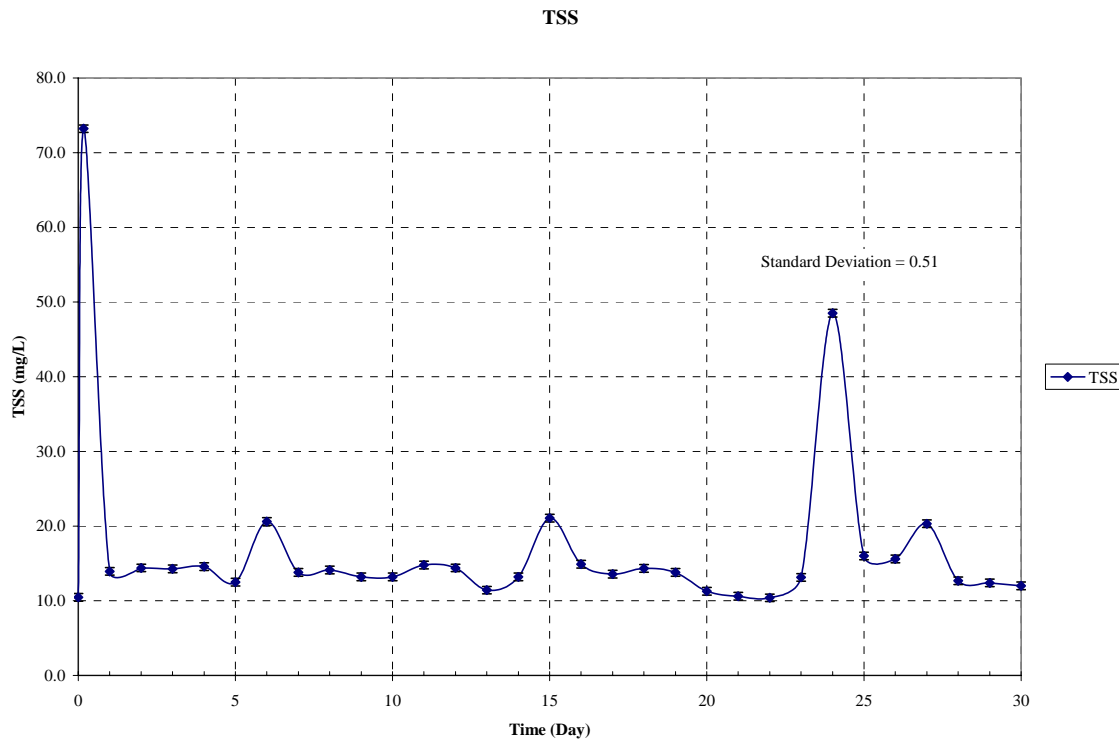
Total Suspended Solids: TSS are measured by filtering a volume of approximately 500 mL through an in-line filter directly at the sample tap. The selected equipment ensures that TSS measurements are not affected by temperature-dependent or time-dependent precipitation reactions that may occur once the process solution is removed from the tank. Figure 3-6 presents Test #3 TSS data as the experiment progressed. The baseline TSS measurement was taken after the addition of latent debris but prior to the Batches 1 and 2 chemical additions. After the addition of the Batch 1 chemicals but prior to the addition of Batch 2 chemicals, a second TSS measurement (not shown on the graph) was taken, and the value was 268 mg/L. Although very high, it appeared to be a reasonable measurement because a large amount of particles was suspended in solution at that time. Four hours into the test, another TSS measurement was taken, and that value was 73.2 mg/L. At that time, fewer particles were seen suspended in solution. After 24 hours, the TSS measurement dropped to 13.9 mg/L, where it leveled out for the rest the test.

Although TSS remained fairly stable over the entirety of the test, TSS measurements from six different days deviated from the trend. The Day 6 TSS measurement was slightly higher at 20.6 mg/L, which was not unexpected because the sample was taken right after the return of excess test solution to the tank. The return of the excess test solution caused some of the particles that were sitting at the bottom of the tank to be become resuspended in the solution, a situation that was reflected in the final measurement. The Day 15 and Days 24–27 measurements were higher than the test

average of approximately 13.4 mg/L that was observed for the majority of the test. The TSS filter weights for these days were confirmed, and there is no direct explanation for these higher values.

Figure 3-6. Test #3 TSS results.

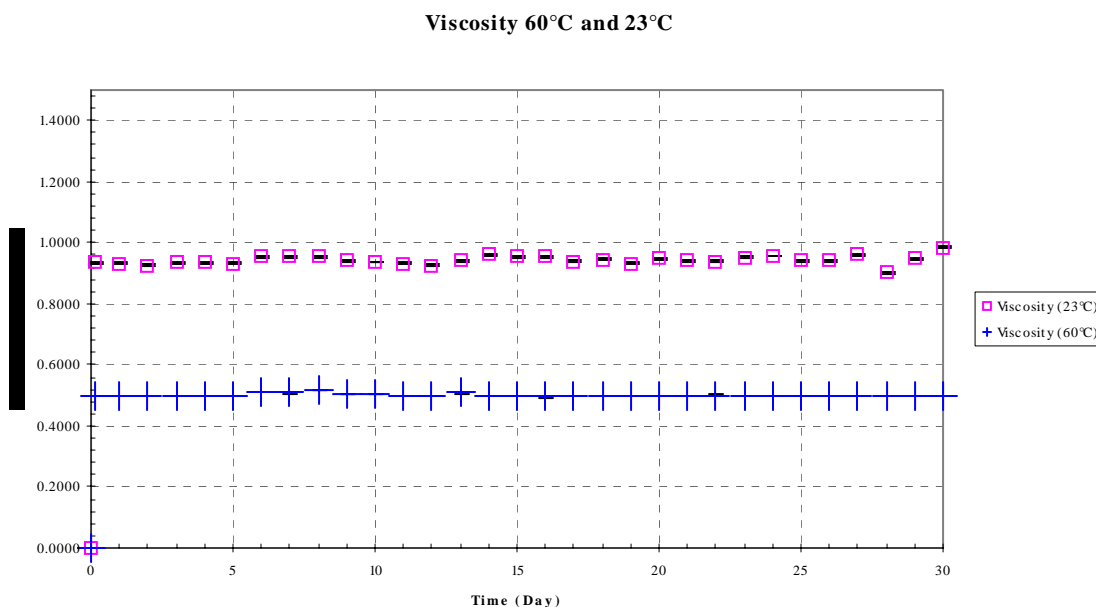
Viscosity remained relatively constant throughout Test #3. The viscosity at 60.0°C (140°F) remained at a value of approximately $0.49 \text{ mm}^2/\text{s}$, and the 23.0°C (73.4°F) measurements remained around $0.95 \text{ mm}^2/\text{s}$. These constant viscosity values are consistent with the steady water conditions in the test. Figure 3-7 shows the viscosity values through the course of the test.

Figure 3-7. Viscosity at 60°C and 23°C.

Kinematic Viscosity: Kinematic viscosity was measured with a Cannon-Fenske capillary viscometer. Viscosity was measured on unfiltered samples, each at a temperature of $60^{\circ}\text{C} \pm 1.0^{\circ}\text{C}$ ($140^{\circ}\text{F} \pm 1.8^{\circ}\text{F}$) and $23^{\circ}\text{C} \pm 2.0^{\circ}\text{C}$ ($73.4^{\circ}\text{F} \pm 3.6^{\circ}\text{F}$). Figure 3-7 shows the viscosity results. Water's viscosity is highly sensitive to temperature, and the allowed temperature range results in a variation of viscosity of 2.9% between 59°C (138.2°F) and 60°C (141.8°F) and 9.3% between 21°C (69.8°F) and 25°C (77.0°F). For this reason, temperature was measured to a 0.1°C accuracy with a National Institute of Standards and Technology (NIST)-traceable thermometer for all viscosity measurements. Also, the measured viscosity values were corrected to common temperatures to facilitate comparisons. The corrected temperatures were 60.0°C (140°F) and 23.0°C (73.4°F).

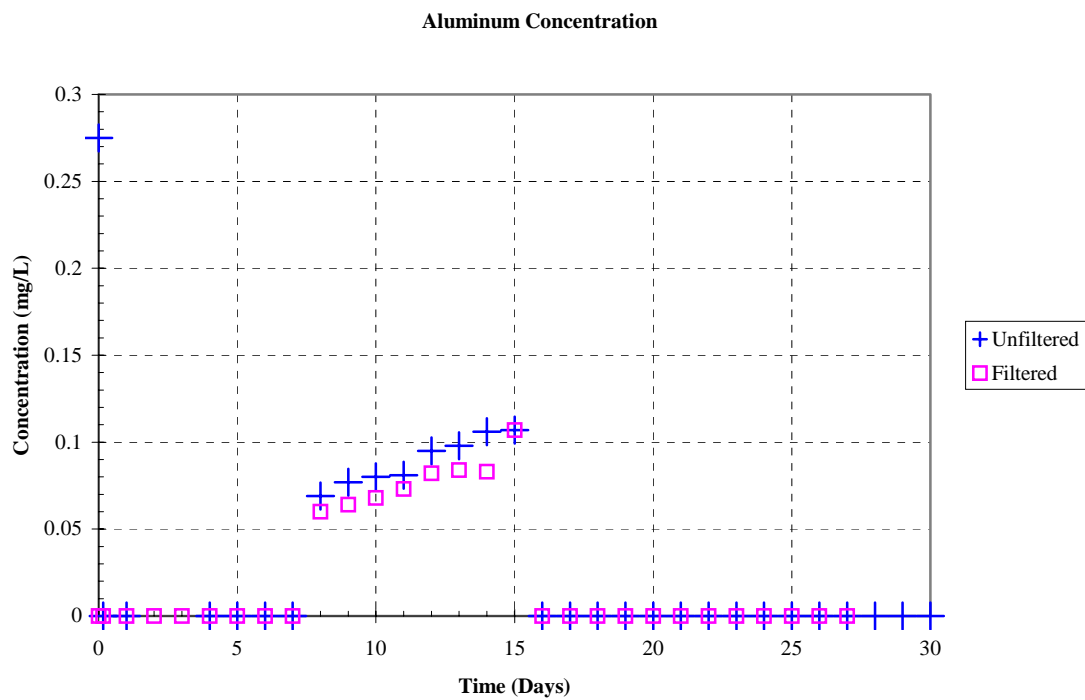
Figure 3-8. Aluminum concentration.

ICP results for Test #3 are displayed in Figures 3-8 through 3-16, which are daily sample results. Table 3-1 contains ICP results for elements that were analyzed on Days 1, 4, 15, and 30. Table 3-1 shows that chloride, boron, lead, lithium, and potassium concentrations remained relatively constant throughout the test. An examination of the figures reveals that phosphate, copper, iron, aluminum, and zinc are present in trace amounts, below 1 mg/L. It also can be seen that calcium, silica, sodium, and magnesium are present in higher concentrations.

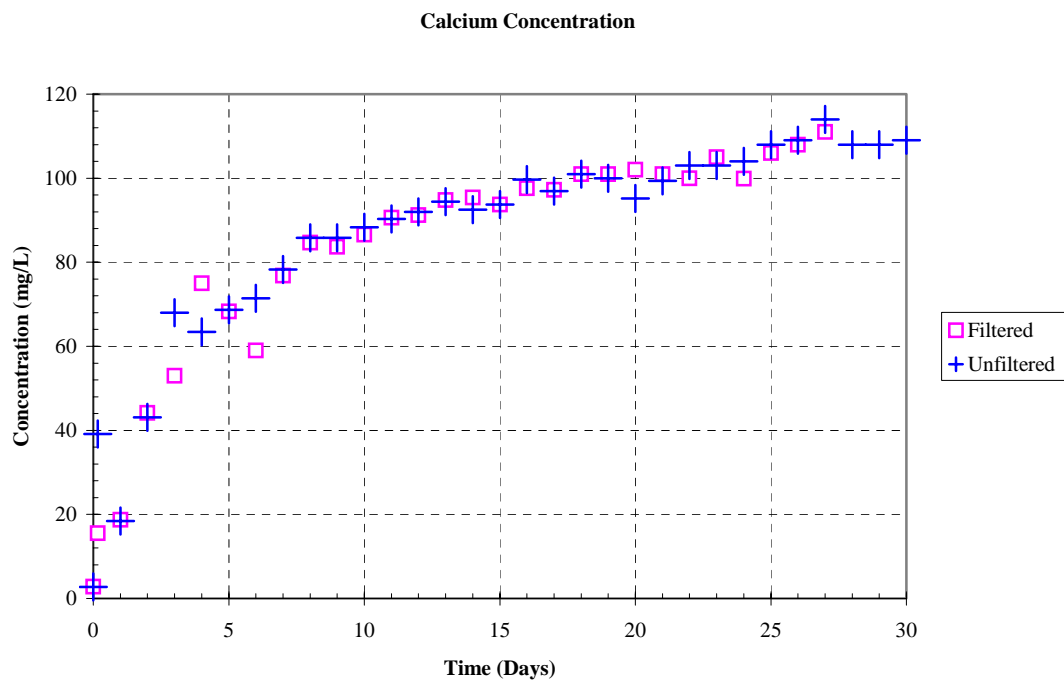
Figure 3-9. Calcium concentration.

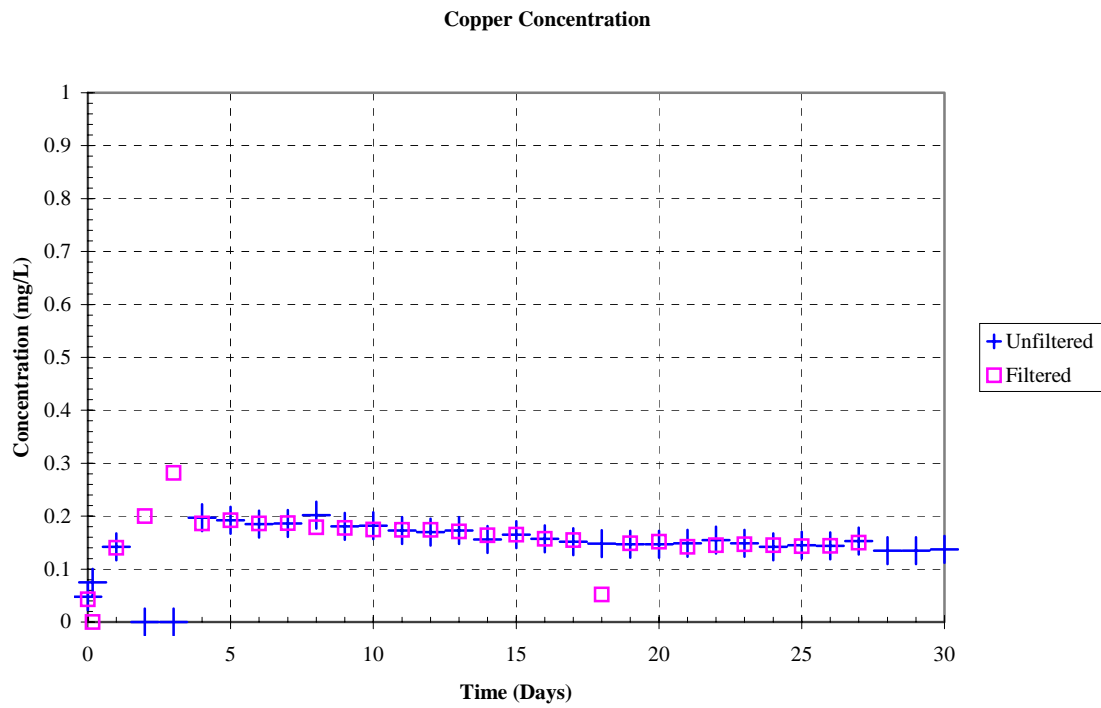
Figure 3-10. Copper concentration.

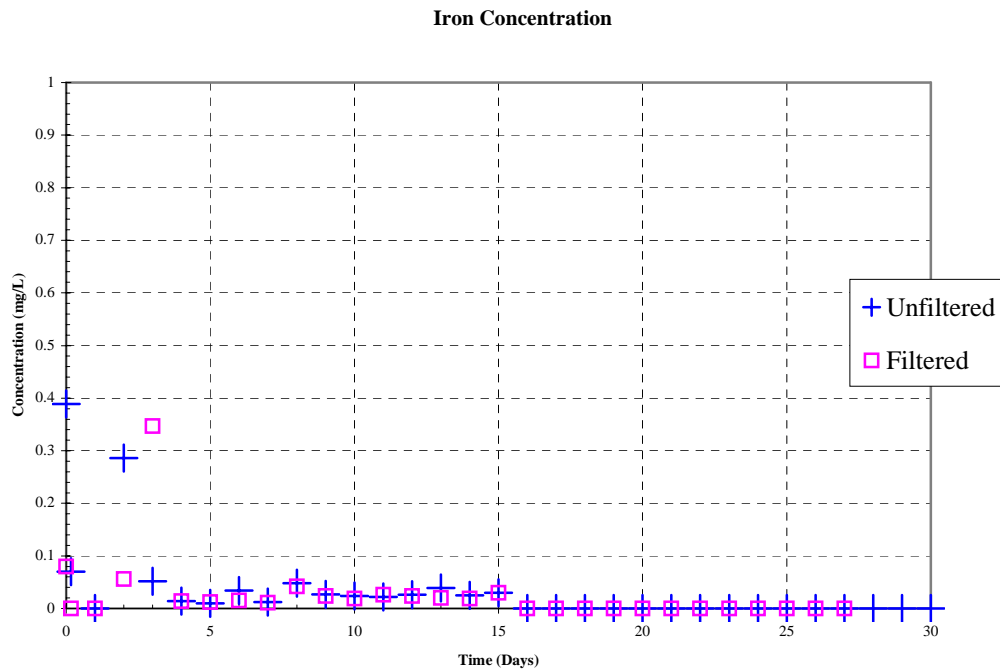
Figure 3-11. Iron concentration.

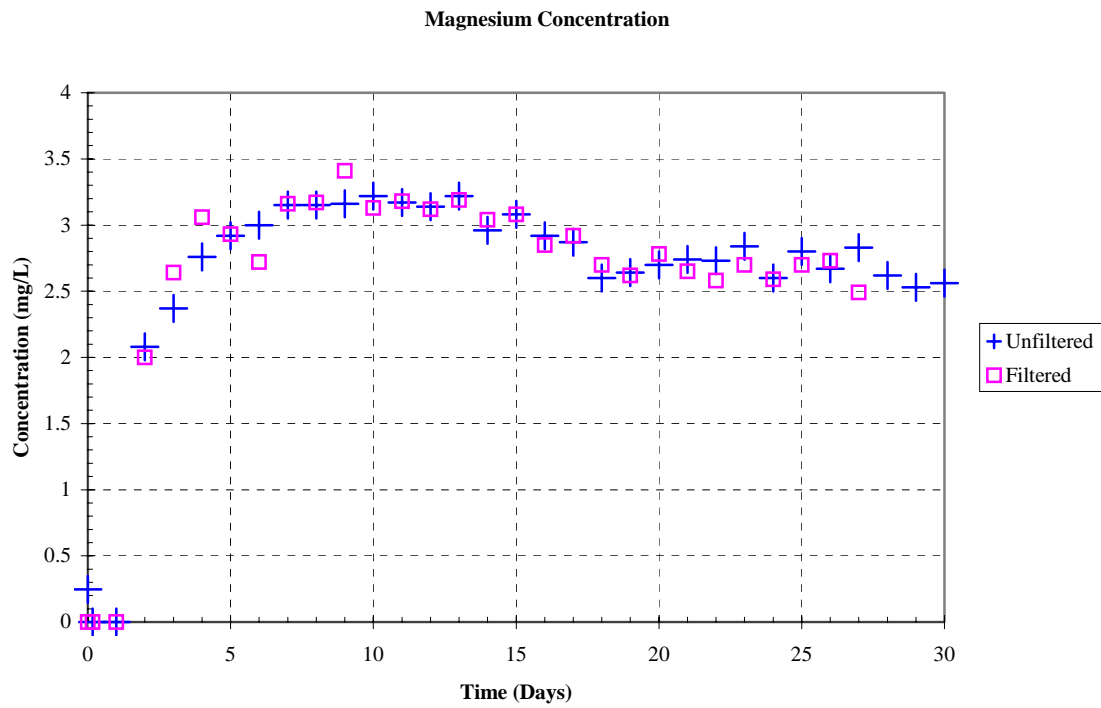
Figure 3-12. Magnesium concentration.

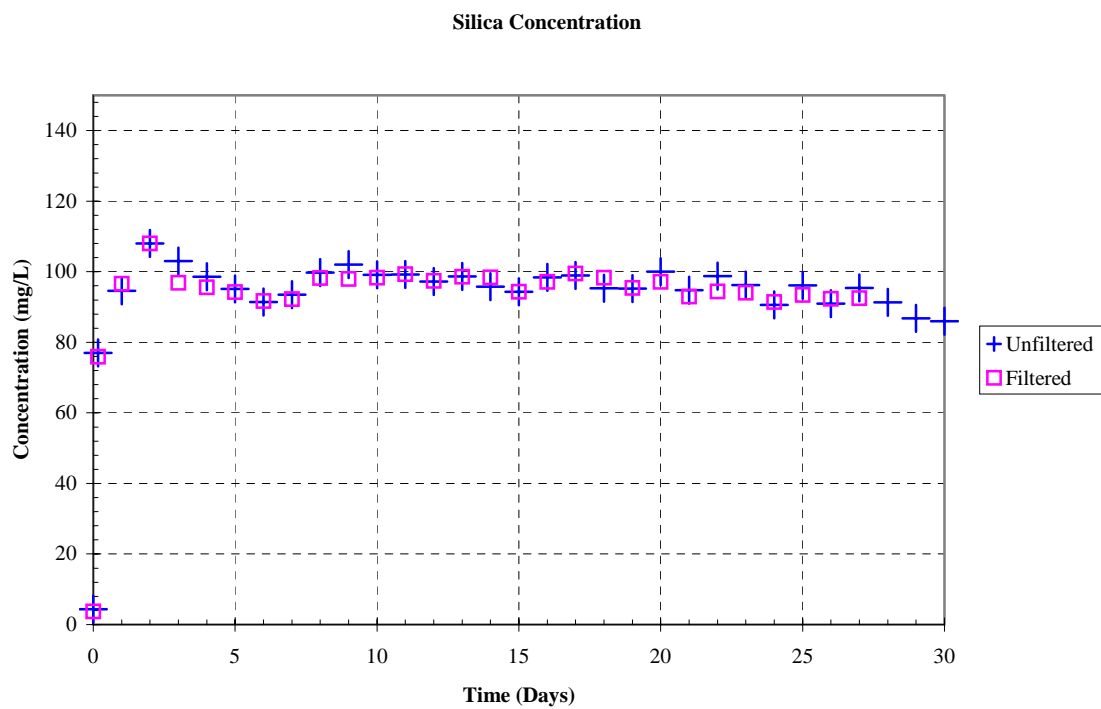
Figure 3-13. Silica concentration.

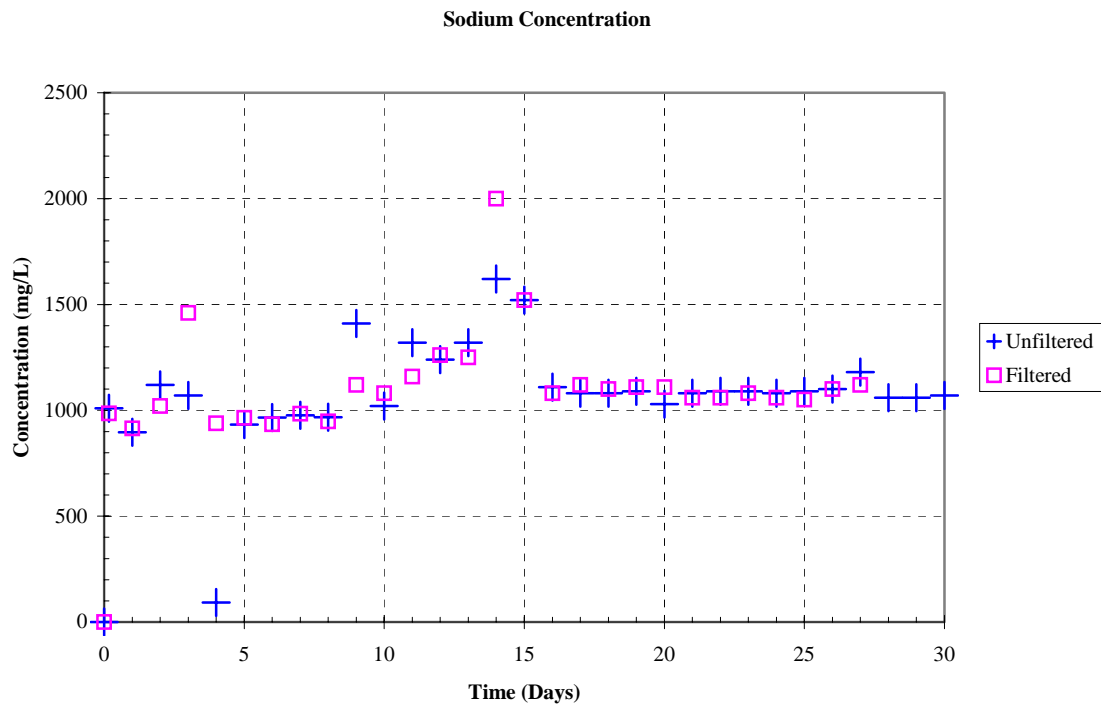
Figure 3-14. Sodium concentration.

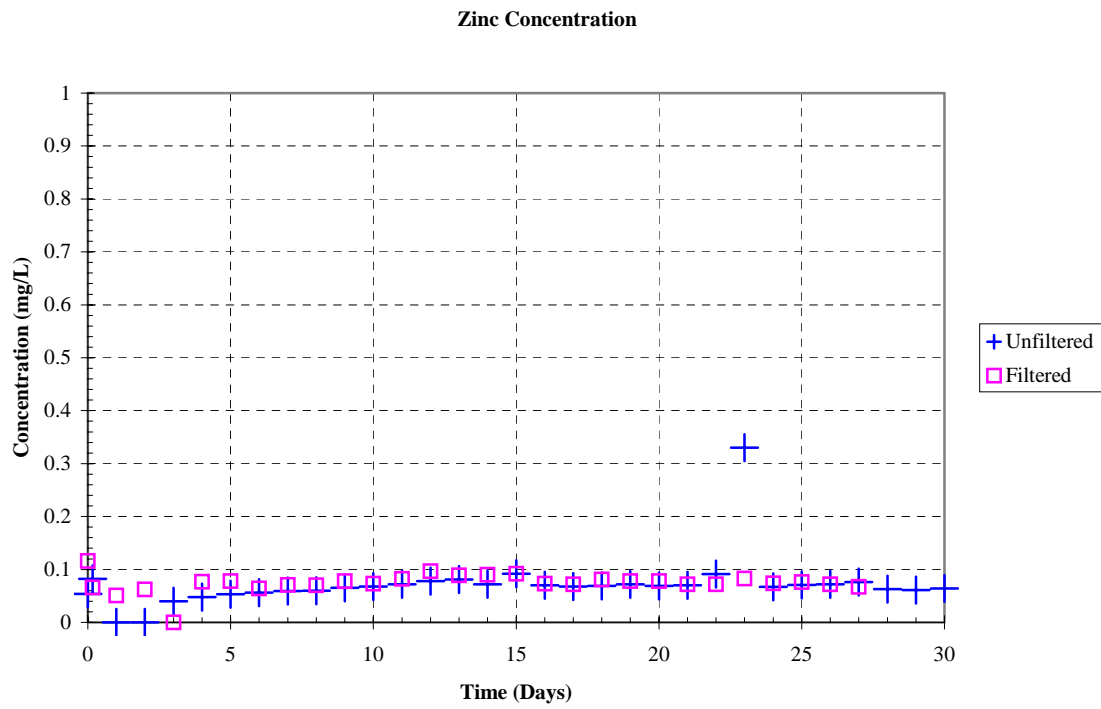
Figure 3-15. Zinc concentration.

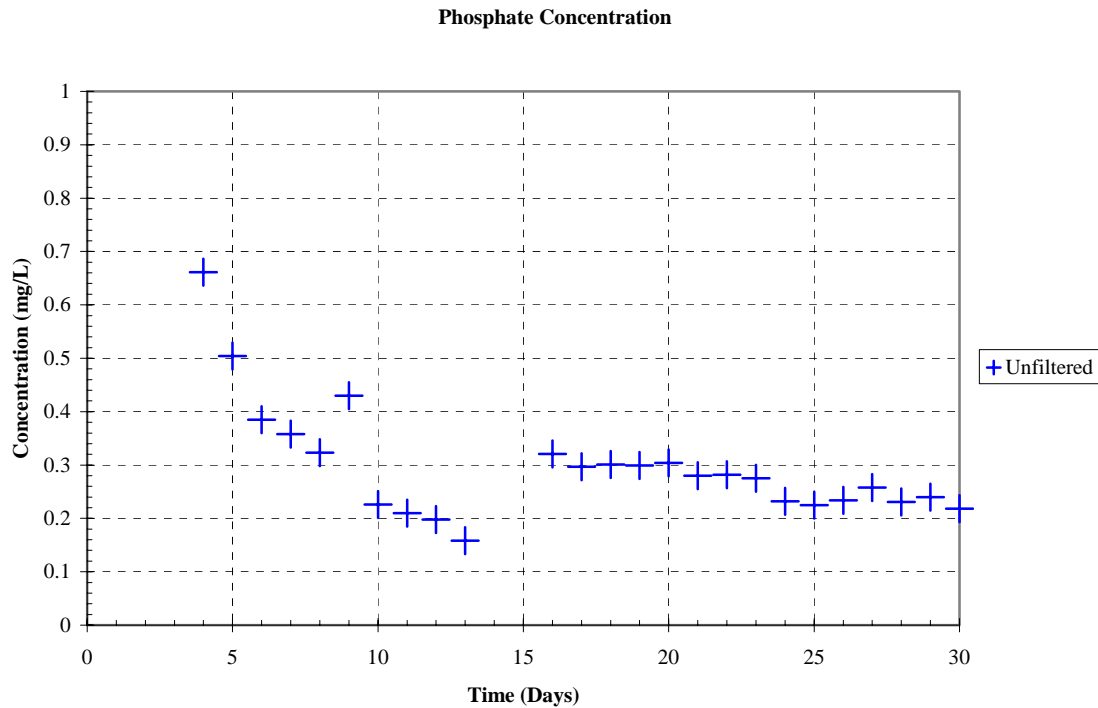
Figure 3-16. Phosphate concentration.

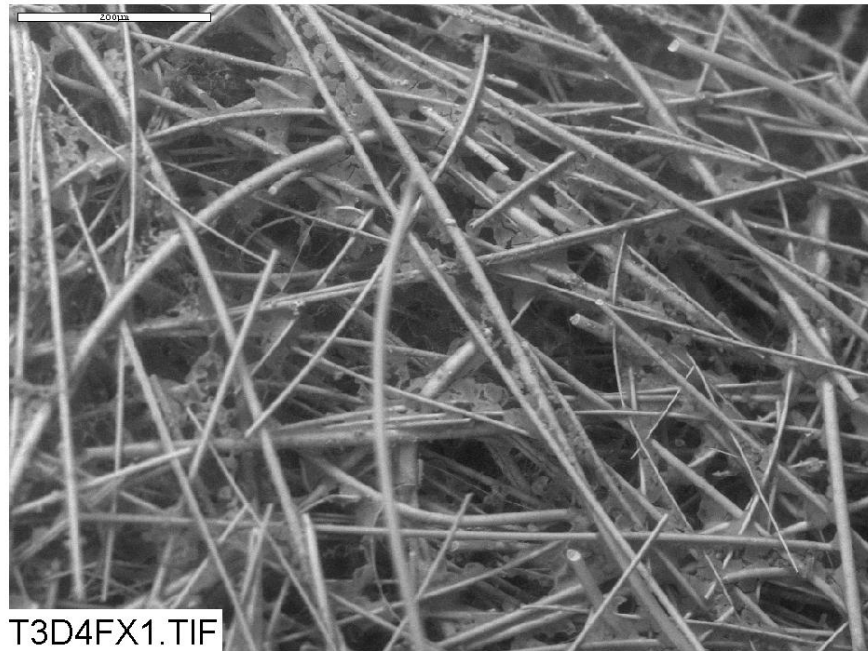
Figure 3-17. ESEM image of a Test #3 Day 4 low-flow exterior fiberglass sample, magnified 150 times. (T3D4FX1, 4/12/05)

Comparing interior and exterior fiberglass samples reveals no significant difference in the amount of deposits, again probably because of a chemical origin for the deposits. Chemical precipitation occurs to the same degree on both exterior and the interior fiberglass samples. Figures 3-17 through 3-27 show the Day 4, low-flow fiberglass results.

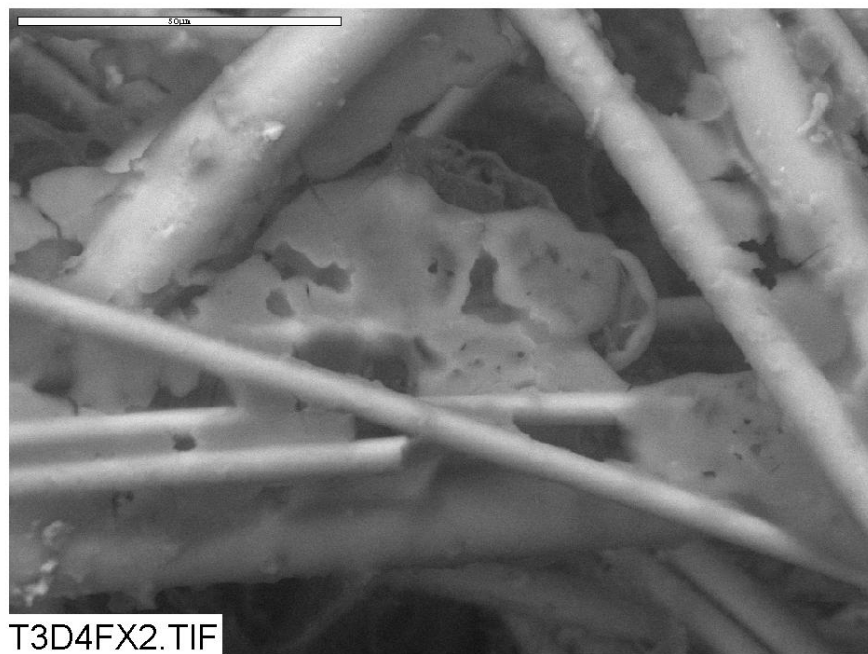
Figure 3-18. ESEM image for a Test #3 Day 4 low-flow exterior fiberglass sample, magnified 1000 times. (T3D4FX2, 4/12/05)

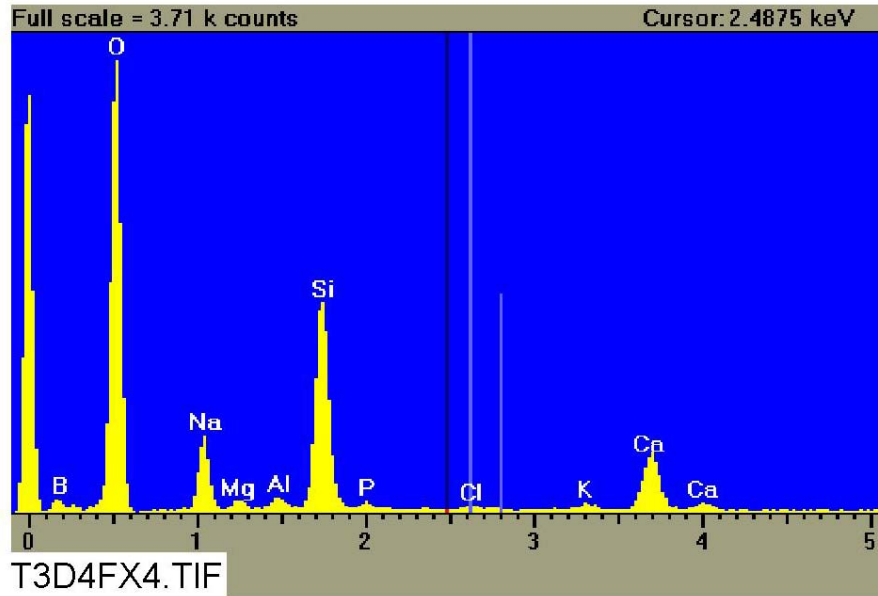
Figure 3-19. EDS counting spectrum (after calibration) for the deposits between the fibers on the ESEM image shown in Figure 3-18. (T3D4FX4, 4/12/05)

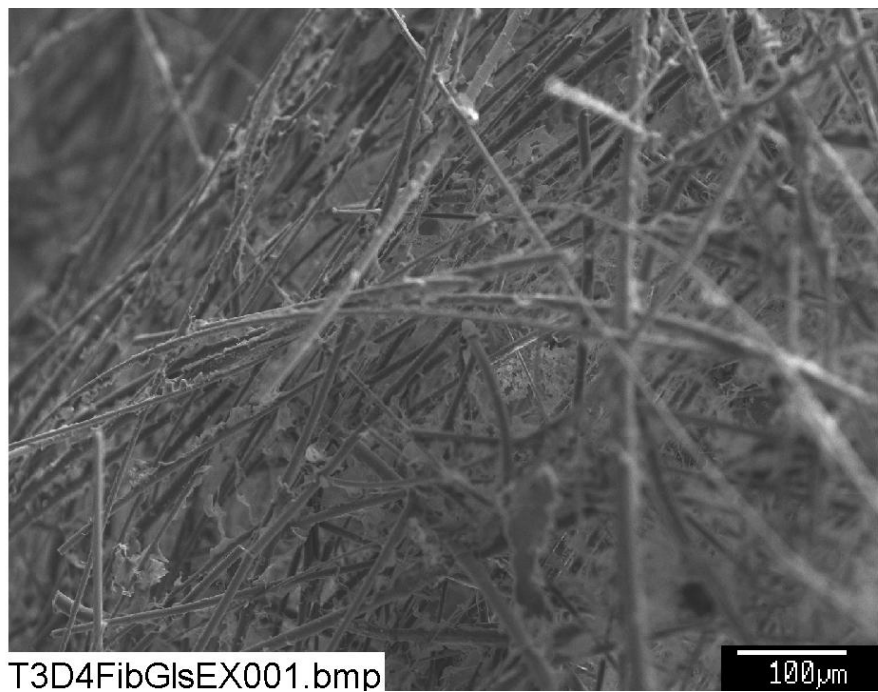
Figure 3-20. SEM image of a Test #3 Day 4 low-flow exterior fiberglass sample, magnified 150 times. (T3D4FibGlsEX001, 4/12/05)

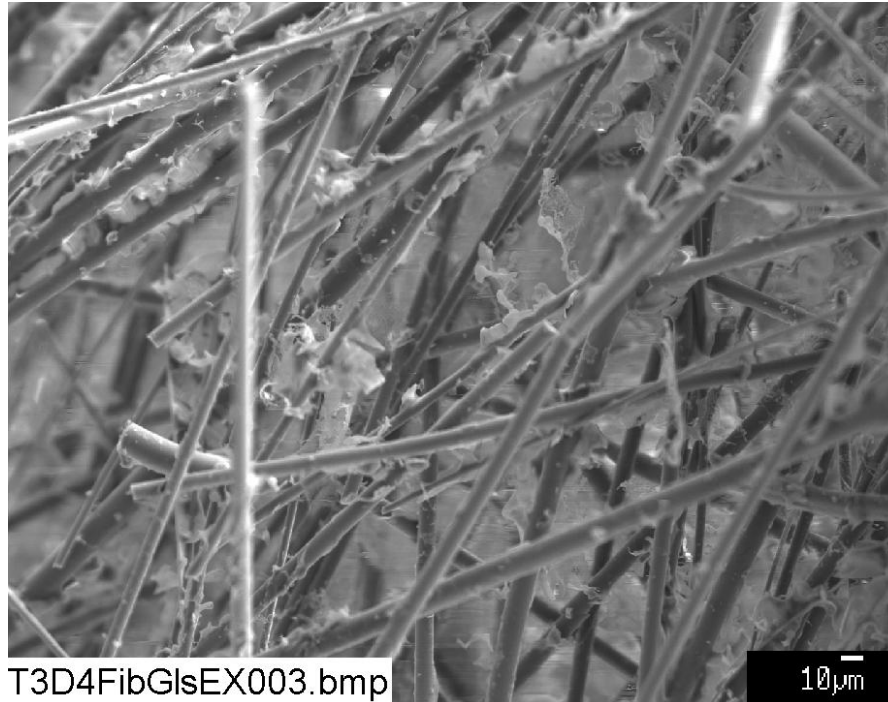
Figure 3-21. SEM image of a Test #3 Day 4 low-flow exterior fiberglass sample, magnified 300 times. (T3D4FibGlsEX003, 4/12/05)

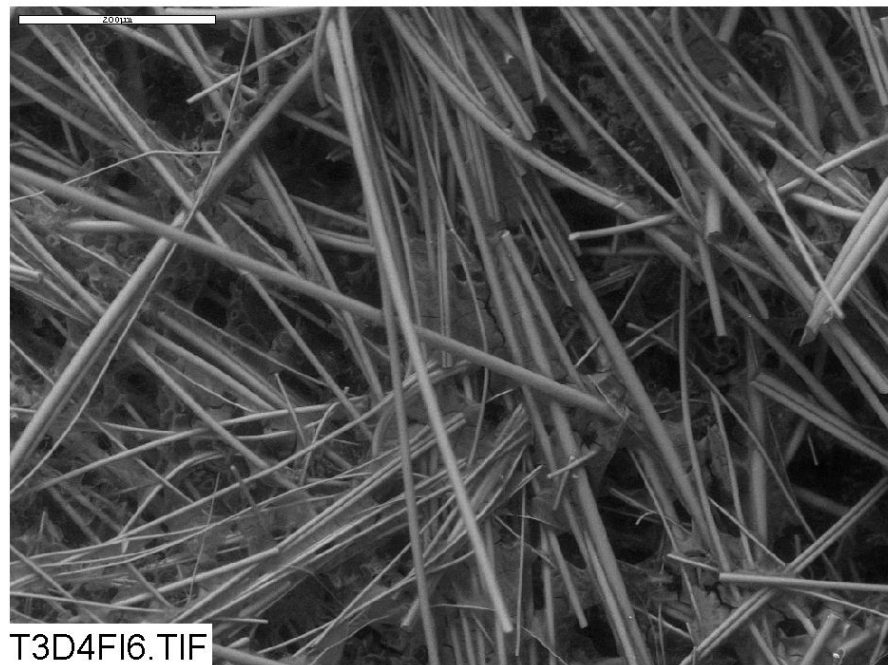
Figure 3-22. ESEM image of a Test #3 Day 4 low-flow interior fiberglass sample, magnified 150 times. (T3D4FI6, 4/12/05)

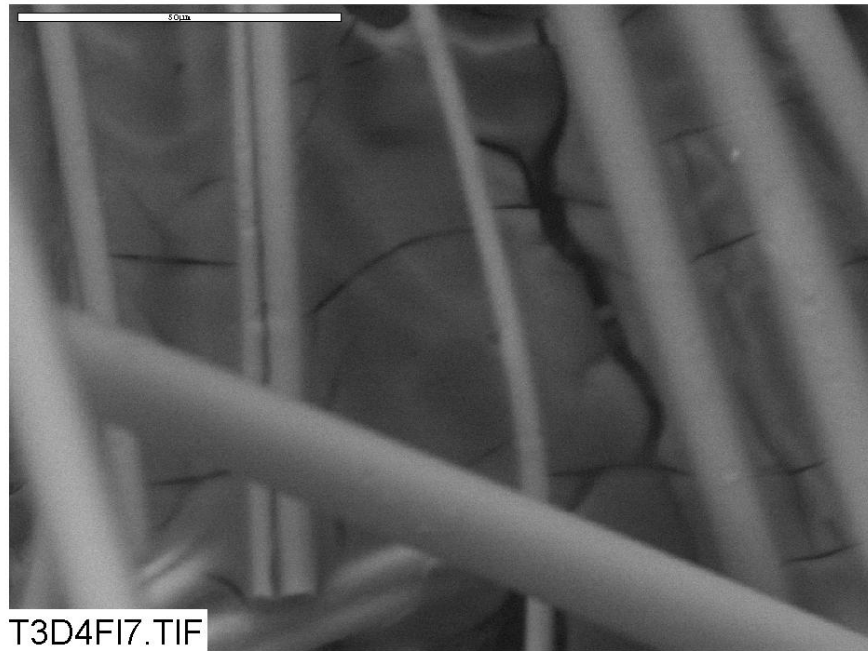
Figure 3-23. ESEM image of a Test #3 Day 4 low-flow interior fiberglass sample, magnified 1000 times. (T3D4FI7, 4/12/05)
