Integrated Chemical Effects Test Project: Test #3 Data Report

Los Alamos National Laboratory

**U.S. Nuclear Regulatory Commission
Office of Nuclear Regulatory Research
Washington, DC 20555-0001**

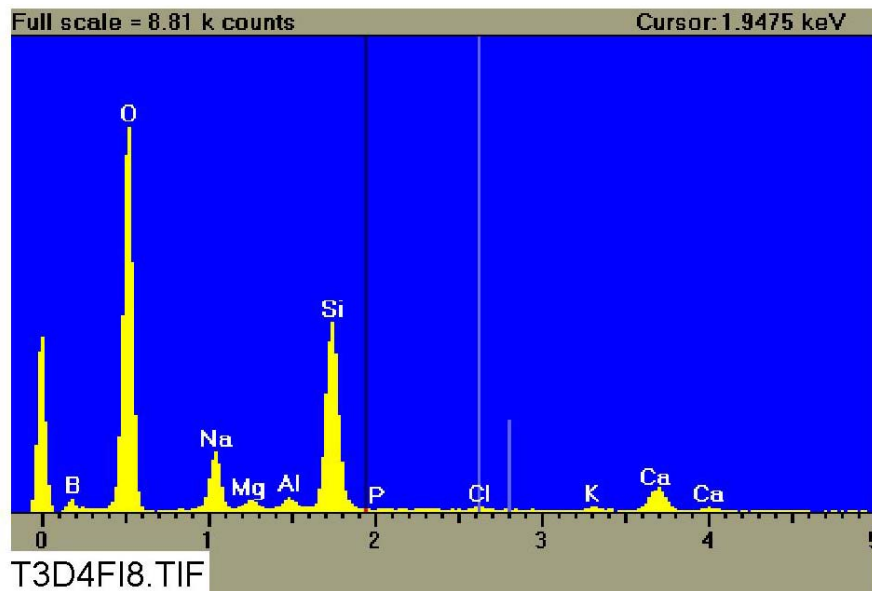
Figure 3-24. EDS counting spectrum (after calibration) for the deposits between the fibers on the ESEM image shown in Figure 3-23. (T3D4FI8, 4/12/05)

Comparing interior and exterior fiberglass samples reveals no significant difference in the amount of deposits, again probably because of a chemical origin for the deposits. Chemical precipitation occurs to the same degree on both exterior and the interior fiberglass samples. Figures 3-17 through 3-27 show the Day 4, low-flow fiberglass results.

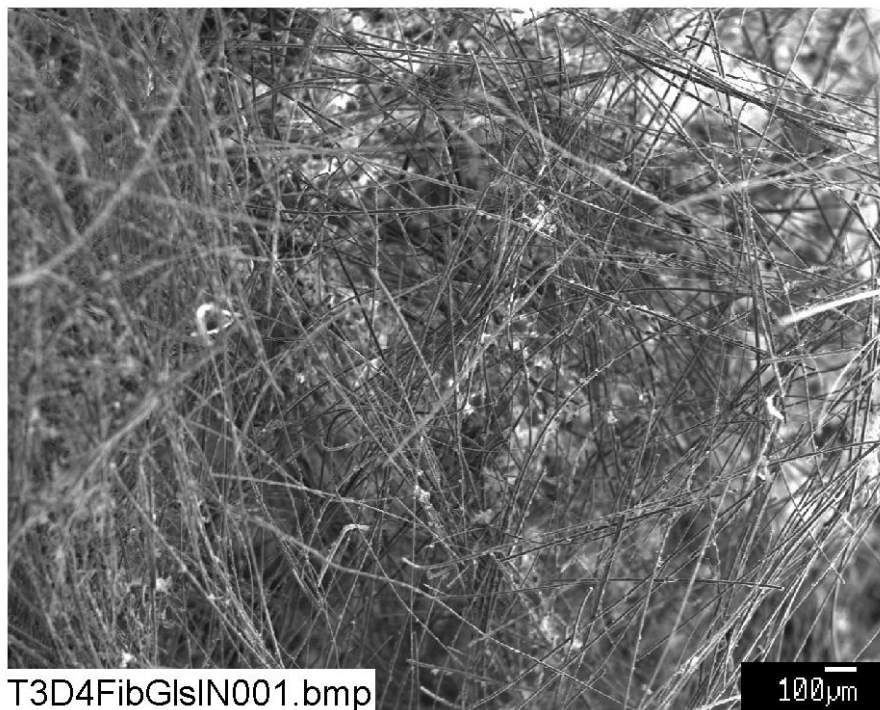
**Figure 3-25. SEM image of a Test #3 Day 4 low-flow interior fiberglass sample, magnified 50 times.
(T3D4FibGlsIN001, 4/12/05)**

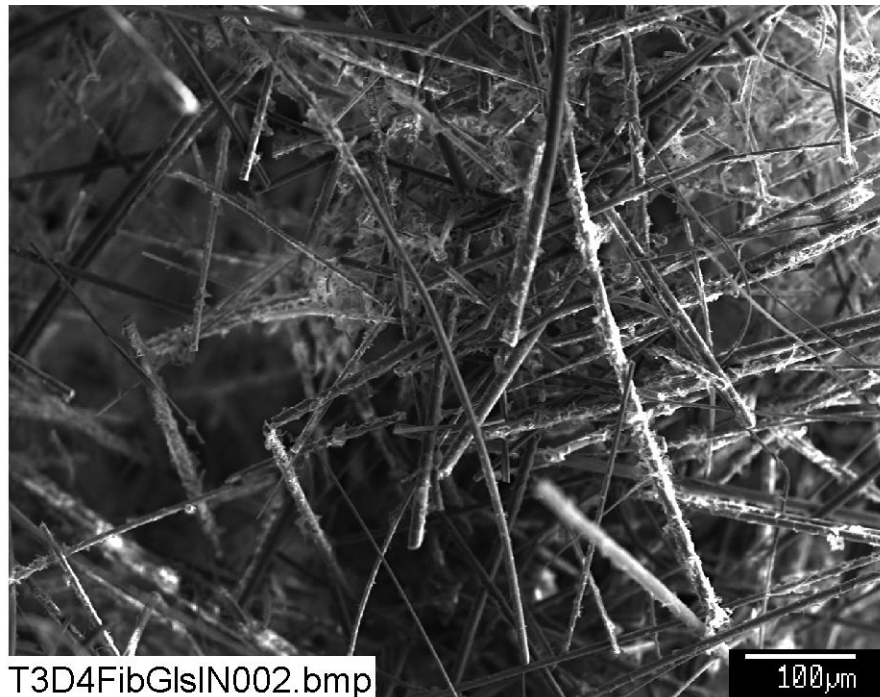
**Figure 3-26. SEM image for a Test #3 Day 4 low-flow interior fiberglass sample, magnified 150 times.
(T3D4FibGlsIN002, 4/12/05)**

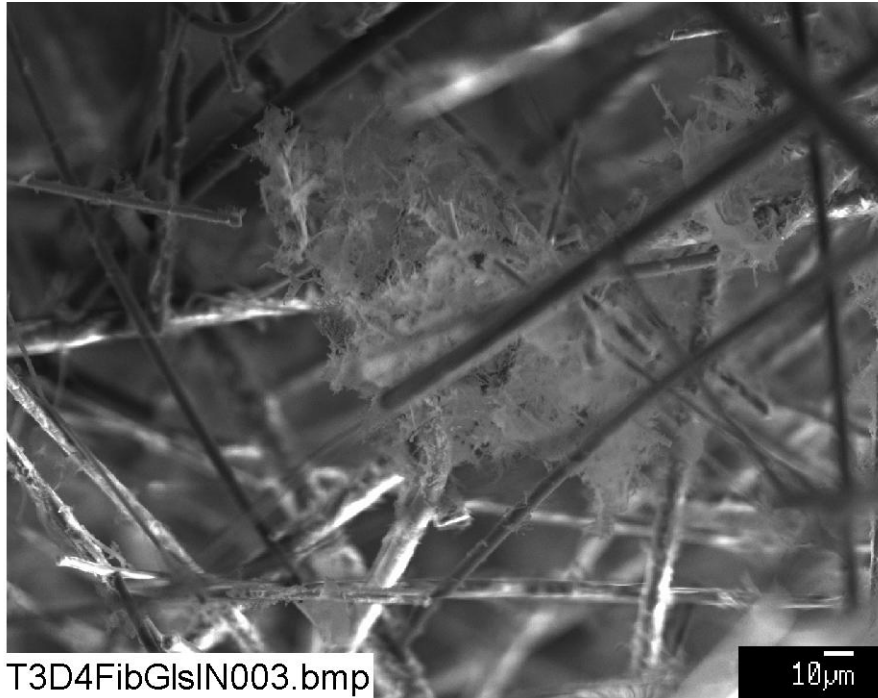
Figure 3-27. SEM image of a Test #3 Day 4 low-flow interior fiberglass sample, magnified 400 times. (T3D4FibGlsIN003, 4/12/05)

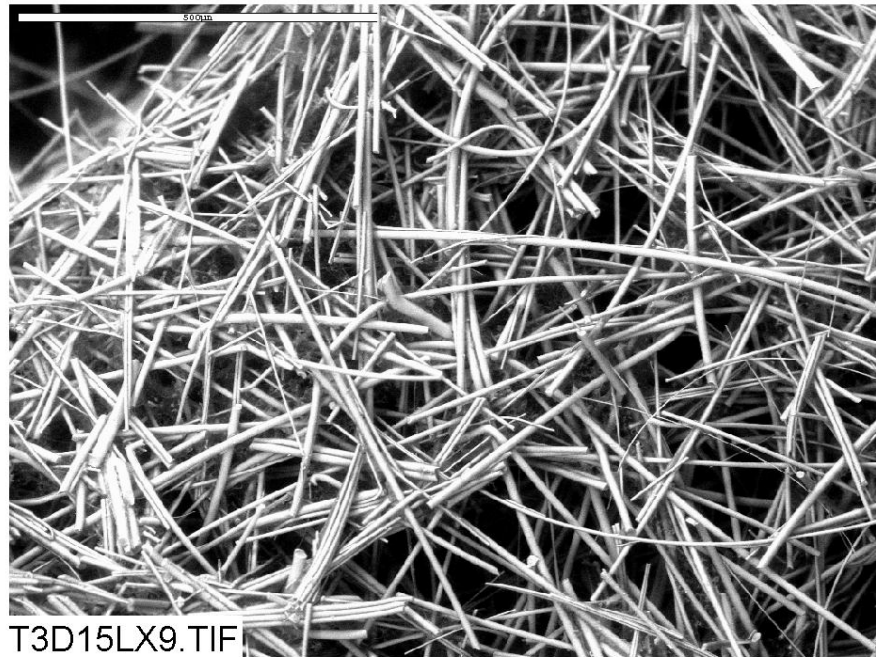
Figure 3-28. ESEM image of a Test #3 Day 15 low-flow exterior fiberglass sample, magnified 110 times. (T3D15LX9)

As with Day 4 samples, dark deposits and white flocculence were found with ESEM and SEM results, respectively, on Day 15 low-flow fiberglass samples. There was no significant increase in the amount of deposits on Day 15 samples compared with Day 4 samples. Comparing the amount of deposits on the exterior and the interior Day 15 low-flow fiberglass samples revealed no significant difference. Again, EDS results show that the deposits on both of the exterior and the interior samples were commonly composed of O, Si (possible), Na, Ca, and small amounts of Mg, Al, B, and P, suggesting the deposits' likely chemical origin. Figures 3-28 through 3-38 show the Day 15 low-flow fiberglass results.

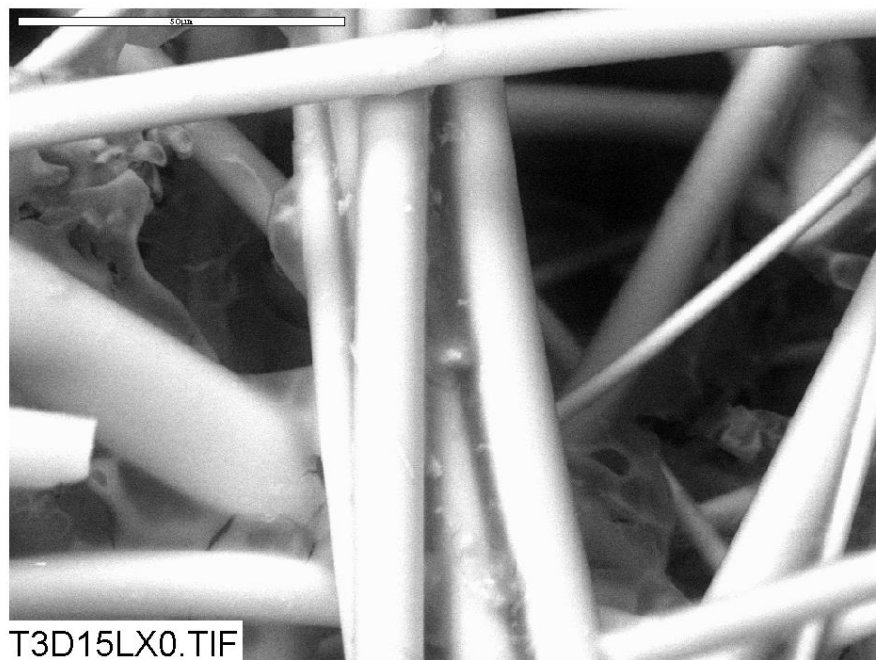
Figure 3-29. ESEM image of a Test #3 Day 15 low-flow exterior fiberglass sample, magnified 1000 times. (T3D15LX0)

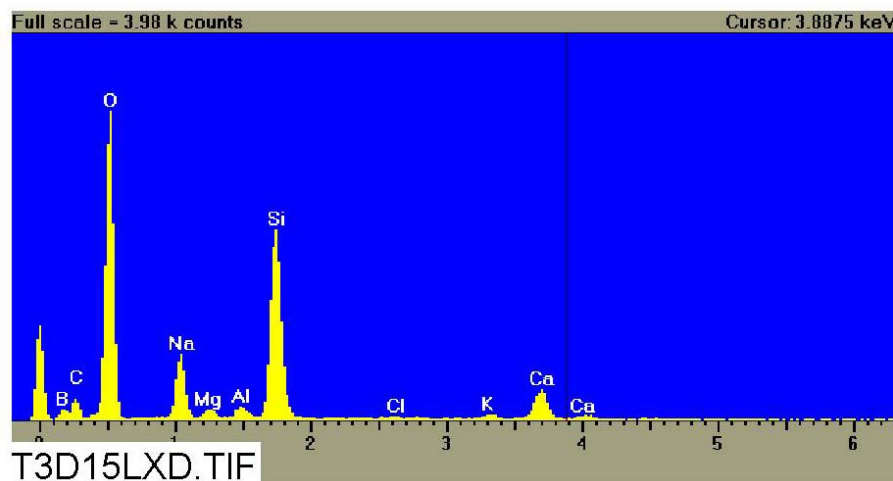
Figure 3-30. EDS counting spectrum for the deposits between the fibers on the ESEM image shown in Figure 3-29. (T3D15LXD)

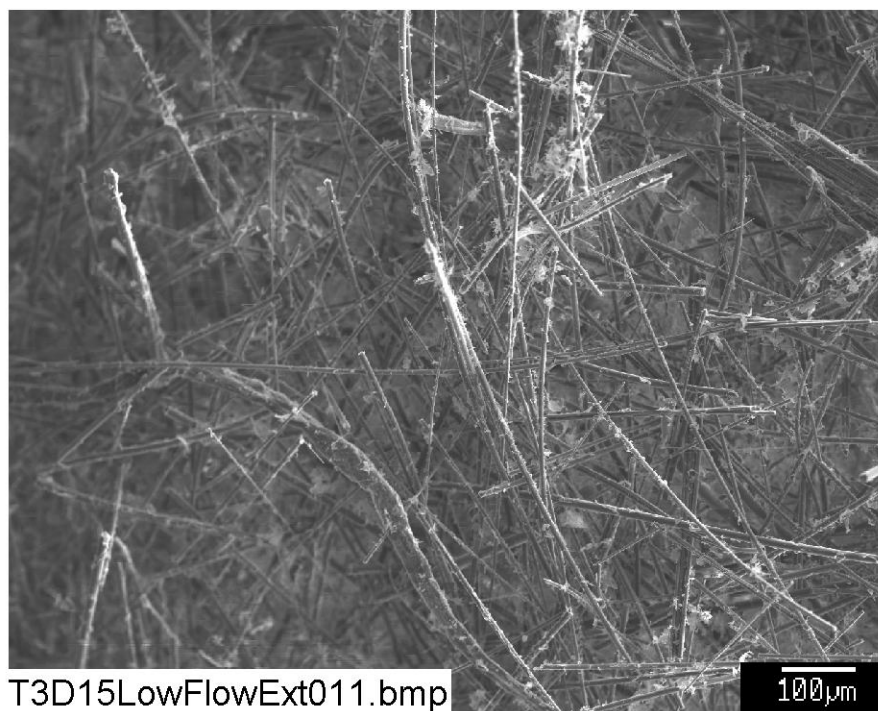
Figure 3-31. SEM image of a Test #3 Day 15 low-flow exterior fiberglass sample, magnified 100 times. (T3D15LowFlowExt011)

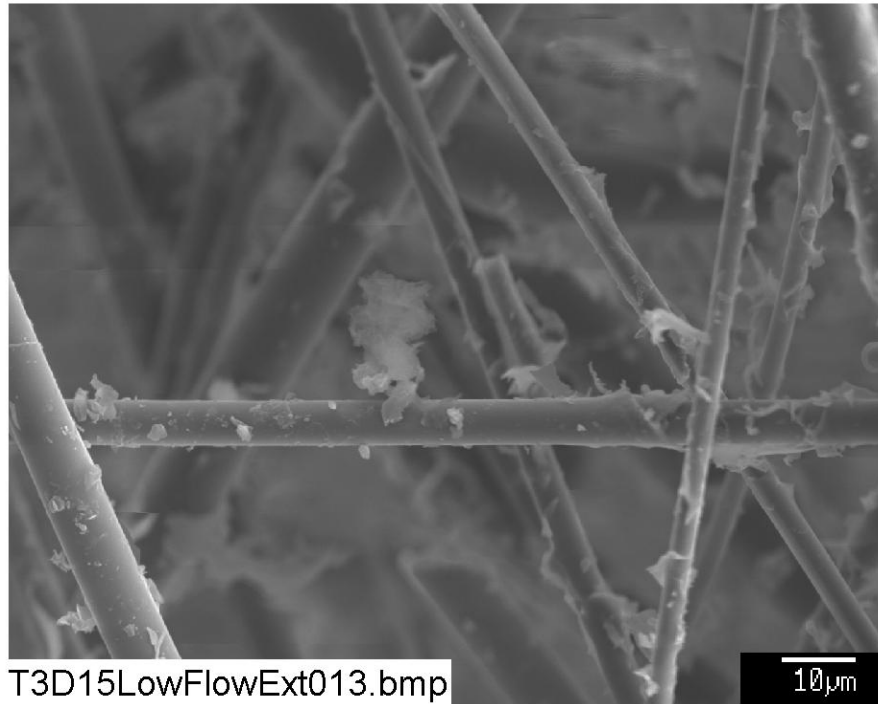
Figure 3-32. SEM image of a Test #3 Day 15 low-flow exterior fiberglass sample, magnified 1000 times. (T3D15LowFlowExt013)

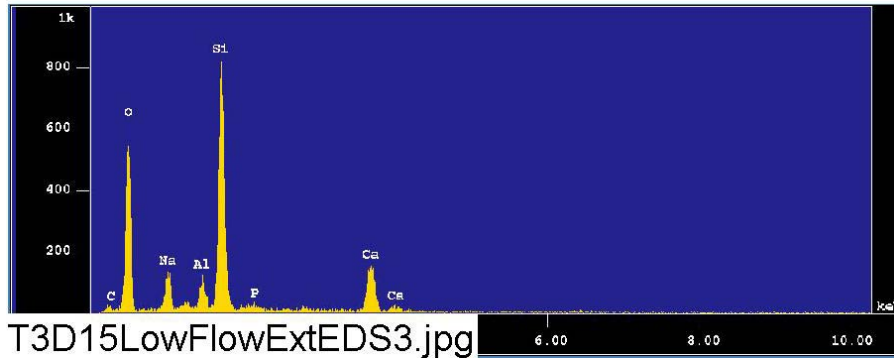
Figure 3-33. EDS counting spectrum for the flocculent deposits between the fibers on the SEM image shown in Figure 3-32. (T3D15LowFlowExtEDS3)

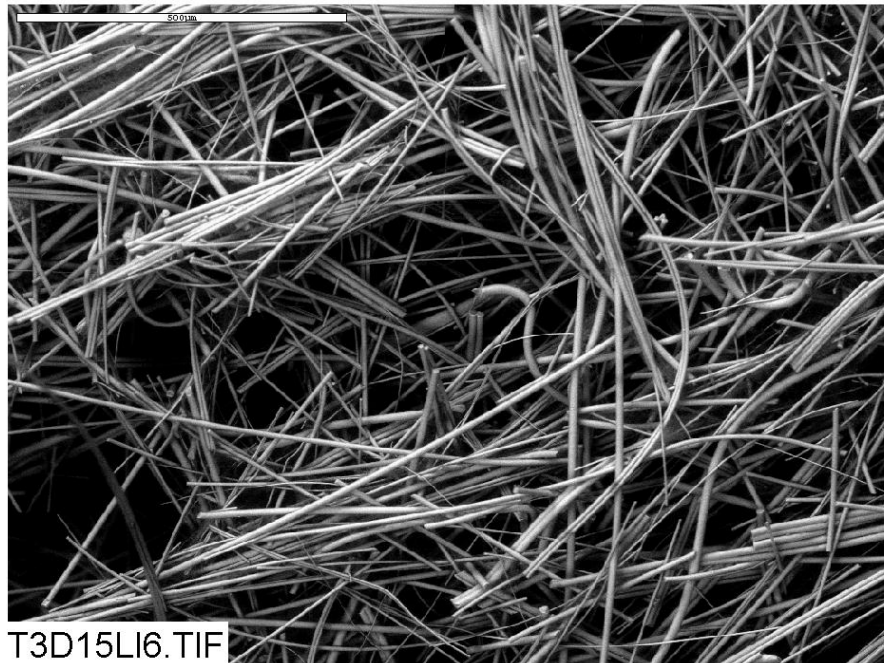
Figure 3-34. ESEM image of a Test #3 Day 15 low-flow interior fiberglass sample, magnified 100 times. (T3D15LI6)

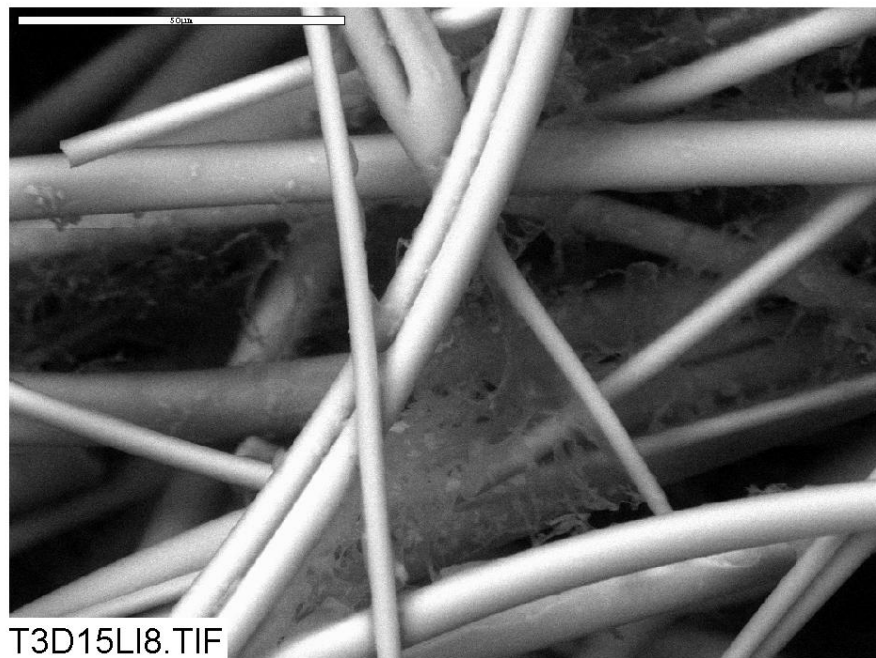
Figure 3-35. ESEM image of a Test# 3 Day 15 low-flow interior fiberglass sample, magnified 1000 times. (T3D15LI8)

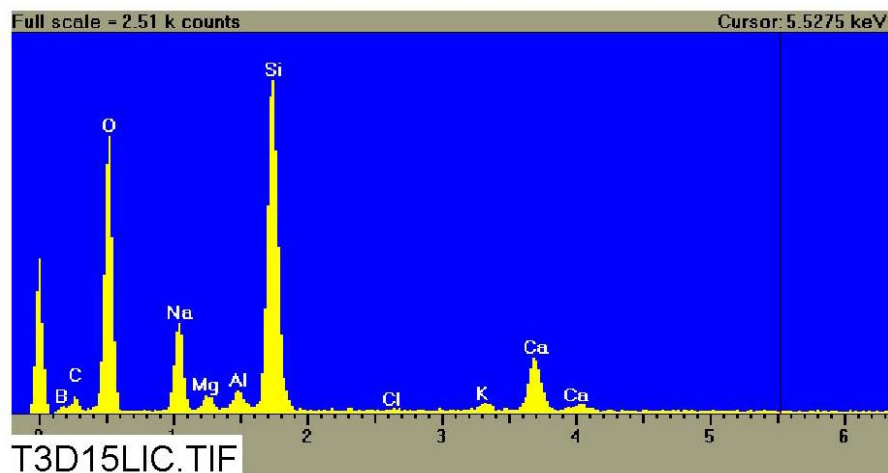
Figure 3-36. EDS counting spectrum for the flocculent deposits between the fibers on the ESEM image shown in Figure 3-35. (T3D15LIC)

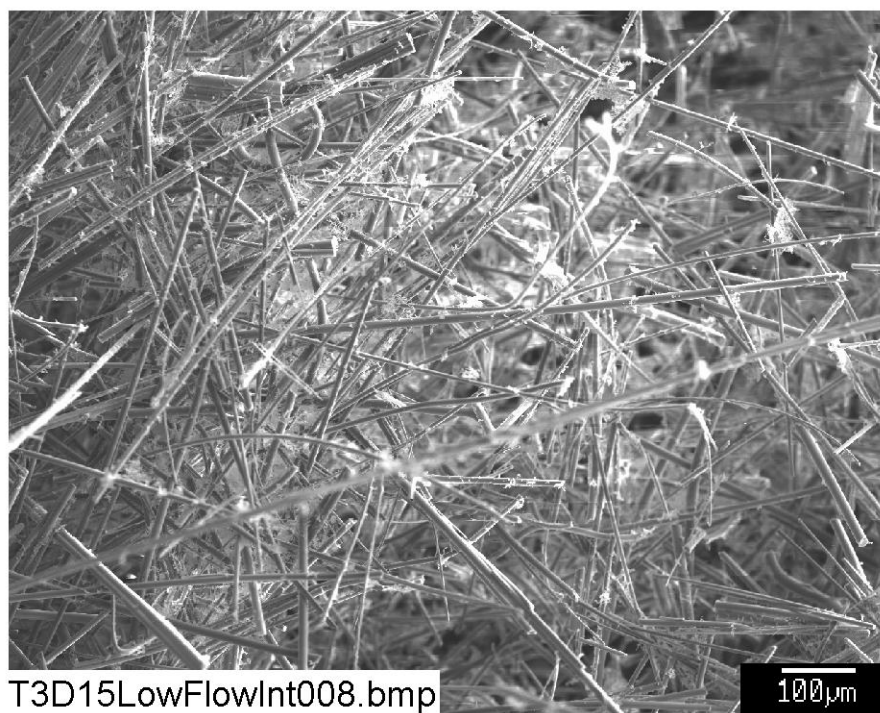
Figure 3-37. SEM image of a Test #3 Day 15 low-flow interior fiberglass sample, magnified 100 times. (T3D15LowFlowInt008)

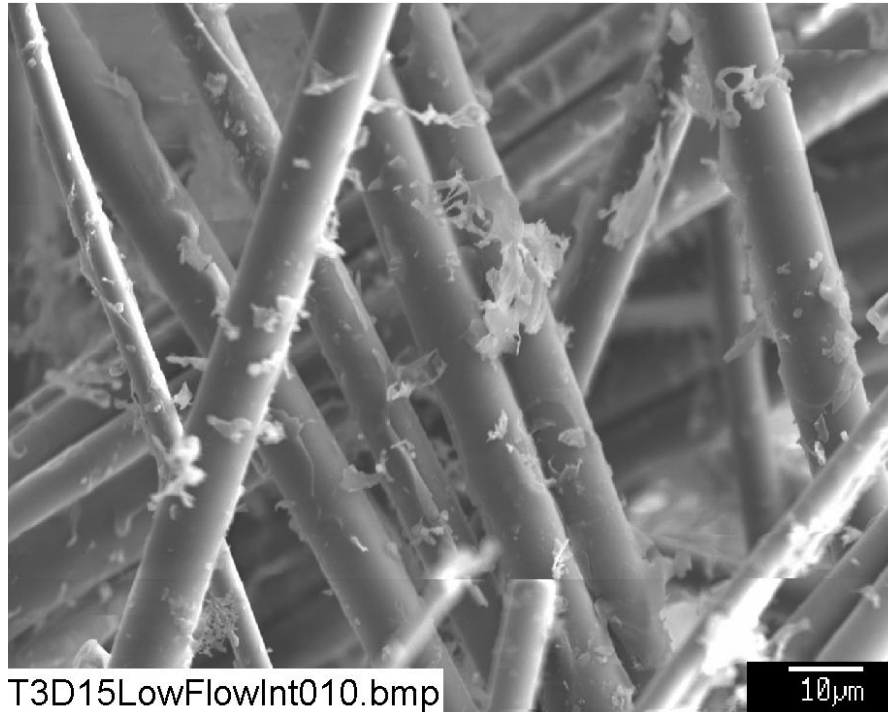
Figure 3-38. SEM image of a Test #3 Day 15 low-flow interior fiberglass sample, magnified 1000 times. (T3D15LowFlowInt010)

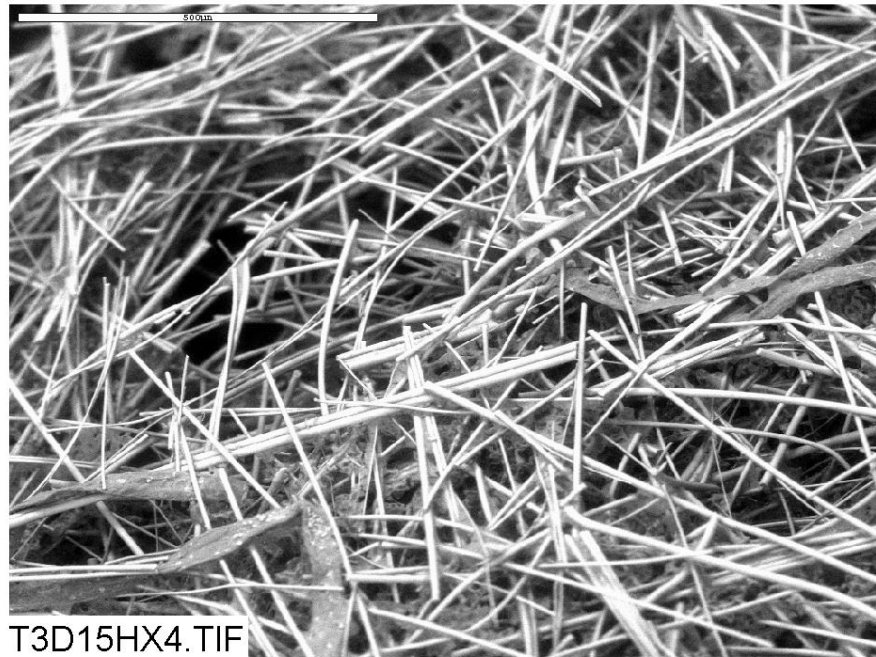
Figure 3-39. ESEM image of a Test #3 Day 15 high-flow exterior fiberglass sample, magnified 110 times. (T3D15HX4, 4/22/05)

No significant difference was found between Day 15 high-flow and low-flow fiberglass samples, except for some large flat fibers found on the Day 15 high-flow exterior fiberglass samples (see lower left corner of Figure 3-39). These large flat fibers, which were likely from the submerged cal-sil samples (see Appendix H), were physically attached/retained on the exterior of the fiberglass samples. No large flat fibers were found in the interior of the fiberglass samples. Again, dark deposits and white flocculence were found with ESEM and SEM results, respectively, on Day 15 high-flow fiberglass samples. There was no significant difference in the amount of deposits on the exterior and interior fiberglass samples. Similarly, EDS results verified that the deposits on the exterior and interior samples were commonly composed of O, Si (possible), Na, Ca, and small amount of Mg, Al, B, and P, suggesting the deposits' likely chemical origin. Figures 3-39 through 3-50 show the Day 15 high-flow fiberglass results.

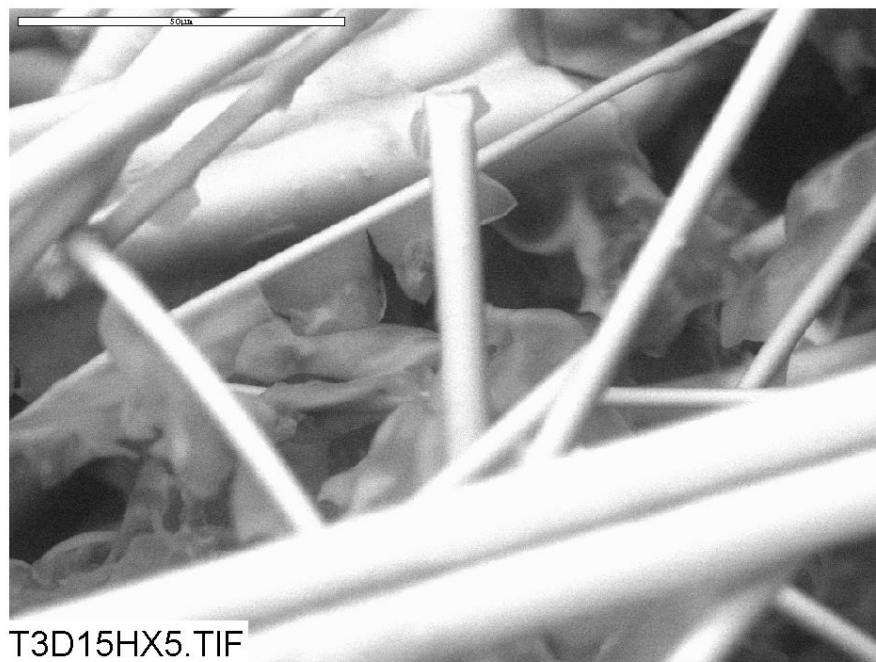
Figure 3-40. ESEM image of a Test #3 Day 15 high-flow exterior fiberglass sample, magnified 1000 times. (T3D15HX5, 4/22/05)

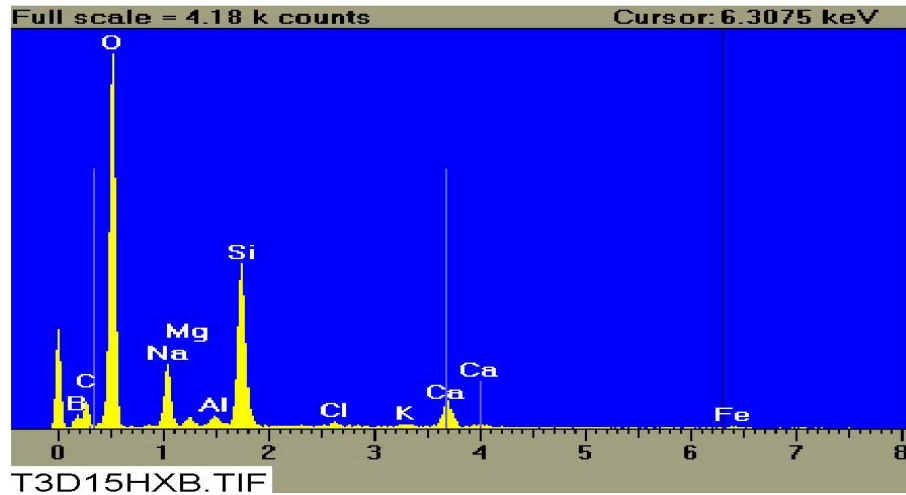
Figure 3-41. EDS counting spectrum for the deposits between the fibers on the ESEM image shown in Figure 3-40. (T3D15HIB, 4/22/05)

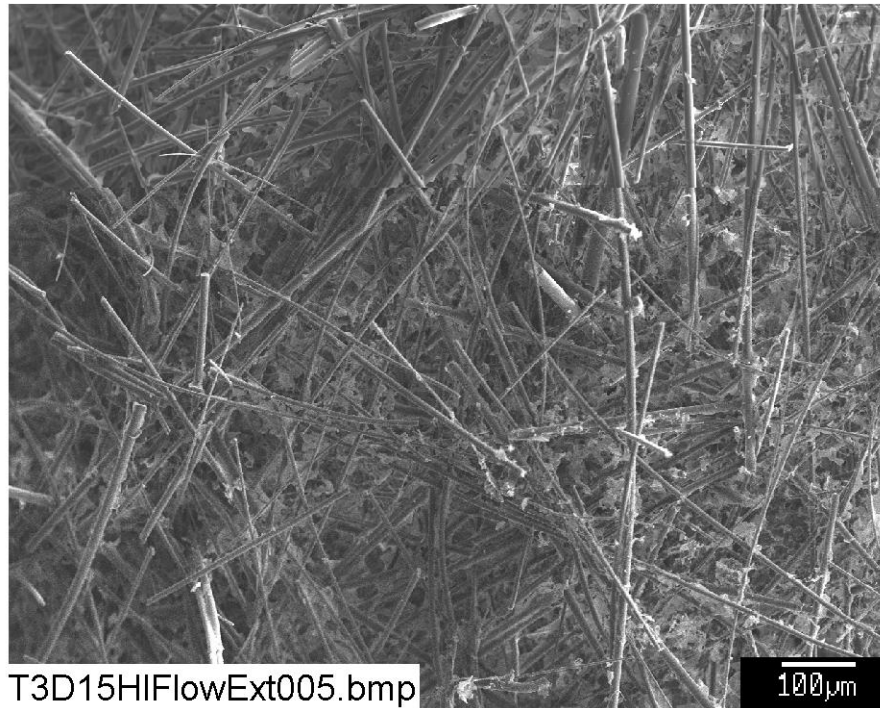
Figure 3-42. SEM image of a Test #3 Day 15 high-flow exterior fiberglass sample, magnified 100 times. (T3D15HIFlowExt005, 4/22/05)

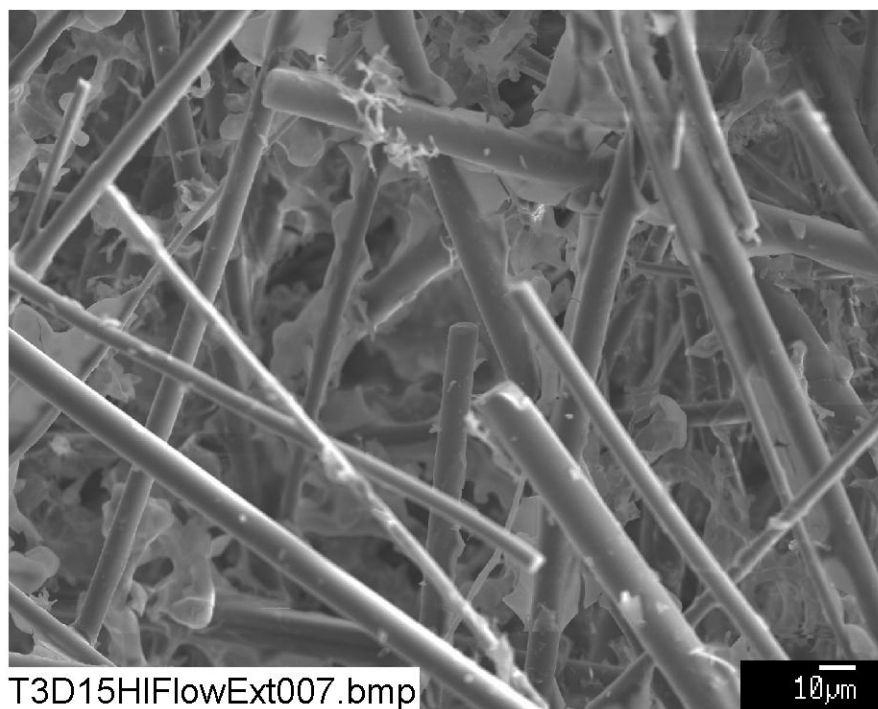
Figure 3-43. SEM image of a Test #3 Day 15 high-flow exterior fiberglass sample, magnified 500 times. (T3D15HiFlowExt007, 4/22/05)

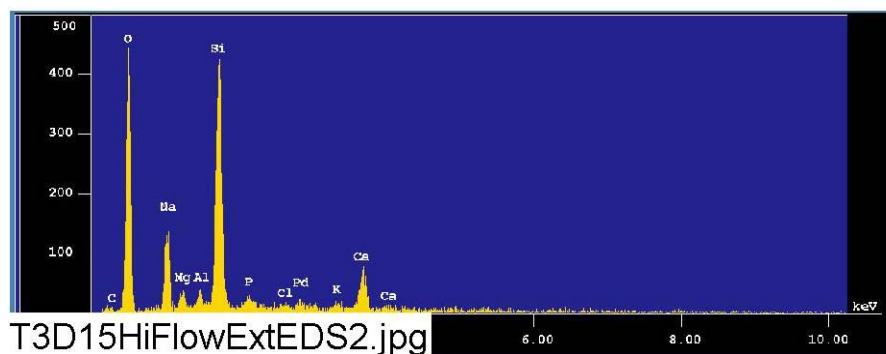
Figure 3-44. EDS counting spectrum for the flocculent deposits between the fibers on the SEM image shown in Figure 3-43. (T3D15HiFlowExtEDS2, 4/22/05)

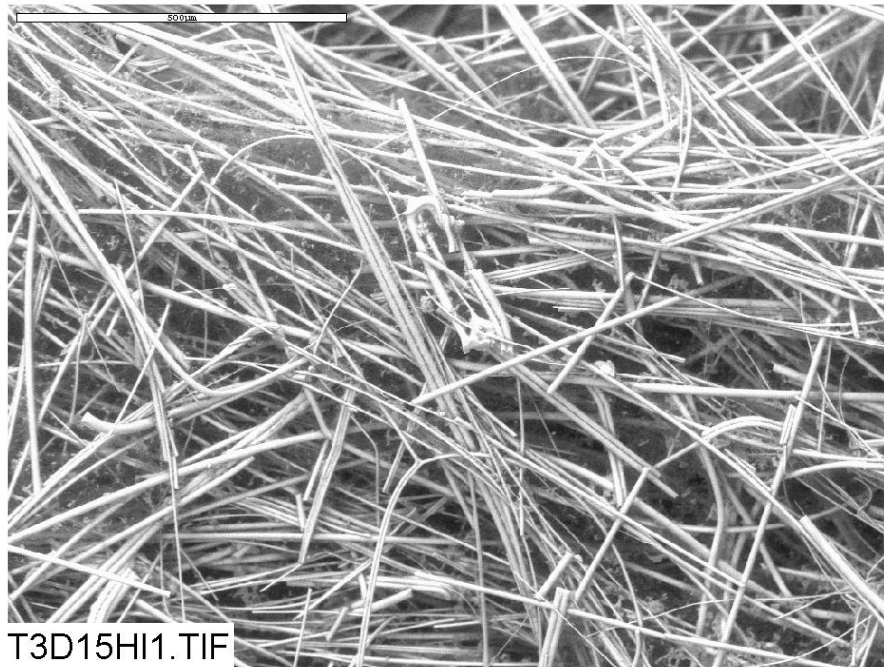
Figure 3-45. ESEM image of a Test #3 Day 15 high-flow interior fiberglass sample, magnified 100 times. (T3D15HI1, 4/22/05)

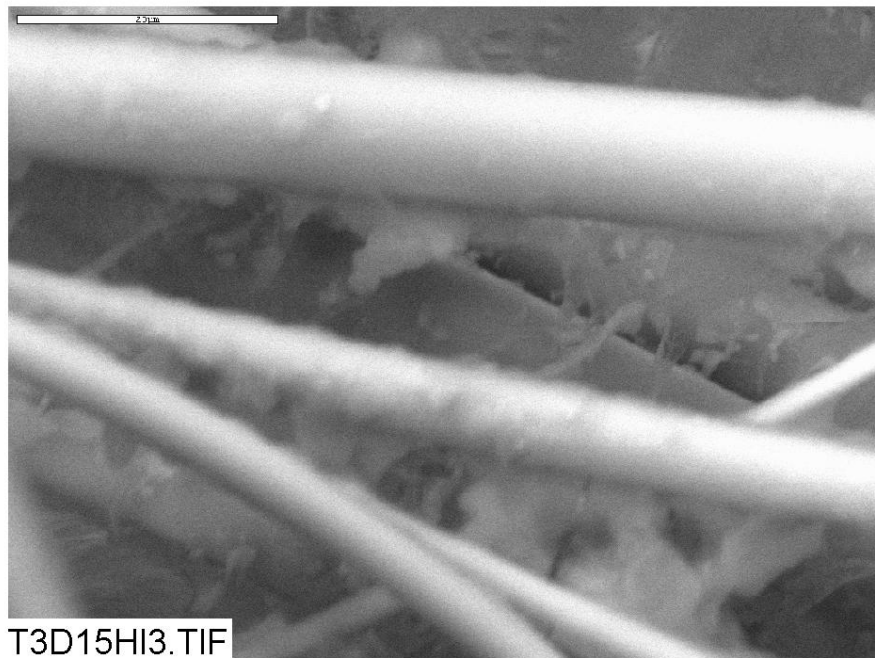
Figure 3-46. ESEM image of a Test #3 Day 15 high-flow interior fiberglass sample, magnified 2000 times. (T3D15HI3, 4/22/05)

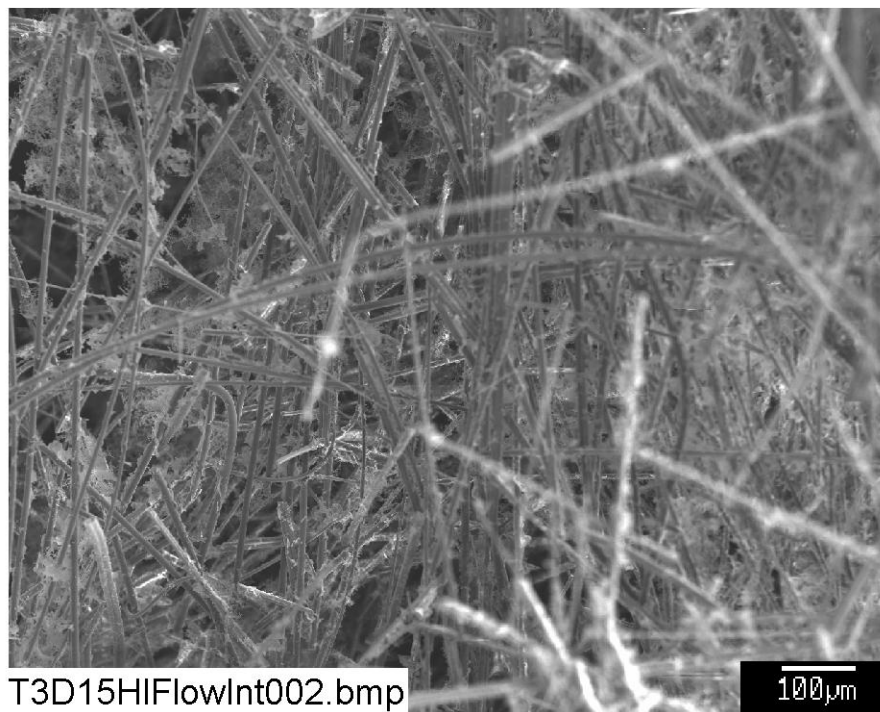
Figure 3-48. SEM image of a Test #3 Day 15 high-flow interior fiberglass sample, magnified 100 times. (T3D15HIFlowInt002, 4/22/05)

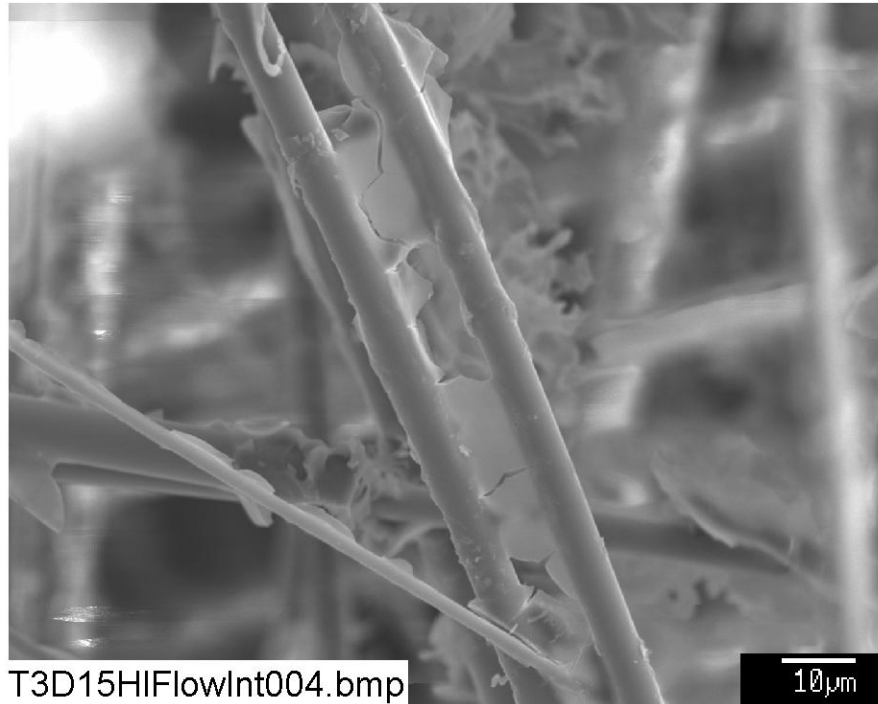
Figure 3-49. SEM image of a Test #3 Day 15 high-flow interior fiberglass sample, magnified 1000 times. (T3D15HiFlowInt004, 4/22/05)

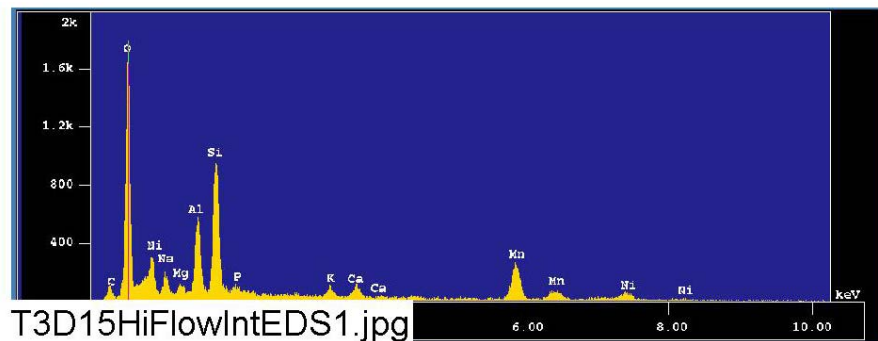
Figure 3-50. EDS counting spectrum for the flocculent deposits between the fibers on the SEM image shown in Figure 3-49. (T3D15HiFlowIntEDS1, 4/22/05)

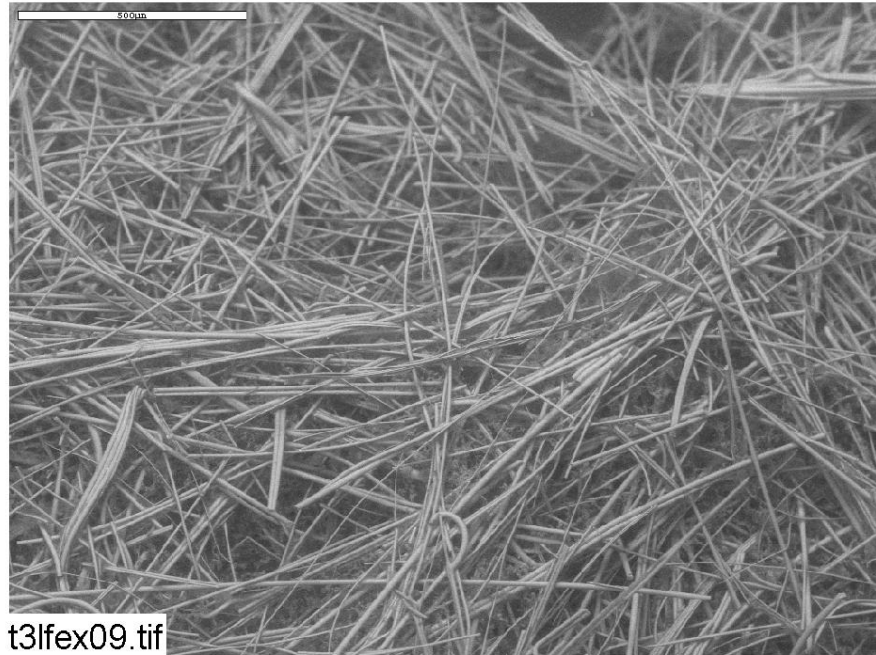
Figure 3-51. ESEM image of a Test #3 Day 30 exterior low-flow fiberglass sample, magnified 70 times. (t3lfex09, 5/6/05)

Comparing Day 30 low-flow fiberglass samples with Day 4 and Day 15 low-flow fiberglass samples revealed deposits that are similar in property and amount. In addition, there was no significant difference in the amount of deposits found in exterior and interior Day 30 low-flow fiberglass samples. Figures 3-51 through 3-54 show the Day 30 low-flow fiberglass results.

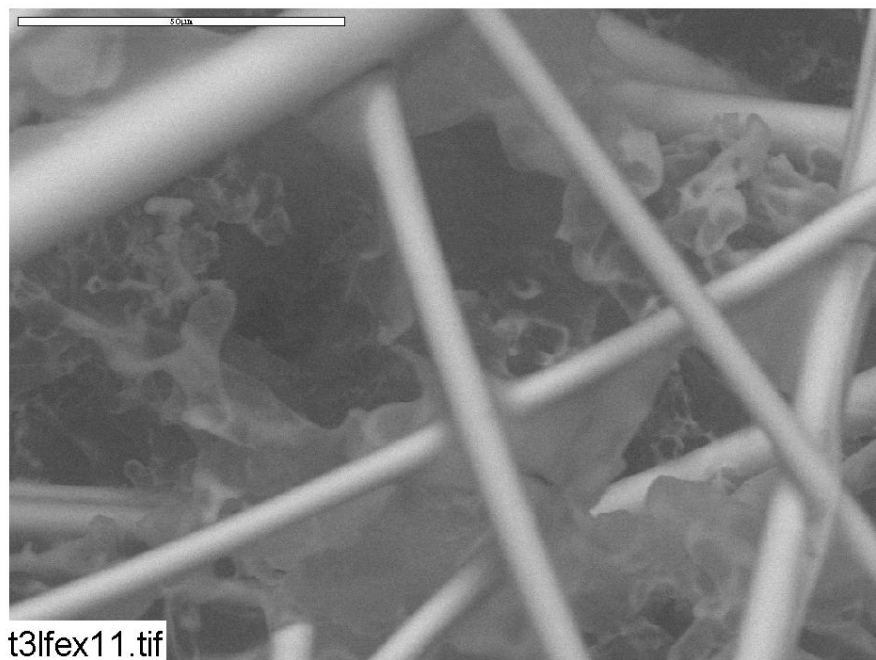
Figure 3-52. ESEM image of a Test #3 Day 30 exterior low-low fiberglass sample, magnified 1000 times. (t3lfex11, 5/6/05)

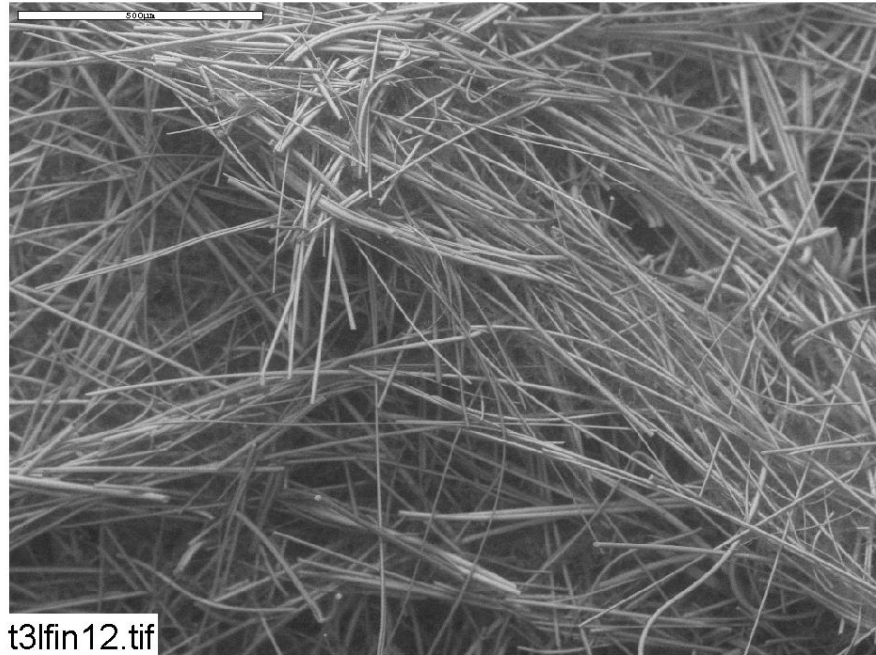
Figure 3-53. ESEM image of a Test #3 Day 30 interior low-flow fiberglass sample, magnified 70 times. (t3lfin12, 5/6/05)

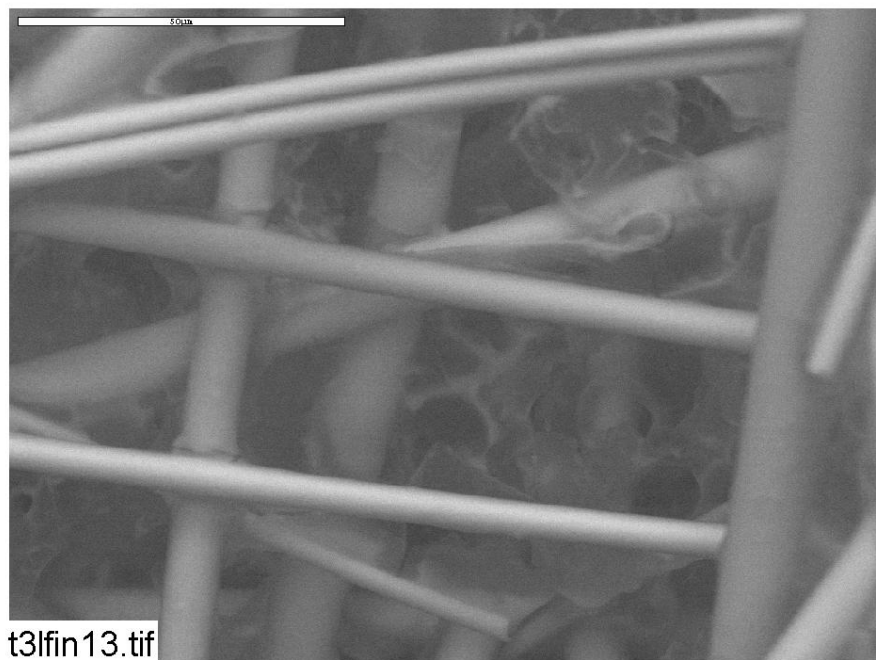
Figure 3-54. ESEM image of a Test #3 Day 30 interior low-flow fiberglass sample, magnified 1000 times. (t3lfin13, 5/6/05)

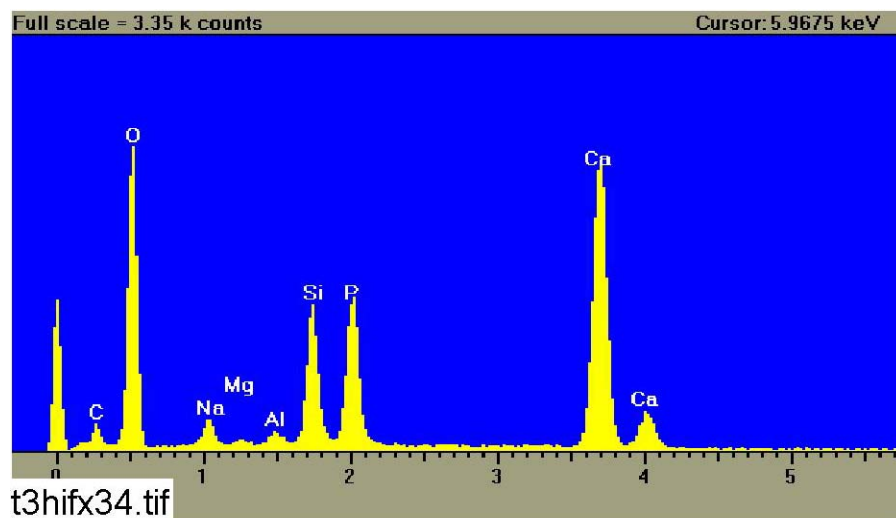
Figure 3-56. EDS counting spectrum for the large masses of particulate deposits shown in Figure 3-55. (t3hifx34, 5/11/05)

Compared with other high- and low-flow fiberglass samples, Day 30 high-flow exterior samples contained a significant amount of particulates. As opposed to the exterior samples, the interior samples were relatively clean, suggesting that the particulate deposits were physically attached/retained on the fiberglass exterior. EDS results show that the particulate deposits were composed of a significant amount of P, which is different from the previous fiberglass samples. The deposits' high P, Ca, and O content suggests that the deposits were $\text{Ca}_3(\text{PO}_4)_2$, which relates to the white gel (cream) formed during the injection of TSP. That $\text{Ca}_3(\text{PO}_4)_2$ was likely precipitated out from the testing solution, followed by sedimentation/transportation onto the Day 30 high-flow fiberglass exterior. Figures 3-55 through 3-59 show the Day 30 high-flow fiberglass results.

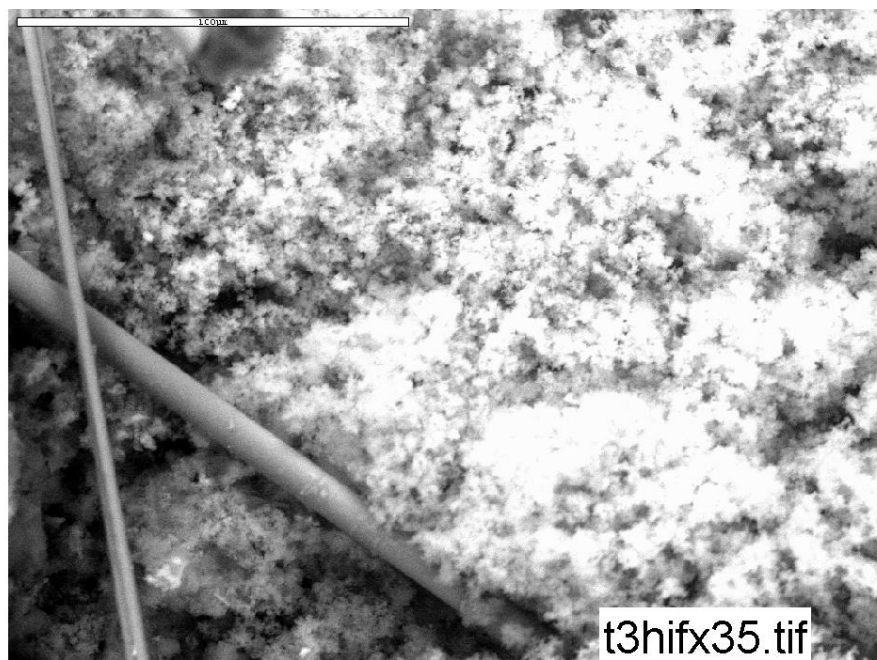
Figure 3-57. ESEM image of a Test #3 Day 30 exterior high-flow fiberglass sample, magnified 600 times. (t3hifx35, 5/11/05)

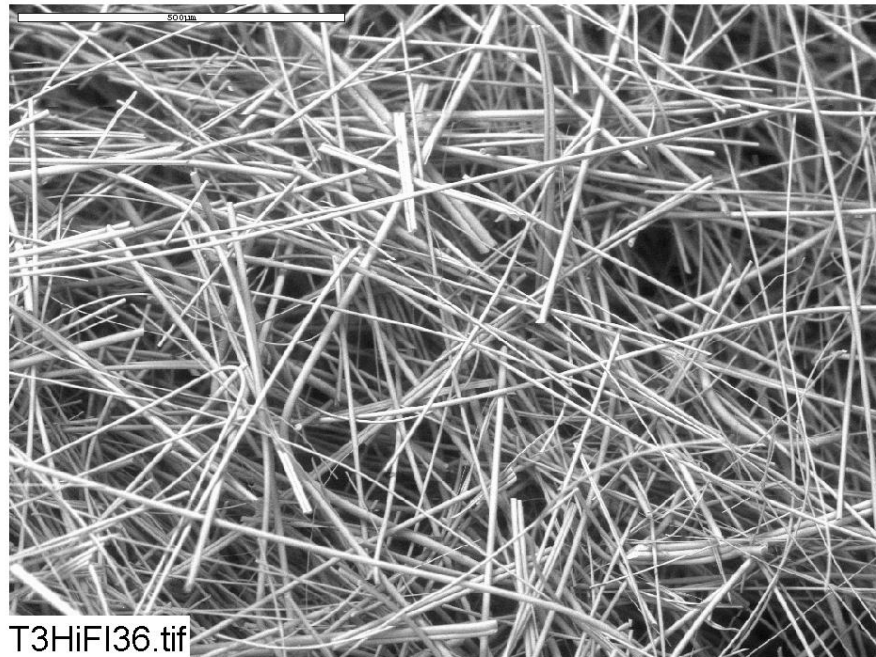
Figure 3-58. ESEM image of a Test #3 Day 30 interior high-flow fiberglass sample, magnified 100 times. (T3HiFI36, 5/11/05)

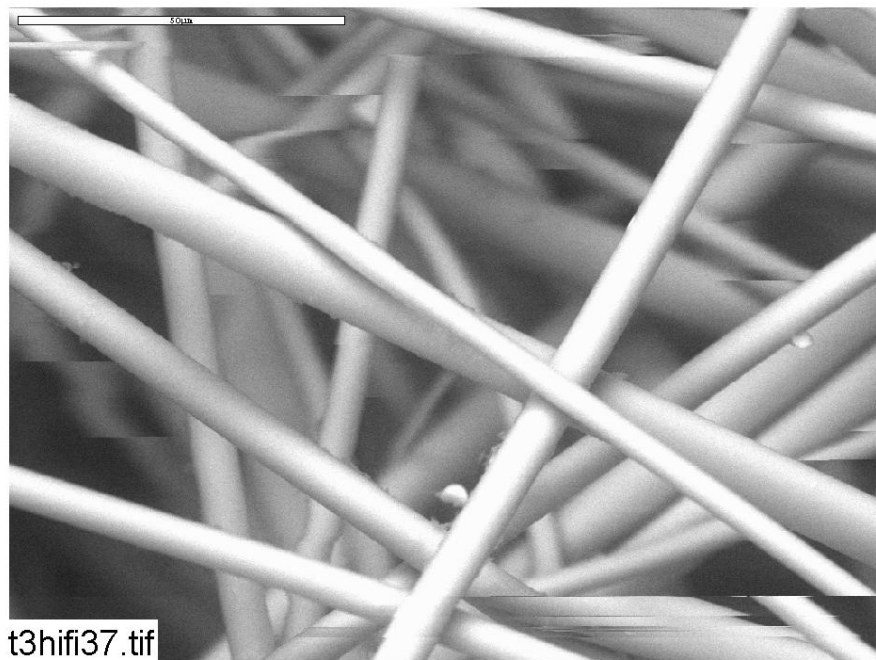
Figure 3-59. ESEM image of a Test #3 Day 30 interior high-flow fiberglass sample, magnified 1000 times. (t3hifi37, 5/11/05)

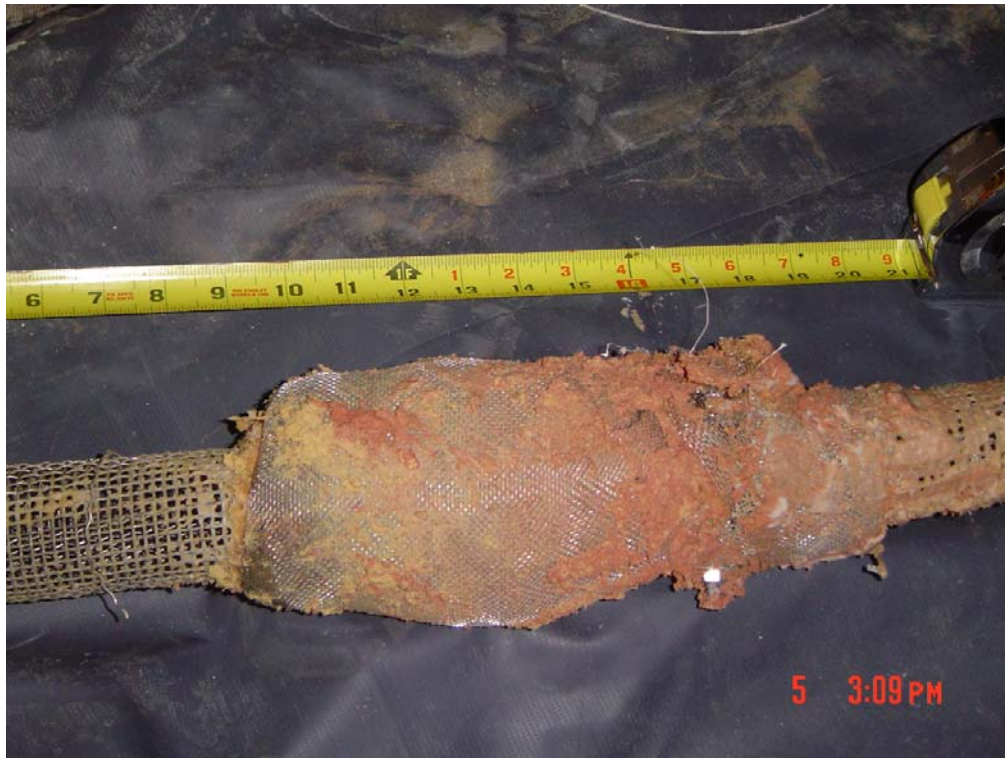
Figure 3-60 shows the drain collar after it was removed from the tank. When the tank was drained, the drain collar was totally surrounded by sediment. Both the exterior fiberglass sample that was farthest from the drain screen and the exterior sample that was next to the drain screen have very significant amounts of particulate deposits. Inspection revealed the development of a continuous coating on the drain collar exterior, including particulate deposits that were likely physically retained or attached. The amount of deposits on the drain collar exterior was greater than on high- and low-flow fiberglass samples. The ESEM images showed that two types of material were retained; an amorphous material that appeared darker in the ESEM images and a lighter granular material. The EDS results indicate that these materials had different P and Si content. The lighter particulate deposits (see Figure 3-62) have a higher percentage of P and a lower percentage of Si than the dark deposits, suggesting that light particulate deposits are likely composed of $\text{Ca}_3(\text{PO}_4)_2$ precipitates and dark deposits of cal-sil particles. Both kinds of deposits could have been transported and/or deposited/retained on the drain collar fiberglass exterior. As opposed to what was found on the exterior sample, no significant deposits were found in the drain collar interior sample, suggesting that that almost all of the particulate deposits were physically retained at the fiberglass exterior. The result is consistent with findings for the Day 30 high-flow fiberglass samples. Figures 3-61 through 3-70 show the drain Day 30 drain collar fiberglass results.

Figure 3-60. Drain screen collar removed from the tank.

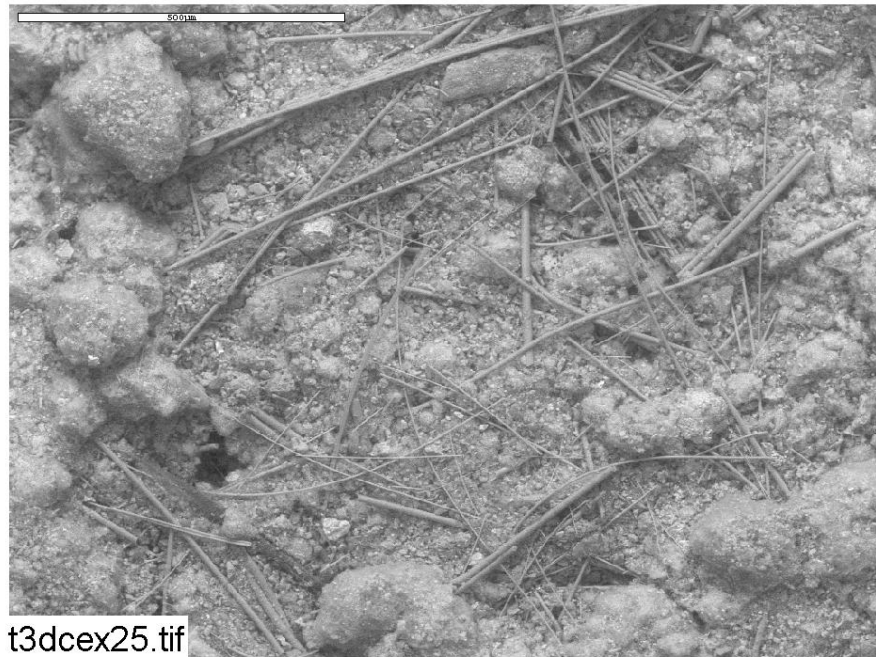
Figure 3-61. ESEM image of a Test #3 Day 30 exterior fiberglass sample on the drain collar (away from the drain screen), magnified 100 times. (t3dcex25, 5/6/05)
