Integrated Chemical Effects Test Project: Test #3 Data Report

Los Alamos National Laboratory

**U.S. Nuclear Regulatory Commission
Office of Nuclear Regulatory Research
Washington, DC 20555-0001**

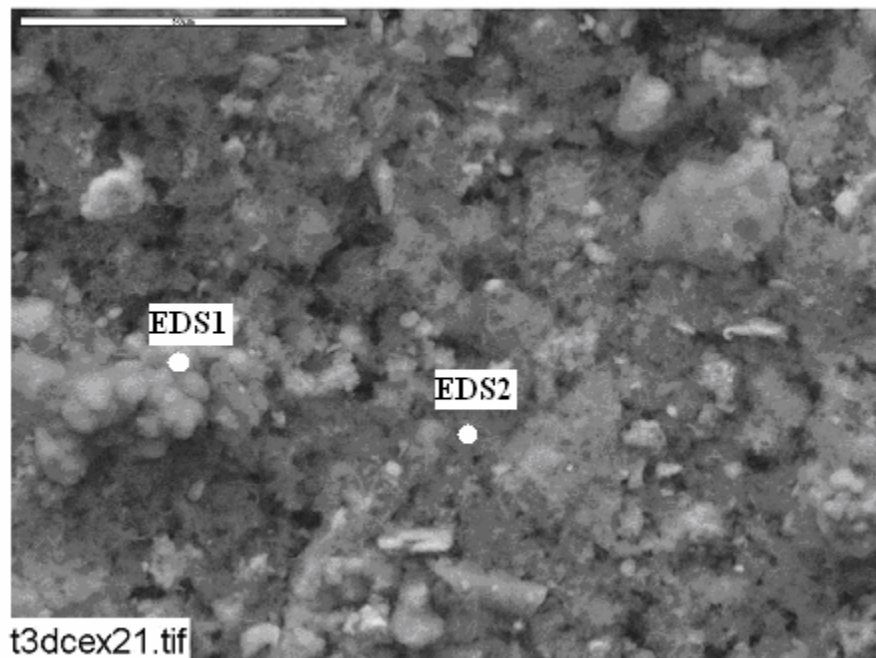
Figure 3-62. ESEM image of a Test #3 Day 30 exterior fiberglass sample on the drain collar (away from the drain screen), magnified 1000 times. (t3dcex21, 5/6/05)

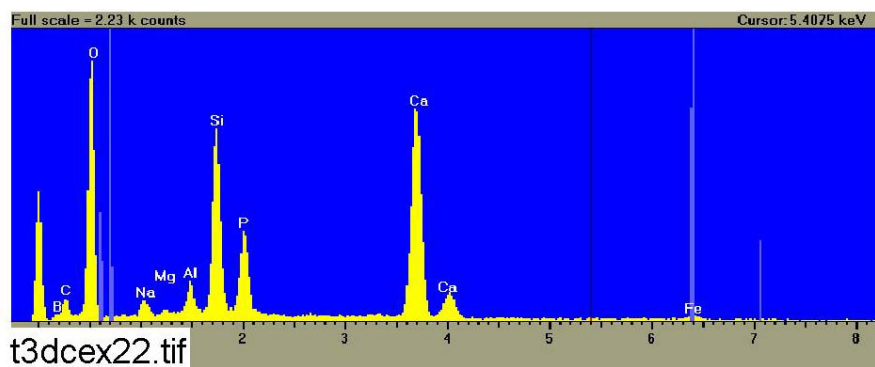
Figure 3-63. EDS counting spectrum for the light particulate deposits (EDS1) shown in Figure 3-62. (t3dcex22, 5/6/05)

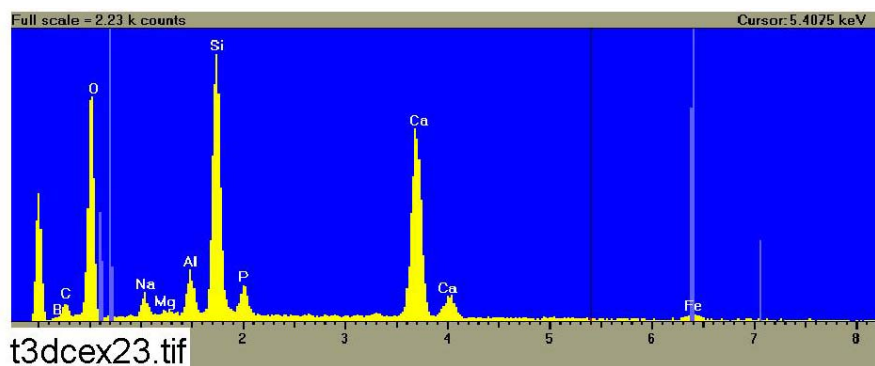
Figure 3-64. EDS counting spectrum for the dark deposits (EDS2) shown in Figure 3-62. (t3dcex23, 5/6/05)

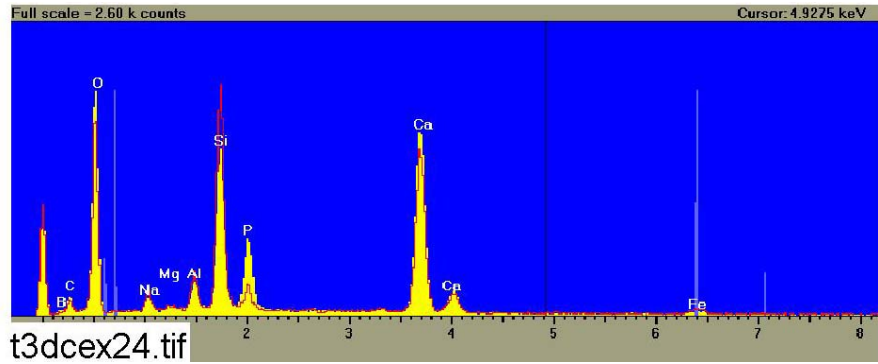
Figure 3-65. Comparison of EDS counting spectra between Figure 3-63 (yellow) and Figure 3-64 (red). (t3dcex24, 5/6/05)

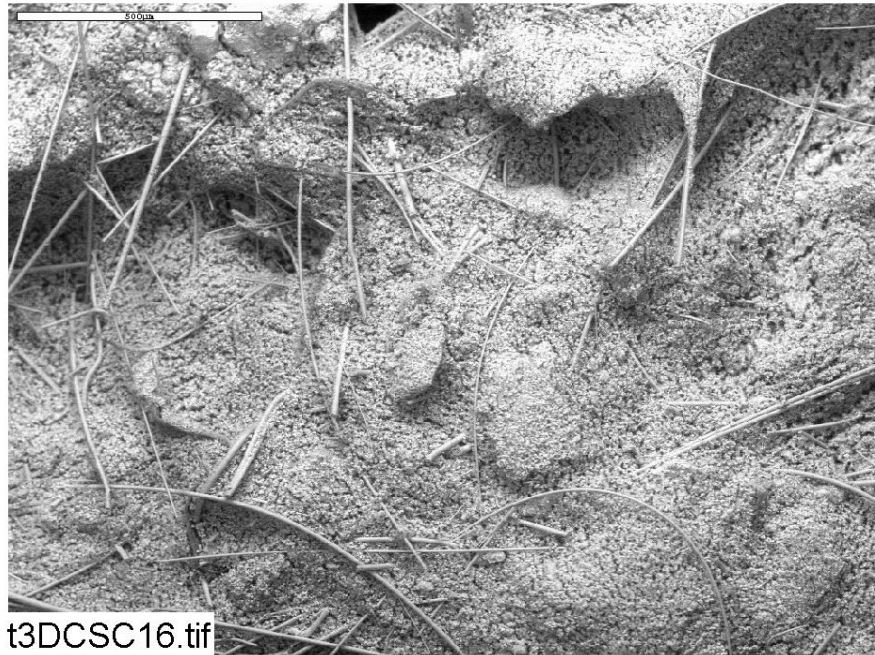
Figure 3-66. ESEM image of a Test #3 Day 30 exterior fiberglass sample on the drain collar (adjacent to the drain screen), magnified 100 times. (t3DCSC16, 5/6/05)

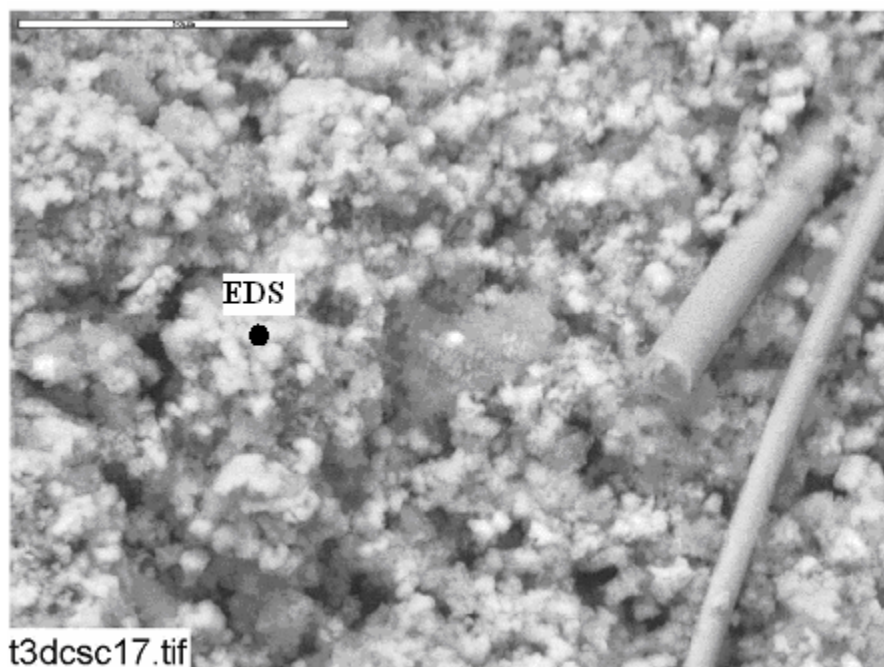
Figure 3-67. ESEM image of a Test #3 Day 30 exterior fiberglass sample on the drain collar (adjacent to the drain screen), magnified 1000 times. (t3dcsc17, 5/6/05)

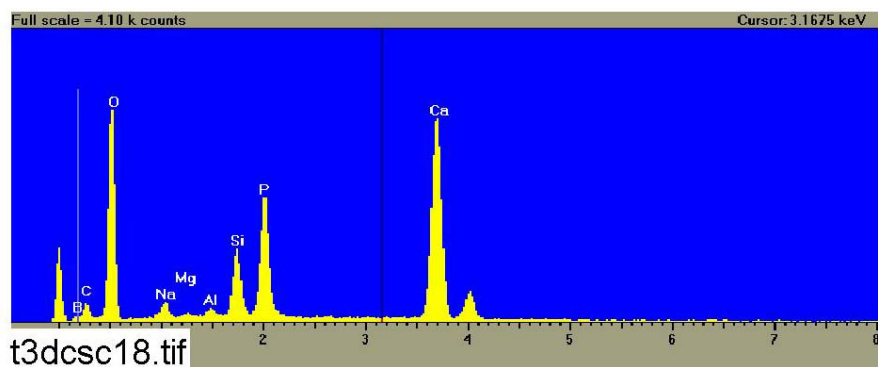
Figure 3-68. EDS counting spectrum for the particulate deposits shown in Figure 3-67. (t3dcsc18, 5/6/05)

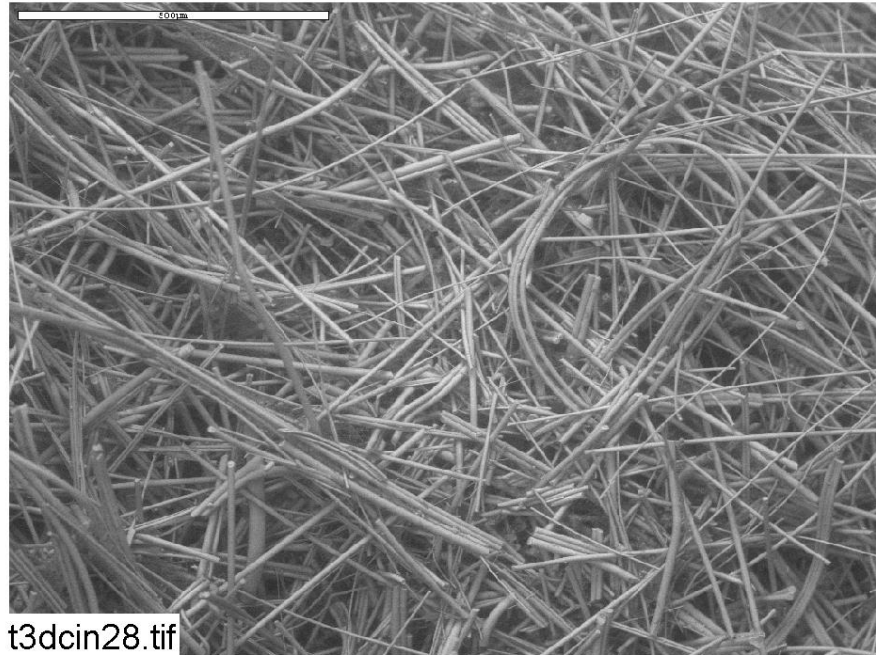
Figure 3-69. ESEM image of a Test #3 Day 30 interior fiberglass sample on the drain collar, magnified 100 times. (t3dcin28, 5/6/05)

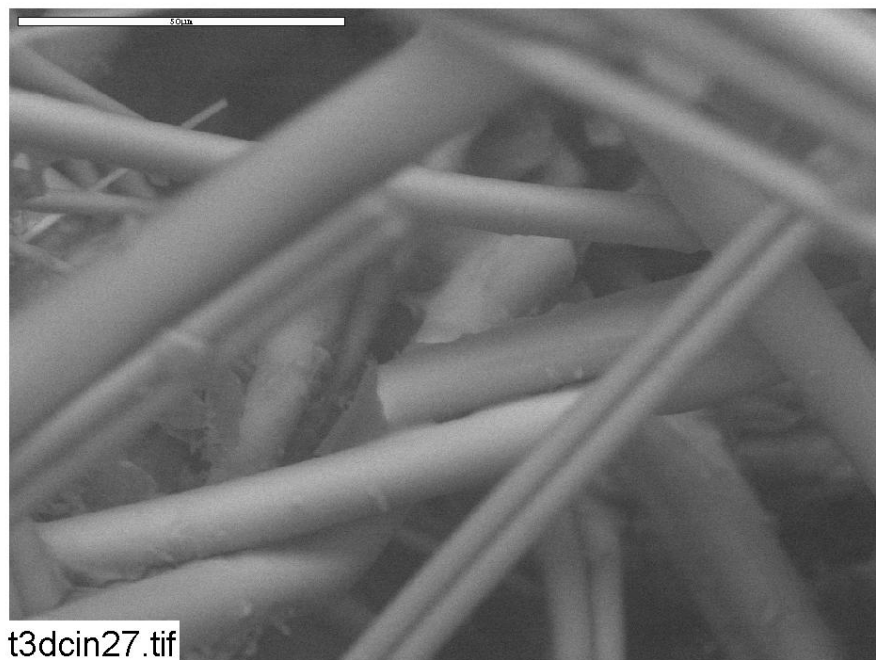
Figure 3-70. ESEM image of a Test #3 Day 30 interior fiberglass sample on the drain collar, magnified 1000 times. (t3dcin27, 5/6/05)

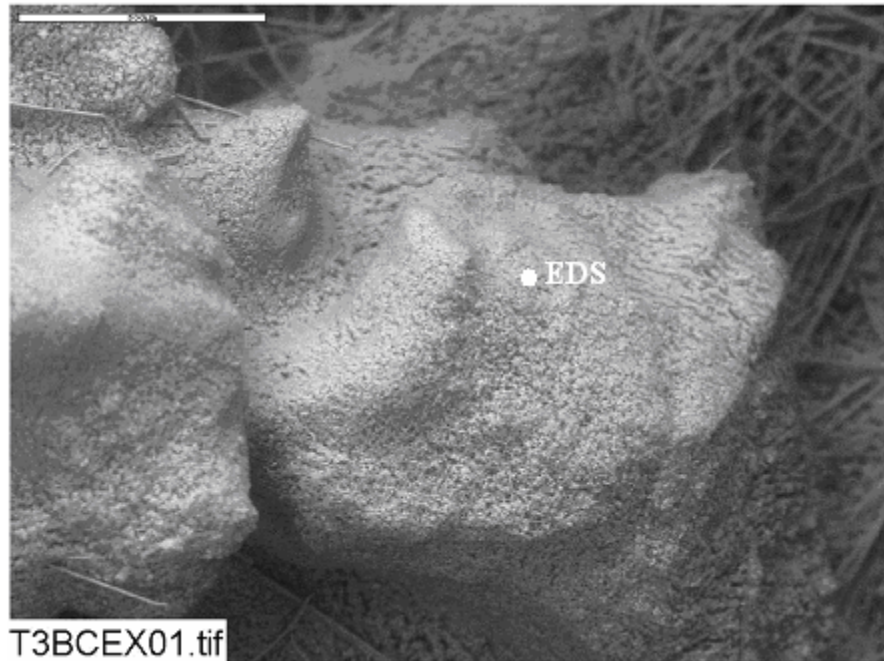
Figure 3-72. ESEM image of a Test #3 Day 30 exterior fiberglass sample within the birdcage, magnified 80 times. (T3BCEX01, 5/6/05)

Figure 3-125. Comparison of EDS counting spectra for Figure 3-124 (yellow: the gel-like materials shown in figure 3-123) and Figure 3-73 (red: the large deposits taken from the birdcage exterior shown in Figure 3-72). (t3geled7, 5/6/05)

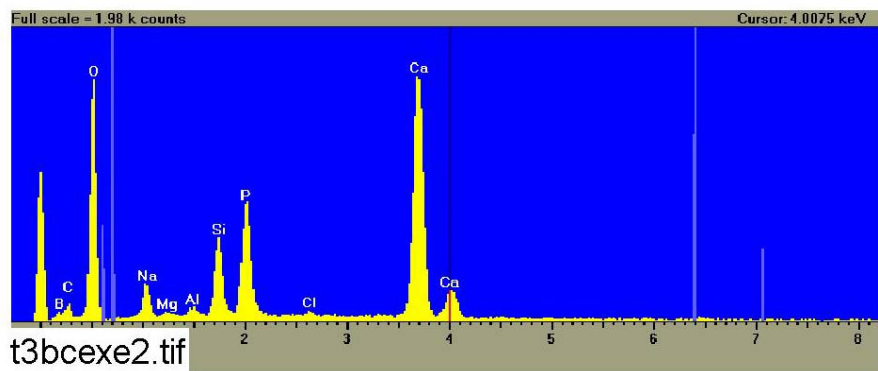
Figure 3-73. EDS counting spectrum for the large deposits shown in Figure 3-72. (t3bcexe2, 5/6/05)

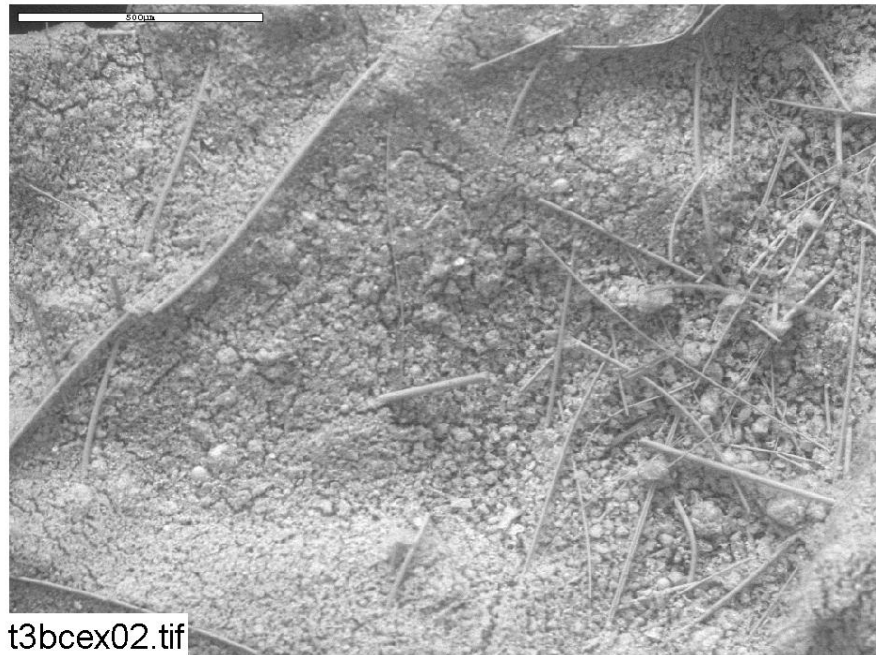
Figure 3-74. ESEM image of a Test #3 Day 30 exterior fiberglass sample within the birdcage, magnified 80 times. (t3bcex02, 5/6/05)

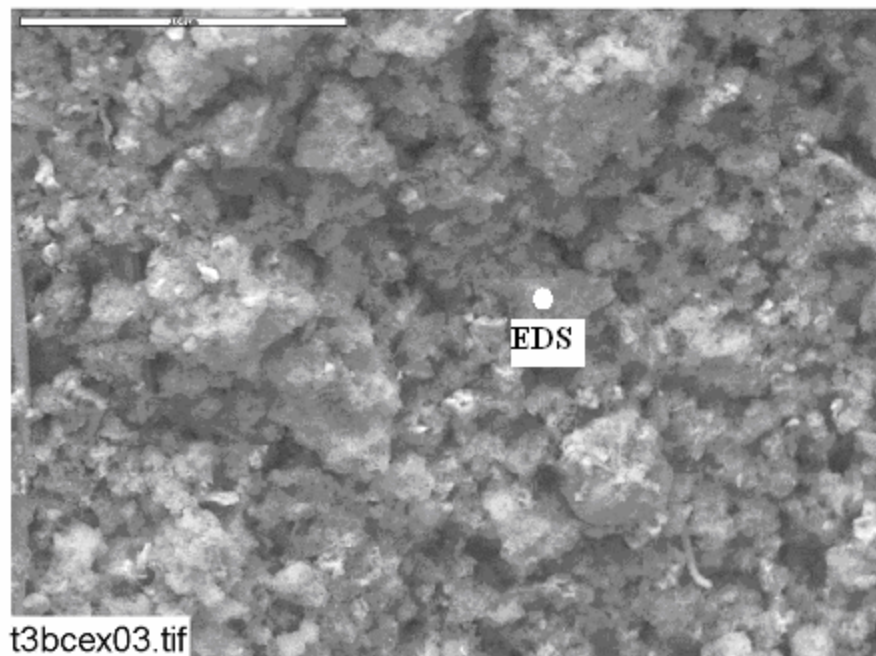
Figure 3-75. ESEM image of a Test #3 Day 30 exterior fiberglass sample within the birdcage, magnified 500 times. (t3bcex03, 5/6/05)

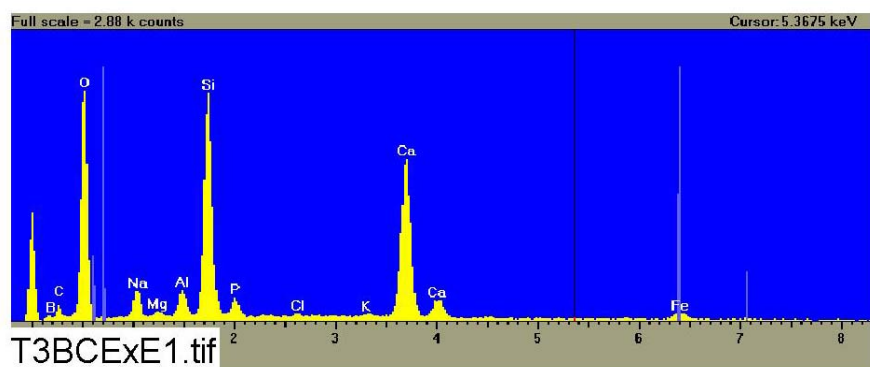
Figure 3-76. EDS counting spectrum for the deposits shown in Figure 3-75. (T3BCExE1, 5/6/05)

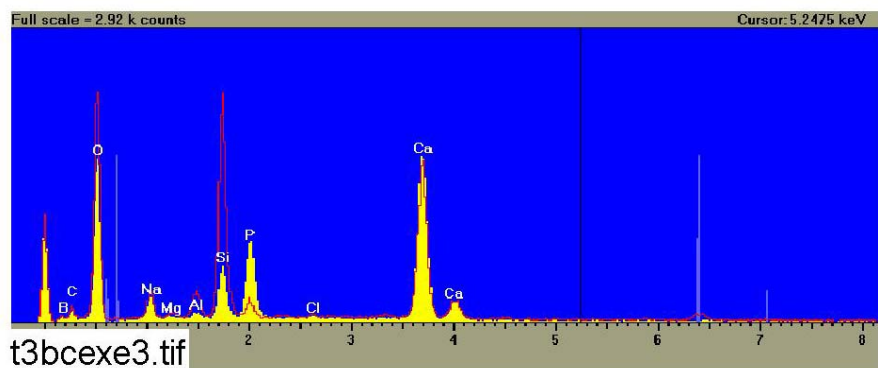
Figure 3-77. Comparison of EDS counting spectra of Figure 3-76 (red) and Figure 3-73 (yellow). (t3bcexe3, 5/6/05)

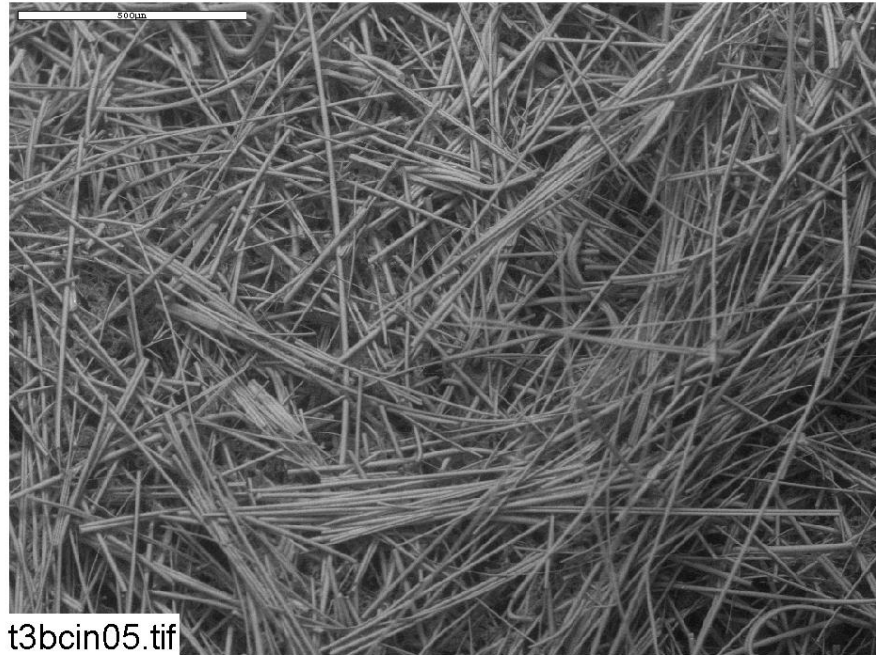
Figure 3-78. ESEM image of a Test #3 Day 30 interior fiberglass sample within the birdcage, magnified 80 times. (t3bcin05, 5/6/05)

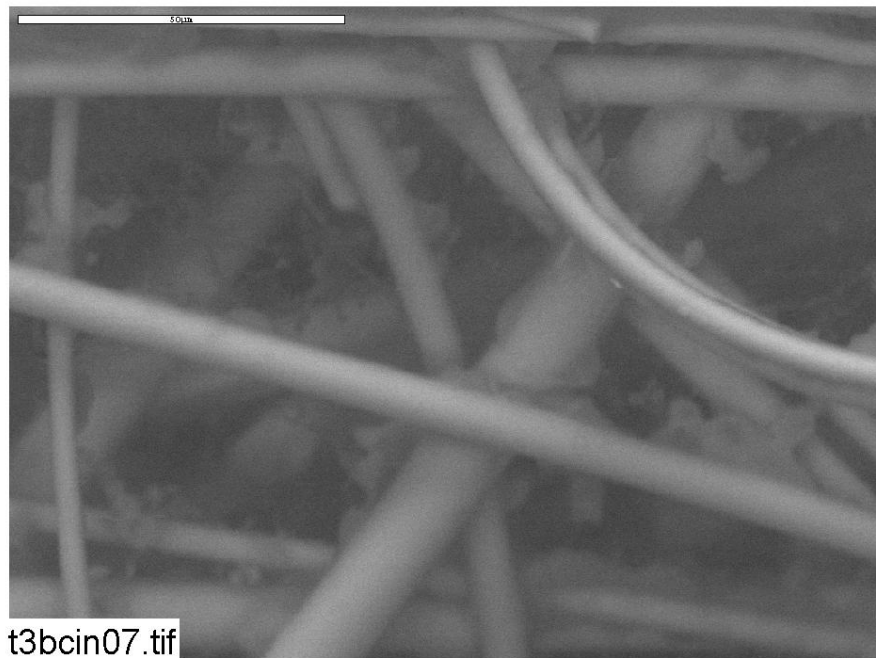
Figure 3-79. ESEM image of a Test #3 Day 30 interior fiberglass sample within the birdcage, magnified 1000 times. (t3bcin07, 5/6/05)

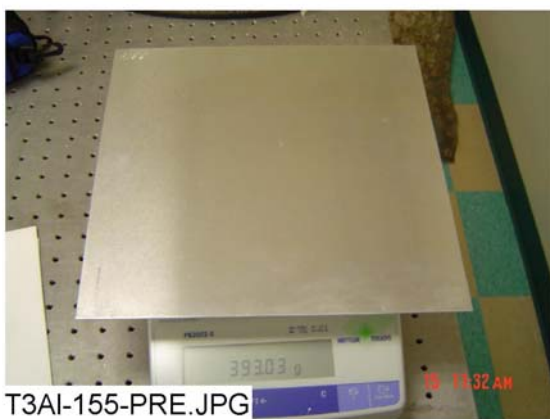
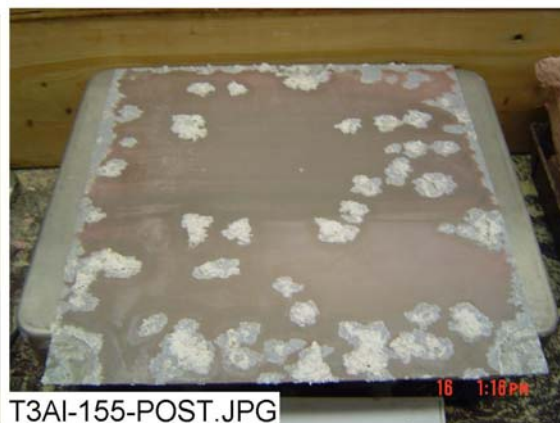
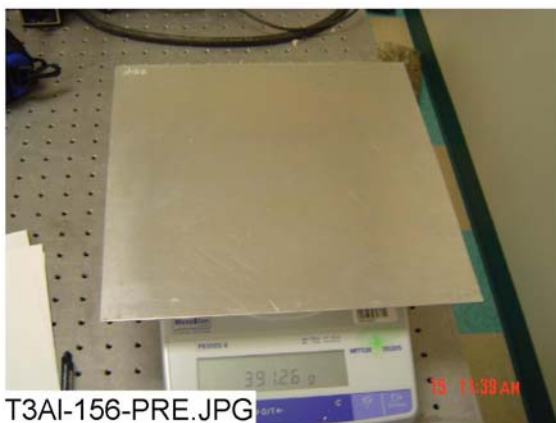
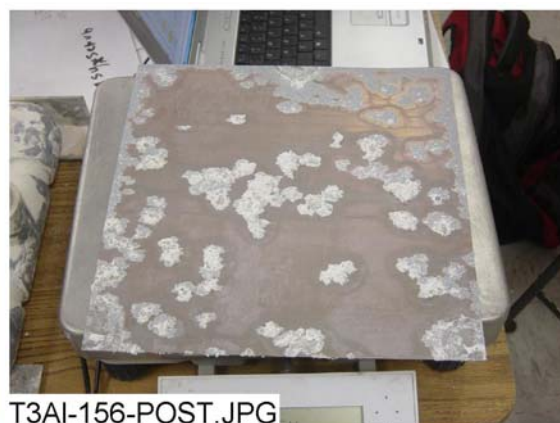
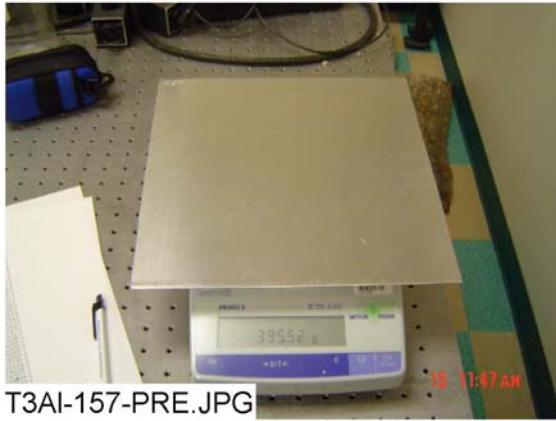
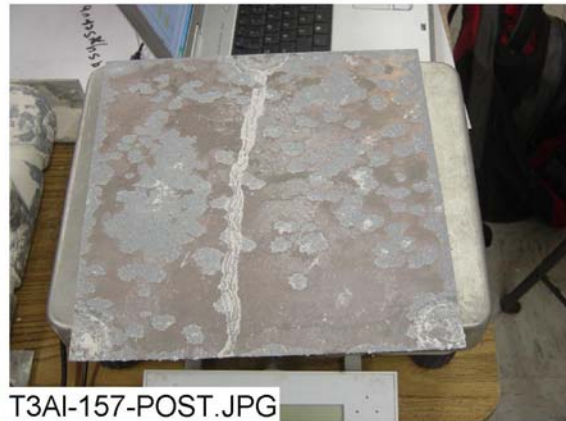
There are three submerged aluminum coupons in each test. Figures 3-80 through 3-85 display the pre- and post-test pictures of those coupons that were in Test #3. Each post-test aluminum coupon exhibits a pattern of white particulate deposition. In addition, each post-test coupon is a light reddish-brown, which may be attributable to copper's leaching into the test solution. The particulate deposition patterns for post-test aluminum coupons 155 and 156 are similar. However, the deposition pattern for the post-test Al-157 possesses a grayish tint, and a stream of white deposition runs from the rack contact point at the top to the bottom of the coupon. The relative spatial location of these coupons, given in order from the west side of the tank to the east side of the tank, is as follows: Al-155, Al-156, and Al-157. The concentration of particles increases slightly from the western-most coupon to the eastern-most coupon.

Figure 3-80. Al-155, submerged, pre-test.

Figure 3-81. Al-155, submerged, post-test.

Figure 3-82. Al-156, submerged, pre-test.

Figure 3-83. Al-156 submerged, post-test.

Figure 3-84. Al-157, submerged, pre-test.

Figure 3-85. Al-157, submerged, post-test.

According to SEM/EDS results, the dominant corrosion products on the submerged Al coupons are likely aluminum hydroxide with other substances containing Si, Ca, and O. For submerged Cu coupons, the possible corrosion products include CuO , $\text{Cu}_2(\text{CO}_3)(\text{OH})_2$, and substances containing Ca, Si, and O. For the submerged galvanized steel coupons, the possible corrosion products are phosphate, silicate, and carbonate compounds of Zn and Ca. For the submerged steel coupons, the possible corrosion products include phosphate, silicate, and carbonate compounds of Fe and Ca and compounds composed of Fe, Al, Si, Ca, P, and O.

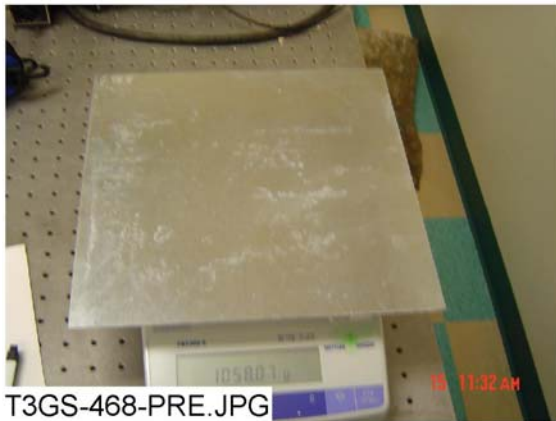
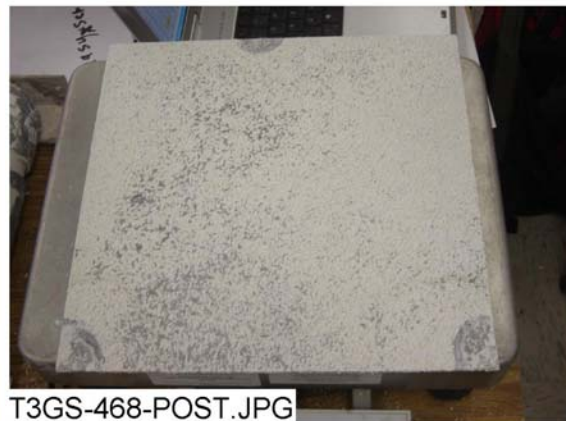
The galvanized steel coupons exhibited nearly identical patterns of dense gray particle deposition. Figures 3-86 and 3-87 present the pre- and post-test pictures of one submerged galvanized steel coupon. There were no observable differences in post-test appearance based on the coupon's location in the rack.

Figure 3-86. GS-468, submerged, pre-test.

Figure 3-87. GS-468, submerged, post-test.

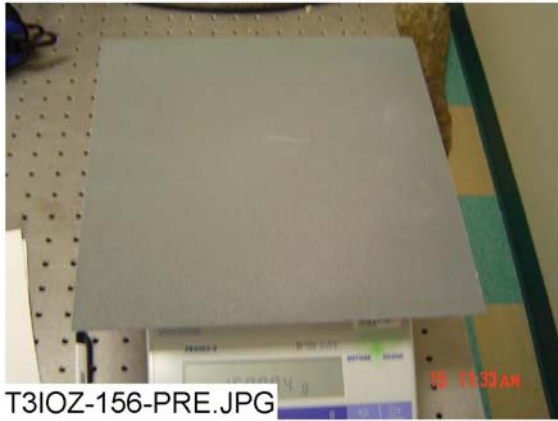
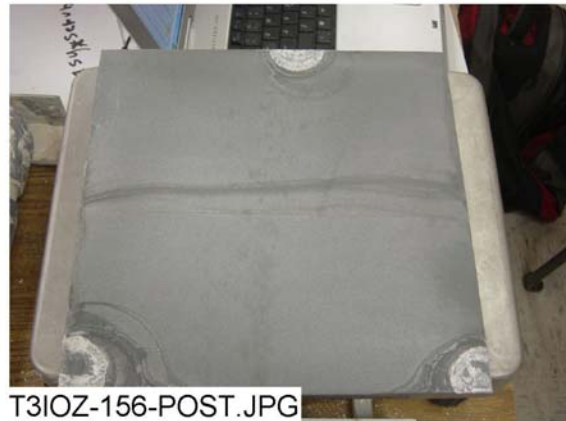
Figures 3-88 and 3-89 present the pre- and post-test pictures of a typical submerged IOZ-coated steel coupon. Each post-test coated steel coupon exhibited a similar pattern of white particle deposition.

Figure 3-88. IOZ-156, submerged, pre-test.

Figure 3-89. IOZ-156, submerged, post-test.

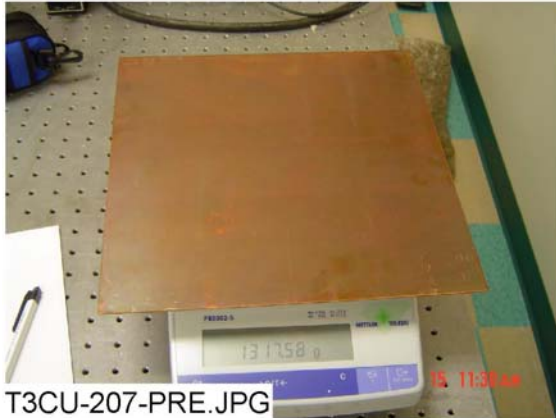
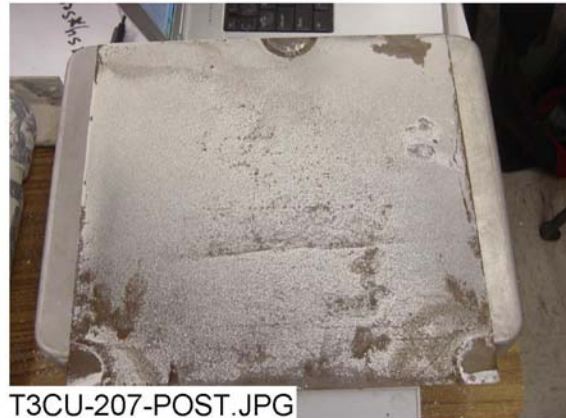
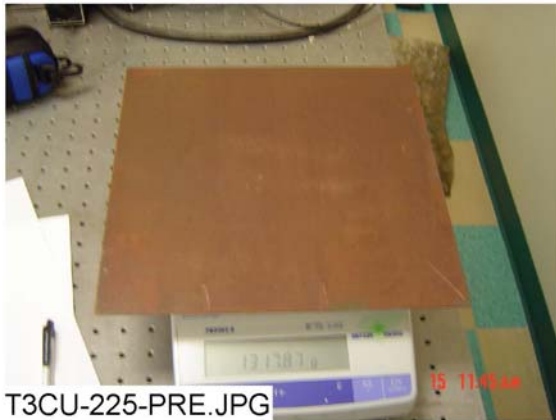
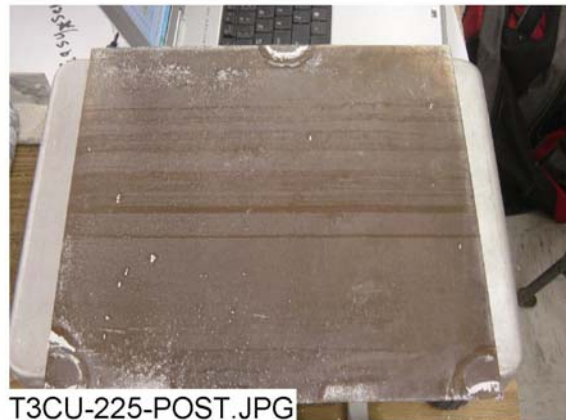
Figures 3-90 through 3-93 present the pre- and post-test pictures of two submerged copper coupons. The patterns of white deposition are different for these post-test coupons. The CU-207 post-test coupon is almost completely covered with a dense collection of white deposits. The CU-225 post-test coupon, in contrast, exhibits faint horizontal streak-lines of white deposits. The CU-207 coupon was located on the west side of the tank in relation to the CU-225 coupon. The CU-207 coupon gained 1.2 g, while the CU-225 coupon lost 0.1 g.

Figure 3-90. CU-207 submerged, pre-test.

Figure 3-91. CU-207, submerged, post-test.

Figure 3-92. CU-225, submerged, pre-test.

Figure 3-93. CU-225, submerged, post-test.

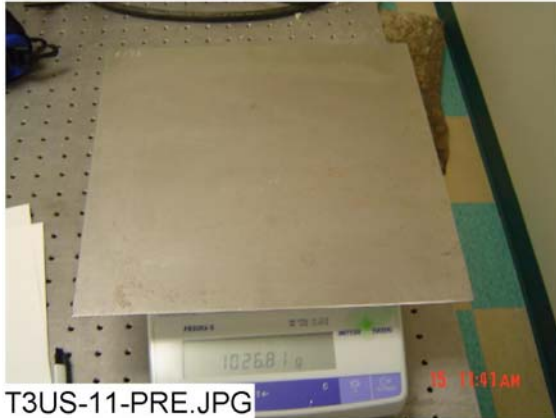
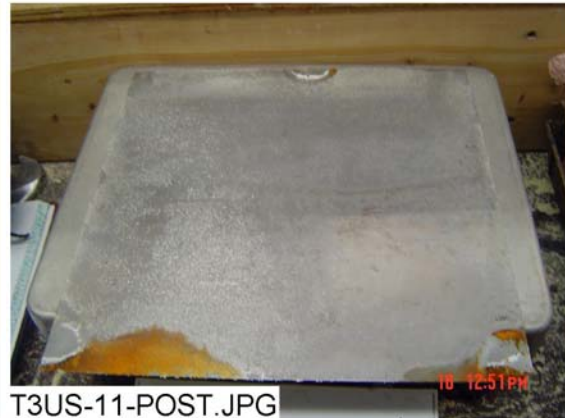
Figures 3-94 and 3-95 present the pre- and post-test pictures of the single submerged carbon steel coupon. It has a light coating of white deposits over a large portion of the surface area. Also, there is observable rust along the bottom edge of the coupon. The rust deposits are mainly congregated near the lower corners of the coupon, near the rack's contact points. Differences in corrosion or deposits at the location of the coupon rack contact points may have been due to stagnant solution conditions that may have limited mass transfer to or from the surface and caused local differences in solution composition. Coupon US-11 lost 1.1 g.

Figure 3-94. US-11, submerged, pre-test.

Figure 3-95. US-11, submerged, post-test.

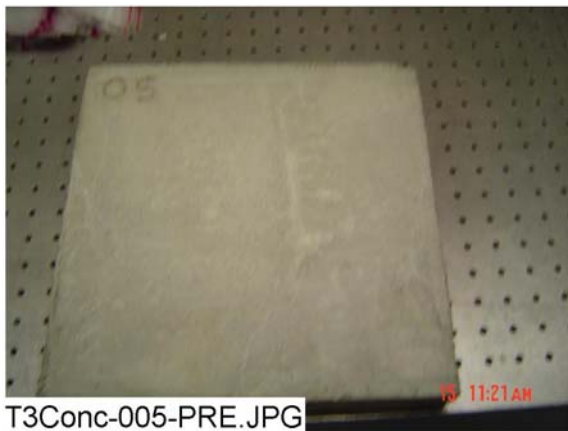
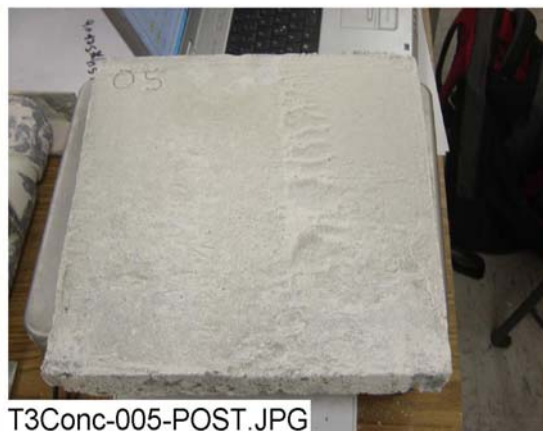
Figures 3-96 and 3-97 present the pre- and post-test pictures of the submerged concrete coupon. The post-test concrete coupon exhibits an enhanced gray compared with the pre-test coupon. The concrete coupon gained 180.5 g, which is estimated to be primarily water absorption.

Figure 3-96. Conc-005, submerged, pre-test.

Figure 3-97. Conc-005, submerged, post-test.

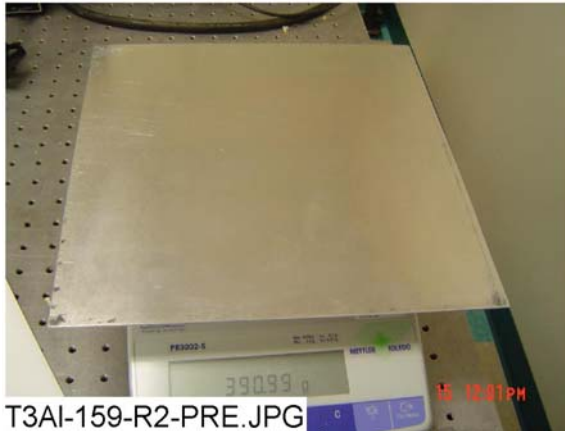
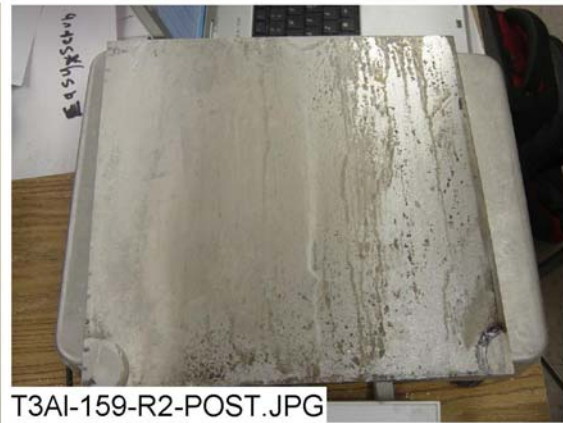
Figures 3-98 and 3-99 show the pre- and post-test pictures of a typical unsubmerged aluminum coupon. The coupons exhibit a light pattern of deposition. Also, each post-test coupon has coarser texture and a less-lustrous surface.

Figure 3-98. Al-159, unsubmerged, pre-test.

Figure 3-99. Al-159, unsubmerged, post-test.

According to SEM/EDS results, the dominant corrosion products on the unsubmerged Al coupons are likely aluminum hydroxide and/or aluminum oxide. For unsubmerged Cu, the corrosion products on the coupon surface are likely CuO and $\text{Cu}_2(\text{CO}_3)(\text{OH})_2$. ZnO and ZnCO_3 are likely the dominant corrosion products on the unsubmerged galvanized steel coupon surface. For the unsubmerged steel coupon, the likely corrosion products are Fe_2O_3 , $\text{Fe}(\text{OH})_3$, and $\text{Fe}_2(\text{CO}_3)_3$.

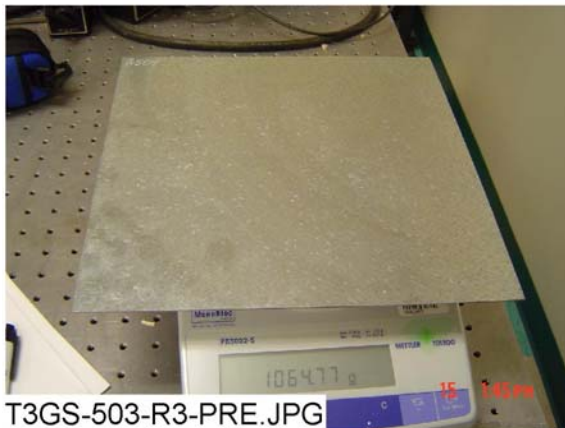
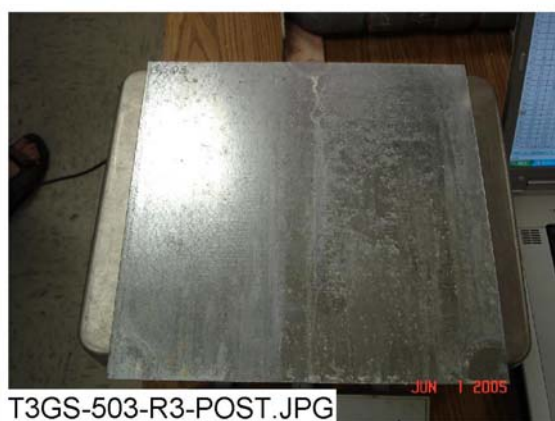
Figures 3-100 and 3-101 show the pre- and post-test pictures of a typical unsubmerged galvanized steel coupon. Each post-test galvanized steel coupon exhibited a similar light deposition.

Figure 3-100. GS-503, unsubmerged, pre-test.

Figure 3-101. GS-503, unsubmerged, post-test.

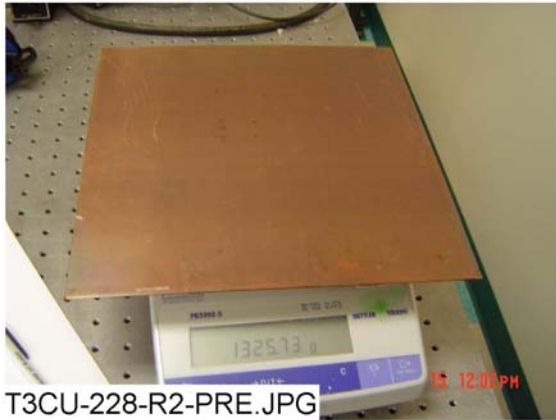
Figures 3-101 and 3-102 present the pre- and post-test pictures of a typical unsubmerged copper coupon. Each post-test copper coupon exhibited a similar pattern of streak-like deposition.

Figure 3-102. CU-228, unsubmerged, pre-test.

Figure 3-103. CU-228 unsubmerged, post-test.

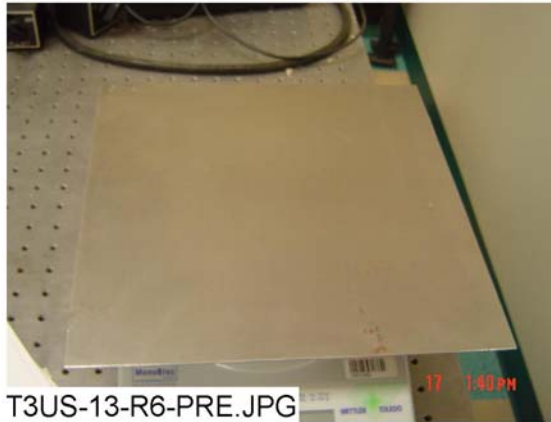
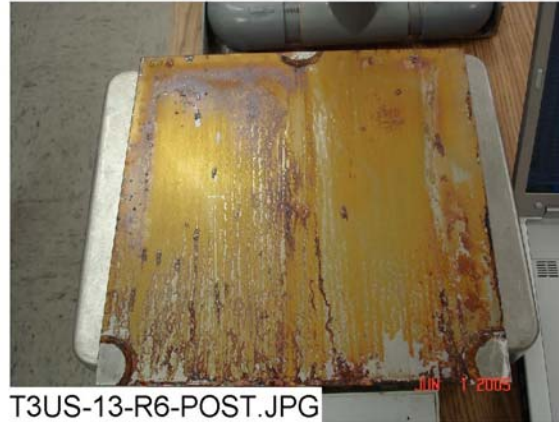
T3US-13-R6-PRE.JPG

Figures 3-106 and 3-107 present the pre- and post-test pictures of a typical unsubmerged carbon steel coupon. The post-test carbon steel coupons turned reddish-brown and exhibited slight corrosion around the edges.

Figure 3-106. US-13, unsubmerged, pre-test.

Figure 3-107. US-13, unsubmerged, post-test.

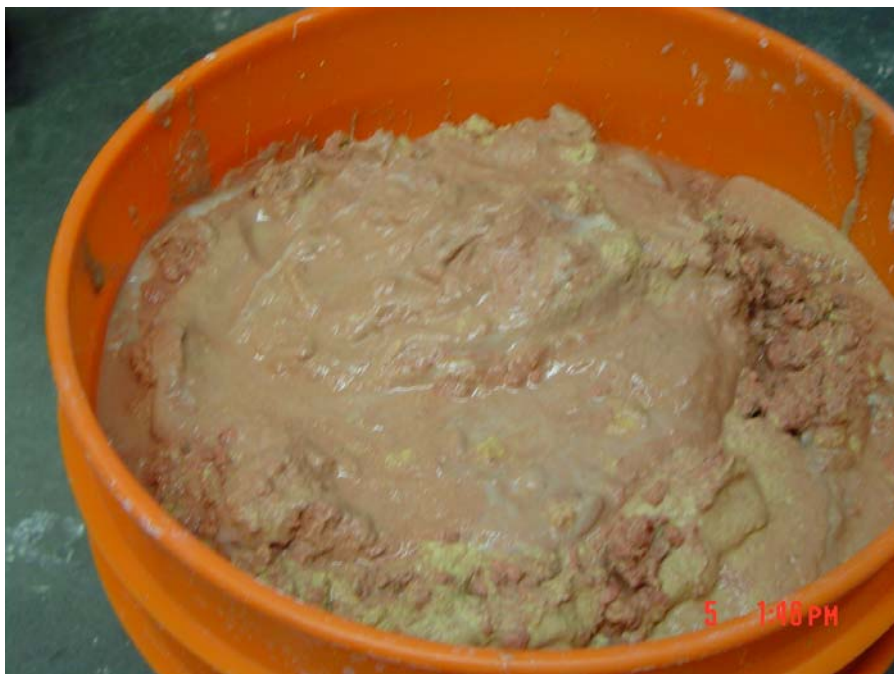
Figure 3-108. Sediment removed from the tank. Some gel appears on the top.

Sediment was collected from the tank bottom after the test solution was drained. It consisted of two main macroscopic quantities, a particulate sediment on the bottom covered in many places with a whitish-pink gel-like material. Figure 3-108 shows this sediment. In addition, Figure 3-109 shows SS mesh holding insulation samples after it was pulled from the tank bottom. The pink and yellow particulate sediment covers much of the mesh, and the gel-like material is seen above it and is being pointed to in the figure.

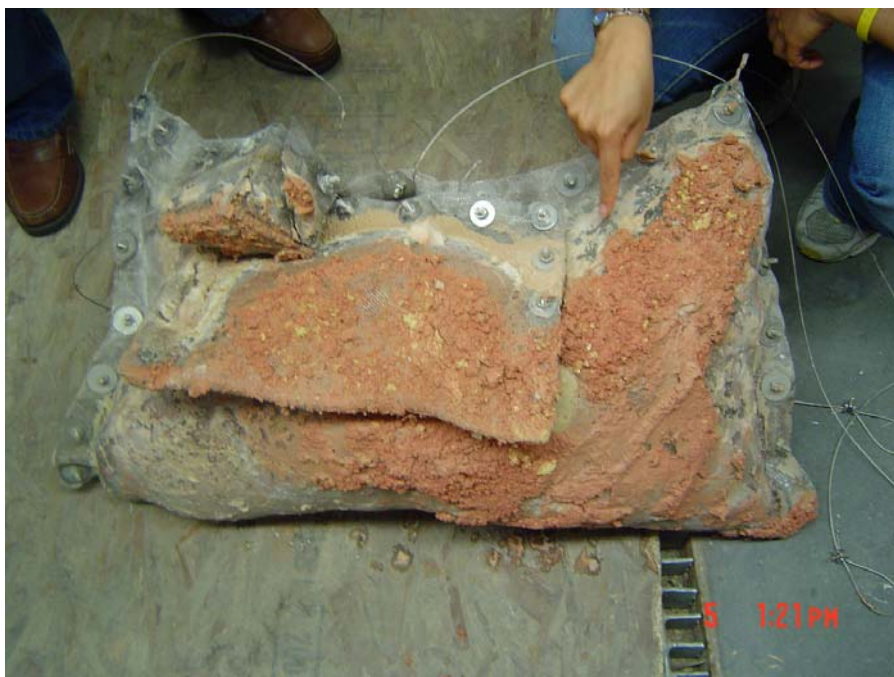
Figure 3-109. Samples removed from the tank bottom.

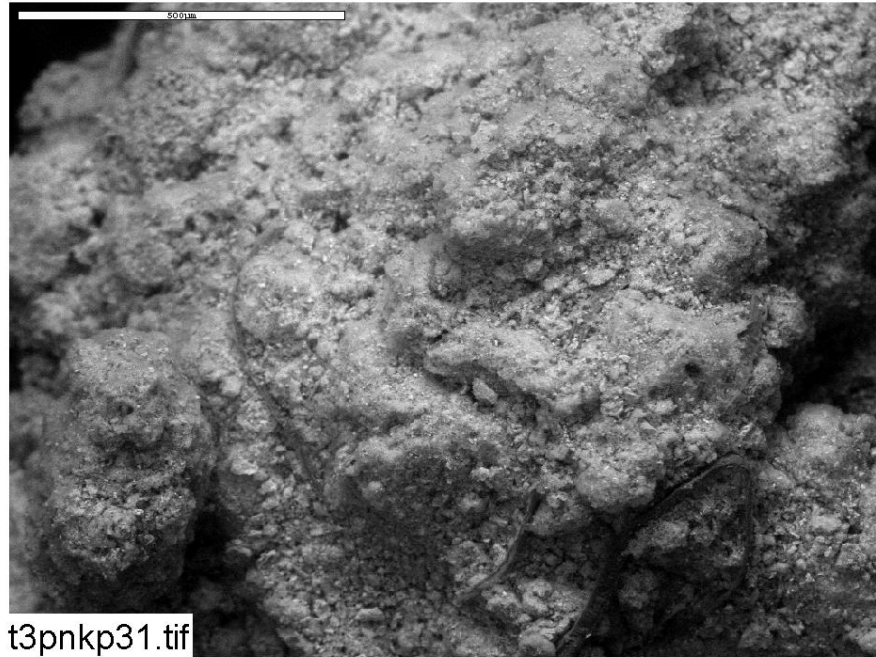
Figure 3-110. ESEM image of a Test #3 Day 30 pink sediment, magnified 100 times. (t3pnkp31, 5/6/05)

The particulate sediment samples were identified and classified by their color: pink or yellow. The yellow or pink sediments were large enough (pea-sized or larger) to be visually seen and picked up from the bulk sediment. The pink sediment likely originated from baked cal-sil debris and the yellow sediment from unbaked cal-sil debris. ESEM/EDS and XRD/XRF analysis provided the information on the morphology and composition of these sediments. EDS results show that there is no significant compositional difference between the yellow and pink sediments. Both contain significant amounts of Si, Ca, and O. XRF results consistently show that Si and Ca are the major elements in the mixed sediments. However, P (present in phosphorus pentoxide, P_2O_5) is less than 2% of the total mass, possibly because Test #3 precipitates containing P make up a smaller portion of the total debris than do particles originating from cal-sil.

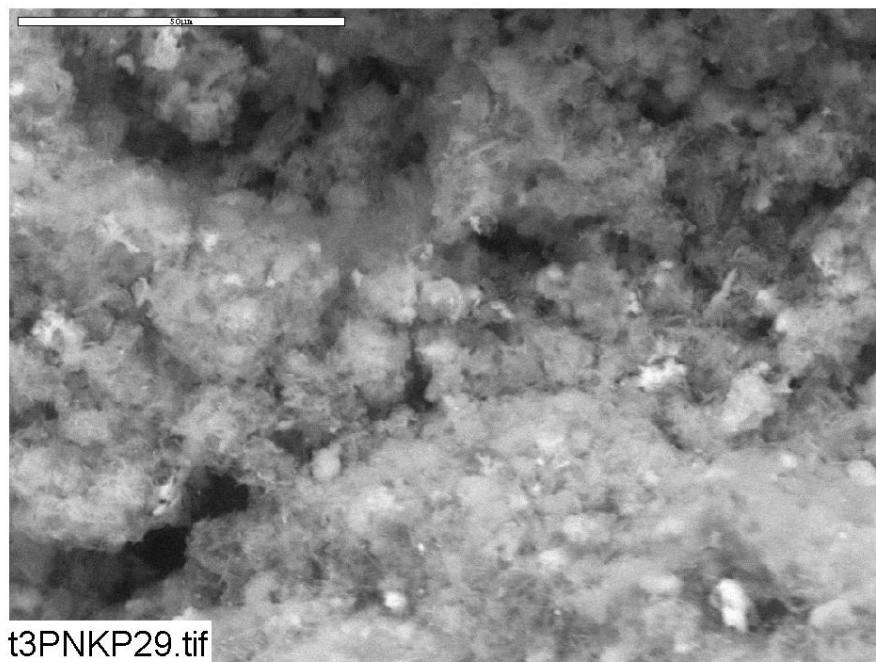
Table 3-111. ESEM image of a Test #3 Day 30 pink sediment, magnified 1000 times. (t3PNKP29, 5/6/05)

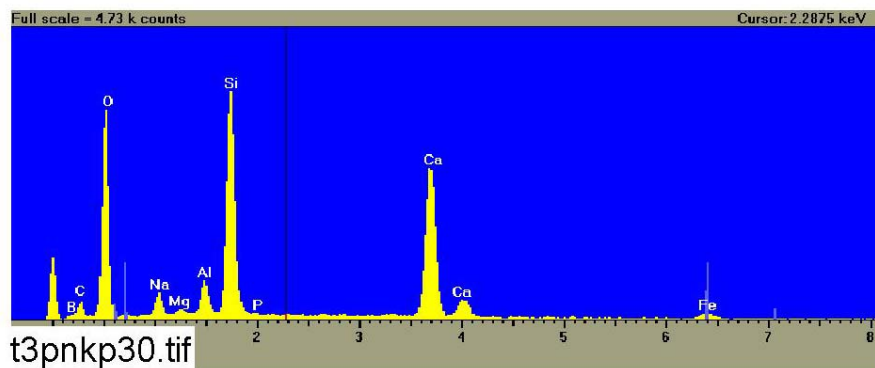
Table 3-112. EDS counting spectrum for the sediment shown in Figure 3-111. (t3pnkp30, 5/6/05)

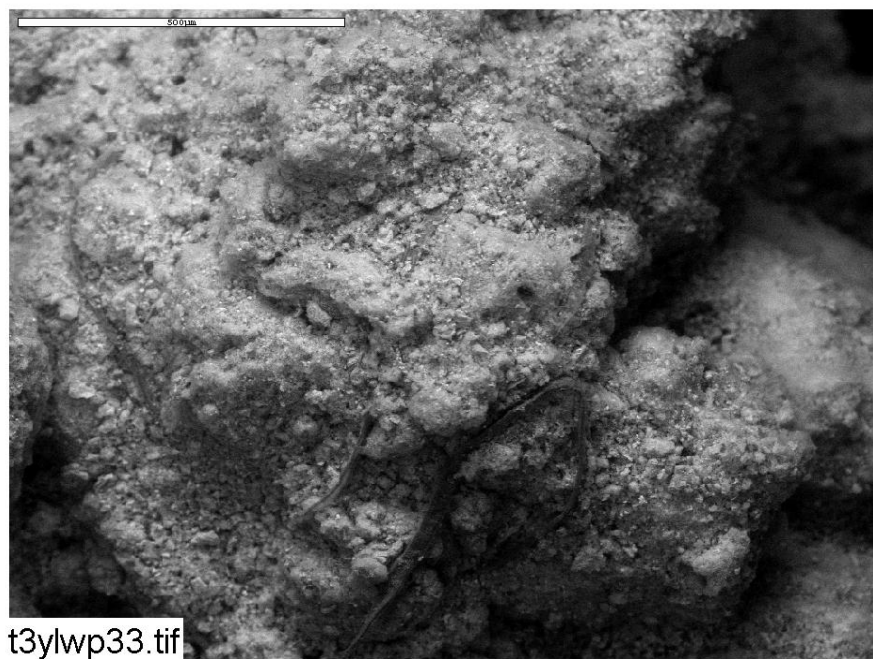
Figure 3-113. ESEM image of a Test #3 Day 30 yellow sediment, magnified 100 times. (t3ylwp33, 5/6/05)

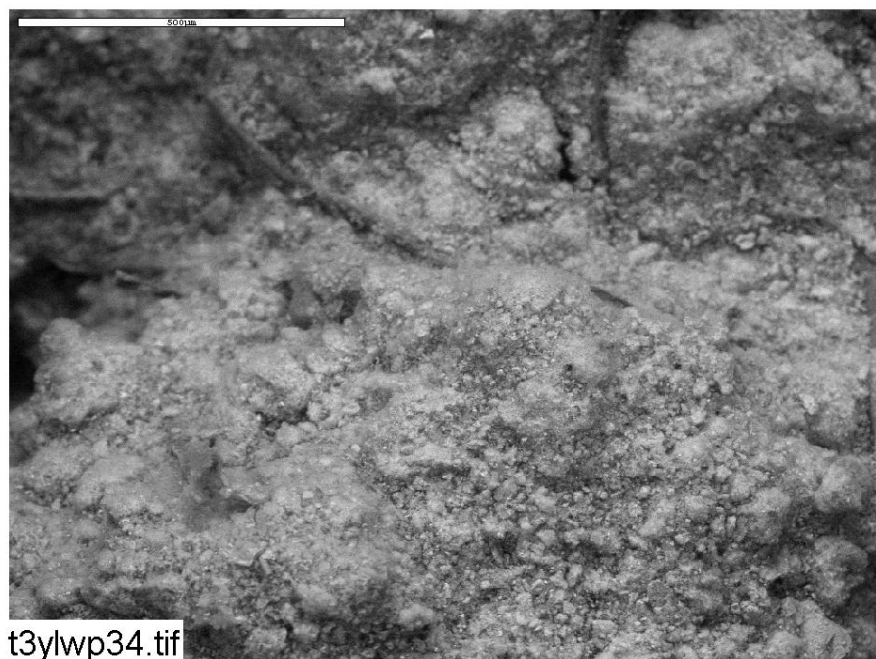
Figure 3-114. ESEM image of a Test #3 Day 30 yellow sediment, magnified 100 times. (t3ylwp34, 5/6/05)

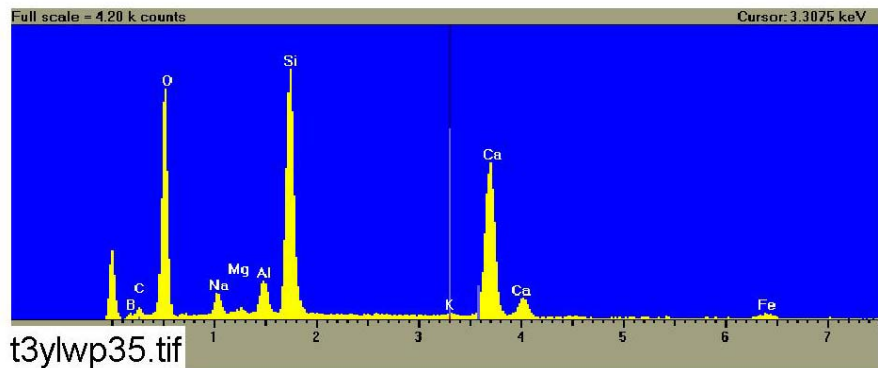
Figure 3-115. EDS counting spectrum for the particles shown in Figure 3-114. (t3ylwp35, 5/6/05)

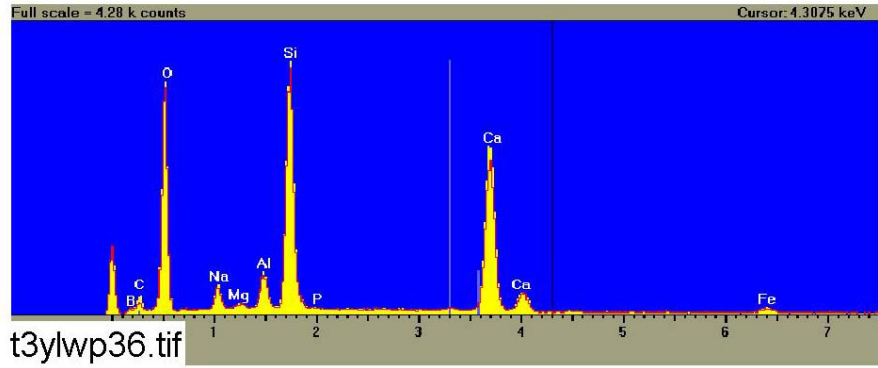
Figure 3-116. Comparison of EDS counting spectra for pink sediment (yellow, t3pnkp30) and yellow sediment (red, t3ylwp35). (t3ylwp36, 5/6/05)

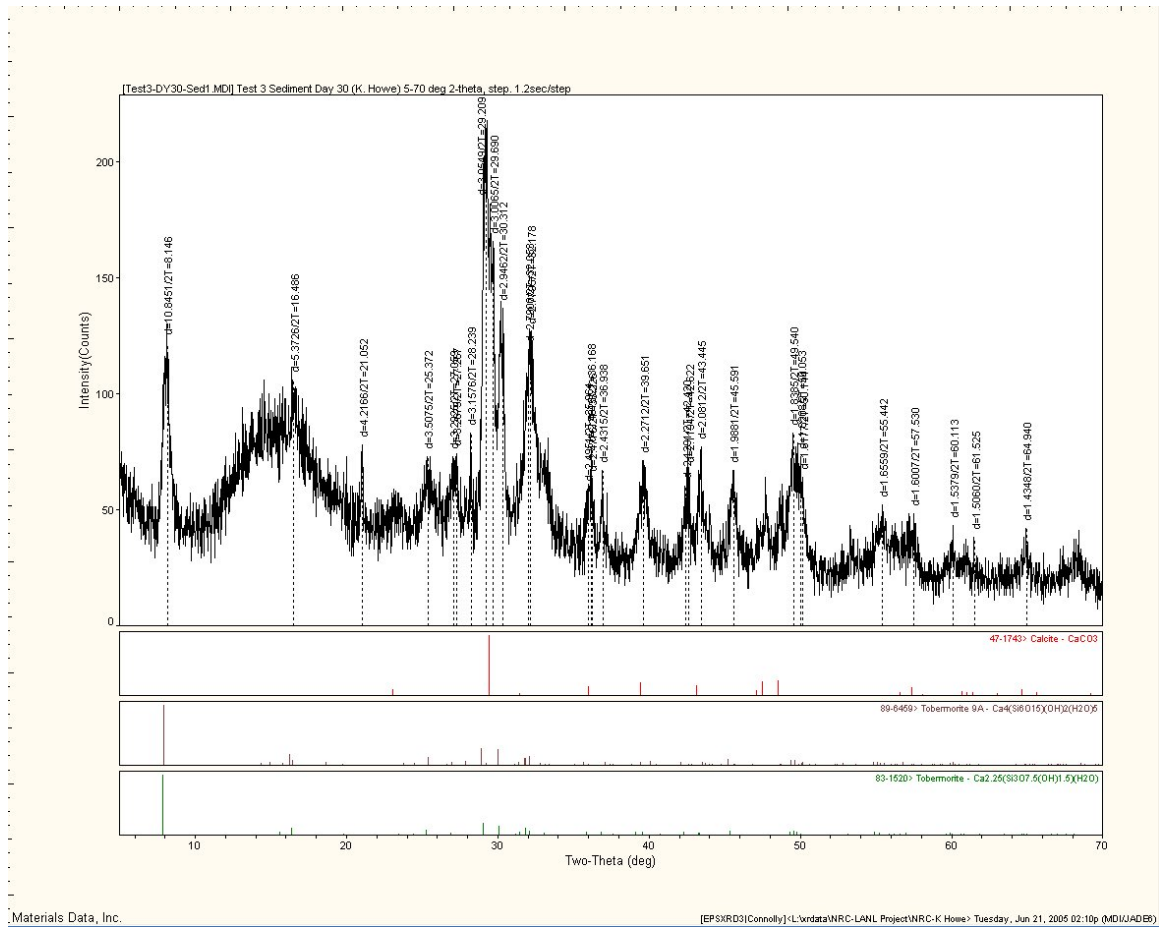
Figure 3-117. XRD results for Test #3 Day 30 mixed sediment.
