Integrated Chemical Effects Test Project: Test #3 Data Report

Los Alamos National Laboratory

**U.S. Nuclear Regulatory Commission
Office of Nuclear Regulatory Research
Washington, DC 20555-0001**

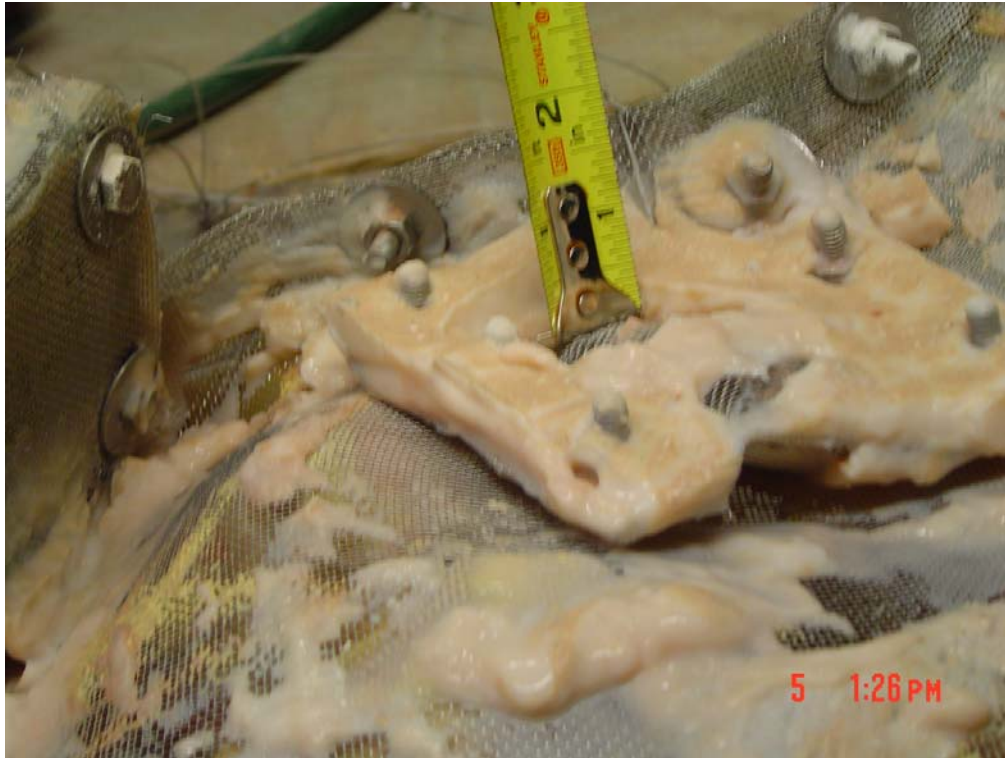
Figure 3-118. Gel-like material covering stainless steel mesh on the bottom of the test tank.

In ICET Test #3, one significant phenomenon is the presence of white gel-like precipitates in the test solution, especially during and after the injection of TSP on the first day of the test. When Test #3 was shut down, deposits of the pinkish-white gel-like precipitates were observed on the top of the birdcage and on other objects on the tank's bottom. Figures 3-118 and 3-119 show the gel-like precipitates.

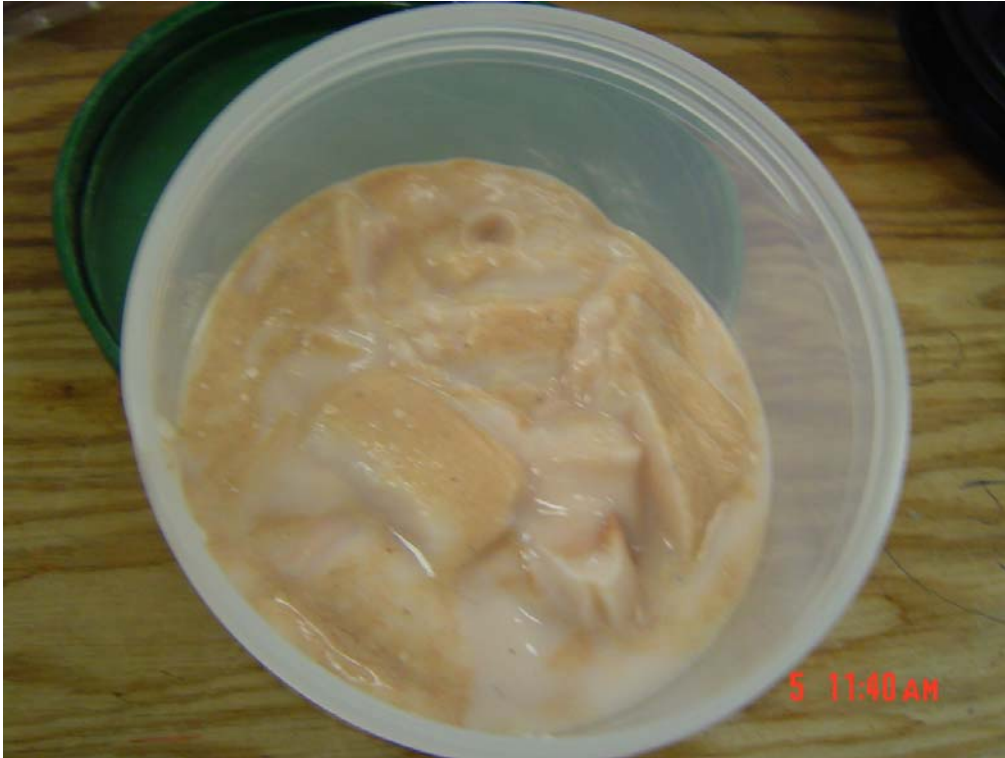
Figure 3-119. Gel-like material recovered from the bottom of the test tank.

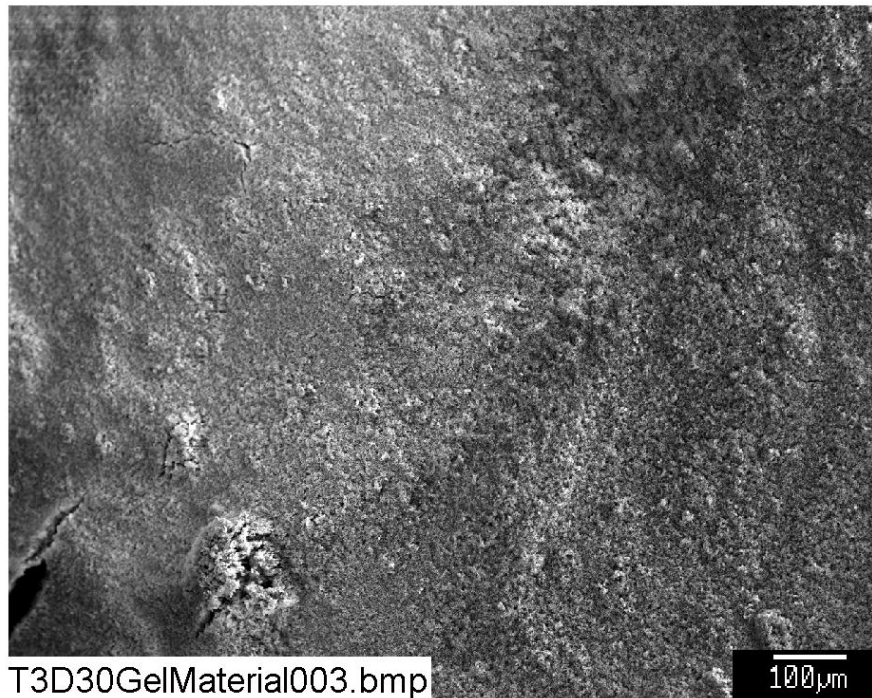
Figure 3-120. SEM image of a Test #3 Day 30 white gel-like material from the top of the birdcage, magnified 100 times. (T3D30GelMaterial003, 5/9/05)

Figures 3-120 through 3-126, Table 3-7, and Table 3-8 provide SEM/ESEM/EDS and XRD/XRF analysis results. The complete set of Day 30 gel analyses is contained in Appendix G.

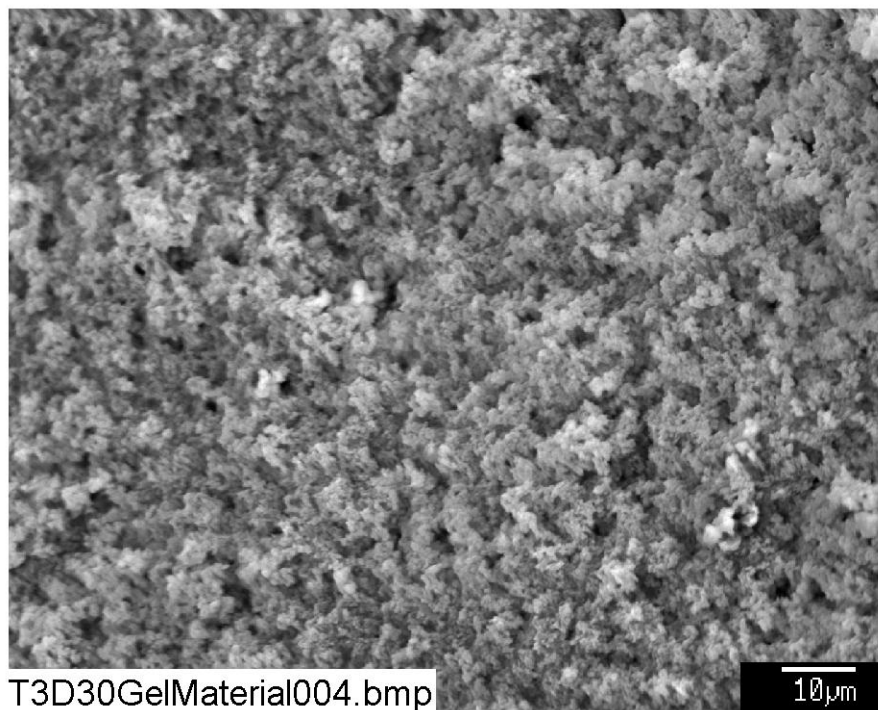
Figure 3-121. SEM image of a Test #3 Day 30 white gel-like material from the top of the birdcage, magnified 1000 times. (T3D30GelMaterial004, 5/9/05)

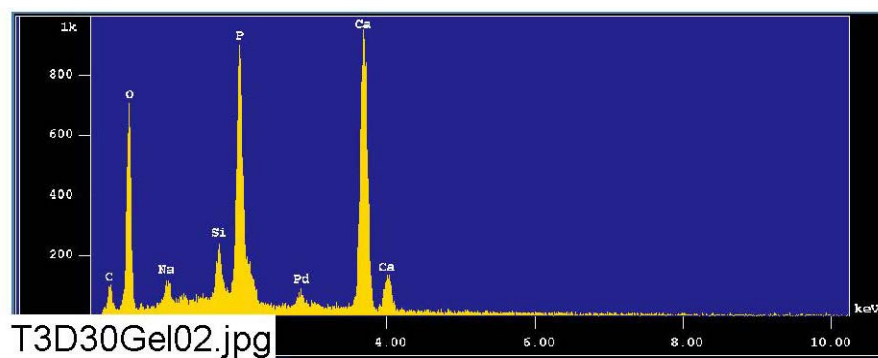
Figure 3-122. EDS counting spectrum for the white, gel-like material (whole image) shown in Figure 3-121. (T3D30Gel02, 5/9/05)

The results from the chemical composition analysis for Figure 3-122 are given in Table 3-7.

Element	Mass%	Atomic%	ZAF	Z	A	F
C	4.355	7.8616	3.7318	1.0194	3.6611	0.9999
O	45.521	61.6928	1.9361	0.9721	1.9917	1.0000
Na	1.639	1.5456	1.4989	1.0256	1.4614	1.0000
Si	2.072	1.5994	1.1451	0.9756	1.1812	0.9937
P	13.776	9.6435	0.8415	1.1708	0.7203	0.9978
Ca	32.638	17.6571	0.9890	0.9947	0.9943	1.0000

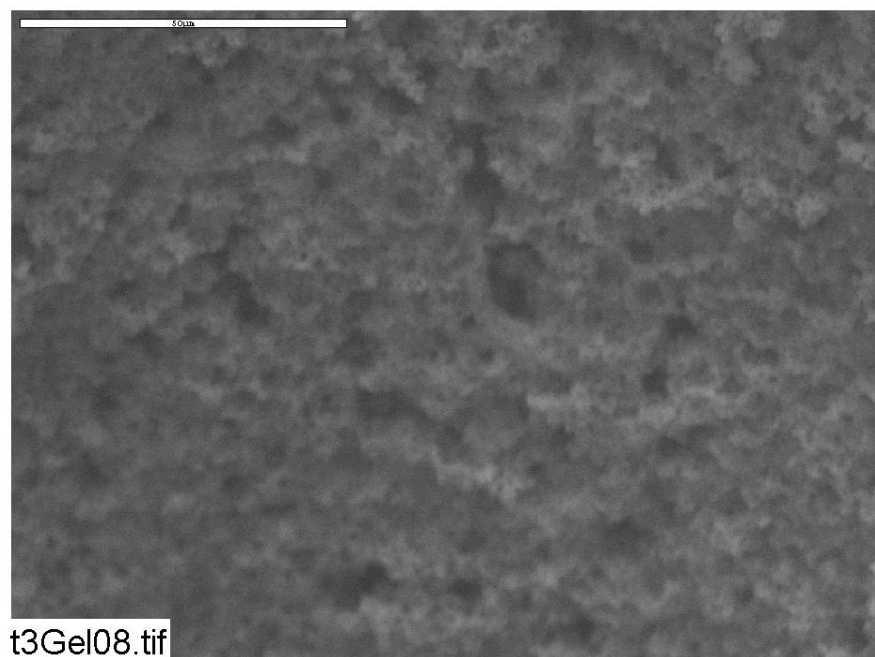
Figure 3-123. ESEM image of a Test #3 Day 30 white gel-like material from the top of the birdcage, magnified 1000 times. (t3Gel08, 5/6/05)

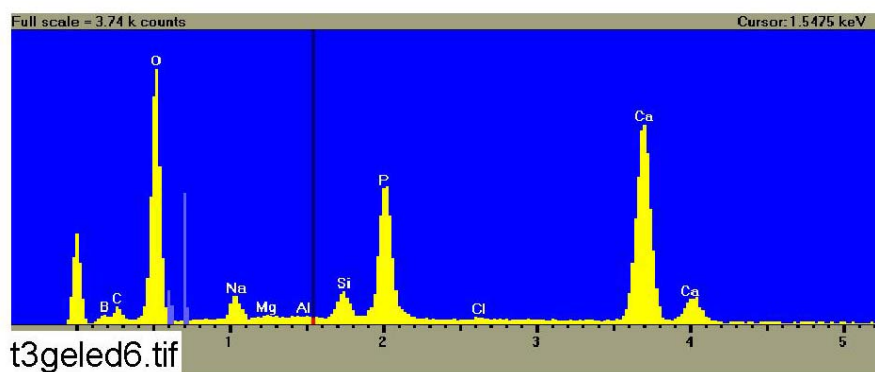
Figure 3-124. EDS counting spectrum for the white, gel-like material shown in Figure 3-123. (t3geled6, 5/6/05)

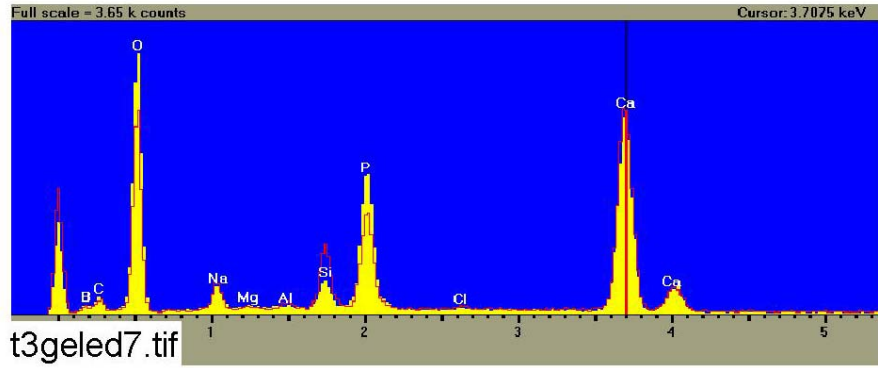
Figure 3-125. Comparison of EDS counting spectra for Figure 3-124 (yellow: the gel-like materials shown in figure 3-123) and Figure 3-73 (red: the large deposits taken from the birdcage exterior shown in Figure 3-72). (t3geled7, 5/6/05)

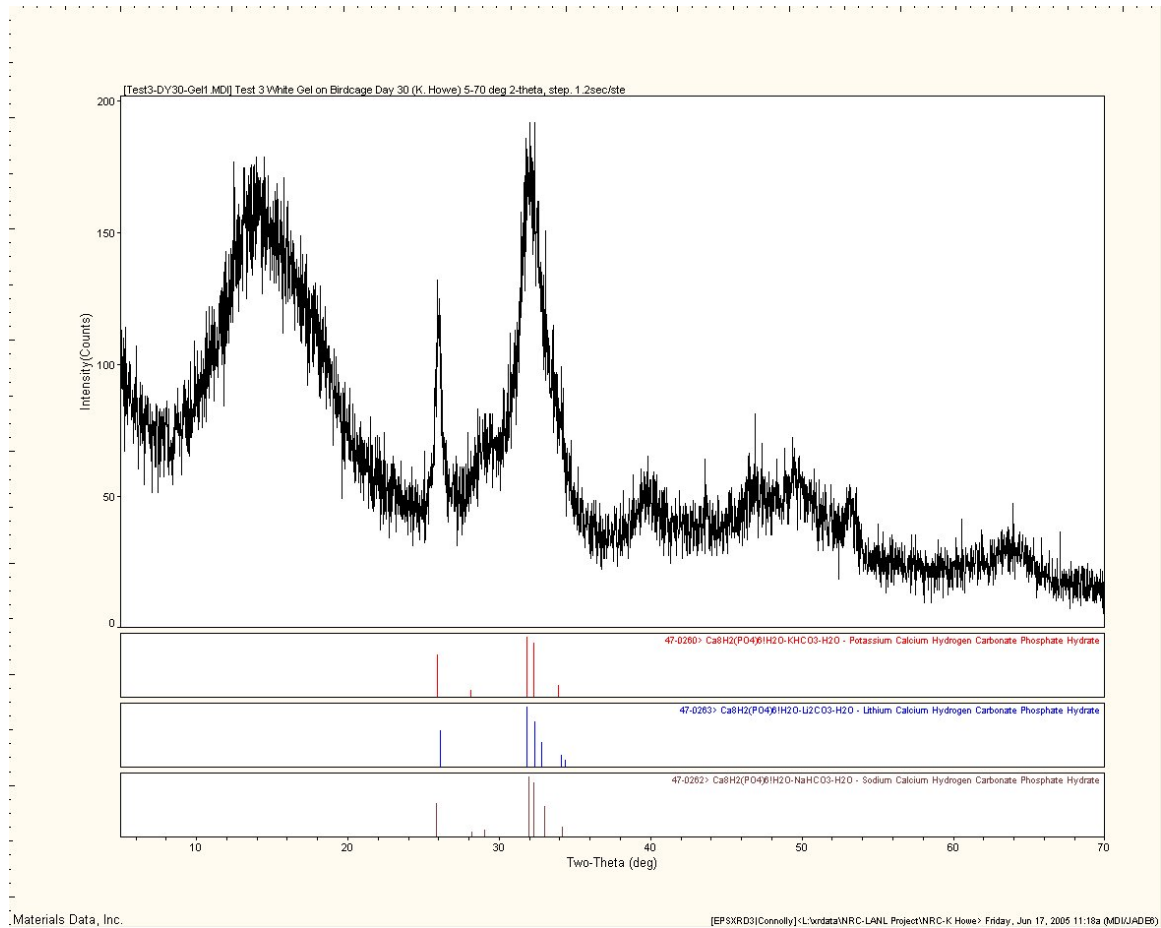
Figure 3-126. XRD results for a Test #3 Day 30 white, gel-like sample.
