Appendix B2

ESEM/EDS and SEM/EDS Data for Test #3 Day-15 Fiberglass in Low-Flow Zones

This appendix shows the ESEM/probe SEM/EDS results on ICET Test #3 Day-15 low-flow zone fiberglass samples. The samples were obtained on April 20, 2005 (15th day of Test #3). Both exterior and interior locations of the fiberglass samples were examined. For probe SEM examination, the fiberglass samples were dried in air at room temperature followed by being coated with Au/Pd. Available logbook entries for this laboratory session are included in this appendix as transcribed notes.

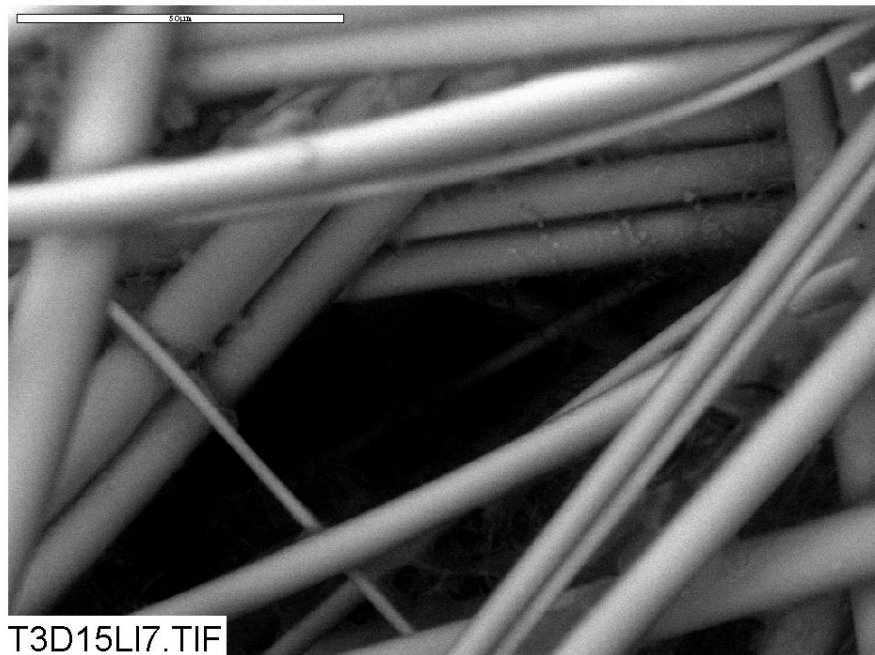
Figure B2-2: Environmental SEM image magnified 1000 times for a Test #3 Day-15 low-flow interior fiberglass sample. (T3D15LI7)

Image:	T3D15LI6	100 ×	Figure B2-1
	T3D15LI7	1000 ×	Figure B2-2
	T3D15LI8	1000 ×	Figure B2-3
EDS:	T3D15LIC	EDS on particles shown in T3D15LI8	Figure B2-4

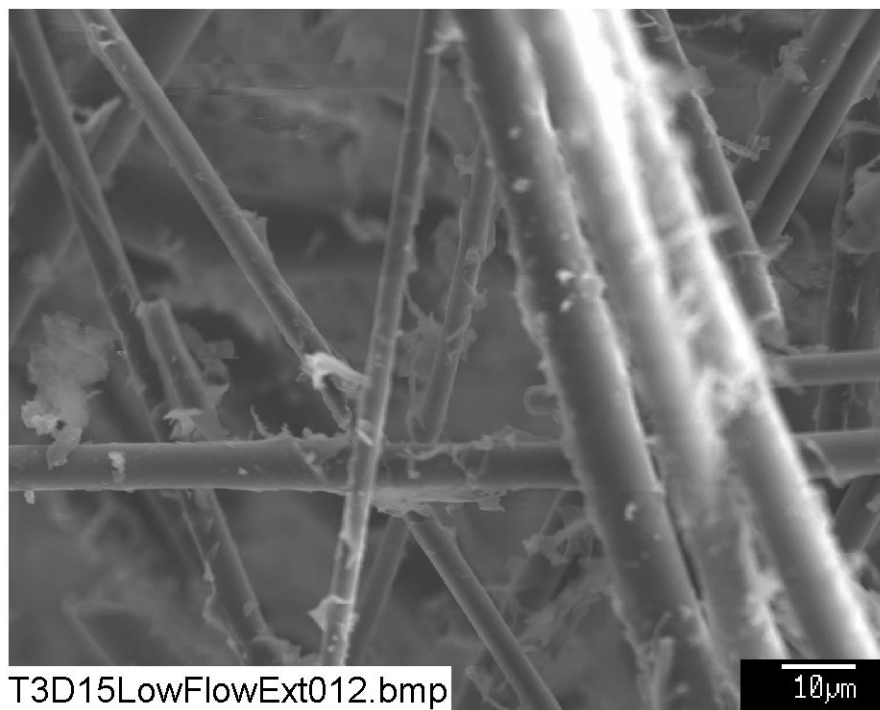
Figure B2-12: SEM image magnified 1000 times for a Test #3 Day-15 low-flow exterior fiberglass sample. (T3D15LowFlowExt012)

Image:	T3D15LowFlowExt011	100 ×	Figure B2-11
	T3D15LowFlowExt012	1000 ×	Figure B2-12
	T3D15LowFlowExt013	1000 ×	Figure B2-13
EDS:	T3D15LowFlowExtEDS3	EDS on particles shown in Ext007	Figure B2-14
