Palisades Nuclear Plant
Operated by Nuclear Management Company, LLC

Response to NRC Requests for Additional Information Relating to License Renewal
dated October 24, 2005

Enclosure 2
NMC Responses to NRC Requests for Additional Information (ML052980038)
dated October 24, 2005

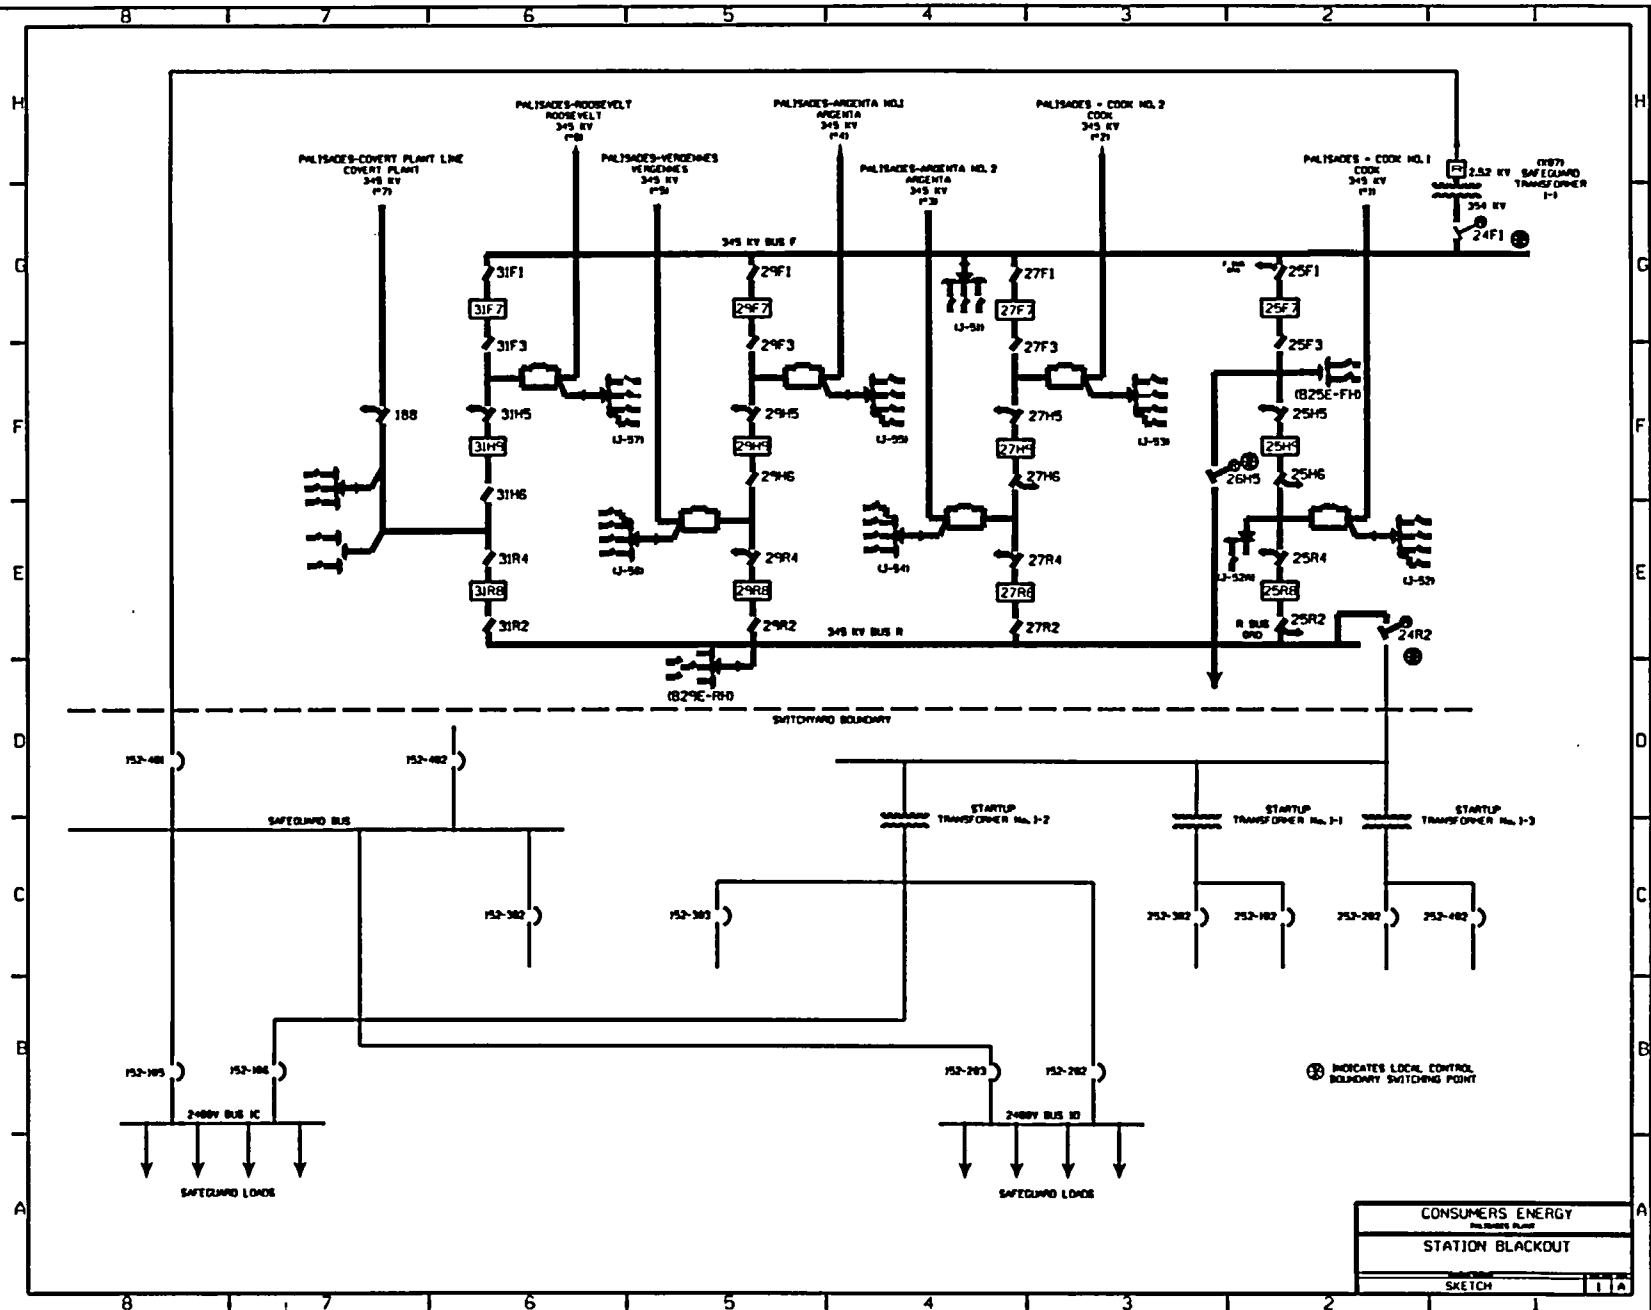
...StationBlackoutSketch.DGN 11/14/2005 9:32:11 AM

BLACK=TRANSMISSION SYSTEM
RED=STATION BLACKOUT

As noted in the NMC response to RAI 2.5-1, in a letter dated August 27, 2005, "The motor operated disconnects are normally closed and can be operated remotely or manually." For an SBO event recovery, the motor operated disconnects would not have to be operated. As discussed in the response to RAI 2.5.9-1 above, the connection of the transmission system with the plant electrical distribution systems are made through circuit breakers. However, even if MOD operation were desired because of some abnormal condition (e.g., if the SBO occurred with a transformer out of service for maintenance), the MOD can be manually operated in accordance with plant procedures. Therefore, battery cables and connections for the MODs are not required for MOD operation, so they do not meet any license renewal scoping criteria, and are not included in scope.
