Appendix C4

ESEM/EDS Data for Test #4 Day-30 Fiberglass in High-Flow Zones

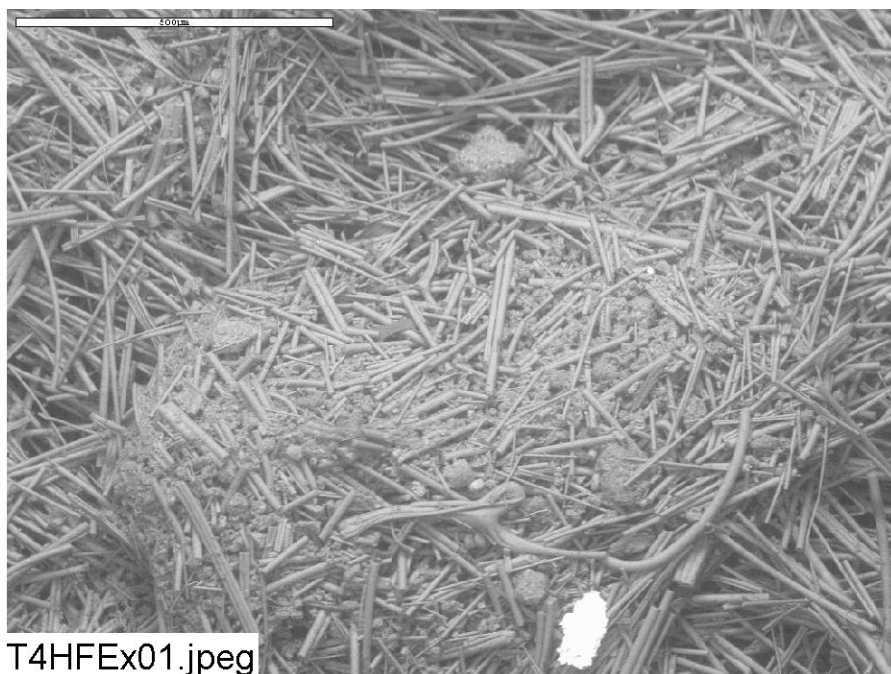
Figure C4-1: Environmental SEM image magnified 100 times for a Test #4 Day-30 exterior high-flow fiberglass sample. (T4HFEx01.jpg)

Image:	T4HFEx01	100 ×	ESEM image	Figure C4-1
	t4hfex02	100 ×	ESEM image	Figure C4-2
	t4hfex07	500 ×	ESEM image	Figure C4-3
	t4hfex06	800 ×	ESEM annotated image	Figure C4-4
EDS:	t4hfex05		Spot of film for t4hfex06	Figure C4-5

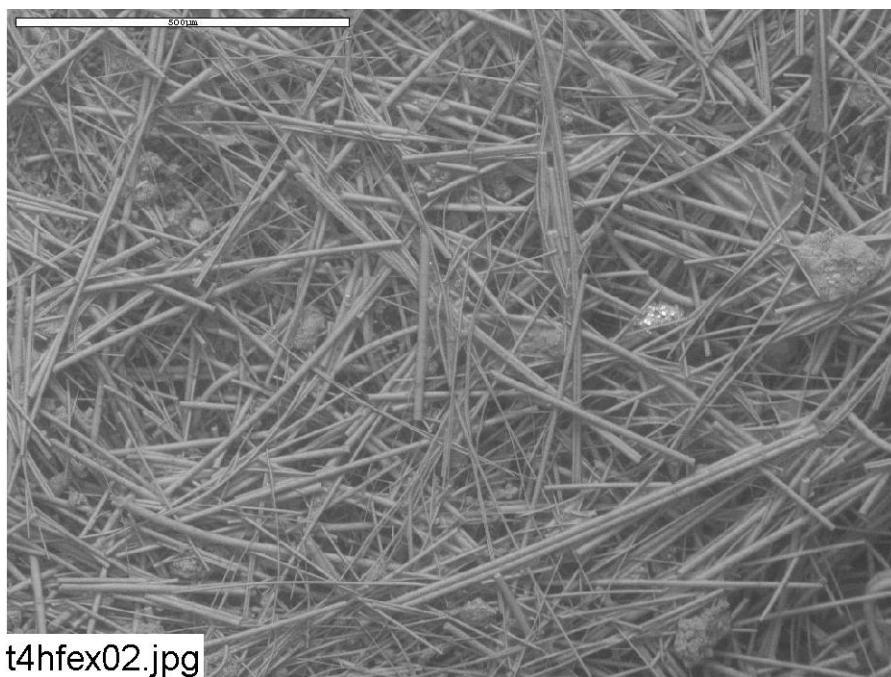
Figure C4-2: Environmental SEM image magnified 100 times for a Test #4 Day-30 exterior high-flow fiberglass sample. (t4hfex02.jpg)

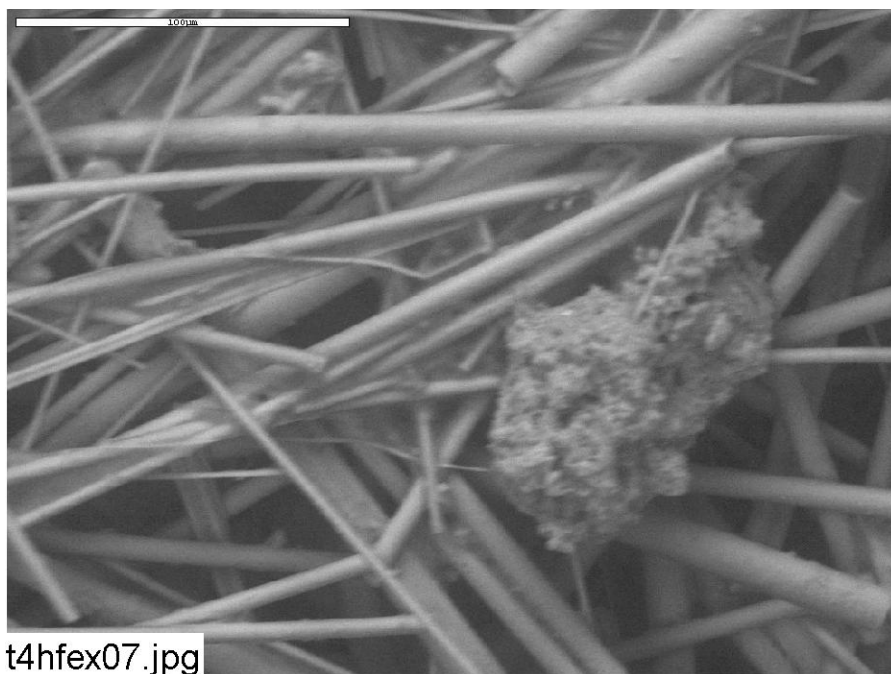
Figure C4-3: Environmental SEM image magnified 500 times for a Test #4 Day-30 exterior high-flow fiberglass sample. (t4hfex07.jpg)

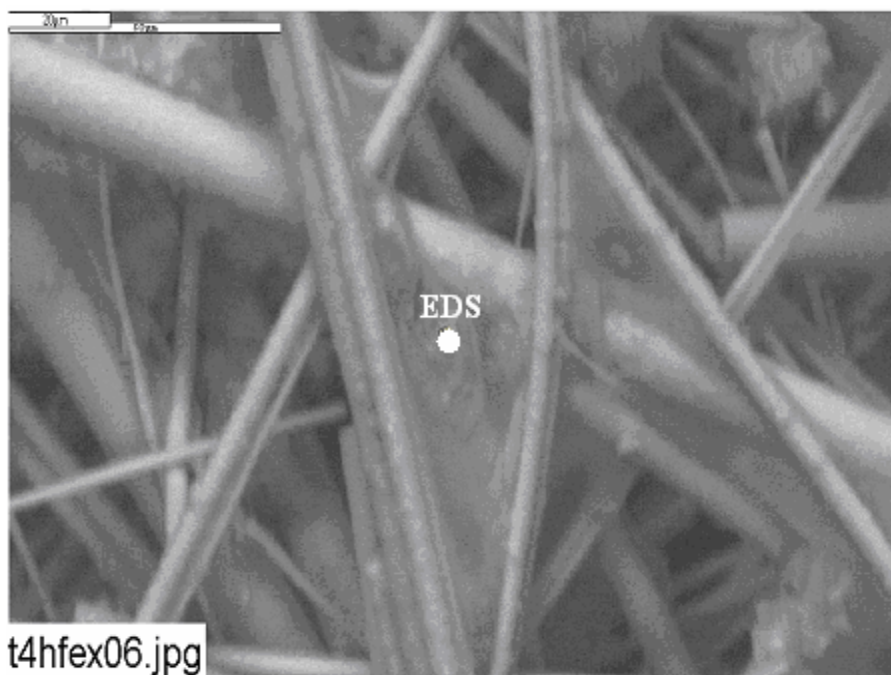
Figure C4-4: Annotated environmental SEM image magnified 800 times for a Test #4 Day-30 exterior high-flow fiberglass sample. EDS spot is shown in the picture. (t4hfex06.jpg)

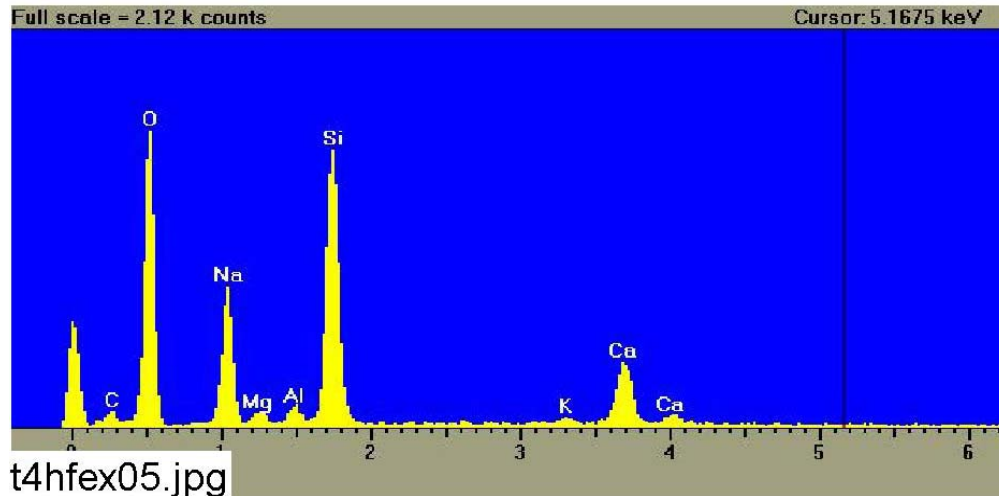
Figure C4-5: EDS counting spectrum for the spot of film between fibers shown in Figure C4-4. (t4hfex05.jpg)

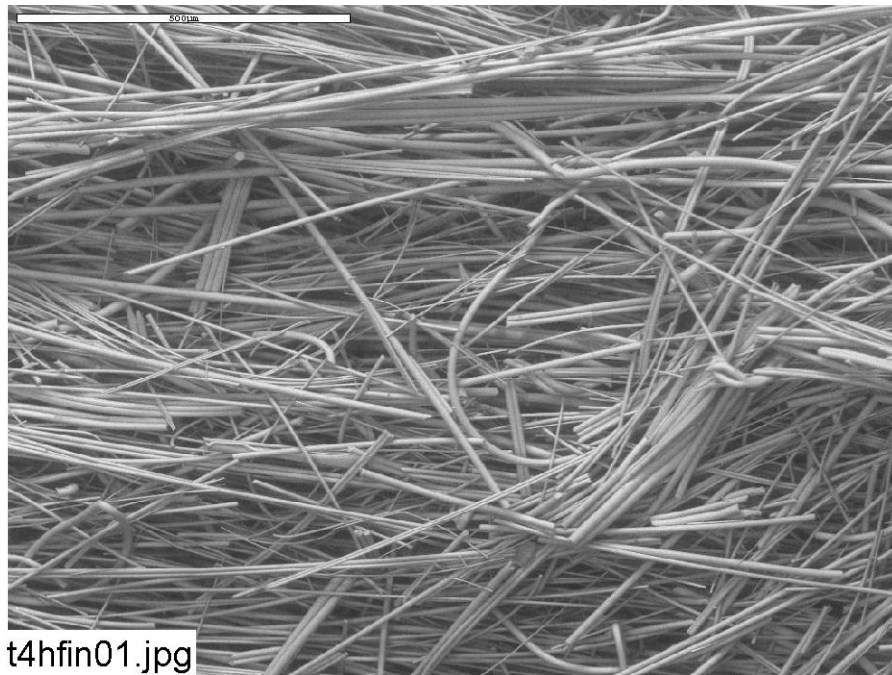
Figure C4-6: Environmental SEM image magnified 100 times for a Test #4 Day-30 interior high-flow fiberglass sample. (t4hfin01.jpg)

Image:	t4hfin01	100 ×	ESEM image of fiberglass	Figure C4-6
	t4hfin02	100 ×	ESEM image	Figure C4-7
	t4hfin03	500 ×	ESEM image high magnification	Figure C4-8
	t4hfin04	500 ×	ESEM image high magnification	Figure C4-9

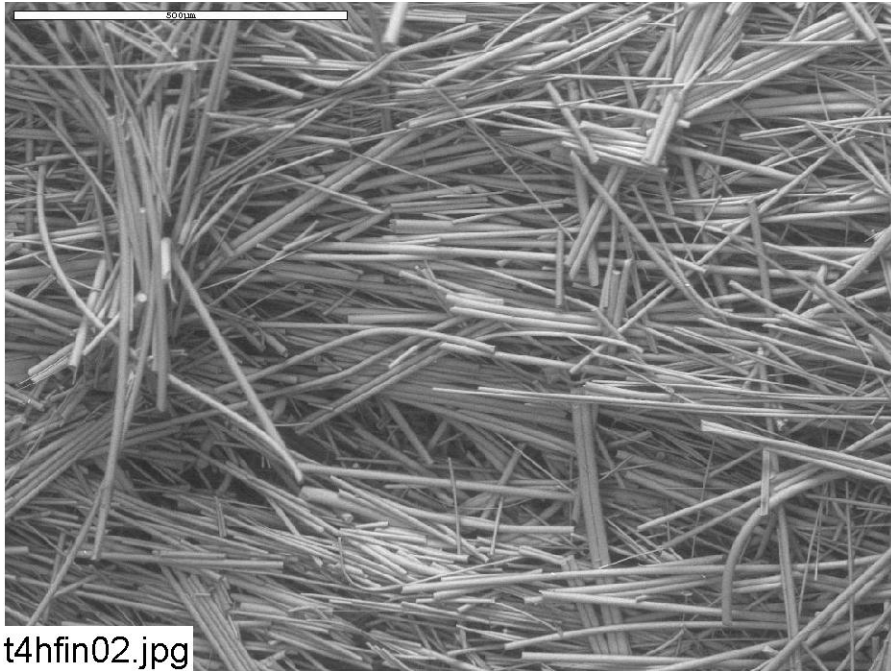
Figure C4-7: Environmental SEM image magnified 100 times for a Test #4 Day-30 interior high-flow fiberglass sample. (t4hfin02.jpg)

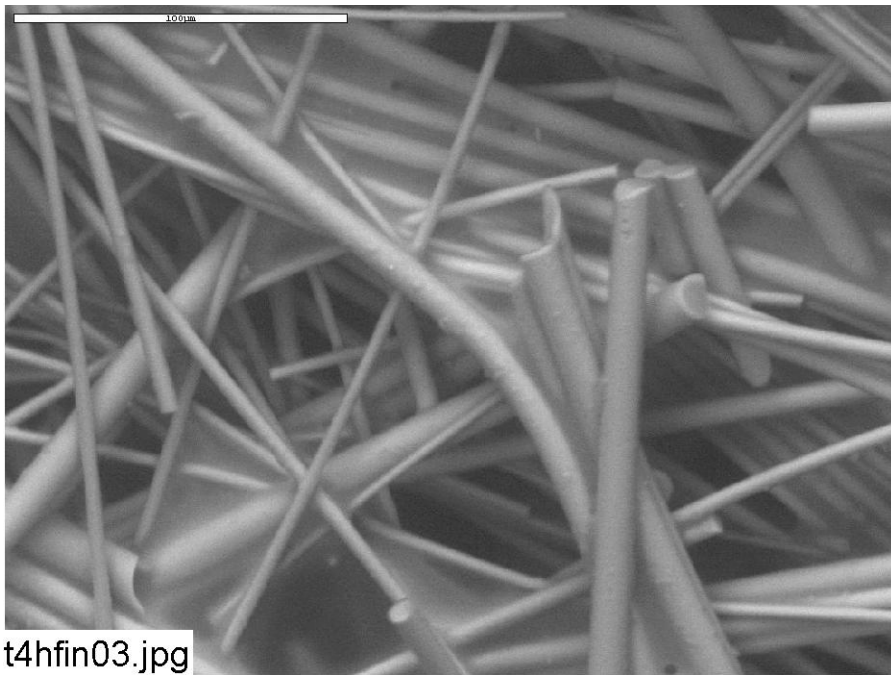
Figure C4-8: Environmental SEM image magnified 500 times for a Test #4 Day-30 interior high-flow fiberglass sample. (t4hfin03.jpg)

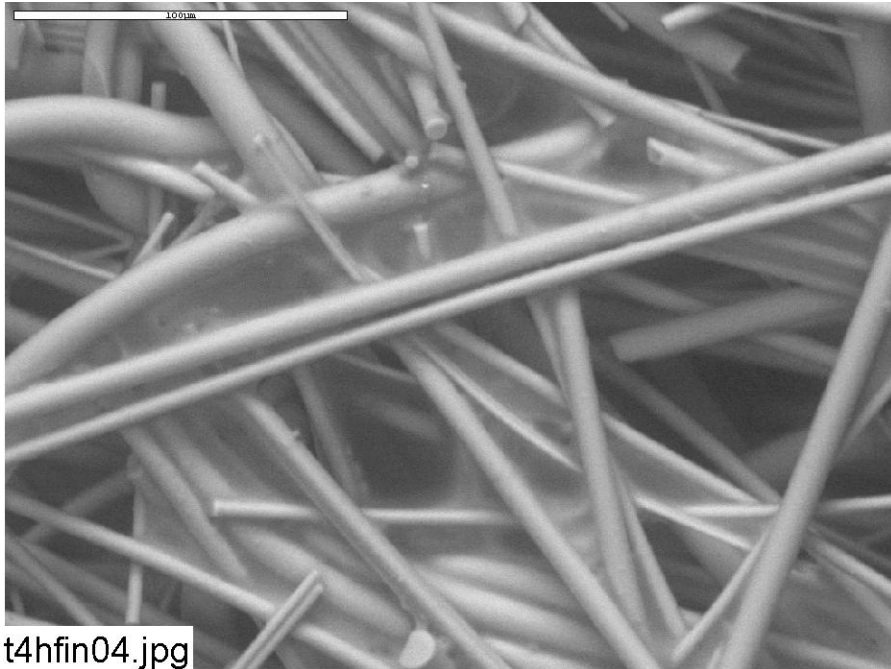
Figure C4-9: Environmental SEM image magnified 500 times for a Test #4 Day-30 interior high-flow fiberglass sample. (t4hfin04.jpg)

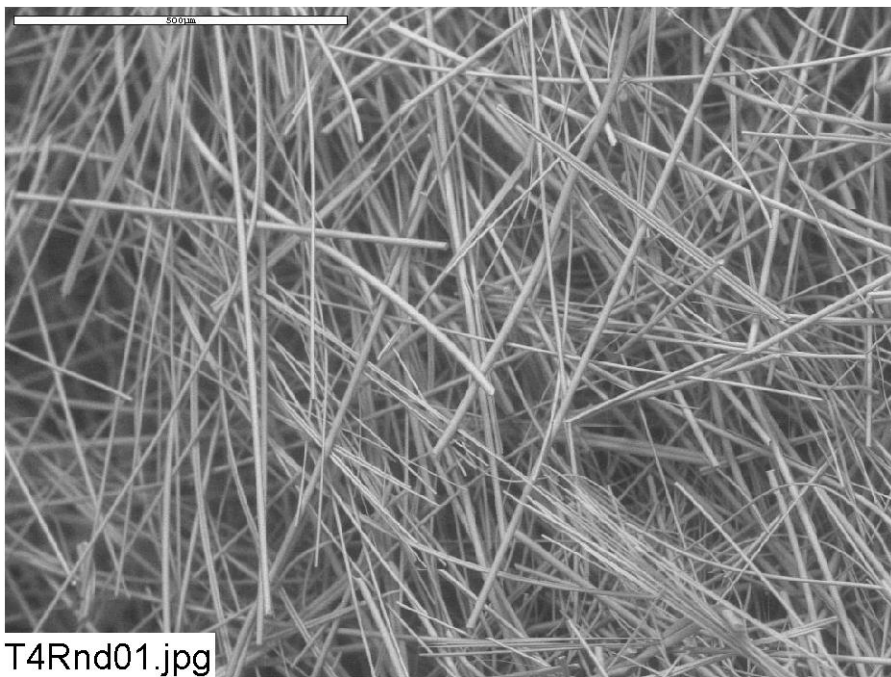
Figure C4-10: Environmental SEM image magnified 100 times for a Test #4 Day-30 interior high-flow fiberglass sample. The sample was gently pre-rinsed with RO water. (T4Rnd01.jpg)

Image:	T4Rnd01	100 ×	ESEM image	Figure C4-10
	t4rnd02	100 ×	ESEM image	Figure C4-11
	t4rnd03	500 ×	ESEM image	Figure C4-12
	t4rnd04	500 ×	ESEM image	Figure C4-13
	t4rnd05	500 ×	ESEM image	Figure C4-14
	t4rnd06	500 ×	ESEM image	Figure C4-15

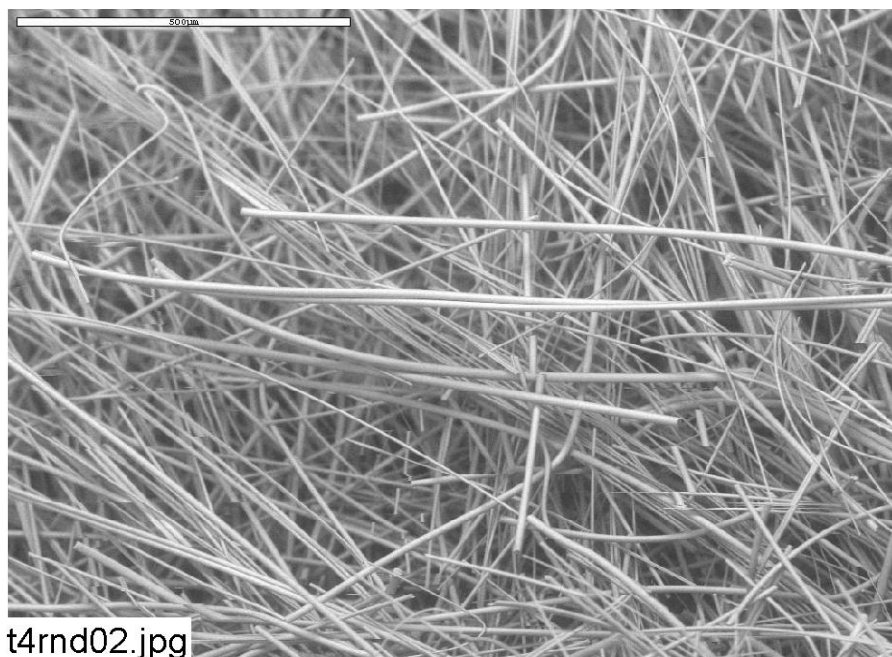
**Figure C4-11: Environmental SEM image magnified 100 times for a Test #4 Day-30 interior high-flow fiberglass sample. The sample was gently pre-rinsed with RO water.
(t4rnd02.jpg)**

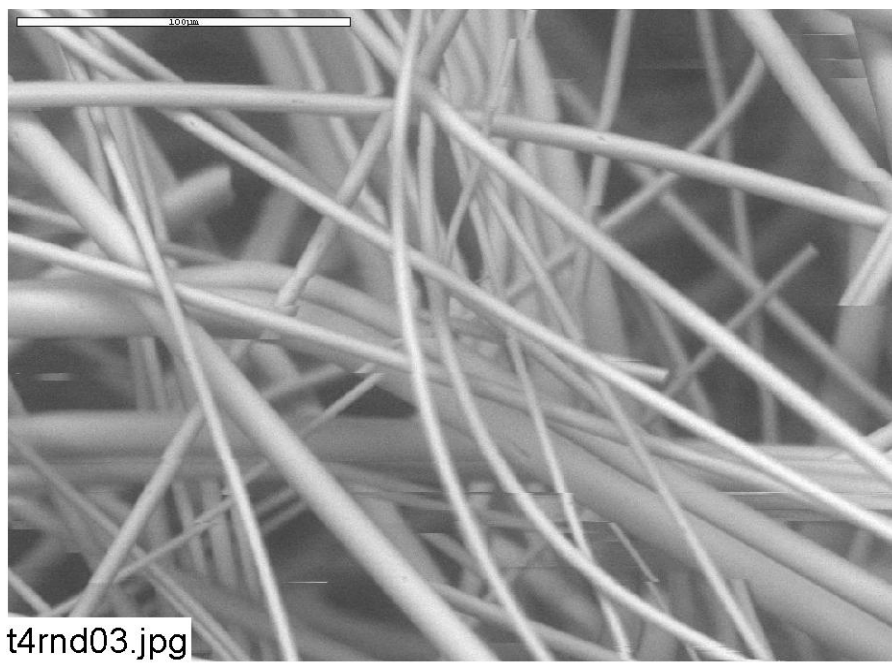
**Figure C4-12: Environmental SEM image magnified 500 times for a Test #4 Day-30 interior high-flow fiberglass sample. The sample was gently pre-rinsed with RO water.
(t4rnd03.jpg)**

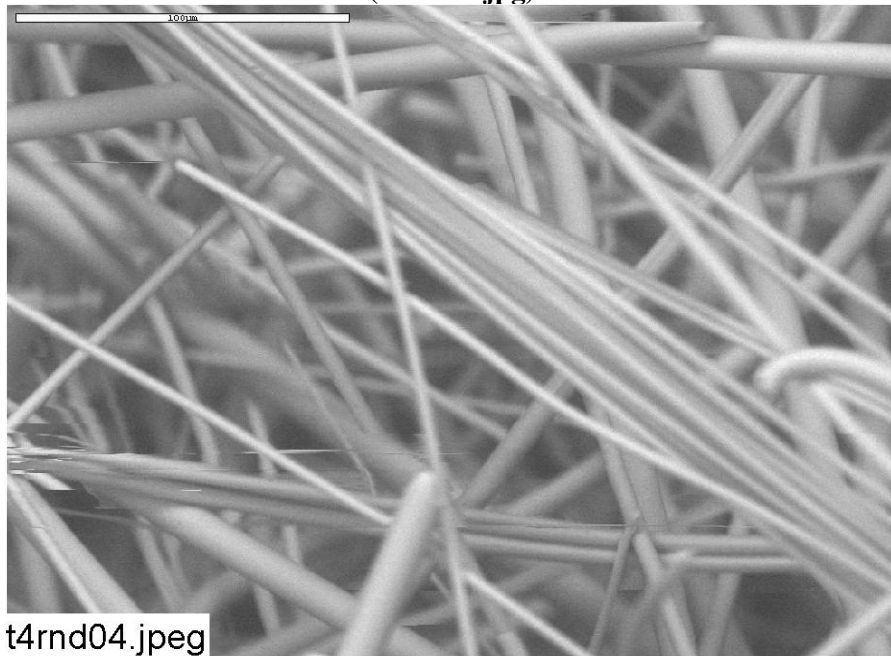
**Figure C4-13: Environmental SEM image magnified 500 times for a Test #4 Day-30 interior high-flow fiberglass sample. The sample was gently pre-rinsed with RO water.
(t4rnd04.jpg)**

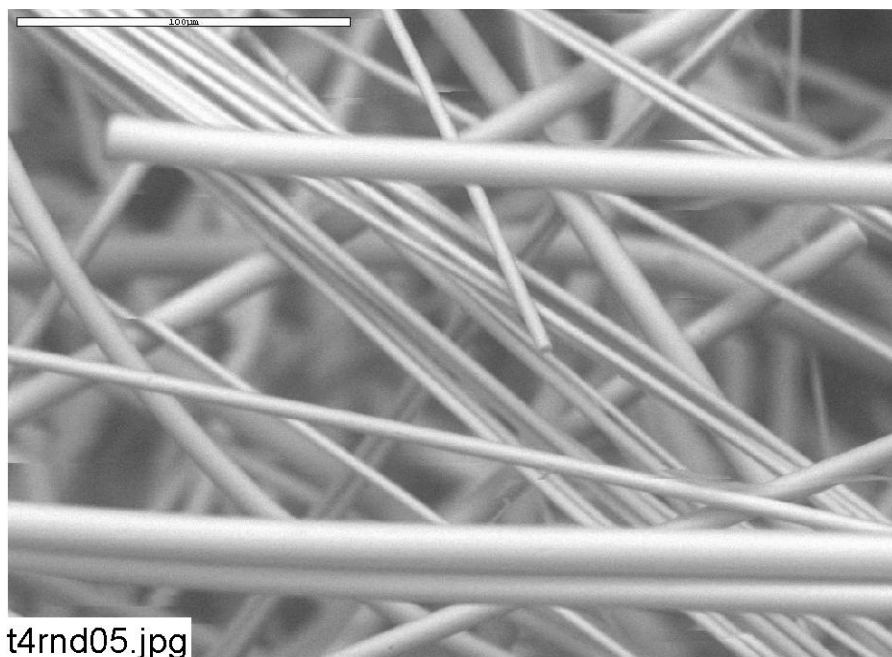
**Figure C4-14: Environmental SEM image magnified 500 times for a Test #4 Day-30 interior high-flow fiberglass sample. The sample was gently pre-rinsed with RO water.
(t4rnd05.jpg)**

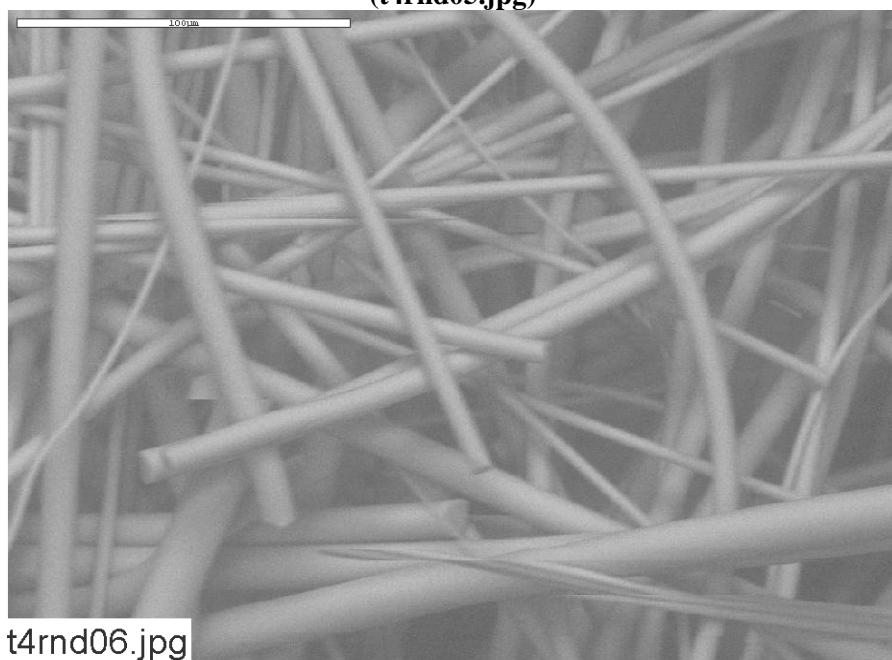
**Figure C4-15: Environmental SEM image magnified 500 times for a Test #4 Day-30 interior high-flow fiberglass sample. The sample was gently pre-rinsed with RO water.
(t4rnd06.jpg)**
