## Appendix C7

### ESEM/EDS Data for Test #4 Day-30 Birdcage Fiberglass

This appendix lists the ESEM/EDS results for the fiberglass samples within a birdcage submerged in the testing solution. The purpose of this analysis was to determine the degree and the extent that particulate debris migrated and attached on fiberglass. In this appendix, the fiberglass samples within the birdcage were extracted on June 23, 2005, the date the test was shut down. Both exterior and interior fiberglass samples were examined. Environmental SEM (ESEM) was employed to analyze the hydrated fiberglass samples without any coating under a low vacuum condition (i.e., 80 Pa), to minimize the modification of the fiberglass samples through drying process. ESEM/EDS results of the Test #4 Day-30 birdcage fiberglass samples were obtained on June 24, 2005.

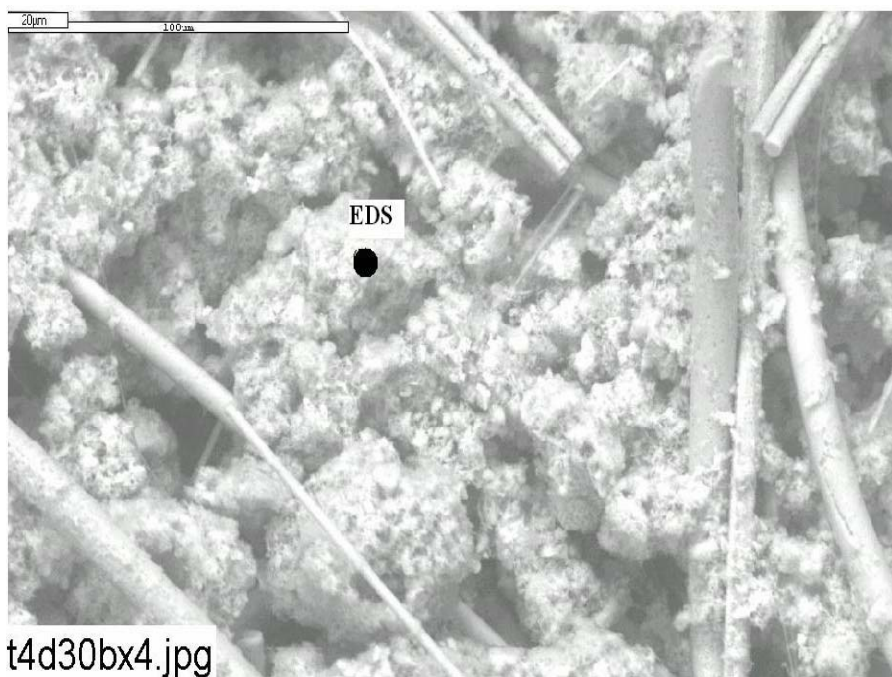
**Figure C7-2: Annotated environmental SEM image magnified 500 times for a Test #4 Day-30 exterior fiberglass sample within the birdcage. (t4d30bx4.jpg)**

Image:	T4D30BX1	100 ×	ESEM image	Figure C7-1
	t4d30bx4	500 ×	ESEM annotated image	Figure C7-2
EDS:	t4d30bx3		EDS on particles in t4d30bx4	Figure C7-3
