From: "Paul Gunter" <pgunter@nirs.org>
To: <hga@nrc.gov>
Date: 07/26/2006 3:22:27 PM
Subject: Interim staff guidance on AMR of embedded steel containment at Oyster Creek

Attached please find a letter from NIRS to NRC regarding the development of interim staff guidance on the Age Management Review of corrosion in the inaccessible and embedded region of the steel drywell liner at Oyster Creek nuclear generating station and other GE MARK I Boiling Water Reactors.

The letter as you will read is prompted by the attached July 26, 2006 memorandum from Dr. Rudolf Hausler to Paul Gunter, NIRS re: the embedded region of Oyster Creek containment and raises several questions regarding the embedded region of the drywell liner and evidence of corrosion of the torus / downcomers, both components also integral to the Mark I containment integrity.

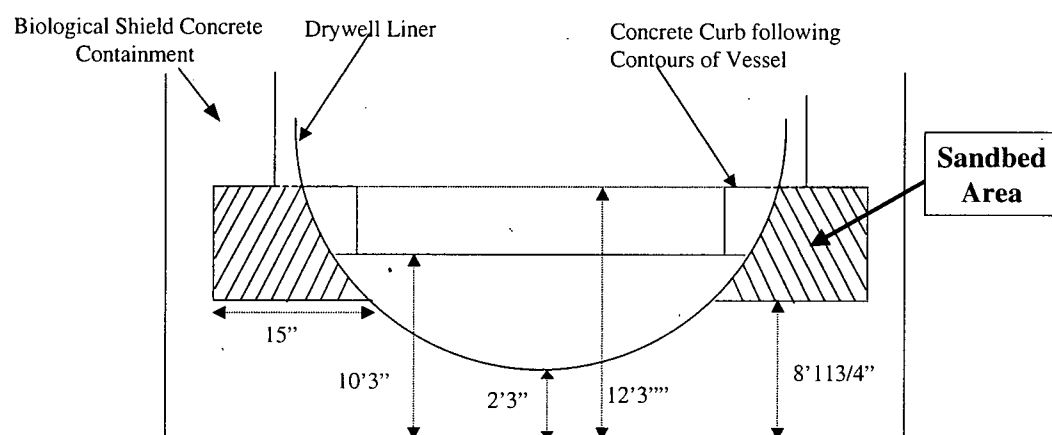
Figure 3

Schematic Drawing of Lower Spherical Section of Drywell Liner
(not to size)

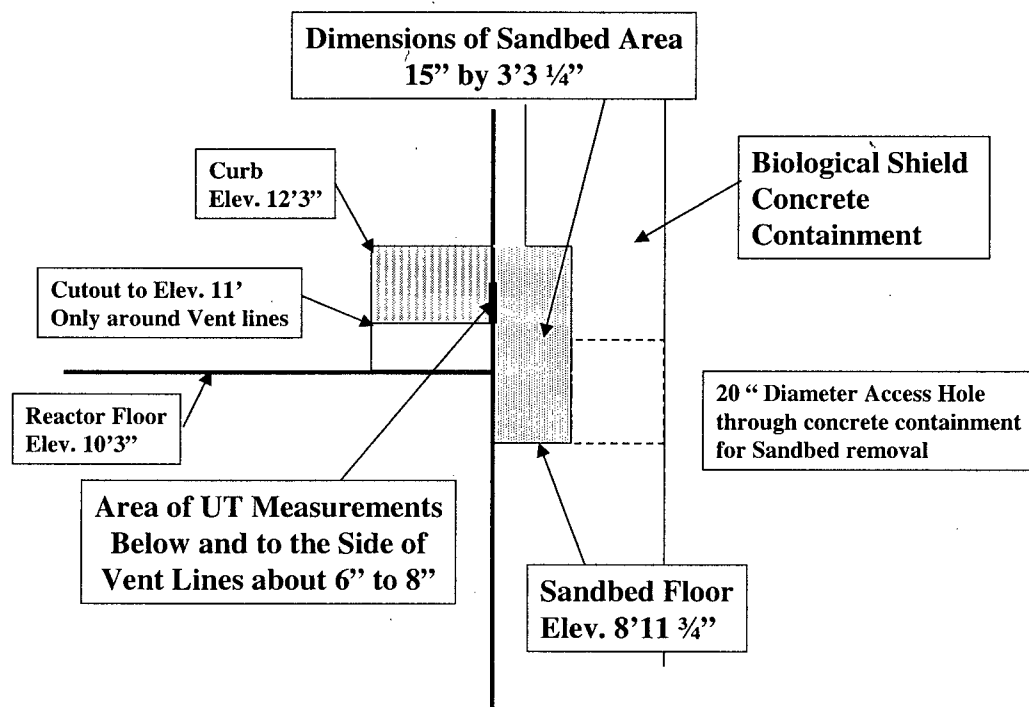
Figure 4

Schematic Cross Section through Sandbed Area

(not to size)

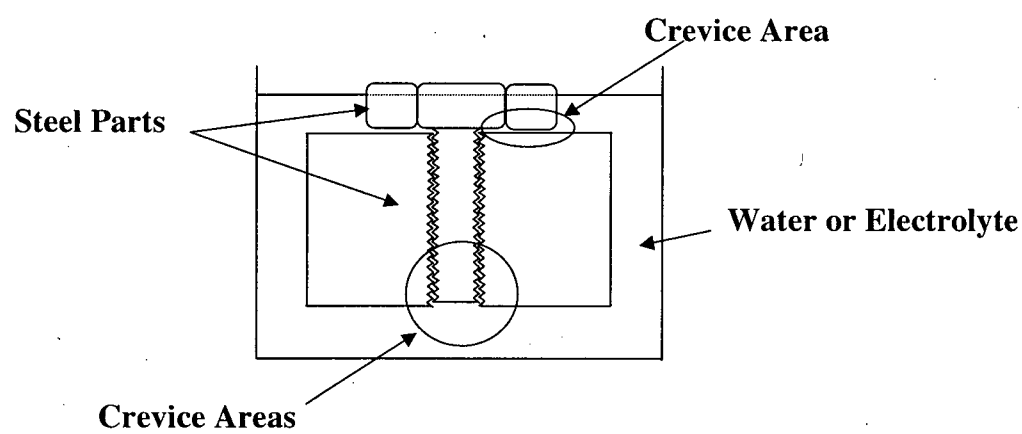
Figure A I-1

Formation of Crevice underneath Screw-head

However, physical observations are quite in tune with the above explanation. Crevice corrosion, as for instance in bolt threads, under washers, etc. is commonly observed. Ground rods corrode a few inches below the surface of earth or mud in which they are embedded. Applied to the sandbed it is indeed observed that corrosion does not occur on top of the sandbed where aeration is greatest, but in fact in an area below that surface. The question then arises as to why the corrosion rate should not be greatest at the very

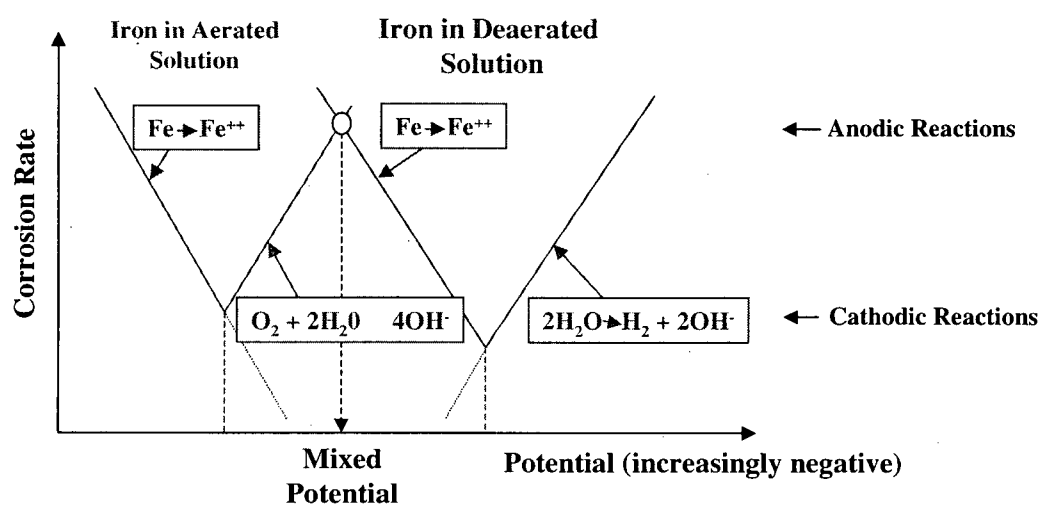
Figure AI-2

**Evans Diagram for Coupling of Iron in Aerated Solution
With Iron in Deaerated Solution**

Such situations can be theoretically discussed by means of polarization diagrams presented in the form of an Evans diagram as in Fig. A I-2. The diagram describes separately the polarization behaviors of the two parts of the iron piece as if they were disconnected and then defines a mixed potential as well as the resulting anodic and cathodic corrosion rates at the mixed potential.

The steel immersed in aerated solution will assume a fairly positive potential (depending on pH perhaps about + 200 mV vs. SCE). The cathodic reaction will be the reduction of oxygen to hydroxyl ions while the anodic reaction is the oxidation of iron to iron ions. The current potential relationships describe the rate of the respective reactions when the potential is moved (for instance by external means) in the negative or positive direction. At the point where anodic and cathodic reactions (currents) are equal is the corrosion potential and the associated corrosion current (corrosion rate). For the part of the steel immersed in the deaerated solution the potential is more negative (depending on pH perhaps on the order of -400 mV vs. SEC). The anodic reaction is the same while in the absence of oxygen water is reduced to hydrogen and hydroxyl ions.

In reality, however, the two pieces of metal are in electrical contact and are furthermore wetted by the same solution (i.e. in electrolytic contact as well). Under these conditions the metal must assume one potential and one potential only, namely the mixed potential. As can be seen from Fig. A I-2 this is only possible if the cathodic reaction rate of the aerated side increases which then forces the anodic reaction of the deaerated side to increase as well. To a certain extent this result may be counter intuitive in that now the area that is starved in oxygen is corroding while the oxygen rich side is, as is often said as well, cathodically protected by the corroding side.
