SEABROOK STATION UPDATED FINAL SAFETY ANALYSIS REPORT	Sketches Detailing W-1, DI-1 and DI-3	
		Figure 2.5-24

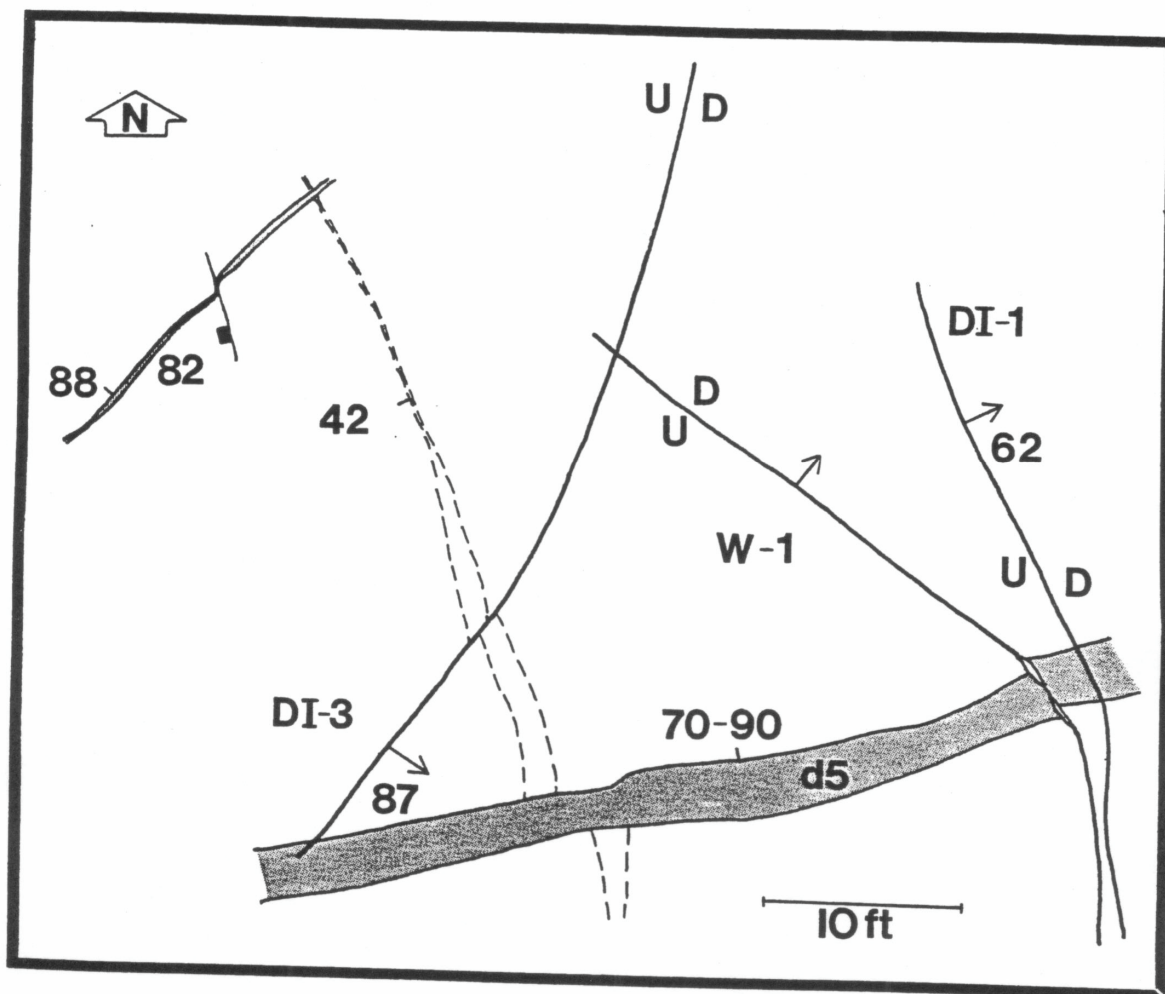
PLAN SKETCH FROM D1. FAULT DI-3 ENDS WITH DIKE d5. FAULT DI-1 APPARENTLY DISPLACES DIKE d5 ALTHOUGH THE FAULT NARROWS TO A SINGLE, NARROW, TIGHT FRACTURE BETWEEN TWO CALCITE PODS AT THE DIKE'S CENTER. FAULT DI-1 APPARENTLY DISPLACES d5 ALTHOUGH HEAVY CALCITE COATINGS PREVENT MEASUREMENT OF DIKE OFFSET. A DIKELET ASSOCIATED WITH d5 IS DEFLECTED ALONG A JOINT IN A MANNER WHICH MIMICS SOME APPARENT OFFSETS OF DIKES ALONG FAULTS OVER THE SITE. DILATION OPENING FOR d5 TOOK PLACE OTHER THAN AT RIGHT ANGLES TO DIKE CONTACTS. DIABASE DIKELET SHOWS PSEUDO-OFFSET ALONG JOINT. HOST ROCK IS NEWBURYPORT.
