# Appendix C1

## SEM/EDS Data for Unused and Test #2, Day-30 Aluminum Coupons

This appendix shows SEM/EDS results for the metal aluminum coupons in three different exposure categories: (1) unused, (2) suspended or unsubmerged, and (3) submerged. *Unused* refers to the coupon condition that existed before being subjected to ICET test conditions. *Suspended* or *unsubmerged* refers to coupons located above the water level of the solution during ICET tests. Suspended coupons contacted the solution only during the 4-hour spray period at the start of the test. In addition, the surface of the suspended coupons may also be affected by moisture in the test chamber gas space. *Submerged* refers to the coupons that were immersed in the test solution for the entire test.

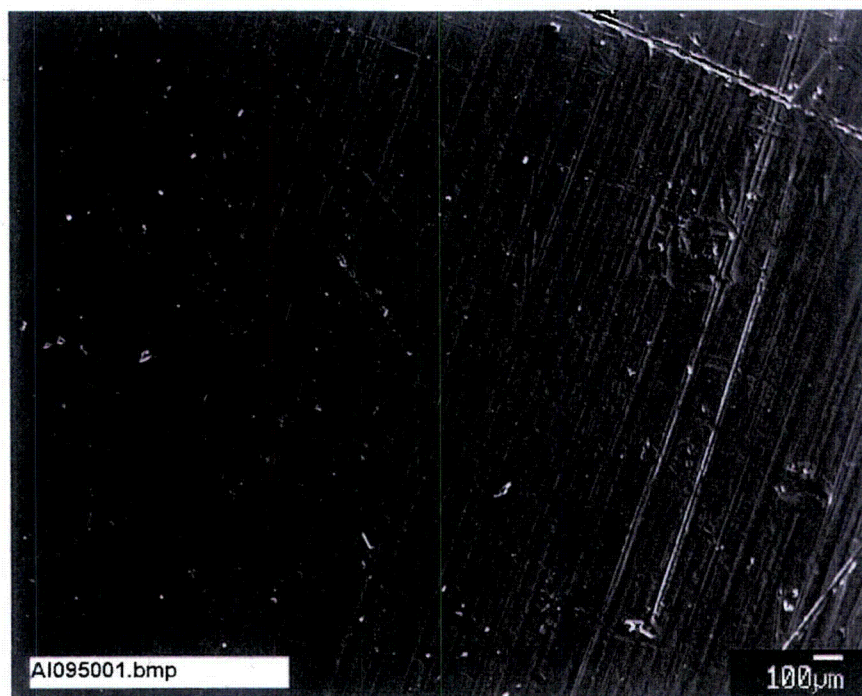
Figure C1-1. SEM image at 40× magnification for an unused aluminum coupon. (AI095001)

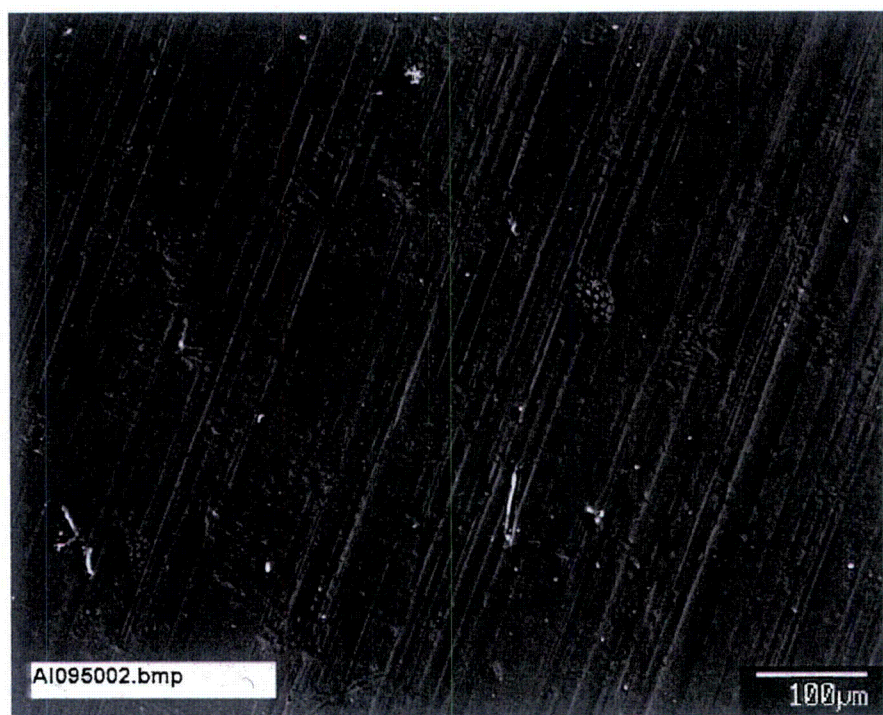
Figure C1-2. SEM image at 150× magnification for an unused aluminum coupon. (AI095002)

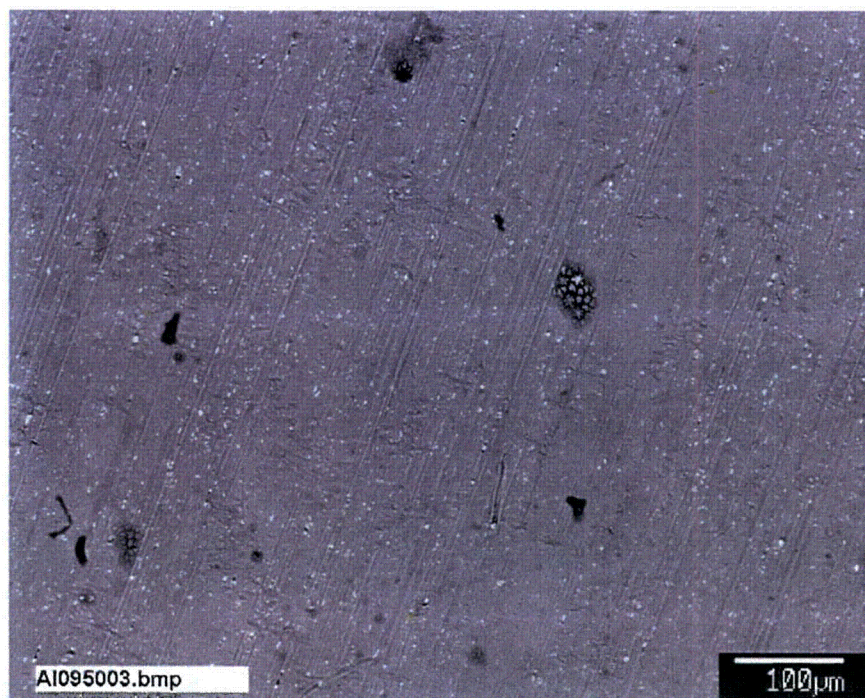
Figure C1-3. Backscattered SEM image at 150× magnification for an unused aluminum coupon. (Al095003)

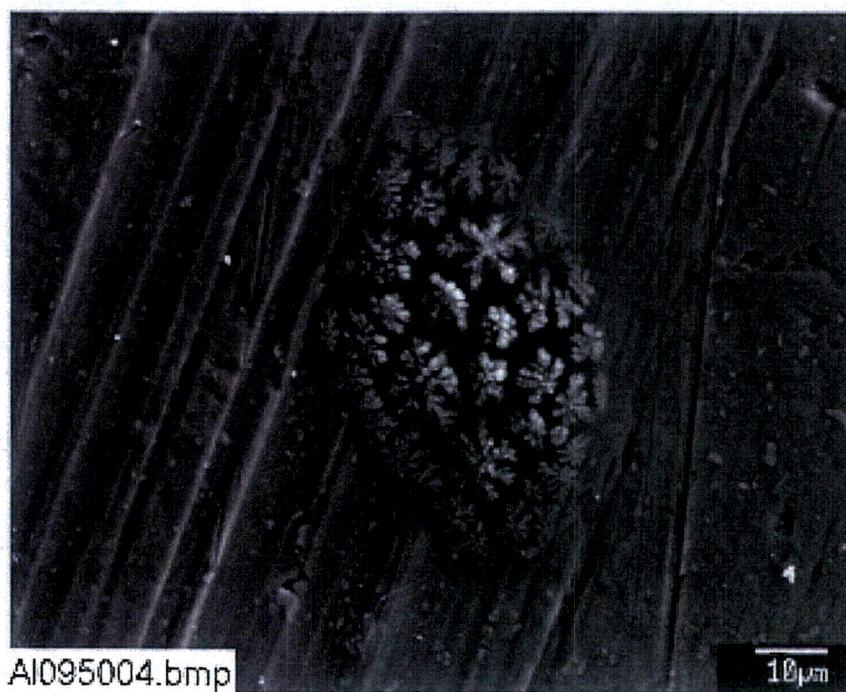
Figure C1-4. SEM image close-up (1000×) of contaminant “flower” on an unused aluminum coupon, as shown in Figure C1-3. (Al095004)

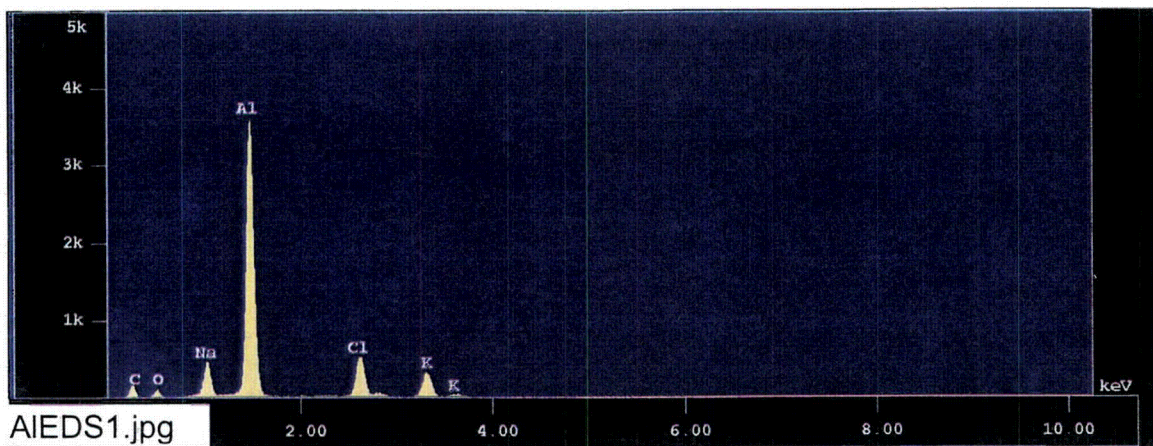
Figure C1-5. EDS counting spectrum for the contaminant “flower” shown in Figure C1-4. (AIEDS1)

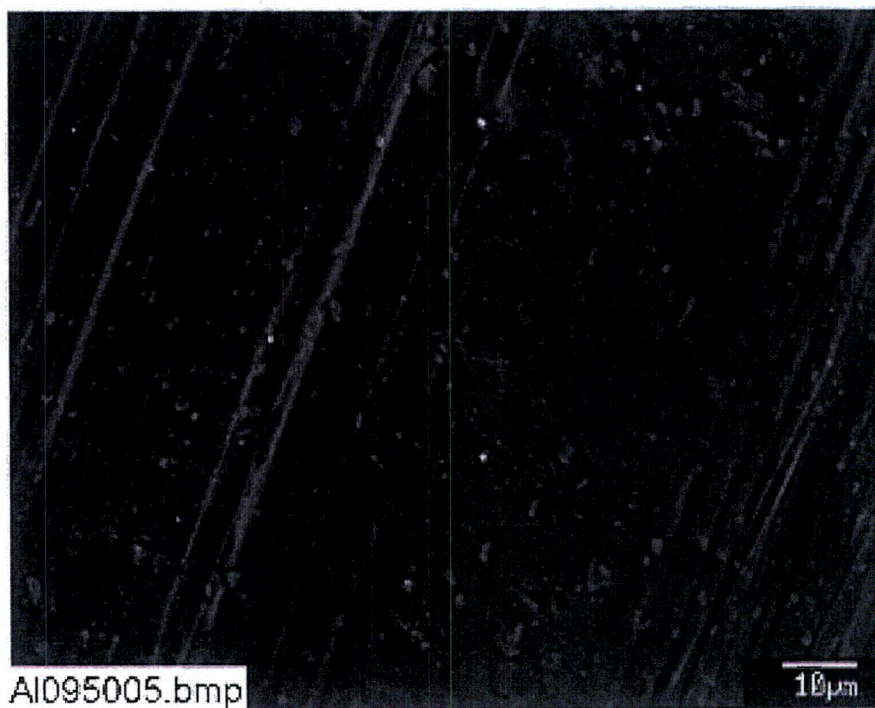
Figure C1-6. SEM image at 1000× magnification for an unused aluminum coupon. (AI095005)

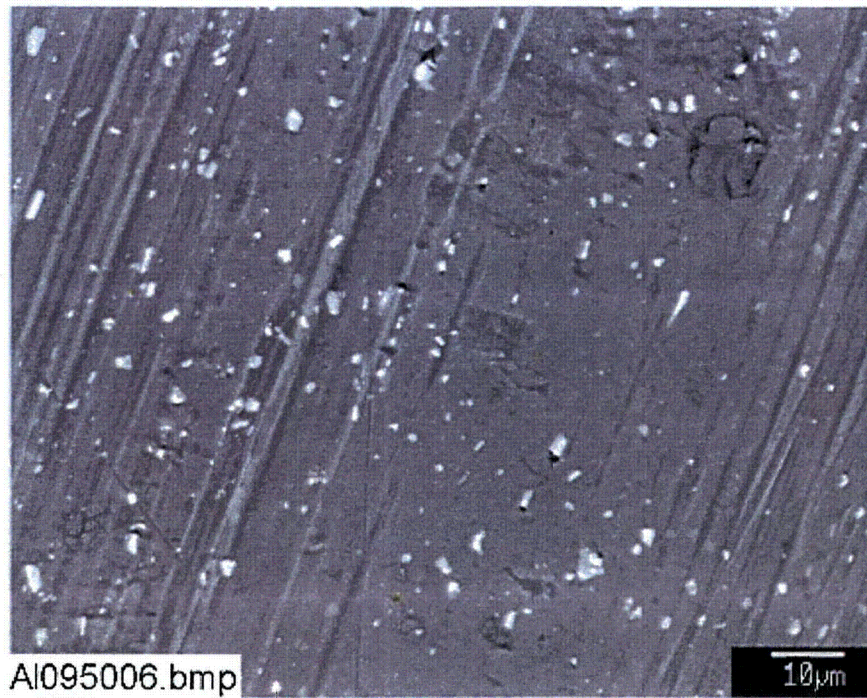
Figure C1-7. Backscattered SEM image at 1000× magnification for an unused aluminum coupon. (Al095006)

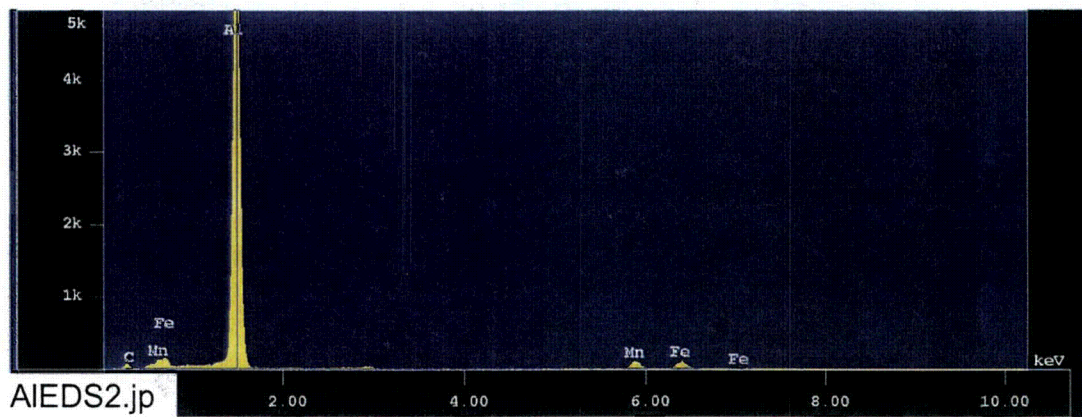
Figure C1-8. EDS counting spectrum for the white spots shown in Figure C1-7. (AlEDS2)

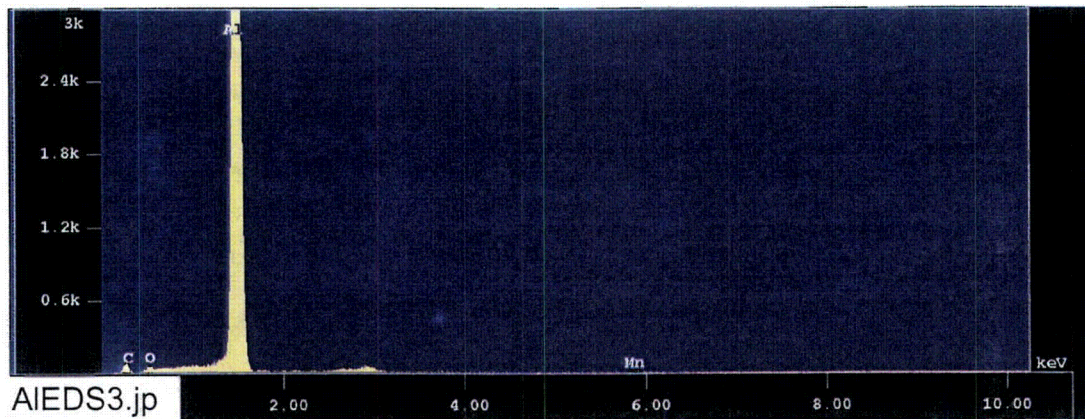
Figure C1-9. EDS counting spectrum for the average composition of an aluminum coupon shown in Figure C1-7. (AIEDS3)

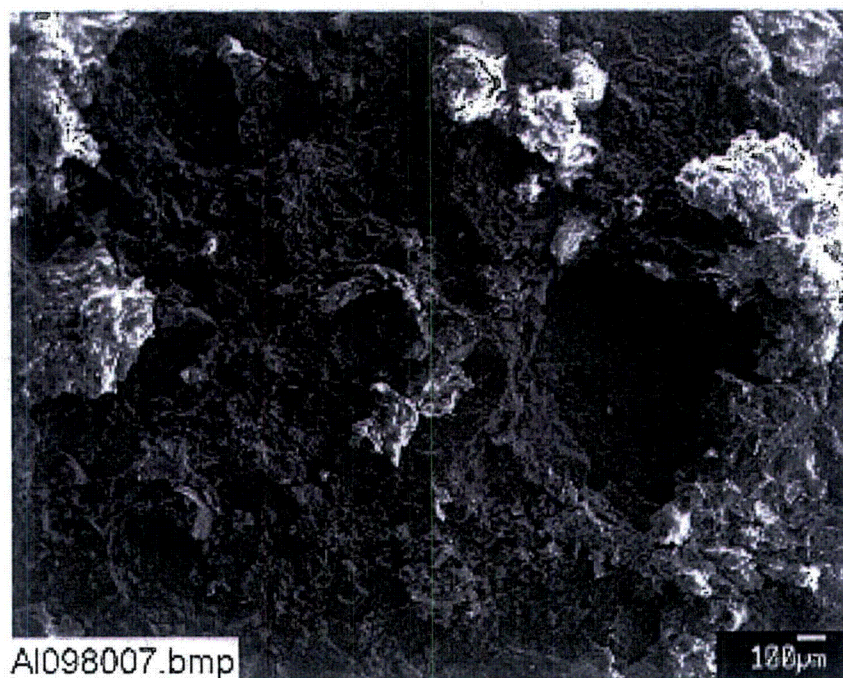
Figure C1-10. SEM image at 40× magnification for a Test #2, Day-30 submerged aluminum coupon. (AI098007)

Image:	Al098007	40 ×	Overview on corroded surface	Figure C1-10
	Al098008	150 ×	On corrosion product (SEI)	Figure C1-11
	Al098009	150 ×	BEI on same area	Figure C1-12
EDS:	AlEDS4		Smooth corrosion product surface	Figure C1-13
Image:	Al098010	1000 ×	SEI on surface & crystals	Figure C1-14
	Al098011	1000 ×	BEI same area	Figure C1-15
EDS:	AlEDS5		Crystals on Al corrosion product	Figure C1-16
Image:	Al098012	150 ×	SEI corroded Al surface (hole in corrosion layer)	Figure C1-17
	Al098013	1000 ×	SEI close-up of corroded surface in hole	Figure C1-18
EDS:	AlEDS6		Wormlike feature on corroded Al in image 013	Figure C1-19

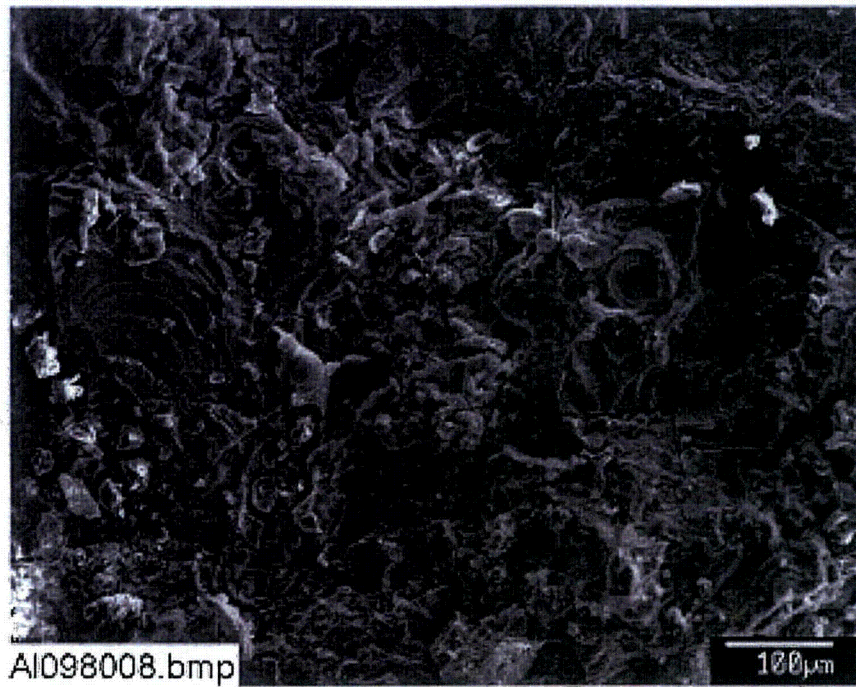
Figure C1-11. SEM image at 150 $\times$  magnification for a Test #2, Day-30 submerged aluminum coupon. (AI098008)

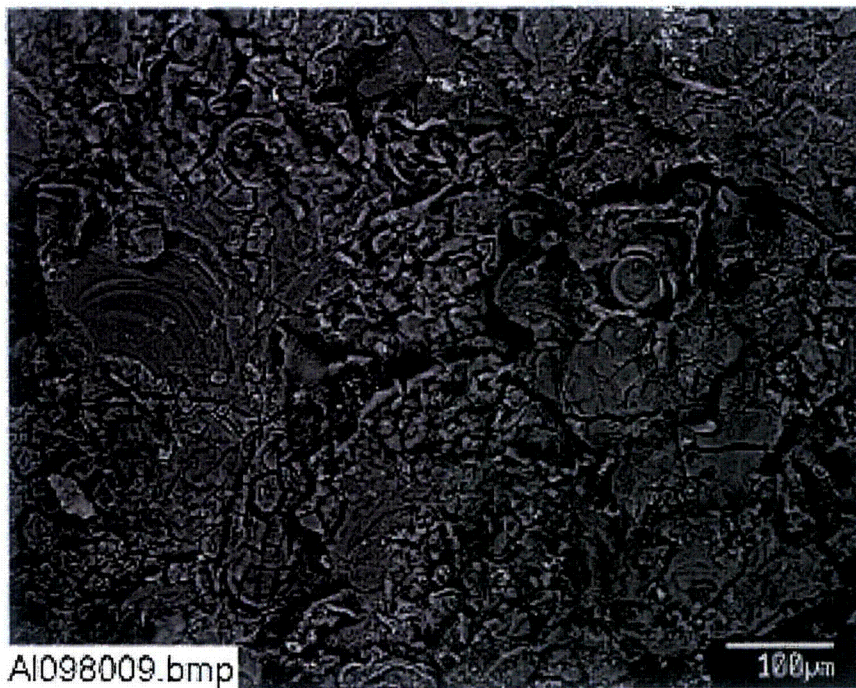
Figure C1-12. Backscattered SEM image at 150 $\times$  magnification for a Test #2, Day-30 submerged aluminum coupon. (AI098009)

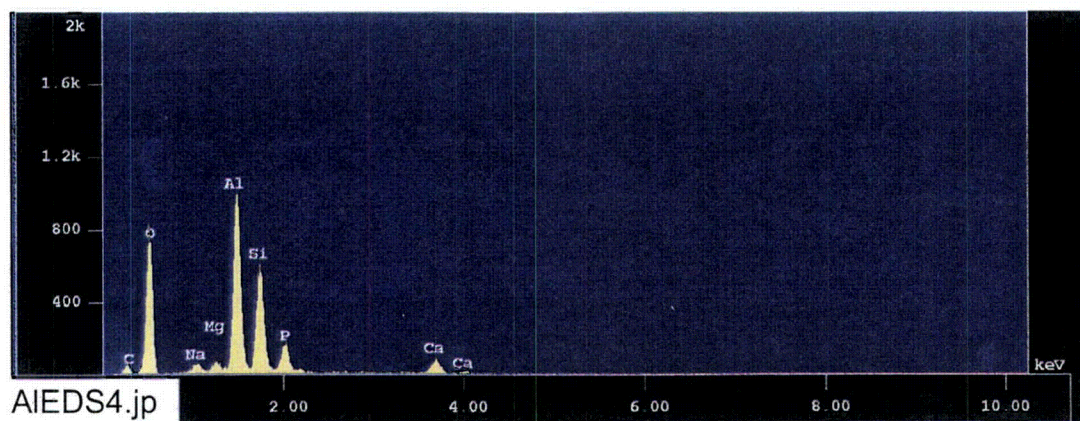
Figure C1-13. EDS counting spectrum for the smooth corrosion product shown on the surface of an aluminum coupon in Figure C1-11. (AIEDS4)

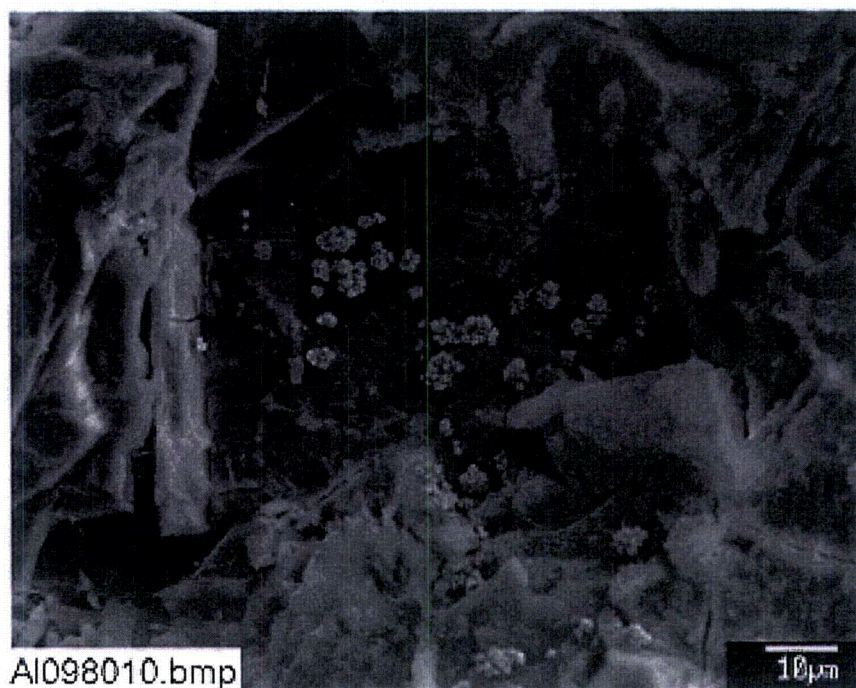
Figure C1-14. SEM image at higher magnification (1000×) for a Test #2, Day-30 submerged aluminum coupon. (A1098010)

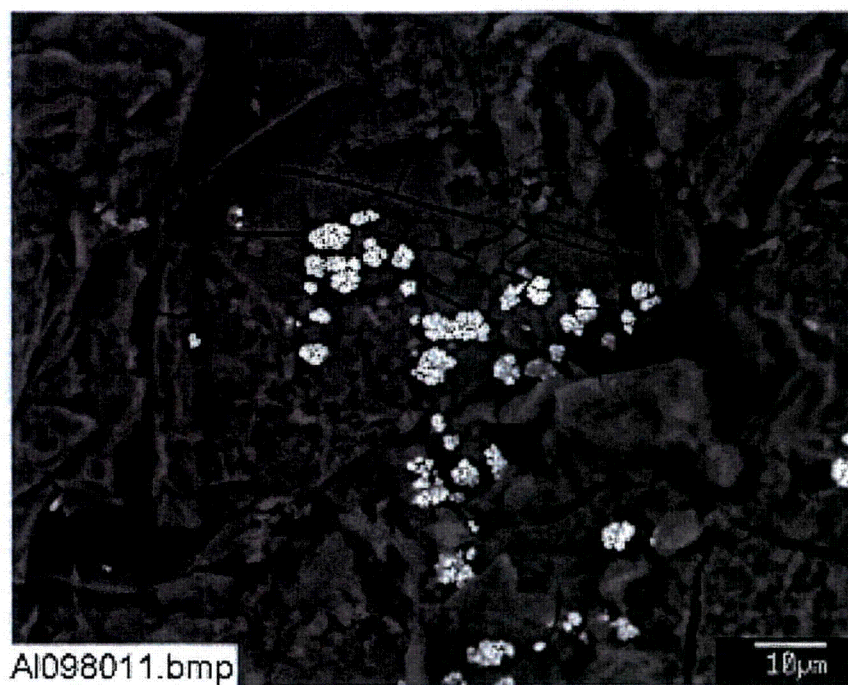
Figure C1-15. Backscattered SEM image of at higher magnification (1000×) for the same area of a submerged aluminum coupon shown in Figure C1-14. (AI098011)

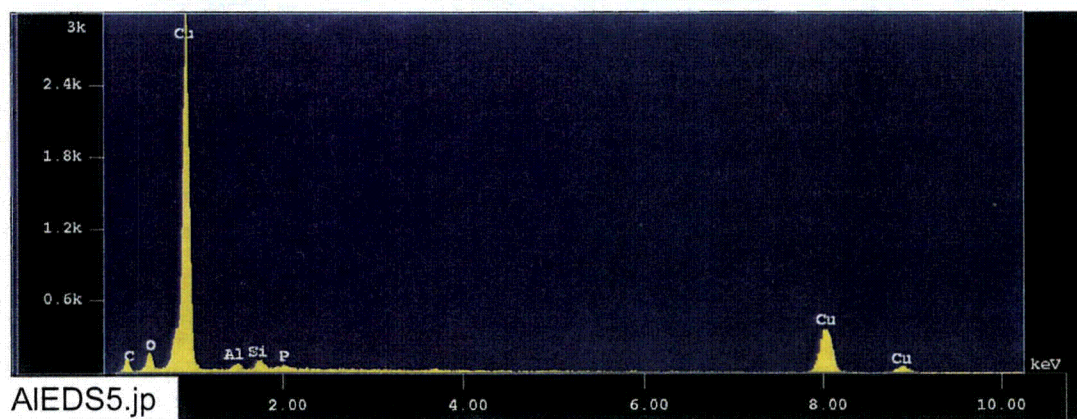
Figure C1-16. EDS counting spectrum for the crystal corrosion product, as shown as white granules in Figure C1-15. (AIEDS5)

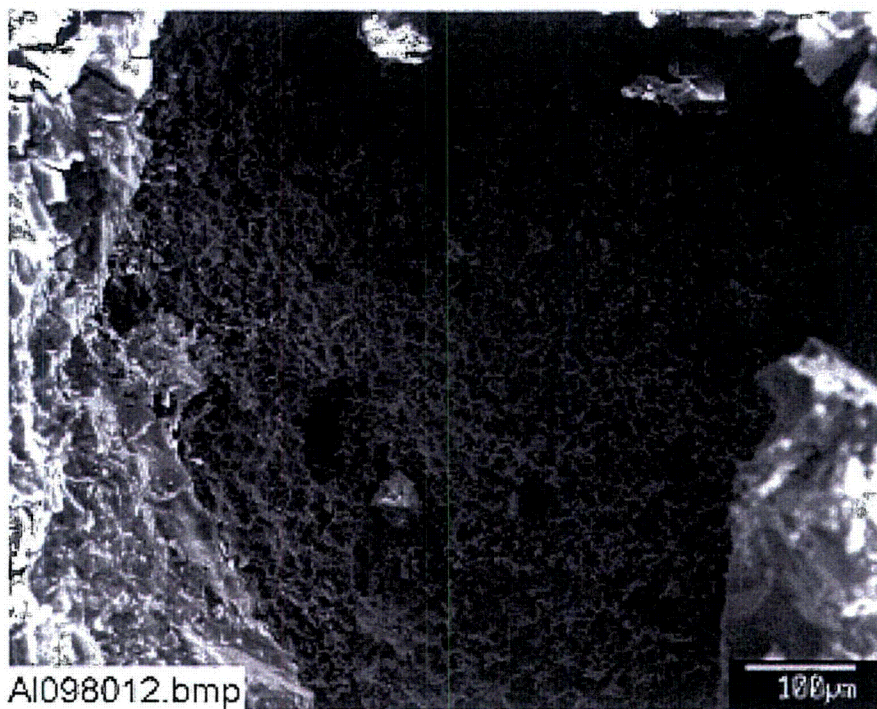
Figure C1-17. SEM image at 150× magnification for a Test #2, Day-30 submerged aluminum coupon showing a hole or defect in the corrosion layer. (Al098012)

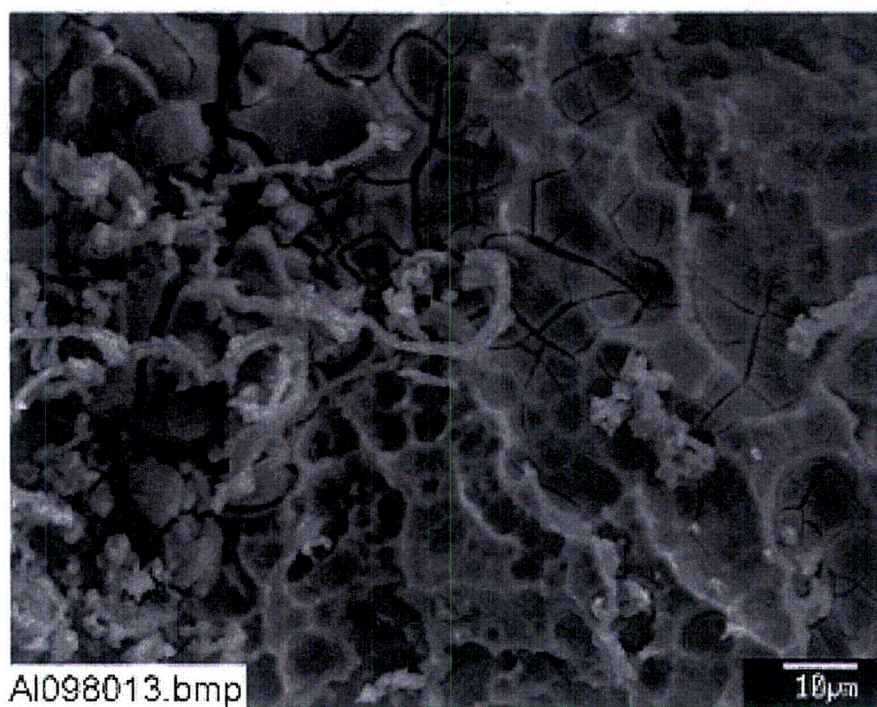
Figure C1-18. SEM image close-up (1000×) of the surface within the corrosion gap shown in Figure C1-17 on a submerged aluminum coupon. (Al098013)

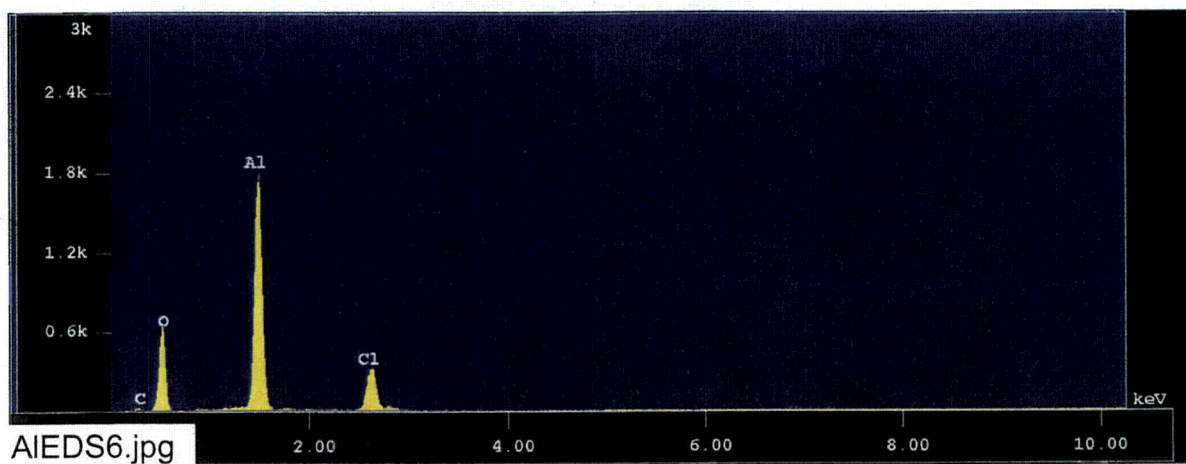
Figure C1-19. EDS counting spectrum for the wormlike corrosion product shown in Figure C1-18. (AIEDS6)

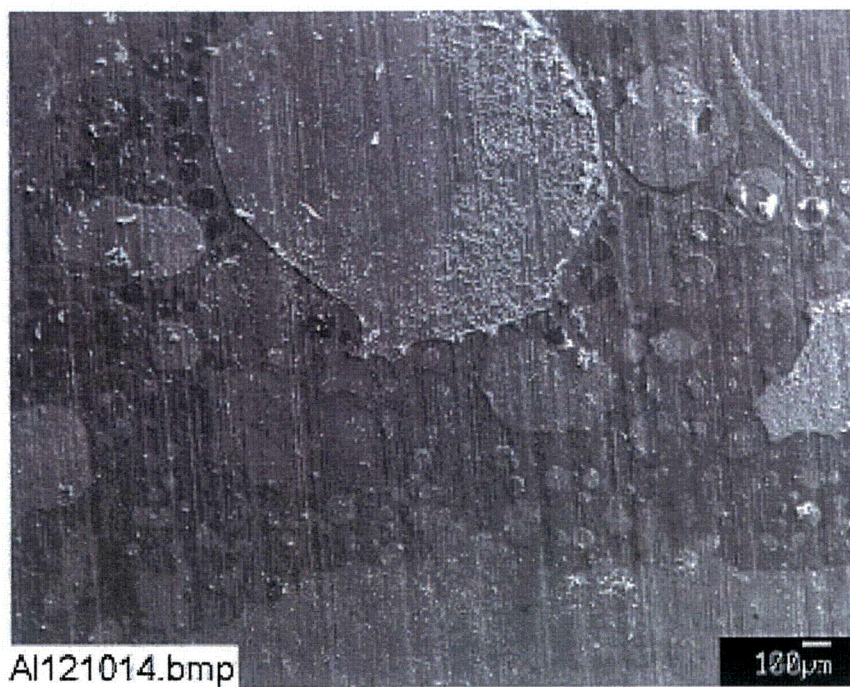
Figure C1-20. SEM image overview at 40× magnification for a Test #2, Day-30 unsubmerged aluminum coupon. (Al121014)

Image:	Al121014	40 ×	Overview of surface SEI	Figure C1-20
	Al121015	40 ×	BSE same area	Figure C1-21
	Al121016	150 ×	SEI on circle in image 015	Figure C1-22
	Al121016annotated		Annotated Photoshop picture of EDS sample locations.	Figure C1-23
	Al121017	150 ×	BEI same area	Figure C1-24
EDS:	AlEDS7		Dark splotch (in image 017)	Figure C1-25
	AlEDS8		Wormlike crystals (see Al121016annotated below)	Figure C1-26
	AlEDS9		Surface away from crystals (see Al121016annotated below)	Figure C1-27
Image:	Al121018	1000 ×	SEI wormlike crystals (see Al121016annotated below)	Figure C1-28

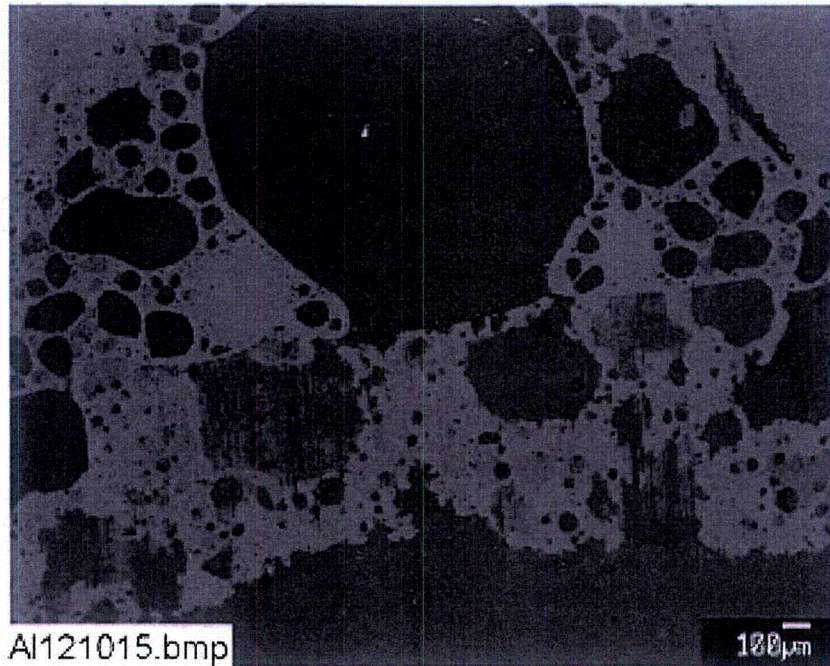
Figure C1-21. Backscattered SEM image overview at 40× magnification for a Test #2, Day-30 unsubmerged aluminum coupon. (Al121015)

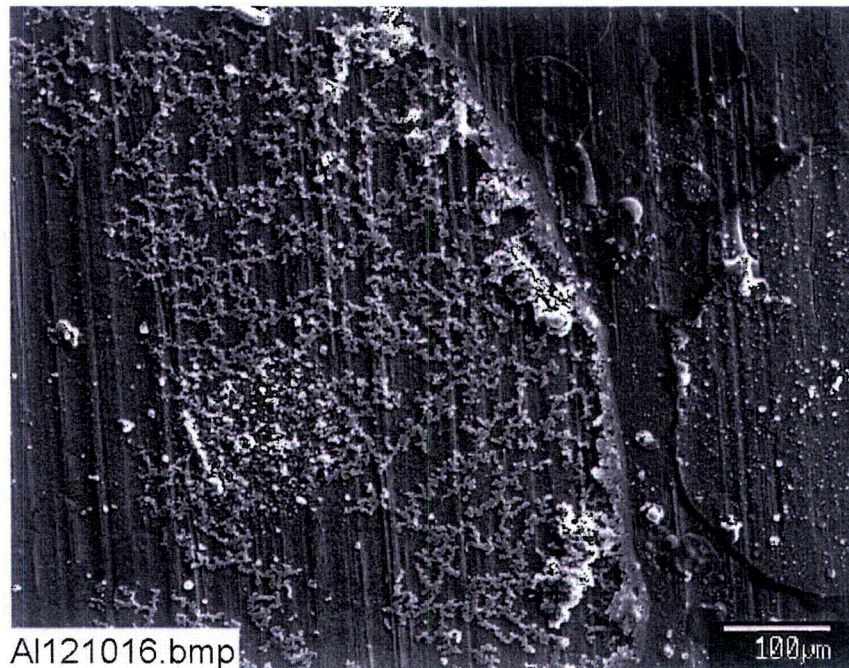
Figure C1-22. SEM image at 150× magnification for the circular corrosion patches shown in Figure C1-21 for a Test #2, Day-30 unsubmerged aluminum coupon. (Al121016)

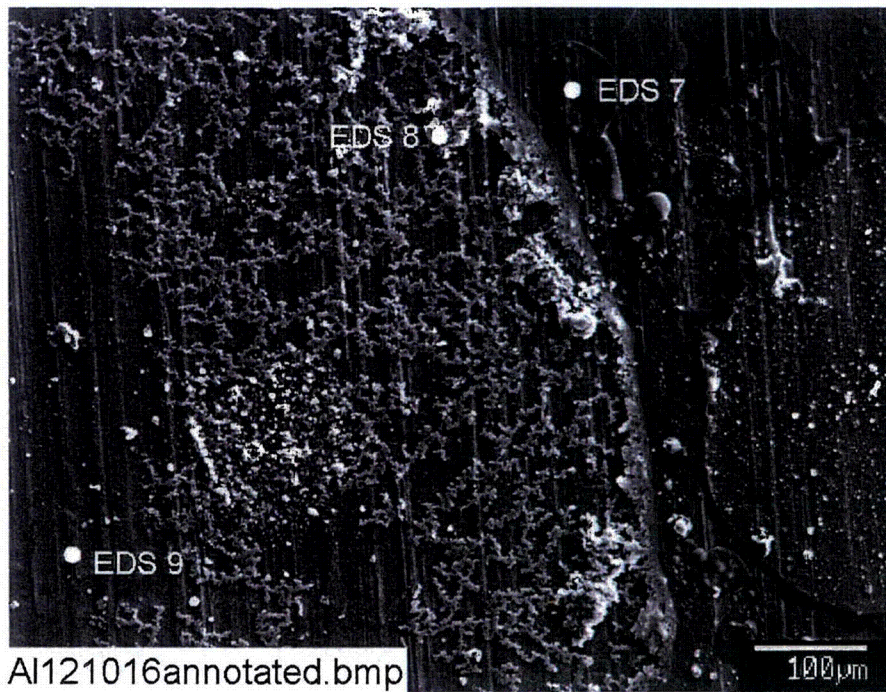
Figure C1-23. SEM image at 150× magnification for a Test #2, Day-30 unsubmerged aluminum coupon illustrating EDS sampling locations. (Al121016annotated)

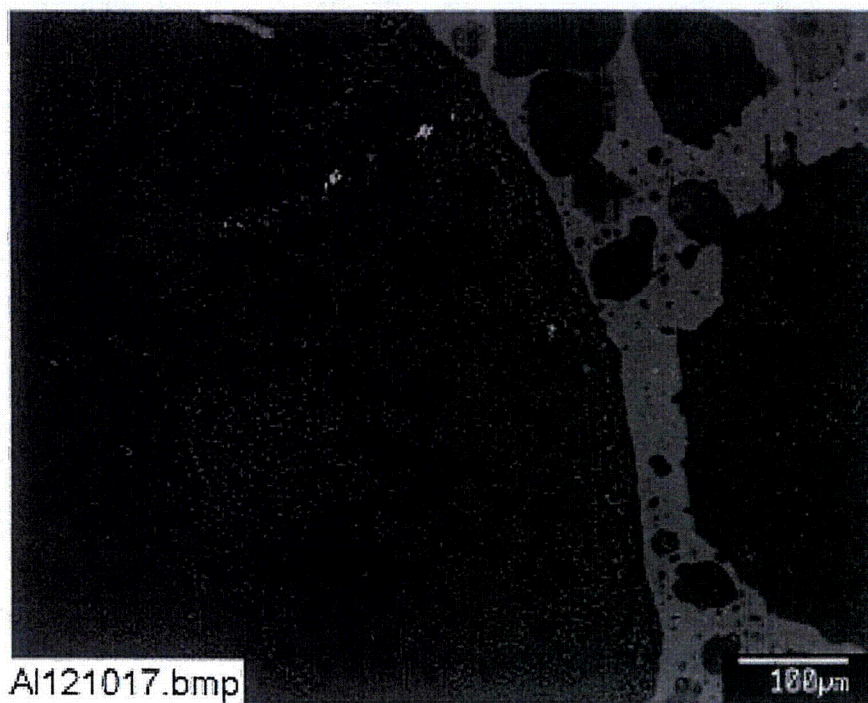
Figure C1-24. Backscattered SEM image at 150× magnification for the circular corrosion patches shown in Figure C1-21 for a Test #2, Day-30 unsubmerged aluminum coupon. (Al121017)

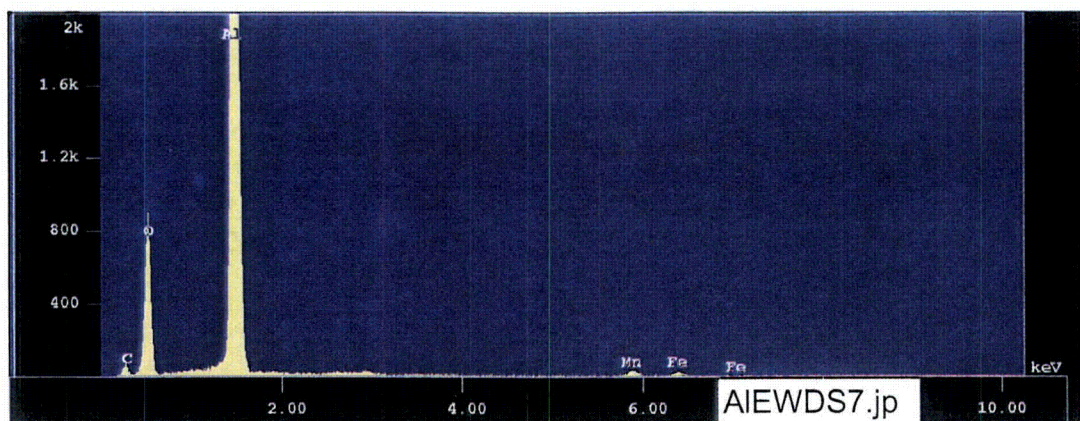
Figure C1-25. EDS counting spectrum for the dark patch shown in Figure C1-24. (AIEWDS7)

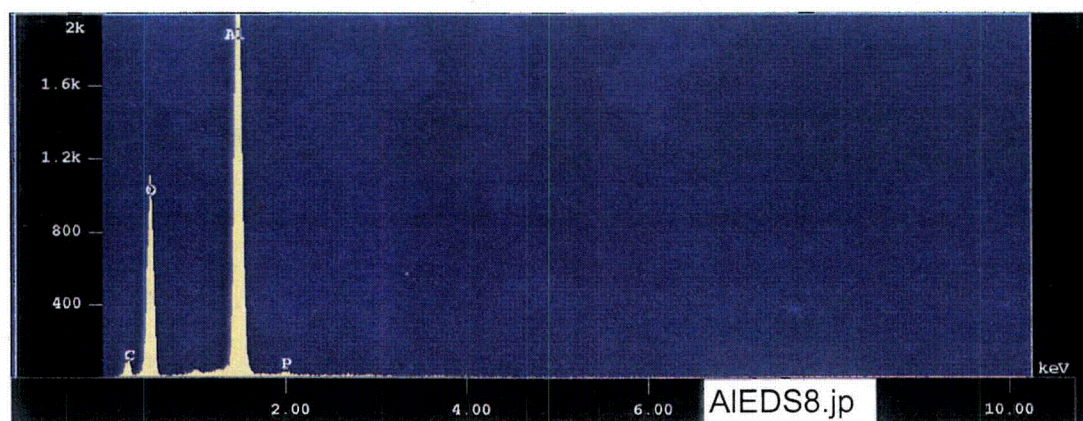
Figure C1-26. EDS counting spectrum for the wormlike crystals shown in Figure C1-22. (AIEDS8)

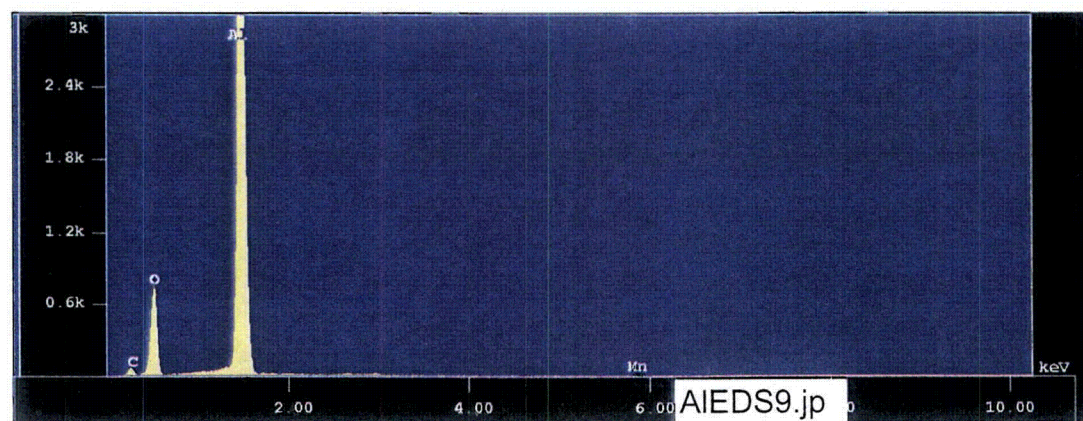
Figure C1-27. EDS counting spectrum for the coupon surface away from wormlike crystals shown in Figure C1-22. (AIEDS9)

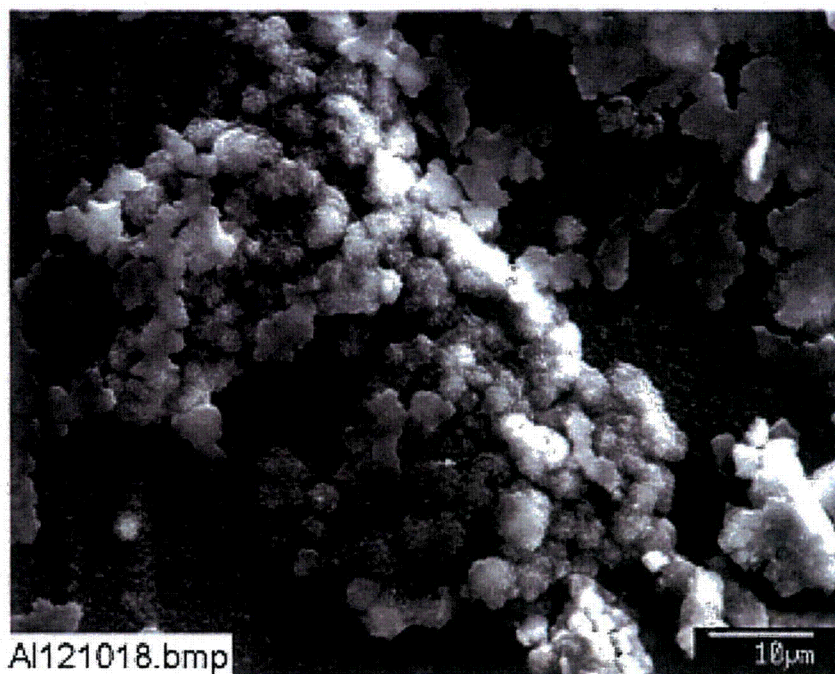
**Figure C1-28. SEM image close-up (1000×) of wormlike crystals shown in Figure C1-22 for a Test #2, Day-30 unsubmerged aluminum coupon. (Al121018)**

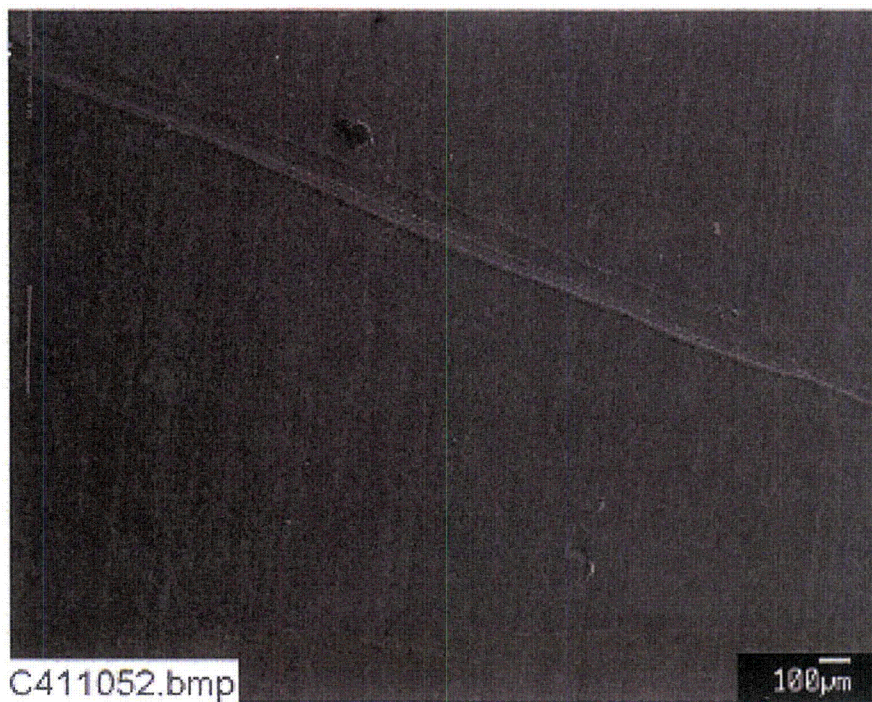
Figure C2-1. SEM image for an unused copper coupon. (C411052)

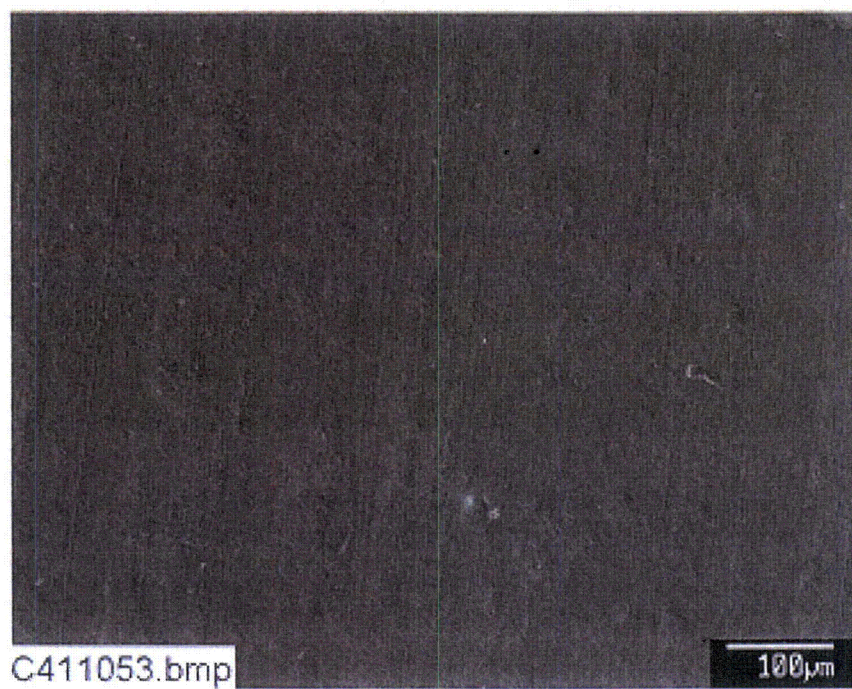
Figure C2-2. SEM image for an unused copper coupon. (C411053)

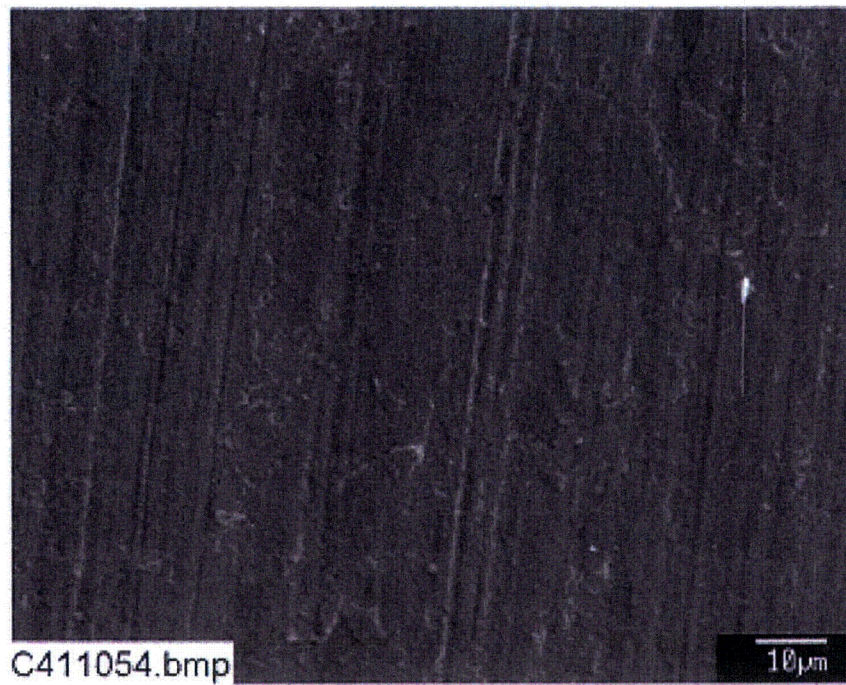
Figure C2-3. SEM image for an unused copper coupon (C411054).

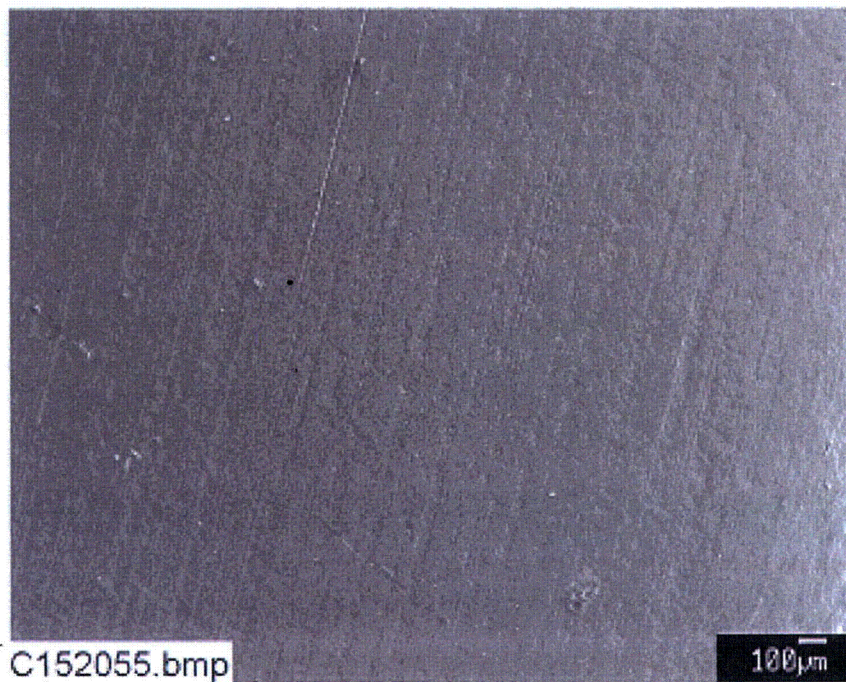
Figure C2-4. SEM image for a Test #2, Day-30 unsubmerged copper coupon. (C152055)

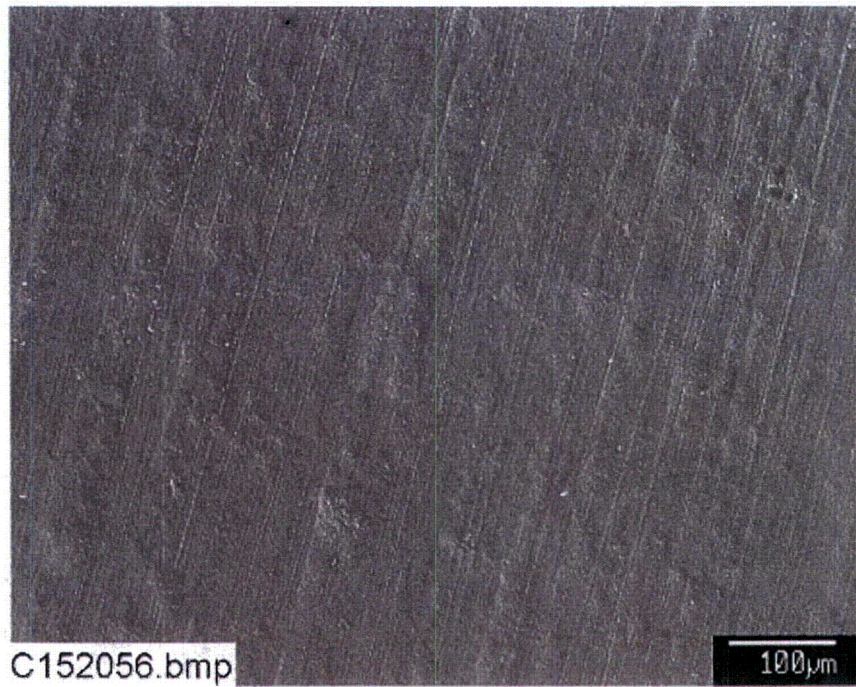
Figure C2-5. SEM image for a Test #2, Day-30 unsubmerged copper coupon. (C152056)

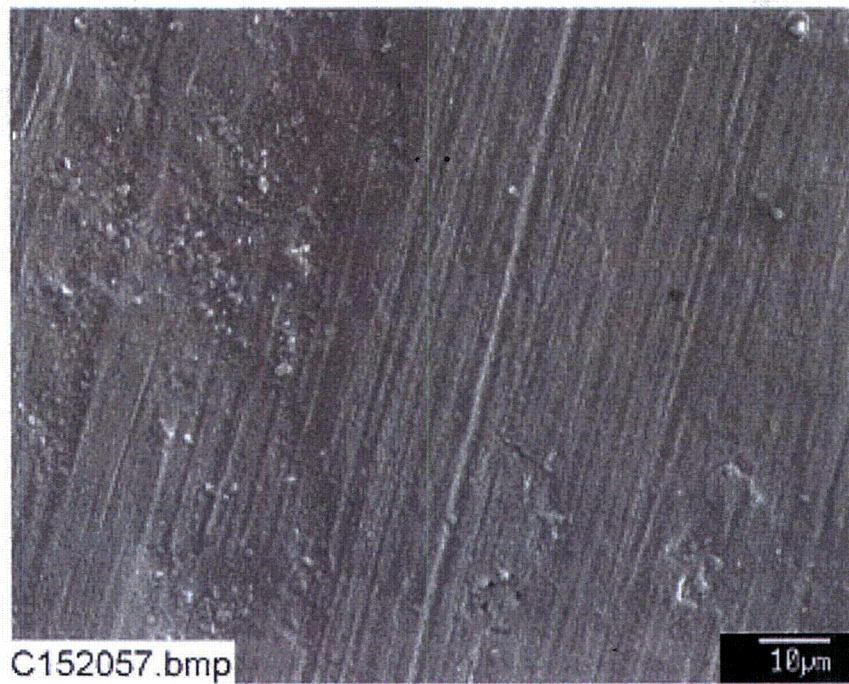
Figure C2-6. SEM image for a Test #2, Day-30 unsubmerged copper coupon. (C152057)

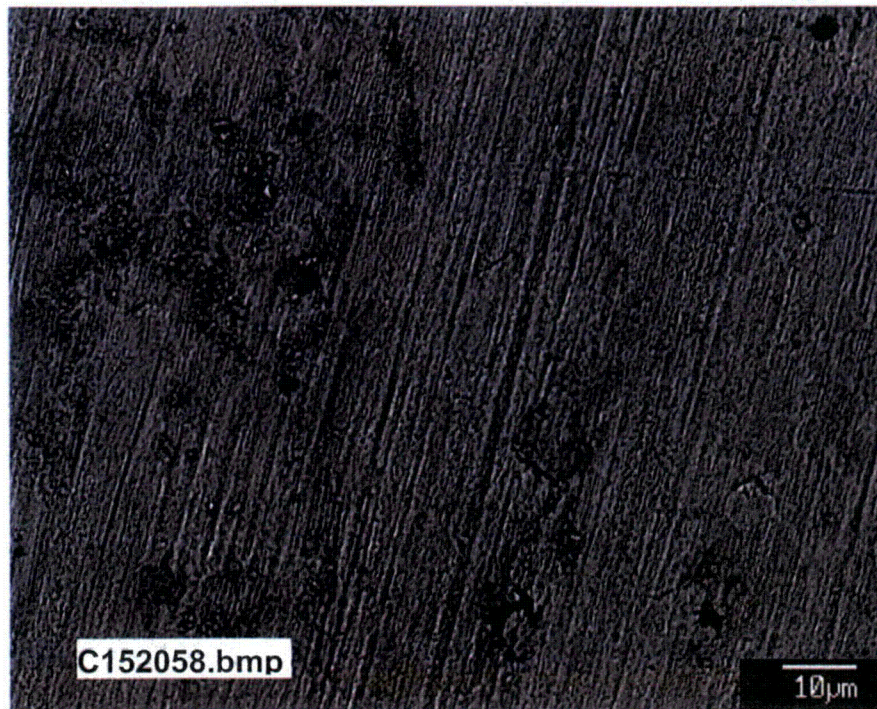
Figure C2-7. Backscattered SEM image for a Test #2, Day-30 unsubmerged copper coupon. (C152058)

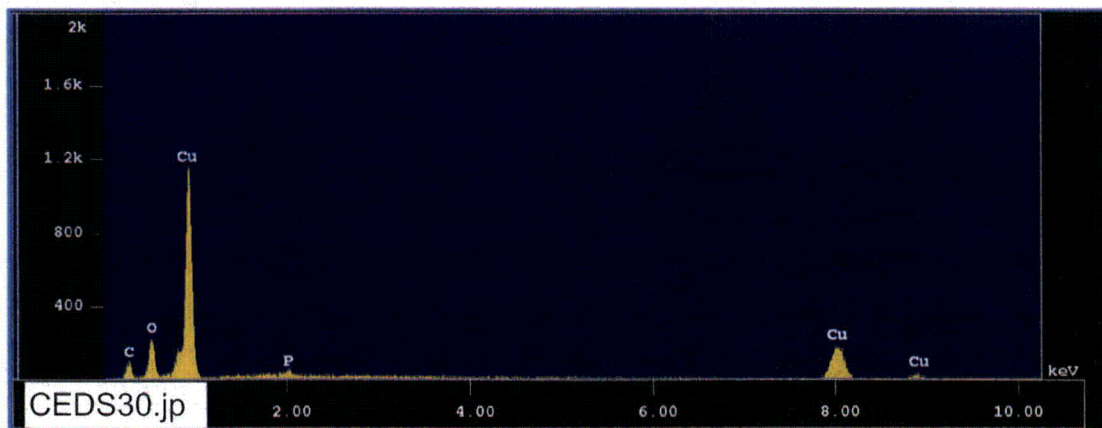
Figure C2-8. EDS counting spectrum for one of the dark spots shown in Figure C2-7. (CEDS30)

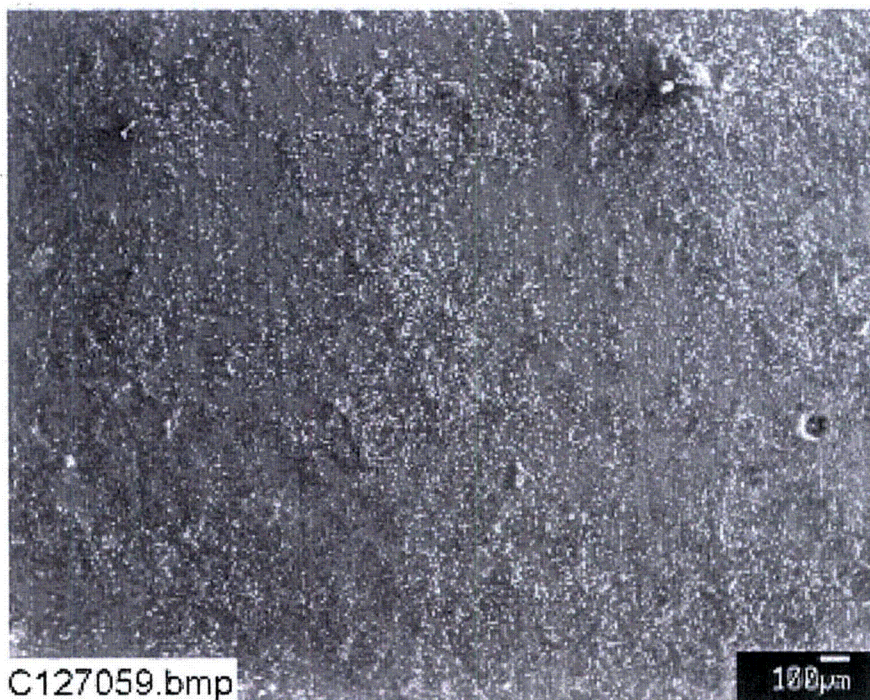
**Figure C2-9. SEM image for a Test #2, Day-30 submerged copper coupon. (C127059)**

Image:	C127059	40 ×	SEI	Figure C2-9
	C127060	150 ×	SEI	Figure C2-10
	C127061	150 ×	BEI	Figure C2-11
	C127062	1000 ×	SEI	Figure C2-12
EDS:	CEDS31		Dark spot on T2D30 submerged Cu	Figure C2-13
	CEDS32		Light spot on T2D30 submerged Cu	Figure C2-14
	CEDS33		Lathlike crystals on T2D30 submerged Cu	Figure C2-15

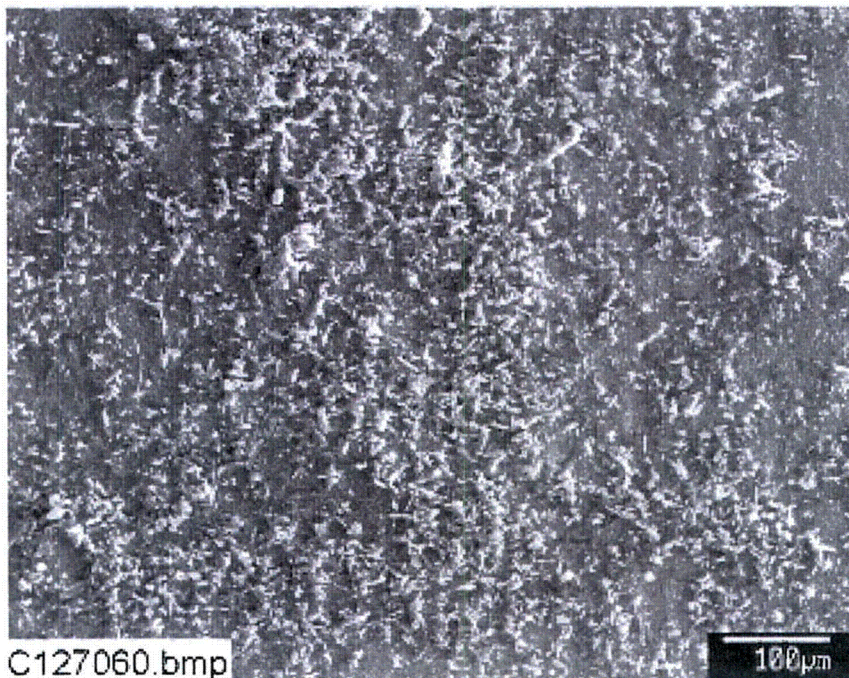
**Figure C2-10. SEM image for a Test #2, Day-30 submerged copper coupon. (C127060)**
