# Appendix C1

## SEM/EDS Data for Unused and Test #2, Day-30 Aluminum Coupons

This appendix shows SEM/EDS results for the metal aluminum coupons in three different exposure categories: (1) unused, (2) suspended or unsubmerged, and (3) submerged. *Unused* refers to the coupon condition that existed before being subjected to ICET test conditions. *Suspended* or *unsubmerged* refers to coupons located above the water level of the solution during ICET tests. Suspended coupons contacted the solution only during the 4-hour spray period at the start of the test. In addition, the surface of the suspended coupons may also be affected by moisture in the test chamber gas space. *Submerged* refers to the coupons that were immersed in the test solution for the entire test.

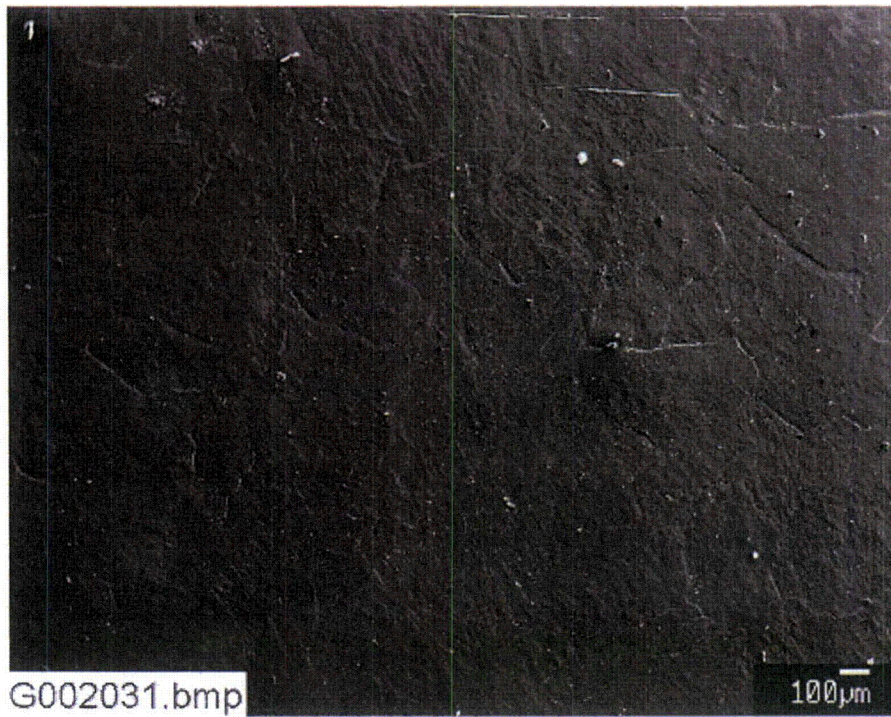
Figure C3-1. SEM image for an unused GS coupon. (G002031)

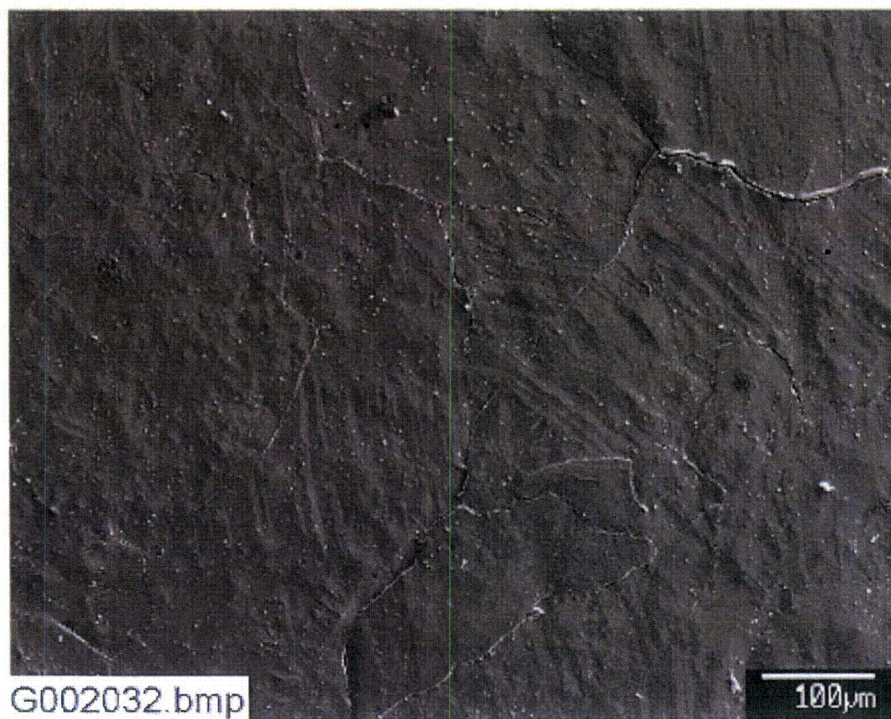
Figure C3-2. SEM image for an unused GS coupon. (G002032)

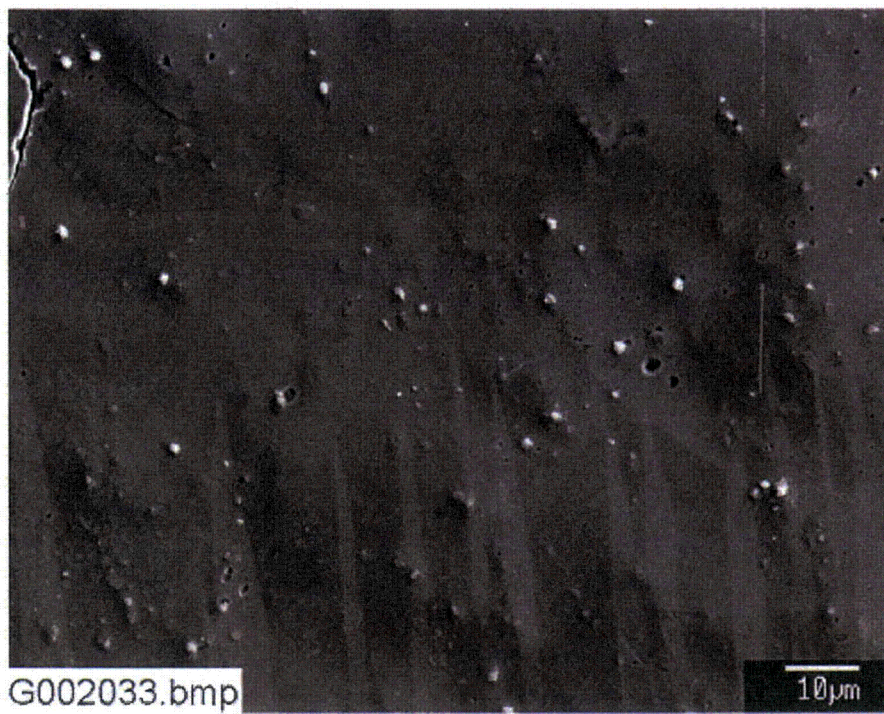
Figure C3-3. SEM image for an unused GS coupon. (G002033)

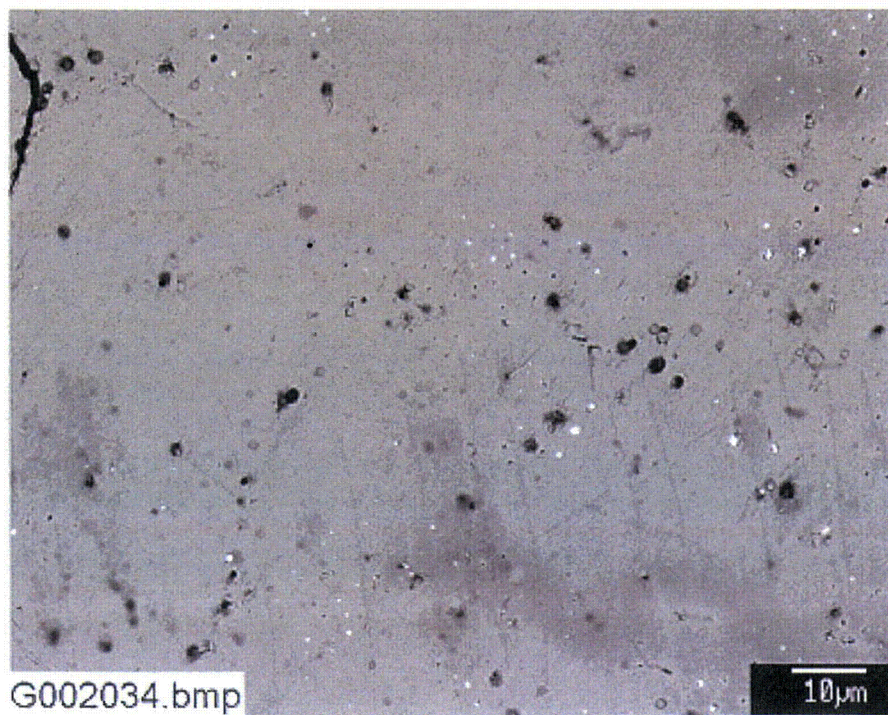
Figure C3-4. Backscattered SEM image for an unused GS coupon. (G002034)

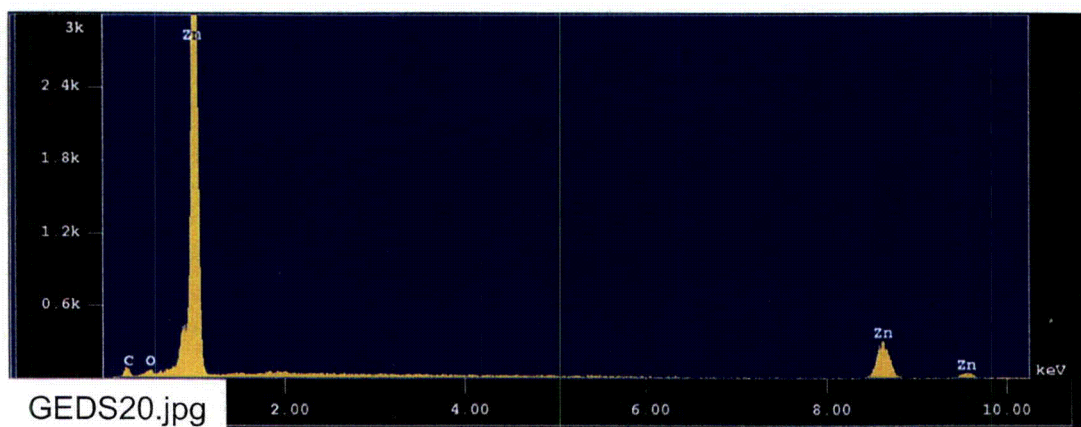
Figure C3-5. EDS counting spectrum for a smooth zinc surface. (GEDS20)

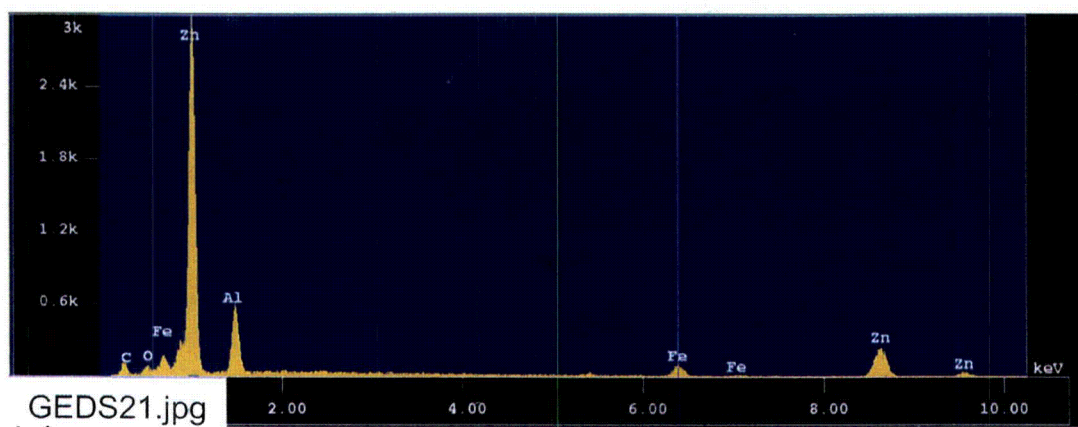
Figure C3-6. EDS counting spectrum for the small dark circular spots shown in Figure C3-4. (GEDS21)

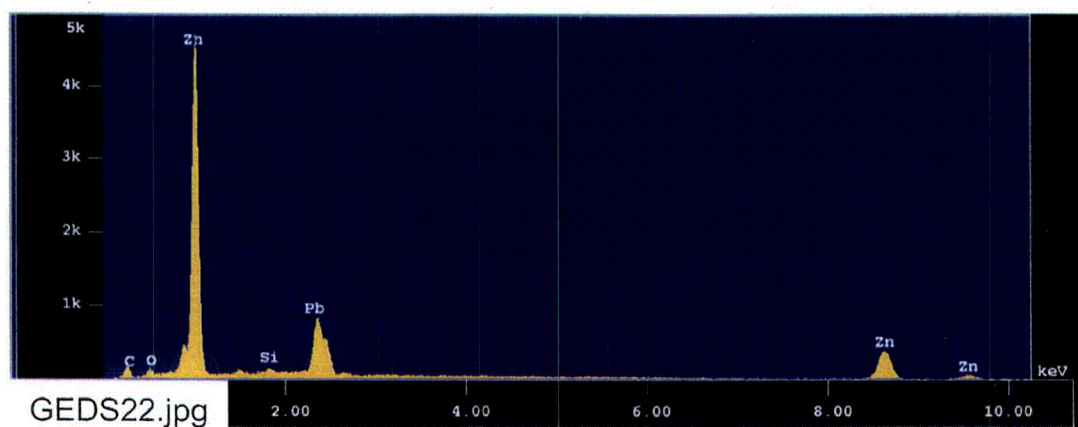
Figure C3-7. EDS counting spectrum for the bright spots shown in Figure C3-4. (GEDS22)

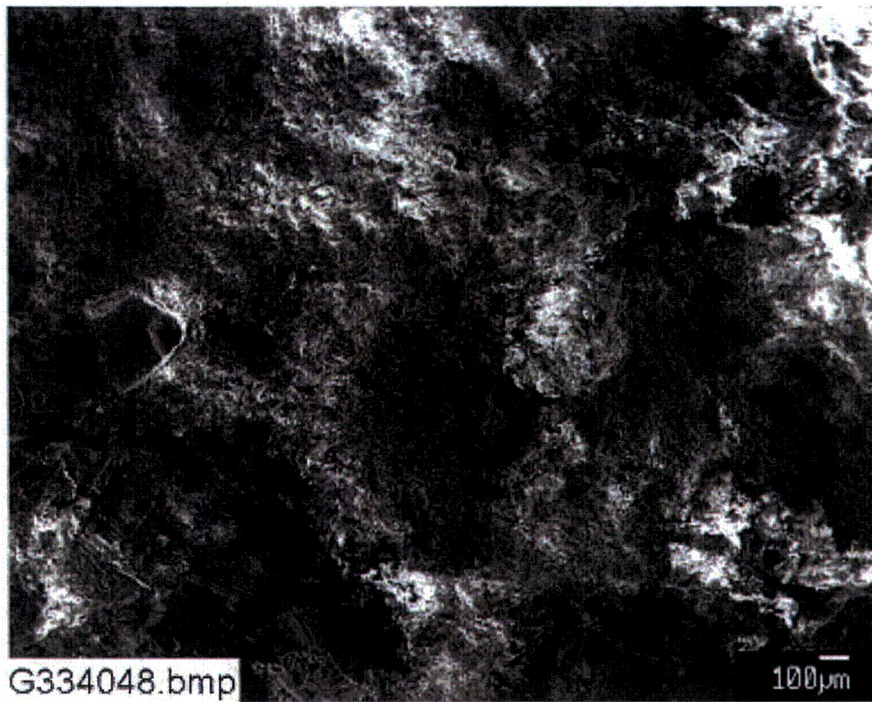
Figure C3-8. SEM image for a Test #2, Day-30 submerged galvanized steel coupon. (G334048)

Image:	G334048	40 ×	On corroded surface	Figure C3-8
	G334049	150 ×	SEI on corroded surface	Figure C3-9
	G334050	150 ×	BEI on corroded surface	Figure C3-10
EDS:	GEDS29		EDS on fiberlike crystals on T2D30 submerged G-Steel	Figure C3-11
Image:	G334051	1000 ×		Figure C3-12

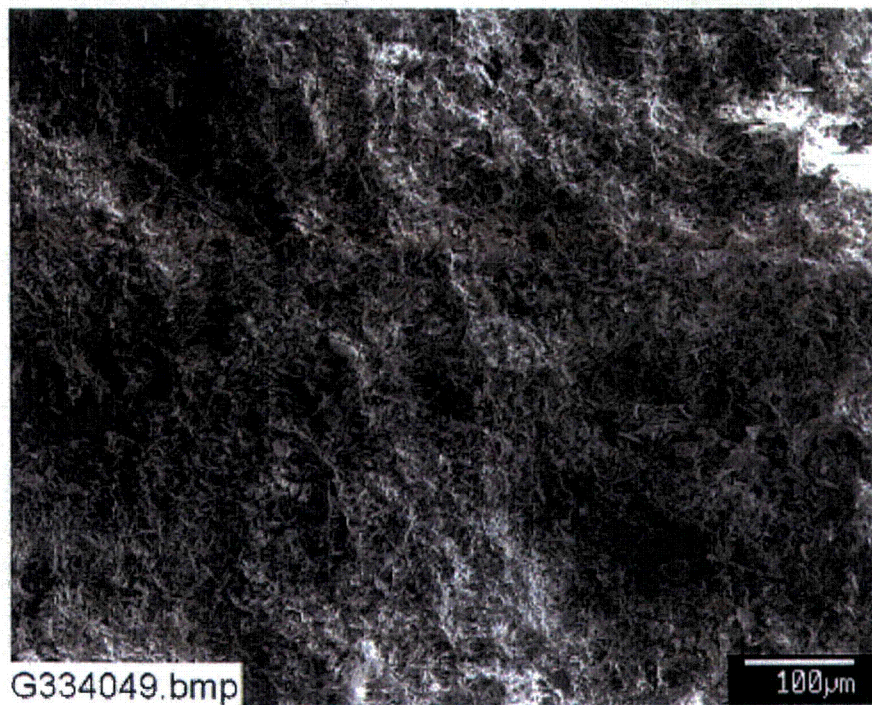
Figure C3-9. SEM image for a Test #2, Day-30 submerged GS coupon. (G334049)

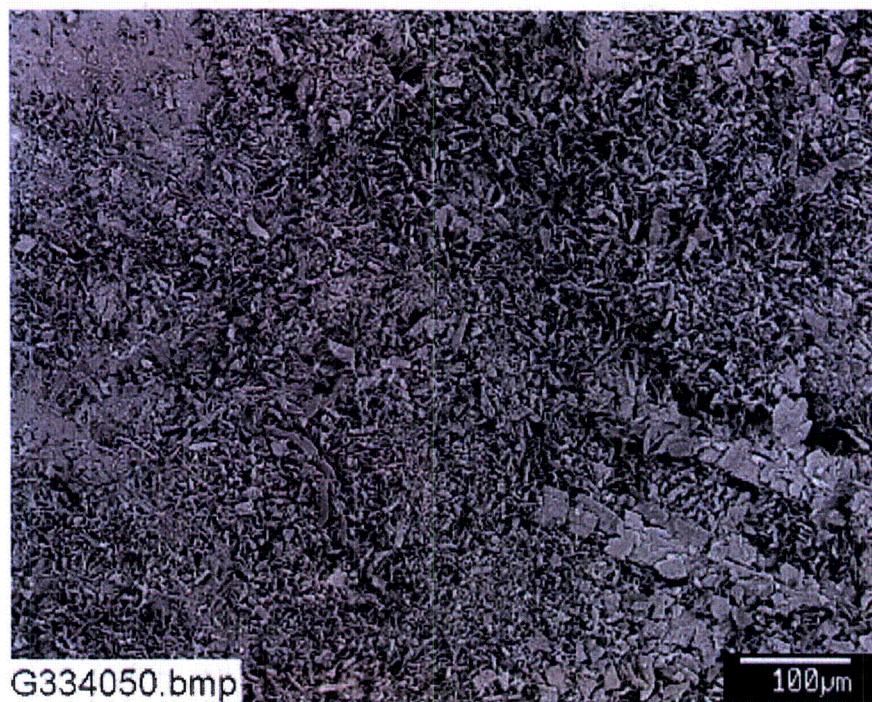
Figure C3-10. Backscattered SEM image for a Test #2, Day-30 submerged GS coupon. (G334050)

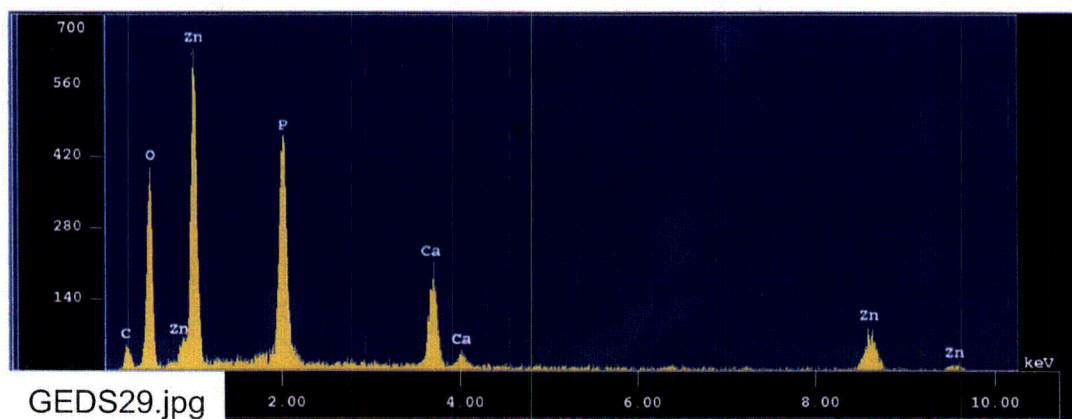
Figure C3-11. EDS counting spectrum on fiberlike crystals shown in Figure C3-10. (GEDS29)

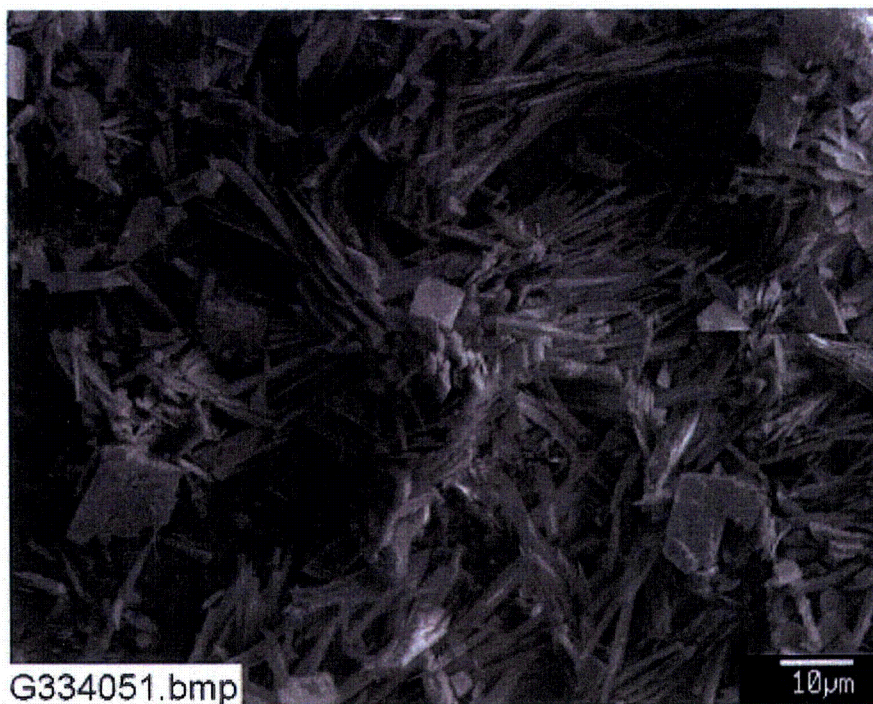
Figure C3-12. SEM image for a Test #2, Day-30 submerged GS coupon. (G334051)

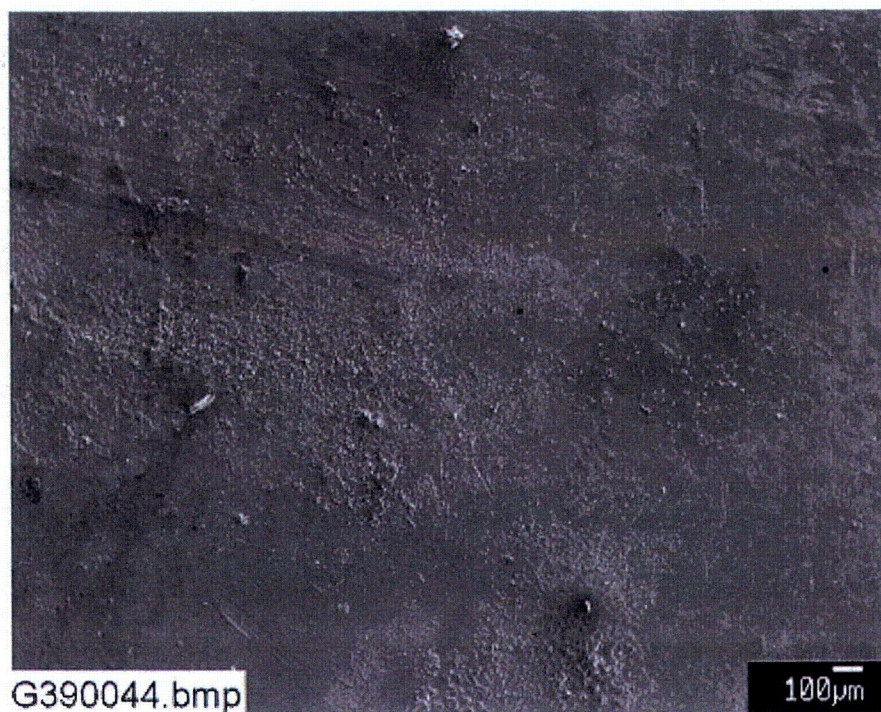
Figure C3-13. SEM image for a Test #2, Day-30 unsubmerged GS coupon. (G390044)

Image:	G390044	40 ×	overview of surface	Figure C3-13
	G390045	150 ×	SEI same as above	Figure C3-14
	G390046	150 ×	BEI same as above	Figure C3-15
EDS:	GEDS27		EDS on dark spot T2D30 unsubmerged G-steel	Figure C3-16
	GEDS28		EDS on light surface of T2D30 unsubmerged G-steel	Figure C3-17
Image:	G390047	1000 ×	SEI on corroded surface	Figure C3-18

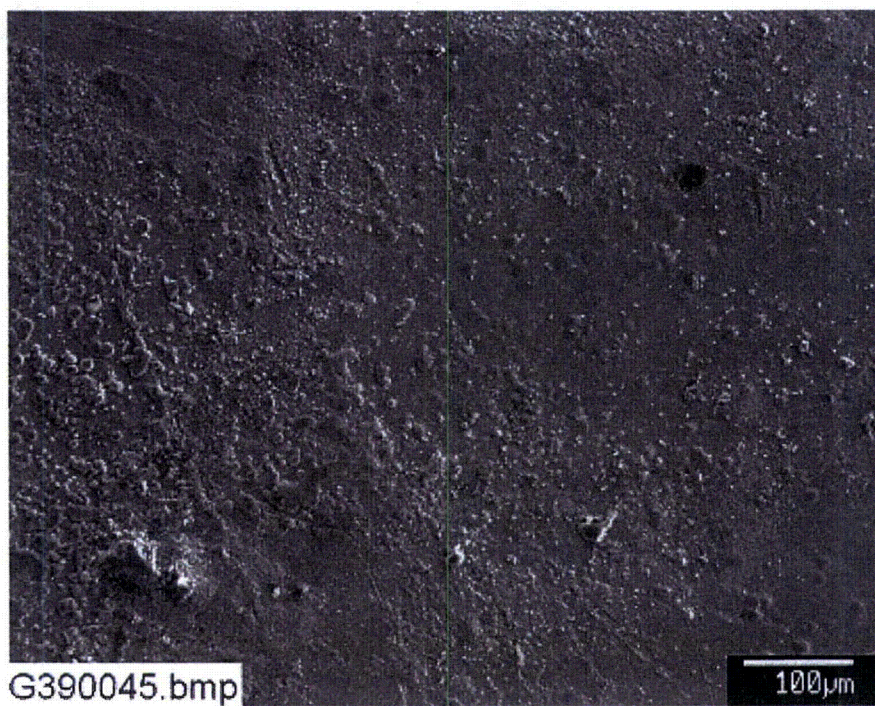
Figure C3-14. SEM image for a Test #2, Day-30 unsubmerged GS coupon. (G390045)

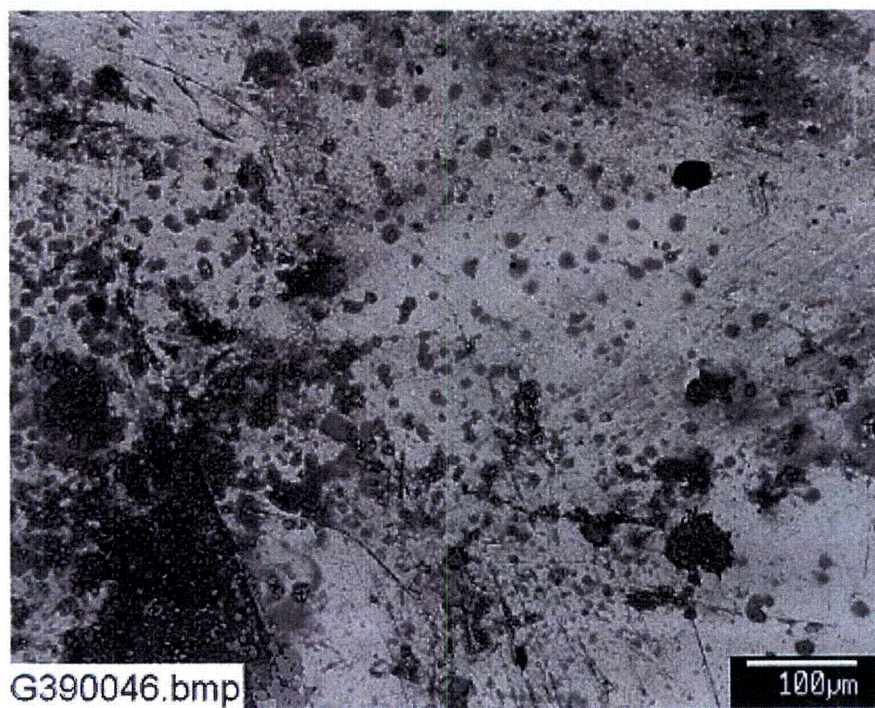
Figure C3-15. Backscattered SEM image for a Test #2, Day-30 unsubmerged GS coupon. (G390046)

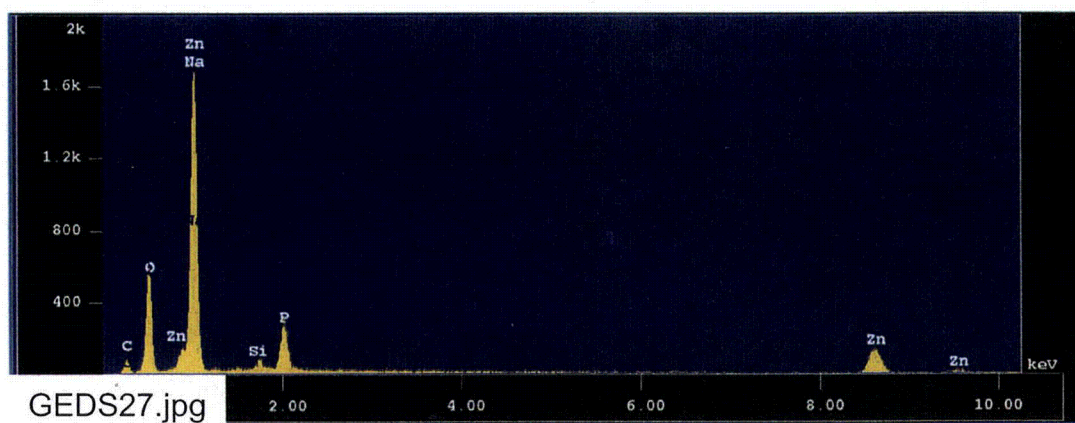
Figure C3-16. EDS counting spectrum on the dark spots shown in Figure C3-15. (GEDS27)

The results from the chemical composition analysis for GEDS27 are given in Table C3-1.

Element	Mass%	Atomic%	ZAF	Z	A	F
O	25.047	54.4632	0.9144	0.8736	1.0468	0.9999
Na	0.000	0.0000	2.3046	0.9205	2.5030	1.0002
Si	1.403	1.7380	1.5824	0.8740	1.8129	0.9987
P	7.881	8.8519	1.0292	1.0482	0.9818	1.0000
Zn	65.668	34.9468	1.1110	1.1123	0.9988	1.0000

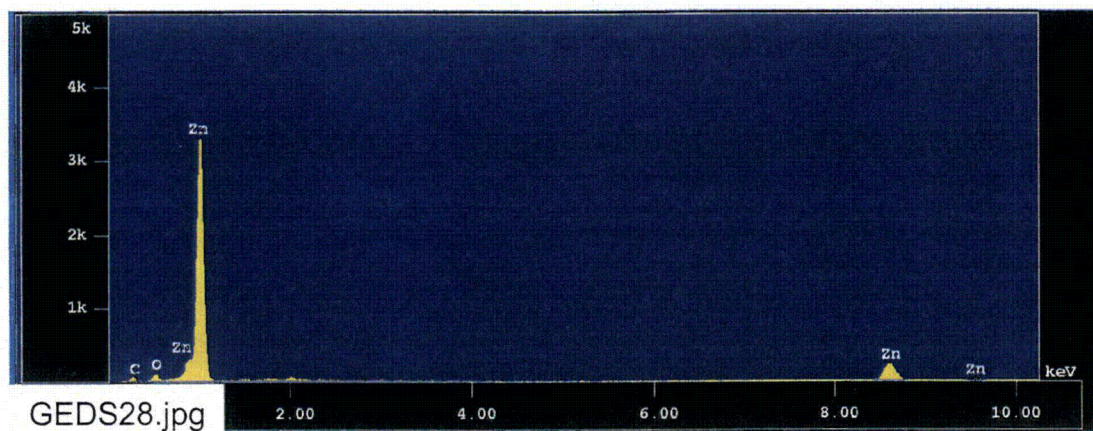
Figure C3-17. EDS counting spectrum on the light surface shown in Figure C3-15. (GEDS28)

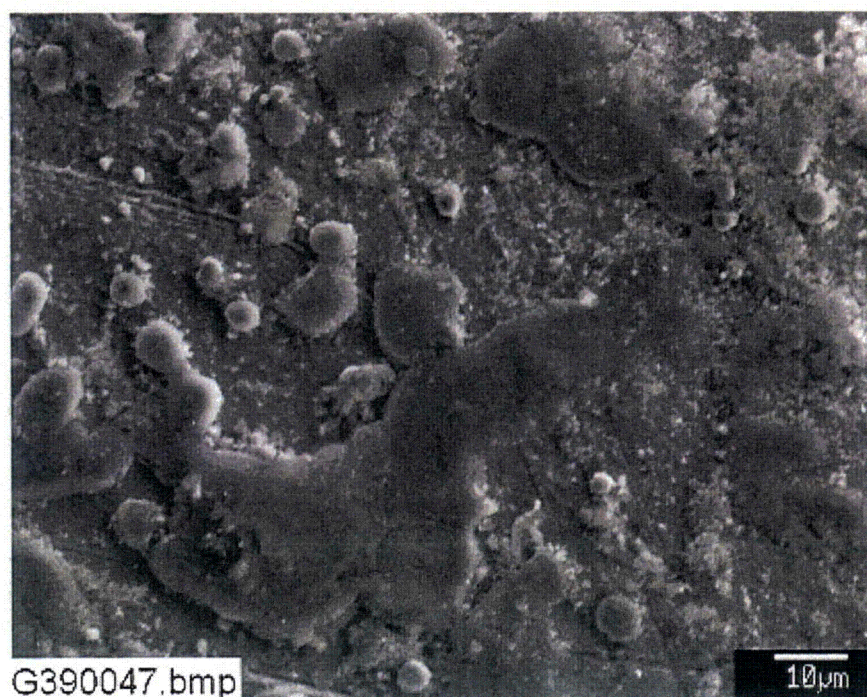
Figure C3-18. SEM image at 1000× magnification for a Test #2, Day-30 unsubmerged GS coupon. (G390047)

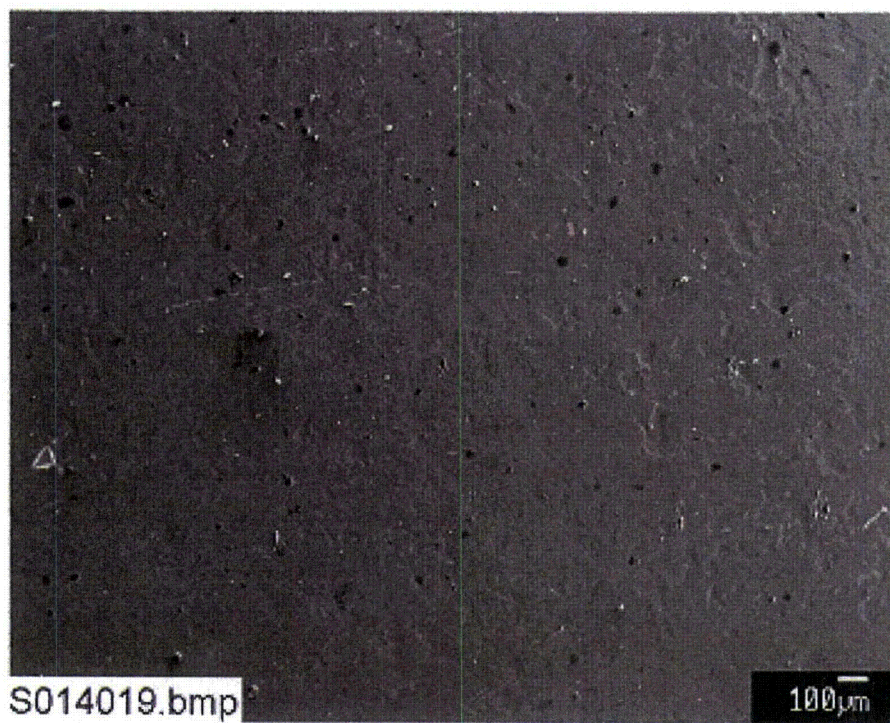
Figure C4-1. SEM image for an unused steel coupon. (S014019)

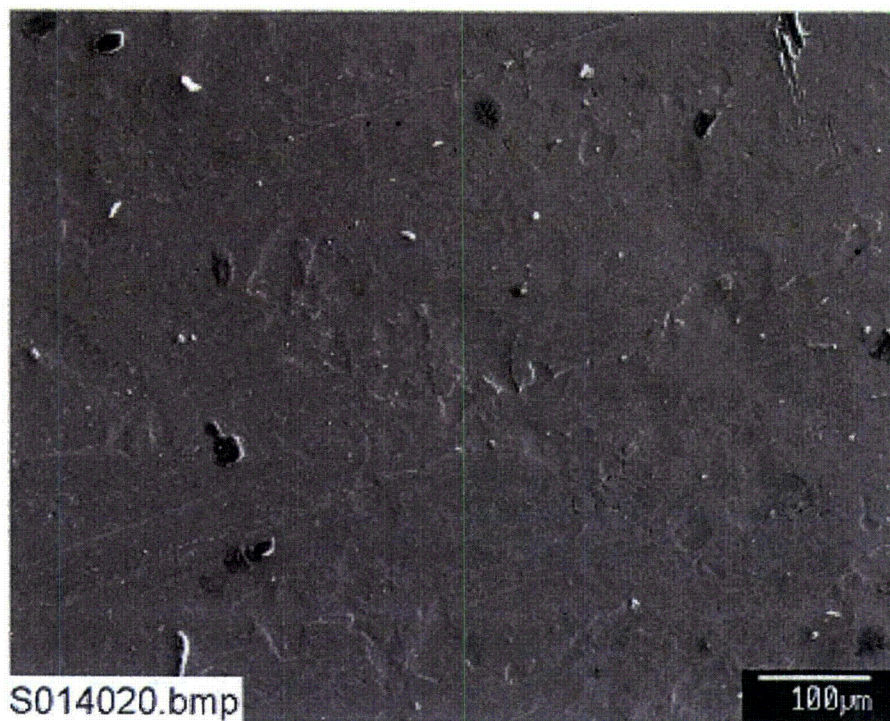
Figure C4-2. SEM image for an unused steel coupon. (S014020)

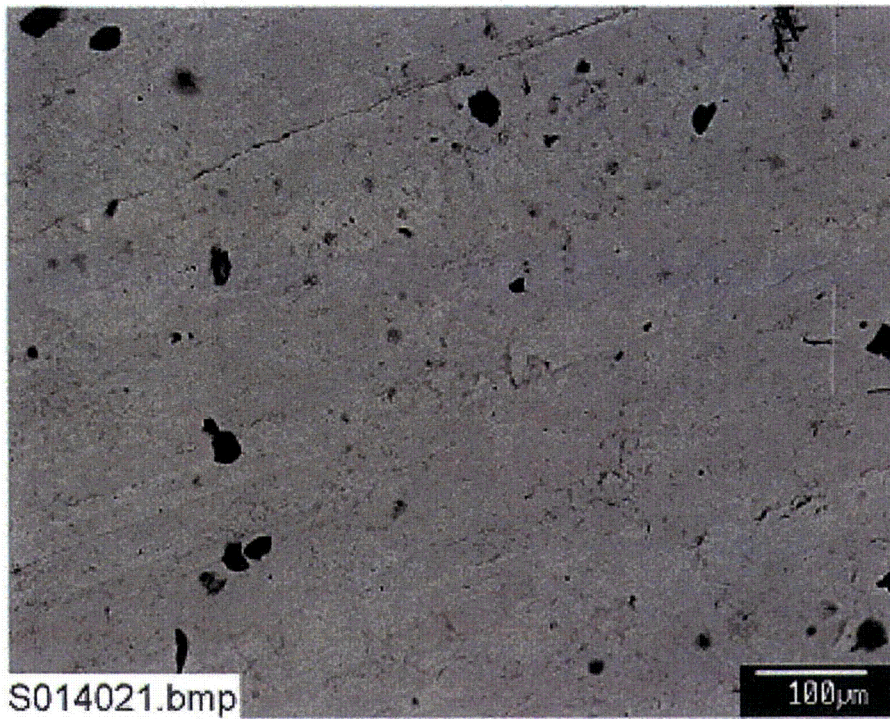
Figure C4-3. Backscattered SEM image for an unused steel coupon. (S014021)

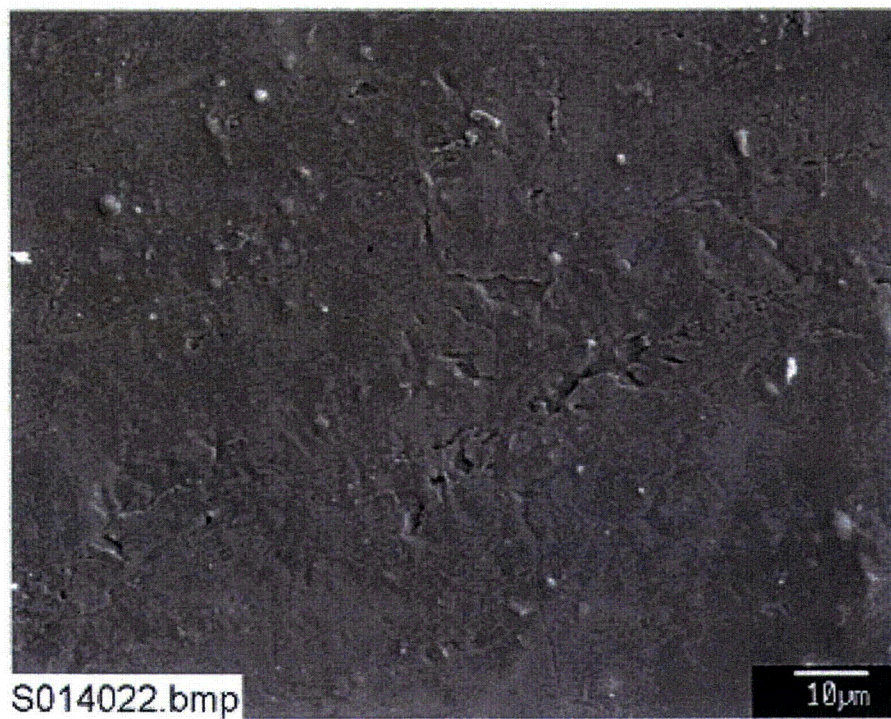
Figure C4-4. SEM image for an unused steel coupon. (S014022)

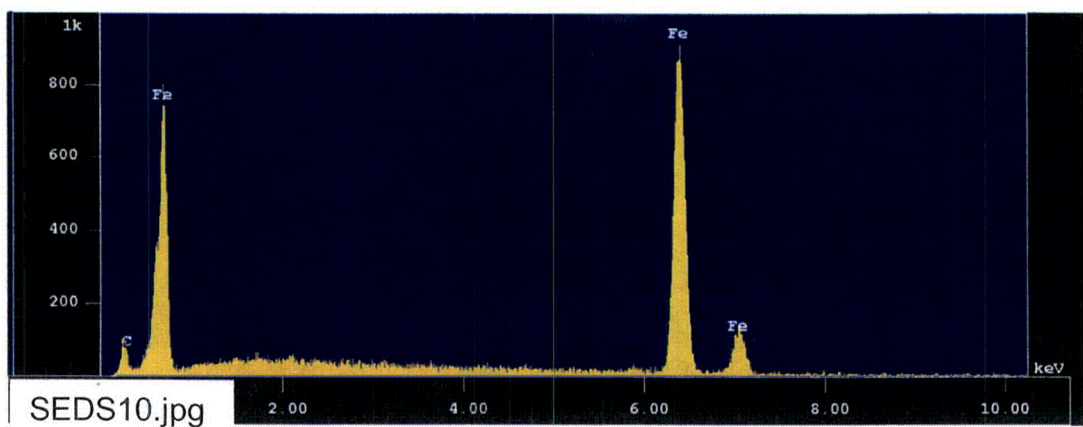
Figure C4-5. EDS counting spectrum for the steel surface shown in Figure C4-4. (SEDS10)

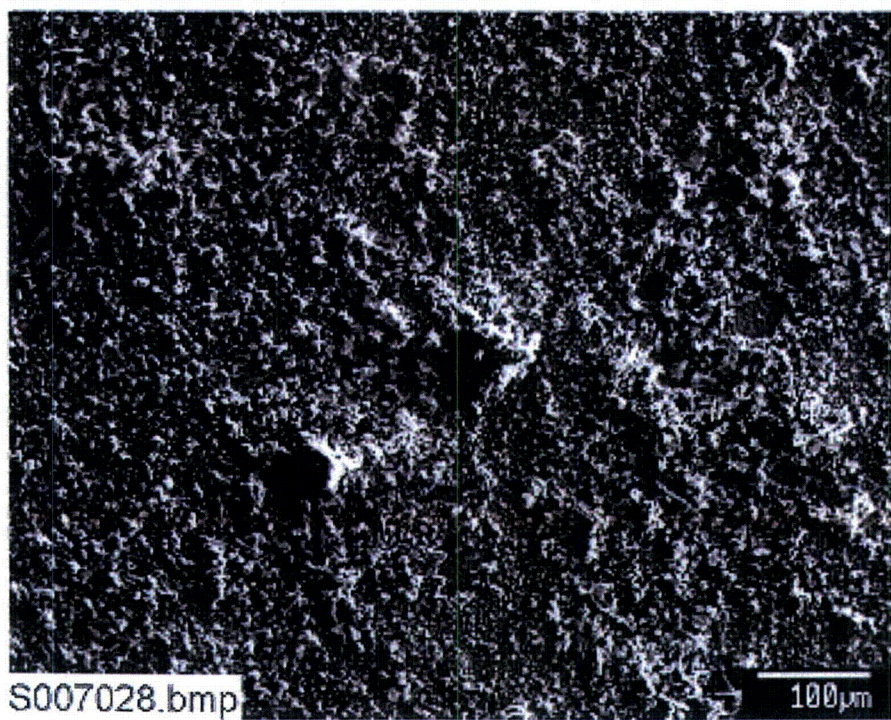
Figure C4-6. SEM image for a Test #2, Day-30 submerged steel coupon. (S007028)

Image:	S007028	150 ×	SEI corroded surface	Figure C4-6
	S007028annotated	150 ×	EDS spots 17–19	Figure C4-7
	S007029	150 ×	BEI same place	Figure C4-8
EDS:	SEDS17		Light area in image 029	Figure C4-9
Image:	S007030	1000 ×	SEI on corrosion surface	Figure C4-10
EDS:	SEDS18		Crystals on corroded steel (see image 030)	Figure C4-11
	SEDS19		Clump of corrosion product	Figure C4-12

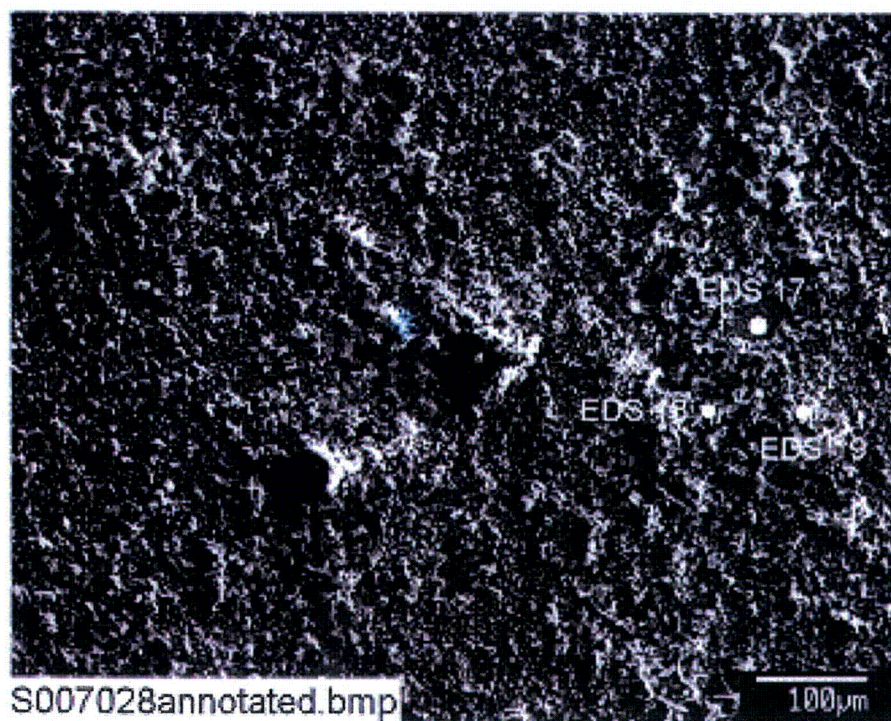
Figure C4-7. SEM image for the corrosion surface of a Test #2, Day-30 submerged steel coupon. (S007028annotated)

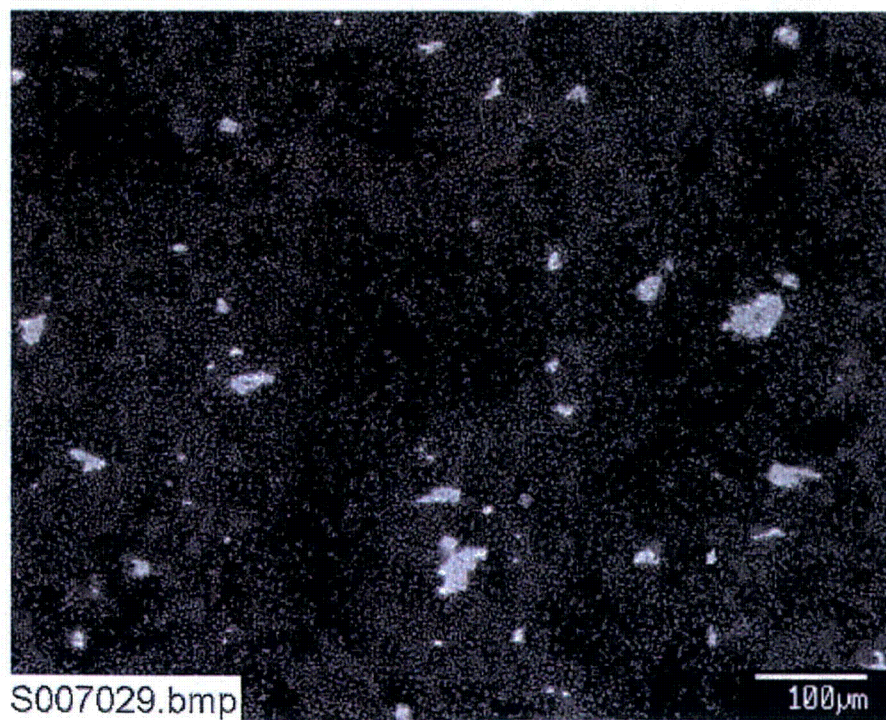
Figure C4-8. Backscattered SEM image for a Test #2, Day-30 submerged steel coupon. (S007029)

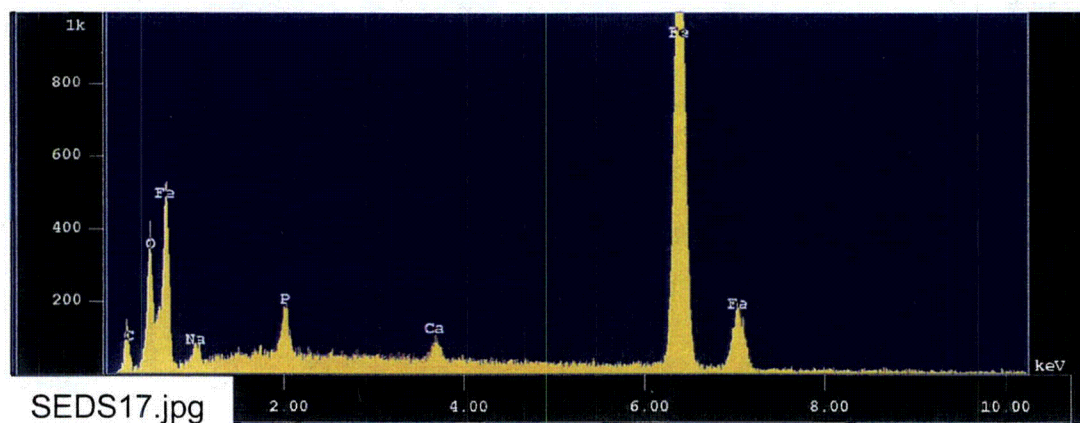
Figure C4-9. EDS counting spectrum for the light spot shown in Figure C4-8. (SEDS17)

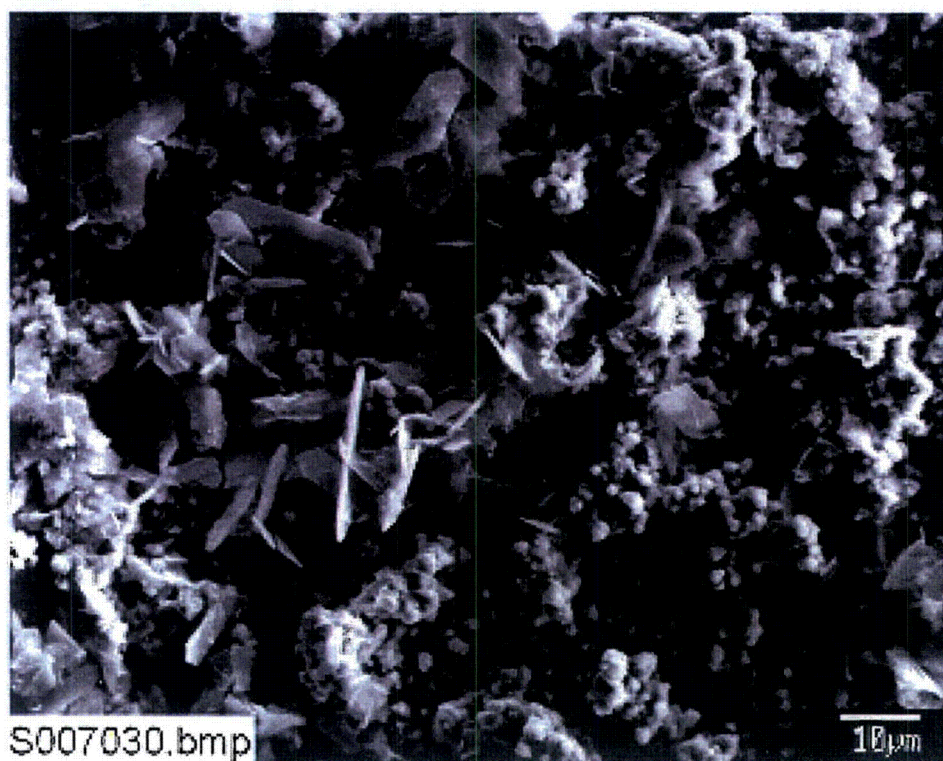
Figure C4-10. SEM image for the corrosion surface of a Test #2, Day-30 submerged steel coupon. (S007030)

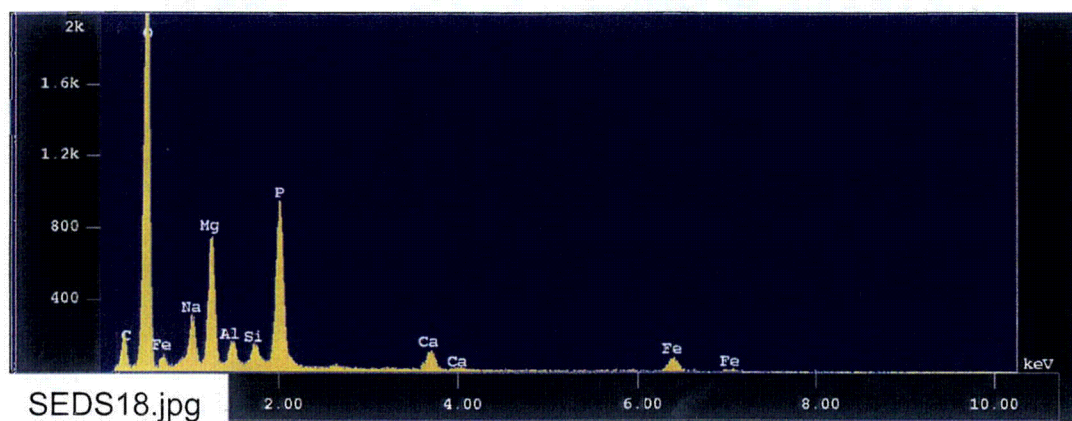
Figure C4-11. EDS counting spectrum for the thin crystals shown in Figure C4-10. (SEDS18)

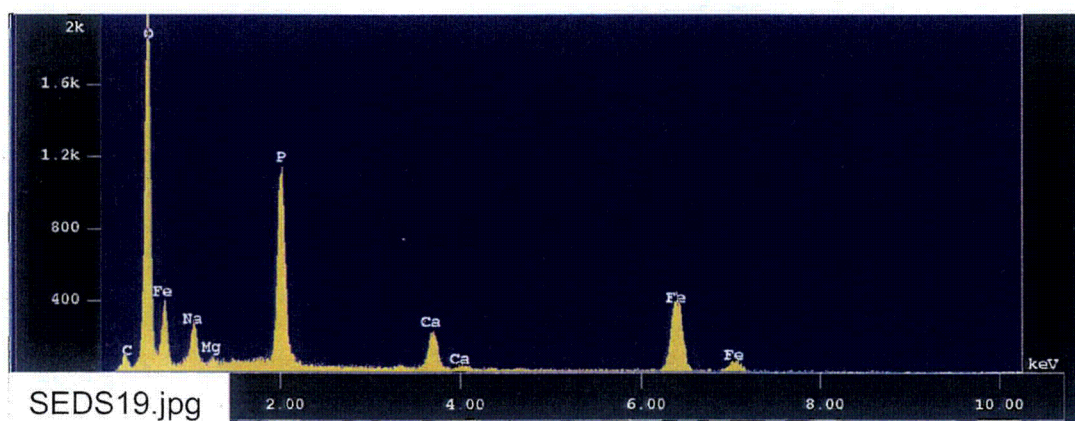
Figure C4-12. EDS counting spectrum for the clumps surrounding crystals shown in Figure C4-10. (SEDS19)

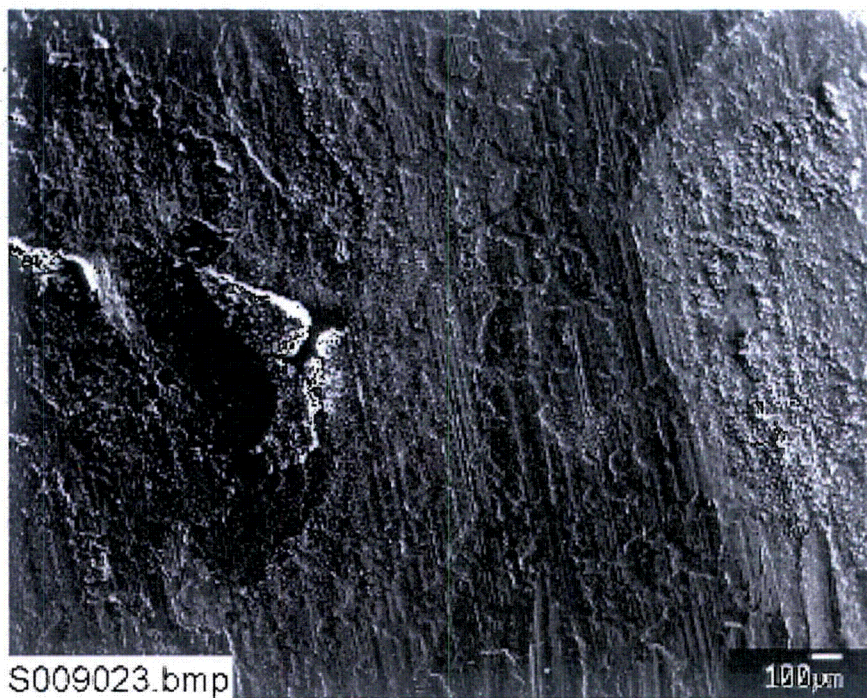
Figure C4-13. SEM image for a Test #2, Day-30 unsubmerged steel coupon. (S009023)

Image:	S009023	40 ×	SEI overview of corroded & noncorroded surface	Figure C4-13
	S009024	40 ×	BEI same area	Figure C4-14
	S009024annotated	40 ×	EDS spots 11–15	Figure C4-15
EDS:	SEDS11		Steel surface- light (in image 024)	Figure C4-16
	SEDS12		Steel—light gray in BSE	Figure C4-17
	SEDS13		Medium gray corrosion on steel	Figure C4-18
	SEDS14		Dark gray corrosion	Figure C4-19
	SEDS15		Dark gray corrosion	Figure C4-20
Image:	S009025	150 ×	SE at interface between badly corroded & less corroded surface	Figure C4-21
	S009026	150 ×	BSE same area	Figure C4-22
	S009027	1000 ×	SE corroded area	Figure C4-23
EDS:	SEDS16		Clump of rounded corrosion crystals	Figure C4-24

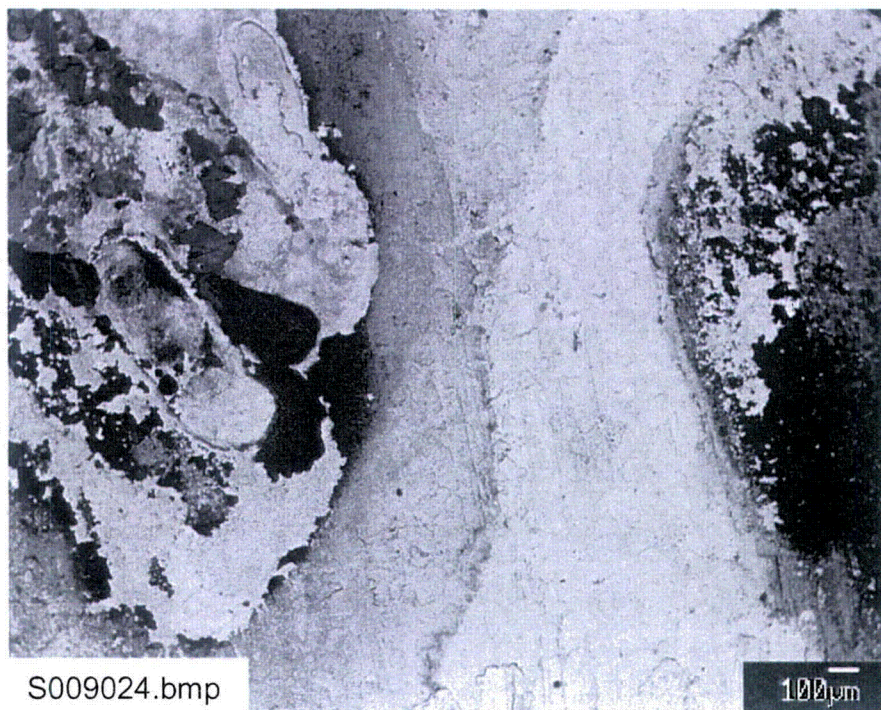
Figure C4-14. Backscattered SEM image for a Test #2, Day-30 unsubmerged steel coupon. (S009024)

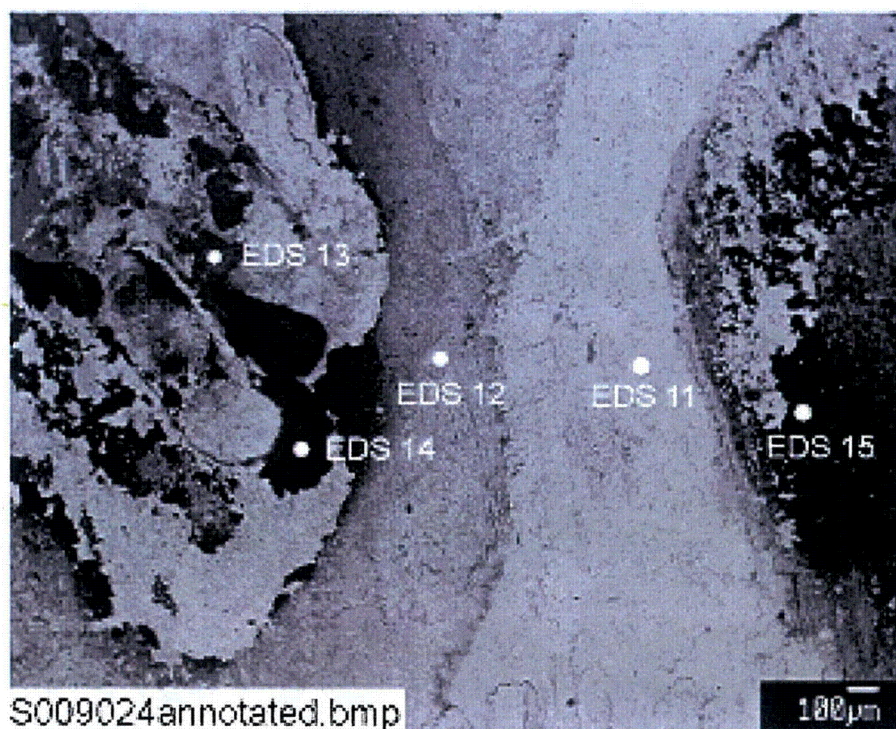
Figure C4-15. Annotated backscattered SEM image for a Test #2, Day-30 unsubmerged steel coupon.  
(S009024annotated)

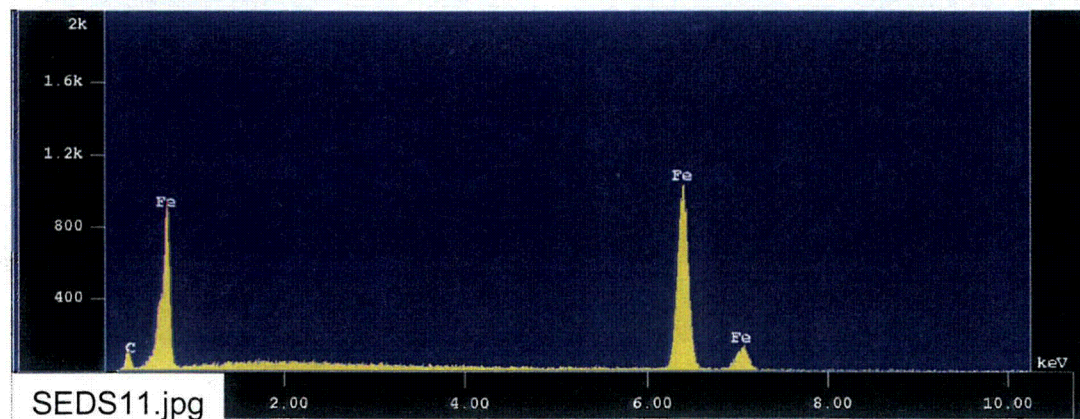
Figure C4-16. EDS counting spectrum for the light streak (EDS-11) shown in Figure C4-15.  
(SEDS11)

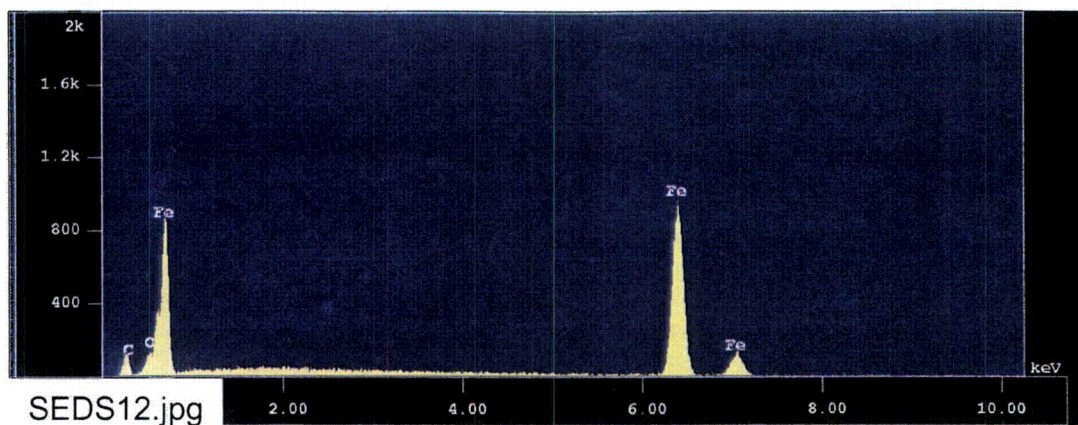
Figure C4-17. EDS counting spectrum for the light grey streak (EDS-12) shown in Figure C4-15. (SEDs12)

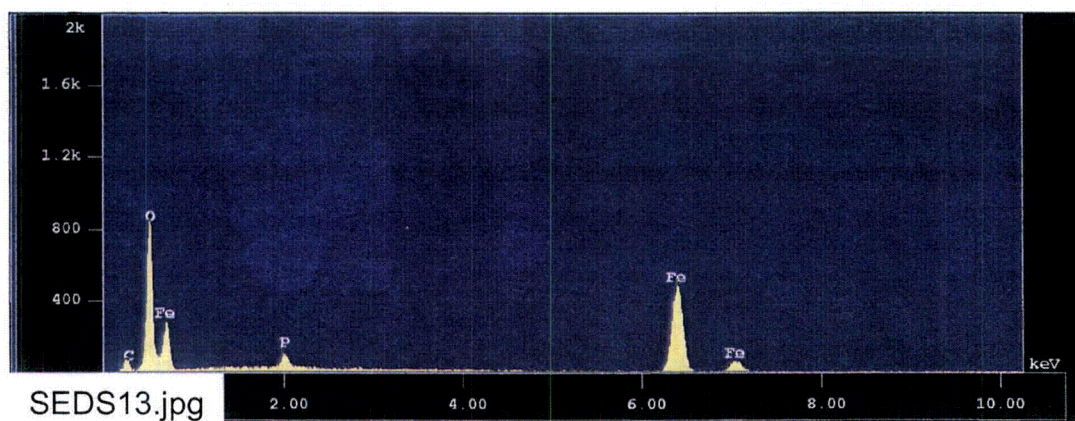
Figure C4-18. EDS counting spectrum for the medium grey spot (EDS-13) shown in Figure C4-15. (SEDs13)

Figure C4-18. EDS counting spectrum for the medium grey spot (EDS-13) shown in Figure C4-15. (SEDS13) .....	C4-13
Figure C4-19. EDS counting spectrum for the dark grey spot (EDS-14) shown in Figure C4-15. (SEDS14) .....	C4-13
Figure C4-20. EDS counting spectrum for the dark spot (EDS-15) shown in Figure C4-15. (SEDS15) .....	C4-14
Figure C4-21. SEM image for a Test #2, Day-30 unsubmerged steel coupon (S009025). The image shows the interface between badly corroded (right) and less corroded surface (left). .....	C4-14
Figure C4-22. Backscattered SEM image for a Test #2, Day-30 unsubmerged steel coupon (S009026). It shows the same area as shown in Figure C4-21. ....	C4-15
Figure C4-23. SEM image for a corroded area of a Test #2, Day-30 unsubmerged steel coupon. (S009027) .....	C4-15
Figure C4-24. EDS counting spectrum for a clump of round corrosion crystals shown in Figure C4-23. (SEDS16) .....	C4-16

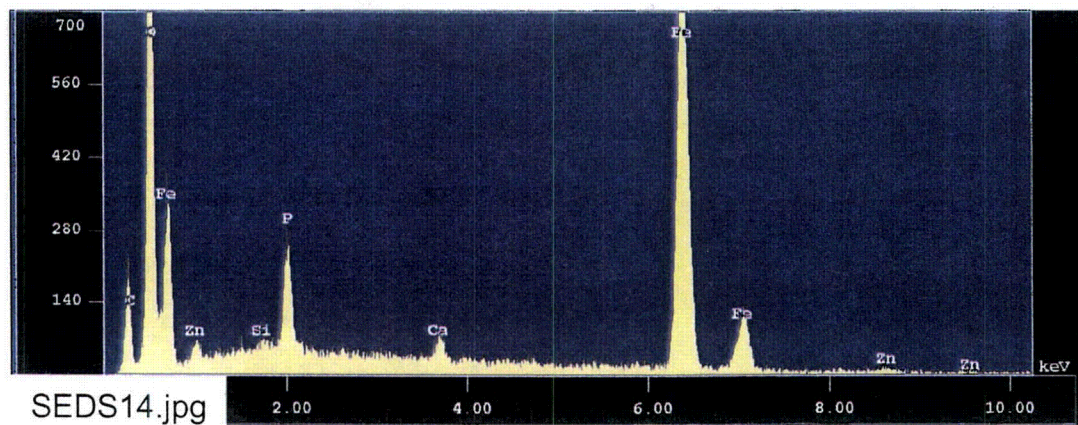
Figure C4-19. EDS counting spectrum for the dark grey spot (EDS-14) shown in Figure C4-15. (SEDs14)
