# Appendix C1

## SEM/EDS Data for Unused and Test #2, Day-30 Aluminum Coupons

This appendix shows SEM/EDS results for the metal aluminum coupons in three different exposure categories: (1) unused, (2) suspended or unsubmerged, and (3) submerged. *Unused* refers to the coupon condition that existed before being subjected to ICET test conditions. *Suspended* or *unsubmerged* refers to coupons located above the water level of the solution during ICET tests. Suspended coupons contacted the solution only during the 4-hour spray period at the start of the test. In addition, the surface of the suspended coupons may also be affected by moisture in the test chamber gas space. *Submerged* refers to the coupons that were immersed in the test solution for the entire test.

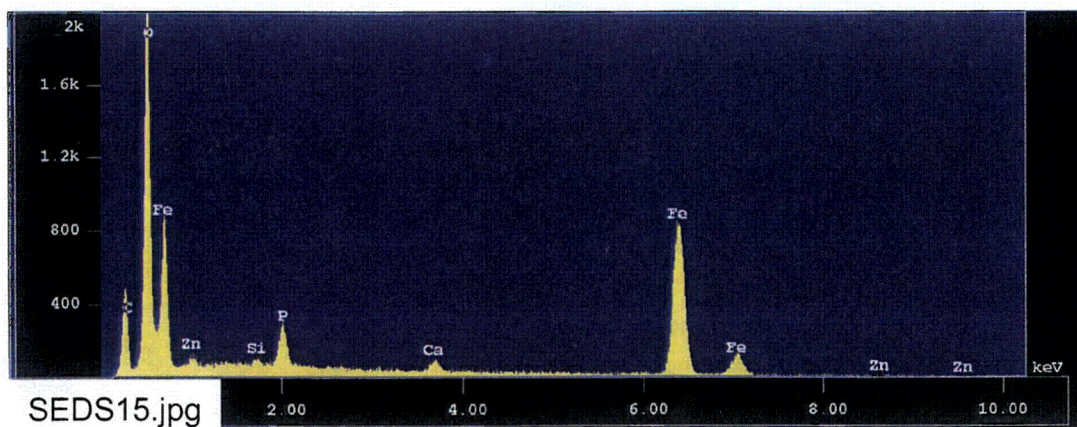
Figure C4-20. EDS counting spectrum for the dark spot (EDS-15) shown in Figure C4-15. (SEDS15)

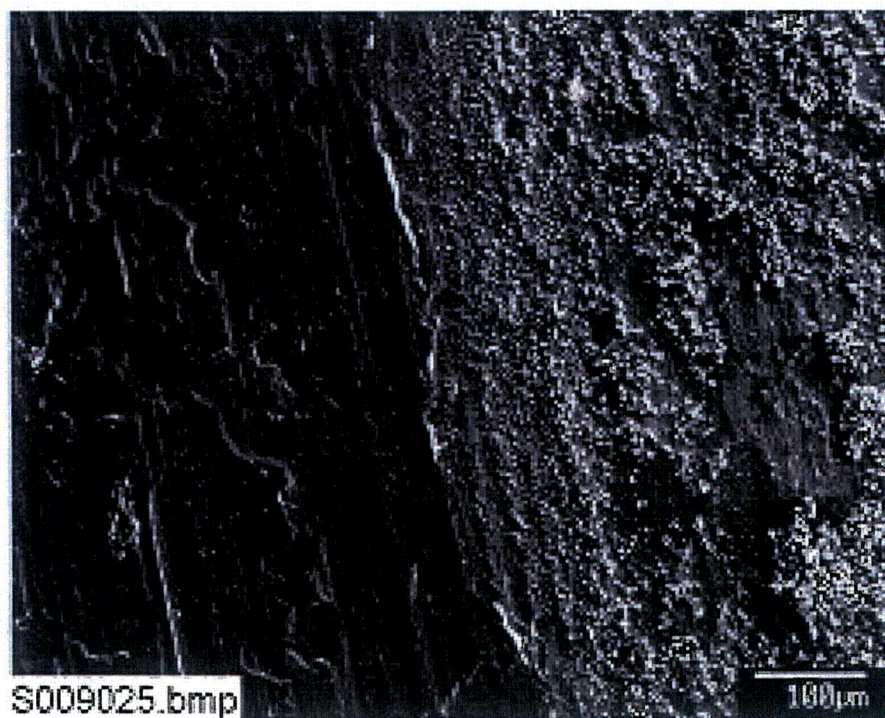
Figure C4-21. SEM image for a Test #2, Day-30 unsubmerged steel coupon (S009025). The image shows the interface between badly corroded (right) and less corroded surface (left).

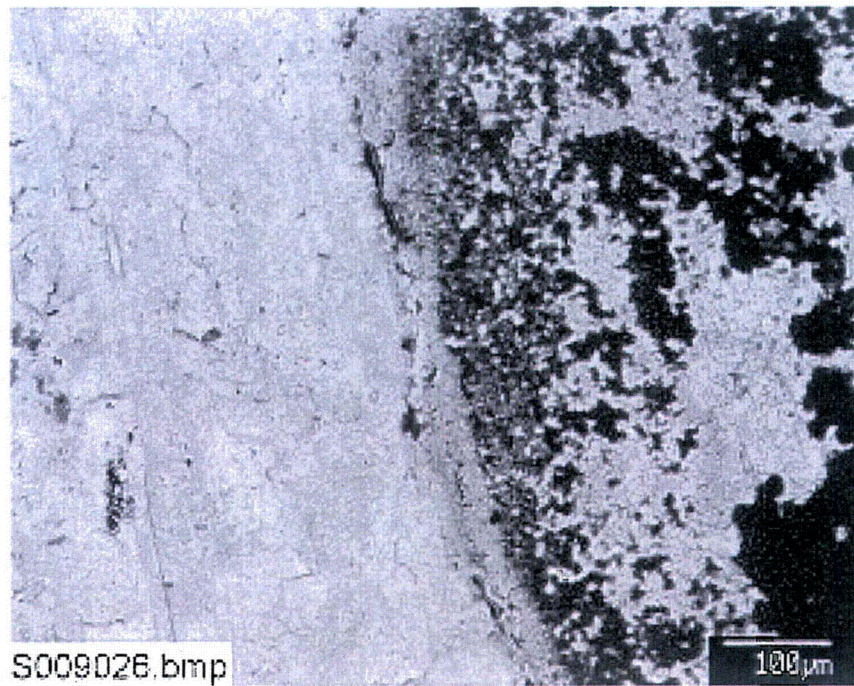
Figure C4-22. Backscattered SEM image for a Test #2, Day-30 unsubmerged steel coupon (S009026). It shows the same area as shown in Figure C4-21.

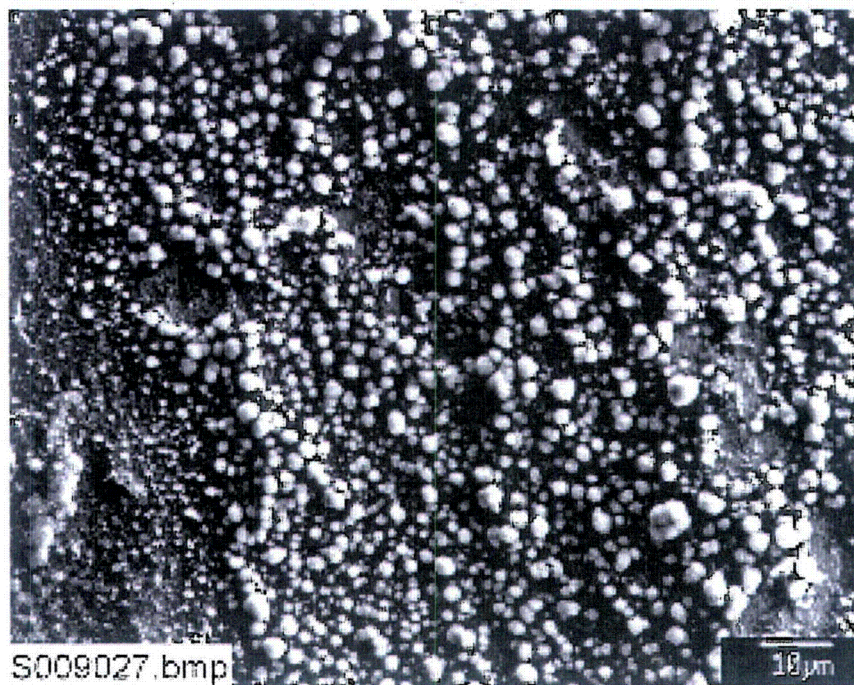
Figure C4-23. SEM image for a corroded area of a Test #2, Day-30 unsubmerged steel coupon. (S009027)

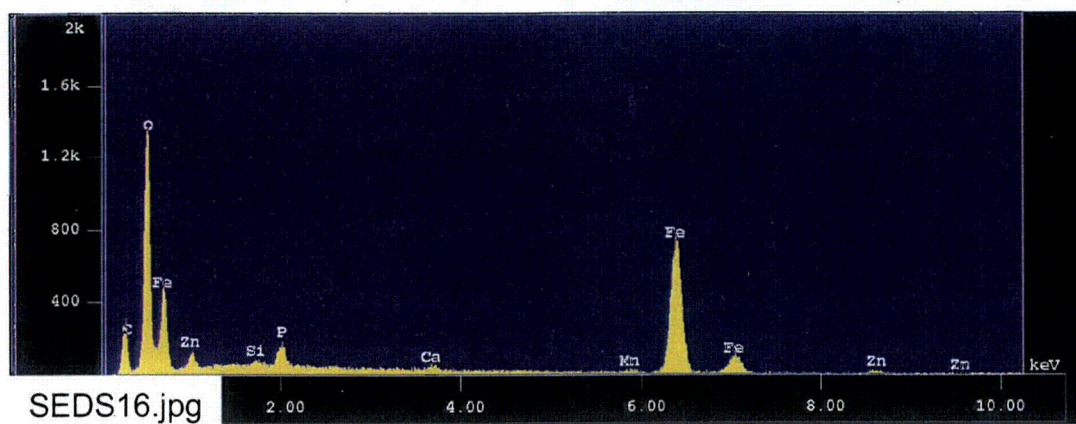
Figure C4-24. EDS counting spectrum for a clump of round corrosion crystals shown in Figure C4-23. (SEDS16)

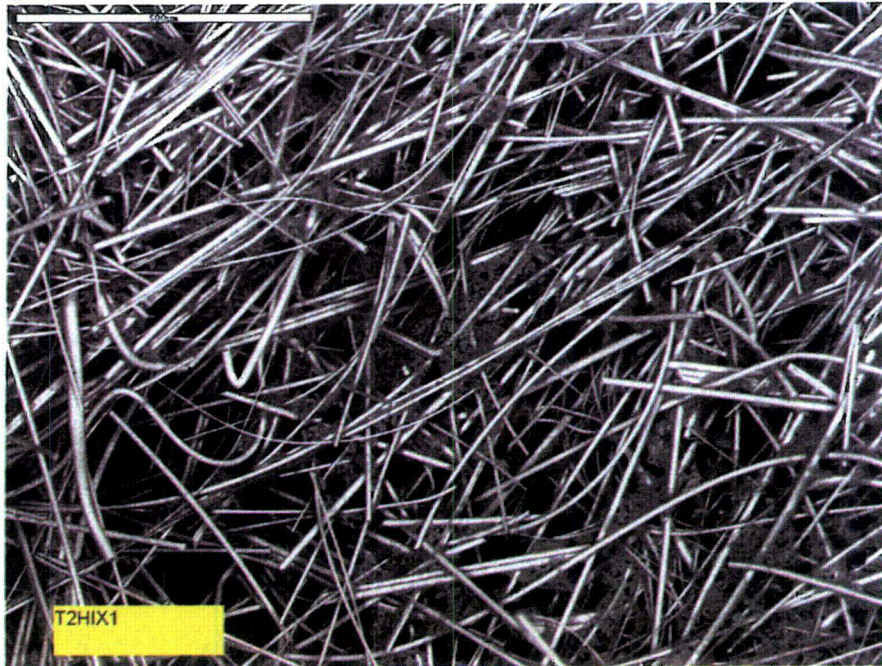
**Figure D1-1. Back-scattered electron (BSE) image overview. (T2HIX1)**

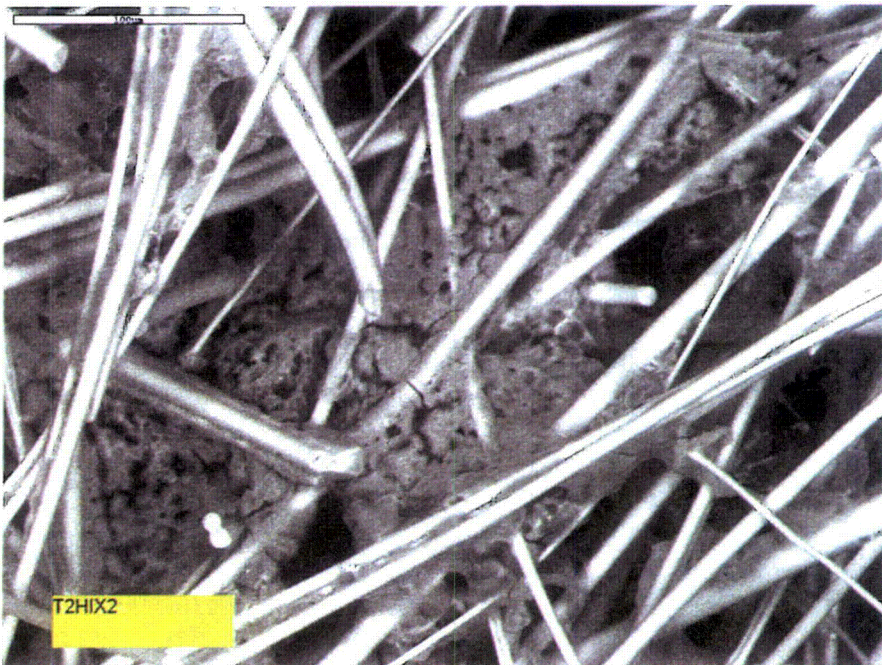
**Figure D1-2. BSE image on center of Figure D1-1. (T2HIX2)**

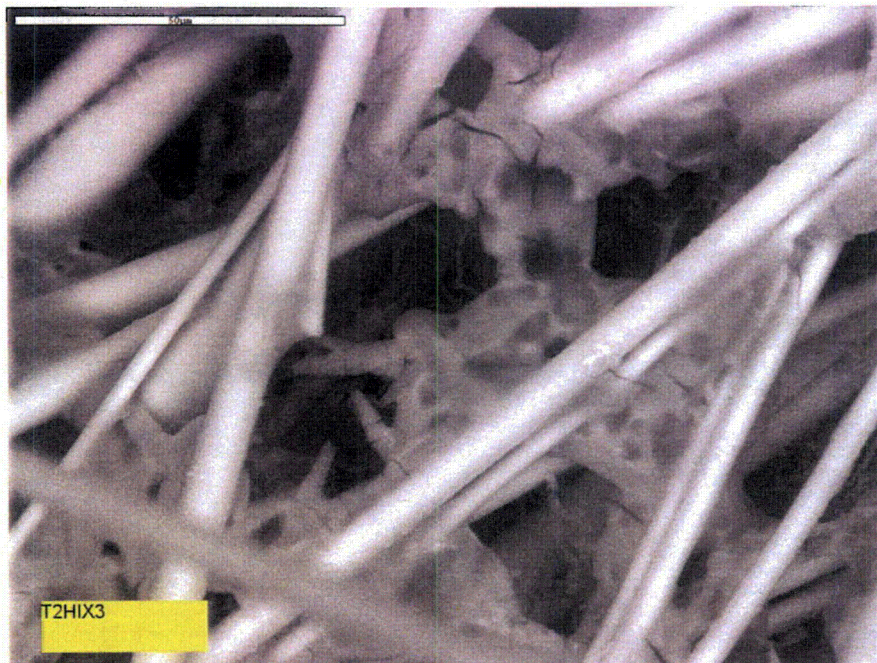
**Figure D1-3. BSE image at 1000 times magnification. (T2HIX3)**

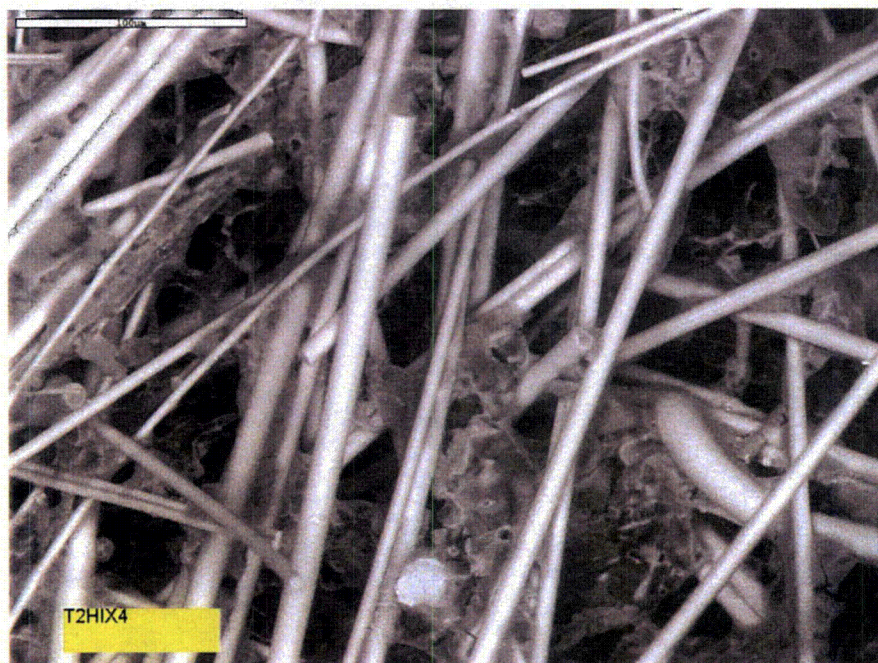
**Figure D1-4. BSE image at another angle on the center of the image. (T2HIX4)**

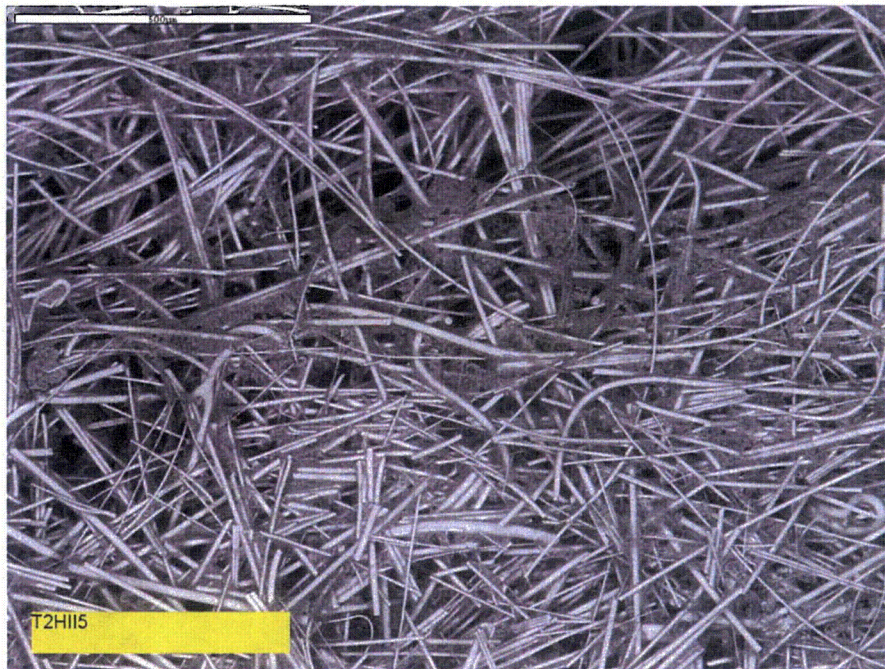
**Figure D1-5. SEM image overview for interior of high flow. (T2HI15)**

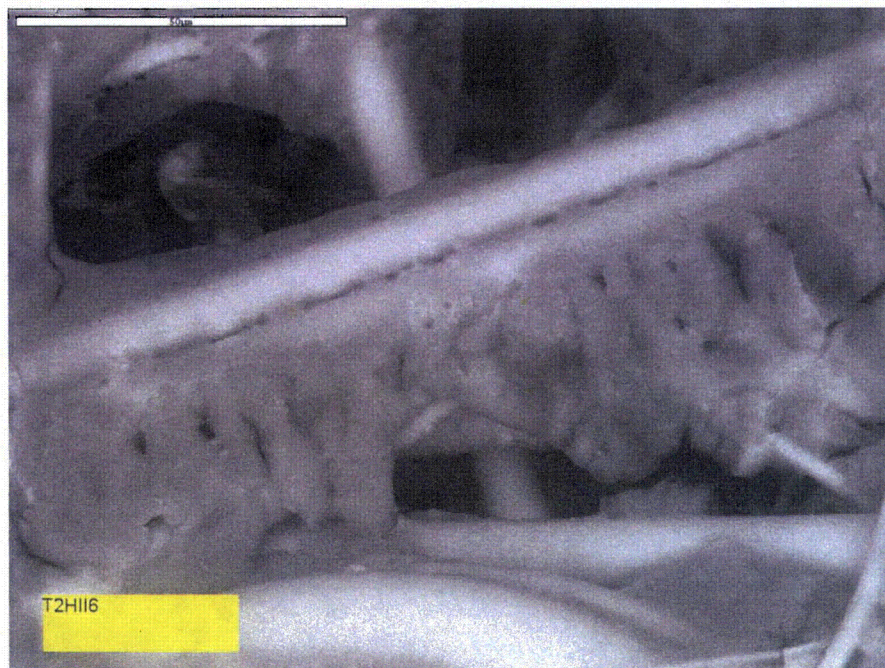
**Figure D1-6. SEM image of Figure D1-5 at 1000 times magnification. (T2HI16)**

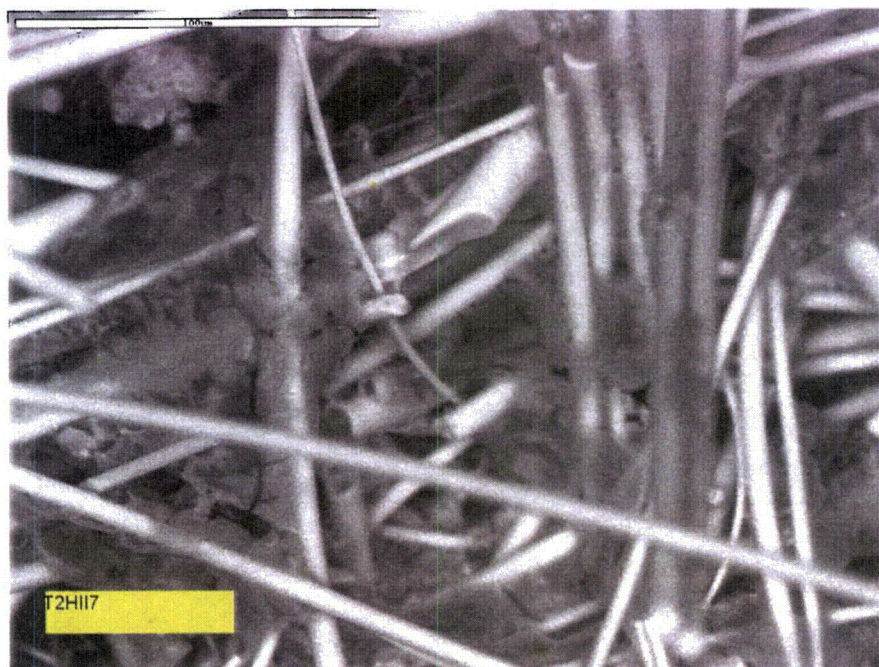
**Figure D1-7. SEM image of high-flow interior for another sample area. (T2H117)**

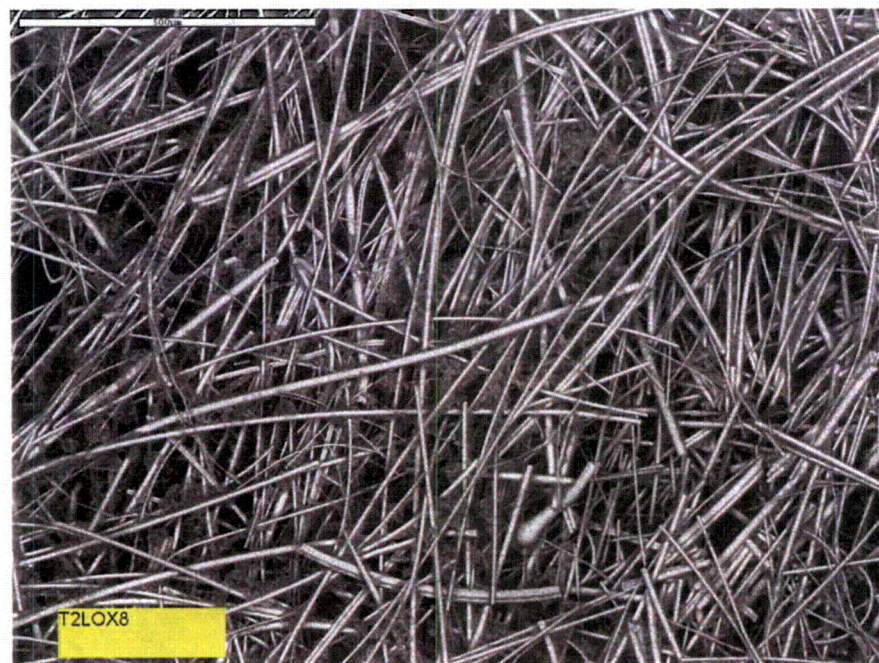
**Figure D1-8. SEM image overview for exterior of the low-flow sample. (T2LOX8)**

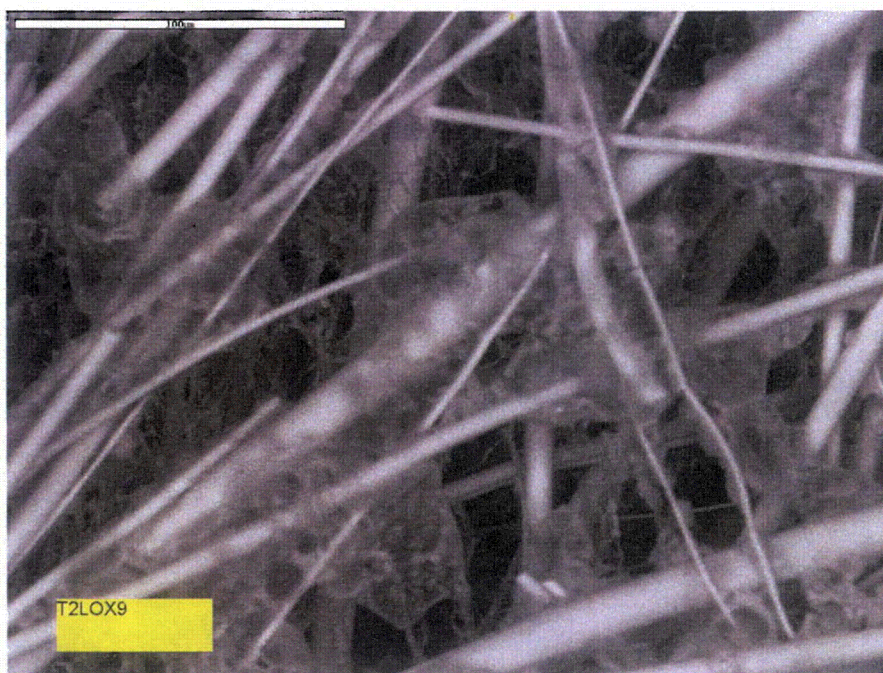
**Figure D1-9. SEM image of the upper left portion of Figure D1-8, low-flow exterior. (T2LOX9)**

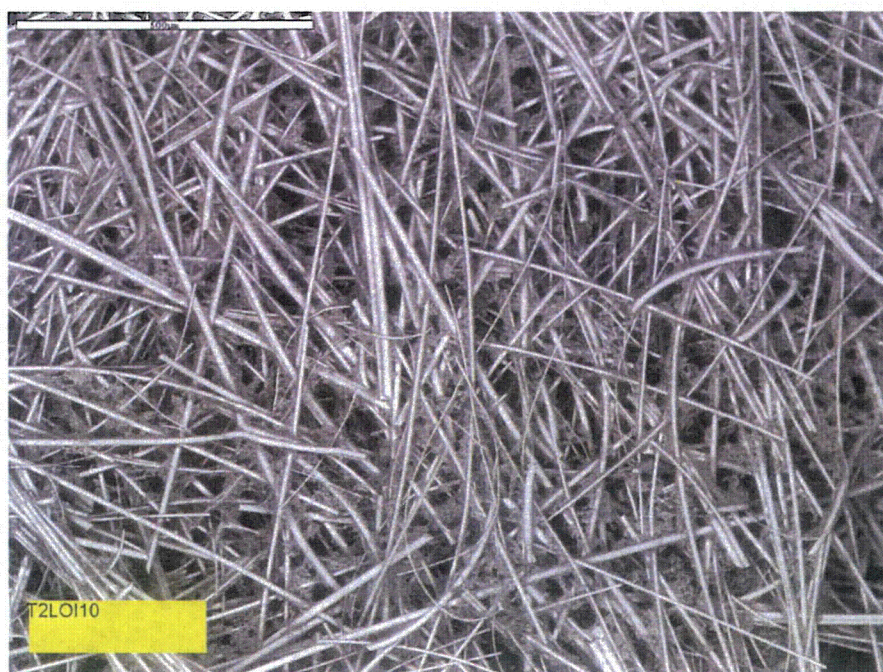
**Figure D1-10. SEM image overview for interior of the low-flow sample. (T2LOI10)**

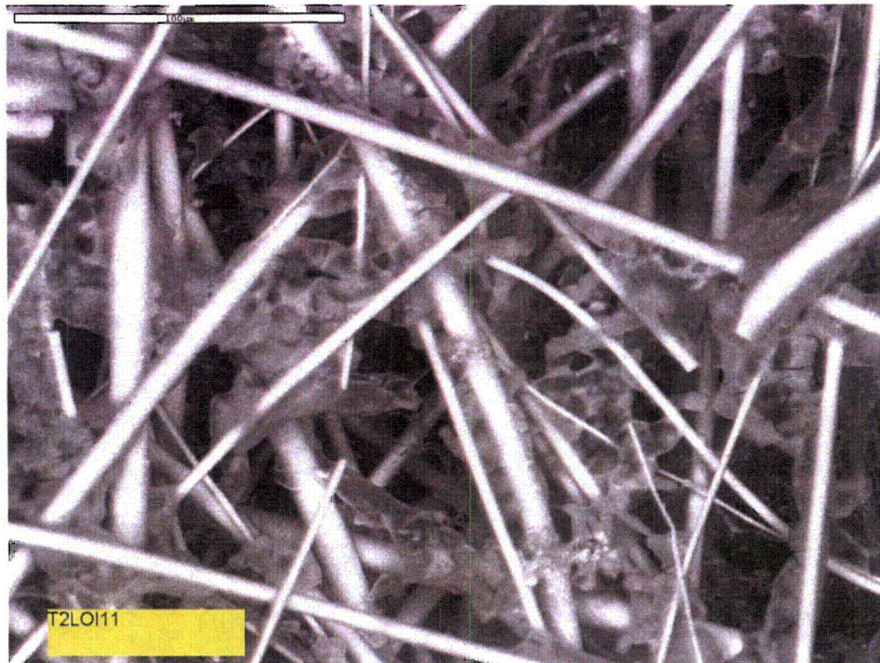
Figure D1-11. SEM image on the center of Figure D1-10, low-flow interior. (T2LOI11)

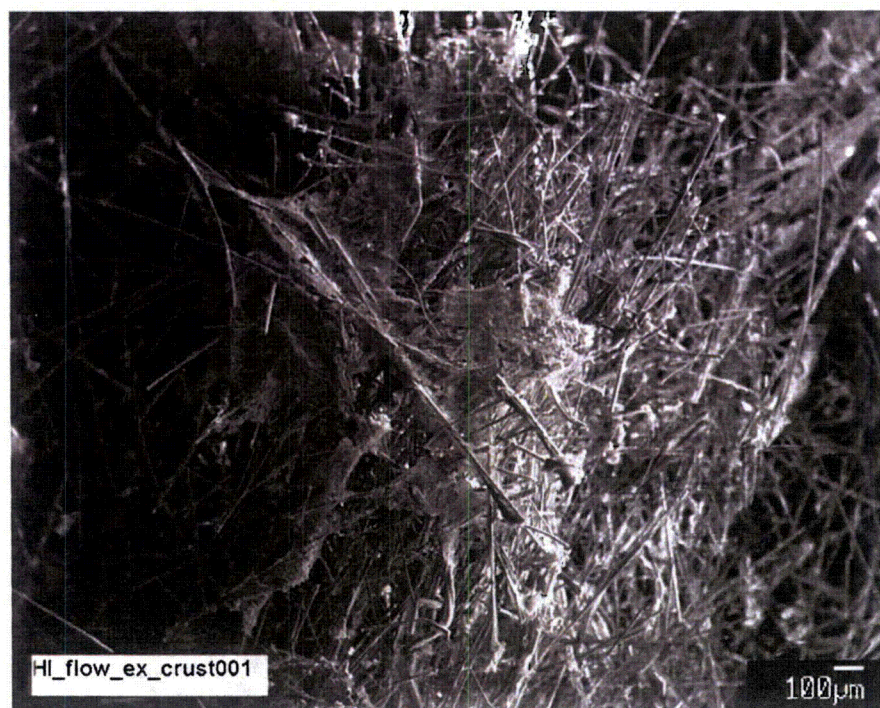
Figure D1-12. SEM image overview of exterior crust. (HI\_flow\_ex\_crust001)

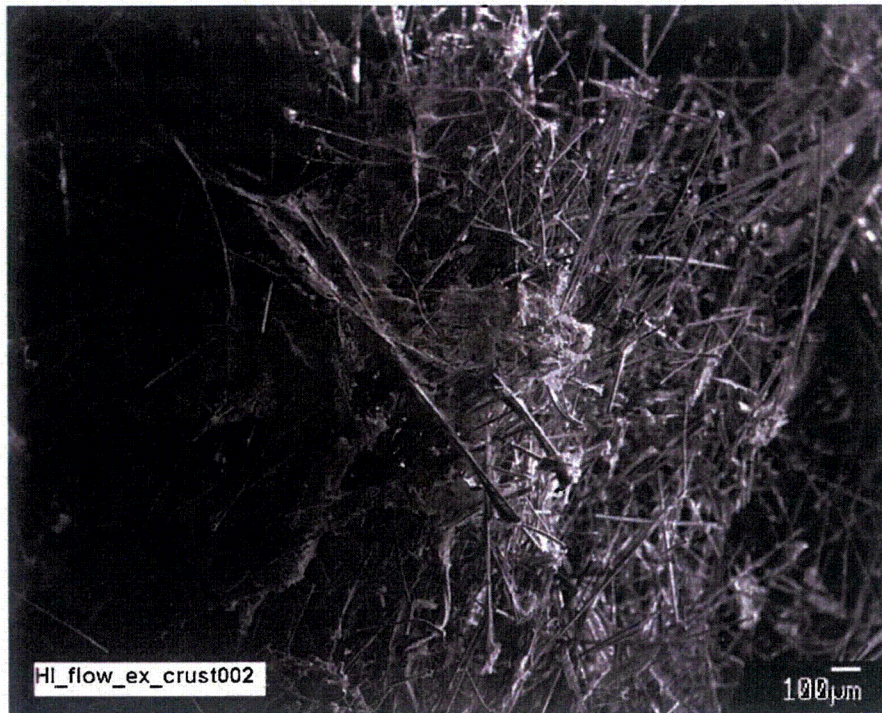
Figure D1-13. SEM image overview of the same area of Figure D1-12. (HI\_flow\_ex\_crust002)

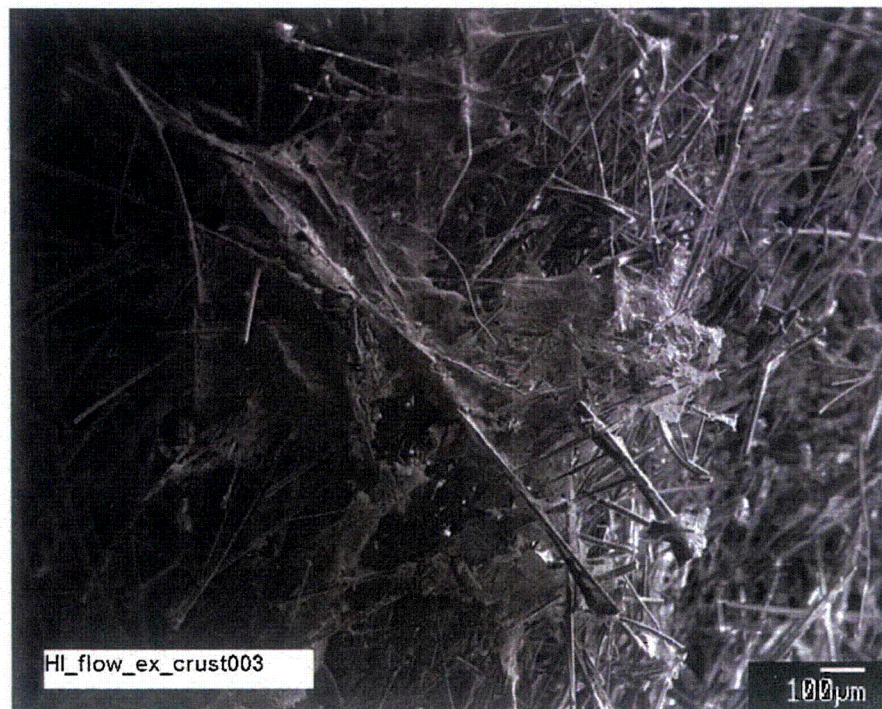
Figure D1-14. SEM image close-up view of crust. (HI\_flow\_ex\_crust003)

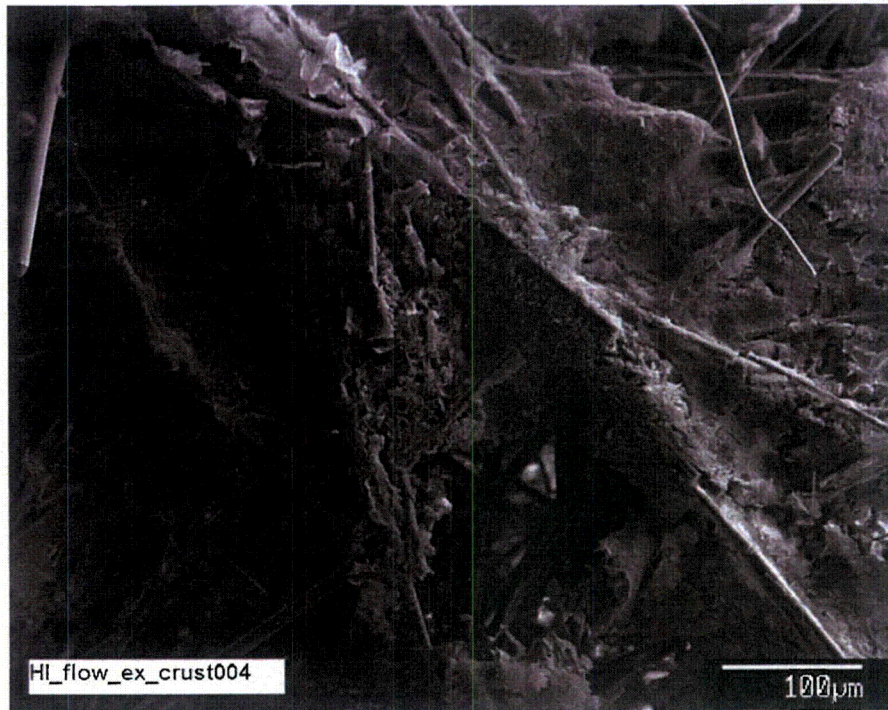
Figure D1-15. SEM image of crust at 150 times magnification. (HI\_flow\_ex\_crust004)

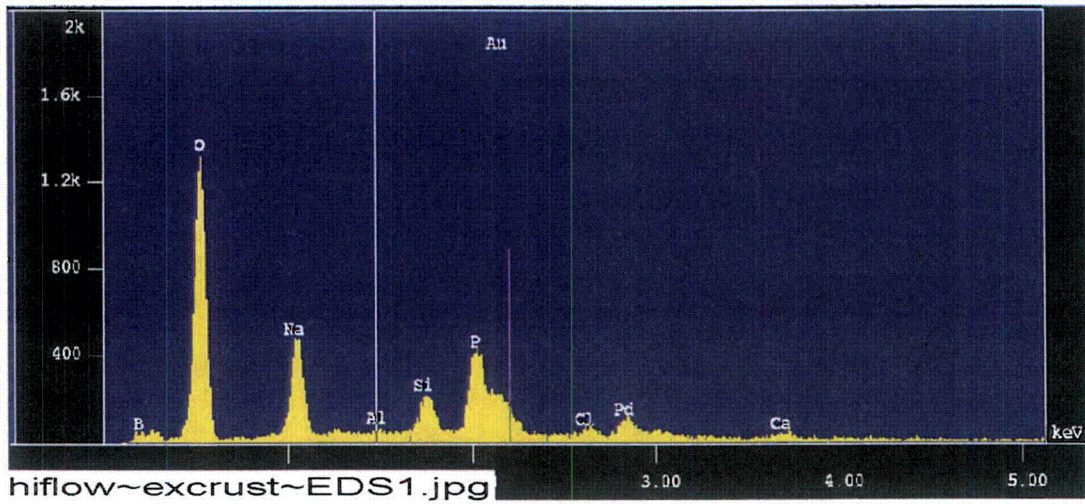
Figure D1-16. Counting spectrum image of the deposit area in Figure D1-15. (hiflow~excrust~EDS1)

The results from the chemical composition analysis for hiflow~excrust~EDS1 are given Table D1-1.

Element	Mass%	Atomic%	ZAF	Z	A	F
O	69.992	80.1268	0.7836	0.9917	0.7902	1.0000
Al	0.265	0.1798	1.1962	1.0046	1.1939	0.9974
Si	2.944	1.9201	1.0946	0.9924	1.1082	0.9953
Ca	1.156	0.5280	0.9997	1.0065	0.9932	1.0001
Na	11.074	8.8224	1.1534	0.9963	1.1562	1.0013
P	11.995	7.0932	0.8861	1.1964	0.7411	0.9993
Cl	2.574	1.3297	1.0964	1.0507	1.0440	0.9996

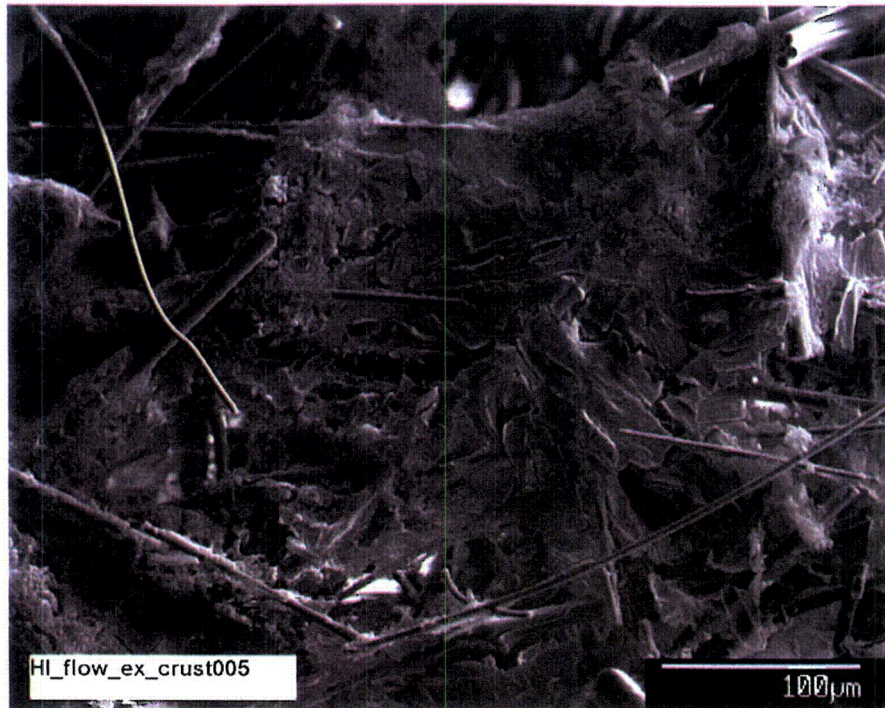
Figure D1-17. SEM image of a new exterior crust area at 270 times magnification. (HI\_flow\_ex\_crust005)

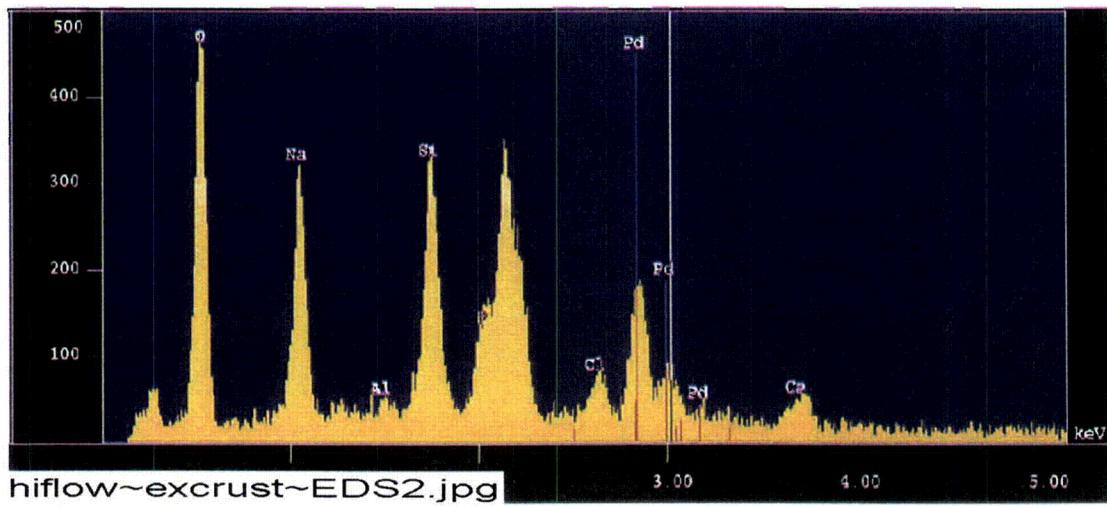
Figure D1-18. Counting spectrum image of the deposit area in Figure D1-17. (hiflow~excrust~EDS2)

The results from the chemical composition analysis for hiflow~excrust~EDS2 are given in Table D1-2.

Element	Mass%	Atomic%	ZAF	Z	A	F
O	63.140	74.8335	0.8873	0.9904	0.8959	1.0000
Al	0.704	0.4946	1.2005	1.0030	1.2008	0.9967
Si	9.996	6.7486	1.1053	0.9908	1.1175	0.9982
Ca	2.633	1.2457	1.0047	1.0045	1.0001	1.0001
Na	13.248	10.9272	1.1201	0.9948	1.1246	1.0012
P	3.262	1.9970	0.9380	1.1944	0.7868	0.9981
Cl	7.017	3.7533	1.0828	1.0488	1.0332	0.9992

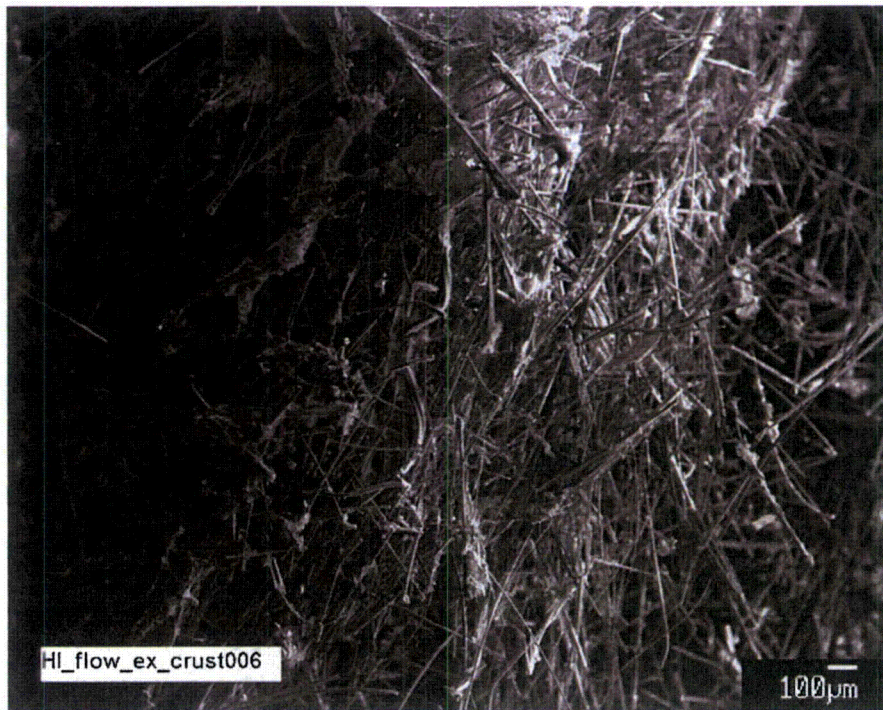
Figure D1-19. SEM image overview of another area for the exterior crust. (HI\_flow\_ex\_crust006)

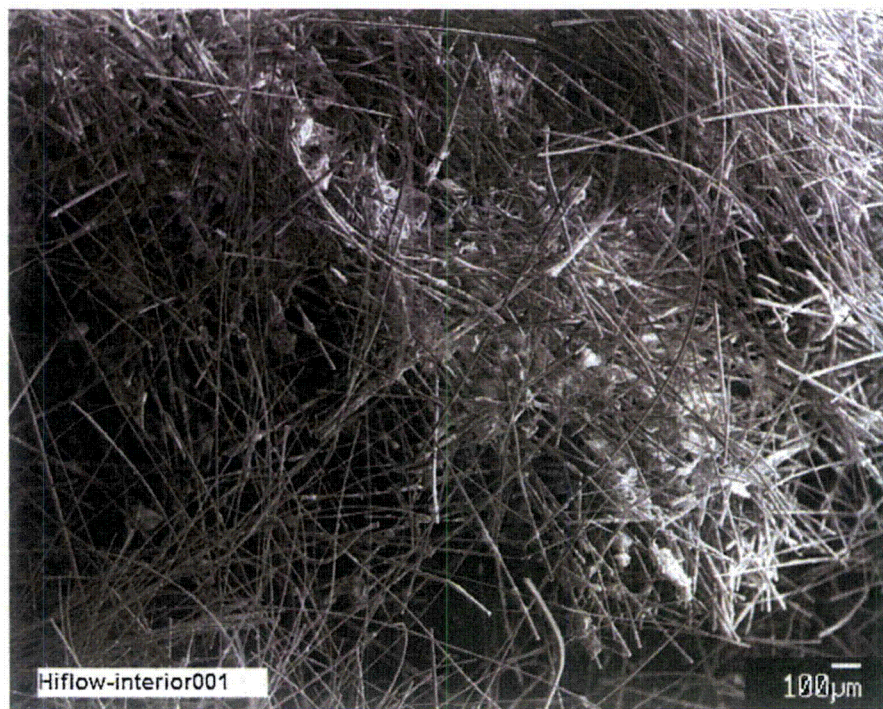
Figure D1-20. Test #2, Day-16 SEM image overview. (Hiflow-interior001)

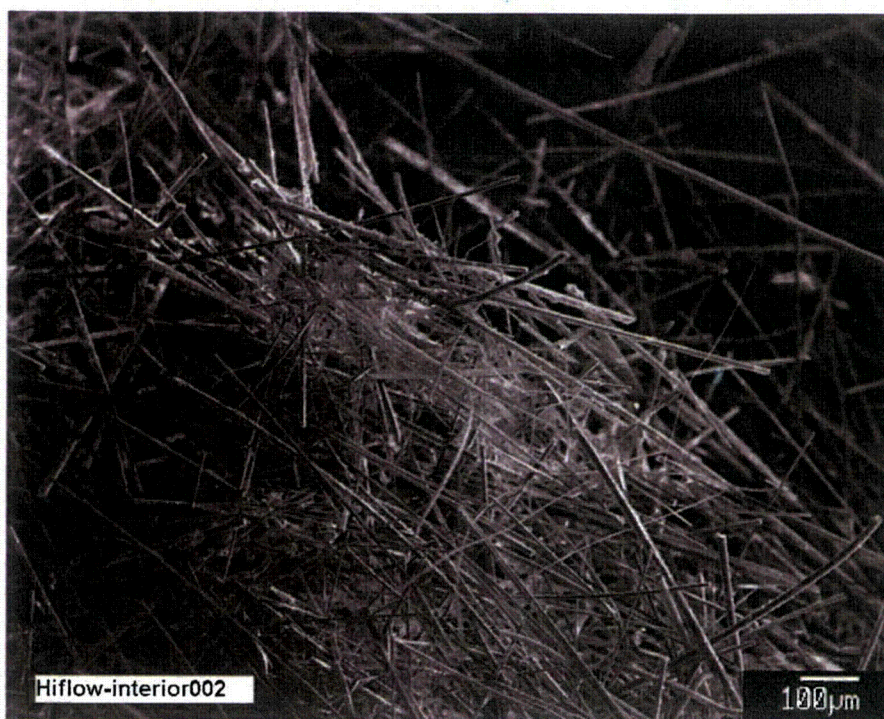
Figure D1-21. Test #2, Day-16 SEM image for high-flow interior. (Hiflow-interior002)

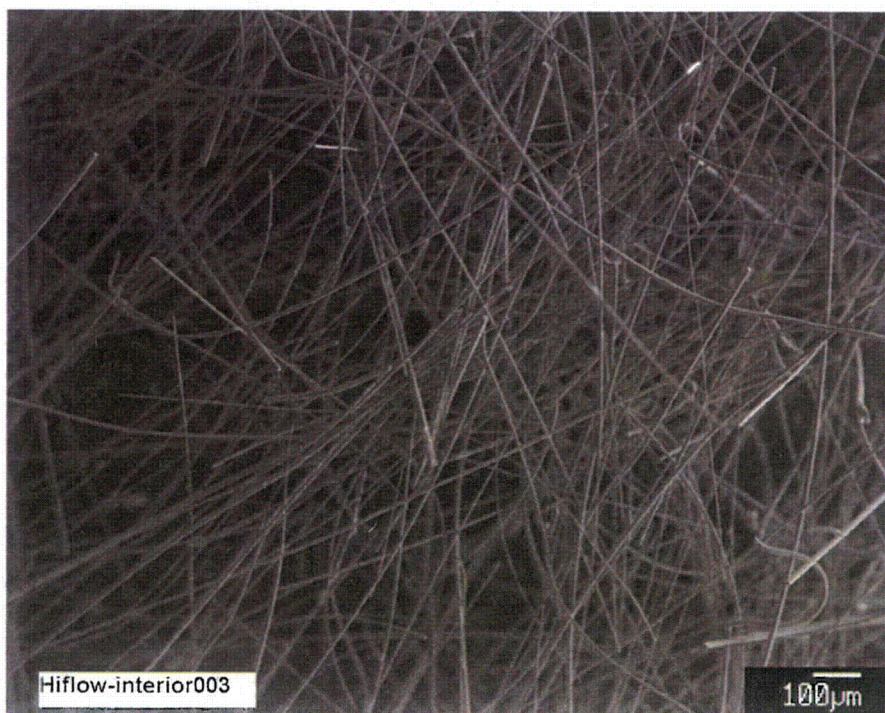
Figure D1-22. Test #2, Day-16 SEM image showing clean fibers. (Hiflow-interior003)

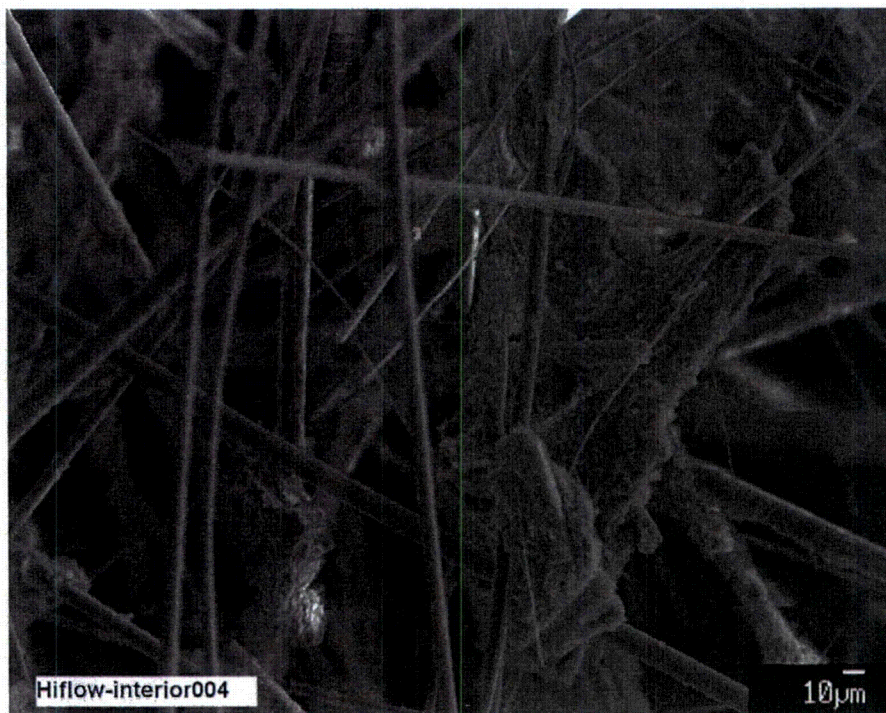
Figure D1-23. Test #2, Day-16 SEM image of deposits for high-flow interior. (Hiflow-interior004)

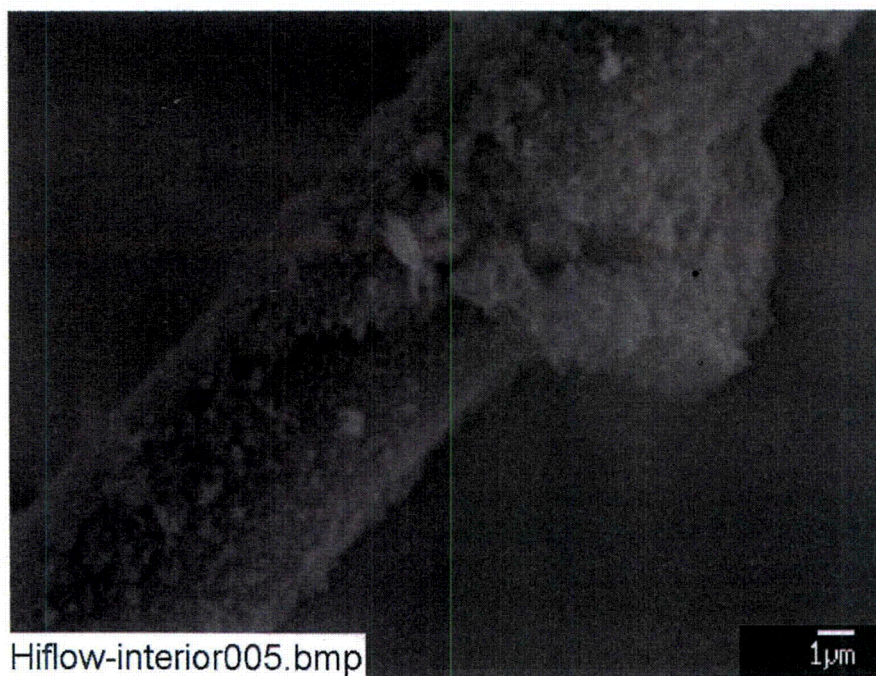
Figure D1-24. Test #2, Day-4 SEM image zoomed in on deposits on fiberglass, magnification 5000 times. (Hiflow-interior005)

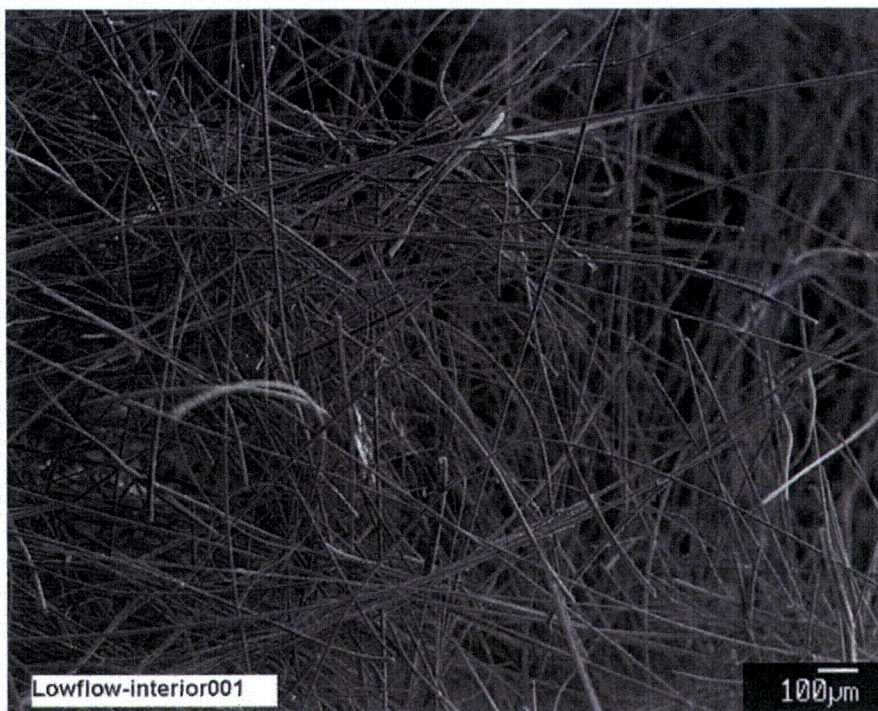
Figure D1-25. Test #2, Day-16 SEM image overview for low-flow interior. (Lowflow-interior001)

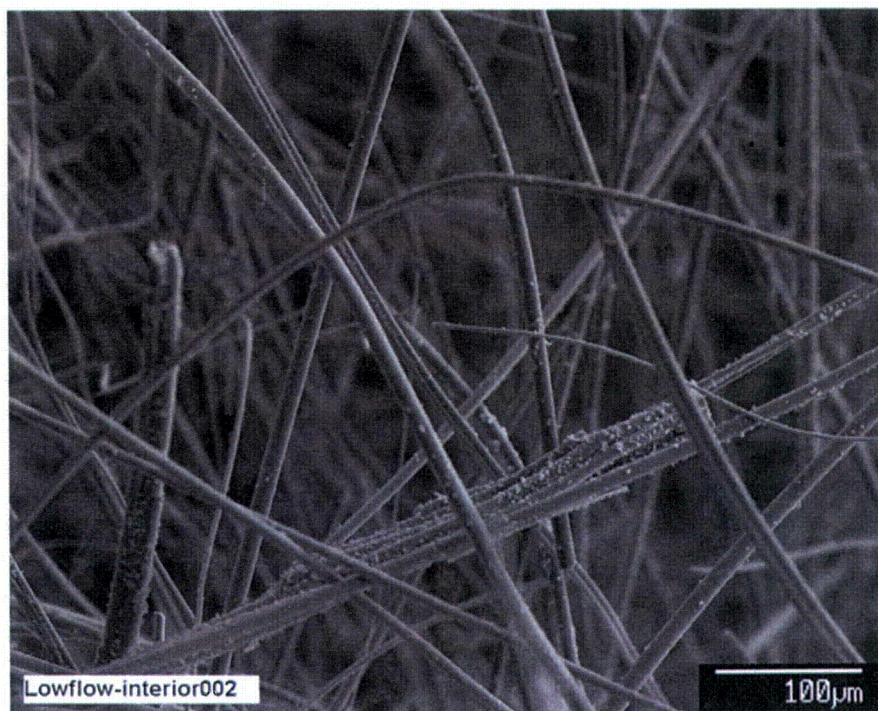
Figure D1-26. Test-2 Day-16 SEM close-up image of Figure D1-25. (Lowflow-interior002)

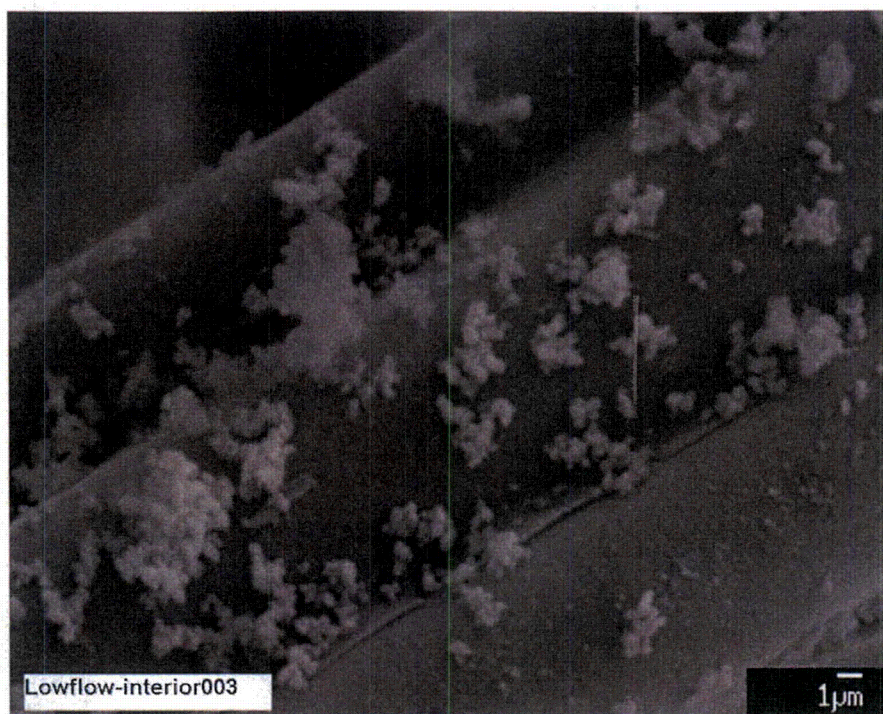
Figure D1-27. Test #2, Day-16 SEM image at 3500 times magnification of deposits shown in Figure D1-26. (Lowflow-interior003)

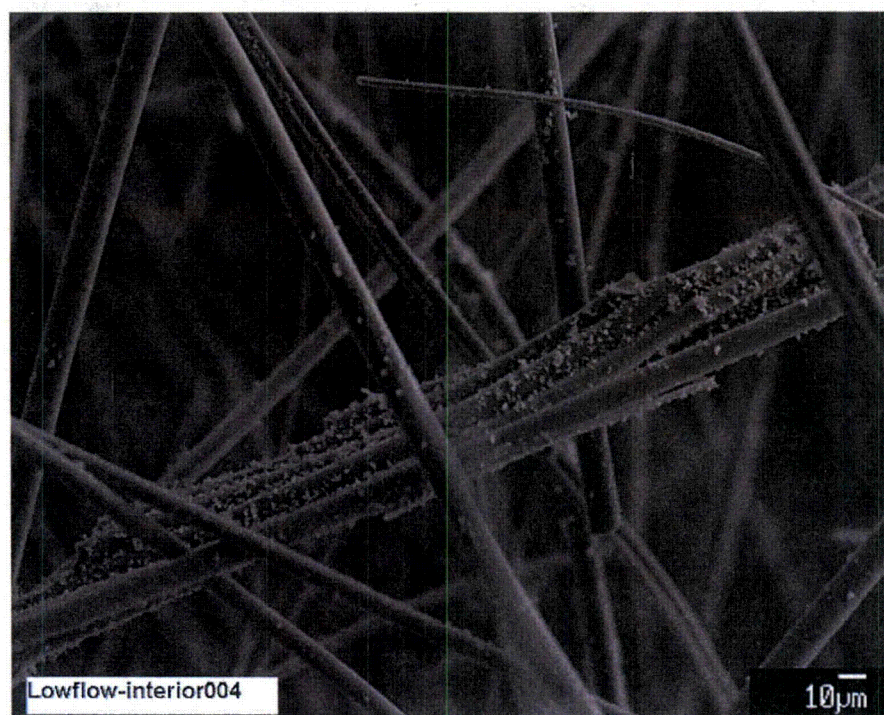
Figure D1-28. Test #2, Day-16 SEM image at 370 times magnification showing close-up of deposits in Figure D1-26. (Lowflow-interior004)

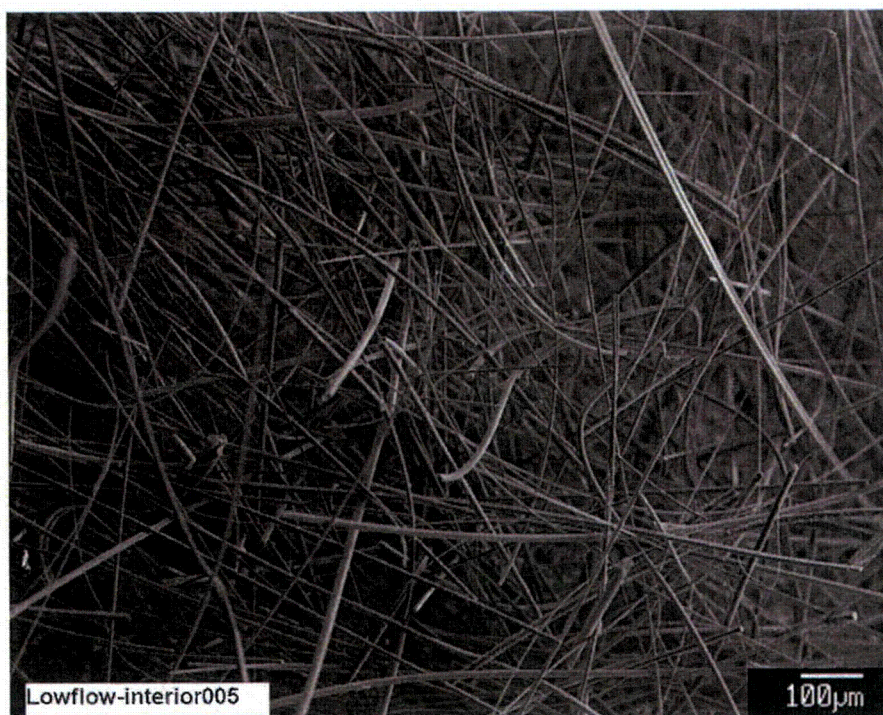
Figure D1-29. Test #2, Day-16 SEM image overview of a new sample area. (Lowflow-interior005)

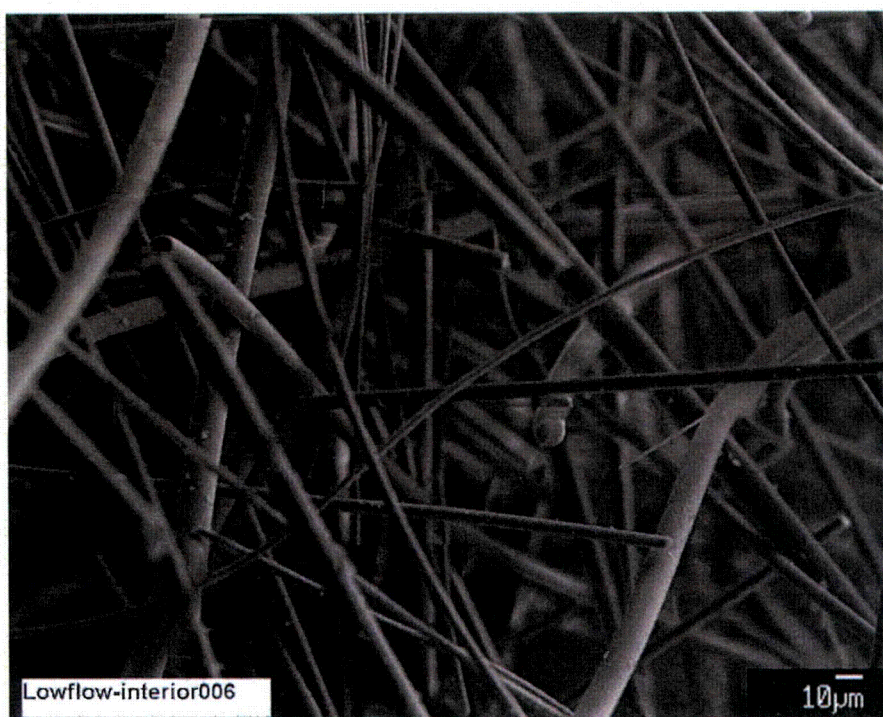
Figure D1-30. Test #2, Day-16 SEM image zooming in on Figure D1-29. (Lowflow-interior006)

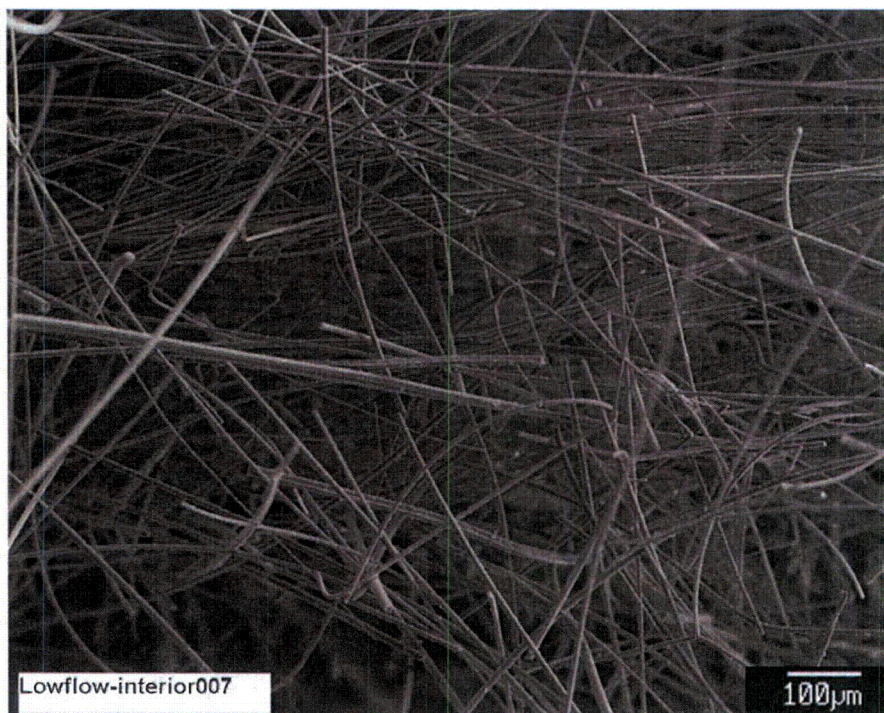
Figure D1-31. Test #2, Day-16 SEM image showing a cleaner appearance than seen in some high-flow interior samples. (Lowflow-interior007)
