# Appendix C1

## SEM/EDS Data for Unused and Test #2, Day-30 Aluminum Coupons

This appendix shows SEM/EDS results for the metal aluminum coupons in three different exposure categories: (1) unused, (2) suspended or unsubmerged, and (3) submerged. *Unused* refers to the coupon condition that existed before being subjected to ICET test conditions. *Suspended* or *unsubmerged* refers to coupons located above the water level of the solution during ICET tests. Suspended coupons contacted the solution only during the 4-hour spray period at the start of the test. In addition, the surface of the suspended coupons may also be affected by moisture in the test chamber gas space. *Submerged* refers to the coupons that were immersed in the test solution for the entire test.

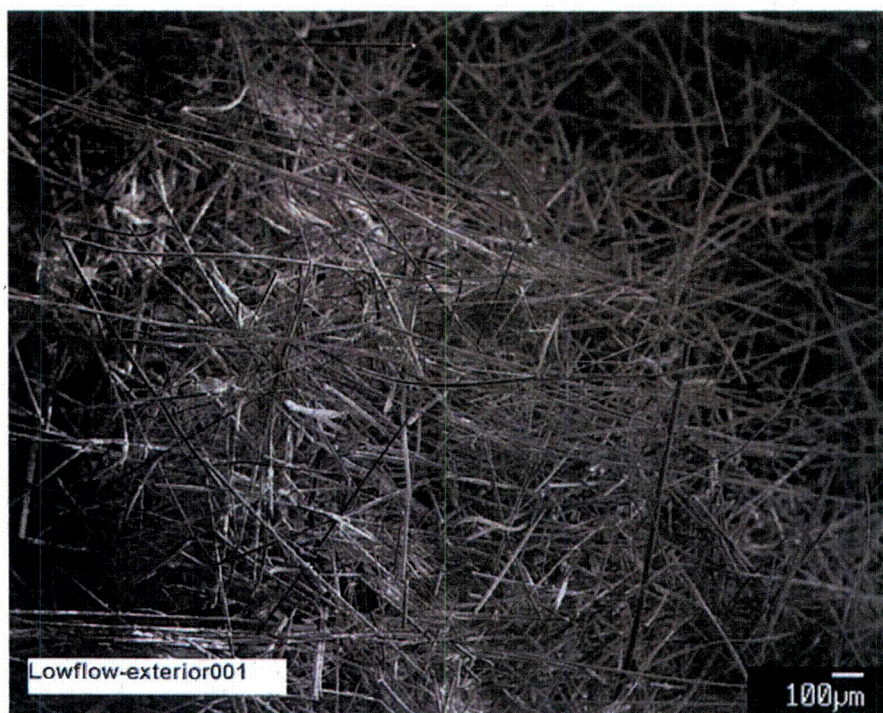
Figure D1-32. Test #2, Day-16 SEM image overview for low-flow exterior. (Lowflow-exterior001)

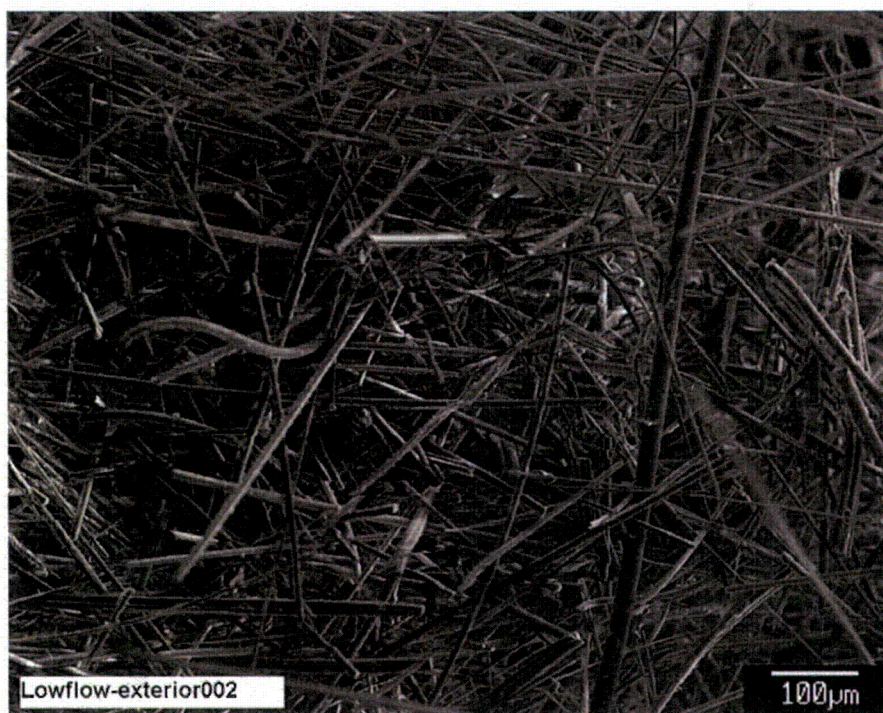
Figure D1-33. Test #2, Day-16 SEM image close-up (charging) of Figure D1-32. (Lowflow-exterior002)

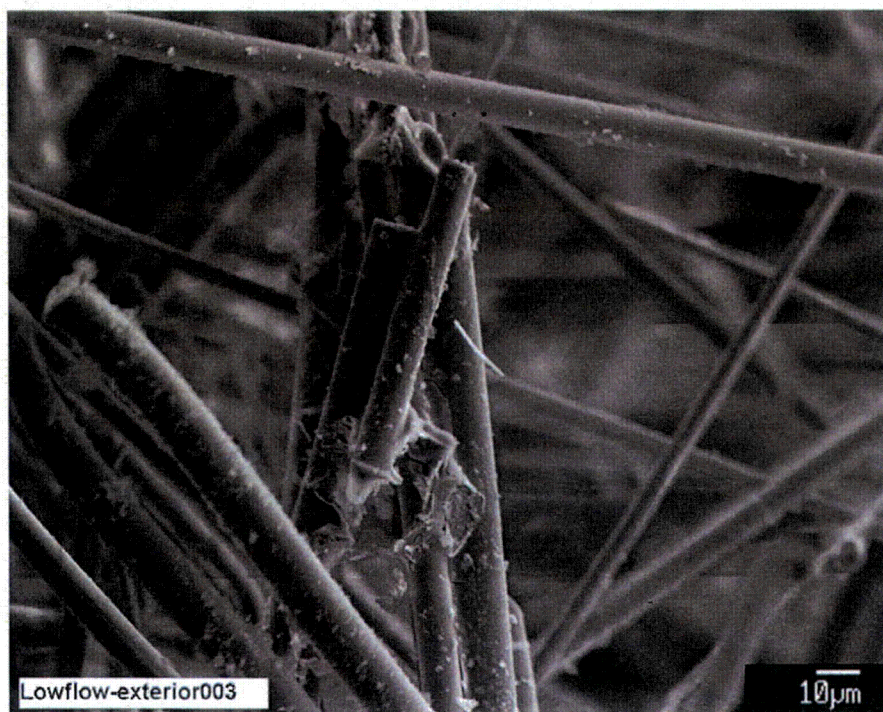
Figure D1-34. Test #2, Day-16 SEM image zooming in on deposits at 600 times magnification. (Lowflow-exterior003)

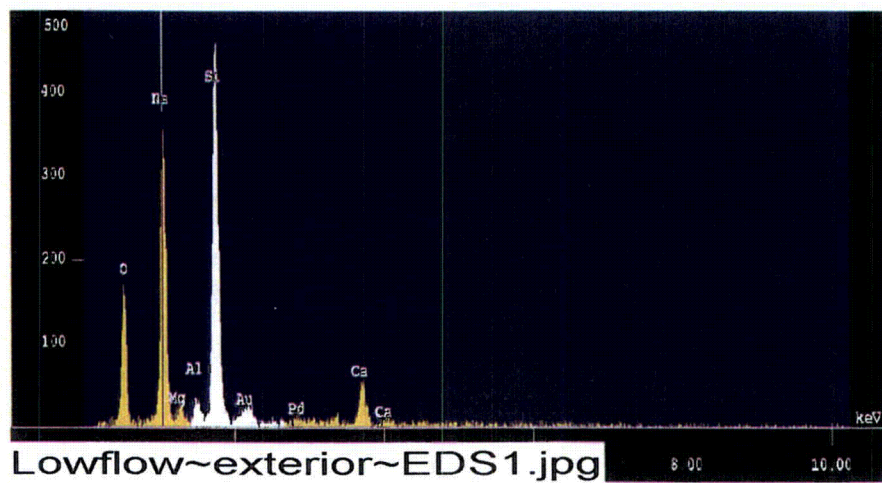
Figure D1-35. Test #2, Day-16 counting spectrum image for a particle on the fiberglass shown in Figure D1-34. (Lowflow~exterior~EDS1)

The results from the chemical composition analysis for Lowflow~exterior~EDS1 are given in Table D1-3.

Group : NRC  
 Sample : T2D16 Low-flow ID# : 1  
 Comment : Exterior particle on fiberglass  
 Condition : Full Scale : 20KeV(10eV/ch,2Kch)  
             Live Time : 60.000 sec Aperture # : 3  
             Acc. Volt : 15.0 KV Probe Current : 2.003E-08 A  
             Stage Point : X=52.122 Y=69.909 Z=12.467  
             Acq. Date : Sun Mar 6 21:42:04 2005

Element	Mass%	Atomic%	ZAF	Z	A	F
O	41.276	53.6697	1.0489	0.9914	1.0580	0.9999
Na	24.595	22.2554	0.9716	0.9956	0.9752	1.0007
Mg	0.973	0.8323	1.2621	0.9981	1.2653	0.9993
Al	1.542	1.1892	1.2481	1.0035	1.2512	0.9940
Si	25.465	18.8616	1.1493	0.9912	1.1597	0.9999
Ca	6.149	3.1917	1.0088	1.0039	1.0048	1.0001

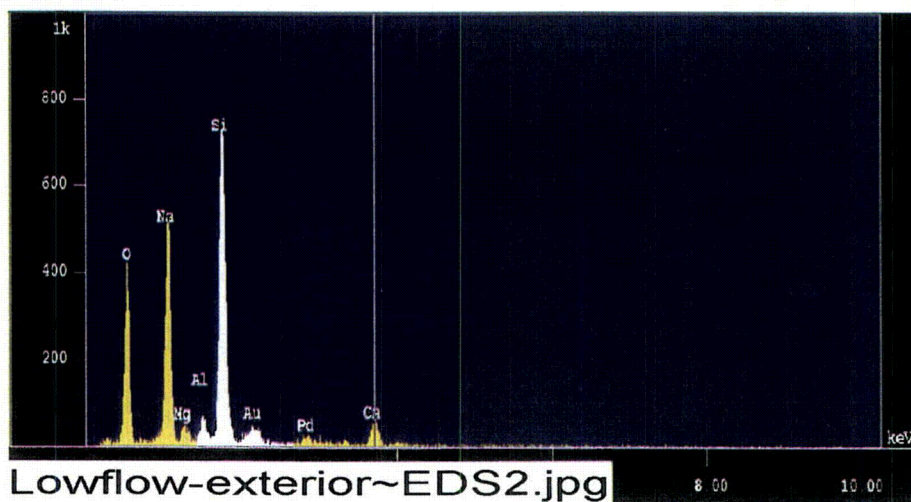
Figure D1-36. Test #2, Day-16 counting spectrum for a particle on the fiberglass shown in Figure D1-34. (Lowflow-exterior~EDS2)

The results from the chemical composition analysis for Lowflow~exterior~EDS2 are given in Table D1-4.

Group : NRC  
 Sample : T2D16 Low-flow ID# : 2  
 Comment : Exterior film on fiberglass  
 Condition : Full Scale : 20KeV(10eV/ch, 2Kch)  
             Live Time : 60.000 sec Aperture # : 3  
             Acc. Volt : 15.0 KV Probe Current : 2.003E-08 A  
             Stage Point : X=52.133 Y=69.884 Z=12.467  
             Acq. Date : Sun Mar 6 21:52:13 2005
