# **Integrated Chemical Effects Test Project: Test #3 Data Report**

**Los Alamos National Laboratory**

**U.S. Nuclear Regulatory Commission  
Office of Nuclear Regulatory Research  
Washington, DC 20555-0001**

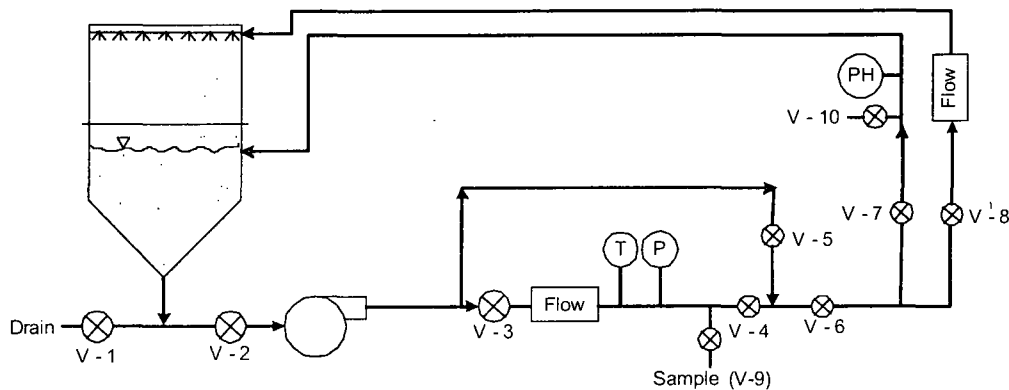
The as-built test loop consists of a test tank, a recirculation pump, 2 flow meters, 10 isolation valves, and pipes that connect the major components, as shown schematically in Figure 2-1. P, T, and pH represent pressure, temperature, and pH probes, respectively.

Figure 2-1. Test loop process flow diagram.

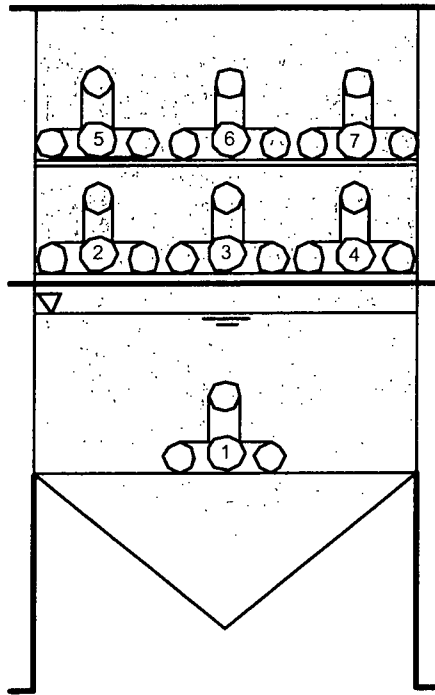
The arrangement of the coupon racks in the test tank is schematically illustrated in Figure 2-2. The figure shows a side view of the ICET tank, with the ends of the seven CPVC racks illustrated. The normal water level is shown with the blue line in the figure. Rack #1 is the only submerged rack, and it sits on angle iron. It is centered in the tank, so that flow from the two headers reaches it equally. Racks #2–#4 are positioned above the water line, supported by angle iron in the tank. Racks #5–#7 are positioned at a higher level, also supported by angle iron. Racks #2–#7 are exposed to spray. In the figure, north is to the right and south is to the left. Directions are used only to identify such items as rack locations and sediment locations.

**Figure 2-2. Coupon rack configuration in the ICET tank. The blue line represents the surface of the test solution.**

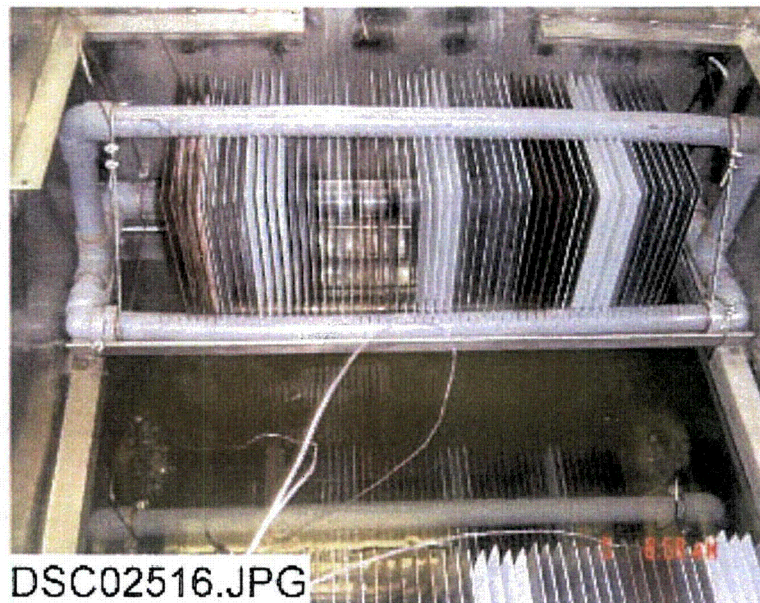
Figure 2-3 shows the configuration of an unsubmerged coupon rack loaded with metal coupons in the ICET tank. The loading pattern of the racks was nearly identical, varying by only one or two coupons. Shown in the figure from left to right, the coupons are arranged as follows: 4 Cu, 4 Al, 4 inorganic zinc (IOZ), 7 GS, 4 Cu, 3 Al, 4 IOZ, 7 GS, 4 Cu, 3 Al, 4 IOZ, and 7 GS.

**Figure 2-3. A loaded coupon rack in the ICET tank.**

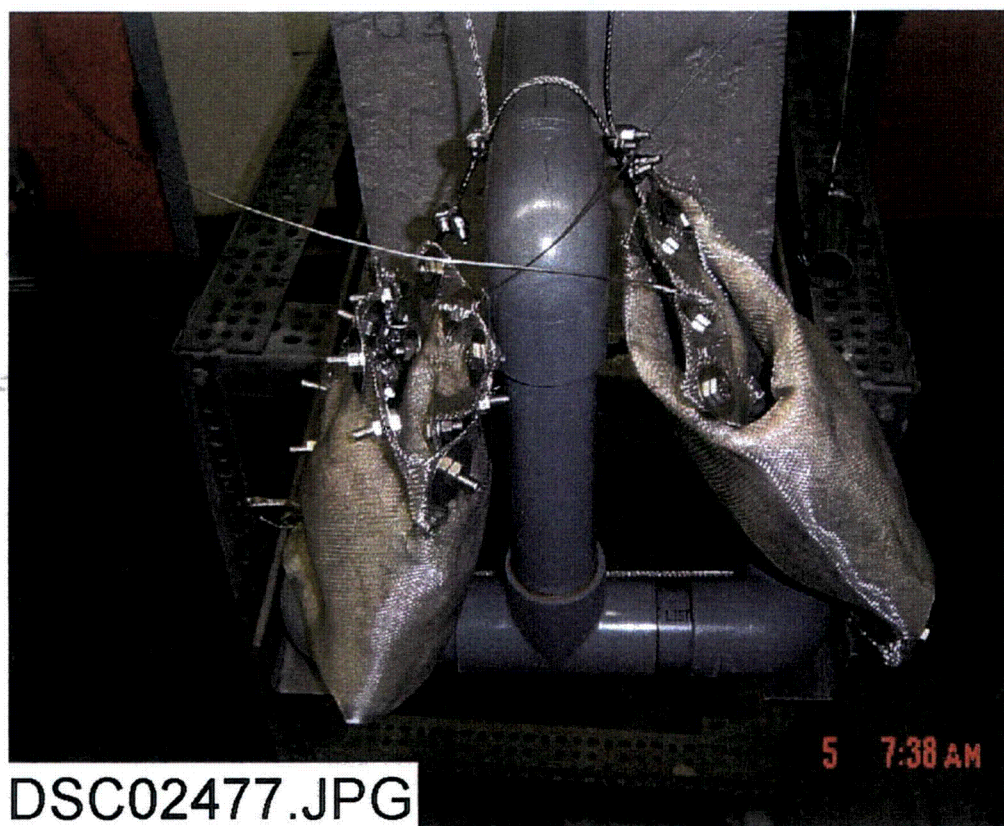
Several fiberglass samples were placed in the ICET tank. Samples were either submerged or held above the water level. The unsubmerged fiberglass samples were positioned so they would be exposed to sprays. The fiberglass samples were contained in SS wire mesh that allowed water flow while confining the fiberglass material. Both loosely-packed and more tightly-packed samples were used. In addition, some submerged fiberglass samples were located where they would be exposed to relatively high-flow conditions, and others were located in quiescent regions of the tank. Figure 2-4 shows the so-called “sacrificial” fiberglass samples in wire mesh pouches attached to the submerged coupon rack (rack 1 in Figure 2-2). Each pouch contains approximately 5 g of fiberglass. Those samples were attached with SS wire and removed from the tank on Days 4, 15, and 30, and examined. As shown in the figure, bigger insulation bags were wrapped around the sacrificial specimens during the test. See Subsection 2.4.1.1 for descriptions of other fiberglass samples.

**Figure 2-4. Fiberglass samples attached to coupon rack.**

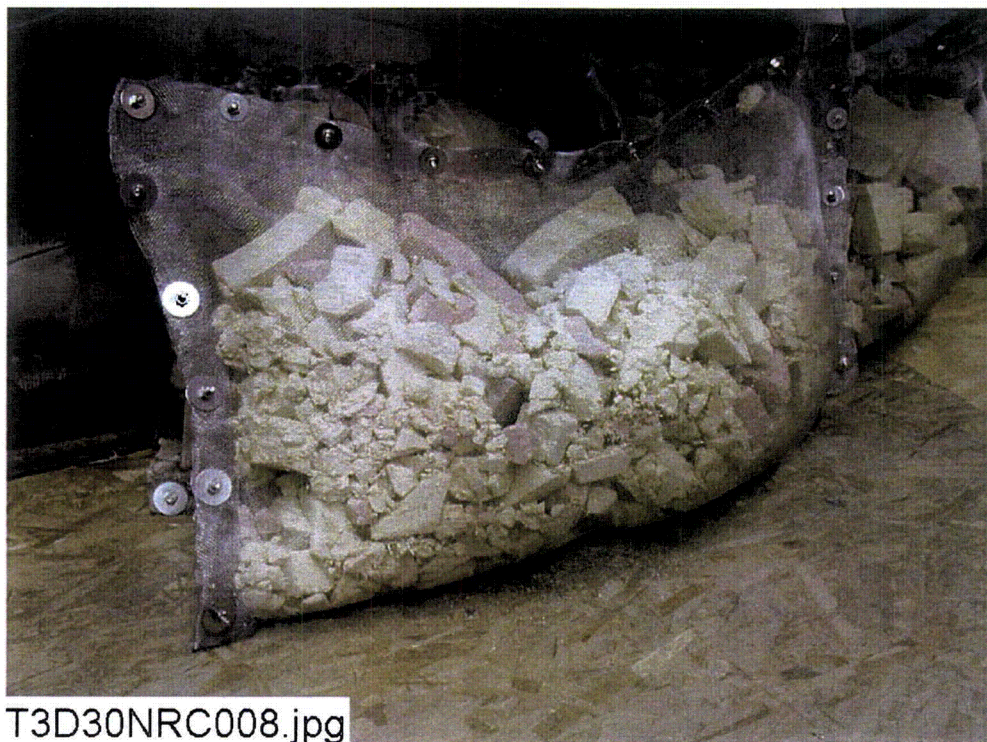
Several cal-sil insulation samples were also placed in the ICET tank. Samples were either submerged or held above the water level. The unsubmerged cal-sil samples were positioned so they would be exposed to sprays. As with the fiberglass samples, all of the cal-sil samples (except for the dust) were contained in SS wire mesh that allowed water flow while confining the cal-sil material. In addition to solid pieces of cal-sil, cal-sil dust (approximately 43.5 lb) was placed in the tank solution before the test began. Both types of samples are shown in Figures 2-5 and 2-6.

Figure 2-5. Solid pieces of cal-sil samples in SS mesh.

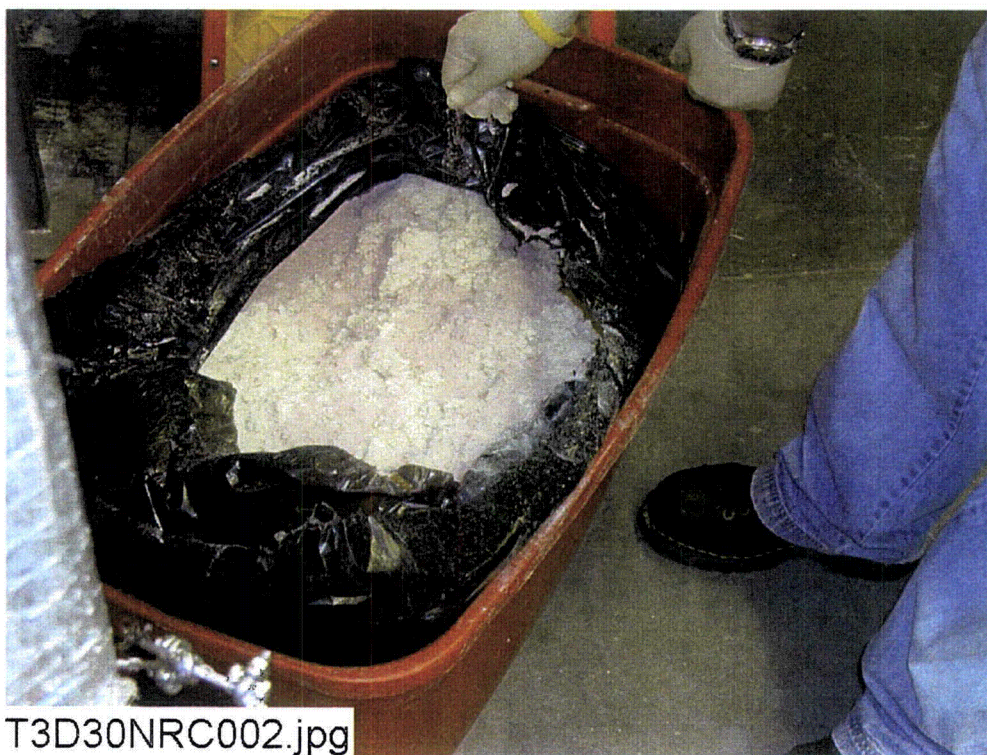
Figure 2-6. Cal-sil dust.

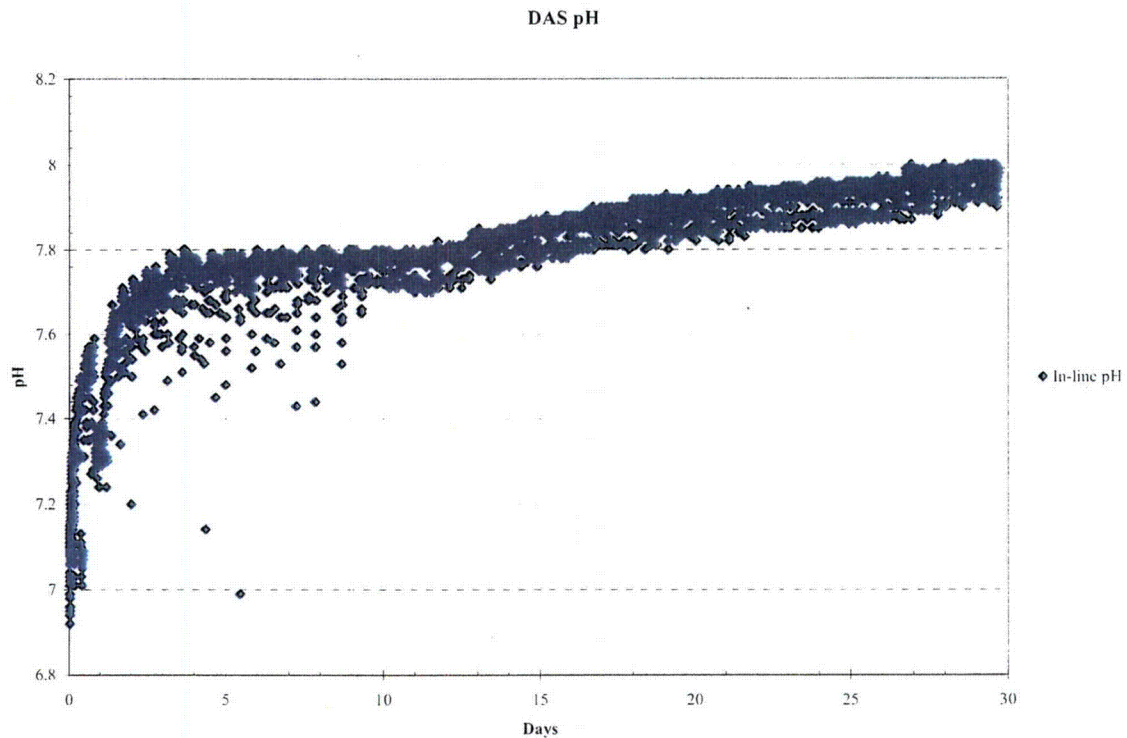
The in-line pH probe tracked the overall bench-top pH readings, but the results have noise and a slight offset. Due to the noise within the raw data, the bench-top pH readings are more reliable. Figure 3-1 shows results from the in-line pH probe.

**Figure 3-1. In-line pH measurements.**

**pH:** Before time zero, 15.45 kg of boric acid and 0.663 g of LiOH were dissolved in the ICET tank. The measured bench-top pH was 4.24, which was similar to the expected value obtained from analytical predictions. Following the addition of the premixed TSP batches, the pH was 7.32. The pH then continued to rise through Day 3 of testing to 7.9. After Day 3, the pH varied in the range of 7.8–8.0.

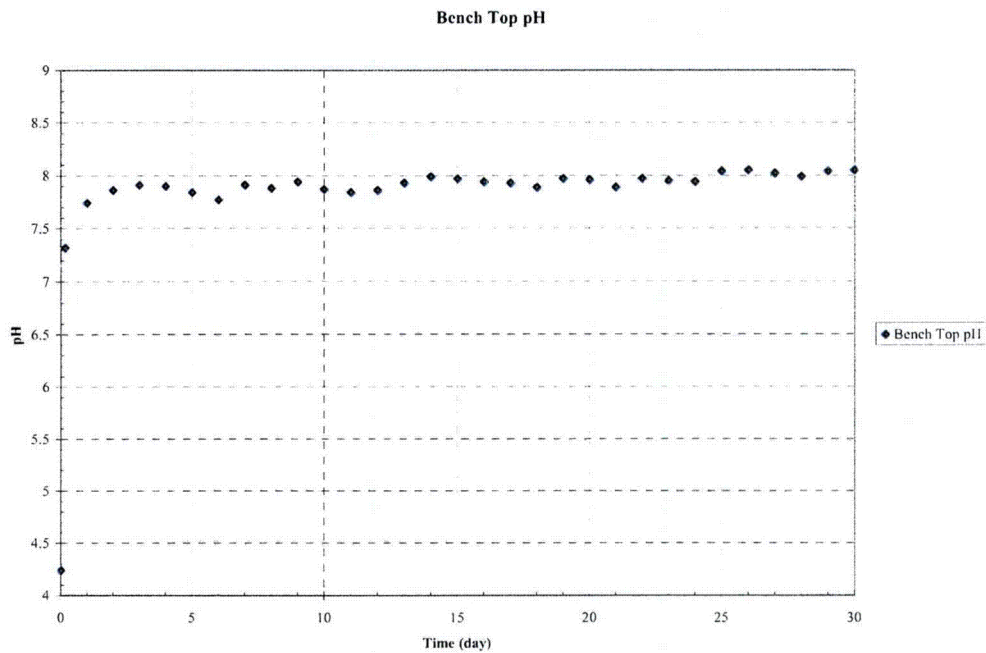
Four hours into the test, the in-line pH measurement was 7.37, and at Day 30 the pH measurement was 7.92. Figure 3-2 presents the bench-top pH readings. Four hours into the test, the bench-top pH measurement was 7.32, and at Day 30 the pH measurement was 8.05.

Figure 3-2. Bench-top pH meter results.

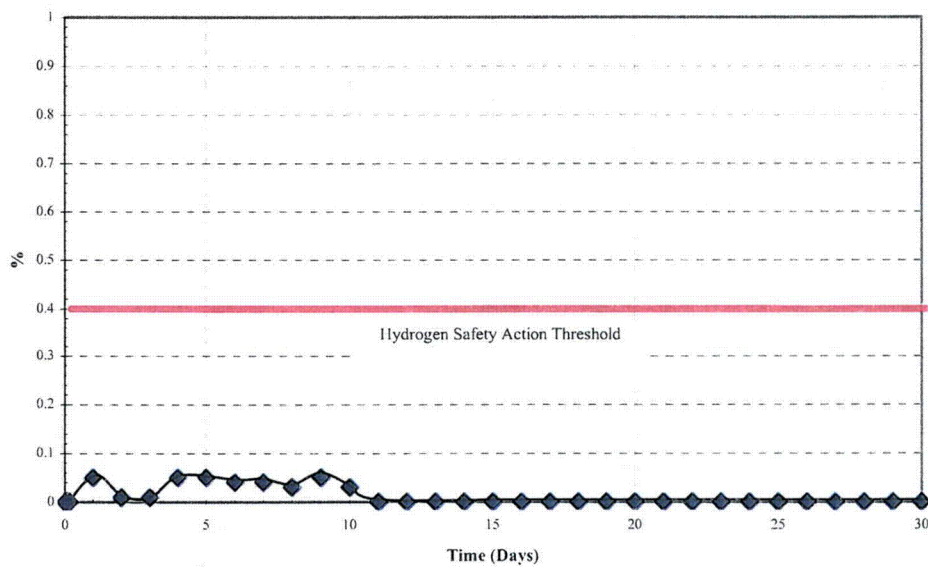
Hydrogen remained at or below 0.05% for Test #3. Figure 3-3 displays the evolution of hydrogen generation throughout the test. A general trend line has been superimposed upon the hydrogen generation data set. Each of the measured values is well below the hydrogen safety action threshold of 0.4%.

Figure 3-3. Hydrogen generation.

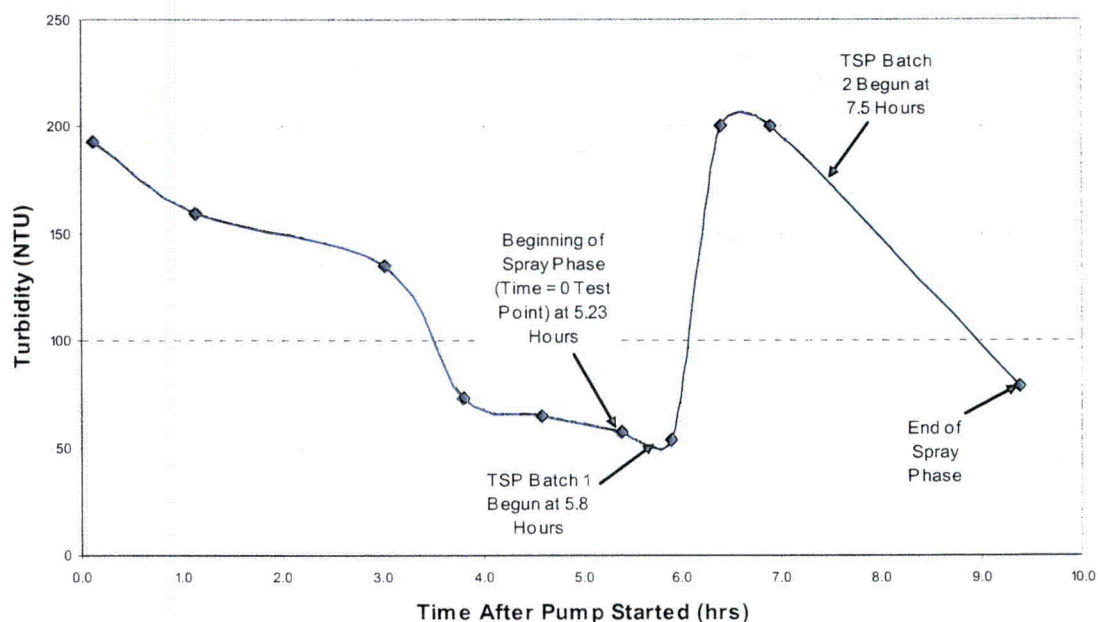
Due to the cloudy nature of the water in the tank after the circulation pump was turned on, additional turbidity values were measured at 60°C over a 9-hour time period, in addition to the regular daily monitoring. Figure 3-4 depicts the evolution of turbidity during that time period. The x-axis on the graph represents the time in hours after the circulation pump was turned on, following cal-sil addition and while the system was heating up. As can be seen, the turbidity gradually decreased from 192 NTU at the 7-minute point to 54 NTU at the 5.9-hour point. Note that the 5.23-hour point on the graph corresponds to the time-zero test point. The spray nozzles were activated at that time. At the 6.4-hour point, the turbidity peaked above 200 NTU. The turbidity decreased to 79 NTU by the end of the spray phase. (Note that the Batch 1 addition began at approximately 5.8 hours on Figure 3-4, and Batch 2 addition began at 7.5 hours.)

Figure 3-4. Day-1 turbidity results.

**Turbidity:** For the 23°C and 60°C water samples, the baseline turbidity values, which were taken after the latent debris and crushed concrete were added, were 7.3 NTU and 7.5 NTU, respectively. After the addition of cal-sil, the tank solution was observed to become much more turbid. Then with time, the turbidity decreased. Upon the addition of Batch 1 and Batch 2 chemicals, particulates were suspended in solution, and the solution was noticeably cloudier. Figure 3-4 presents the daily turbidity results.

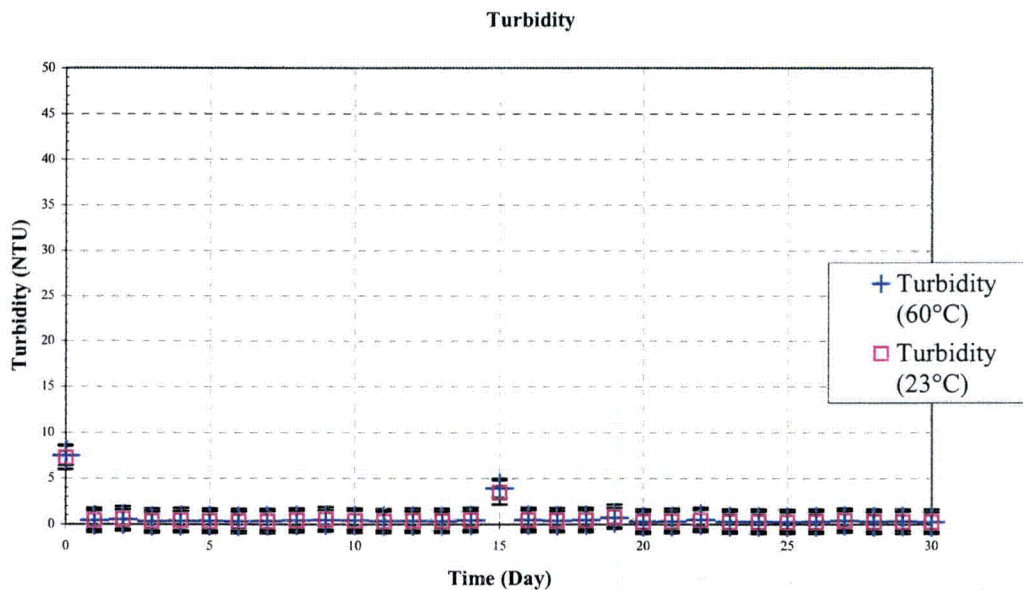
Figure 3-5 depicts the evolution of turbidity at 23°C and 60°C throughout Test #3. The trend of each curve exhibits an initial spike during the addition of Batch 1 chemicals, followed by a sharp decline to the Day-1 test point and steady behavior from then on. The turbidity values on Day 15 were slightly higher, but no direct cause has been identified. The Day-15 values were 3.9 NTU and 3.5 NTU for the 60°C and 23°C samples, respectively. Thereafter, the turbidity values decreased and remained steady.

Figure 3-5. Daily turbidity results.

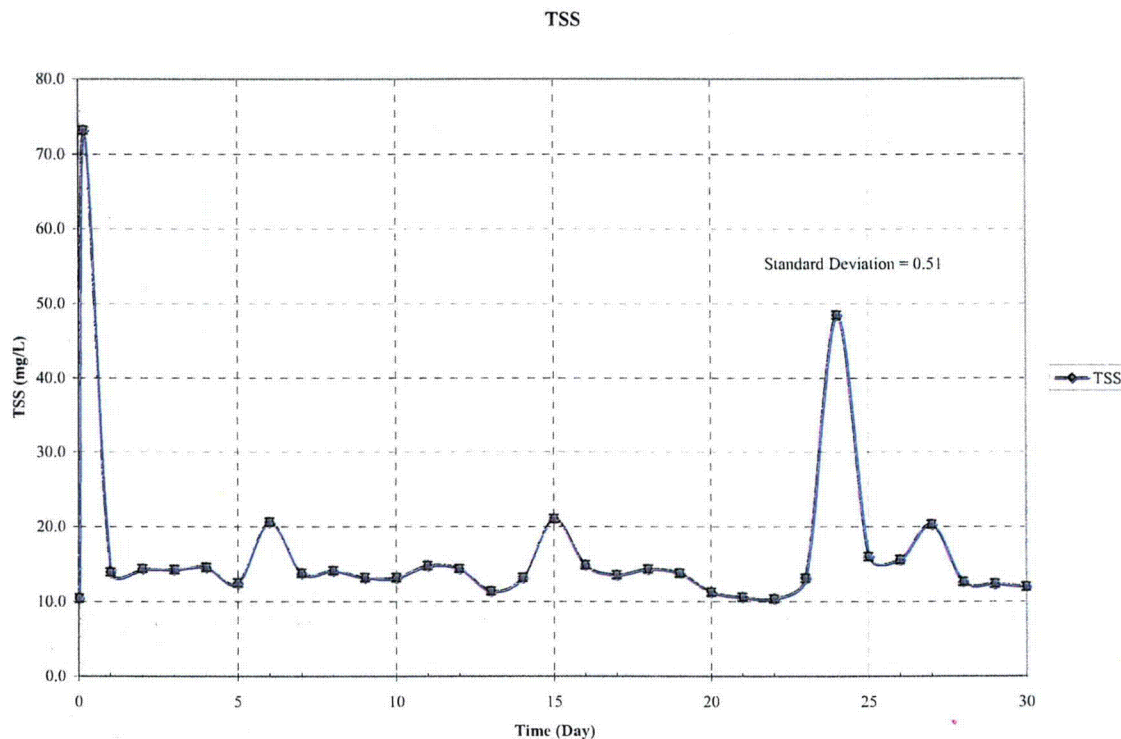
Although TSS remained fairly stable over the entirety of the test, TSS measurements from six different days deviated from the trend. The Day-6 TSS measurement was slightly higher at 20.6 mg/L, which was not unexpected because the sample was taken right after the return of excess test solution to the tank. The return of the excess test solution caused some of the particles that were sitting at the bottom of the tank to be

become resuspended in the solution, a situation that was reflected in the final measurement. The Day-15 and Days-24–27 measurements were higher than the test average of approximately 13.4 mg/L that was observed for the majority of the test. The TSS filter weights for these days were confirmed, and there is no direct explanation for these higher values.

Figure 3-6. Test #3 TSS results.

**Total Suspended Solids:** TSS are measured by filtering a volume of approximately 500 mL through an in-line filter directly at the sample tap. The selected equipment ensures that TSS measurements are not affected by temperature-dependent or time-dependent precipitation reactions that may occur once the process solution is removed from the tank. Figure 3-6 presents Test #3 TSS data as the experiment progressed. The baseline TSS measurement was taken after the addition of latent debris but before the Batches 1 and 2 chemical additions. After the addition of the Batch 1 chemicals but before the addition of Batch 2 chemicals, a second TSS measurement (not shown on the graph) was taken, and the value was 268 mg/L. Although very high, it appeared to be a reasonable measurement because a large amount of particles was suspended in solution at that time. Four hours into the test, another TSS measurement was taken, and that value was 73.2 mg/L. At that time, fewer particles were seen suspended in solution. After 24 hours, the TSS measurement dropped to 13.9 mg/L, where it leveled out for the rest the test.

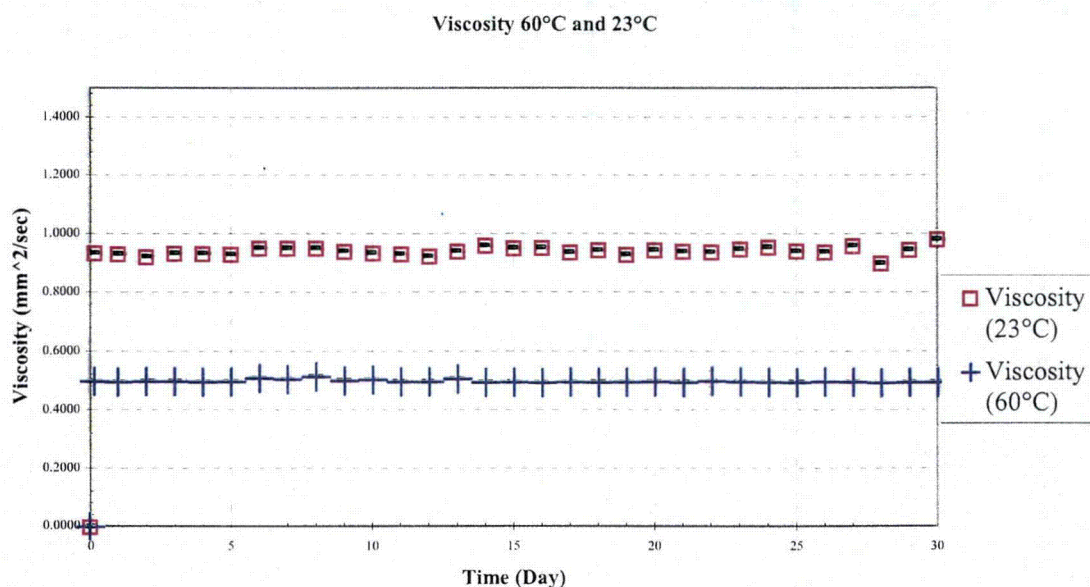
Viscosity remained relatively constant throughout Test #3. The viscosity at  $60.0^{\circ}\text{C}$  ( $140^{\circ}\text{F}$ ) remained at a value of approximately  $0.49 \text{ mm}^2/\text{s}$ , and the  $23.0^{\circ}\text{C}$  ( $73.4^{\circ}\text{F}$ ) measurements remained around  $0.95 \text{ mm}^2/\text{s}$ . These constant viscosity values are consistent with the steady water conditions in the test. Figure 3-7 shows the viscosity values through the course of the test.

Figure 3-7. Viscosity at 60°C and 23°C.

**Kinematic Viscosity:** Kinematic viscosity was measured with a Cannon-Fenske capillary viscometer. Viscosity was measured on unfiltered samples, each at a temperature of  $60^{\circ}\text{C} \pm 1.0^{\circ}\text{C}$  ( $140^{\circ}\text{F} \pm 1.8^{\circ}\text{F}$ ) and  $23^{\circ}\text{C} \pm 2.0^{\circ}\text{C}$  ( $73.4^{\circ}\text{F} \pm 3.6^{\circ}\text{F}$ ). Figure 3-7 shows the viscosity results. Water's viscosity is highly sensitive to temperature, and the allowed temperature range results in a variation of viscosity of 2.9% between  $59^{\circ}\text{C}$  ( $138.2^{\circ}\text{F}$ ) and  $60^{\circ}\text{C}$  ( $141.8^{\circ}\text{F}$ ) and 9.3% between  $21^{\circ}\text{C}$  ( $69.8^{\circ}\text{F}$ ) and  $25^{\circ}\text{C}$  ( $77.0^{\circ}\text{F}$ ). For this reason, temperature was measured to a  $0.1^{\circ}\text{C}$  accuracy with a National Institute of Standards and Technology (NIST)-traceable thermometer for all viscosity measurements. Also, the measured viscosity values were corrected to common temperatures to facilitate comparisons. The corrected temperatures were  $60.0^{\circ}\text{C}$  ( $140^{\circ}\text{F}$ ) and  $23.0^{\circ}\text{C}$  ( $73.4^{\circ}\text{F}$ ).

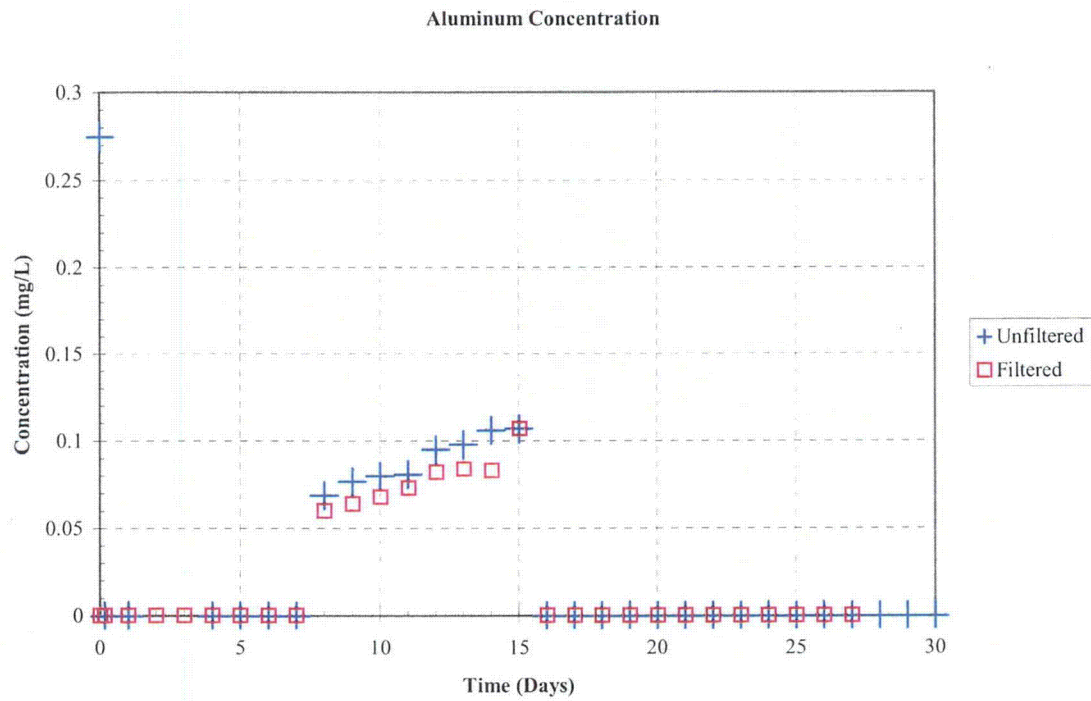
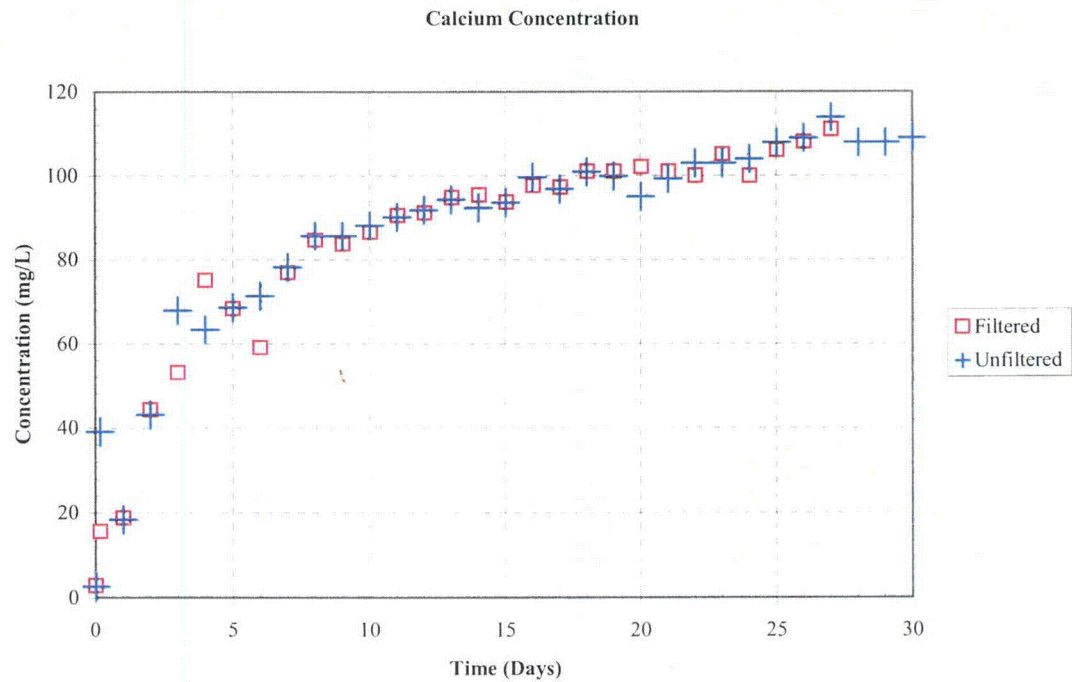
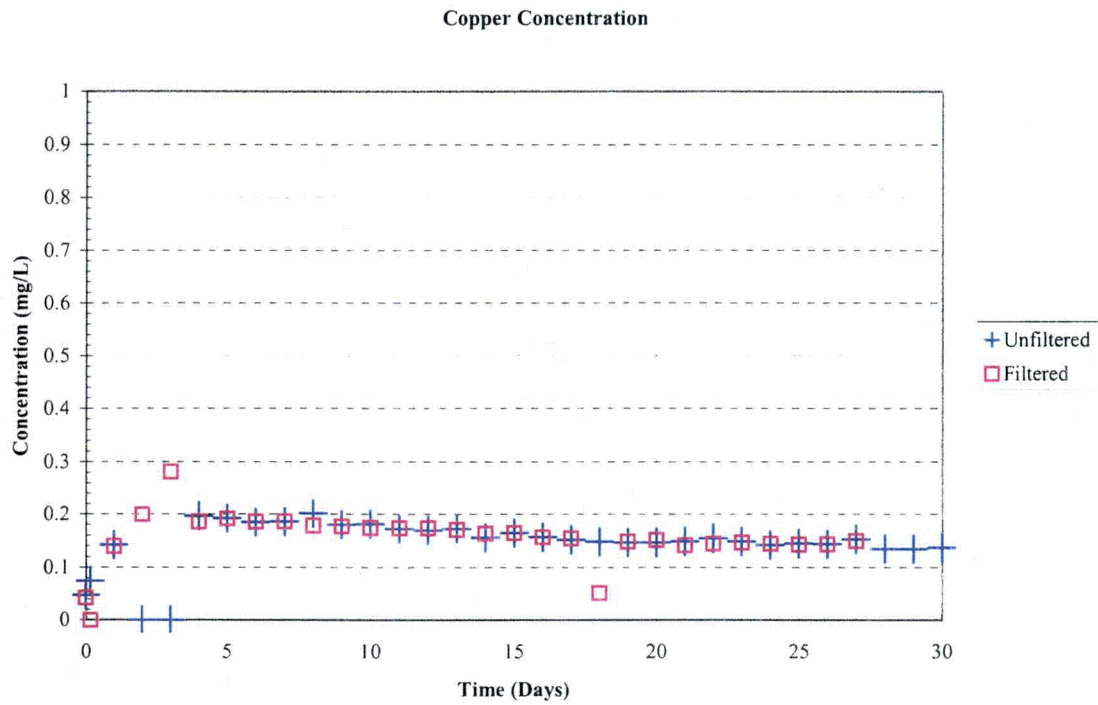
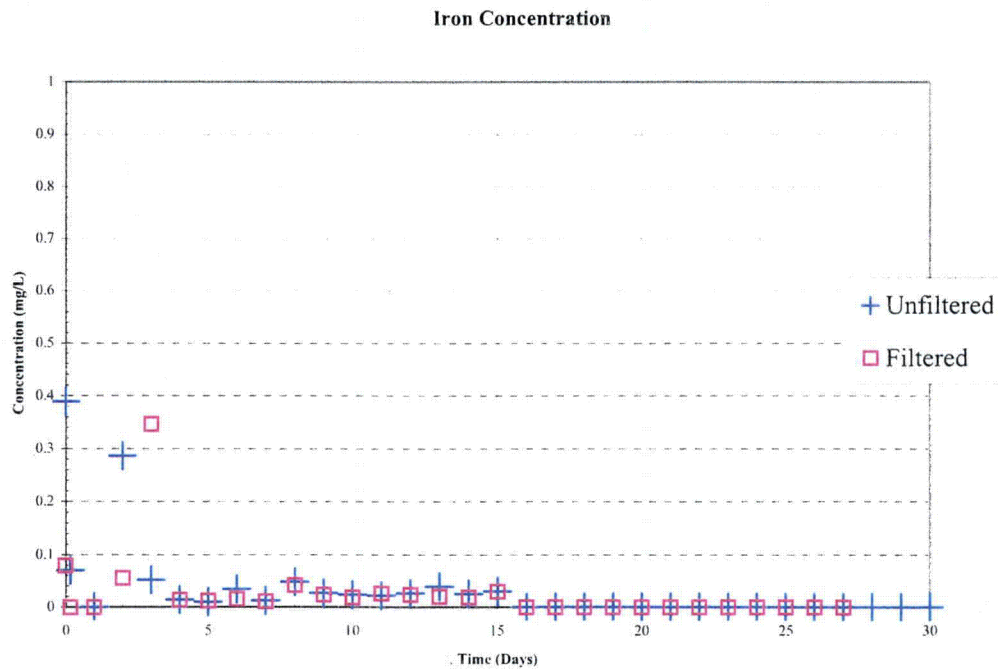
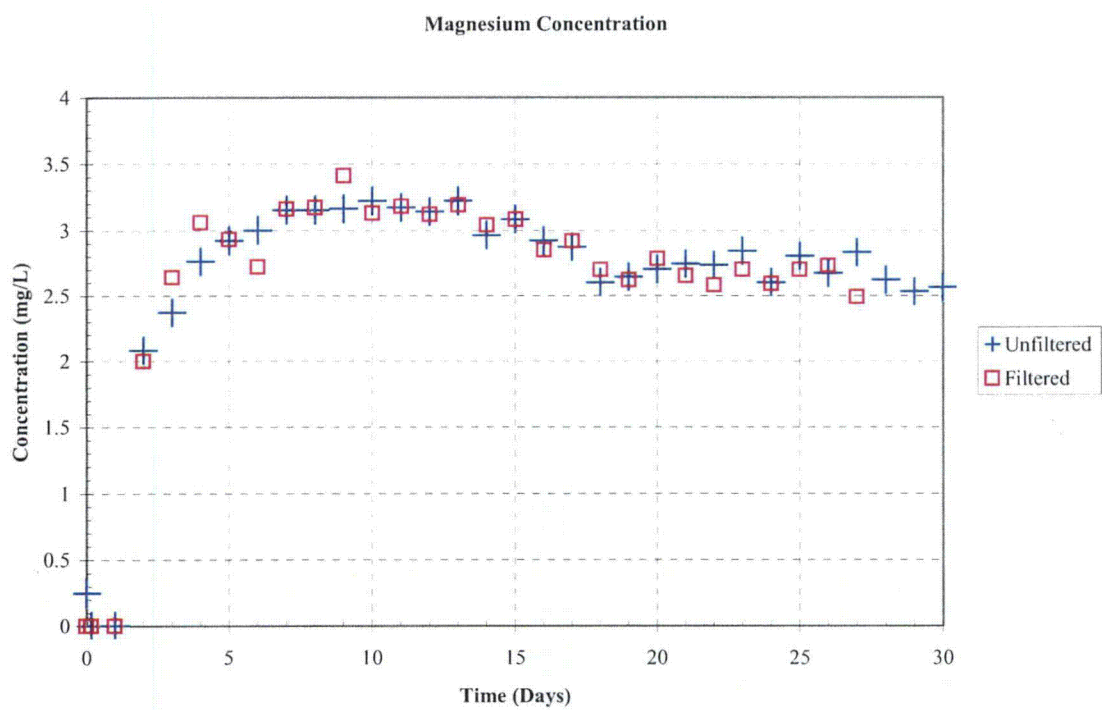
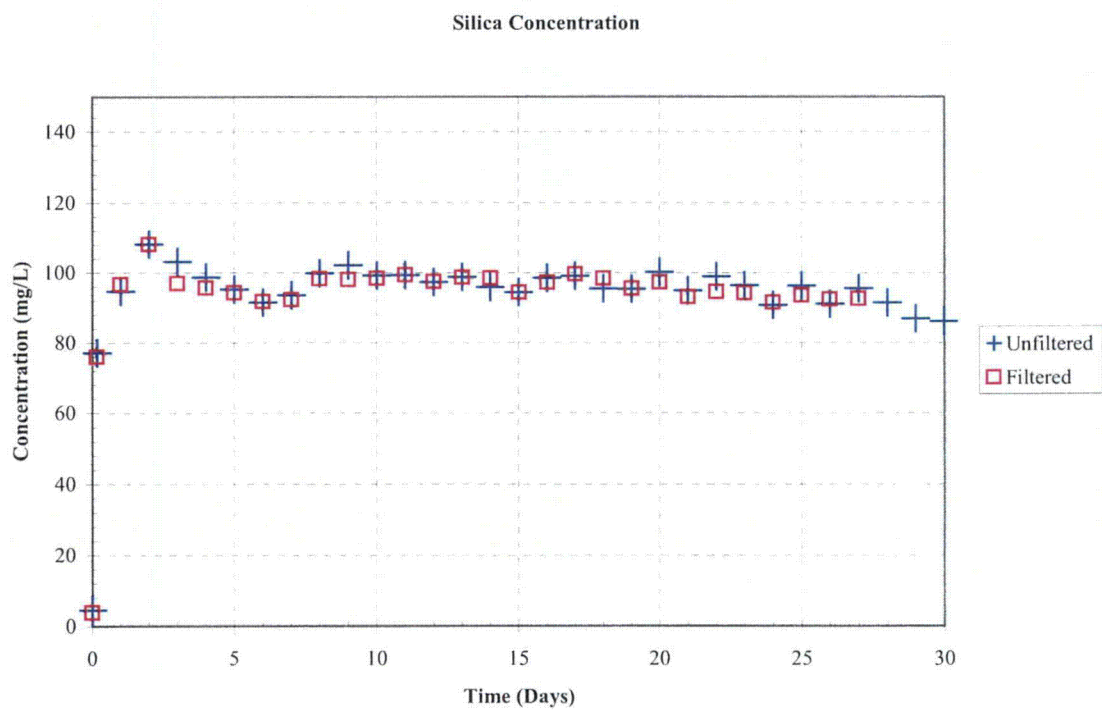
ICP results for Test #3 are displayed in Figures 3-8 through 3-16, which are daily sample results. Table 3-1 contains ICP results for elements that were analyzed on Days 1, 4, 15, and 30. Table 3-1 shows that chloride, boron, lead, lithium, and potassium concentrations remained relatively constant throughout the test. An examination of the figures reveals that phosphate, copper, iron, aluminum, and zinc are present in trace amounts, below 1 mg/L. It also can be seen that calcium, silica, sodium, and magnesium are present in higher concentrations.

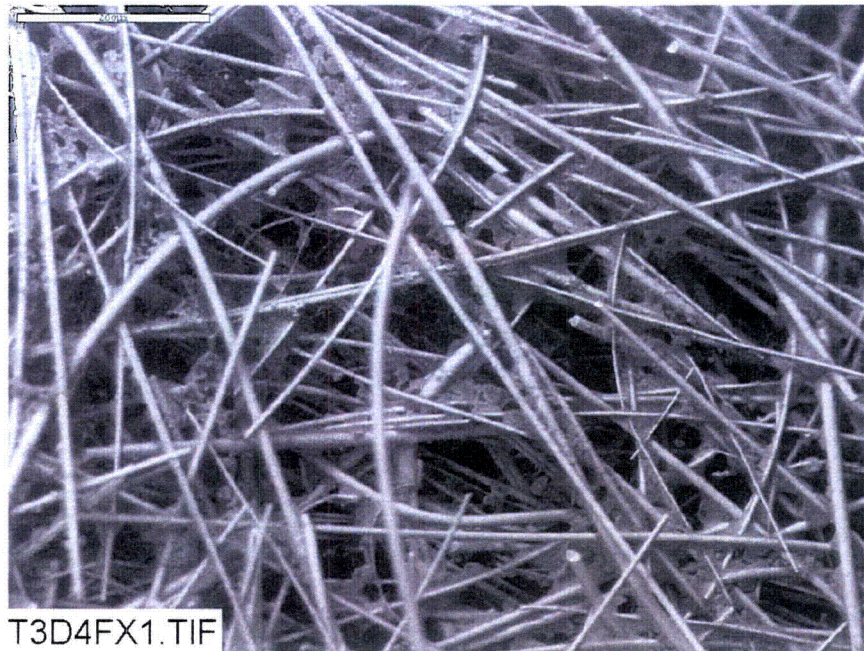
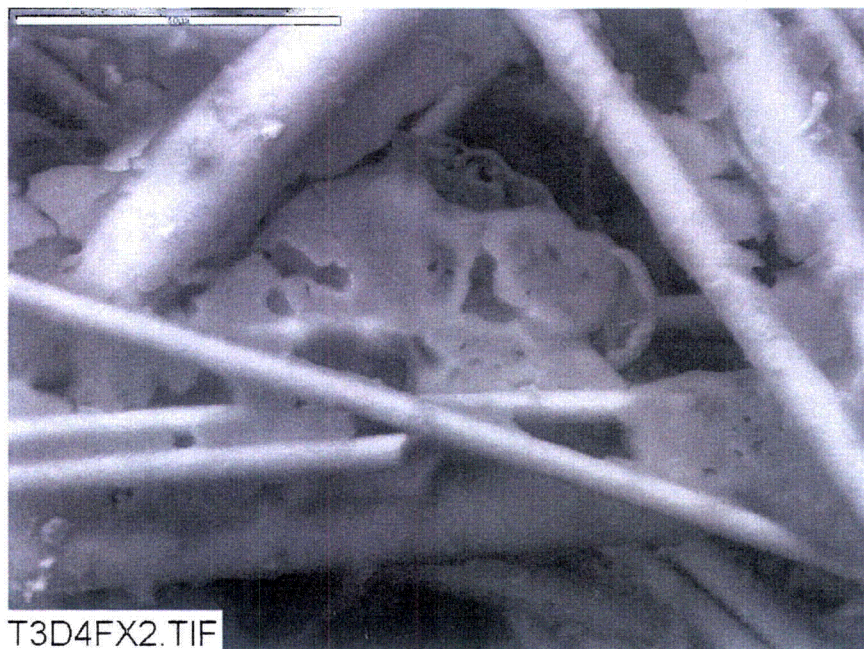
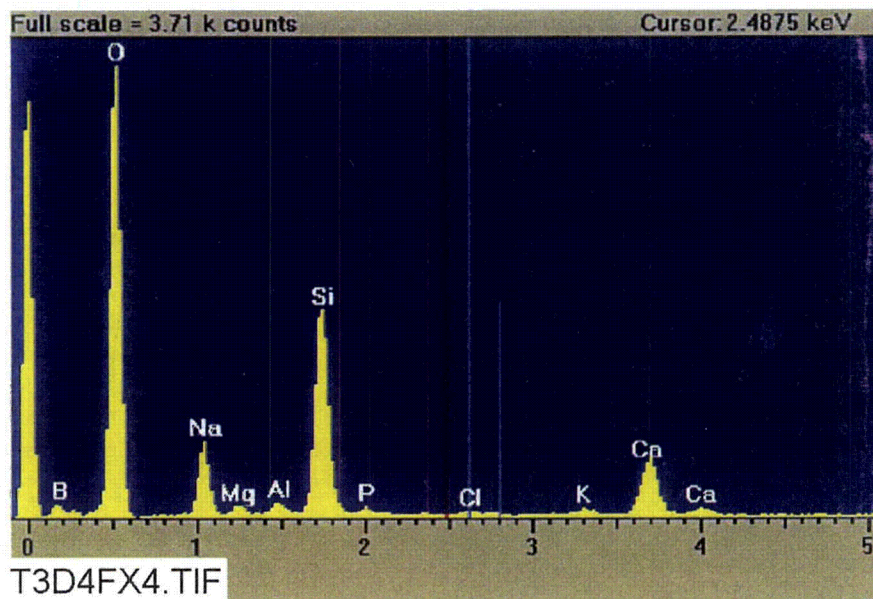
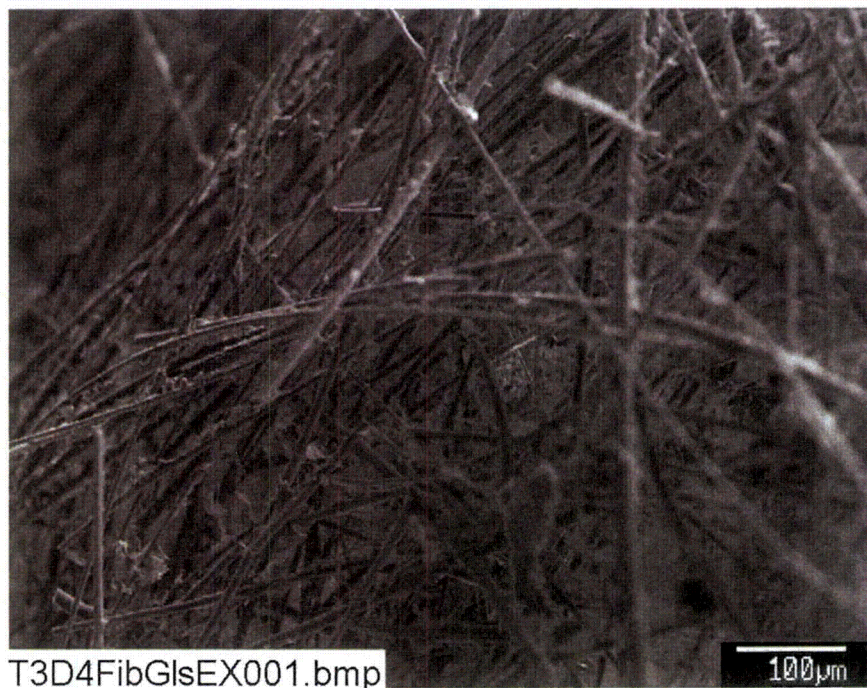
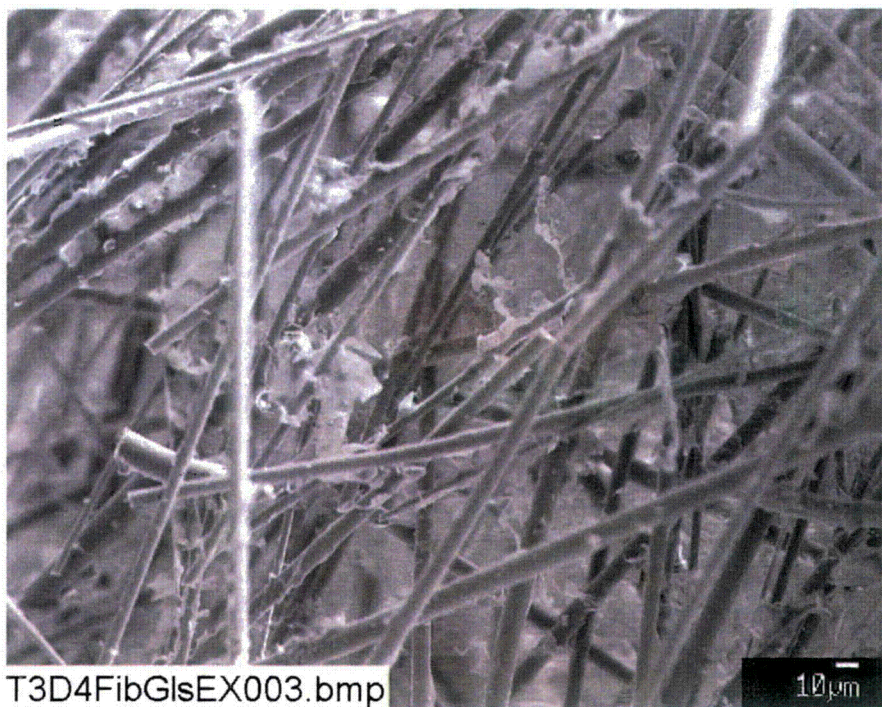
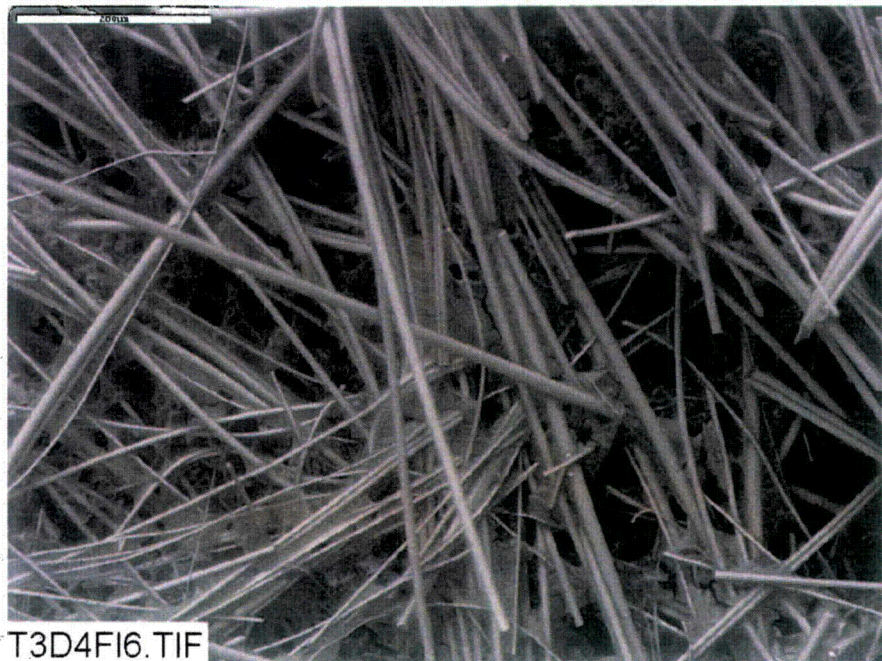
Since there was no significant water flow through the fiberglass samples during the test, particle migration from the solution into the fiberglass interior is insignificant. Based on the ESEM/SEM results, deposits were found on both the exterior and the interior of the low-flow fiberglass samples after test Day 4. Because these deposits formed continuously among glass fibers and even coated the fibers, it is likely that these deposits are of chemical origin instead of being physically attached/retained. Comparing ESEM and SEM results for the same fiberglass sample reveals that some dark deposits were found with ESEM results only. However, when the fiberglass samples were totally dried for SEM analysis, only white flocculence deposits were found, possibly because the fiberglass samples were semidried (partially dehydrated) with ESEM analysis. It is likely that the dark deposits began to precipitate out when the fiberglass samples were partially dehydrated during ESEM analysis. However, these dark deposits were totally precipitated out and dehydrated for SEM analysis. As a result, a significant amount of the white flocculence was found with SEM results. EDS results show that the deposits were commonly composed of O, Si (possible), Na, Ca, and small amounts of Mg, Al, B, and P, whether they were found on the exterior or interior of the fiberglass samples. The uncertainty of Si is due to the fact that x-ray may be scattered and/or penetrate the deposits. As a result, the signal may be reflected to the detector by the fiberglass in addition to the deposits. Therefore, when Si peaks show up, the existence of Si in the deposits cannot be confirmed or excluded. In addition, it should be noted that the deposits contained insignificant amounts of P, which means that the deposits did not have a direct relation to the white particles observed in the tank during TSP injection on the first day of the test.

Comparing interior and exterior fiberglass samples reveals no significant difference in the amount of deposits, again probably because of a chemical origin for the deposits. Chemical precipitation occurs to the same degree on both exterior and the interior fiberglass samples. Figures 3-17 through 3-27 show the Day-4, low-flow fiberglass results.
