# **Integrated Chemical Effects Test Project: Test #3 Data Report**

**Los Alamos National Laboratory**

**U.S. Nuclear Regulatory Commission  
Office of Nuclear Regulatory Research  
Washington, DC 20555-0001**

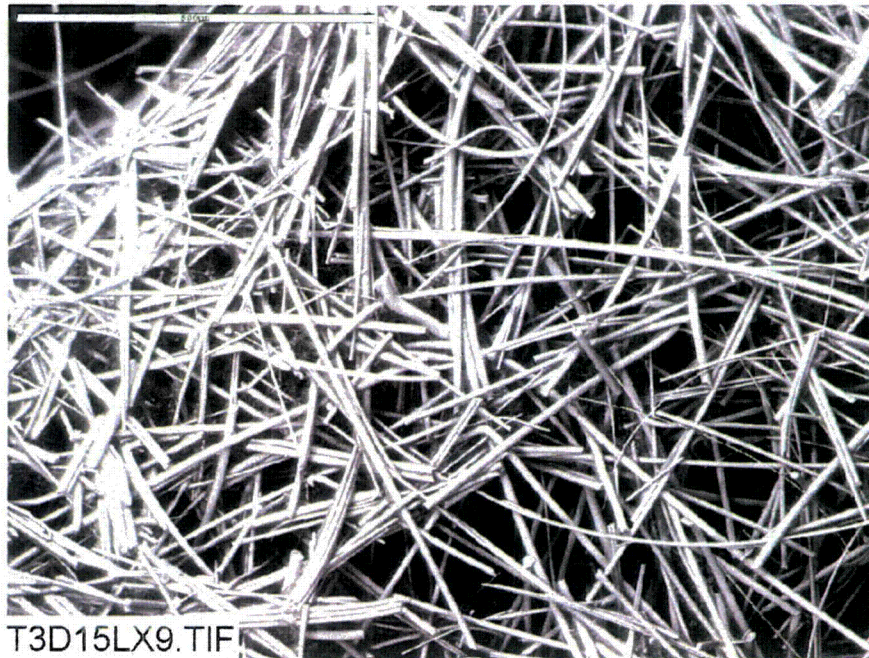
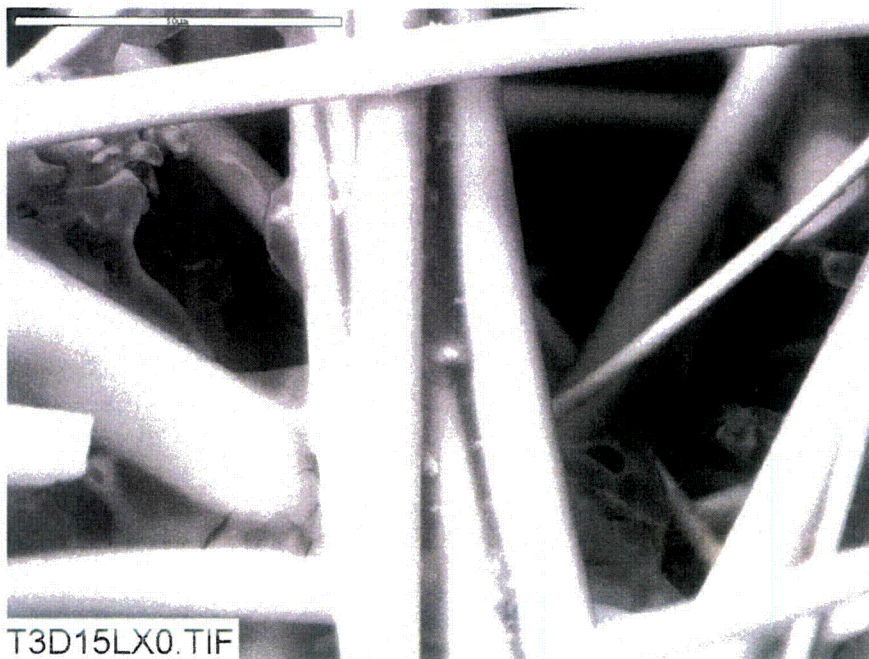
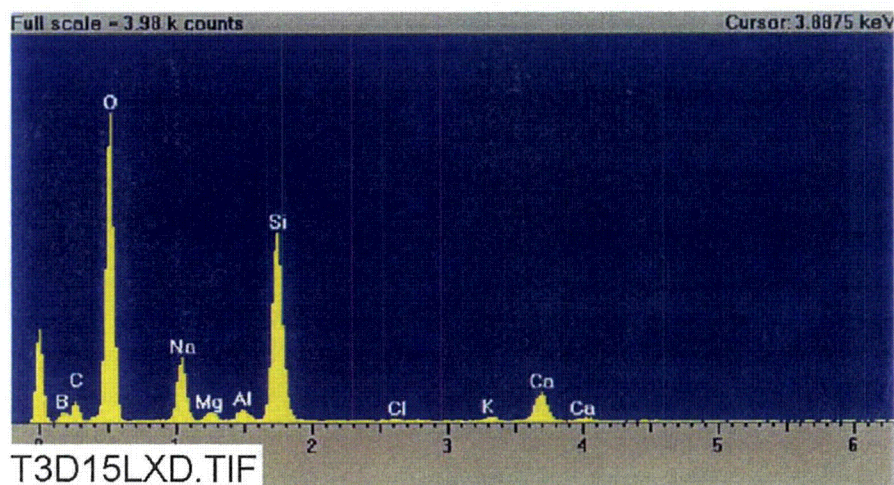
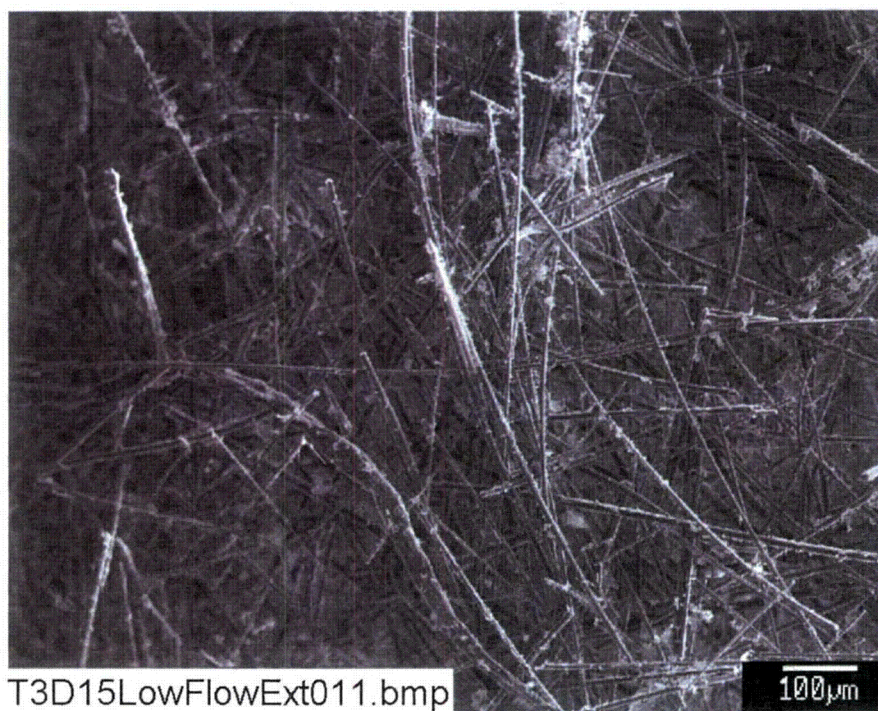
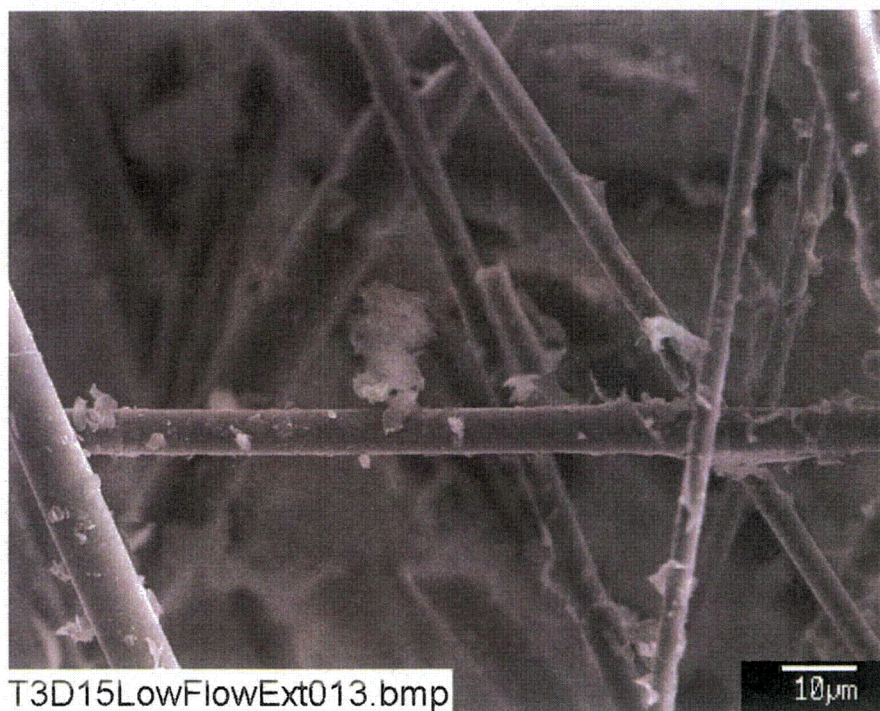
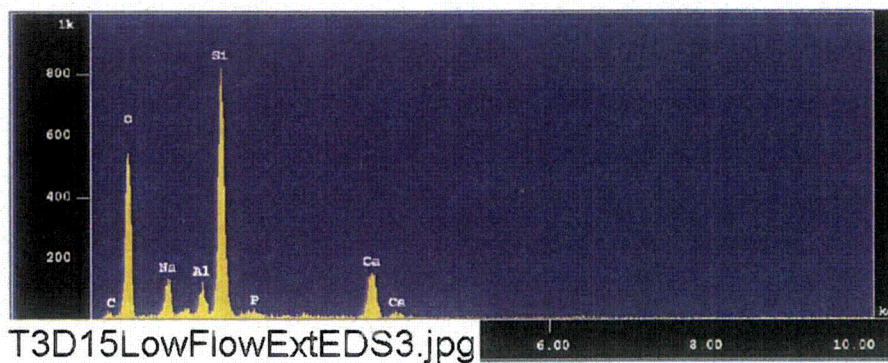
As with Day-4 samples, dark deposits and white flocculence were found with ESEM and SEM results, respectively, on Day-15 low-flow fiberglass samples. There was no significant increase in the amount of deposits on Day-15 samples compared with Day-4 samples. Comparing the amount of deposits on the exterior and the interior Day-15 low-flow fiberglass samples revealed no significant difference. Again, EDS results show that the deposits on both of the exterior and the interior samples were commonly composed of O, Si (possible), Na, Ca, and small amounts of Mg, Al, B, and P, suggesting the deposits' likely chemical origin. Figures 3-28 through 3-38 show the Day-15 low-flow fiberglass results.

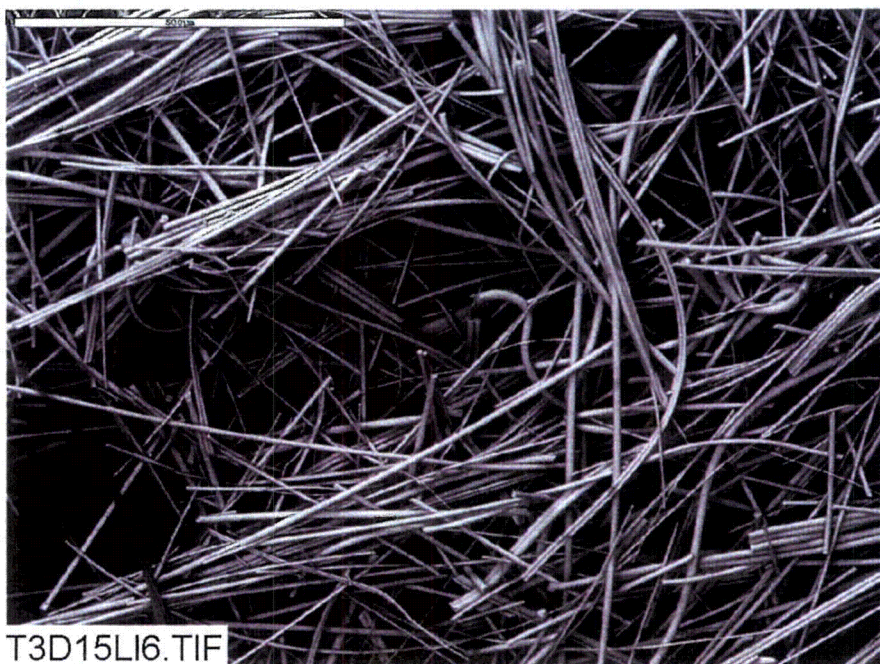
Figure 3-34. ESEM image of a Test #3, Day-15 low-flow interior fiberglass sample, magnified 100 times. (T3D15LI6)

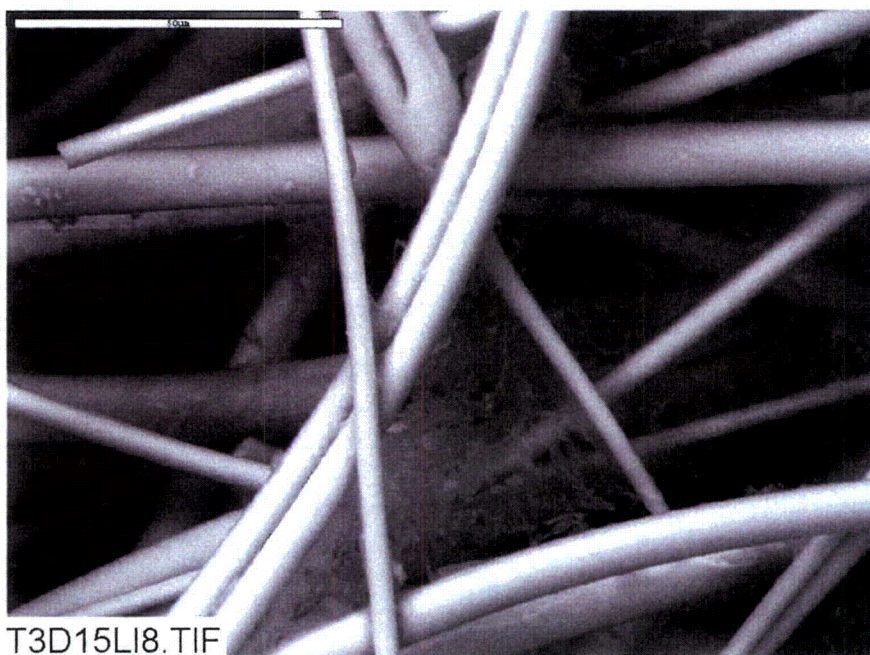
Figure 3-35. ESEM image of a Test# 3, Day-15 low-flow interior fiberglass sample, magnified 1000 times. (T3D15LI8)

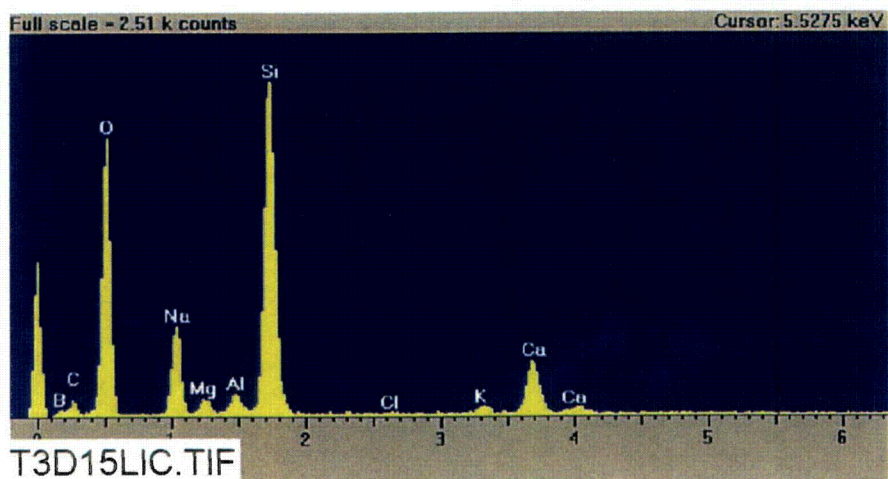
Figure 3-36. EDS counting spectrum for the flocculent deposits between the fibers on the ESEM image shown in Figure 3-35. (T3D15LIC)

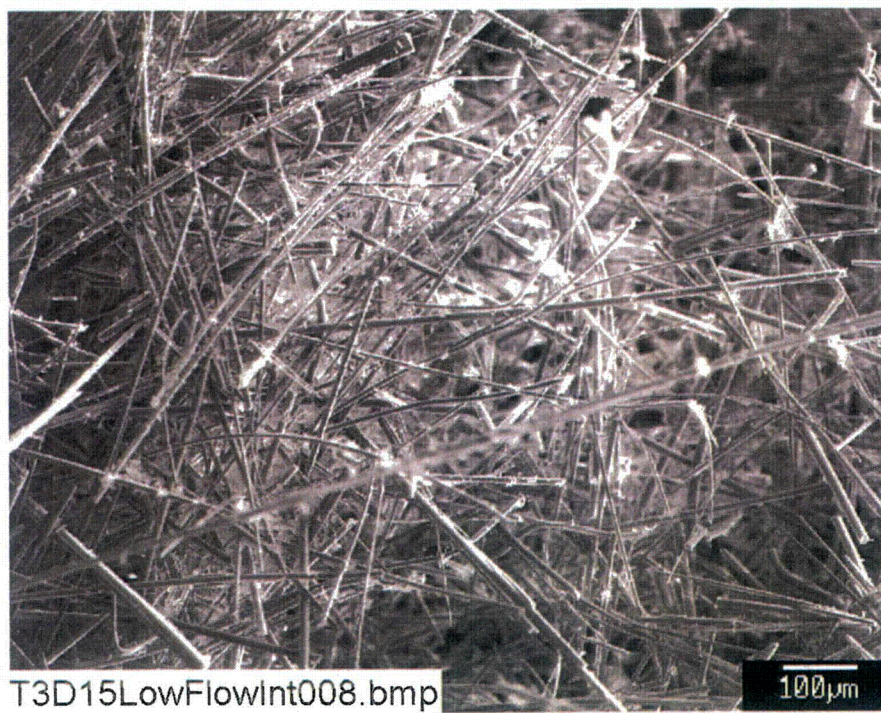
Figure 3-37. SEM image of a Test #3, Day-15 low-flow interior fiberglass sample, magnified 100 times. (T3D15LowFlowInt008)

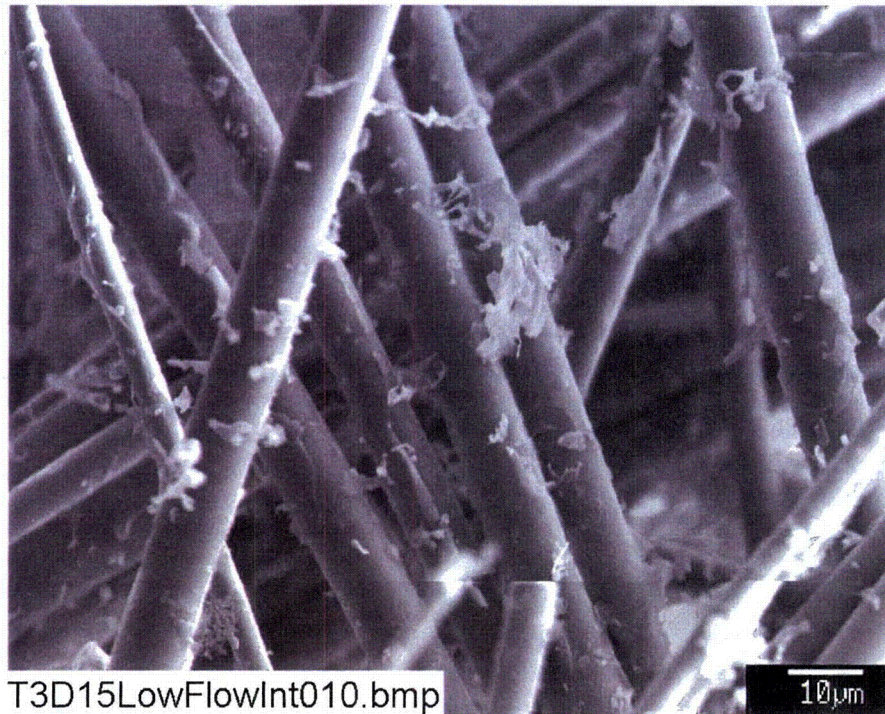
Figure 3-38. SEM image of a Test #3, Day-15 low-flow interior fiberglass sample, magnified 1000 times. (T3D15LowFlowInt010)

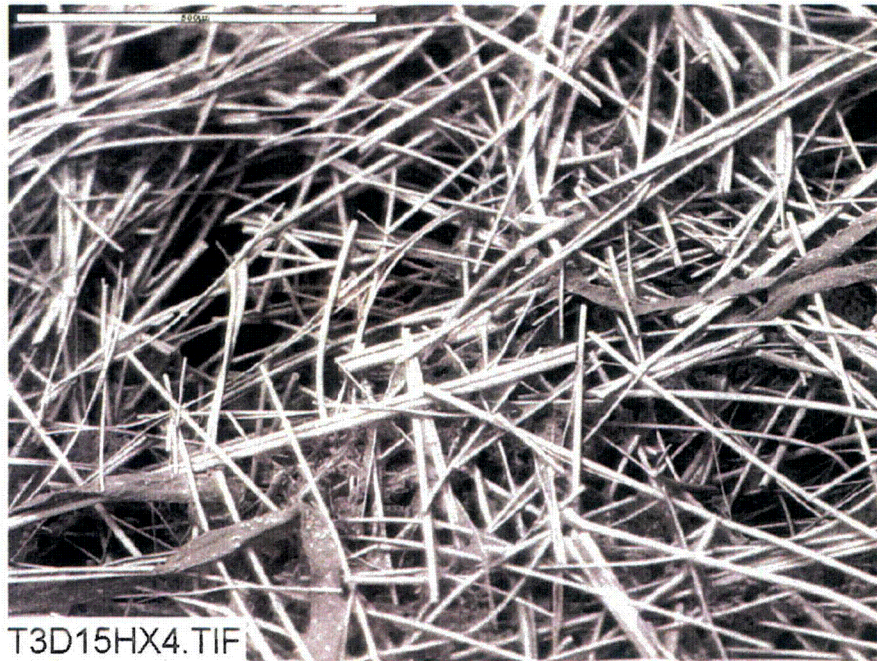
**Figure 3-39. ESEM image of a Test #3, Day-15 high-flow exterior fiberglass sample, magnified 110 times. (T3D15HX4, 4/22/05)**

No significant difference was found between Day-15 high-flow and low-flow fiberglass samples, except for some large flat fibers found on the Day-15 high-flow exterior fiberglass samples (see lower left corner of Figure 3-39). These large flat fibers, which were likely from the submerged cal-sil samples (see Appendix H), were physically attached/retained on the exterior of the fiberglass samples. No large flat fibers were found in the interior of the fiberglass samples. Again, dark deposits and white flocculence were found with ESEM and SEM results, respectively, on Day-15 high-flow fiberglass samples. There was no significant difference in the amount of deposits on the exterior and interior fiberglass samples. Similarly, EDS results verified that the deposits on the exterior and interior samples were commonly composed of O, Si (possible), Na, Ca, and small amount of Mg, Al, B, and P, suggesting the deposits' likely chemical origin. Figures 3-39 through 3-50 show the Day-15 high-flow fiberglass results.

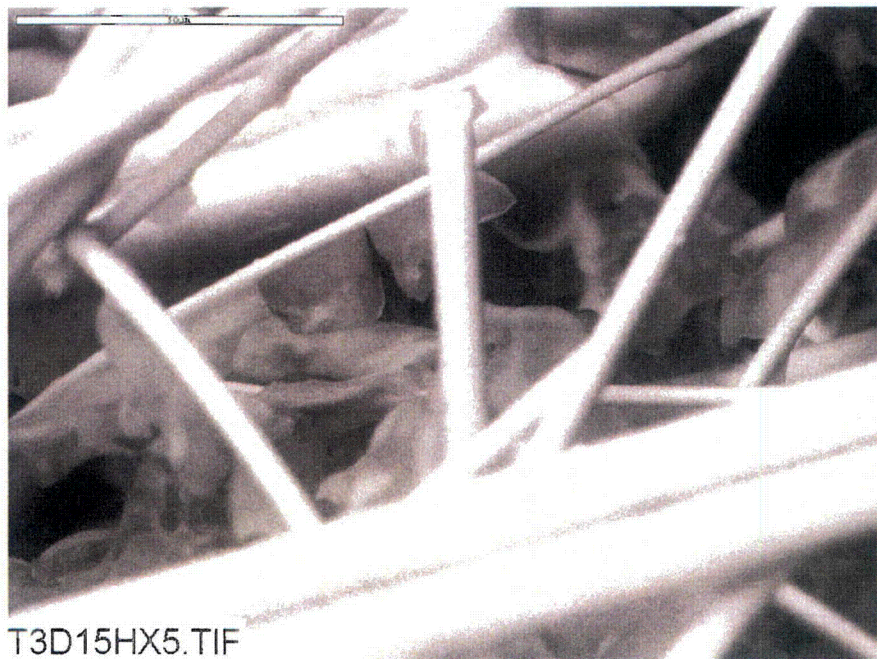
**Figure 3-40. ESEM image of a Test #3, Day-15 high-flow exterior fiberglass sample, magnified 1000 times. (T3D15HX5, 4/22/05)**

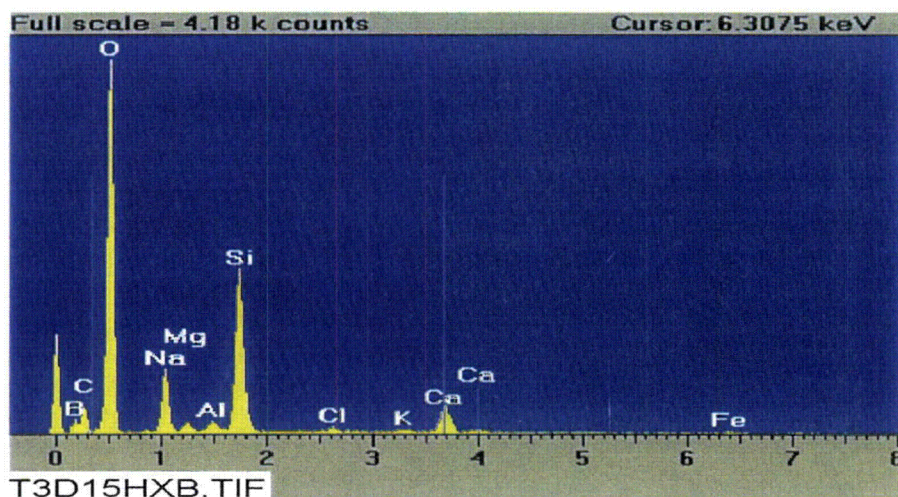
Figure 3-41. EDS counting spectrum for the deposits between the fibers on the ESEM image shown in Figure 3-40. (T3D15HIB, 4/22/05)

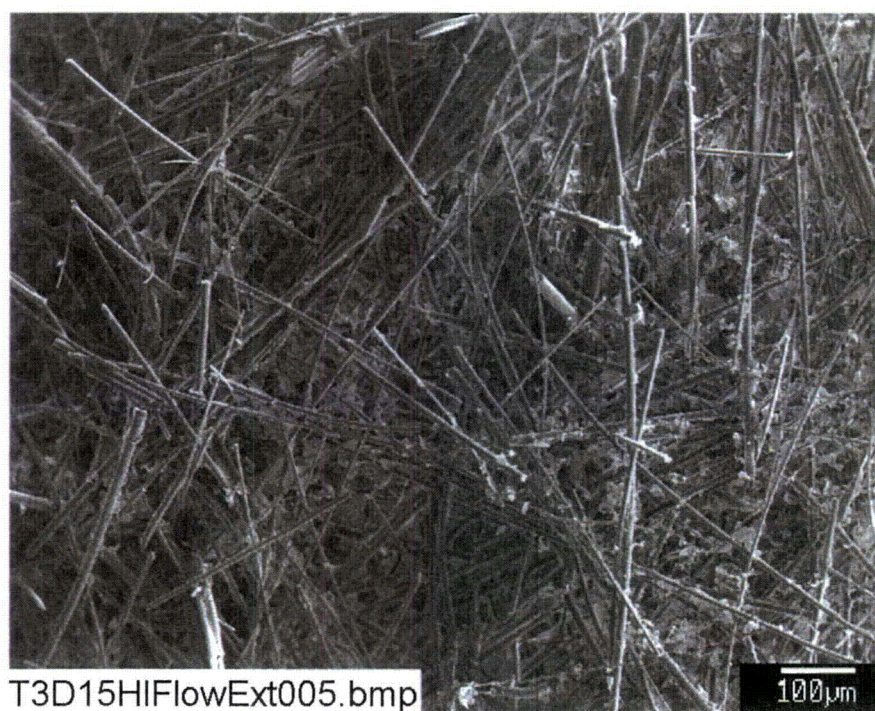
Figure 3-42. SEM image of a Test #3, Day-15 high-flow exterior fiberglass sample, magnified 100 times. (T3D15HIFlowExt005, 4/22/05)

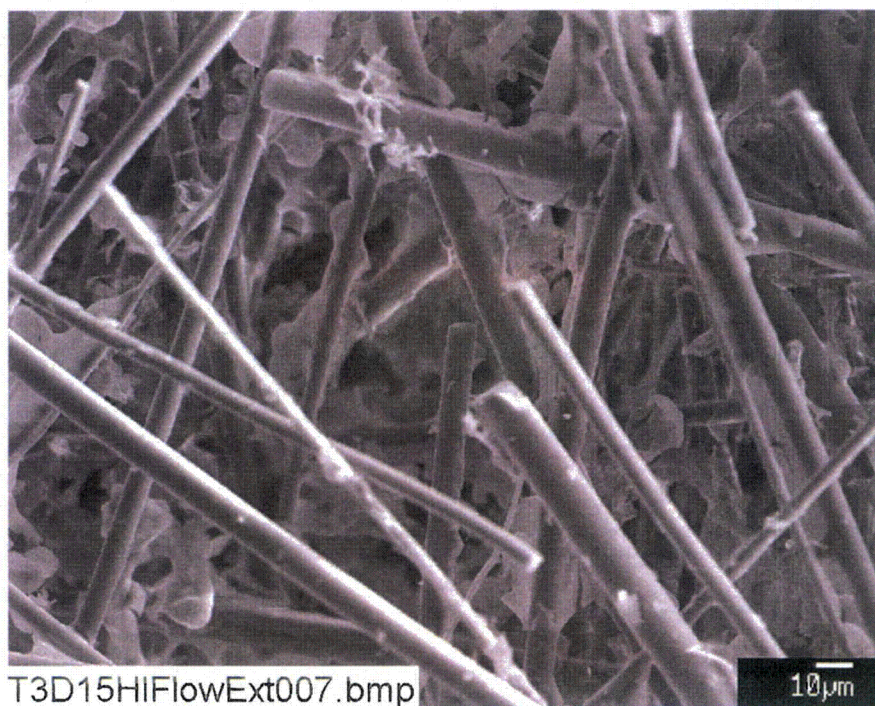
Figure 3-43. SEM image of a Test #3, Day-15 high-flow exterior fiberglass sample, magnified 500 times. (T3D15HiFlowExt007, 4/22/05)

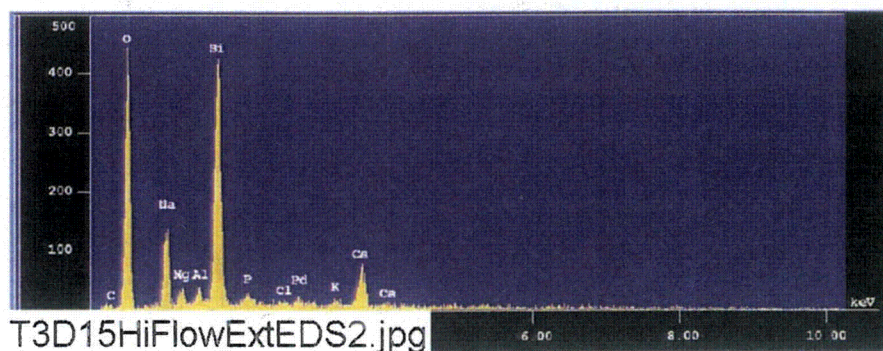
Figure 3-44. EDS counting spectrum for the flocculent deposits between the fibers on the SEM image shown in Figure 3-43. (T3D15HiFlowExtEDS2, 4/22/05)

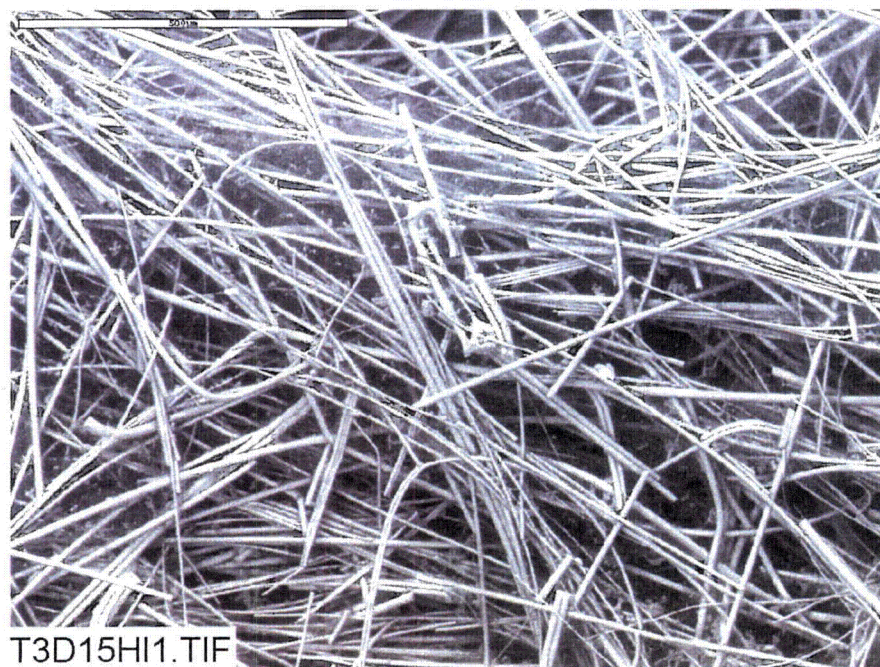
Figure 3-45. ESEM image of a Test #3, Day-15 high-flow interior fiberglass sample, magnified 100 times. (T3D15HI1, 4/22/05)

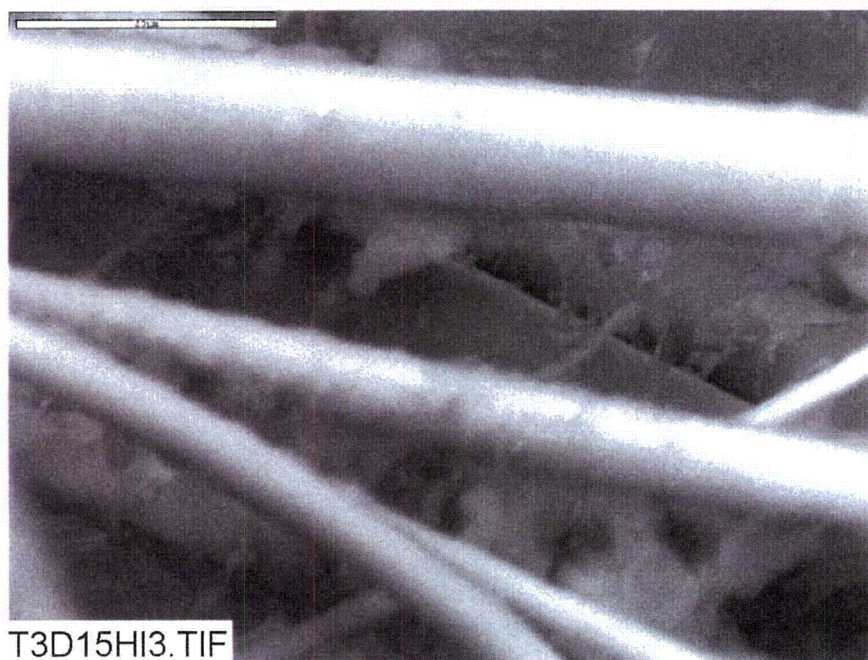
Figure 3-46. ESEM image of a Test #3, Day-15 high-flow interior fiberglass sample, magnified 2000 times. (T3D15HI3, 4/22/05)

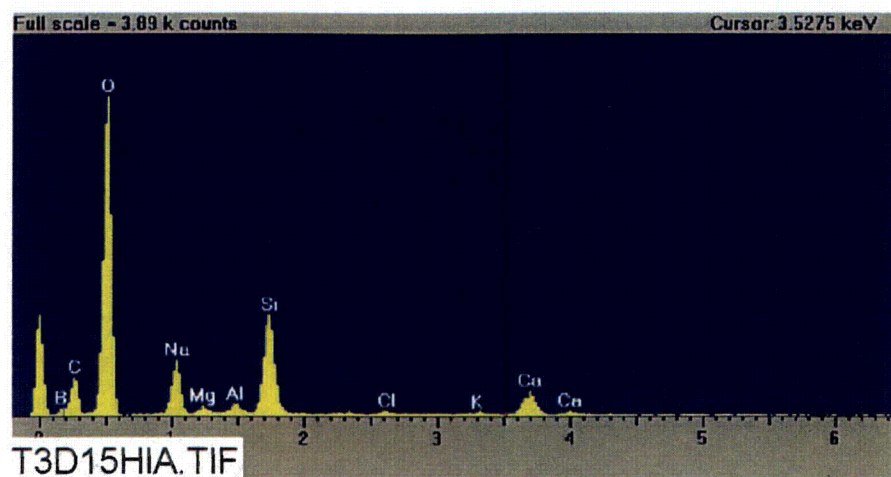
Figure 3-47. EDS counting spectrum for the flocculent deposits between the fibers on the ESEM image shown in Figure 3-46. (T3D15HIA, 4/22/05)

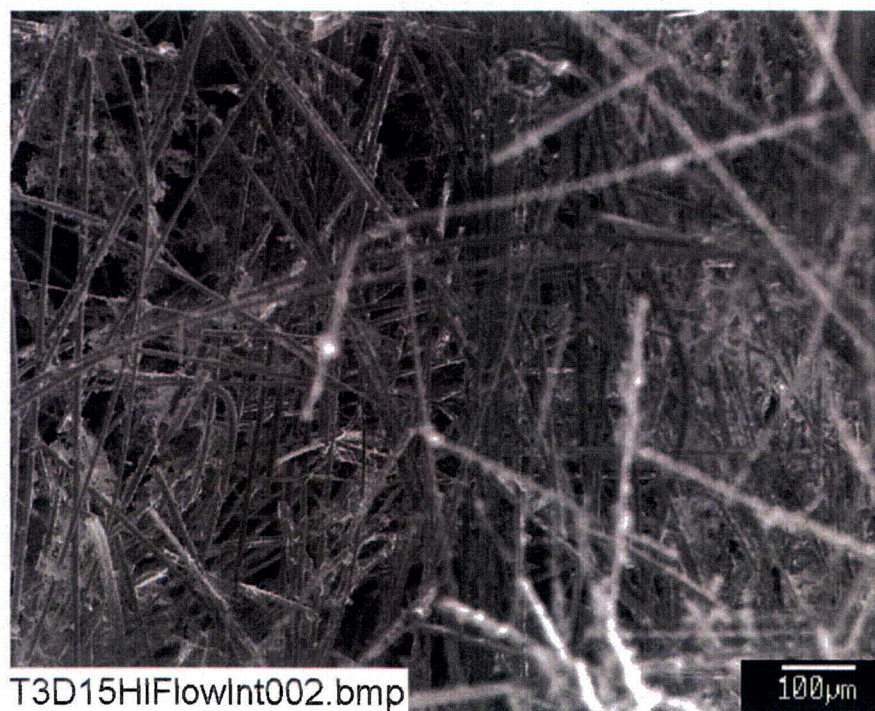
Figure 3-48. SEM image of a Test #3, Day-15 high-flow interior fiberglass sample, magnified 100 times. (T3D15HIFlowInt002, 4/22/05)

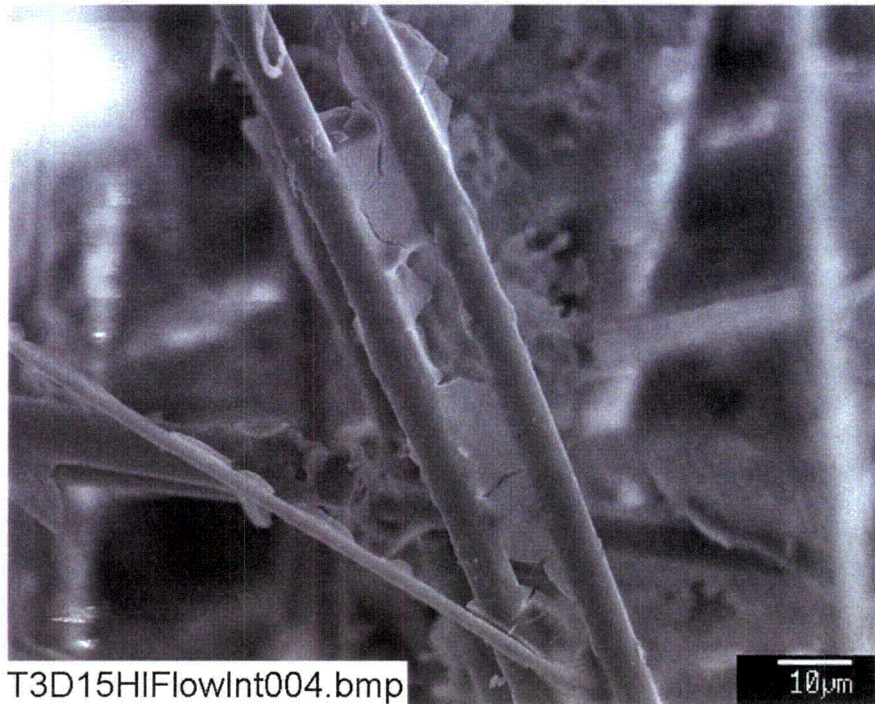
Figure 3-49. SEM image of a Test #3, Day-15 high-flow interior fiberglass sample, magnified 1000 times. (T3D15HiFlowInt004, 4/22/05)

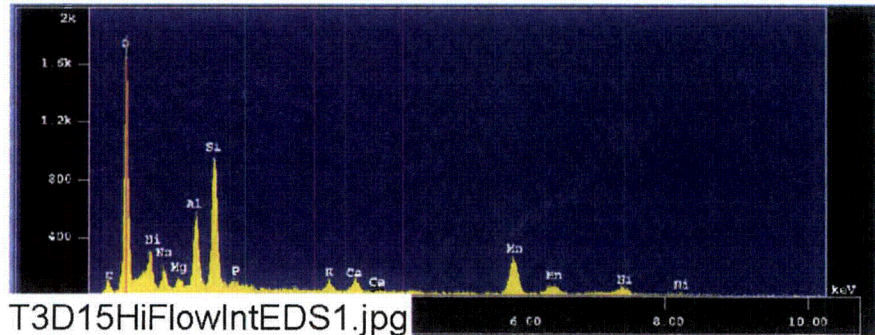
Figure 3-50. EDS counting spectrum for the flocculent deposits between the fibers on the SEM image shown in Figure 3-49. (T3D15HiFlowIntEDS1, 4/22/05)

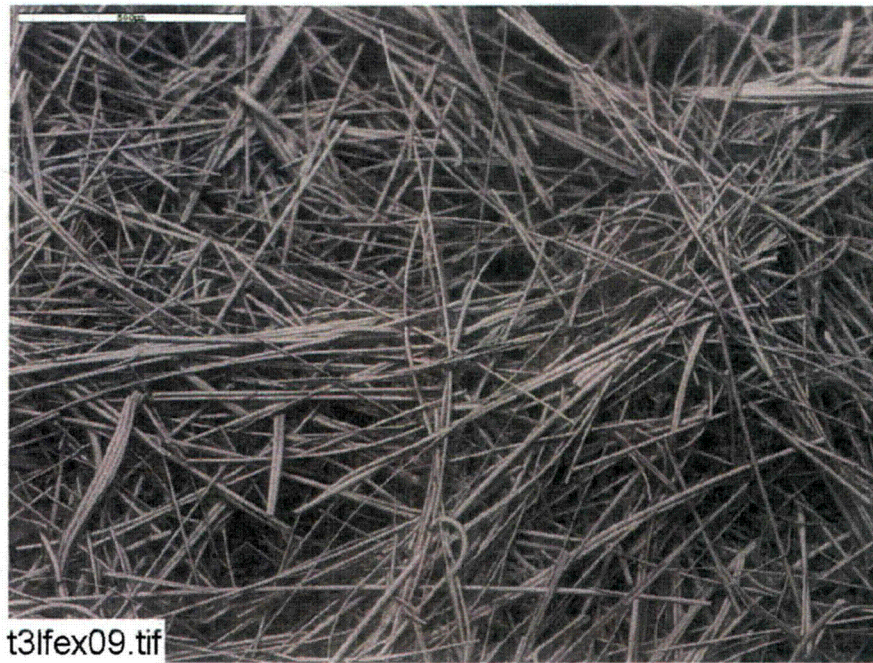
Figure 3-51. ESEM image of a Test #3, Day-30 exterior low-flow fiberglass sample, magnified 70 times. (t3lfex09, 5/6/05)

Comparing Day-30 low-flow fiberglass samples with Day-4 and Day-15 low-flow fiberglass samples revealed deposits that are similar in property and amount. In addition, there was no significant difference in the amount of deposits found in exterior and interior Day-30 low-flow fiberglass samples. Figures 3-51 through 3-54 show the Day-30 low-flow fiberglass results.

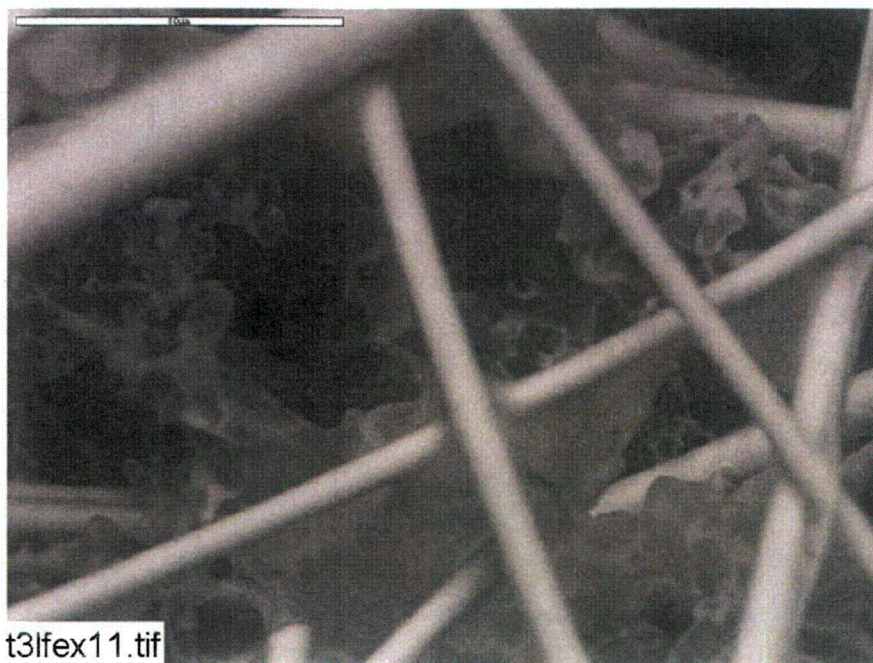
Figure 3-52. ESEM image of a Test #3, Day-30 exterior low-low fiberglass sample, magnified 1000 times. (t3lfex11, 5/6/05)

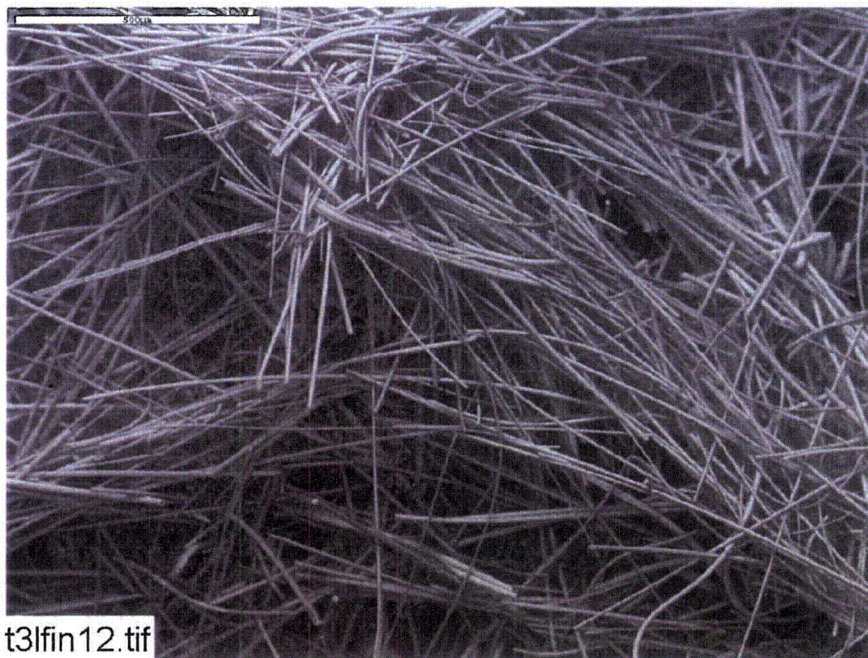
Figure 3-53. ESEM image of a Test #3, Day-30 interior low-flow fiberglass sample, magnified 70 times. (t3lfin12, 5/6/05)

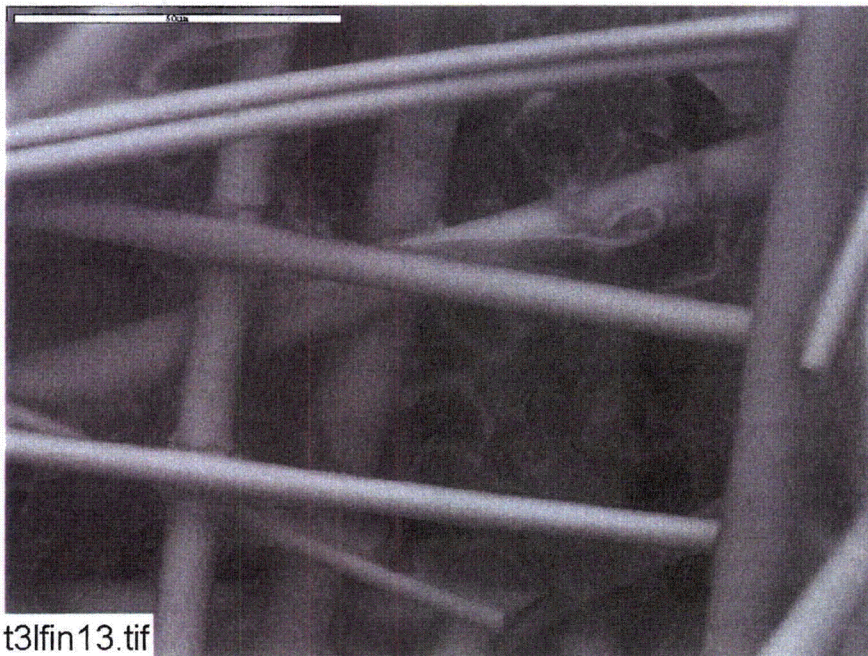
Figure 3-54. ESEM image of a Test #3, Day-30 interior low-flow fiberglass sample, magnified 1000 times. (t3lfin13, 5/6/05)

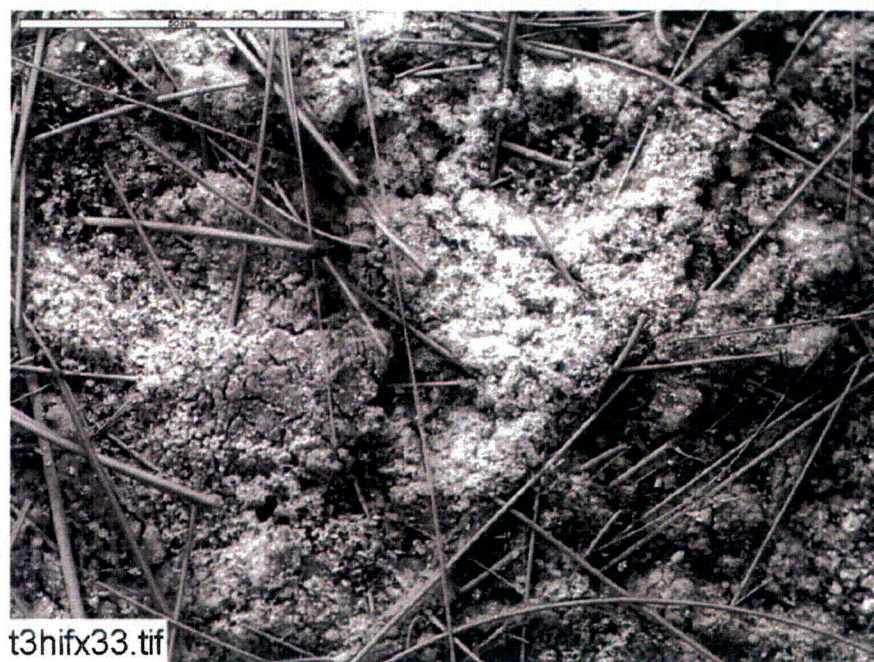
Figure 3-55. ESEM image of a Test #3, Day-30 exterior high-flow fiberglass sample, magnified 100 times. (t3hifx33, 5/11/05)

Compared with other high- and low-flow fiberglass samples, Day-30 high-flow exterior samples contained a significant amount of particulates. As opposed to the exterior samples, the interior samples were relatively clean, suggesting that the particulate deposits were physically attached/retained on the fiberglass exterior. EDS results show that the particulate deposits were composed of a significant amount of P, which is different from the previous fiberglass samples. The deposits' high P, Ca, and O content suggests that the deposits were  $\text{Ca}_3(\text{PO}_4)_2$ , which relates to the white gel (cream) formed during the injection of TSP. That  $\text{Ca}_3(\text{PO}_4)_2$  was likely precipitated out from the testing solution, followed by sedimentation/transportation onto the Day-30 high-flow fiberglass exterior. Figures 3-55 through 3-59 show the Day-30 high-flow fiberglass results.

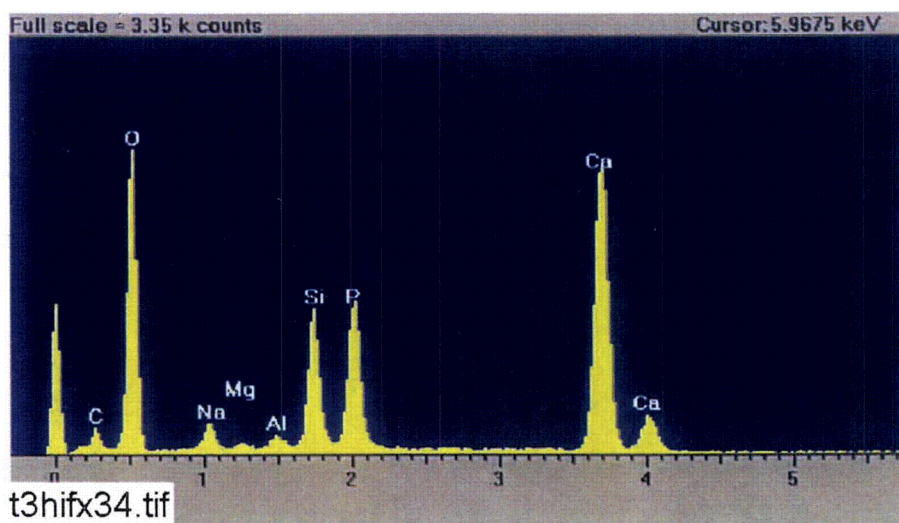
Figure 3-56. EDS counting spectrum for the large masses of particulate deposits shown in Figure 3-55. (t3hifx34, 5/11/05)

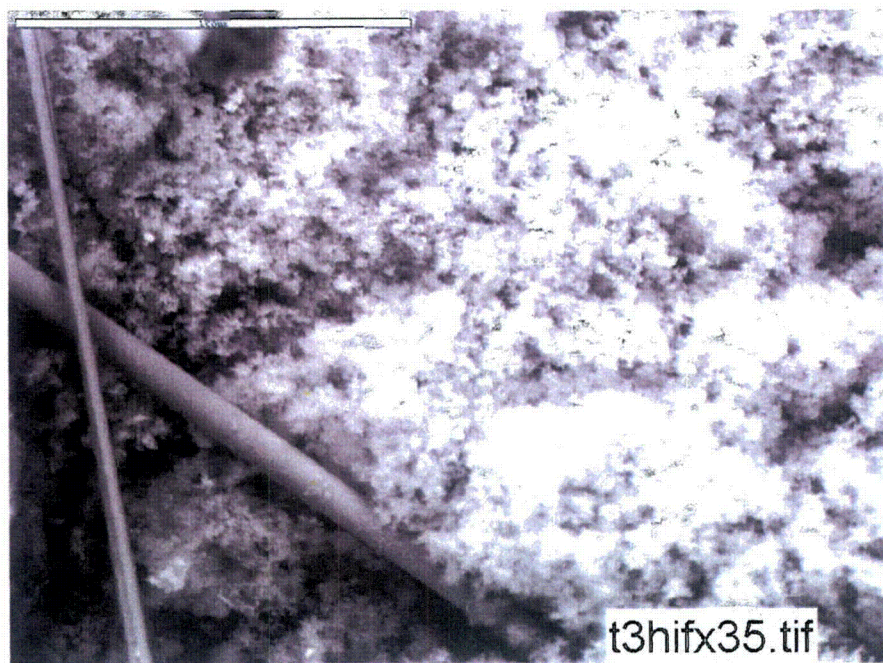
Figure 3-57. ESEM image of a Test #3, Day-30 exterior high-flow fiberglass sample, magnified 600 times. (t3hifx35, 5/11/05)

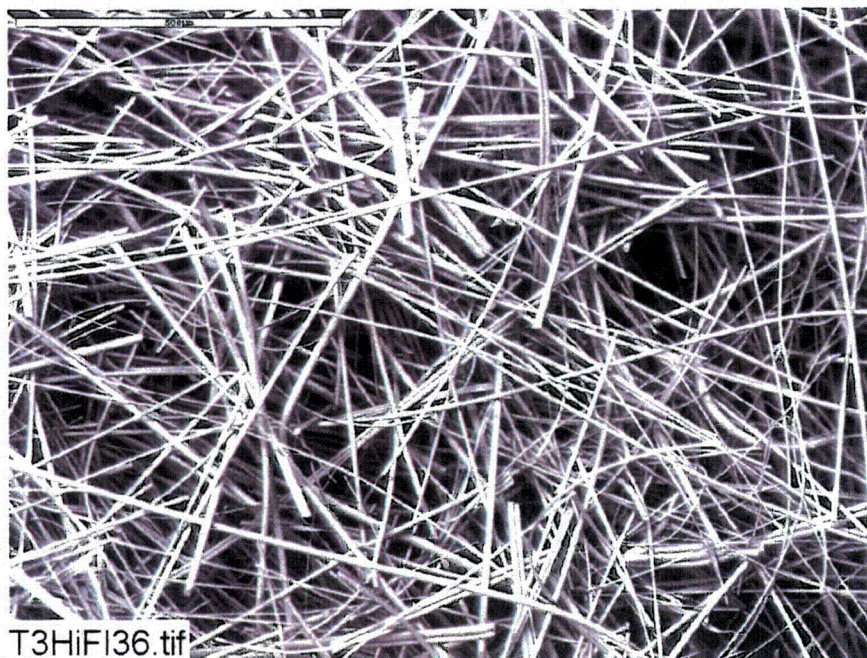
Figure 3-58. ESEM image of a Test #3, Day-30 interior high-flow fiberglass sample, magnified 100 times. (T3HiFI36, 5/11/05)

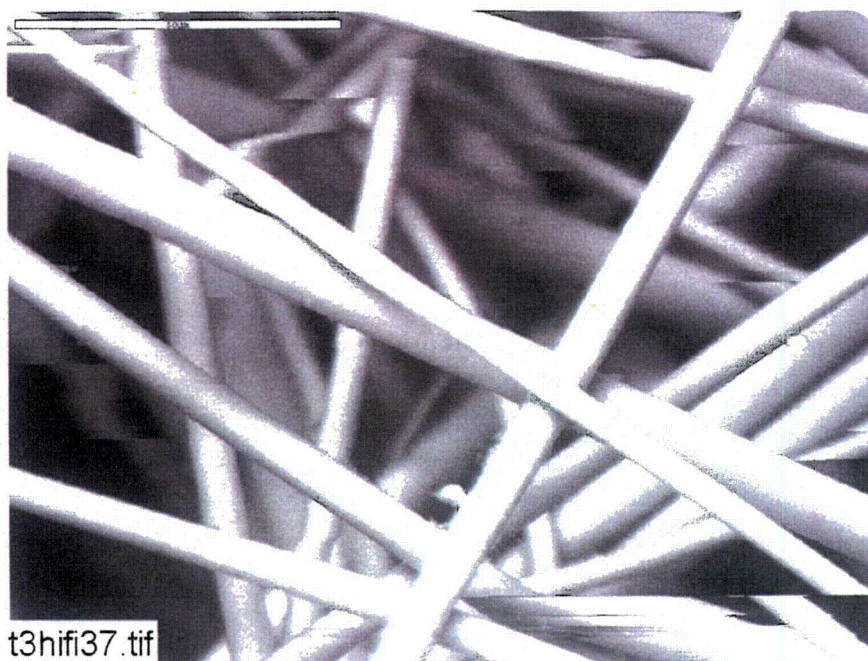
Figure 3-59. ESEM image of a Test #3, Day-30 interior high-flow fiberglass sample, magnified 1000 times. (t3hifi37, 5/11/05)

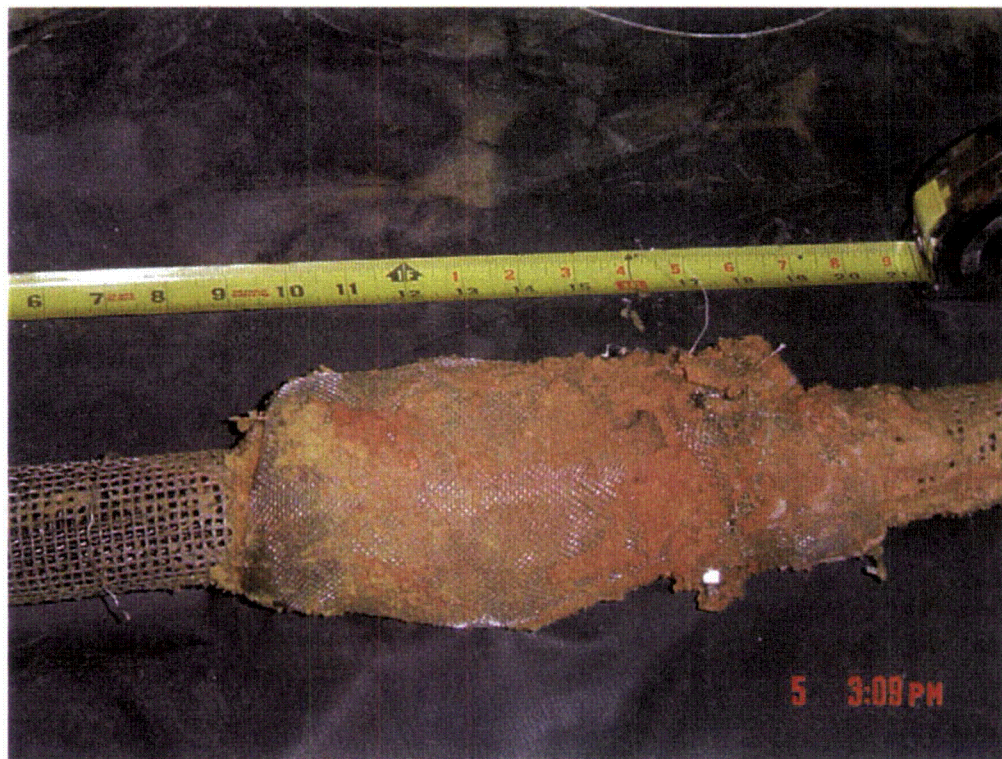
Figure 3-60. Drain screen collar removed from the tank.

Figure 3-60 shows the drain collar after it was removed from the tank. When the tank was drained, the drain collar was totally surrounded by sediment. Both the exterior fiberglass sample that was farthest from the drain screen and the exterior sample that was next to the drain screen have very significant amounts of particulate deposits. Inspection revealed the development of a continuous coating on the drain collar exterior, including particulate deposits that were likely physically retained or attached. The amount of deposits on the drain collar exterior was greater than on high- and low-flow fiberglass samples. The ESEM images showed that two types of material were retained; an amorphous material that appeared darker in the ESEM images and a lighter granular material. The EDS results indicate that these materials had different P and Si content. The lighter particulate deposits (see Figure 3-62) have a higher percentage of P and a lower percentage of Si than the dark deposits, suggesting that light particulate deposits are likely composed of  $\text{Ca}_3(\text{PO}_4)_2$  precipitates and dark deposits of cal-sil particles. Both kinds of deposits could have been transported and/or deposited/retained on the drain collar fiberglass exterior. As opposed to what was found on the exterior sample, no significant deposits were found in the drain collar interior sample, suggesting that almost all of the particulate deposits were physically retained at the fiberglass exterior. The result is consistent with findings for the Day-30 high-flow fiberglass samples. Figures 3-61 through 3-70 show the drain Day-30 drain collar fiberglass results.

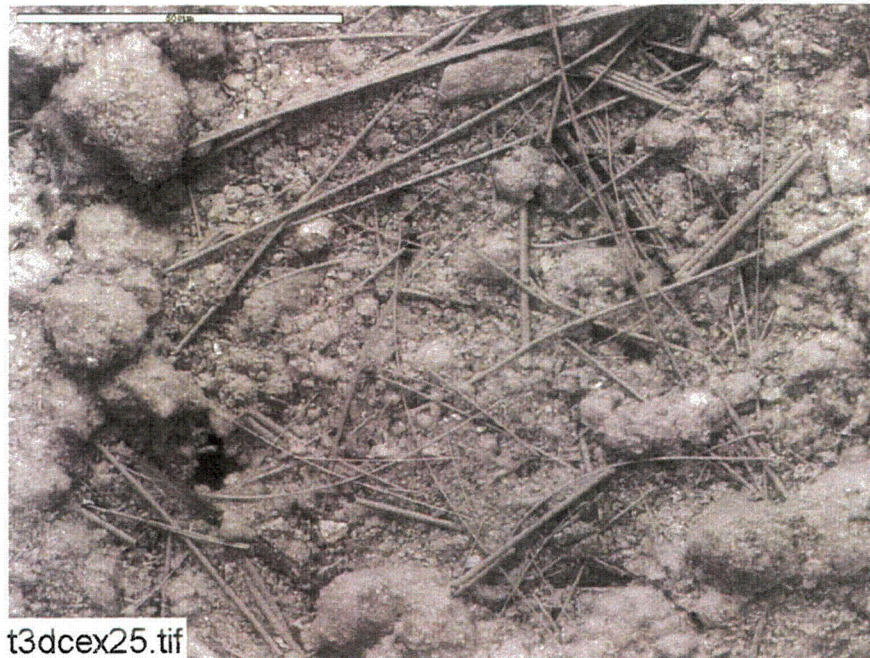
Figure 3-61. ESEM image of a Test #3, Day-30 exterior fiberglass sample on the drain collar (away from the drain screen), magnified 100 times. (t3dcex25, 5/6/05)

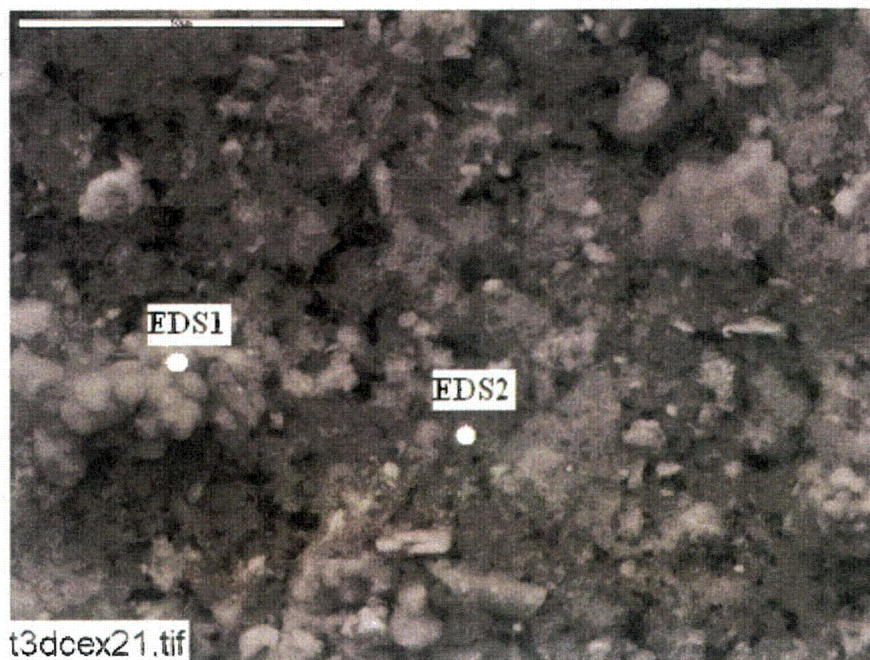
Figure 3-62. ESEM image of a Test #3, Day-30 exterior fiberglass sample on the drain collar (away from the drain screen), magnified 1000 times. (t3dcex21, 5/6/05)

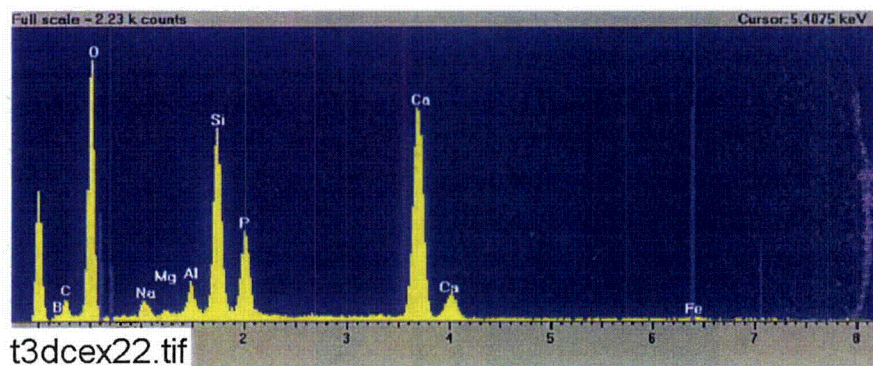
Figure 3-63. EDS counting spectrum for the light particulate deposits (EDS1) shown in Figure 3-62. (t3dcex22, 5/6/05)

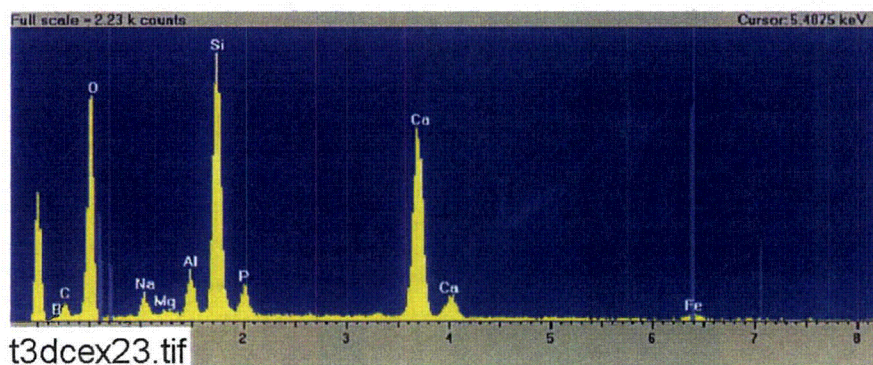
Figure 3-64. EDS counting spectrum for the dark deposits (EDS2) shown in Figure 3-62. (t3dcex23, 5/6/05)
