# **Integrated Chemical Effects Test Project: Test #3 Data Report**

**Los Alamos National Laboratory**

**U.S. Nuclear Regulatory Commission  
Office of Nuclear Regulatory Research  
Washington, DC 20555-0001**

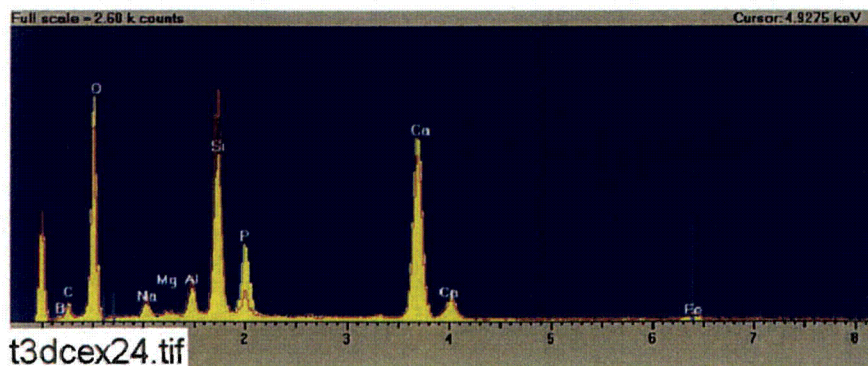
Figure 3-65. Comparison of EDS counting spectra between Figure 3-63 (yellow) and Figure 3-64 (red). (t3dcex24, 5/6/05)

Figure 3-60 shows the drain collar after it was removed from the tank. When the tank was drained, the drain collar was totally surrounded by sediment. Both the exterior fiberglass sample that was farthest from the drain screen and the exterior sample that was next to the drain screen have very significant amounts of particulate deposits. Inspection revealed the development of a continuous coating on the drain collar exterior, including particulate deposits that were likely physically retained or attached. The amount of deposits on the drain collar exterior was greater than on high- and low-flow fiberglass samples. The ESEM images showed that two types of material were retained; an amorphous material that appeared darker in the ESEM images and a lighter granular material. The EDS results indicate that these materials had different P and Si content. The lighter particulate deposits (see Figure 3-62) have a higher percentage of P and a lower percentage of Si than the dark deposits, suggesting that light particulate deposits are likely composed of  $\text{Ca}_3(\text{PO}_4)_2$  precipitates and dark deposits of cal-sil particles. Both kinds of deposits could have been transported and/or deposited/retained on the drain collar fiberglass exterior. As opposed to what was found on the exterior sample, no significant deposits were found in the drain collar interior sample, suggesting that almost all of the particulate deposits were physically retained at the fiberglass exterior. The result is consistent with findings for the Day-30 high-flow fiberglass samples. Figures 3-61 through 3-70 show the drain Day-30 drain collar fiberglass results.

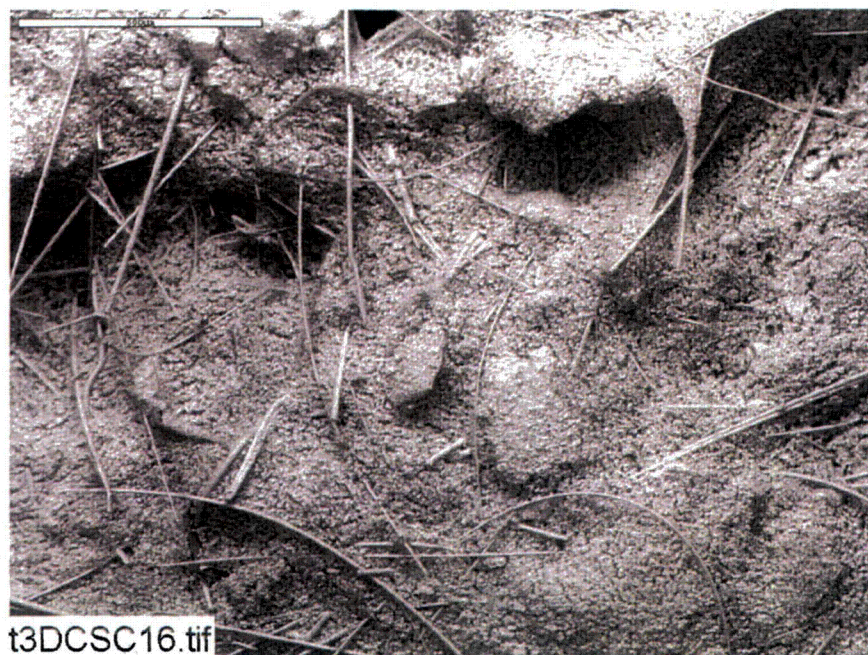
Figure 3-66. ESEM image of a Test #3, Day-30 exterior fiberglass sample on the drain collar (adjacent to the drain screen), magnified 100 times. (t3DCSC16, 5/6/05)

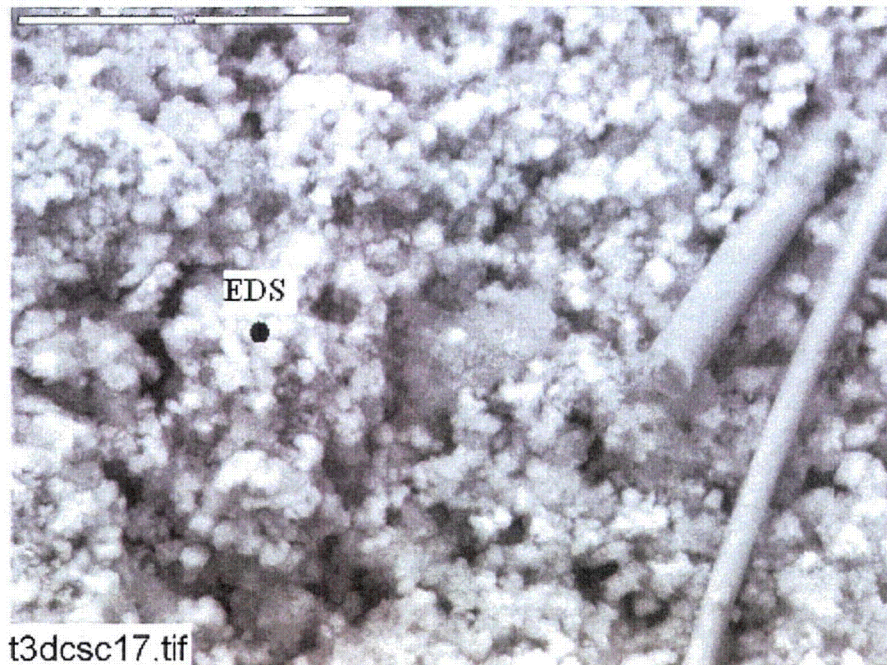
Figure 3-67. ESEM image of a Test #3, Day-30 exterior fiberglass sample on the drain collar (adjacent to the drain screen), magnified 1000 times. (t3dcsc17, 5/6/05)

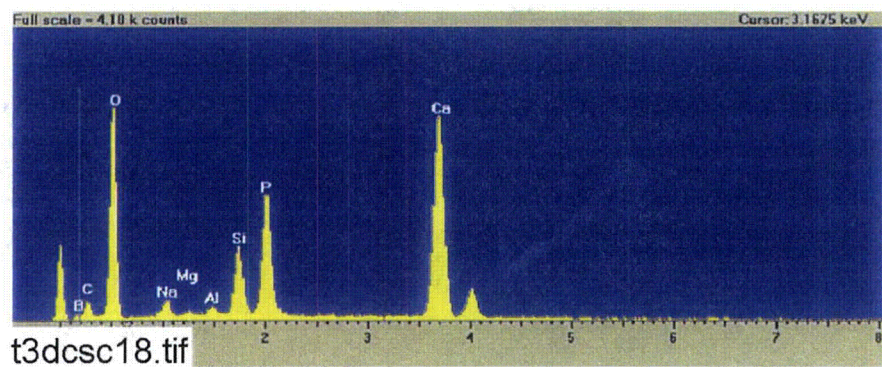
Figure 3-68. EDS counting spectrum for the particulate deposits shown in Figure 3-67. (t3dcsc18, 5/6/05)

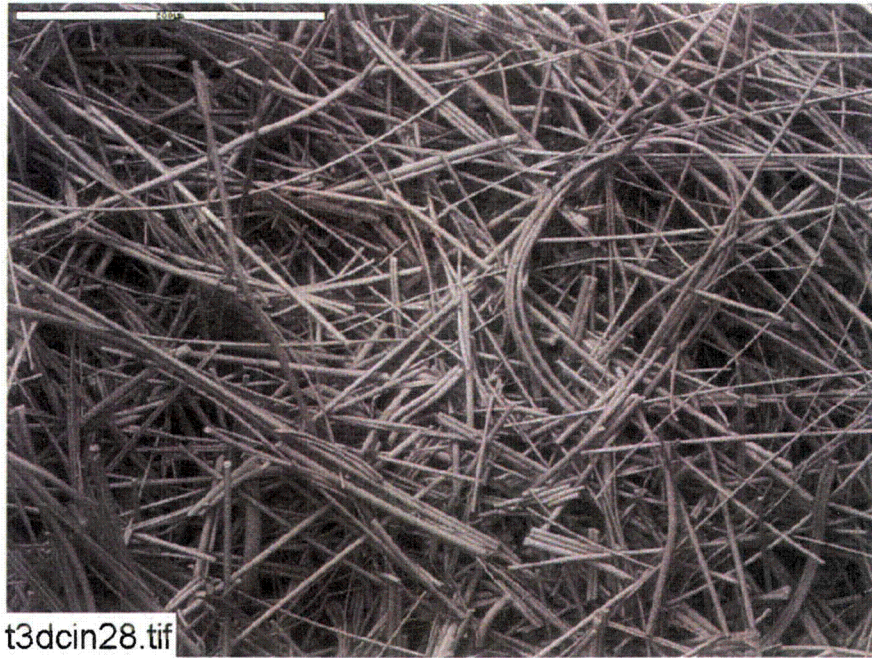
**Figure 3-69. ESEM image of a Test #3, Day-30 interior fiberglass sample on the drain collar, magnified 100 times. (t3dcin28, 5/6/05)**

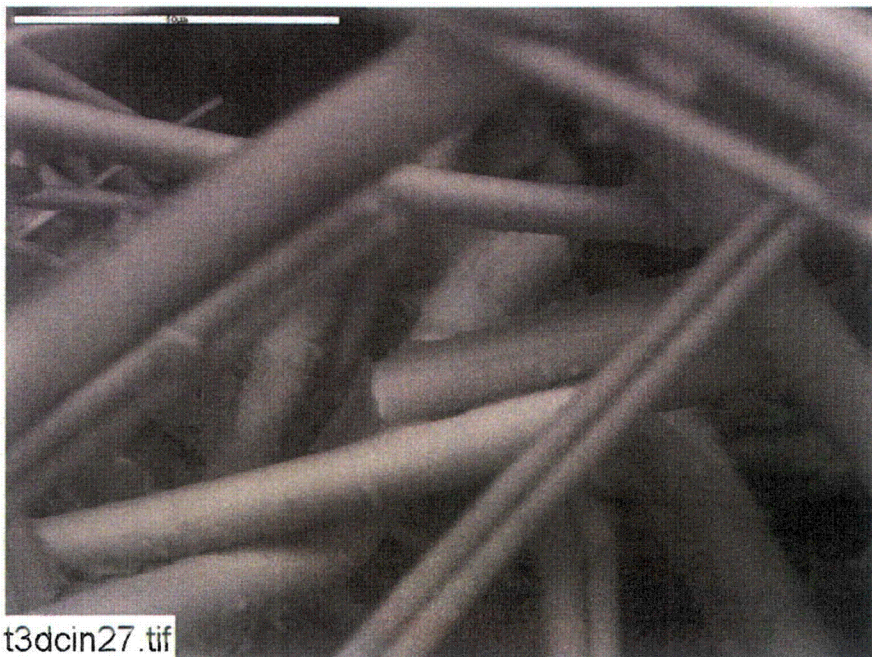
**Figure 3-70. ESEM image of a Test #3, Day-30 interior fiberglass sample on the drain collar, magnified 1000 times. (t3dcin27, 5/6/05)**

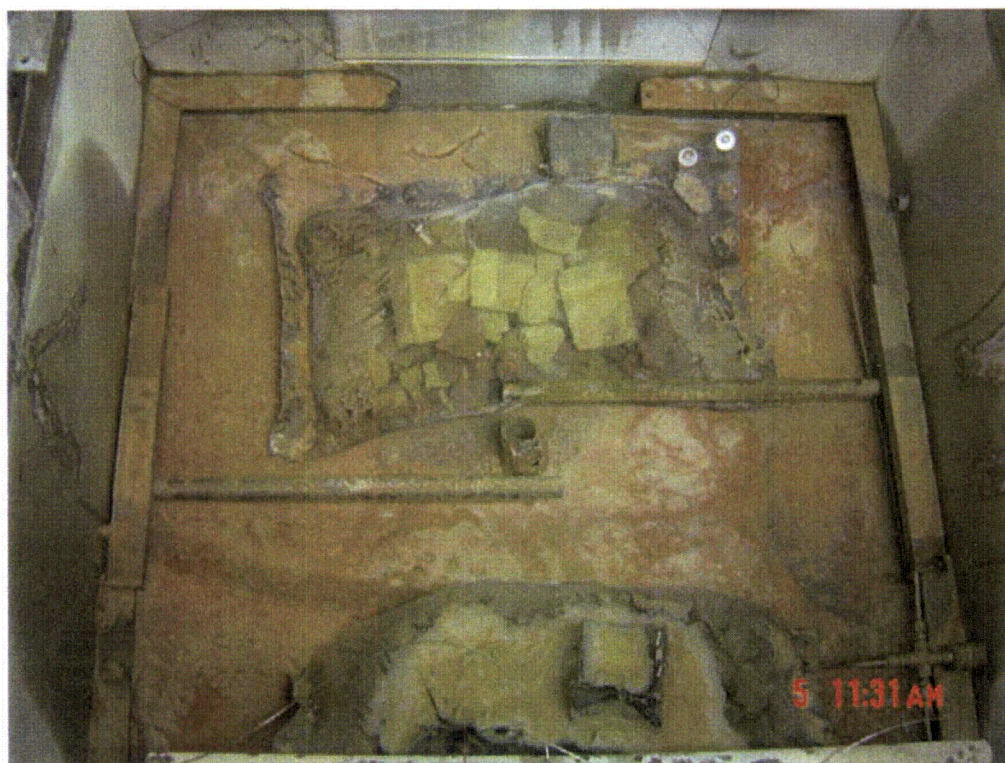
The test fluid was drained from the tank at the end of the 30-day test. Figure 3-71 shows the bottom of the tank after the tank was emptied. The birdcage is the cube in the center bottom of the figure, covered on its top with and sitting in light-colored gel-like material. For the Day-30 fiberglass sample within the birdcage, SEM images indicate large deposits (Figure 3-72) as well as a continuous coating (Figure 3-74) over the exterior of the fiberglass. The amount of particulate deposits within the birdcage was greater than on high- and low-flow fiberglass samples. The EDS result shows that the large particulate deposits had higher P and lower Si percentages than did the continuous coating shown in Figure 3-74. As with the particulate deposits on the drain collar, the large deposits are likely composed of  $\text{Ca}_3(\text{PO}_4)_2$  precipitates, while the continuous coating was likely cal-sil particles. Both kinds of deposits were physically transported and/or deposited/retained on the birdcage fiberglass exterior. Compared with the exterior sample, the interior sample was relatively clean. Only small amounts of deposits were found. These deposits were similar to the deposits observed on high- and low-flow interior samples, which were likely caused by chemical precipitation during the drying process. Again, this result suggests that almost all of the particulate deposits were physically retained at the fiberglass exterior, consistent with conditions on the Day-30 high-flow and drain-collar fiberglass samples. Figures 3-72 through 3-79 show the Day-30 birdcage fiberglass results.

Figure 3-71. Tank bottom after the test fluid was drained.

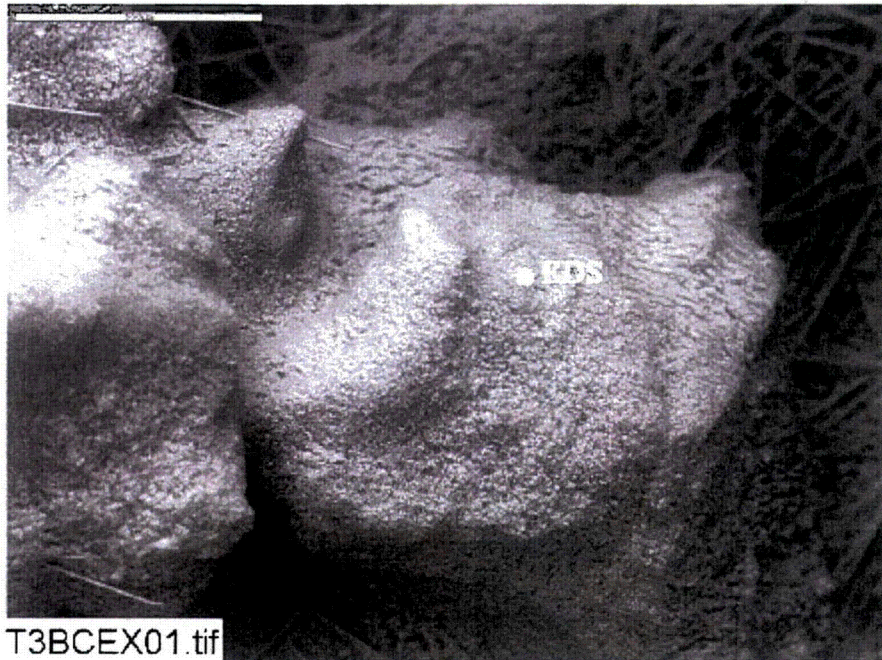
Figure 3-72. ESEM image of a Test #3, Day-30 exterior fiberglass sample within the birdcage, magnified 80 times. (T3BCEX01, 5/6/05)

Figure 3-125. Comparison of EDS counting spectra for Figure 3-124 (yellow: the gel-like materials shown in Figure 3-123) and Figure 3-73 (red: the large deposits taken from the birdcage exterior shown in Figure 3-72). (t3geled7, 5/6/05)

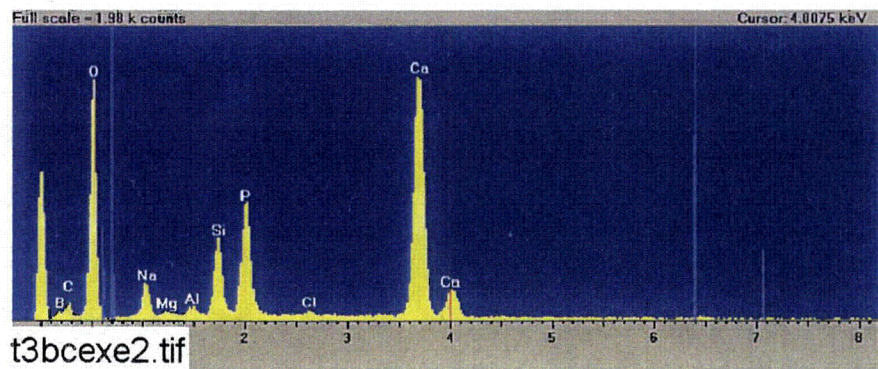
Figure 3-73. EDS counting spectrum for the large deposits shown in Figure 3-72. (t3bcexe2, 5/6/05)

Figure 3-77. Comparison of EDS counting spectra of Figure 3-76 (red) and Figure 3-73 (yellow). (t3bcexe3, 5/6/05)

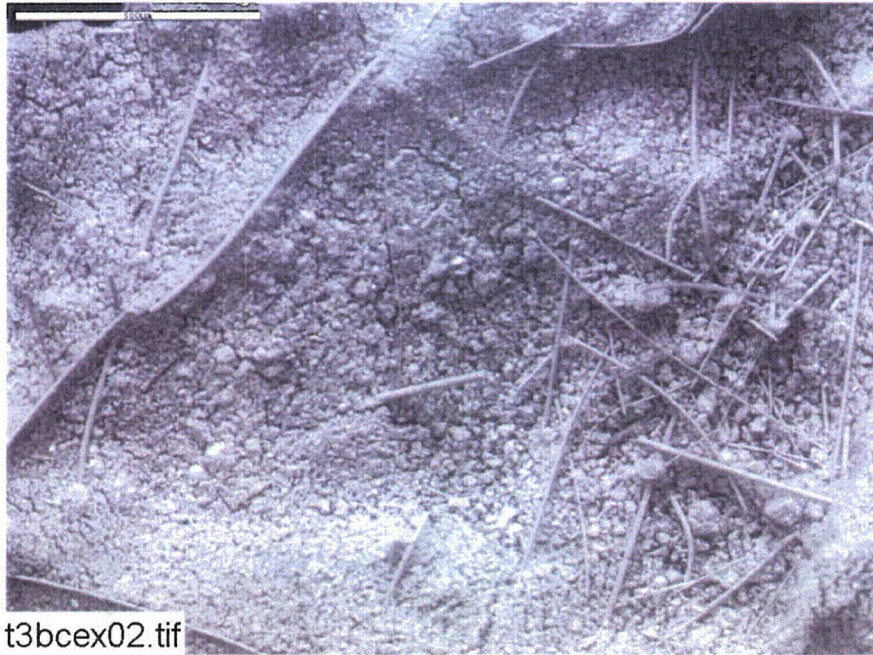
Figure 3-74. ESEM image of a Test #3, Day-30 exterior fiberglass sample within the birdcage, magnified 80 times. (t3bcex02, 5/6/05)

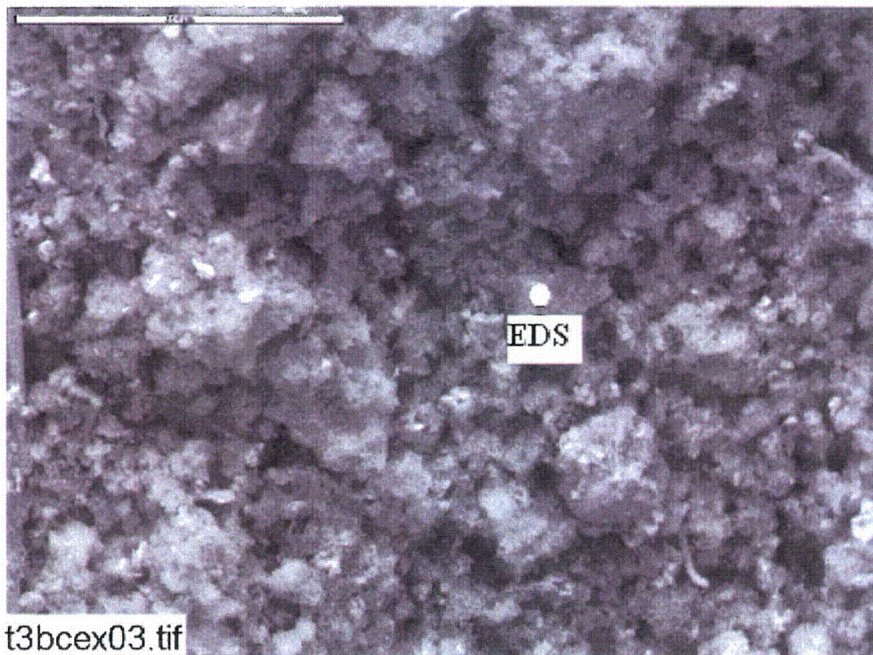
Figure 3-75. ESEM image of a Test #3, Day-30 exterior fiberglass sample within the birdcage, magnified 500 times. (t3bcex03, 5/6/05)

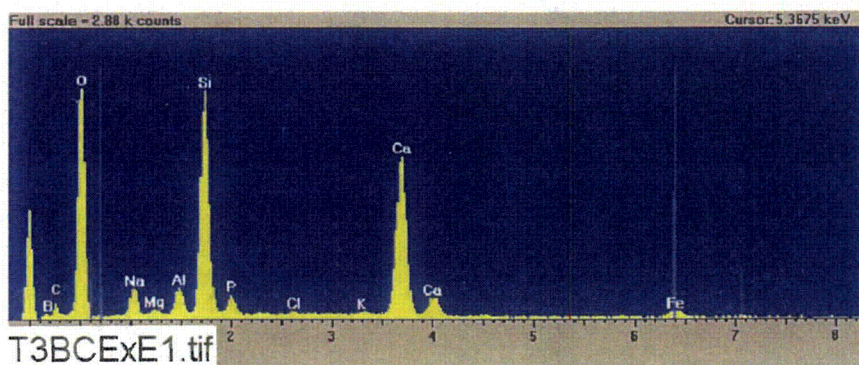
Figure 3-76. EDS counting spectrum for the deposits shown in Figure 3-75. (T3BCExE1, 5/6/05)

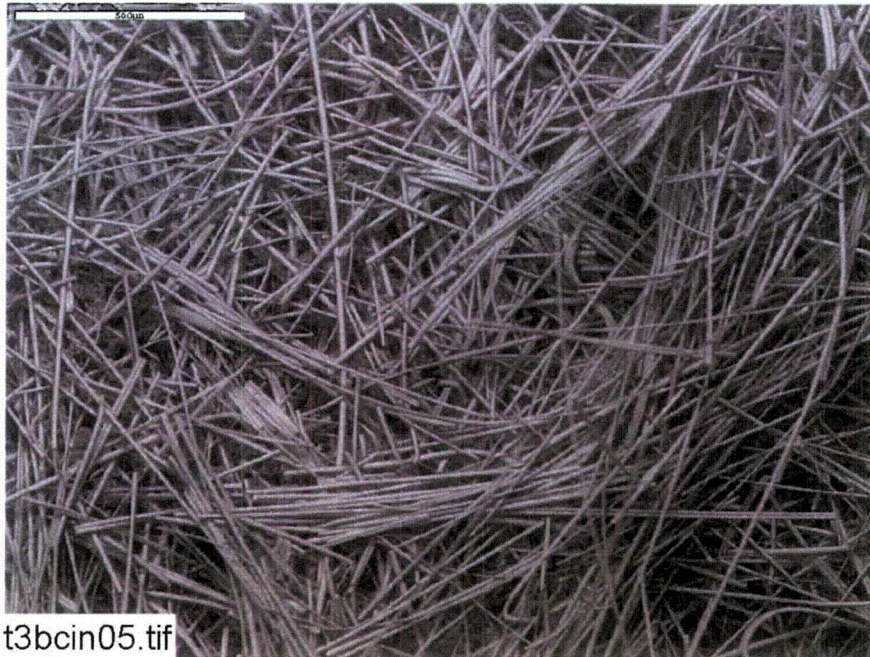
Figure 3-78. ESEM image of a Test #3, Day-30 interior fiberglass sample within the birdcage, magnified 80 times. (t3bcin05, 5/6/05)

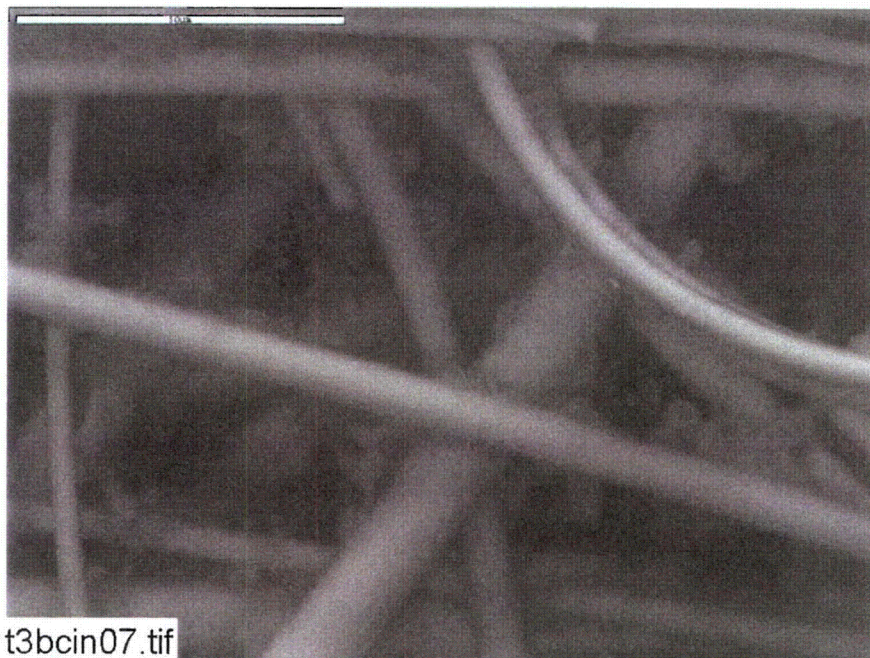
Figure 3-79. ESEM image of a Test #3, Day-30 interior fiberglass sample within the birdcage, magnified 1000 times. (t3bcin07, 5/6/05)

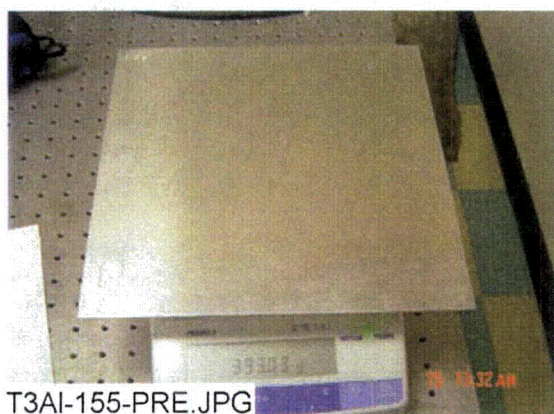
Figure 3-80. Al-155, submerged, pre-test.

There are three submerged aluminum coupons in each test. Figures 3-80 through 3-85 display the pre- and post-test pictures of those coupons that were in Test #3. Each post-test aluminum coupon exhibits a pattern of white particulate deposition. In addition, each post-test coupon is a light reddish-brown, which may be attributable to copper's leaching into the test solution. The particulate deposition patterns for post-test aluminum coupons 155 and 156 are similar. However, the deposition pattern for the post-test Al-157 possesses a grayish tint, and a stream of white deposition runs from the rack contact point at the top to the bottom of the coupon. The relative spatial location of these coupons, given in order from the west side of the tank to the east side of the tank, is as follows: Al-155, Al-156, and Al-157. The concentration of particles increases slightly from the western-most coupon to the eastern-most coupon.

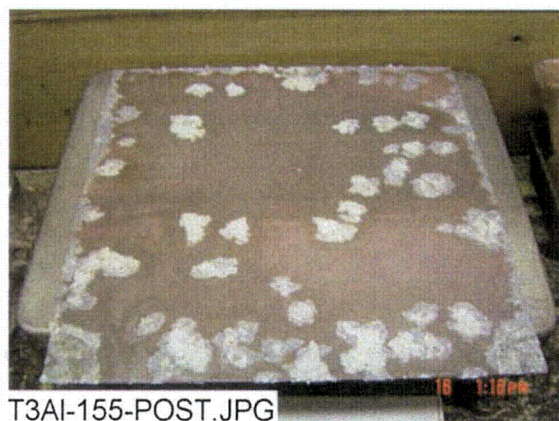
Figure 3-81. Al-155, submerged, post-test.

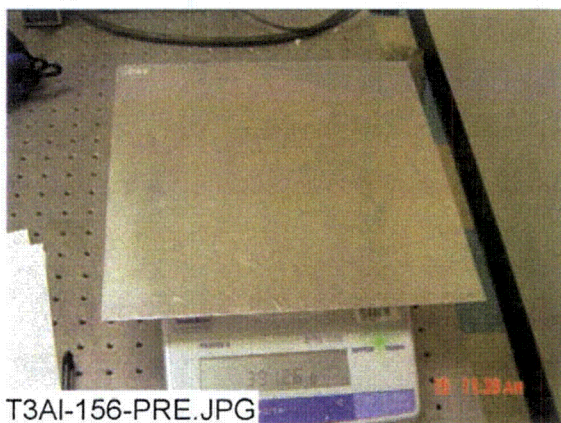
Figure 3-82. Al-156, submerged, pre-test.

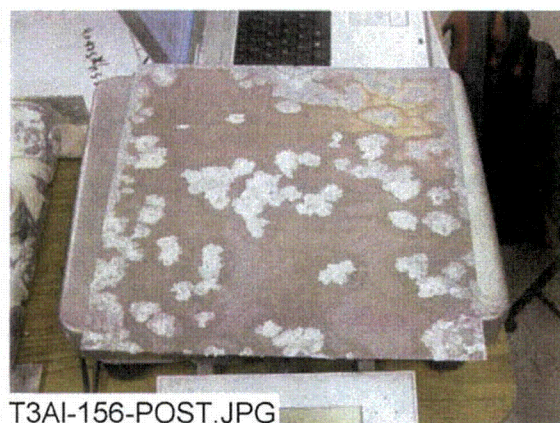
Figure 3-83. Al-156 submerged, post-test.

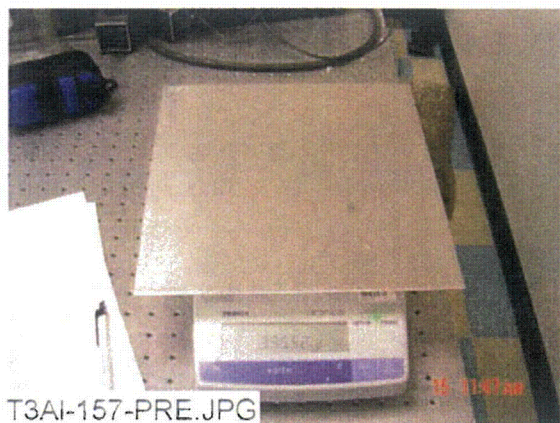
T3AI-157-PRE.JPG

**Figure 3-84. AI-157, submerged, pre-test.**

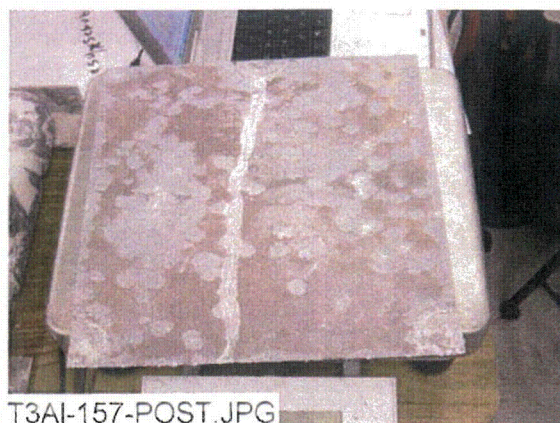
T3AI-157-POST.JPG

**Figure 3-85. AI-157, submerged, post-test.**

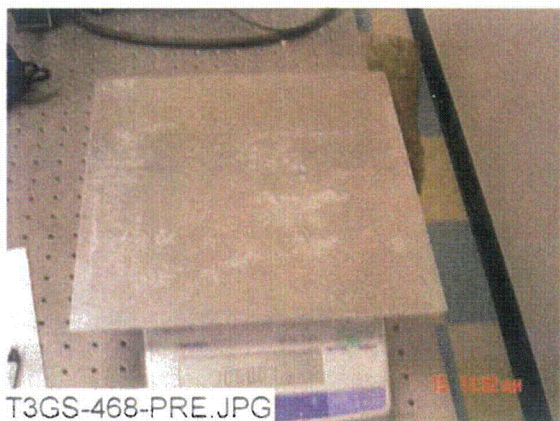
T3GS-468-PRE.JPG

**Figure 3-86. GS-468, submerged, pre-test.**

The galvanized steel coupons exhibited nearly identical patterns of dense gray particle deposition. Figures 3-86 and 3-87 present the pre- and post-test pictures of one submerged galvanized steel coupon. There were no observable differences in post-test appearance based on the coupon's location in the rack.

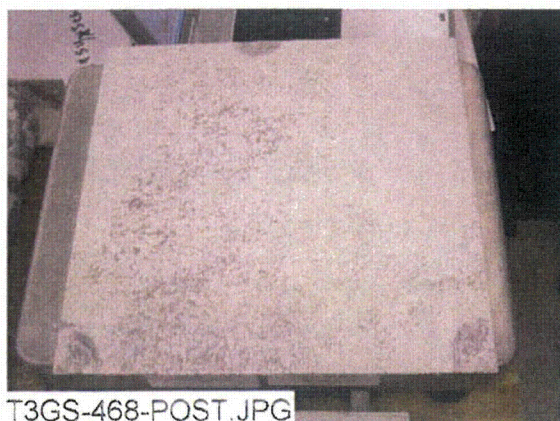
T3GS-468-POST.JPG

**Figure 3-87. GS-468, submerged, post-test.**

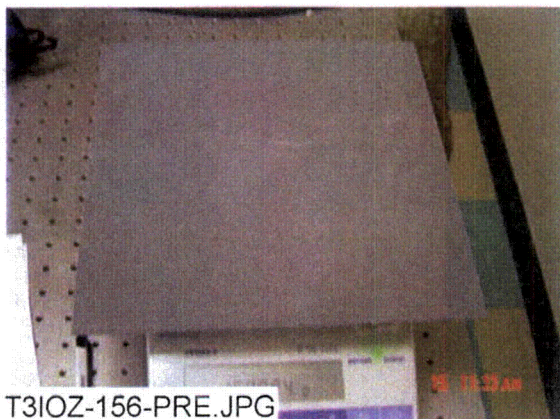
T3IOZ-156-PRE.JPG

Figure 3-88. IOZ-156, submerged, pre-test.

Figures 3-88 and 3-89 present the pre- and post-test pictures of a typical submerged IOZ-coated steel coupon. Each post-test coated steel coupon exhibited a similar pattern of white particle deposition.

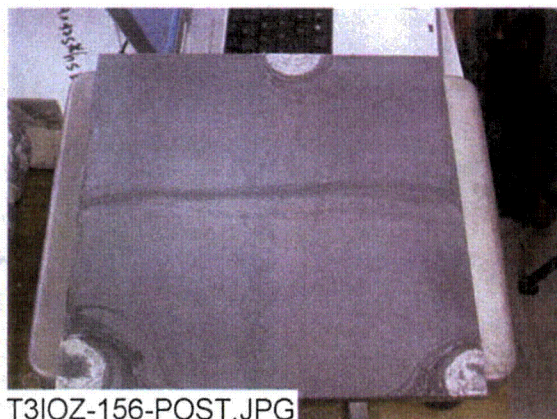
T3IOZ-156-POST.JPG

Figure 3-89. IOZ-156, submerged, post-test.

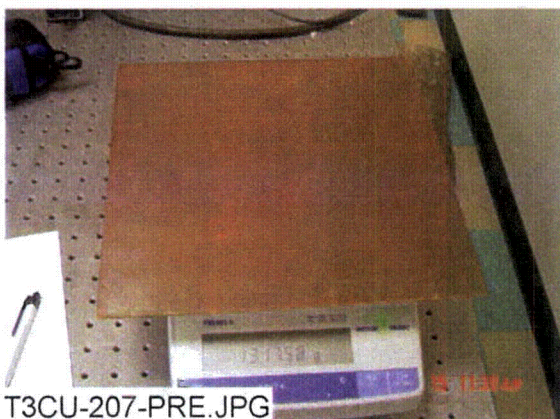
T3CU-207-PRE.JPG

Figure 3-90. CU-207 submerged, pre-test.

Figures 3-90 through 3-93 present the pre- and post-test pictures of two submerged copper coupons. The patterns of white deposition are different for these post-test coupons. The CU-207 post-test coupon is almost completely covered with a dense collection of white deposits. The CU-225 post-test coupon, in contrast, exhibits faint horizontal streak-lines of white deposits. The CU-207 coupon was located on the west side of the tank in relation to the CU-225 coupon. The CU-207 coupon gained 1.2 g, while the CU-225 coupon lost 0.1 g.

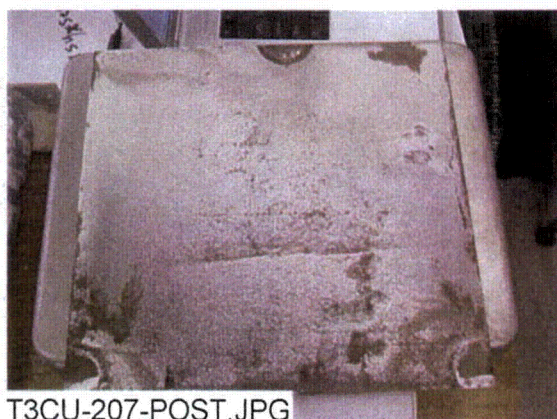
T3CU-207-POST.JPG

Figure 3-91. CU-207, submerged, post-test.

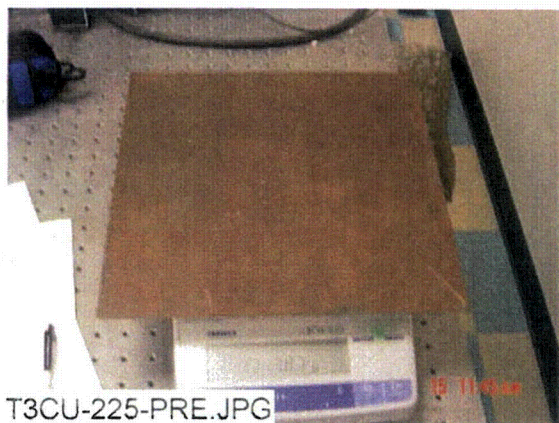
Figure 3-92. CU-225, submerged, pre-test.

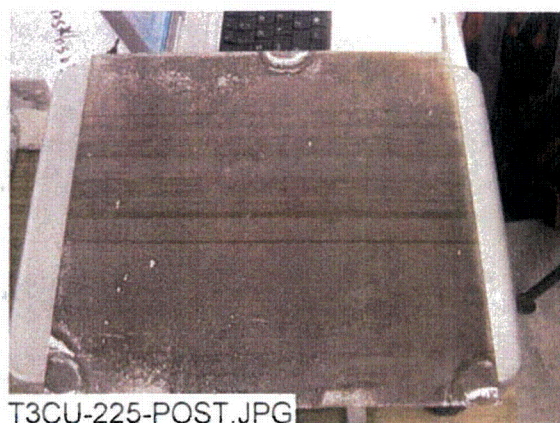
Figure 3-93. CU-225, submerged, post-test.

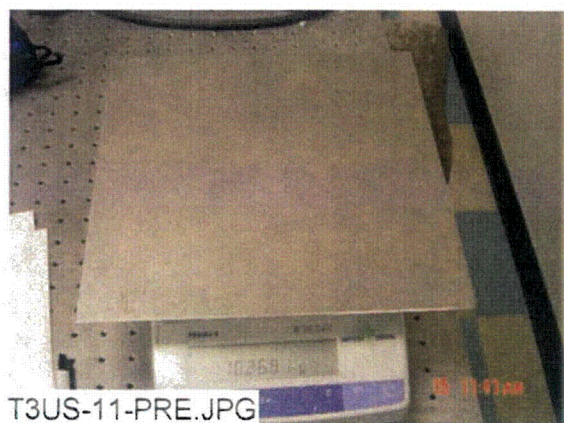
Figure 3-94. US-11, submerged, pre-test.

Figures 3-94 and 3-95 present the pre- and post-test pictures of the single submerged carbon steel coupon. It has a light coating of white deposits over a large portion of the surface area. Also, there is observable rust along the bottom edge of the coupon, near the rack's contact points. The rust deposits are mainly congregated near the lower corners of the coupon, near the rack's contact points. Differences in corrosion or deposits at the location of the coupon rack contact points may have been due to stagnant solution conditions that may have limited mass transfer to or from the surface and caused local differences in solution composition. Coupon US-11 lost 1.1 g.

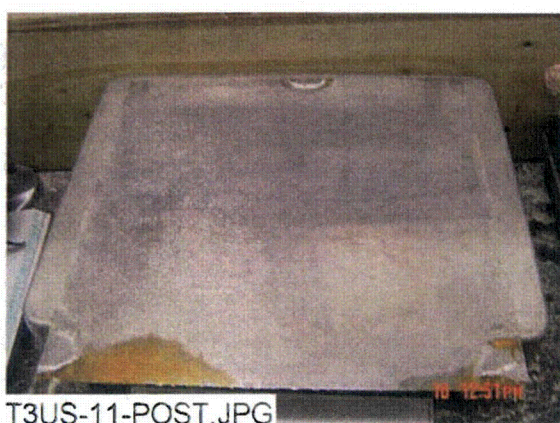
Figure 3-95. US-11, submerged, post-test.

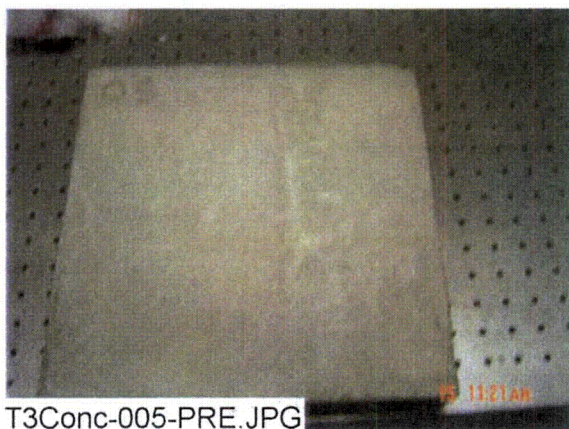
T3Conc-005-PRE.JPG

Figure 3-96. Conc-005, submerged, pre-test.

Figures 3-96 and 3-97 present the pre- and post-test pictures of the submerged concrete coupon. The post-test concrete coupon exhibits an enhanced gray compared with the pre-test coupon. The concrete coupon gained 180.5 g, which is estimated to be primarily water absorption.

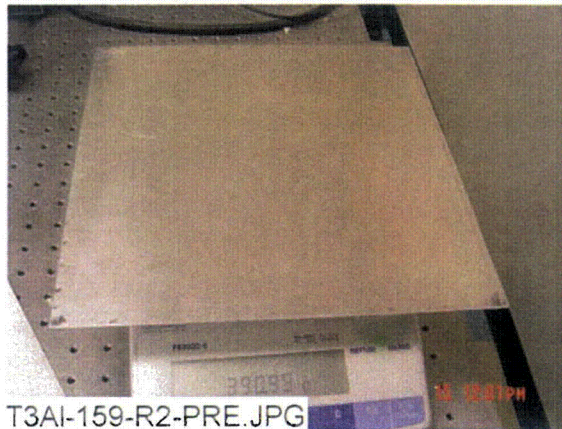
Figure 3-98. AI-159, unsubmerged, pre-test.

Figures 3-98 and 3-99 show the pre- and post-test pictures of a typical unsubmerged aluminum coupon. The coupons exhibit a light pattern of deposition. Also, each post-test coupon has coarser texture and a less-lustrous surface.

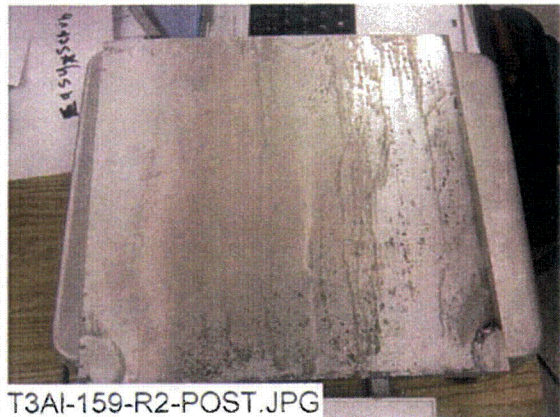
Figure 3-99. AI-159, unsubmerged, post-test.

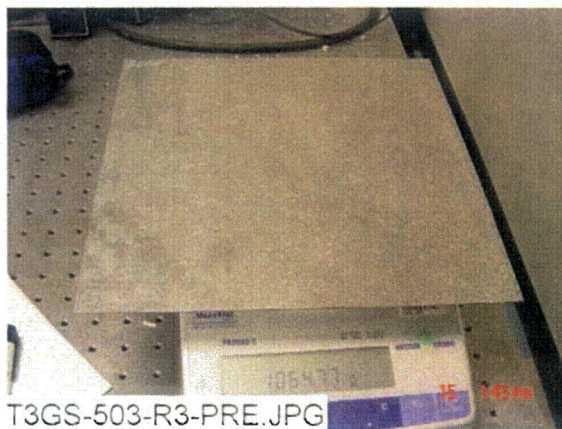
Figure 3-100. GS-503, unsubmerged, pre-test.

Figures 3-100 and 3-101 show the pre- and post-test pictures of a typical unsubmerged galvanized steel coupon. Each post-test galvanized steel coupon exhibited a similar light deposition.

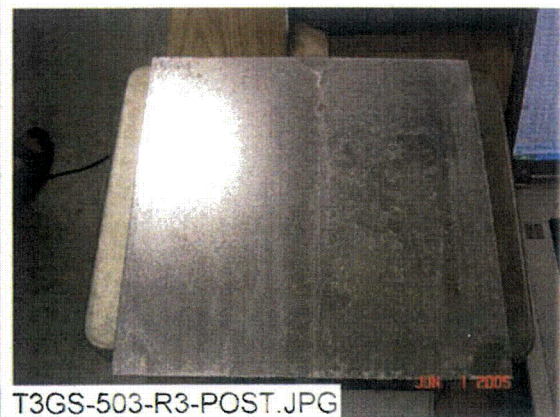
Figure 3-101. GS-503, unsubmerged, post-test.

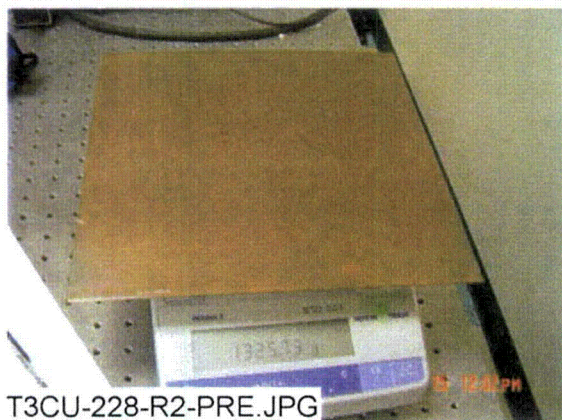
T3CU-228-R2-PRE.JPG

Figure 3-102. CU-228, unsubmerged, pre-test.

Figures 3-101 and 3-102 present the pre- and post-test pictures of a typical unsubmerged copper coupon. Each post-test copper coupon exhibited a similar pattern of streak-like deposition.

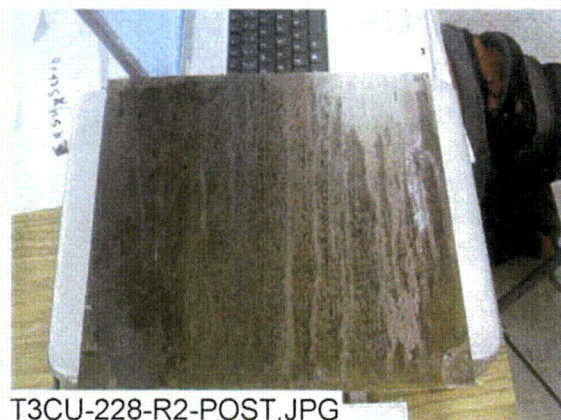
T3CU-228-R2-POST.JPG

Figure 3-103. CU-228 unsubmerged, post-test.

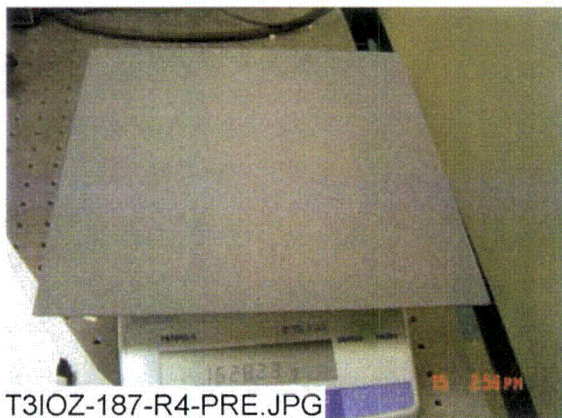
T3IOZ-187-R4-PRE.JPG

Figure 3-104. IOZ-187, unsubmerged, pre-test.

Figures 3-104 and 3-105 present the pre- and post-test pictures of a typical unsubmerged IOZ-coated steel coupon. Each post-test coated steel coupon exhibited a similar pattern of deposition.

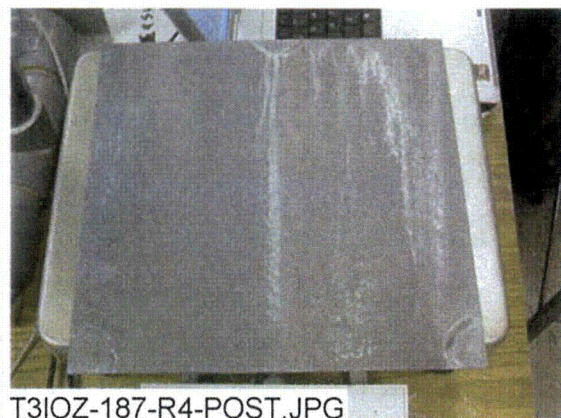
T3IOZ-187-R4-POST.JPG

Figure 3-105. IOZ-187, unsubmerged, post-test.

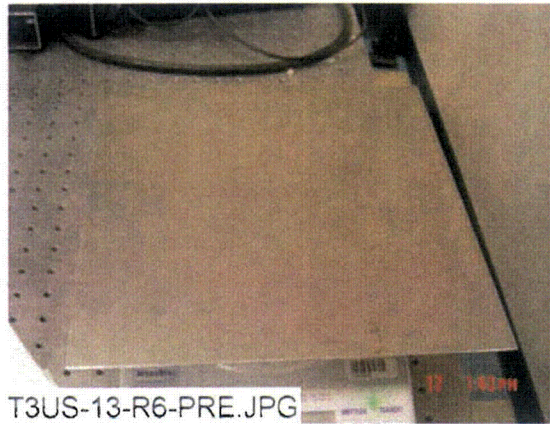
Figure 3-106. US-13, unsubmerged, pre-test.

Figures 3-106 and 3-107 present the pre- and post-test pictures of a typical unsubmerged carbon steel coupon. The post-test carbon steel coupons turned reddish-brown and exhibited slight corrosion around the edges.

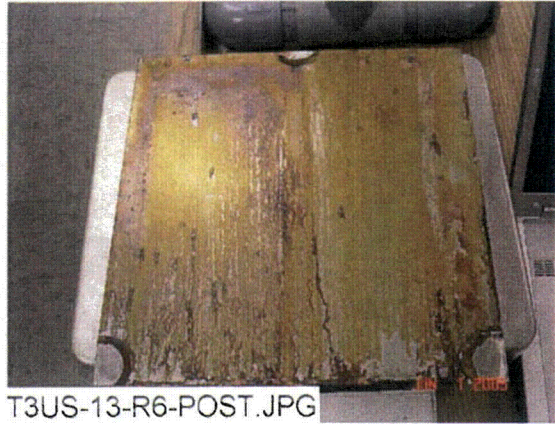
Figure 3-107. US-13, unsubmerged, post-test.

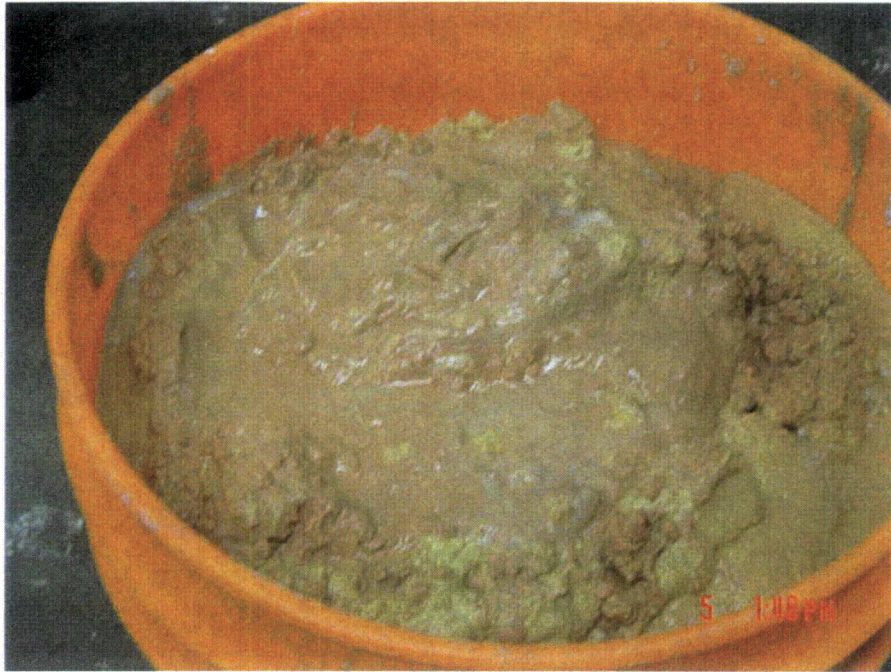
Figure 3-108. Sediment removed from the tank. Some gel appears on the top.

Sediment was collected from the tank bottom after the test solution was drained. It consisted of two main macroscopic quantities, a particulate sediment on the bottom covered in many places with a whitish-pink gel-like material. Figure 3-108 shows this sediment. In addition, Figure 3-109 shows SS mesh holding insulation samples after it was pulled from the tank bottom. The pink and yellow particulate sediment covers much of the mesh, and the gel-like material is seen above it and is being pointed to in the figure.

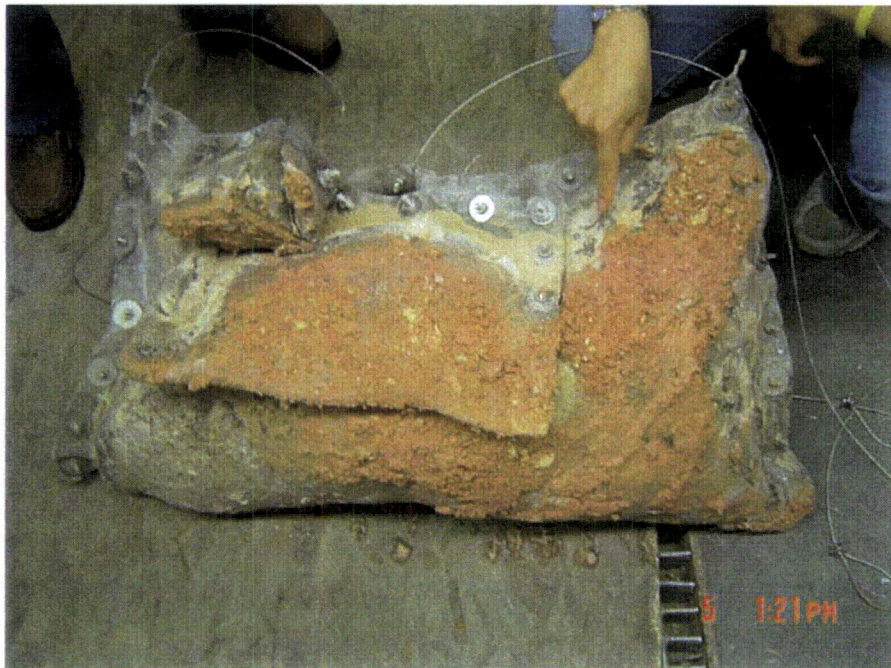
Figure 3-109. Samples removed from the tank bottom.

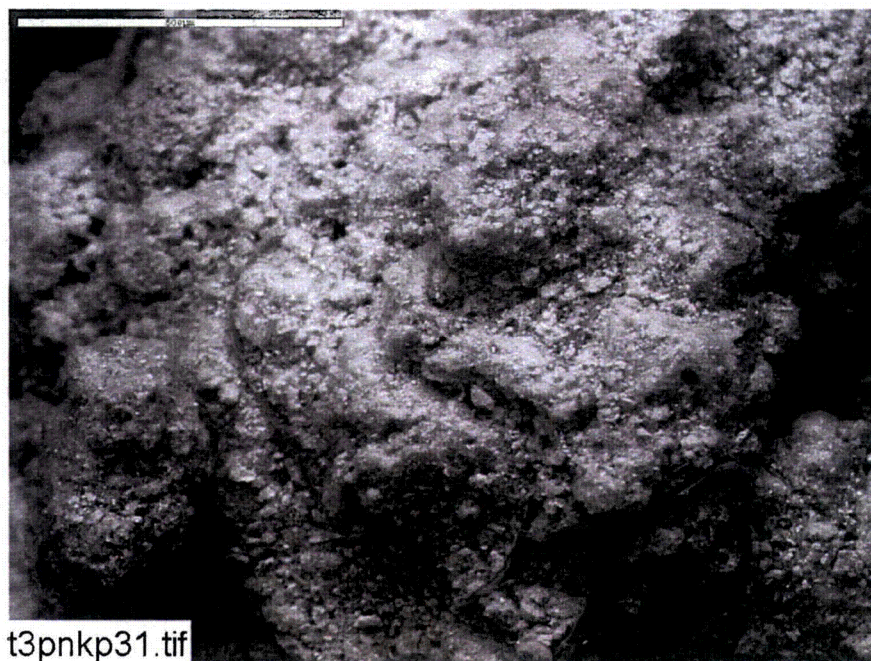
Figure 3-110. ESEM image of a Test #3, Day-30 pink sediment, magnified 100 times. (t3pnkp31, 5/6/05)

The particulate sediment samples were identified and classified by their color: pink or yellow. The yellow or pink sediments were large enough (pea-sized or larger) to be visually seen and picked up from the bulk sediment. The pink sediment likely originated from baked cal-sil debris and the yellow sediment from unbaked cal-sil debris. ESEM/EDS and XRD/XRF analysis provided the information on the morphology and composition of these sediments. EDS results show that there is no significant compositional difference between the yellow and pink sediments. Both contain significant amounts of Si, Ca, and O. XRF results consistently show that Si and Ca are the major elements in the mixed sediments. However, P (present in phosphorus pentoxide,  $P_2O_5$ ) is less than 2% of the total mass, possibly because Test #3 precipitates containing P make up a smaller portion of the total debris than do particles originating from cal-sil.

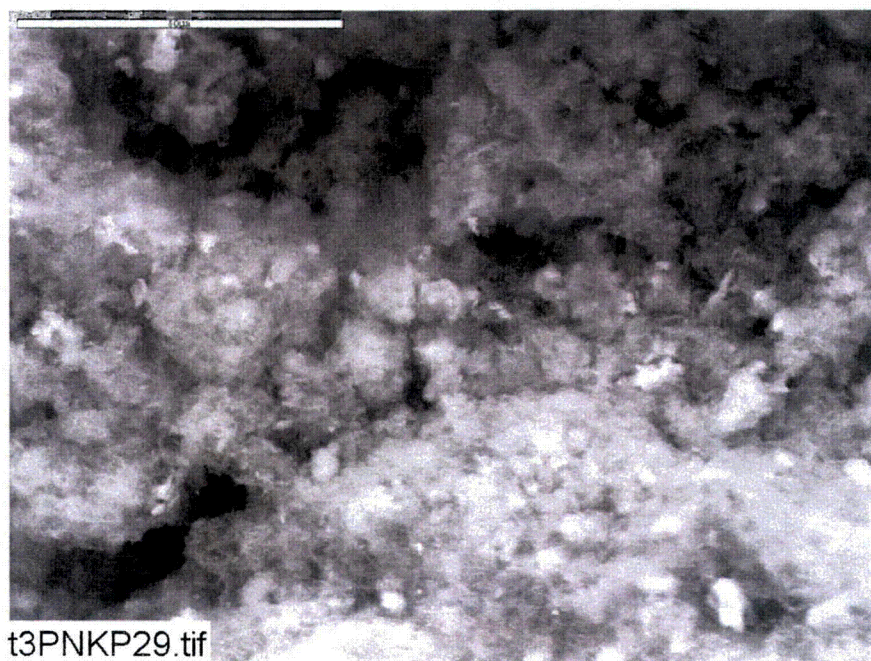
Table 3-111. ESEM image of a Test #3, Day-30 pink sediment, magnified 1000 times. (t3PNKP29, 5/6/05)

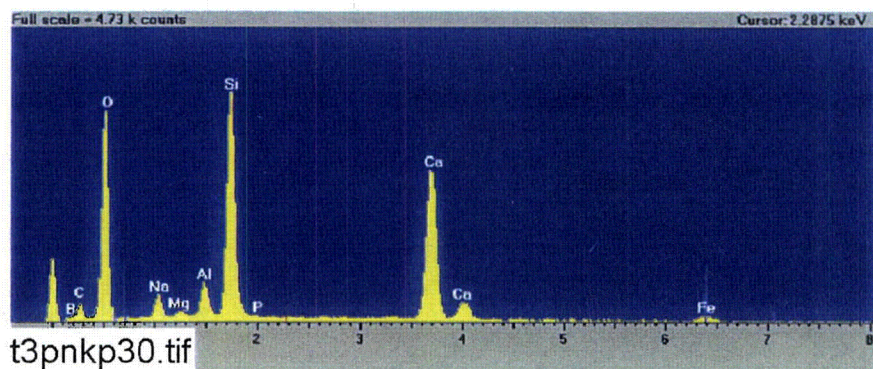
Table 3-112. EDS counting spectrum for the sediment shown in Figure 3-111. (t3pnkp30, 5/6/05)

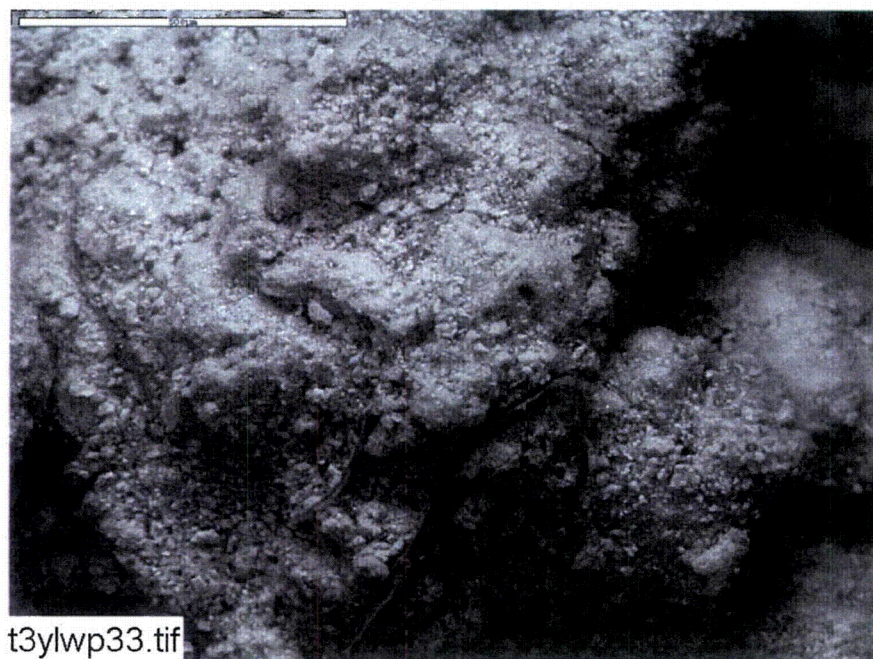
Figure 3-113. ESEM image of a Test #3, Day-30 yellow sediment, magnified 100 times. (t3ylwp33, 5/6/05)

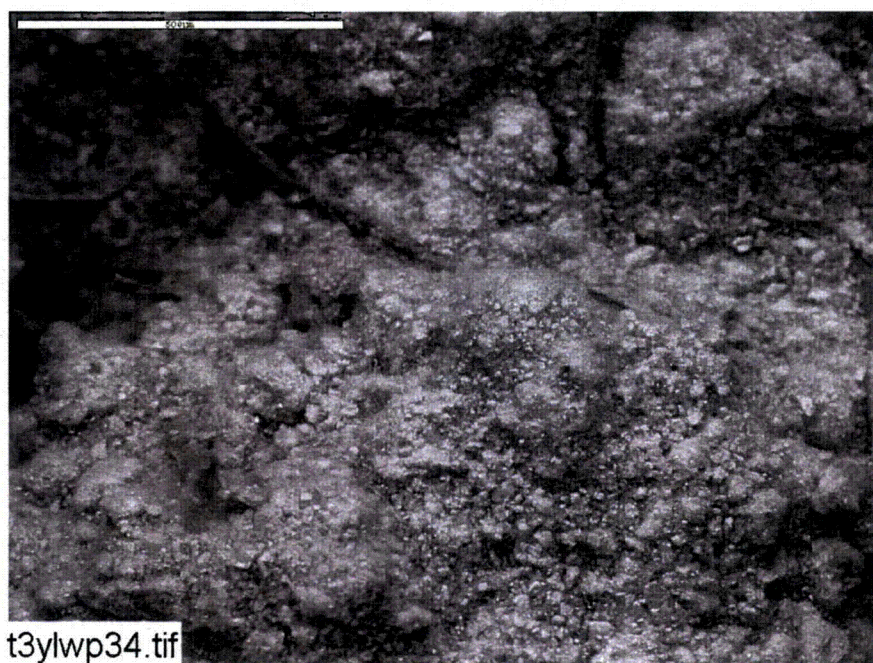
Figure 3-114. ESEM image of a Test #3, Day-30 yellow sediment, magnified 100 times. (t3ylwp34, 5/6/05)

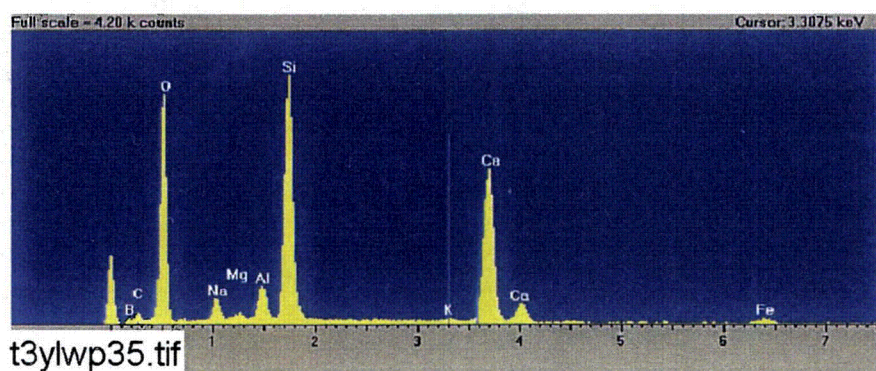
Figure 3-115. EDS counting spectrum for the particles shown in Figure 3-114. (t3ylwp35, 5/6/05)

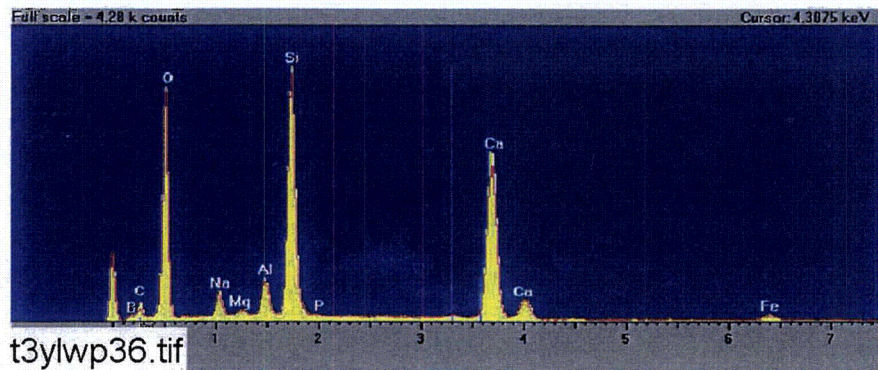
Figure 3-116. Comparison of EDS counting spectra for pink sediment (yellow, t3pnkp30) and yellow sediment (red, t3ylwp35). (t3ylwp36, 5/6/05)

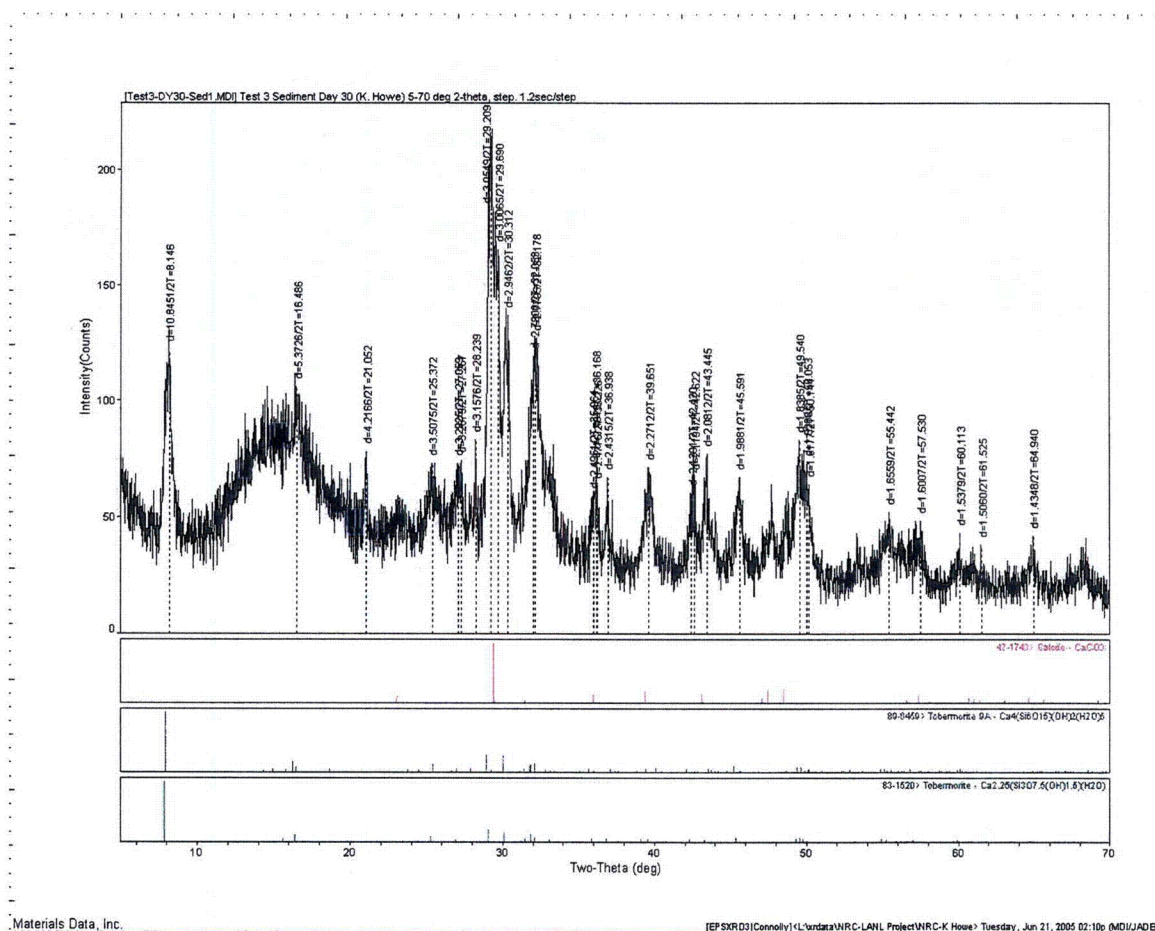
Figure 3-117. XRD results for Test #3, Day-30 mixed sediment.
