# **Integrated Chemical Effects Test Project: Test #3 Data Report**

**Los Alamos National Laboratory**

**U.S. Nuclear Regulatory Commission  
Office of Nuclear Regulatory Research  
Washington, DC 20555-0001**

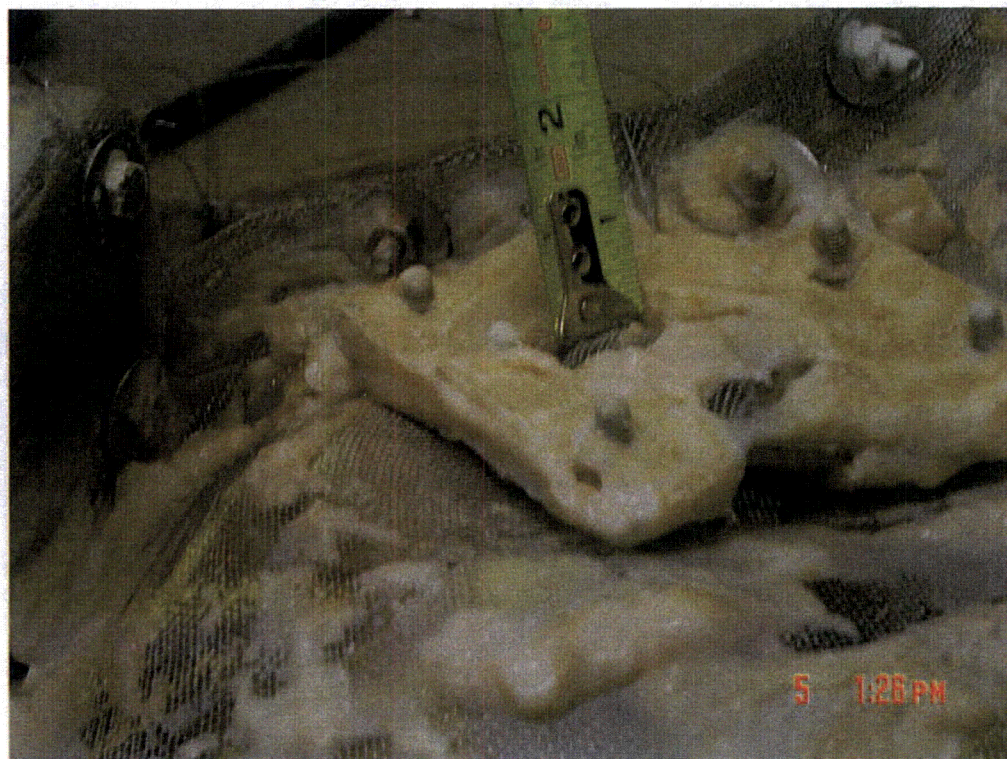
Figure 3-118. Gel-like material covering SS mesh on the bottom of the test tank.

In ICET Test #3, one significant phenomenon is the presence of white gel-like precipitates in the test solution, especially during and after the injection of TSP on the first day of the test. When Test #3 was shut down, deposits of the pinkish-white gel-like precipitates were observed on the top of the birdcage and on other objects on the tank's bottom. Figures 3-118 and 3-119 show the gel-like precipitates.

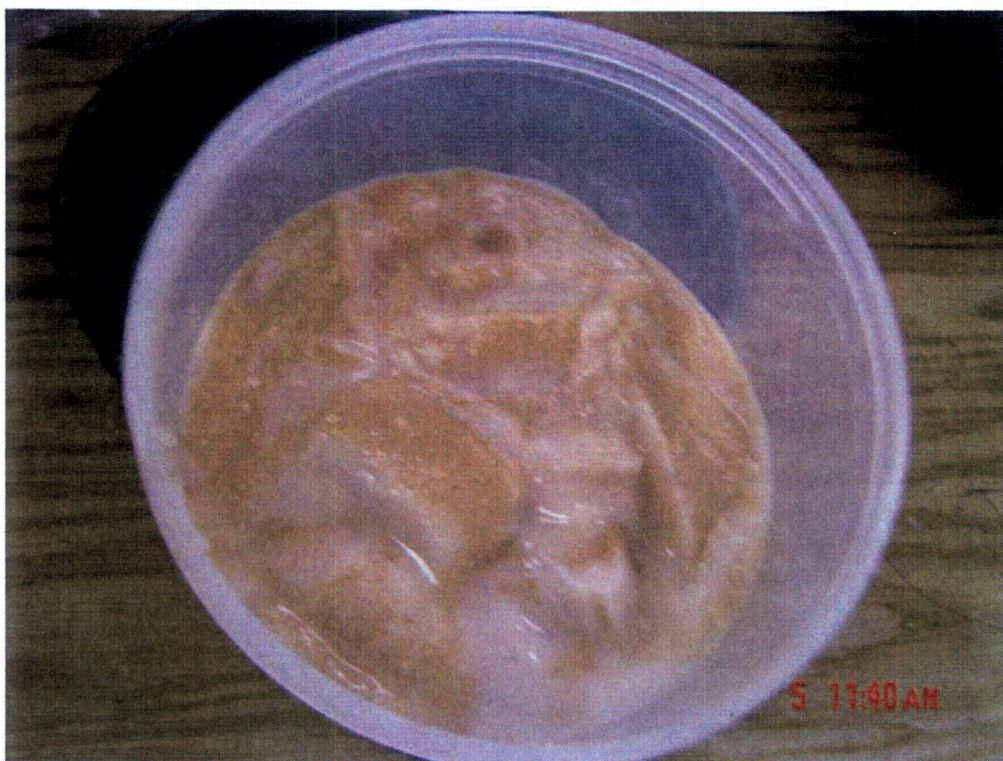
Figure 3-119. Gel-like material recovered from the bottom of the test tank.

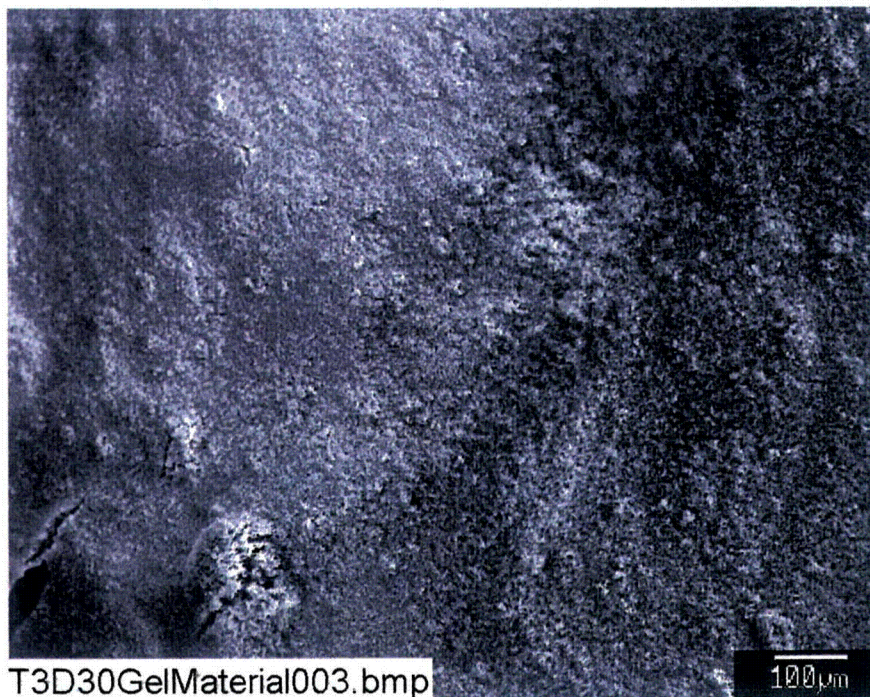
**Figure 3-120. SEM image of a Test #3, Day-30 white gel-like material from the top of the birdcage, magnified 100 times. (T3D30GelMaterial003, 5/9/05)**

Figures 3-120 through 3-126, Table 3-7, and Table 3-8 provide SEM/ESEM/EDS and XRD/XRF analysis results. The complete set of Day-30 gel analyses is contained in Appendix G.

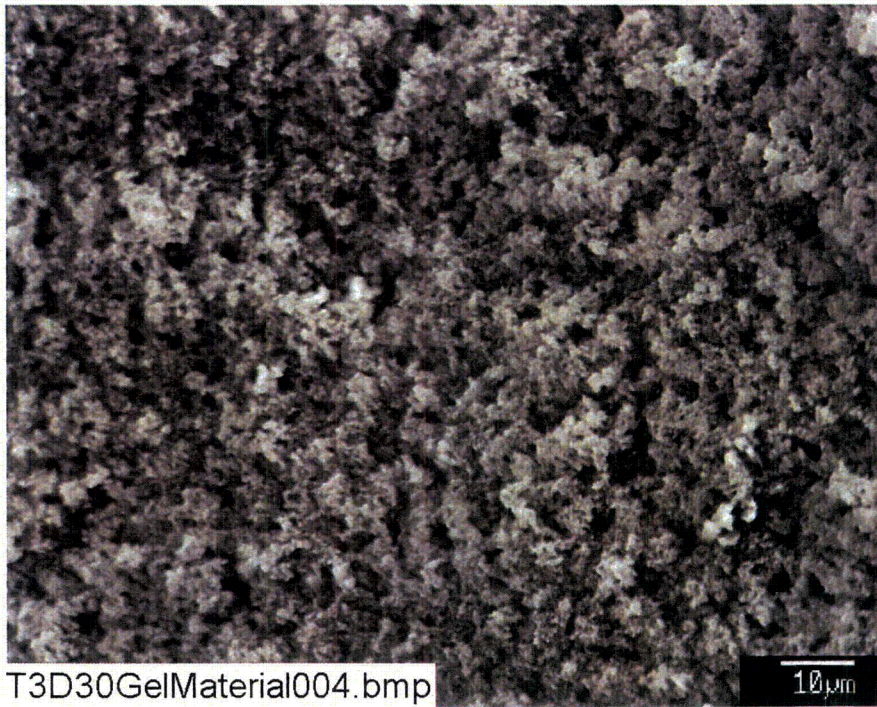
Figure 3-121. SEM image of a Test #3, Day-30 white gel-like material from the top of the birdcage, magnified 1000 times. (T3D30GelMaterial004, 5/9/05)

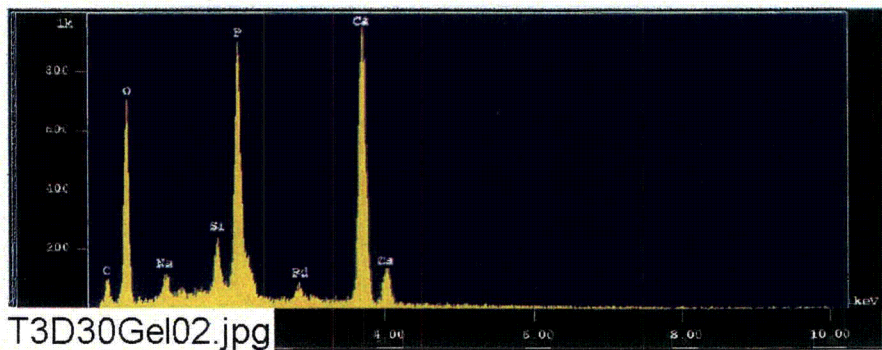
Figure 3-122. EDS counting spectrum for the white, gel-like material (whole image) shown in Figure 3-121. (T3D30Gel02, 5/9/05)

The results from the chemical composition analysis for Figure 3-122 are given in Table 3-7.

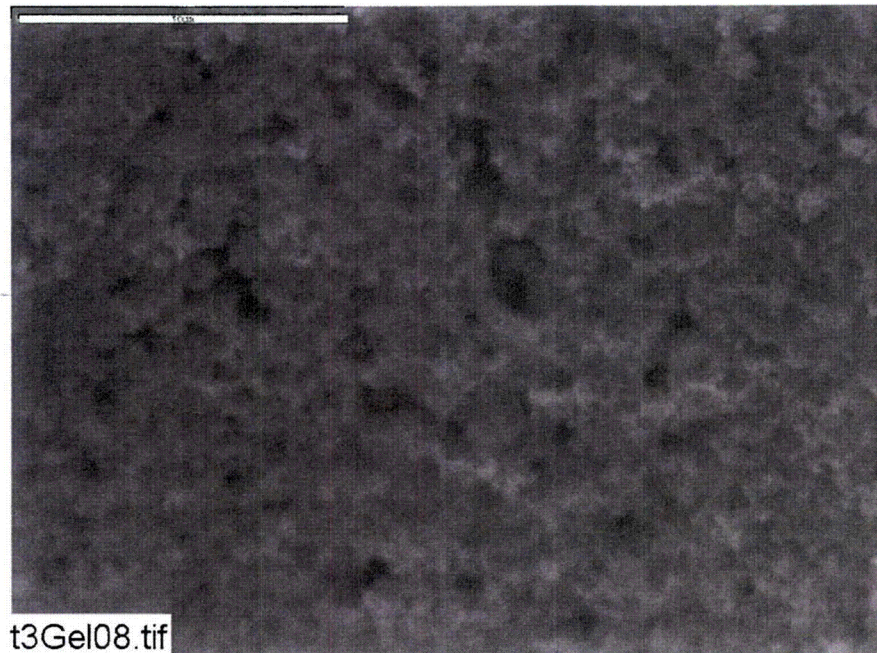
Figure 3-123. ESEM image of a Test #3, Day-30 white gel-like material from the top of the birdcage, magnified 1000 times. (t3Gel08, 5/6/05)

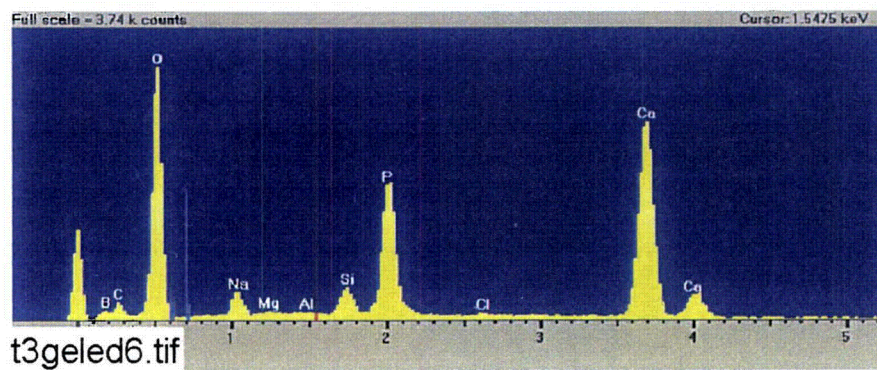
Figure 3-124. EDS counting spectrum for the white, gel-like material shown in Figure 3-123. (t3geled6, 5/6/05)

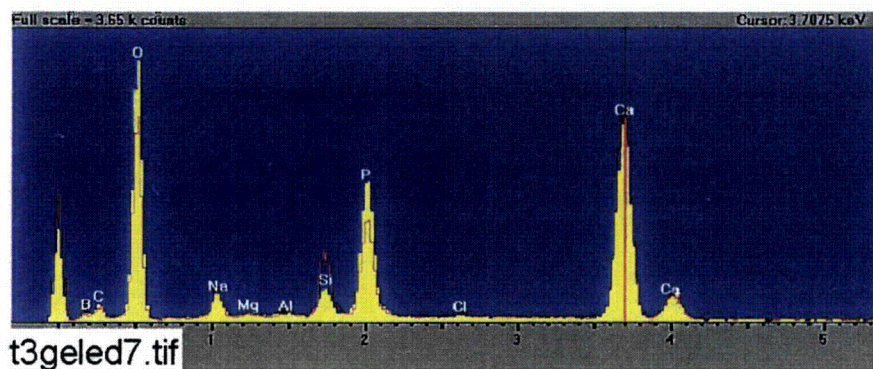
Figure 3-125. Comparison of EDS counting spectra for Figure 3-124 (yellow: the gel-like materials shown in Figure 3-123) and Figure 3-73 (red: the large deposits taken from the birdcage exterior shown in Figure 3-72). (t3geled7, 5/6/05)

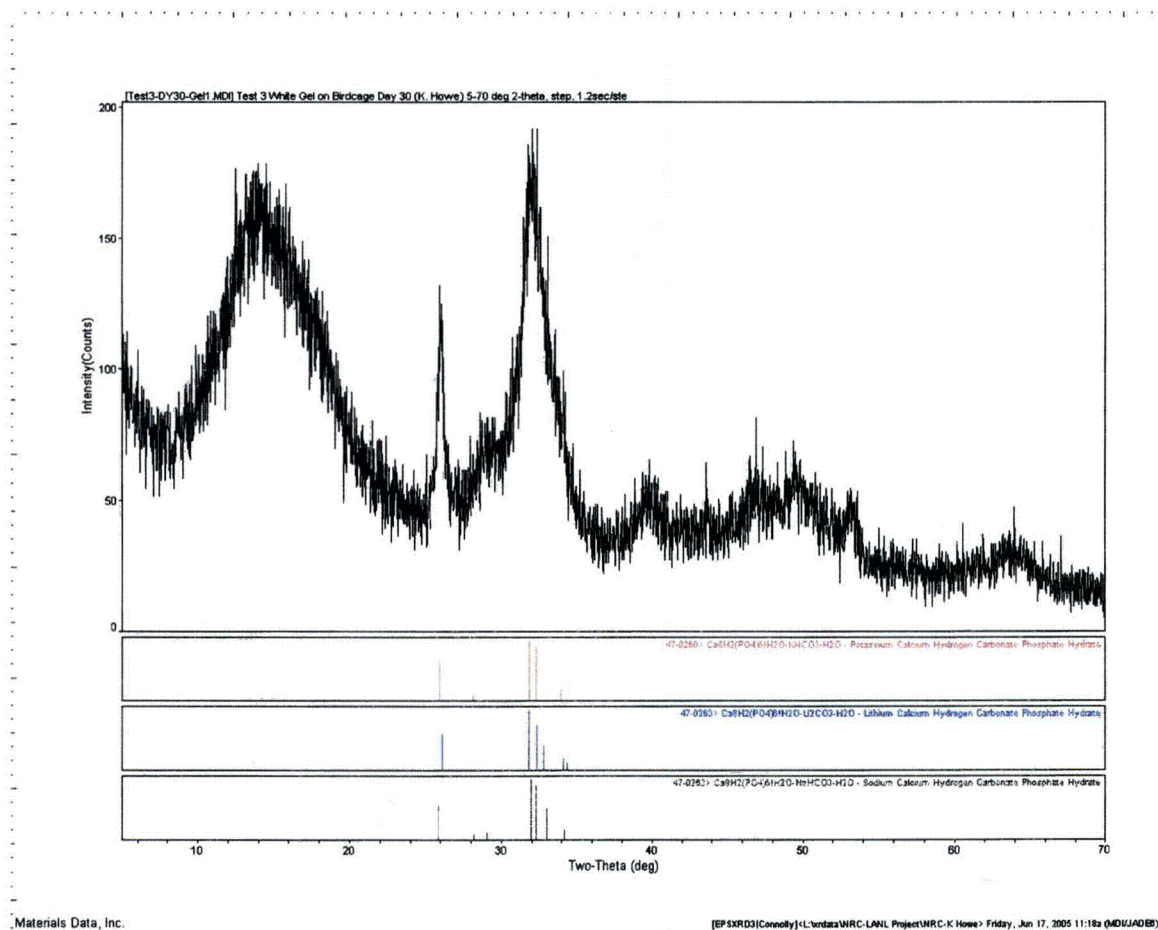
Figure 3-126. XRD results for a Test #3, Day-30 white, gel-like sample.
