#### 4. SUMMARY OF KEY OBSERVATIONS

**Appendix D. ESEM and SEM/EDS Data for Test #3 Day-30 Corrosion Products**

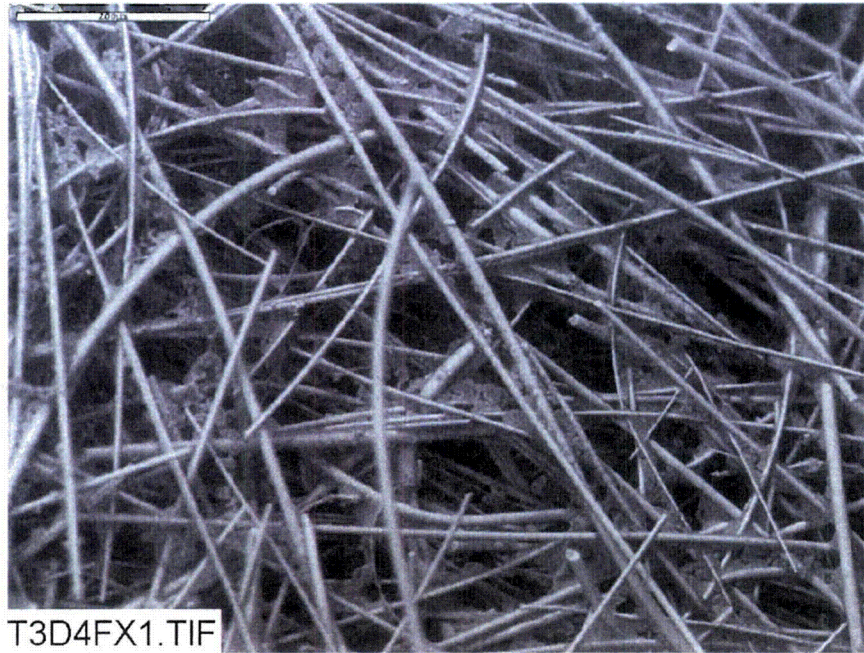
Figure A-1. Environmental SEM image magnified 150 times for a Test #3, Day-4 low-flow exterior fiberglass sample. (T3D4FX1)

Image:	T3D4FX1	150 ×	ESEM image	Figure A-1
	T3D4FX2	1000 ×	ESEM at higher magnification	Figure A-2
EDS:	T3D4FX3		Particles on Image FX2	Figure A-3
	T3D4FX4		FX2 particles after calibration with primed elemental analysis	Figure A-4
Image:	T3D4FX5	500 ×	ESEM image	Figure A-5

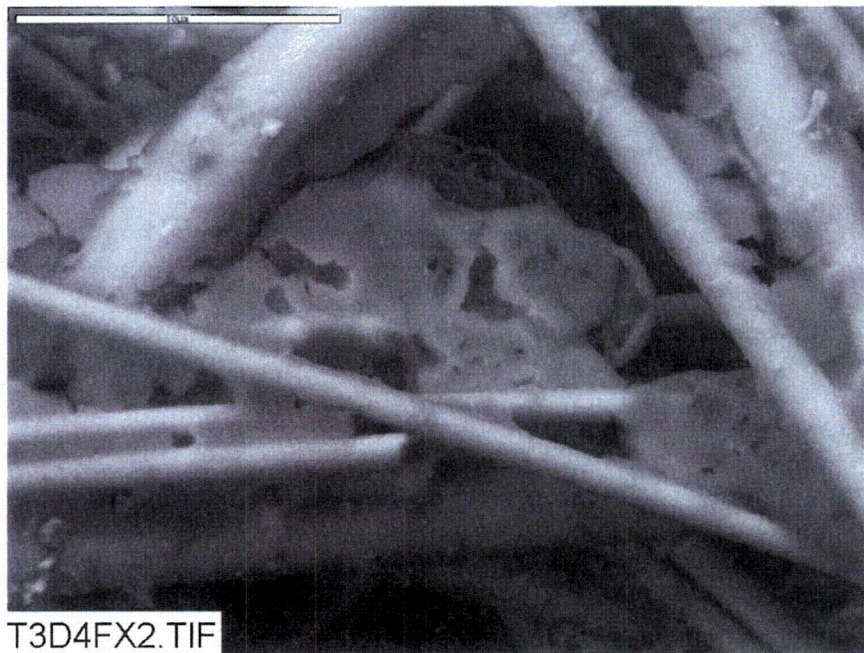
Figure A-2. Environmental SEM image magnified 1000 times for a Test #3, Day-4 low-flow exterior fiberglass sample. (T3D4FX2)

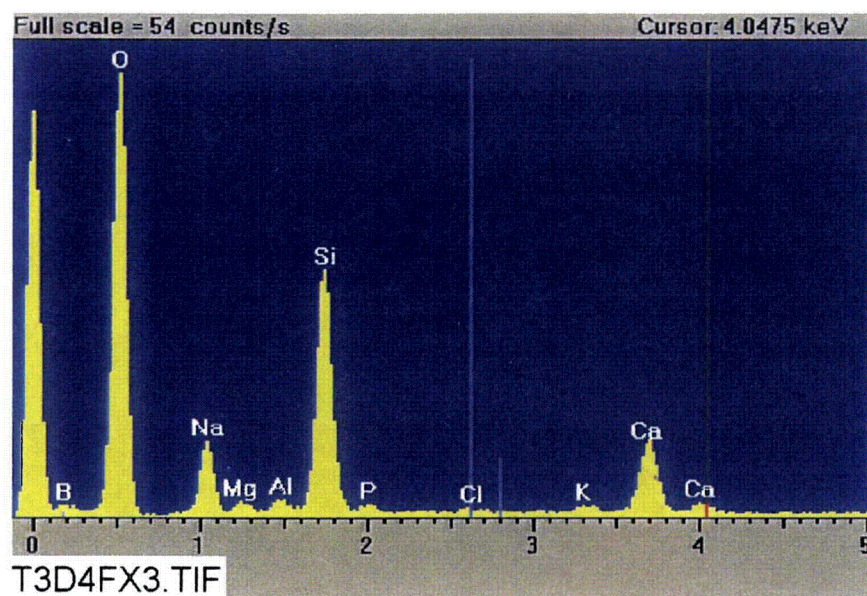
Figure A-3. EDS counting spectrum for the deposits between the fibers on ESEM image shown in Figure A-2. (T3D4FX3)

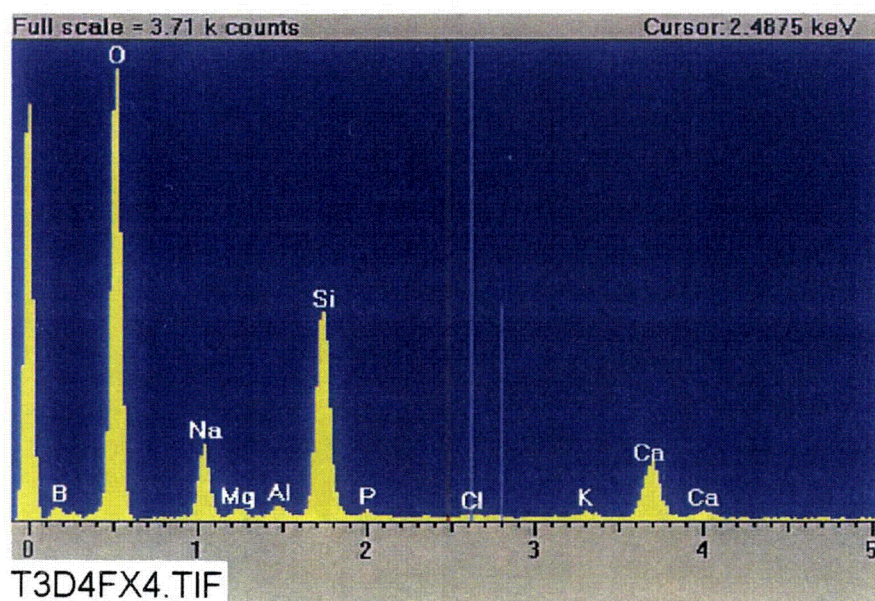
Figure A-4. EDS counting spectrum (after calibration) for the deposits between the fibers on ESEM image shown in Figure A-2. (T3D4FX4)

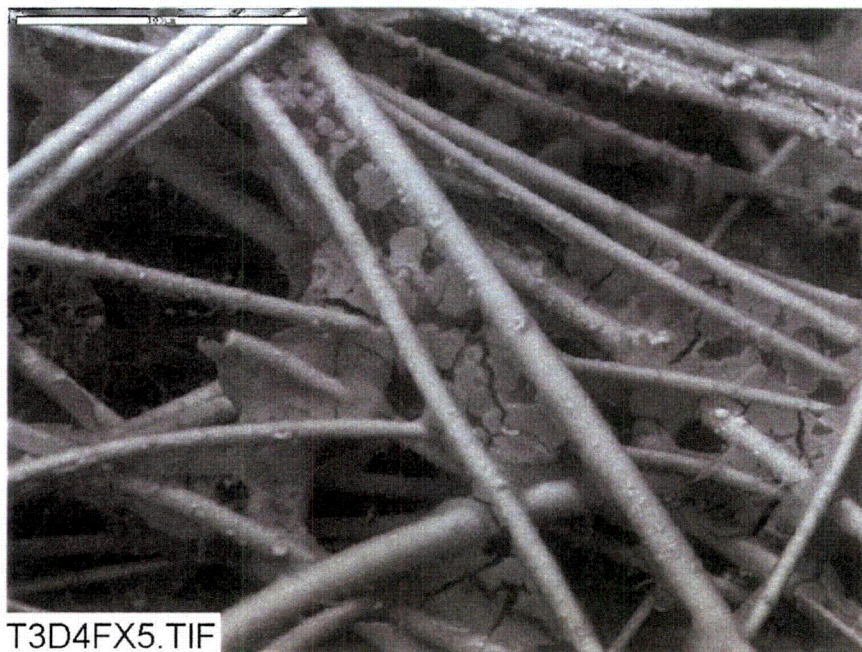
Figure A-5. Environmental SEM image magnified 500 times for a Test #3, Day-4 low-flow exterior fiberglass sample. (T3D4FX5)

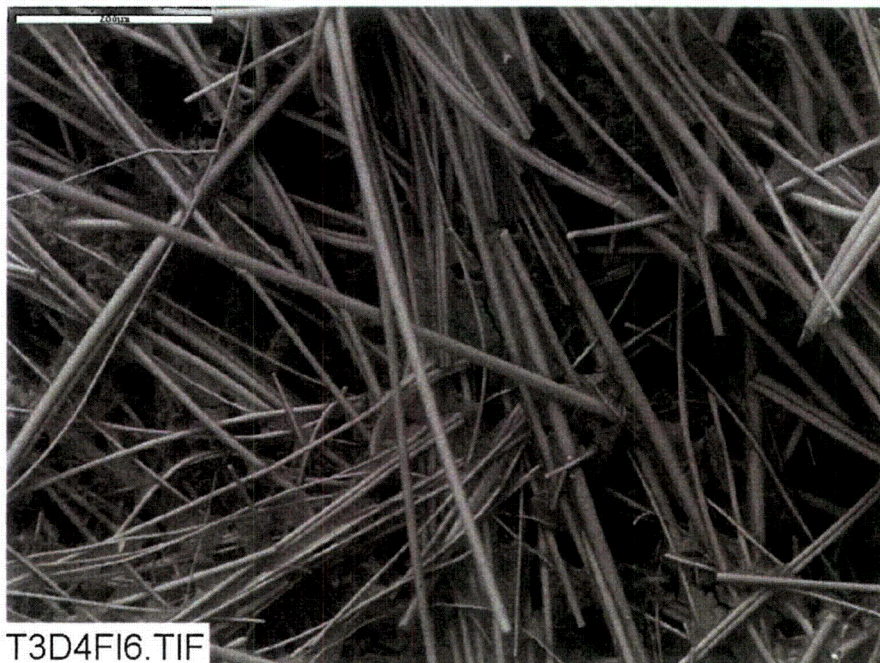
Figure A-6. Environmental SEM image magnified 150 times for a Test #3, Day-4 low-flow interior fiberglass sample. (T3D4FI6)

Image:	T3D4FI6	150 ×	ESEM image	Figure A-6
	T3D4FI7	1000 ×	ESEM at higher magnification	Figure A-7
EDS:	T3D4FI8		EDS of particles on FI7	Figure A-8

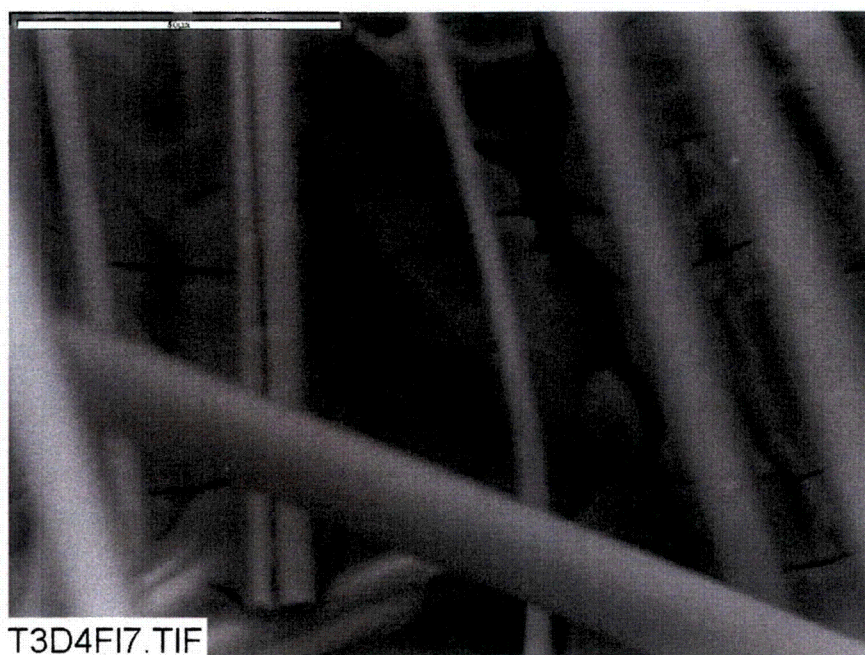
Figure A-7. Environmental SEM image magnified 1000 times for a Test #3, Day-4 low-flow interior fiberglass sample. (T3D4FI7)

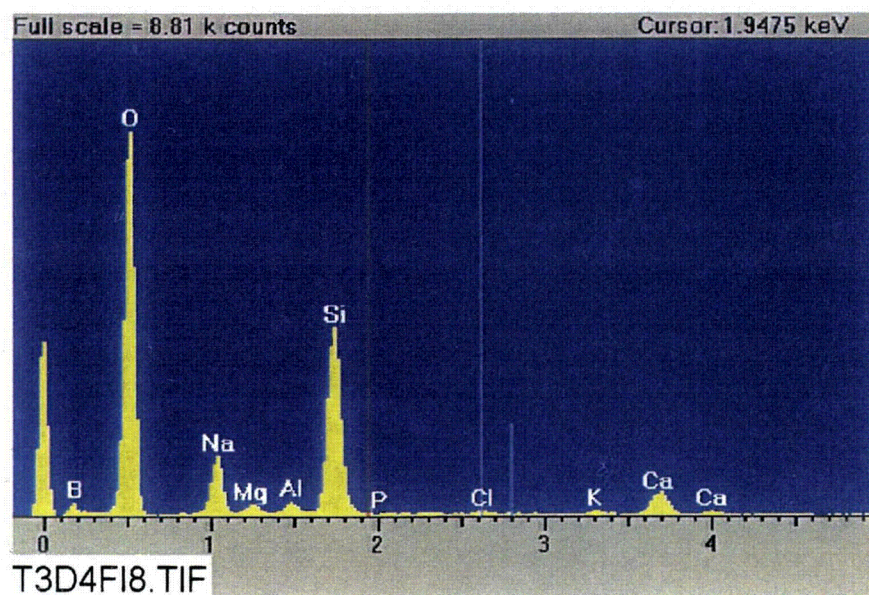
Figure A-8. EDS counting spectrum (after calibration) for the deposits between the fibers on ESEM image shown in Figure A-7. (T3D4FI8)

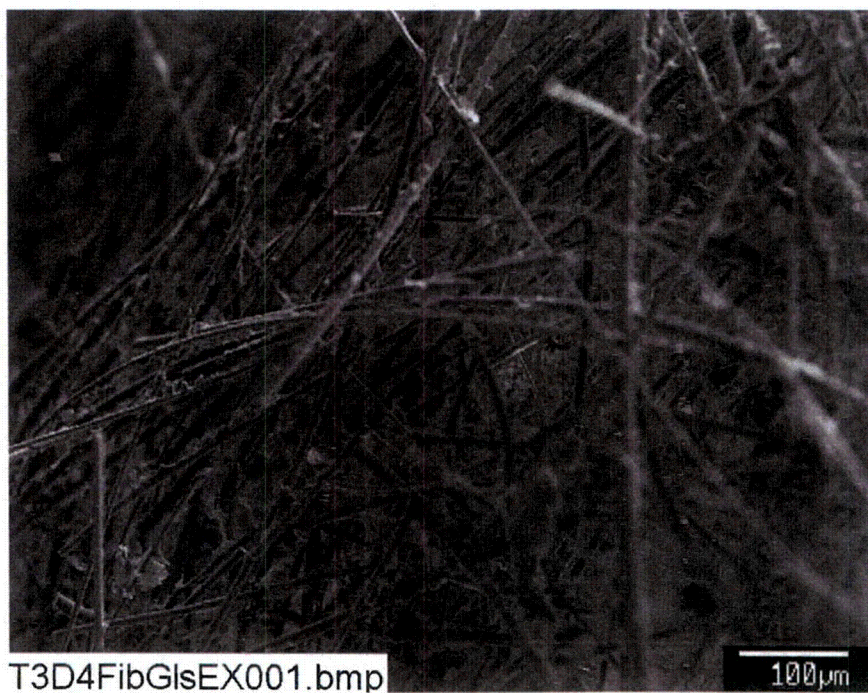
**Figure A-9.** SEM image magnified 150 times for a Test #3, Day-4 low-flow exterior fiberglass sample. (T3D4FibGlsEX001)

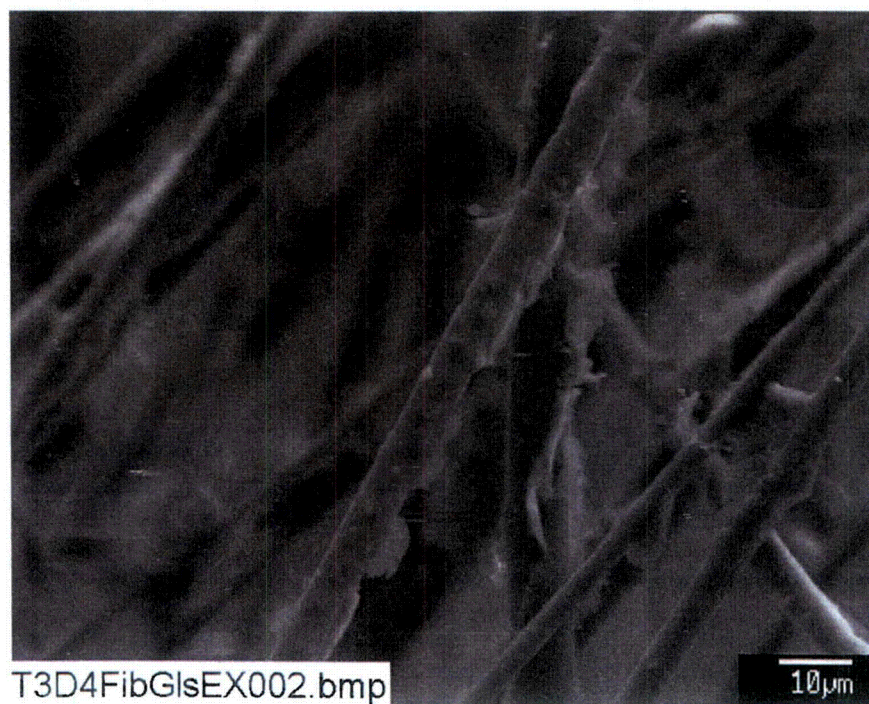
**Figure A-10.** SEM image magnified 1000 times for a Test #3, Day-4 low-flow exterior fiberglass sample. (T3D4FibGlsEX002)

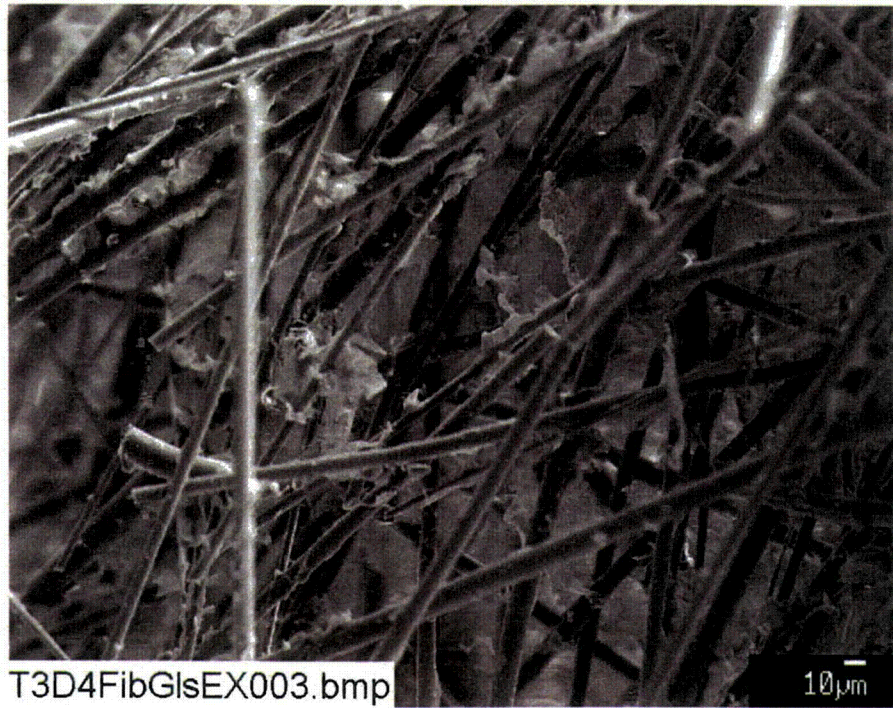
**Figure A-11.** SEM image magnified 300 times for a Test #3, Day-4 low-flow exterior fiberglass sample. (T3D4FibGlsEX003)

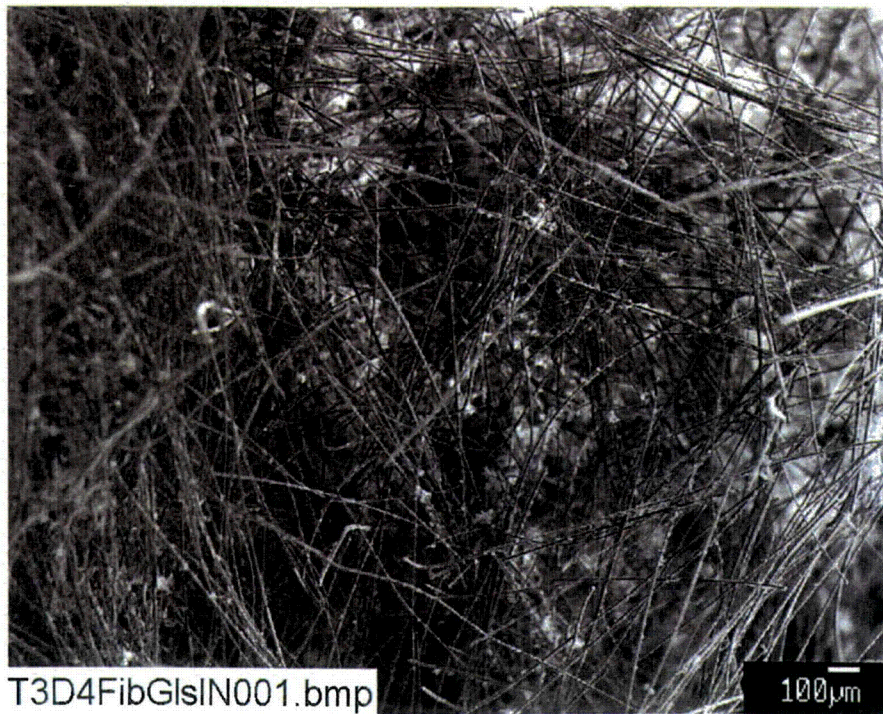
**Figure A-12.** SEM image magnified 50 times for a Test #3, Day-4 low-flow interior fiberglass sample. (T3D4FibGlsIN001)

Image:	T3D4FibGlsIn001	50 ×	SEM image	Figure A-12
	T3D4FibGlsIn002	150 ×	SEM image	Figure A-13
	T3D4FibGlsIn003	400 ×	SEM image	Figure A-14
	T3D4FibGlsIn004	1000 ×	SEM at higher magnification	Figure A-15

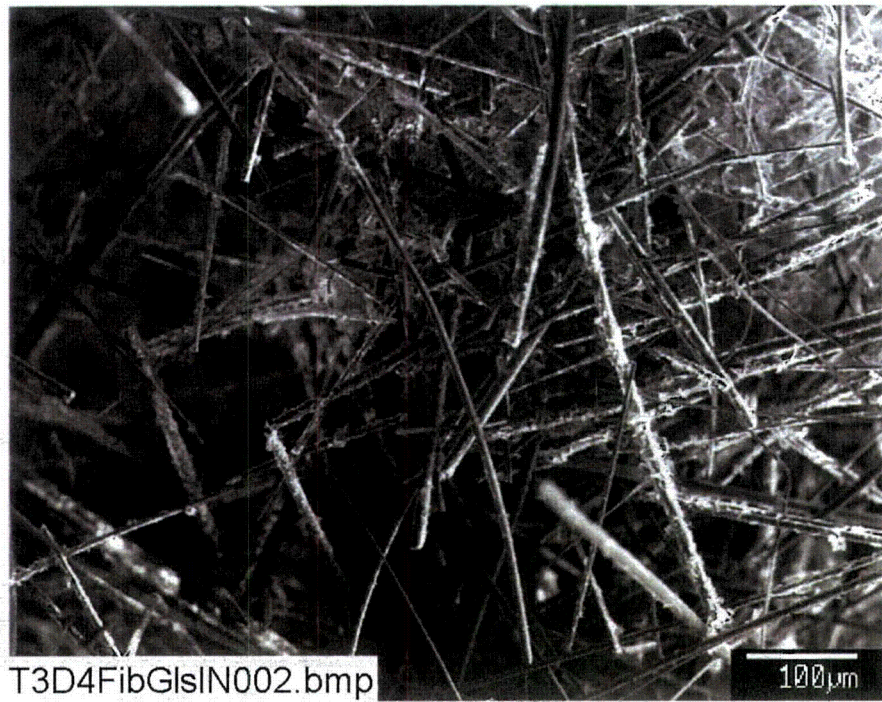
Figure A-13. SEM image magnified 150 times for a Test #3, Day-4 low-flow interior fiberglass sample. (T3D4FibGlsIN002)

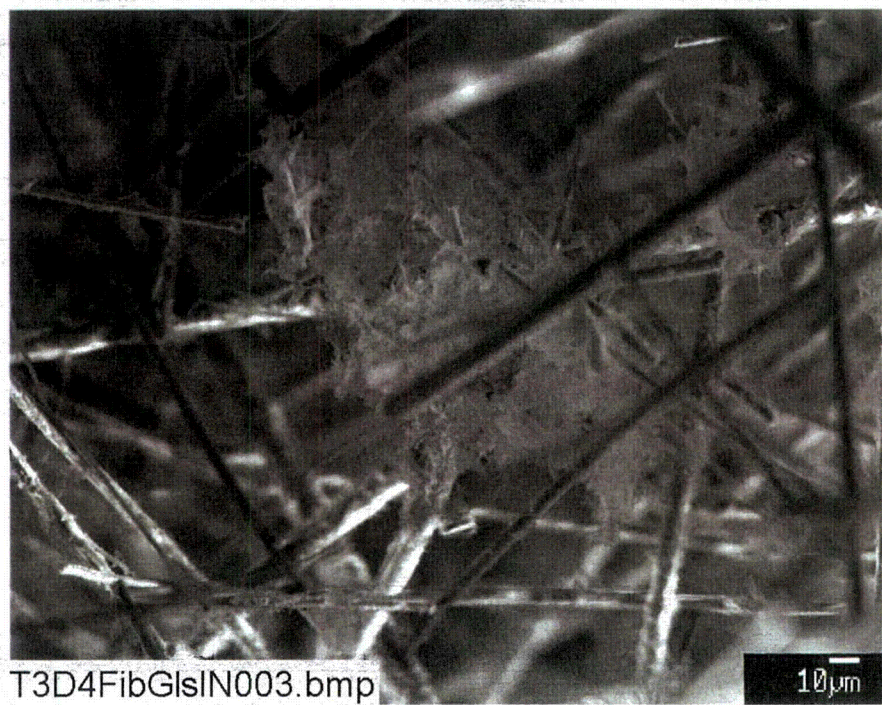
Figure A-14. SEM image magnified 400 times for a Test #3, Day-4 low-flow interior fiberglass sample. (T3D4FibGlsIN003)

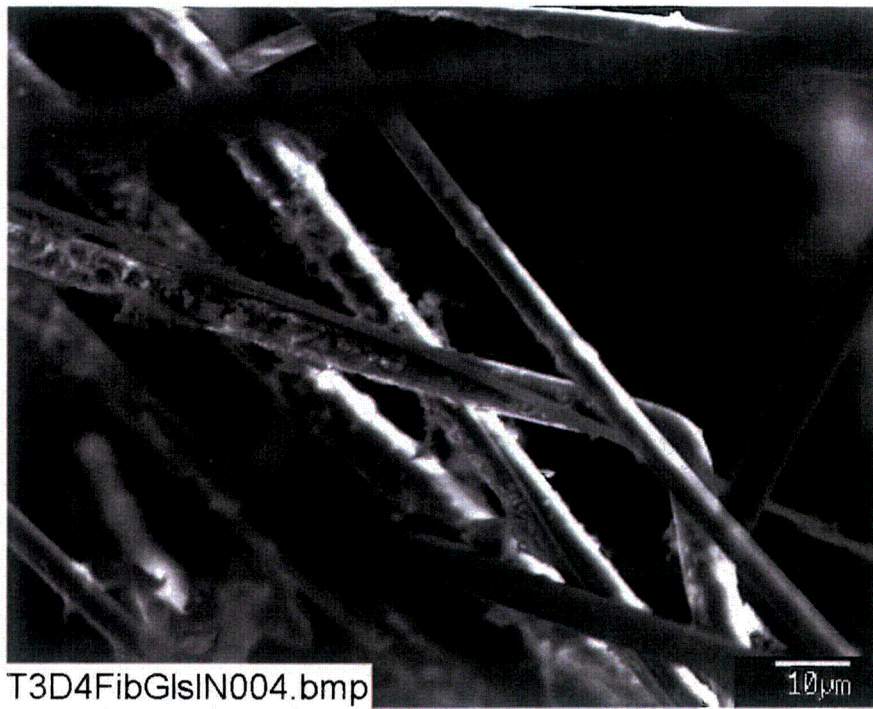
**Figure A-15.** SEM image magnified 1000 times for a Test #3, Day-4 low-flow interior fiberglass sample. (T3D4FibGlsIN004)

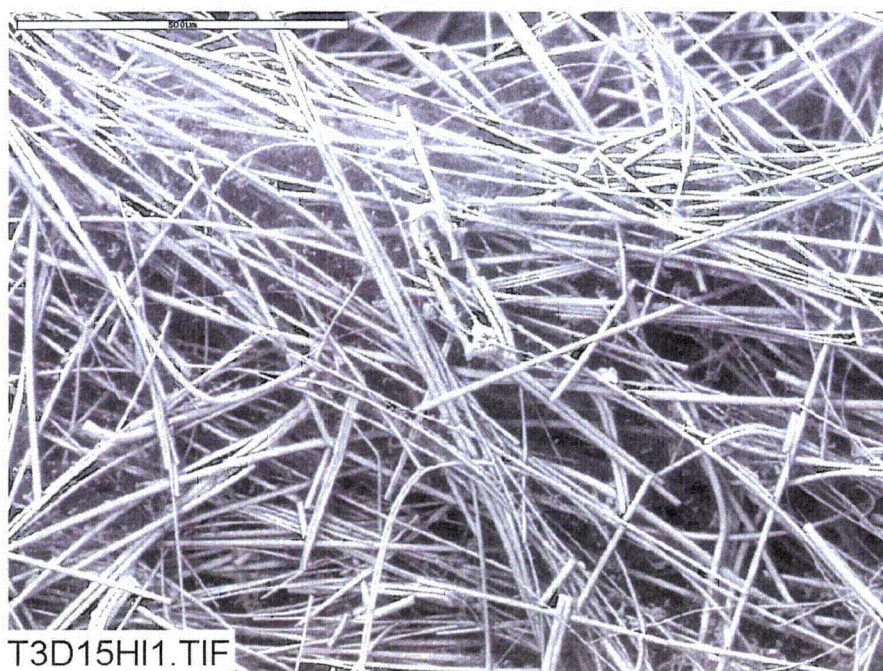
Figure B1-1. Environmental SEM image magnified 100 times for a Test #3, Day-15 high-flow interior fiberglass sample. (T3D15HI1)

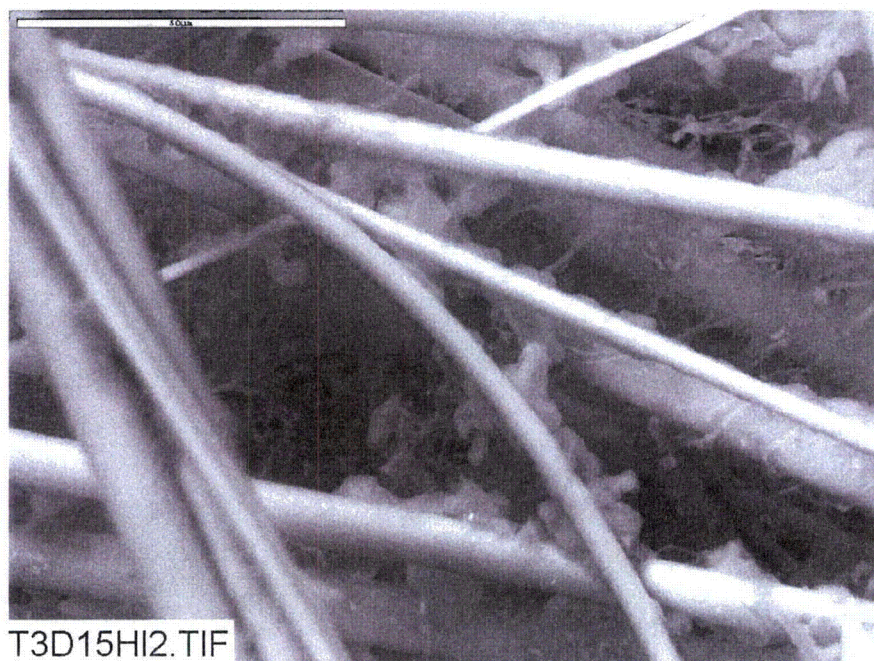
Figure B1-2. Environmental SEM image magnified 1000 times for a Test #3, Day-15 high-flow interior fiberglass sample. (T3D15HI2)

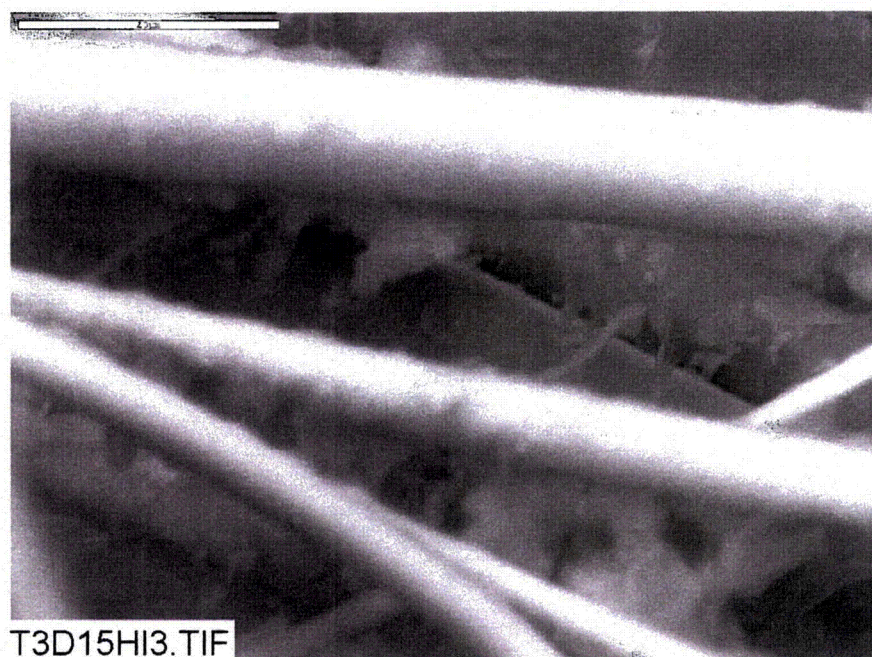
**Figure B1-3.** Environmental SEM image magnified 2000 times for a Test #3, Day-15 high-flow interior fiberglass sample. (T3D15HI3)

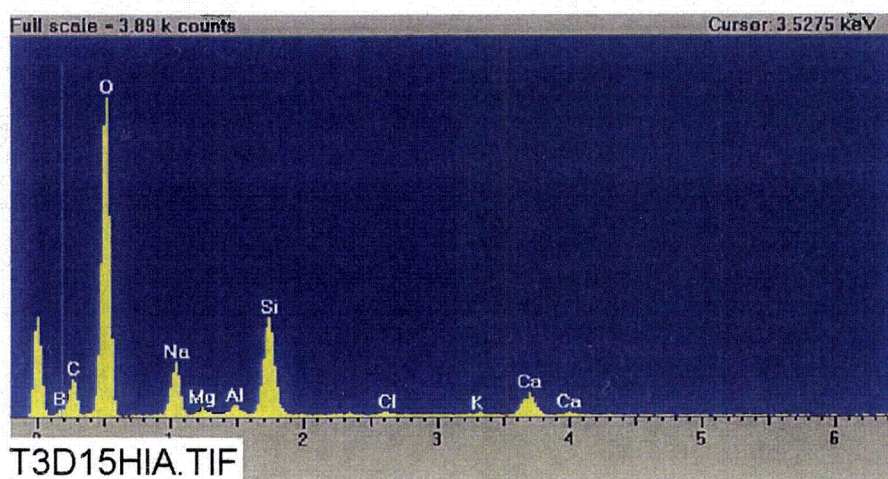
**Figure B1-4.** EDS counting spectrum for the flocculence deposits between the fibers on ESEM image shown in Figure B1-3. (T3D15HIA)

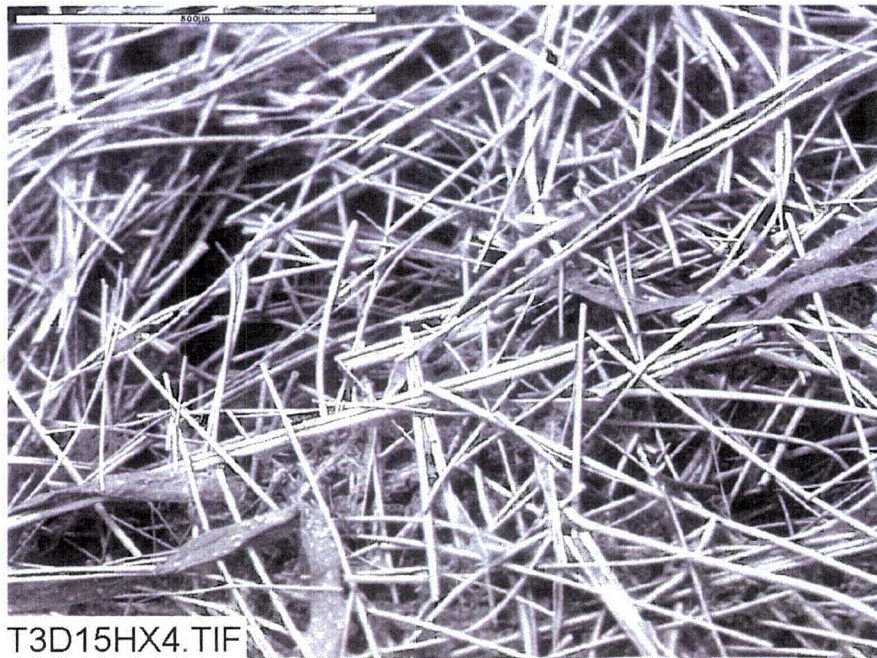
Figure B1-5. Environmental SEM image magnified 110 times for a Test #3, Day-15 high-flow exterior fiberglass sample. (T3D15HX4)

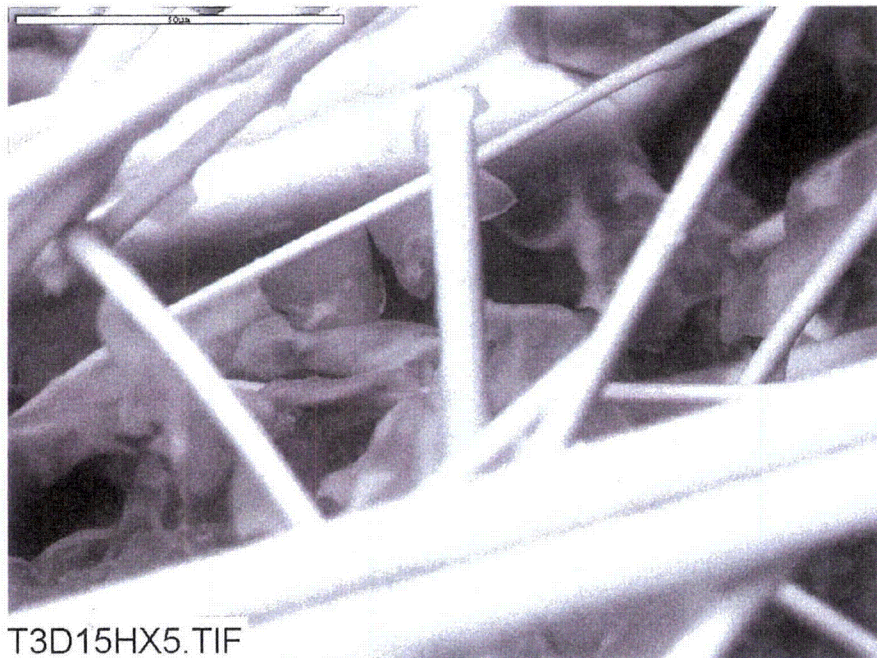
Figure B1-6. Environmental SEM image magnified 1000 times for a Test #3, Day-15 high-flow exterior fiberglass sample. (T3D15HX5)

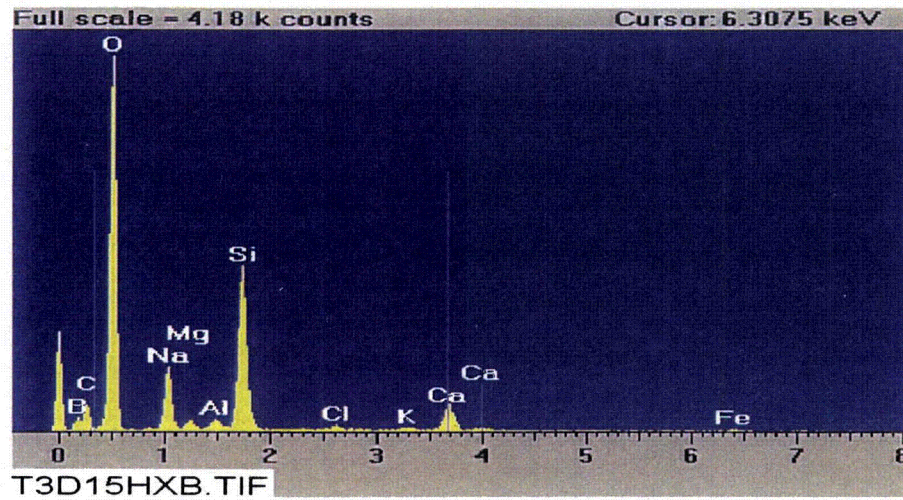
Figure B1-7. EDS counting spectrum for the deposits between the fibers on ESEM image shown in Figure B1-6. (T3D15HXB)

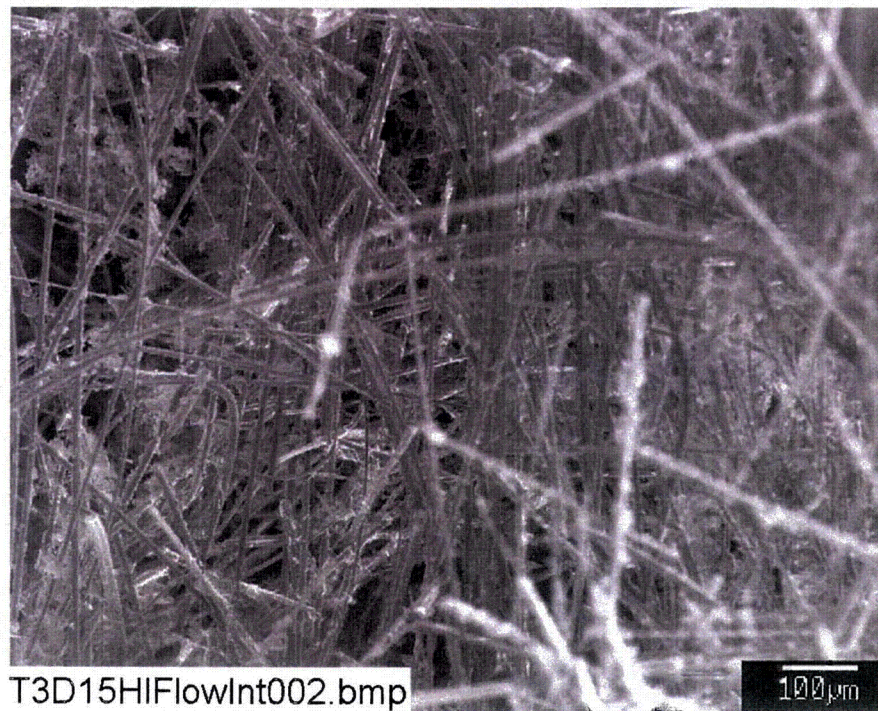
Figure B1-8. SEM image magnified 100 times for a Test #3, Day-15 high-flow interior fiberglass sample. (T3D15HIFlowInt002)

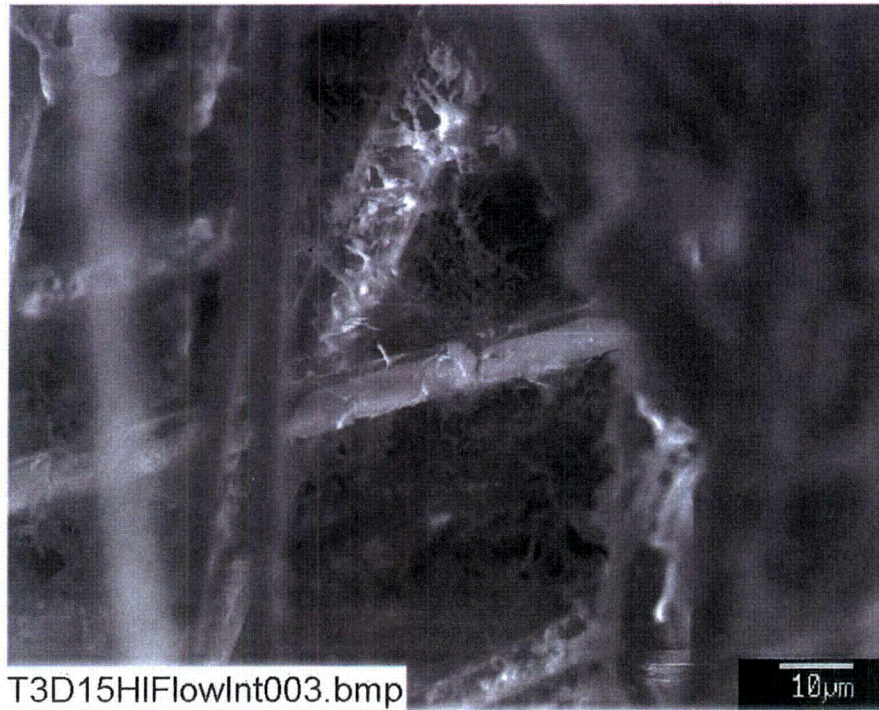
**Figure B1-9.** SEM image magnified 1000 times for a Test #3, Day-15 high-flow interior fiberglass sample. (T3D15HIFlowInt003)

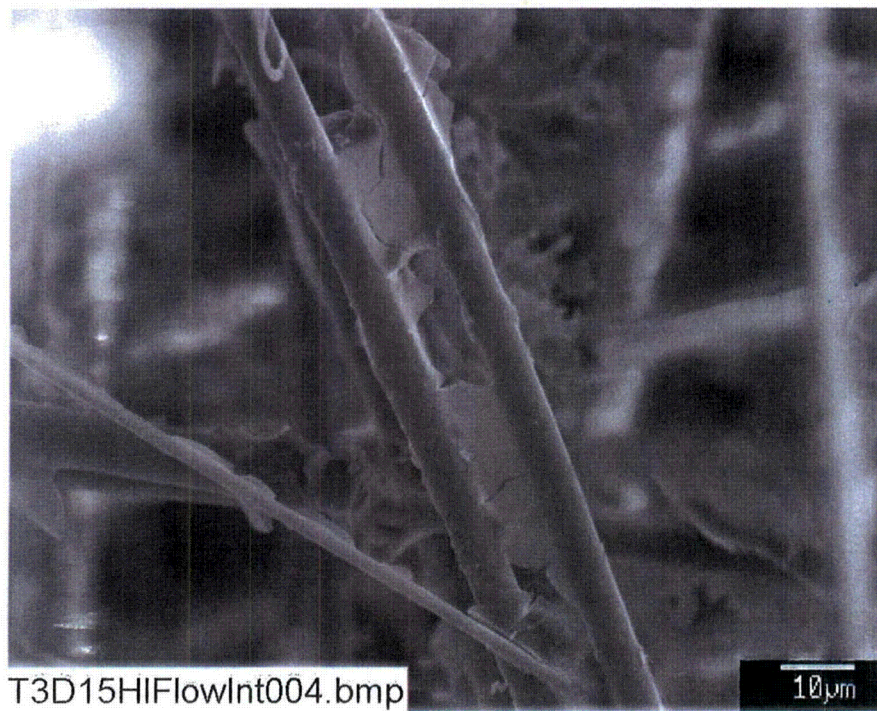
**Figure B1-10.** SEM image magnified 1000 times for a Test #3, Day-15 high-flow interior fiberglass sample. (T3D15HIFlowInt004)

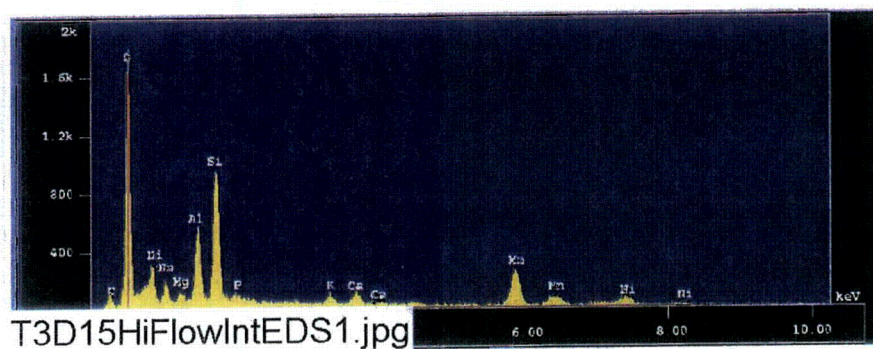
**Figure B1-11. EDS counting spectrum for the flocculence deposits between the fibers on SEM image shown in Figure B1-10. (T3D15HiFlowIntEDS1)**

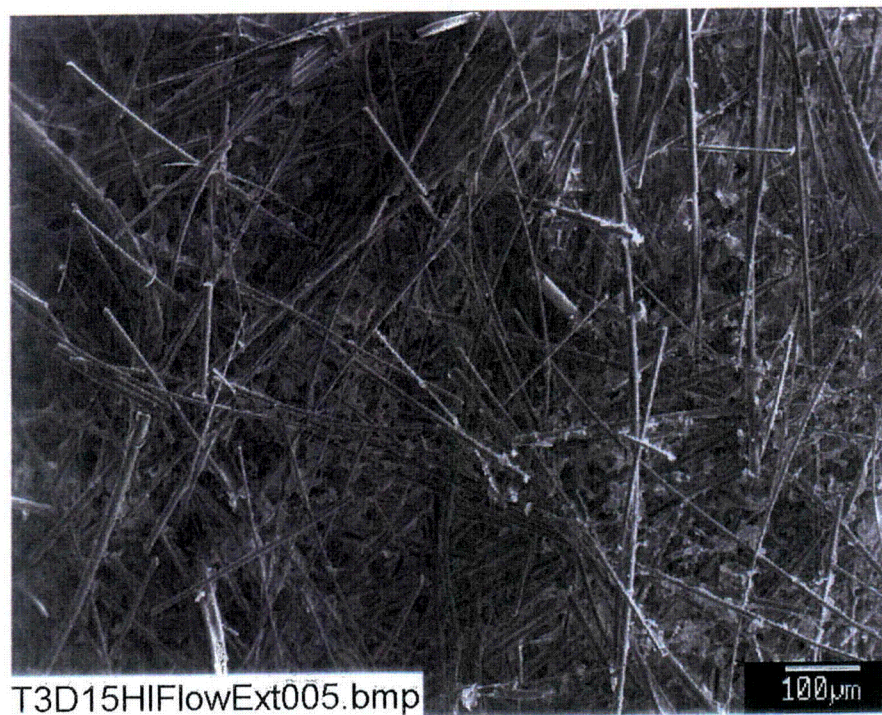
**Figure B1-12. SEM image magnified 100 times for a Test #3, Day-15 high-flow exterior fiberglass sample. (T3D15HiFlowExt005)**

Image:	T3D15HIFlowExt005	100 ×	Figure B1-12
	T3D15HIFlowExt006	1000 ×	Figure B1-13
	T3D15HIFlowExt007	500 ×	Figure B1-14
EDS:	T3D15HIFlowExtEDS 2	EDS on particles shown in Ext007	Figure B1-15

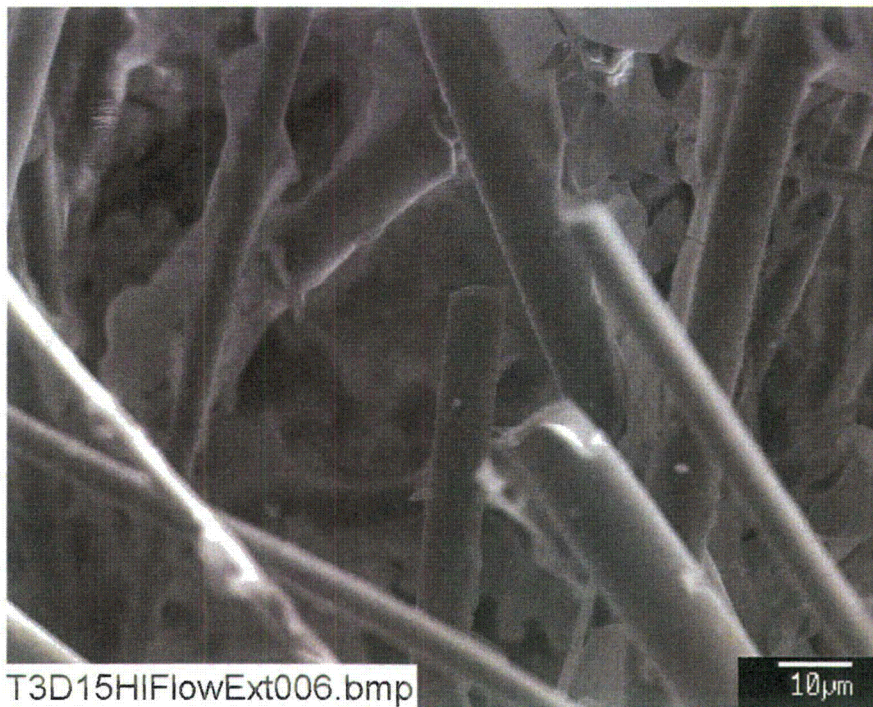
**Figure B1-13.** SEM image magnified 1000 times for a Test #3, Day-15 high-flow exterior fiberglass sample. (T3D15HIFlowExt006)

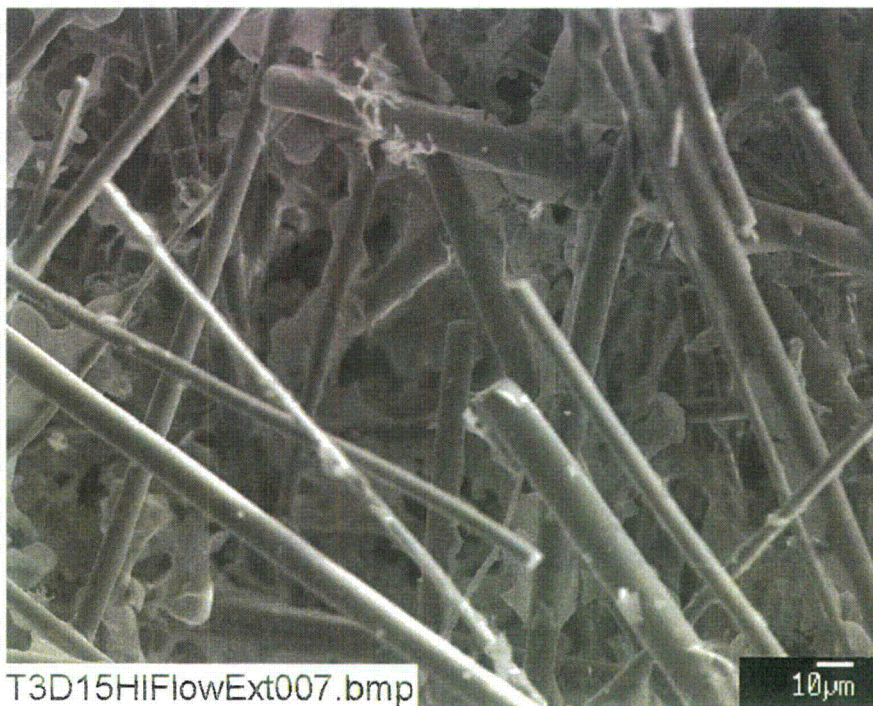
**Figure B1-14.** SEM image magnified 500 times for a Test #3, Day-15 high-flow exterior fiberglass sample. (T3D15HIFlowExt007)

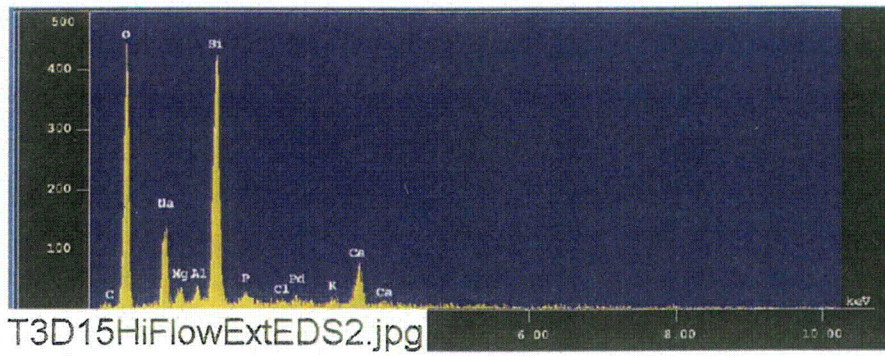
**Figure B1-15. EDS counting spectrum for the flocculence deposits between the fibers on SEM image shown in Figure B1-14. (T3D15HiFlowExtEDS2)**

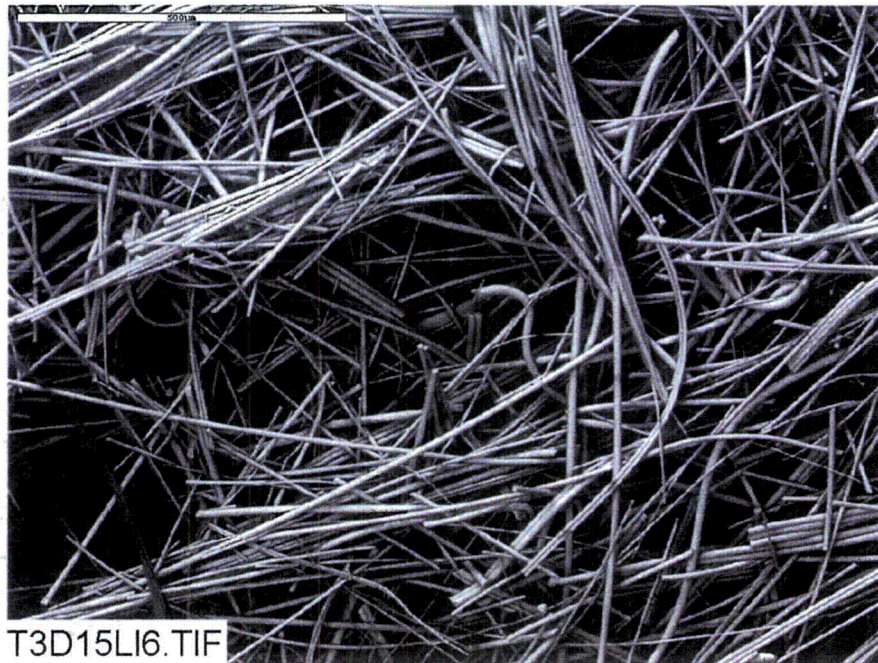
**Figure B2-1.** Environmental SEM image magnified 100 times for a Test #3, Day-15 low-flow interior fiberglass sample. (T3D15LI6)

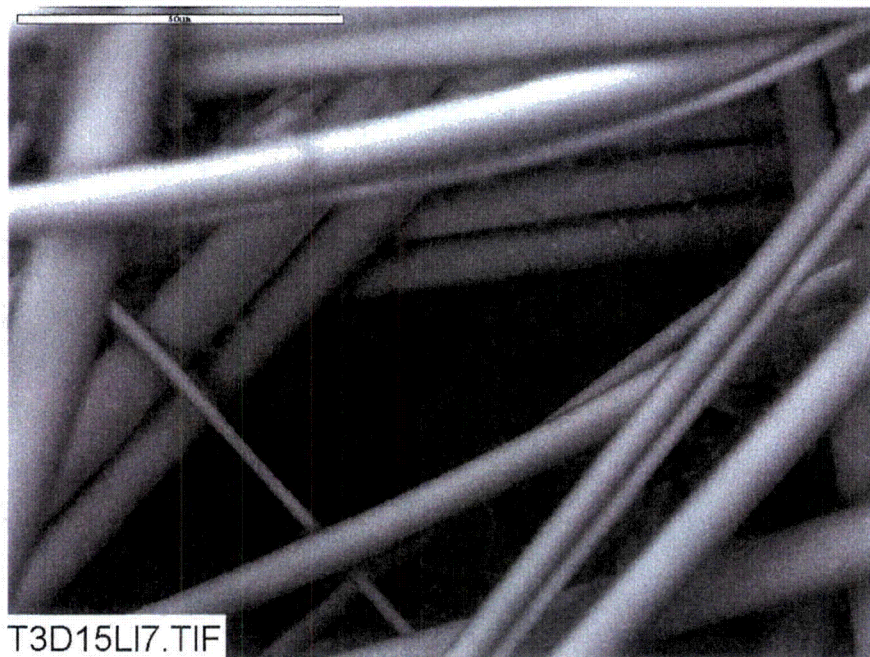
**Figure B2-2.** Environmental SEM image magnified 1000 times for a Test #3, Day-15 low-flow interior fiberglass sample. (T3D15LI7)

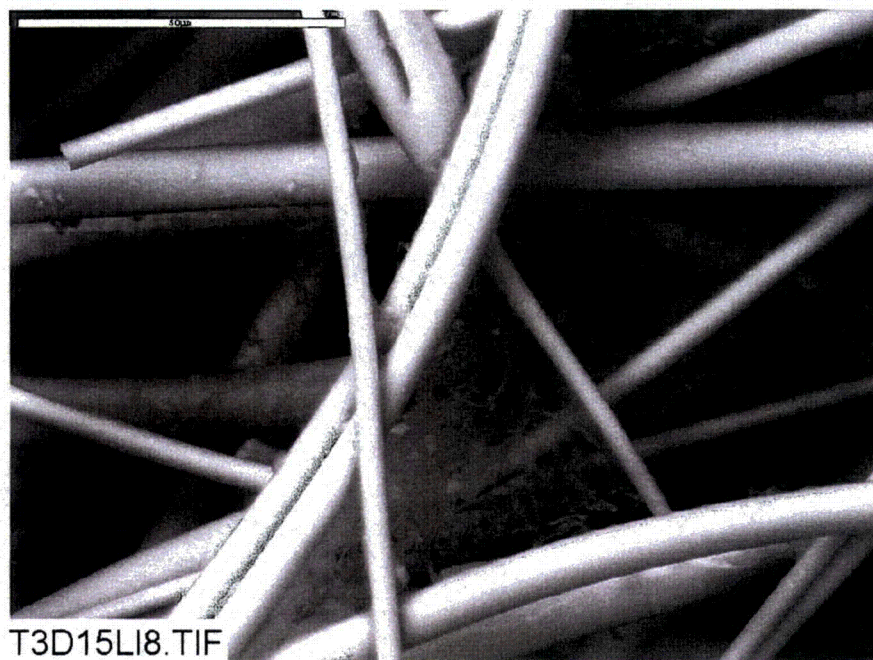
**Figure B2-3.** Environmental SEM image magnified 1000 times for a Test #3, Day-15 low-flow interior fiberglass sample. (T3D15LI8)

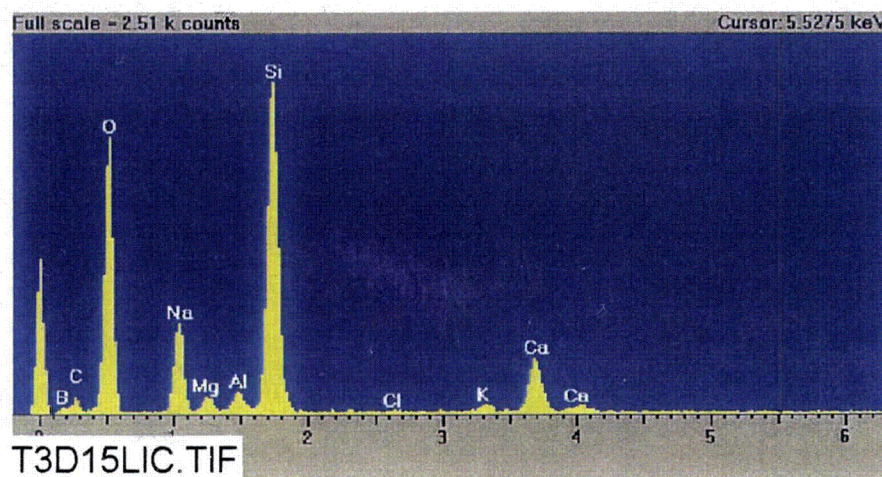
**Figure B2-4.** EDS counting spectrum for the flocculence deposits between the fibers on ESEM image shown in Figure B2-3. (T3D15LIC)

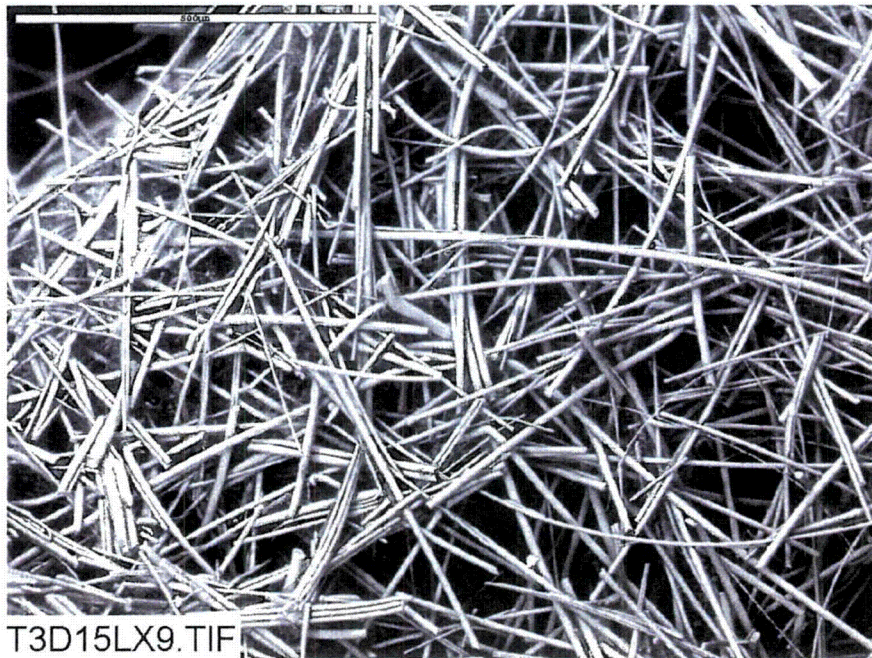
**Figure B2-5.** Environmental SEM image magnified 110 times for a Test #3, Day-15 low-flow exterior fiberglass sample. (T3D15LX9)

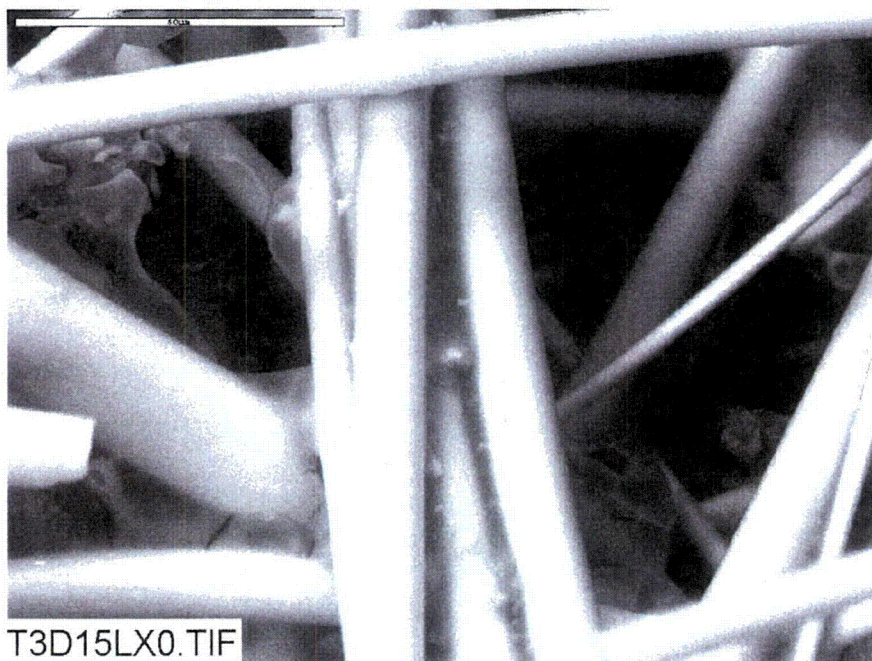
**Figure B2-6.** Environmental SEM image magnified 1000 times for a Test #3, Day-15 low-flow exterior fiberglass sample. (T3D15LX0)

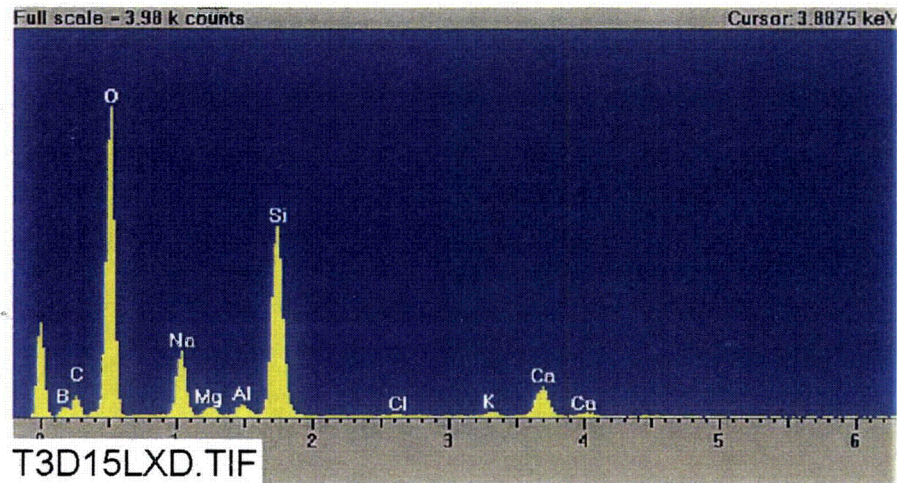
Figure B2-7. EDS counting spectrum for the deposits between the fibers on ESEM image shown in Figure B2-6. (T3D15LXD)

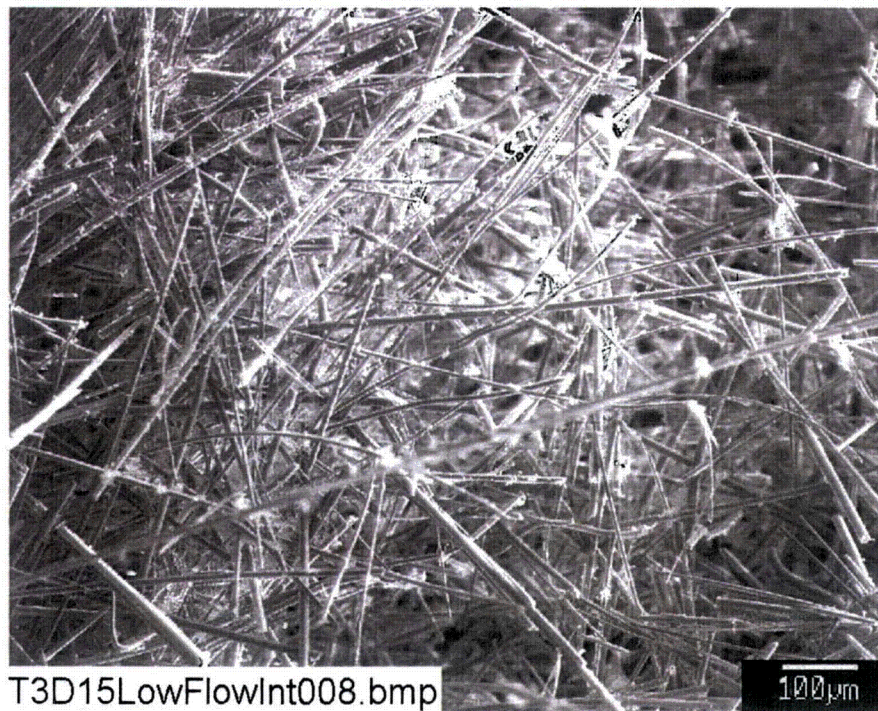
Figure B2-8. SEM image magnified 100 times for a Test #3, Day-15 low-flow interior fiberglass sample. (T3D15LowFlowInt008)
