#### 4. SUMMARY OF KEY OBSERVATIONS

**Appendix D. ESEM and SEM/EDS Data for Test #3 Day-30 Corrosion Products**

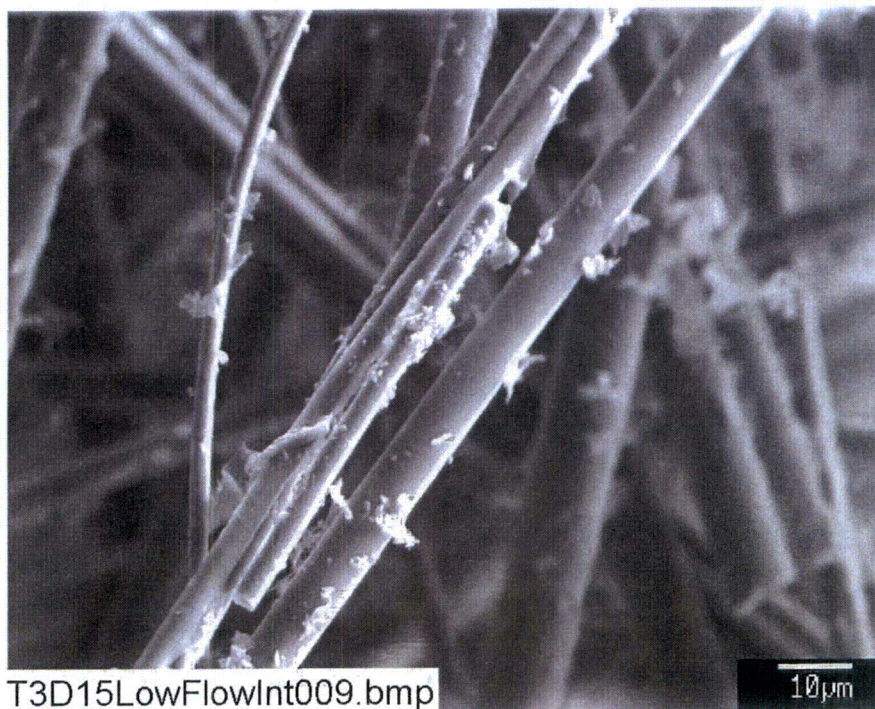
**Figure B2-9.** SEM image magnified 1000 times for a Test #3, Day-15 low-flow interior fiberglass sample. (T3D15LowFlowInt009)

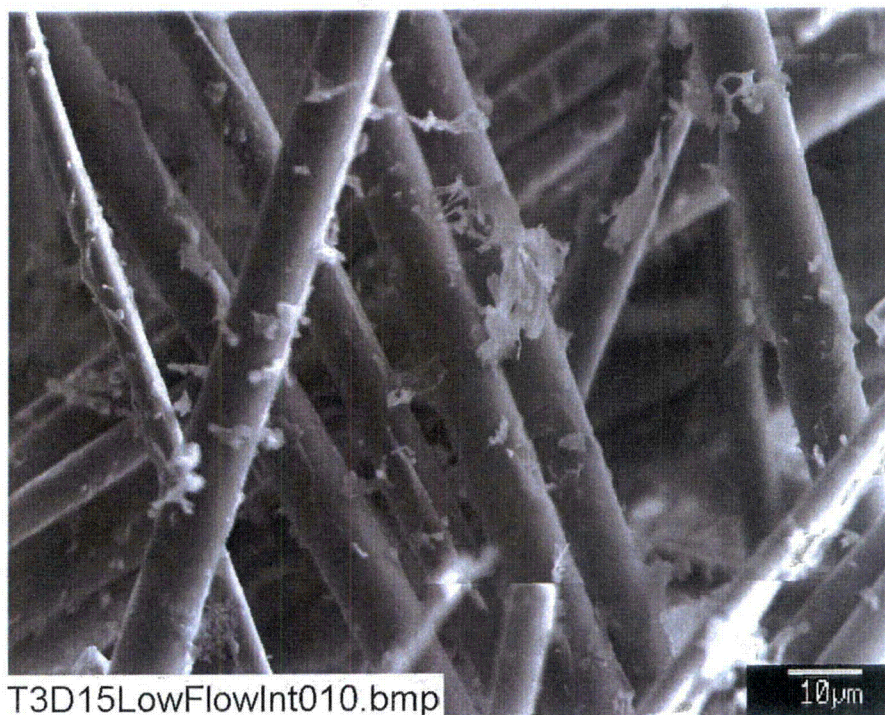
**Figure B2-10.** SEM image magnified 1000 times for a Test #3, Day-15 low-flow interior fiberglass sample. (T3D15LowFlowInt010)

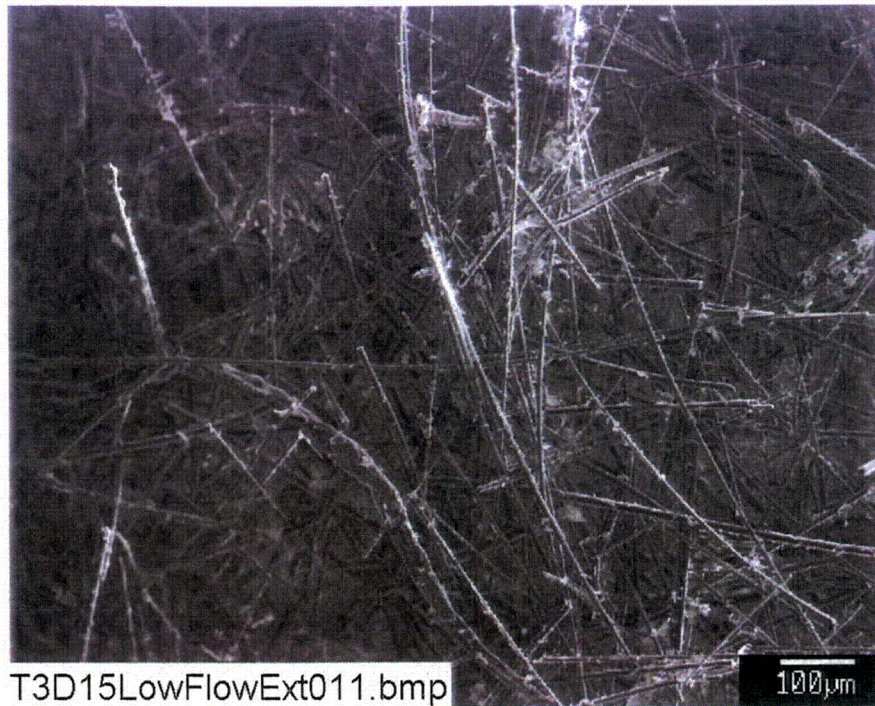
**Figure B2-11.** SEM image magnified 100 times for a Test #3, Day-15 low-flow exterior fiberglass sample. (T3D15LowFlowExt011)

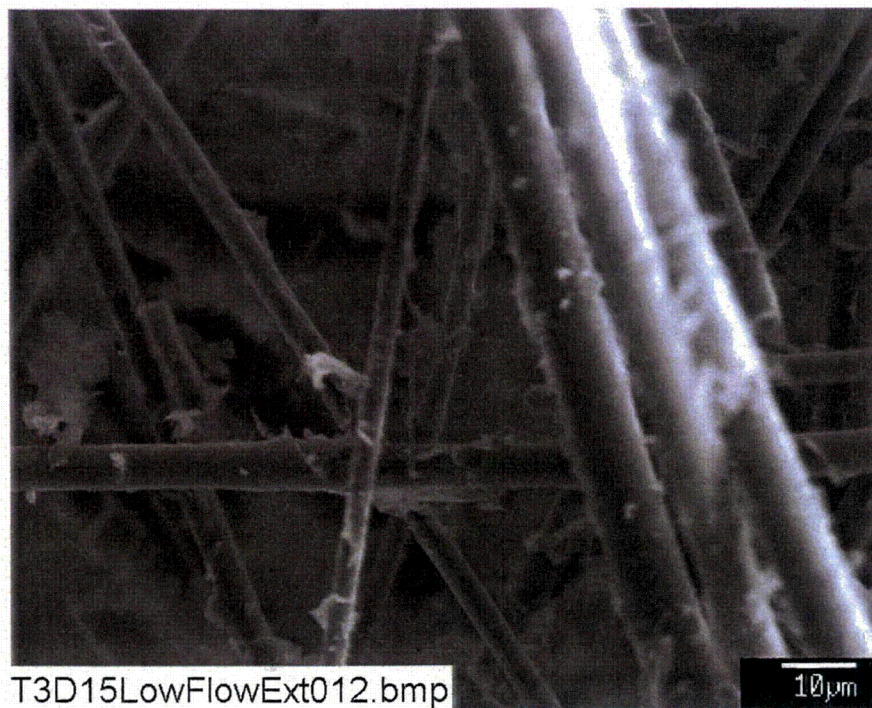
**Figure B2-12.** SEM image magnified 1000 times for a Test #3, Day-15 low-flow exterior fiberglass sample. (T3D15LowFlowExt012)

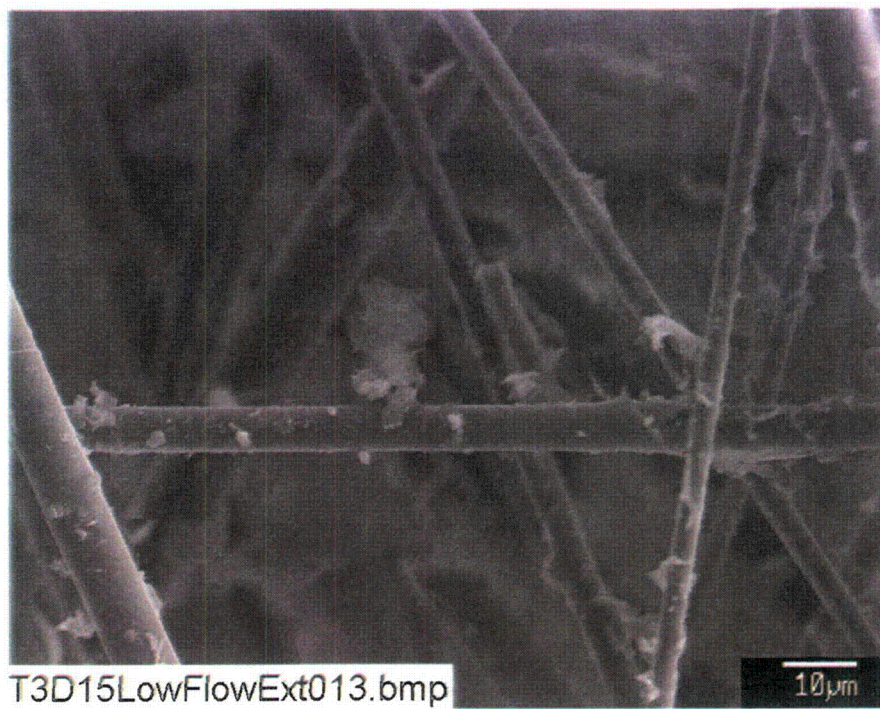
**Figure B2-13.** SEM image magnified 1000 times for a Test #3, Day-15 low-flow exterior fiberglass sample. (T3D15LowFlowExt013)

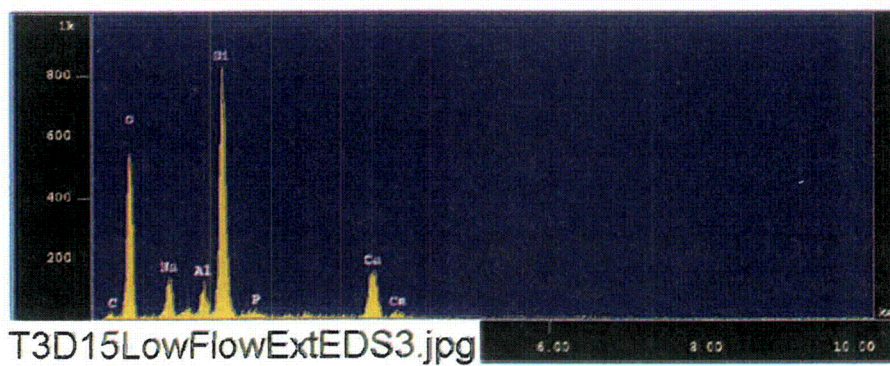
**Figure B2-14.** EDS counting spectrum for the floculence deposits between the fibers on SEM image shown in Figure B2-13. (T3D15LowFlowExtEDS3)

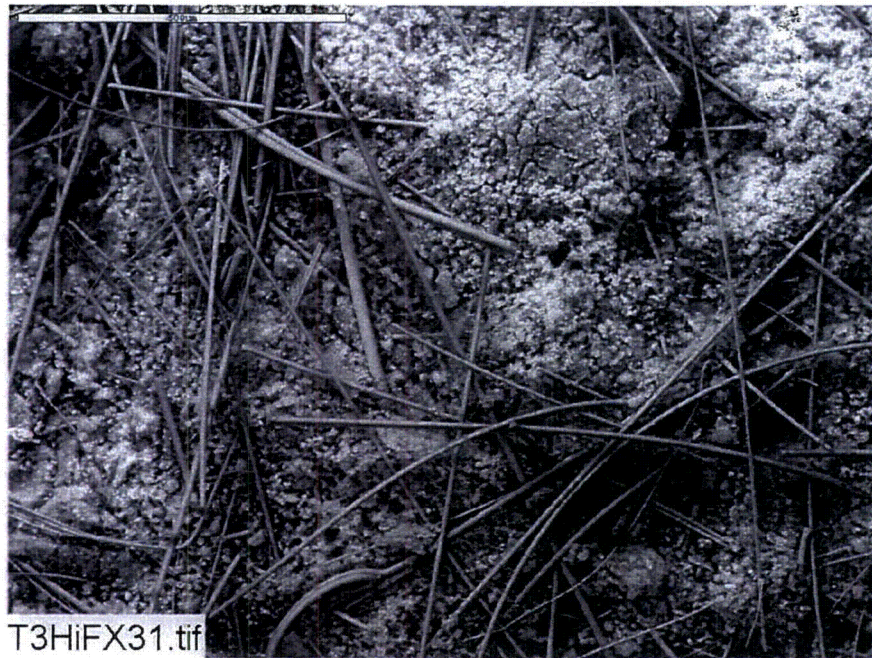
Figure C1-1. ESEM image magnified 100 times for a Test #3, Day-30 exterior high-flow fiberglass sample. (T3HiFX31)

Image: T3HiFX31	100 ×	ESEM image	Figure C1-1
t3hifX32	1000 ×	ESEM image higher magnification	Figure C1-2
t3hifX33	100 ×	ESEM image	Figure C1-3
EDS: t3hifX34		EDS on particles in T3HiFX33	Figure C1-4
Image: t3hifX35	600 ×	ESEM image on fiberglass	Figure C1-5

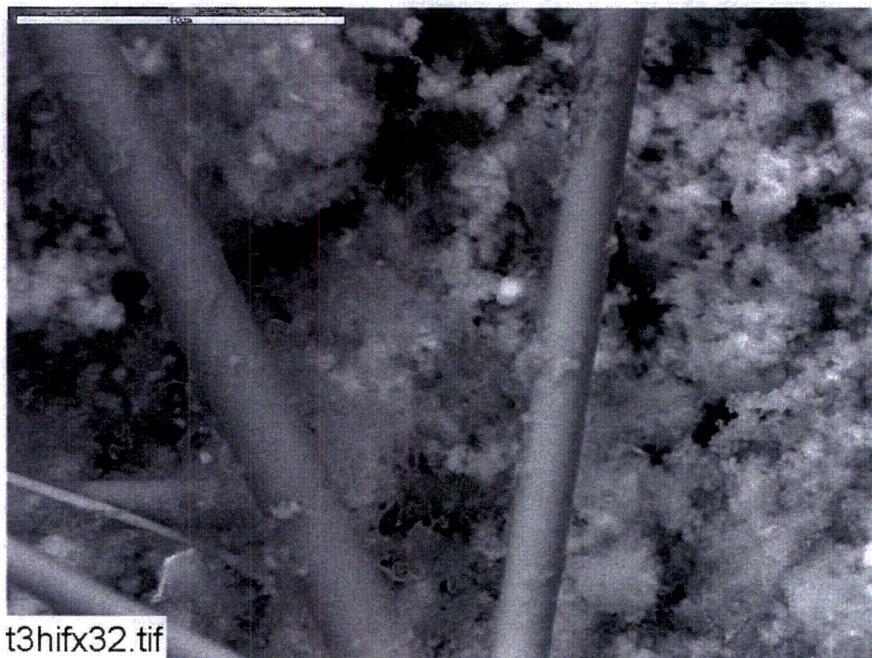
Figure C1-2. ESEM image magnified 1000 times for a Test #3, Day-30 exterior high-flow fiberglass sample. (t3hifx32)

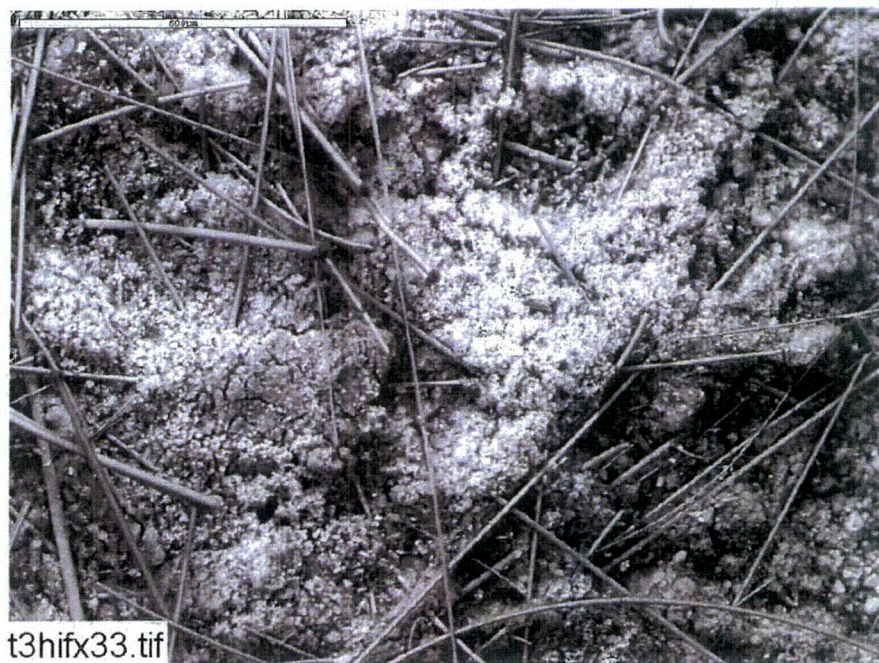
Figure C1-3. ESEM image magnified 100 times for a Test #3, Day-30 exterior high-flow fiberglass sample. (t3hifx33)

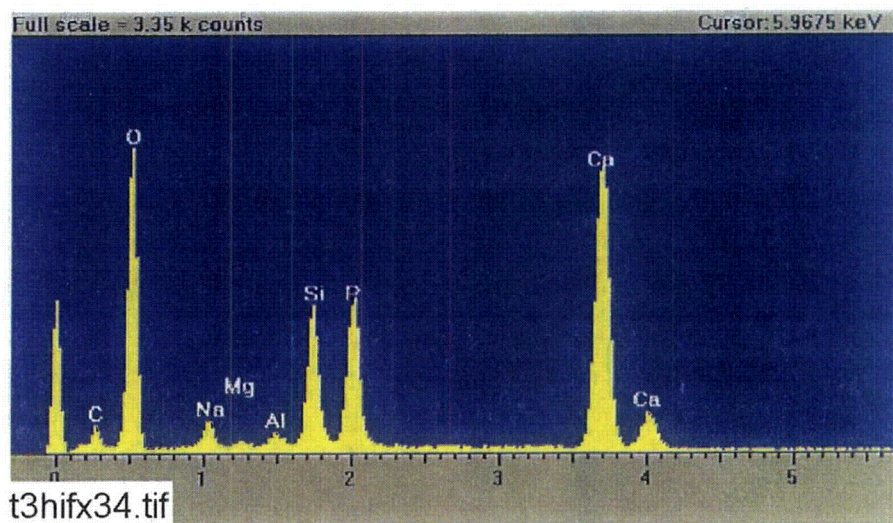
Figure C1-4. EDS counting spectrum for the large masses of particulate deposits shown in Figure C1-3. (t3hifx34)

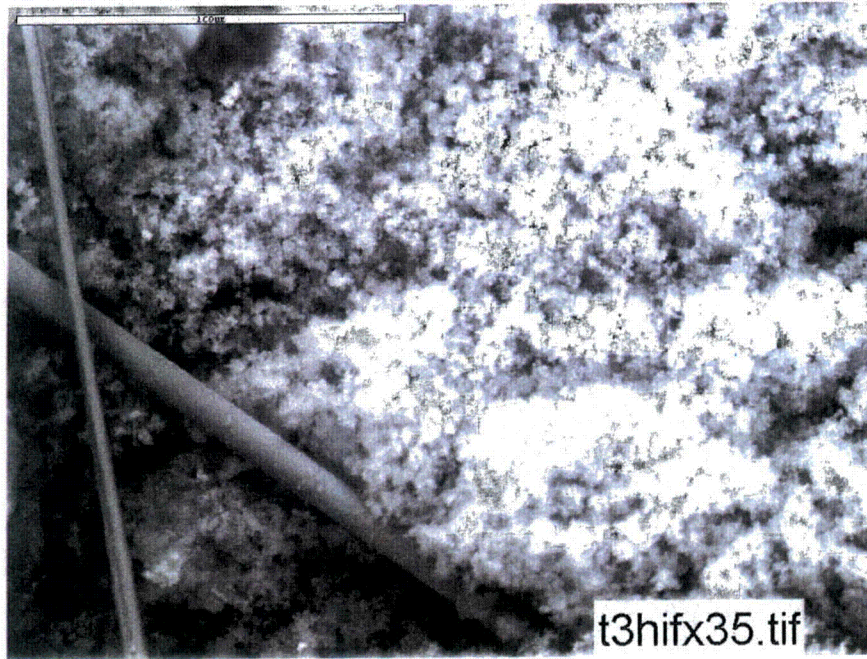
Figure C1-5. ESEM image magnified 600 times for a Test #3, Day-30 exterior high-flow fiberglass sample. (t3hifx35)

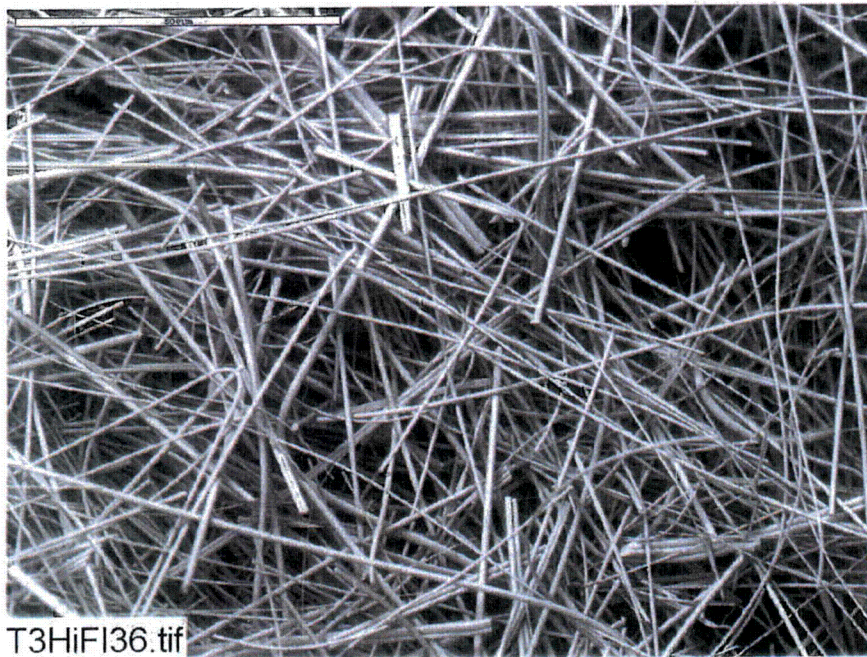
Figure C1-6. ESEM image magnified 100 times for a Test #3, Day-30 interior high-flow fiberglass sample. (T3HiFI36)

Image: T3HiFI36	100 ×	ESEM image of fiberglass	Figure C1-6
t3hifI37	1000 ×	ESEM image higher magnification	Figure C1-7
t3hifI38	100 ×	ESEM image	Figure C1-8

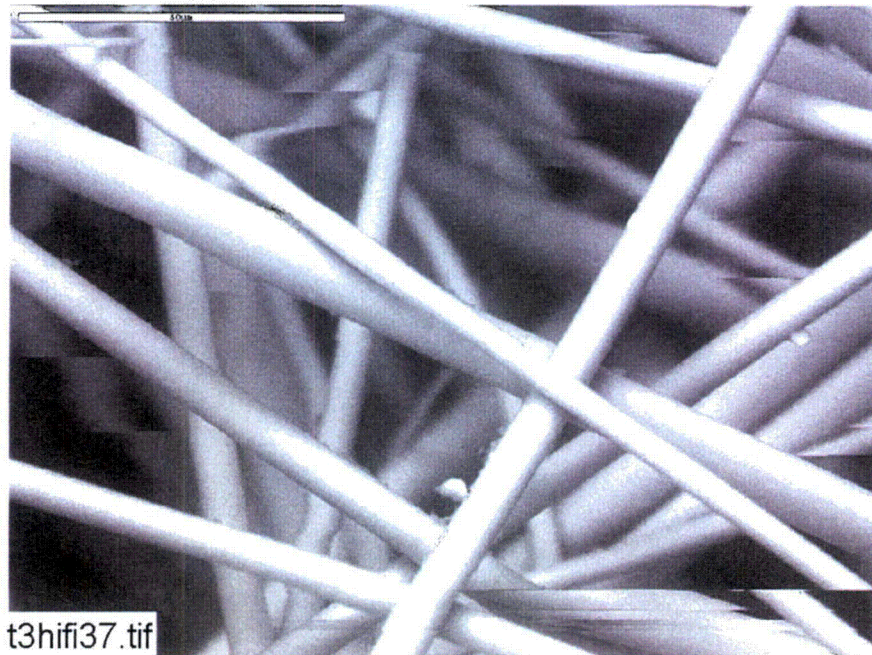
Figure C1-7. ESEM image magnified 1000 times for a Test #3, Day-30 interior high-flow fiberglass sample. (t3hifi37)

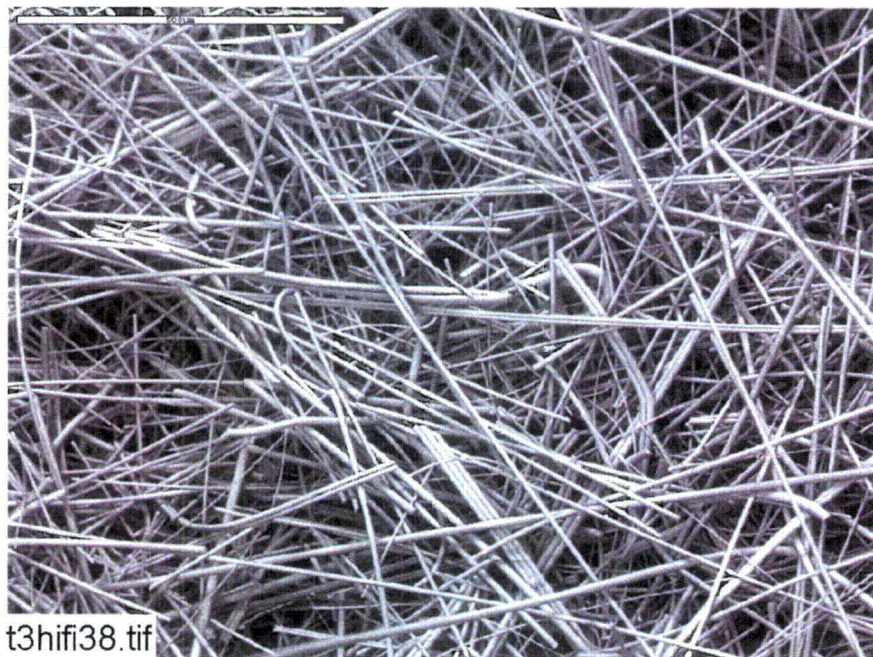
Figure C1-8. ESEM image magnified 100 times for a Test #3, Day-30 interior high-flow fiberglass sample. (t3hifi38)

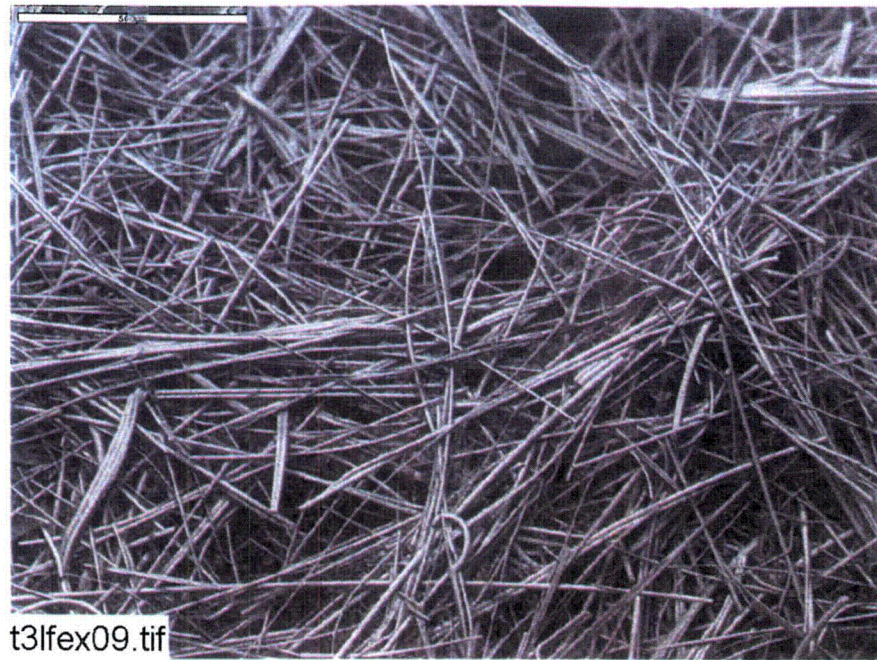
**Figure C2-1.** ESEM image magnified 70 times for a Test #3, Day-30 exterior low-flow fiberglass sample. (t3lfex09)

Image: t3lfex09	70 ×	ESEM image of fiberglass sample	Figure C2-1
t3lfex10	1000 ×	ESEM at higher magnification	Figure C2-2
t3lfex11	1000 ×	ESEM image	Figure C2-3

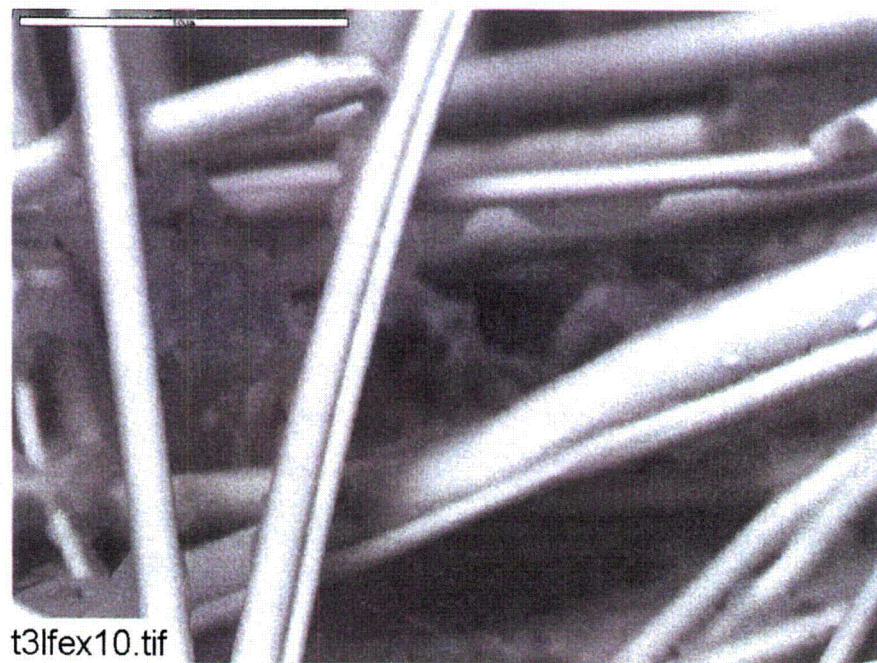
**Figure C2-2.** ESEM image magnified 1000 times for a Test #3, Day-30 exterior low-flow fiberglass sample. (t3lfex10)

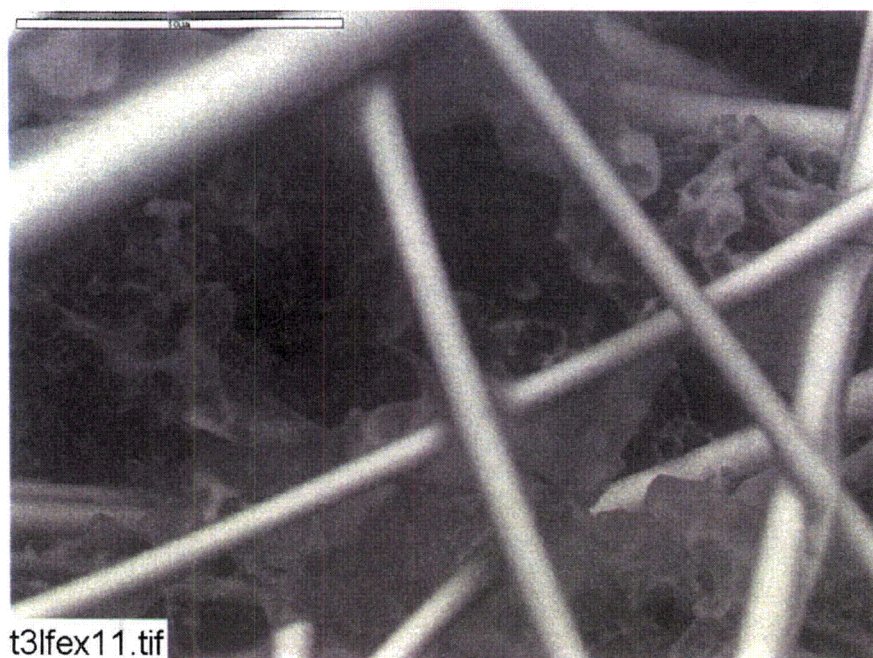
**Figure C2-3.** ESEM image magnified 1000 times for a Test #3, Day-30 exterior low-flow fiberglass sample. (t3lfex11)

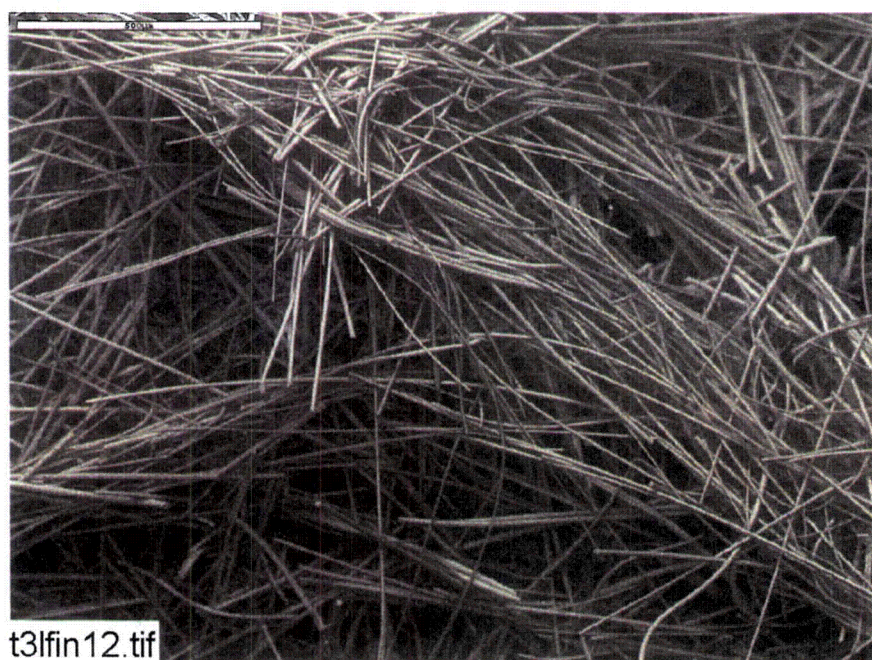
**Figure C2-4.** ESEM image magnified 70 times for a Test #3, Day-30 interior low-flow fiberglass sample. (t3lfin12)

Image: t3lfin12	70 ×	ESEM image of fiberglass sample	Figure C2-4
t3lfin13	1000 ×	ESEM image at higher mag.	Figure C2-5
t3lfin14	1000 ×	ESEM image	Figure C2-6
t3lfin15	1000 ×	ESEM image	Figure C2-7

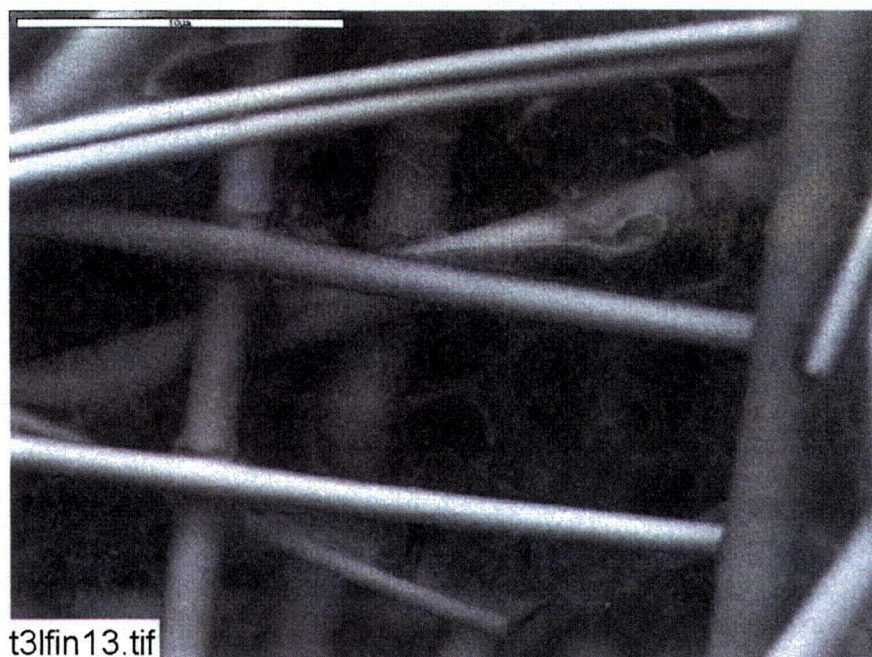
**Figure C2-5.** ESEM image magnified 1000 times for a Test #3, Day-30 interior low-flow fiberglass sample. (t3lfin13)

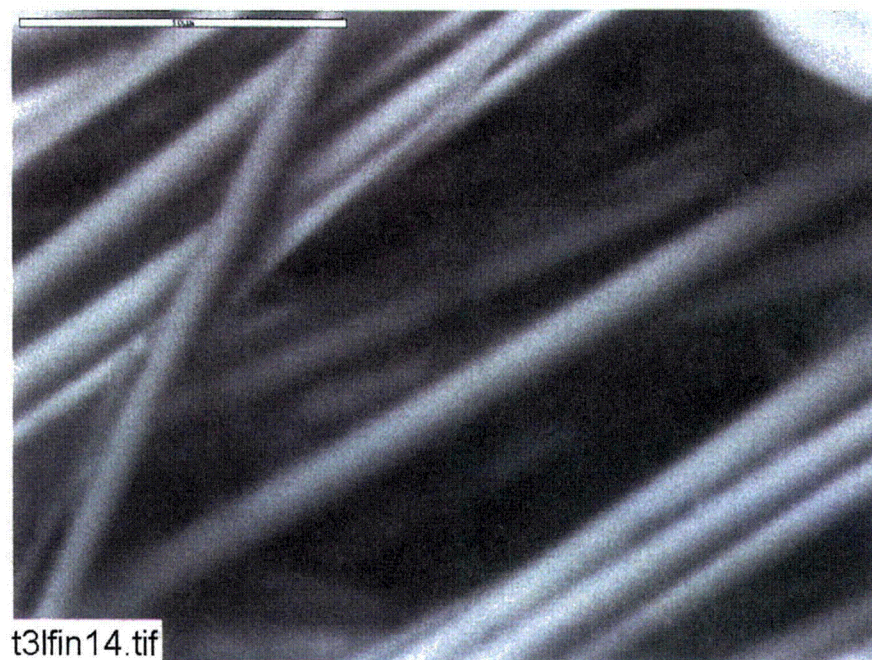
**Figure C2-6.** ESEM image magnified 1000 times for a Test #3, Day-30 interior low-flow fiberglass sample. (t3lfin14)

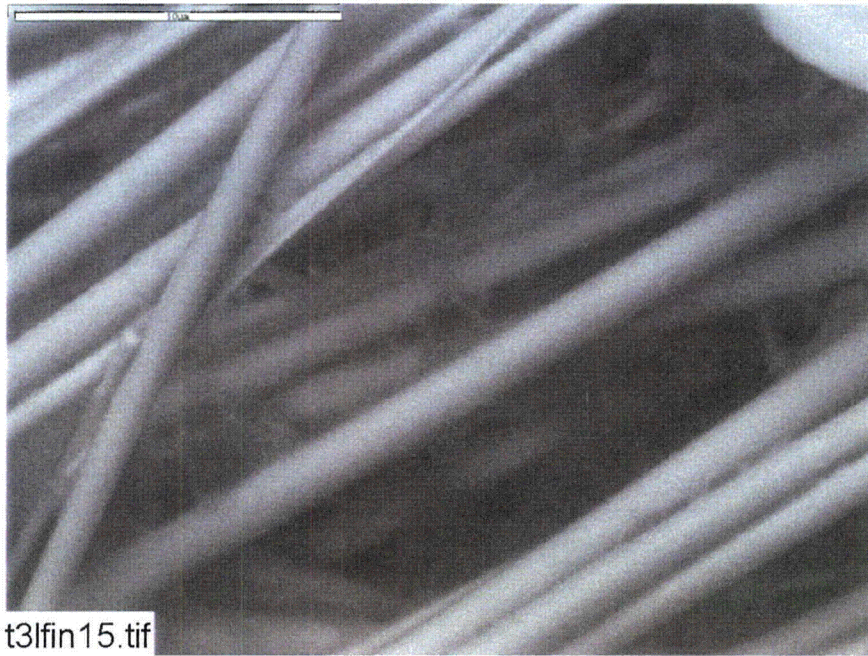
**Figure C2-7.** ESEM image magnified 1000 times for a Test #3, Day-30 interior low-flow fiberglass sample. (t3lfin15)

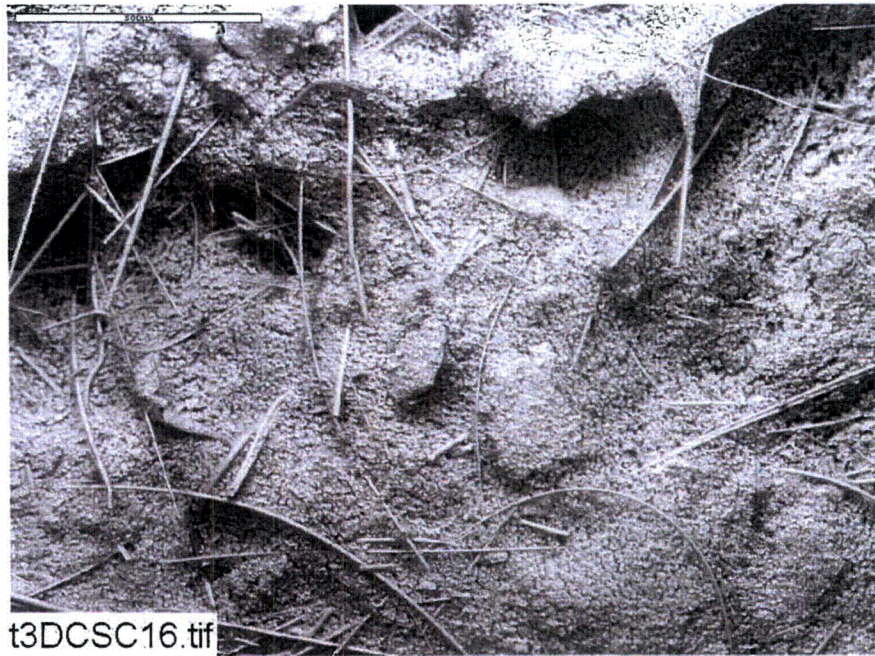
**Figure C3-1.** ESEM image magnified 100 times for a Test #3, Day-30 exterior fiberglass sample on the drain collar (adjacent to the drain screen). (t3DCSC16)

Image:	t3DCSC16	100 ×		Figure C3-1
	t3dcsc17	1000 ×	Particles	Figure C3-2
EDS:	t3dcsc18		EDS on particles	Figure C3-3
Image:	t3dcsc19	70 ×		Figure C3-4

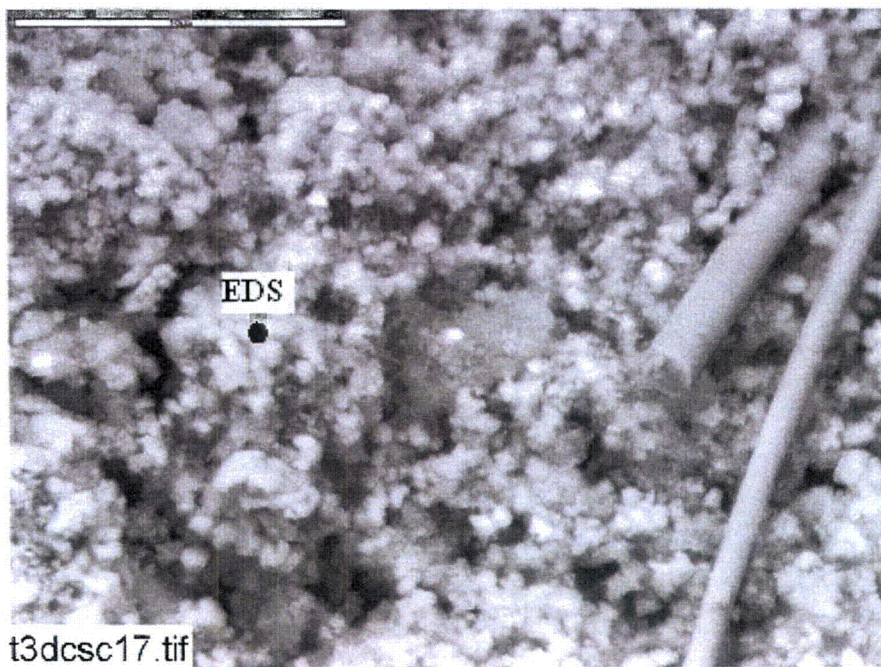
**Figure C3-2.** ESEM image magnified 1000 times for a Test #3, Day-30 exterior fiberglass sample on the drain collar (adjacent to the drain screen). (t3dcsc17)

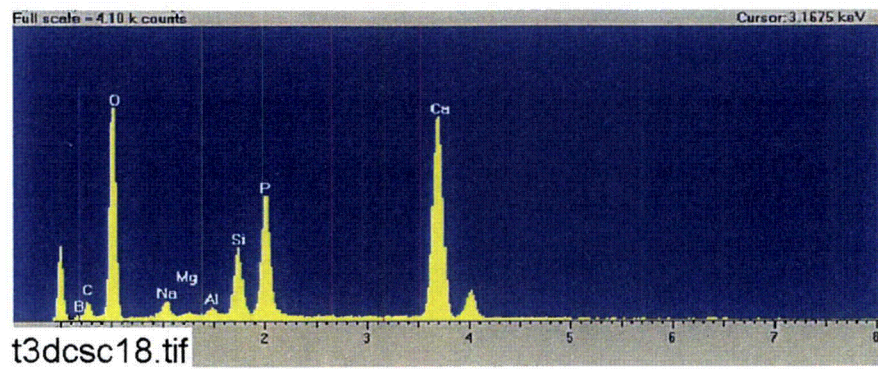
Figure C3-3. EDS counting spectrum for the particulate deposits shown in Figure C3-2. (t3dcsc18)

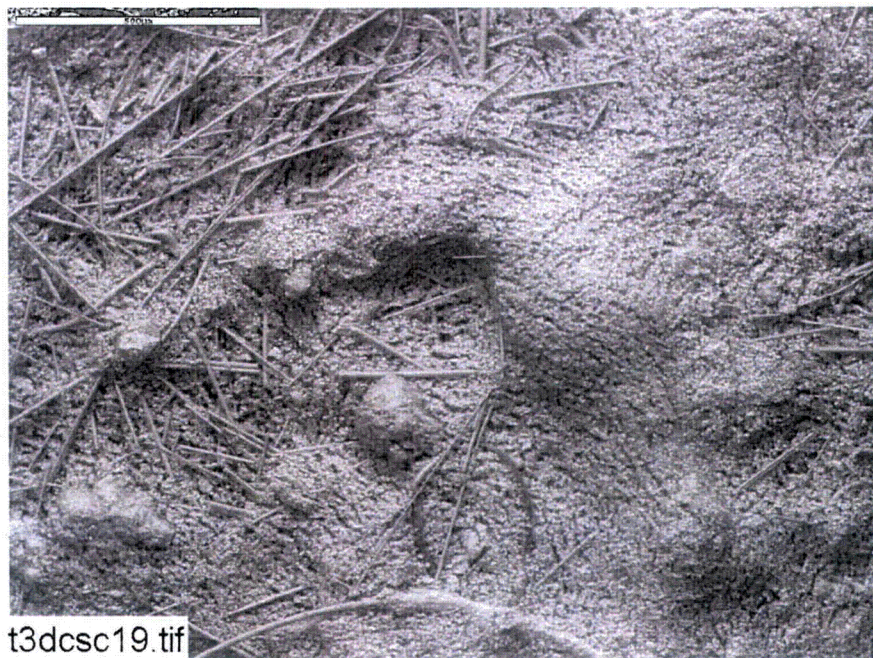
Figure C3-4. ESEM image magnified 70 times for a Test #3, Day-30 exterior fiberglass sample on the drain collar (adjacent to the drain screen). (t3dcsc19)

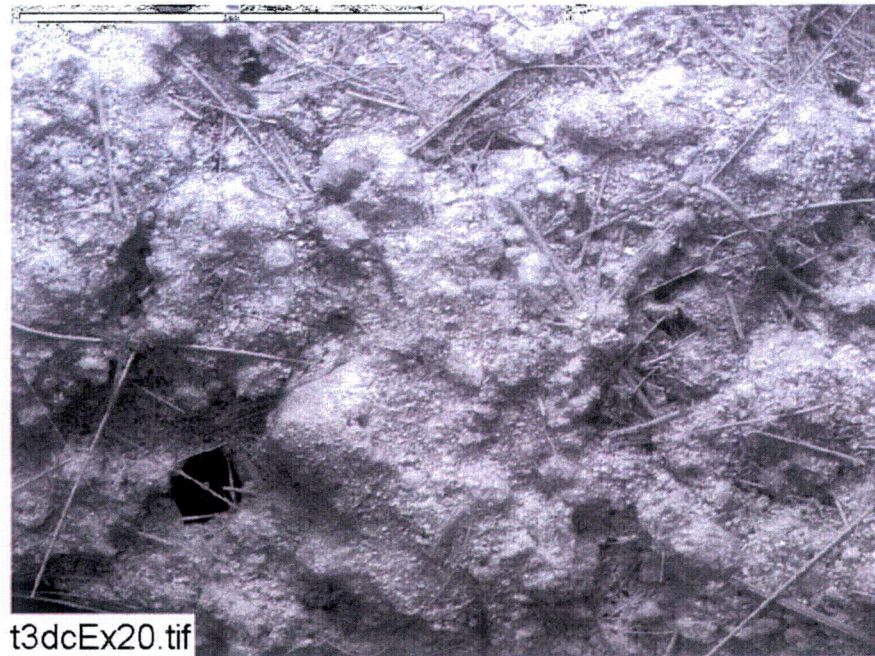
Figure C3-5. ESEM image magnified 70 times for a Test #3, Day-30 exterior fiberglass sample on the drain collar (away from the drain screen). (t3dcEx20)

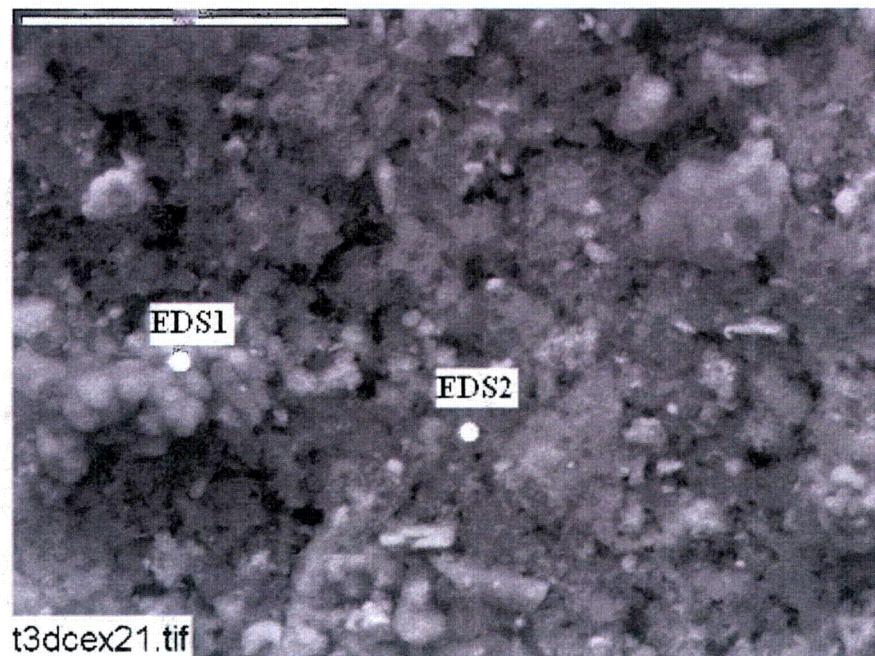
Figure C3-6. ESEM image magnified 1000 times for a Test #3, Day-30 exterior fiberglass sample on the drain collar (away from the drain screen). (t3dcex21)

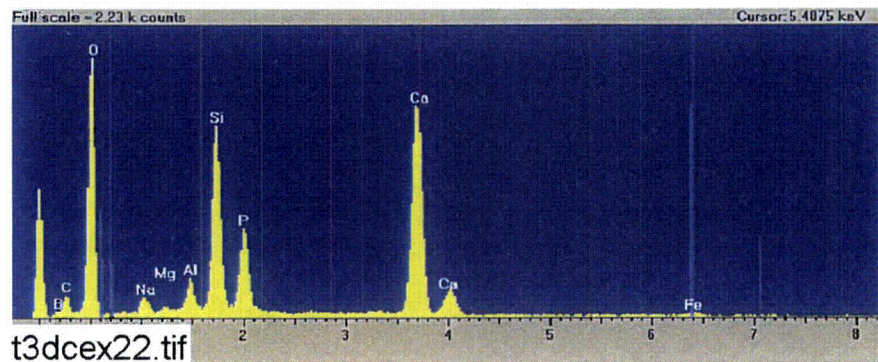
Figure C3-7. EDS counting spectrum for the light particulate deposits (EDS1) shown in Figure C3-6. (t3dcex22)

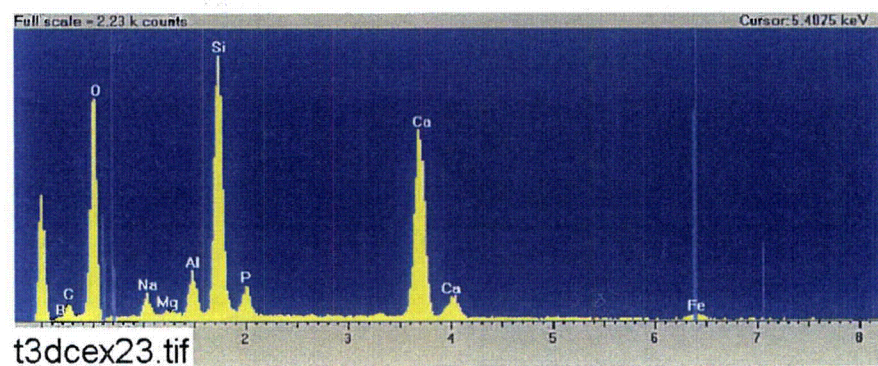
Figure C3-8. EDS counting spectrum for the dark deposits (EDS2) shown in Figure C3-6. (t3dcex23)

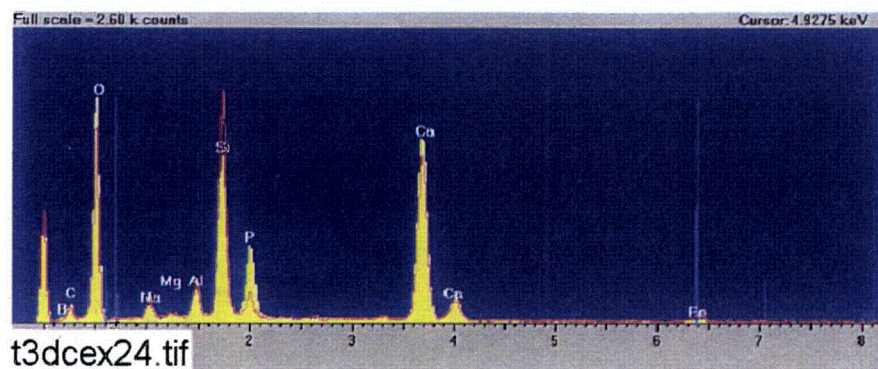
Figure C3-9. Comparison of EDS counting spectra between Figure C3-7 (yellow) and Figure C3-8 (red). (t3dcex24)

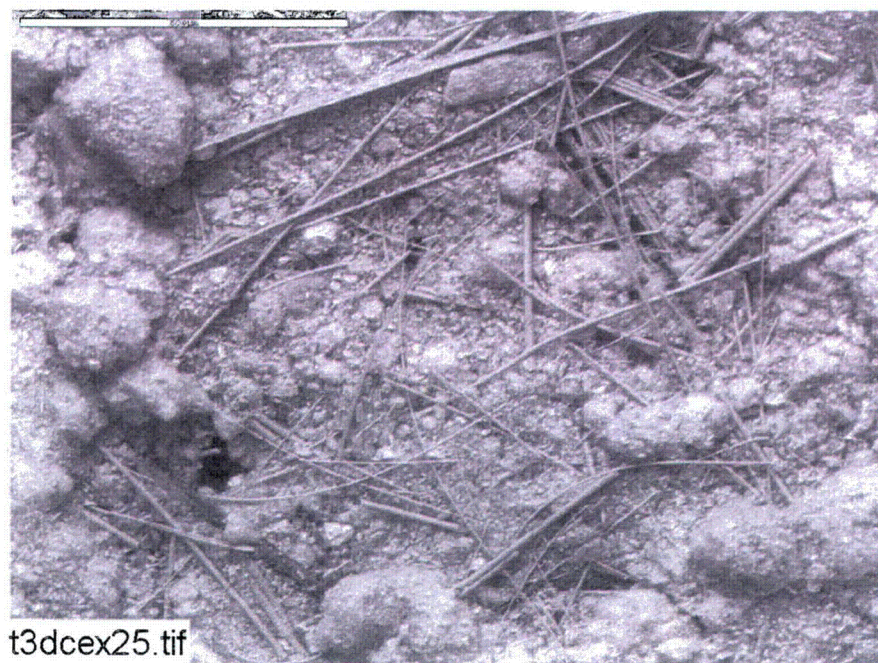
Figure C3-10. ESEM image magnified 100 times for a Test #3, Day-30 exterior fiberglass sample on the drain collar (away from the drain screen). (t3dcex25)

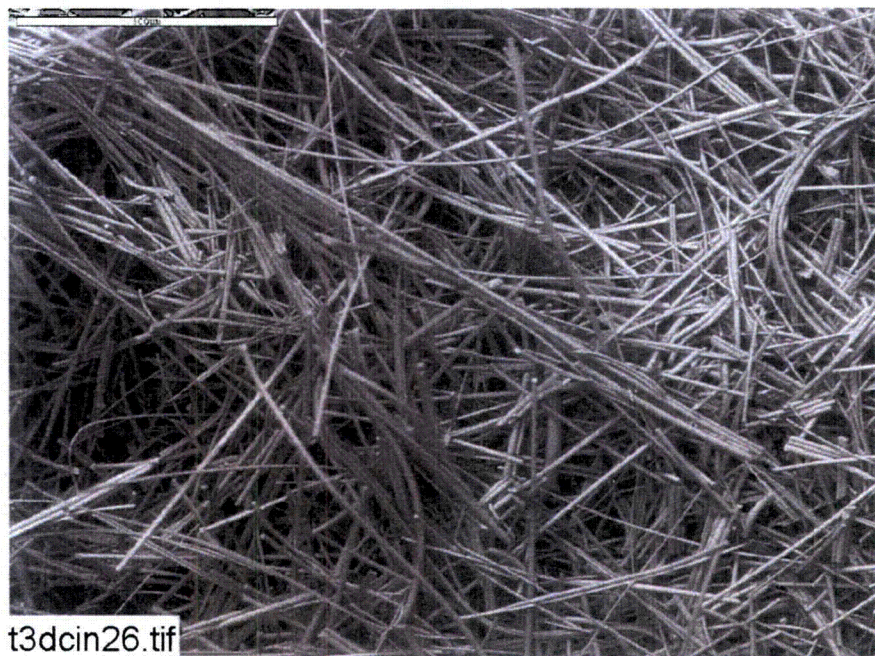
**Figure C3-11.** ESEM image magnified 80 times for a Test #3, Day-30 interior fiberglass sample on the drain collar. (t3dcin26)

Image:	t3dcin26	80 ×		Figure C3-11
	t3dcin27	1000 ×		Figure C3-12
	t3dcin28	100 ×		Figure C3-13

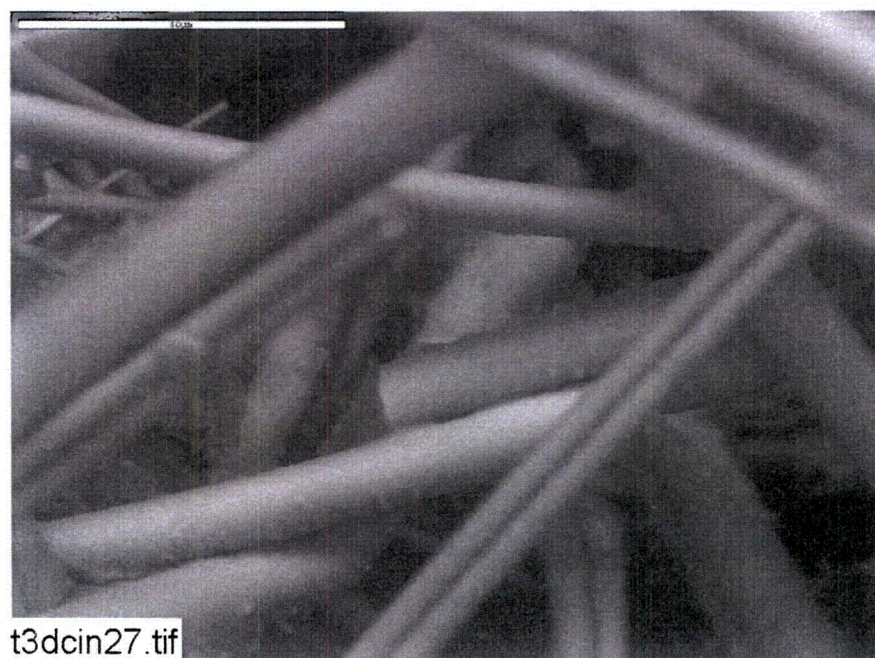
**Figure C3-12.** ESEM image magnified 1000 times for a Test #3, Day-30 interior fiberglass sample on the drain collar. (t3dcin27)

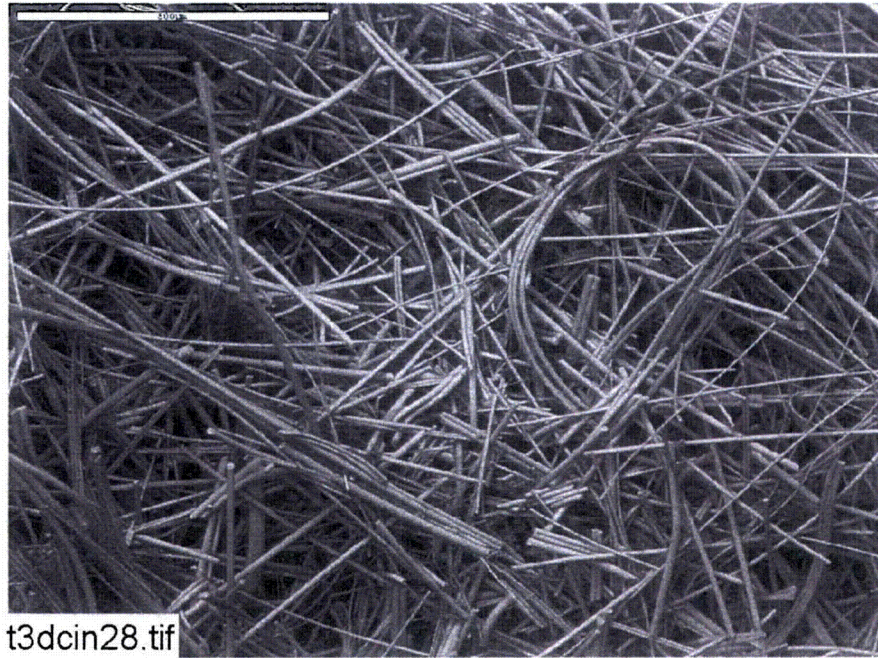
**Figure C3-13. ESEM image magnified 100 times for a Test #3, Day-30 interior fiberglass sample on the drain collar. (t3dcin28)**

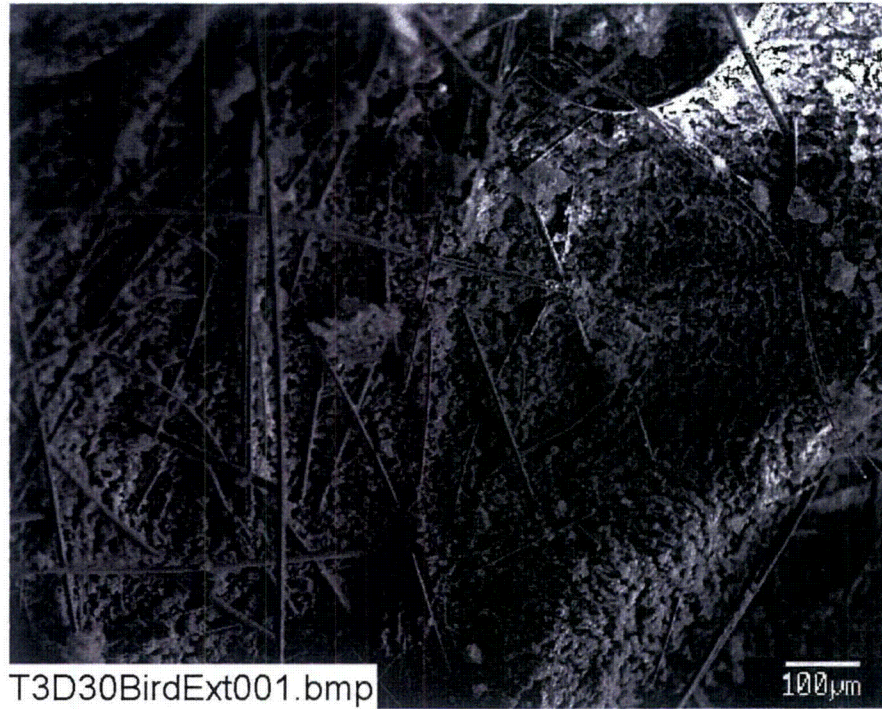
Figure C4-1. SEM image magnified 100 times for a Test #3, Day-30 exterior fiberglass sample within a birdcage. (T3D30BirdExt001)

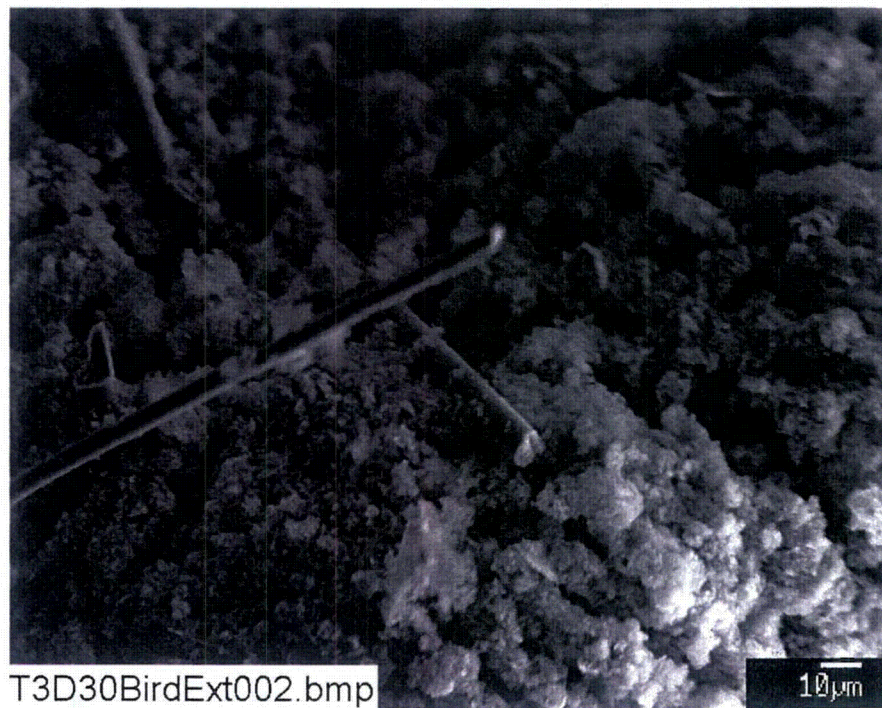
Figure C4-2. SEM image magnified 550 times for a Test #3, Day-30 exterior fiberglass sample within a birdcage. (T3D30BirdExt002)

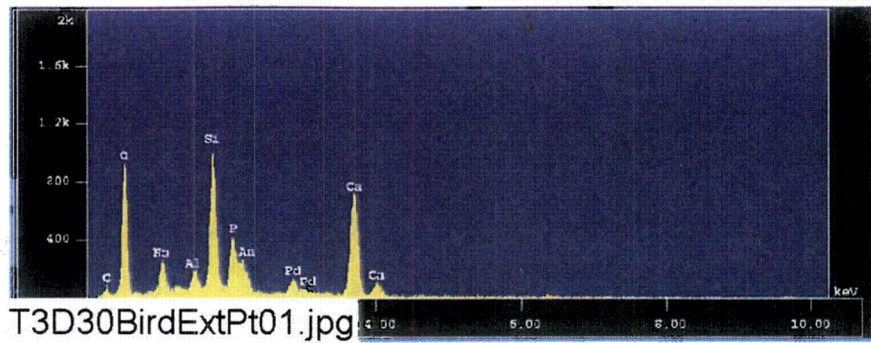
Figure C4-3. EDS counting spectrum for the large masses of particulate deposits shown in Figure C4-2. (T3D30BirdExtPt01)

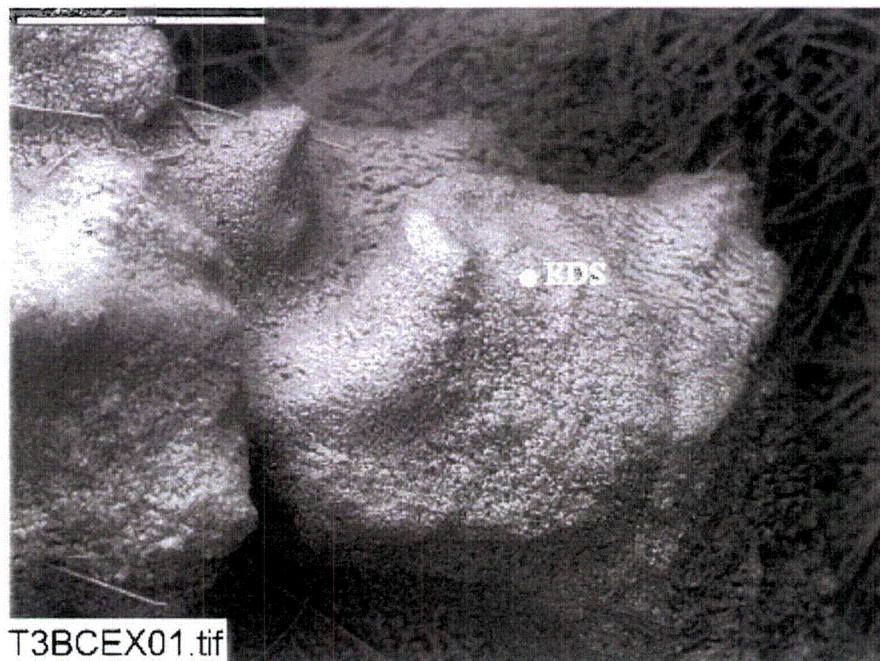
Figure C4-4. ESEM image magnified 80 times for a Test #3, Day-30 exterior fiberglass sample within a birdcage. (T3BCEX01)

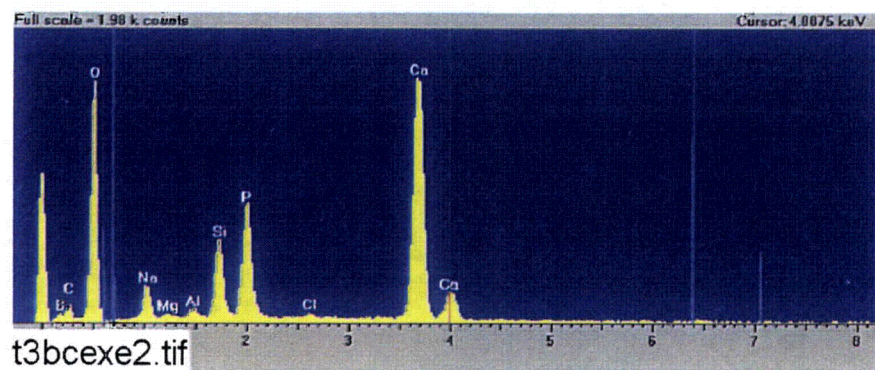
Figure C4-5. EDS counting spectrum for the the large deposits shown in Figure C4-4. (t3bcexe2)

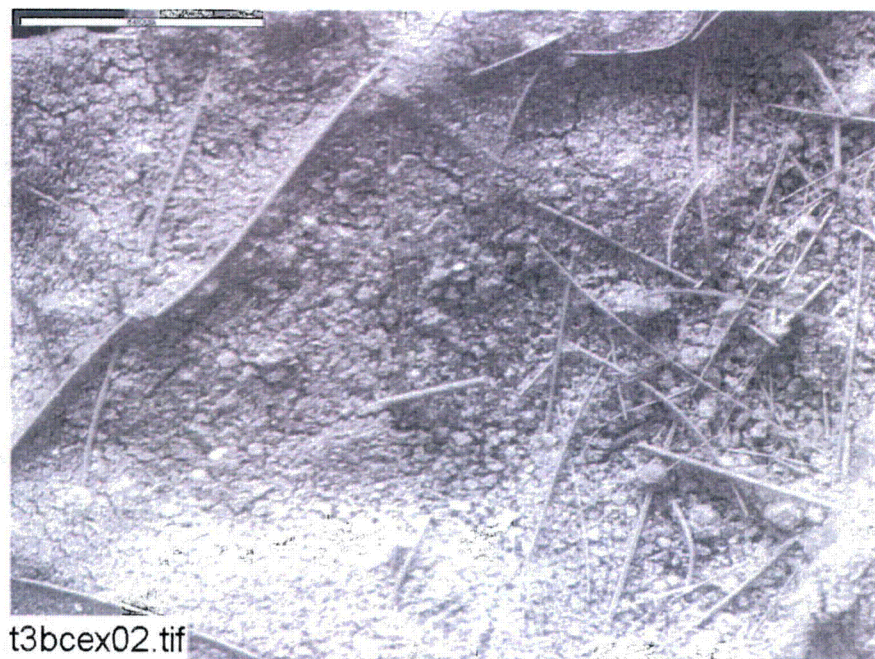
Figure C4-6. ESEM image magnified 80 times for a Test #3, Day-30 exterior fiberglass sample within a birdcage. (t3bcex02)
