#### 4. SUMMARY OF KEY OBSERVATIONS

**Appendix D. ESEM and SEM/EDS Data for Test #3 Day-30 Corrosion Products**

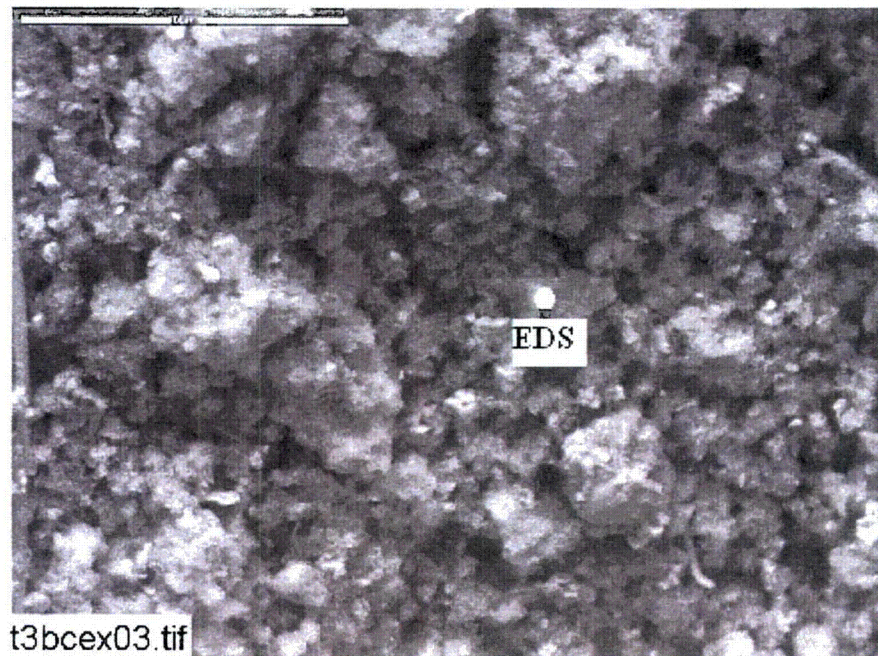
Figure C4-7. ESEM image magnified 500 times for a Test #3, Day-30 exterior fiberglass sample within a birdcage. (t3bcex03)

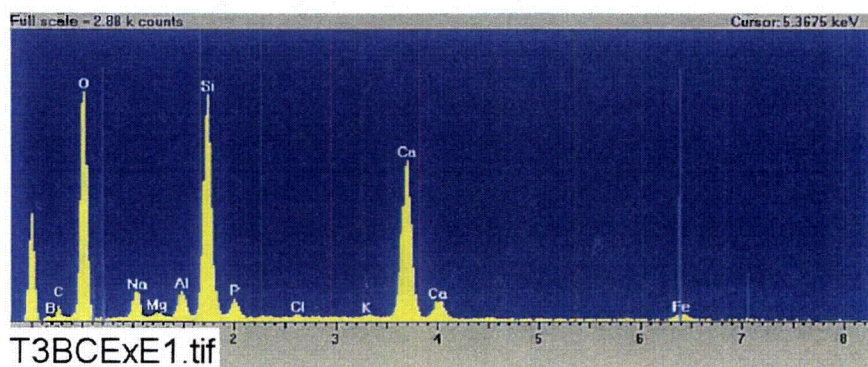
Figure C4-8. EDS counting spectrum for the deposits shown in Figure C4-7. (T3BCExE1)

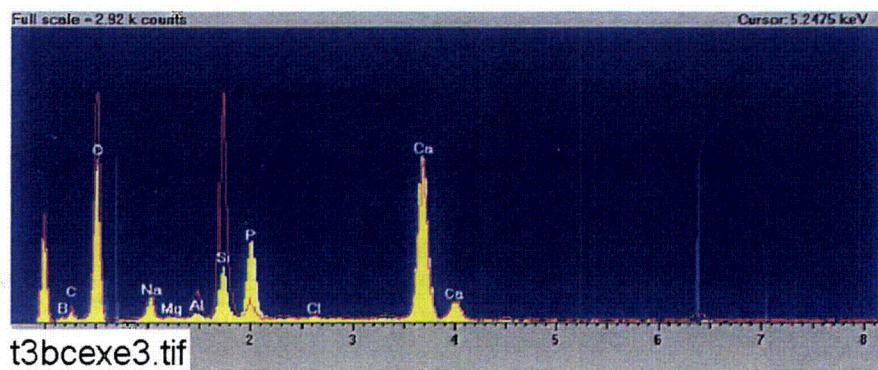
Figure C4-9. Comparison of EDS counting spectra of Figure C4-5 (yellow) and Figure C4-8 (red). (t3bcexe3)

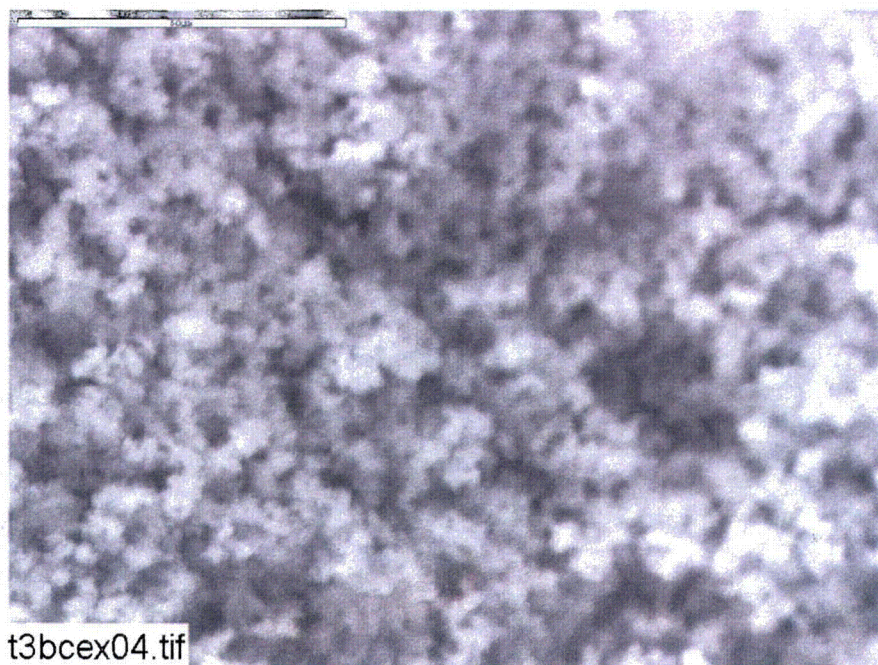
Figure C4-10. ESEM image magnified 1000 times for a Test #3, Day-30 exterior fiberglass sample within a birdcage. (t3bcex04)

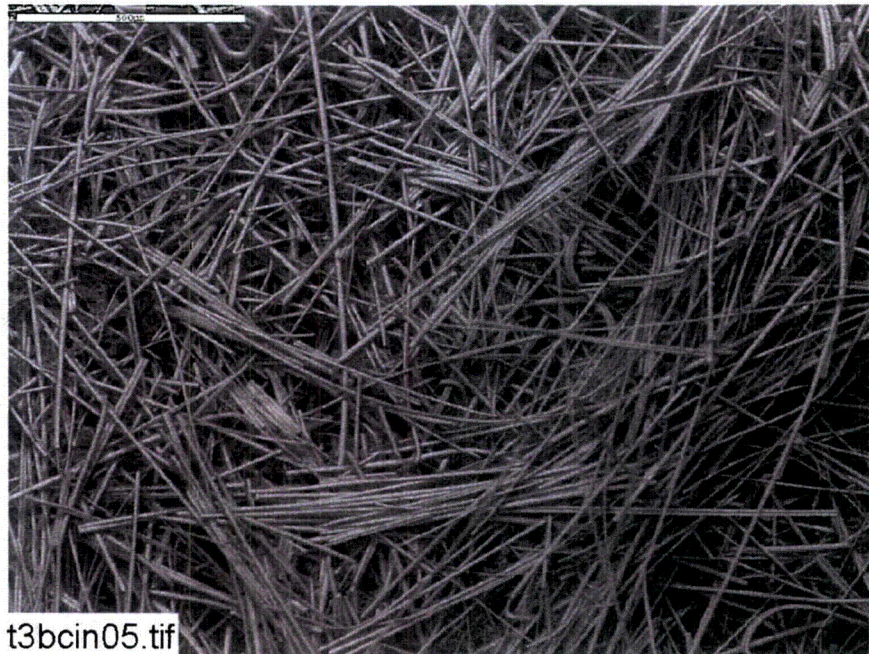
**Figure C4-11.** ESEM image magnified 80 times for a Test #3, Day-30 interior fiberglass sample within a birdcage. (t3bcin05)

Image:	t3bcin05	80 ×		Figure C4-11
	t3bcin06	950 ×		Figure C4-12
	t3bcin07	1000 ×		Figure C4-13

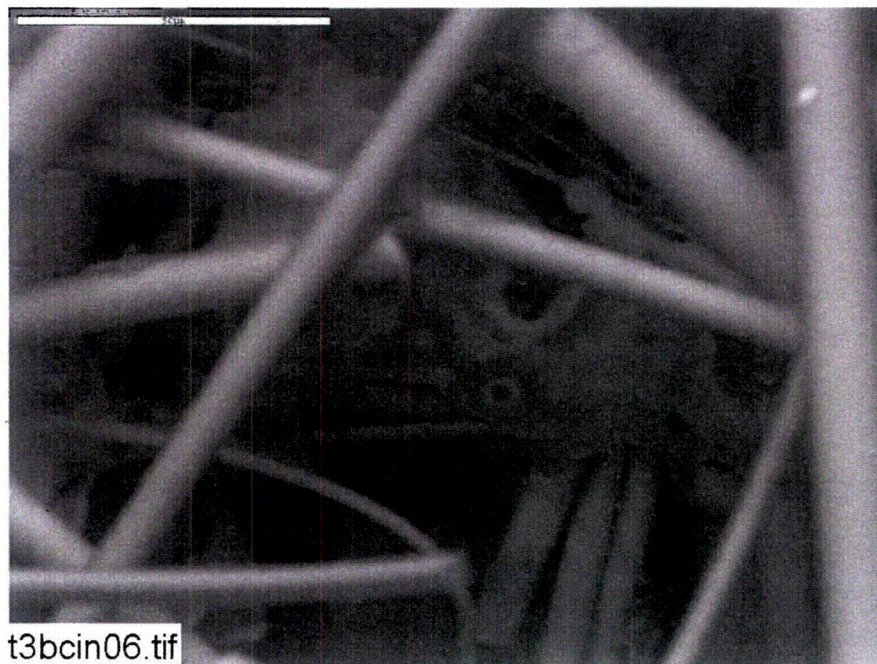
**Figure C4-12.** ESEM image magnified 950 times for a Test #3, Day-30 interior fiberglass sample within a birdcage. (t3bcin06)

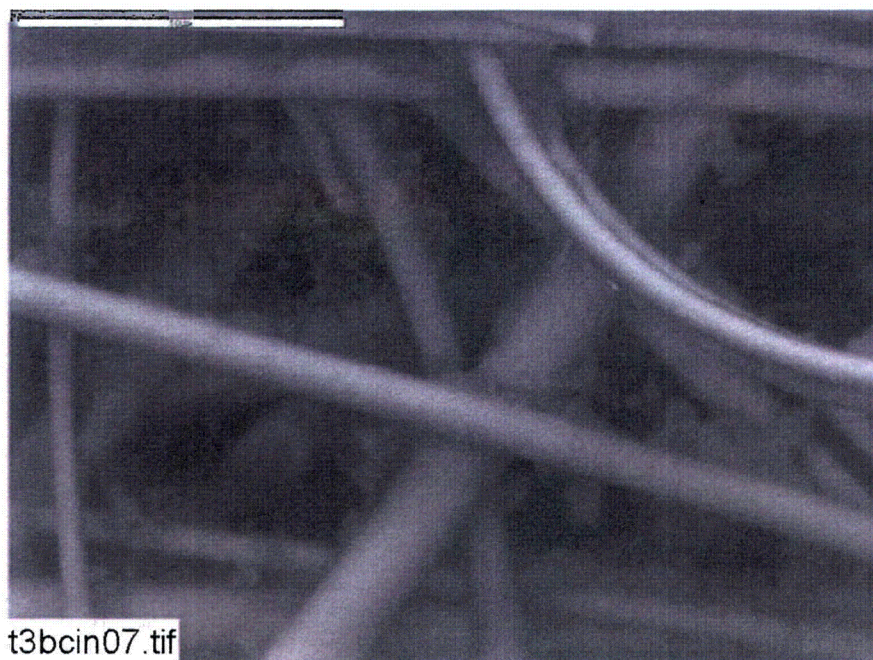
**Figure C4-13. ESEM image magnified 1000 times for a Test #3, Day-30 interior fiberglass sample within a birdcage. (t3bcin07)**

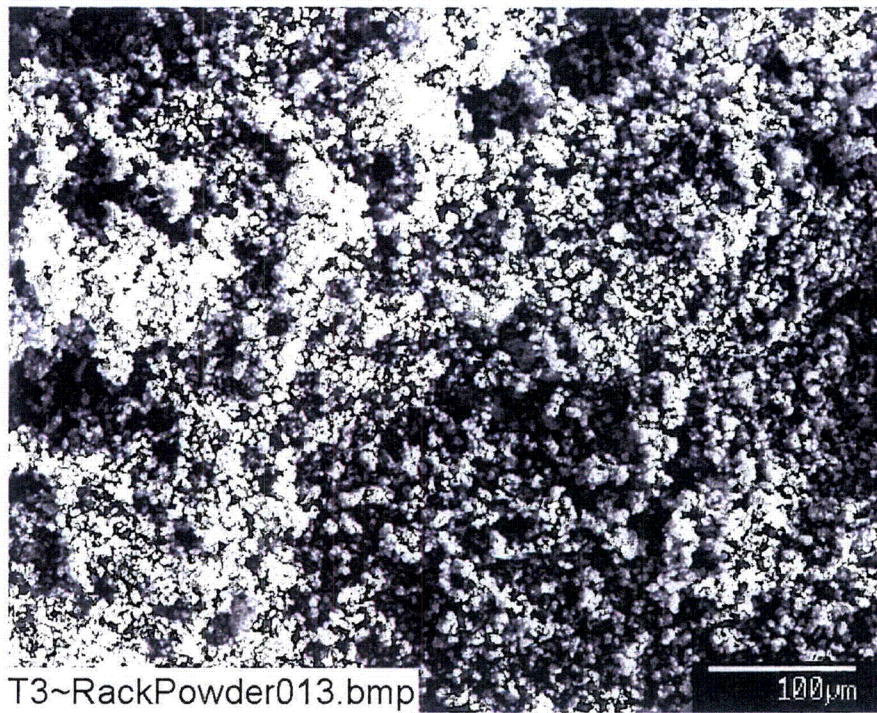
Figure D-1. SEM image magnified 200 times for a Test #3, Day-30 powder on the submerged rack. (T3~RackPowder013)

Image: T3~RackPowder013 200 ×

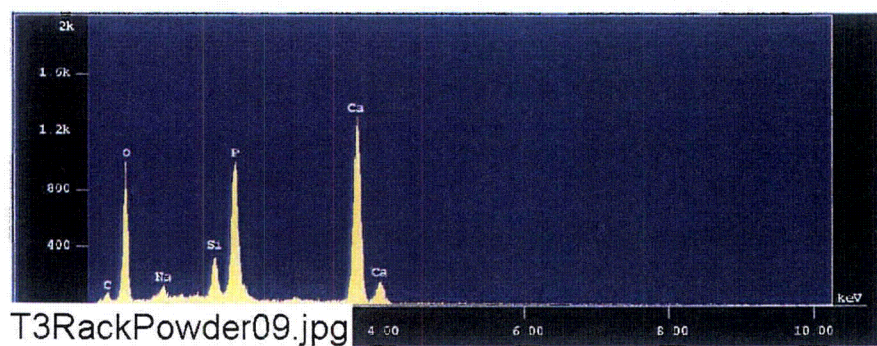
Figure D-2. EDS counting spectrum for the powder on the submerged rack shown in Figure D-1. (T3RackPowder09)

The results from the chemical composition analysis for T3RackPowder09 are given in Table D-1.

Element	Mass%	Atomic%	ZAF	Z	A	F
O	48.147	67.3988	1.8951	0.9734	1.9469	1.0000
Na	0.977	0.9516	1.5243	1.0269	1.4843	1.0000
Si	3.302	2.6332	1.1493	0.9767	1.1837	0.9941
P	13.197	9.5423	0.8517	1.1722	0.7283	0.9977
Ca	34.174	19.0962	0.9909	0.9956	0.9953	1.0000
C	0.203	0.3778	3.7963	1.0208	3.7192	0.9999

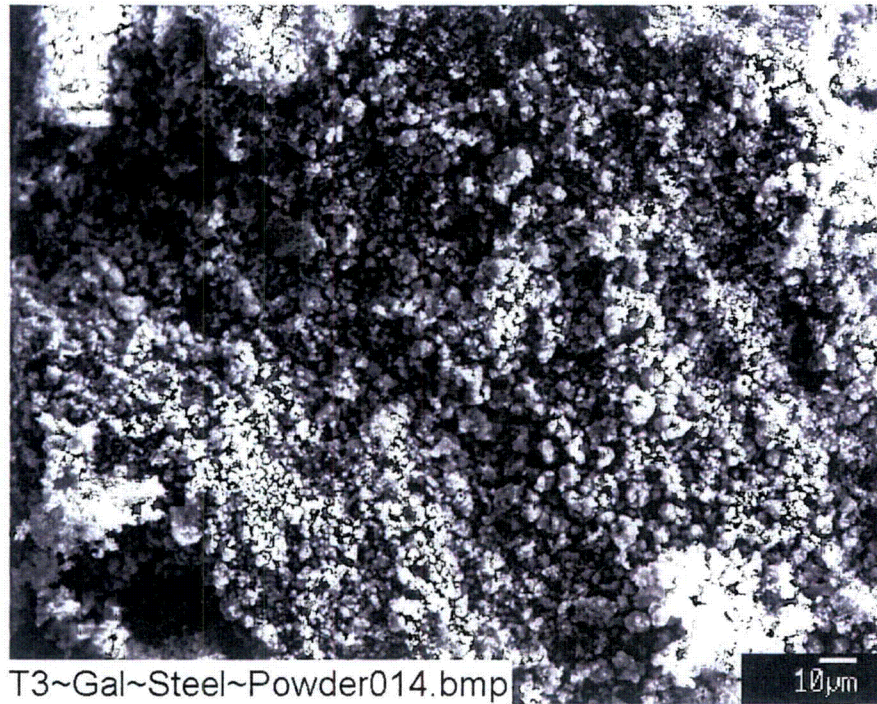
Figure D-3. SEM image magnified 500 times for a Test #3, Day-30 powder on a submerged galvanized steel coupon. (T3~Gal~Steel~Powder014)

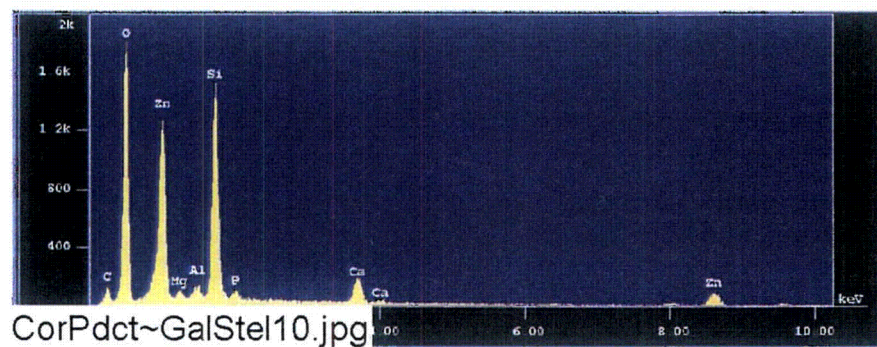
Figure D-4. EDS counting spectrum for the white powder on galvanized steel shown in Figure D-3. (CorPdct~GalStel10)

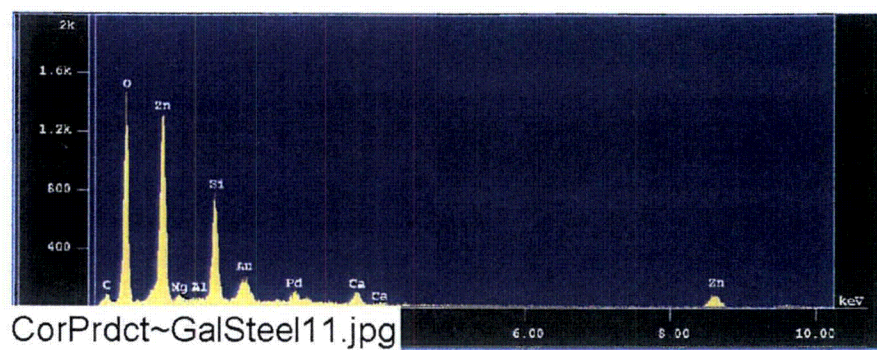
Figure D-5. EDS counting spectrum for the dark powder on galvanized steel shown in Figure D-3. (CorPrdct~GalSteel11)

The results from the chemical composition analysis for CorPrdct~GalSteel11 are given in Table D-2.

Element	Mass%	Atomic%	ZAF	Z	A	F
O	47.383	72.4077	0.9119	0.9354	0.9750	1.0000
Mg	0.655	0.6591	2.3126	0.9284	2.4928	0.9993
Si	13.143	11.4404	1.4344	0.9377	1.5298	0.9999
Ca	3.059	1.8657	0.9770	0.9542	1.0247	0.9991
Zn	35.285	13.1966	1.2102	1.2129	0.9978	1.0000
Al	0.475	0.4304	1.7897	0.9594	1.8692	0.9979
C	0.000	0.0000	5.2279	0.9811	5.3287	1.0000

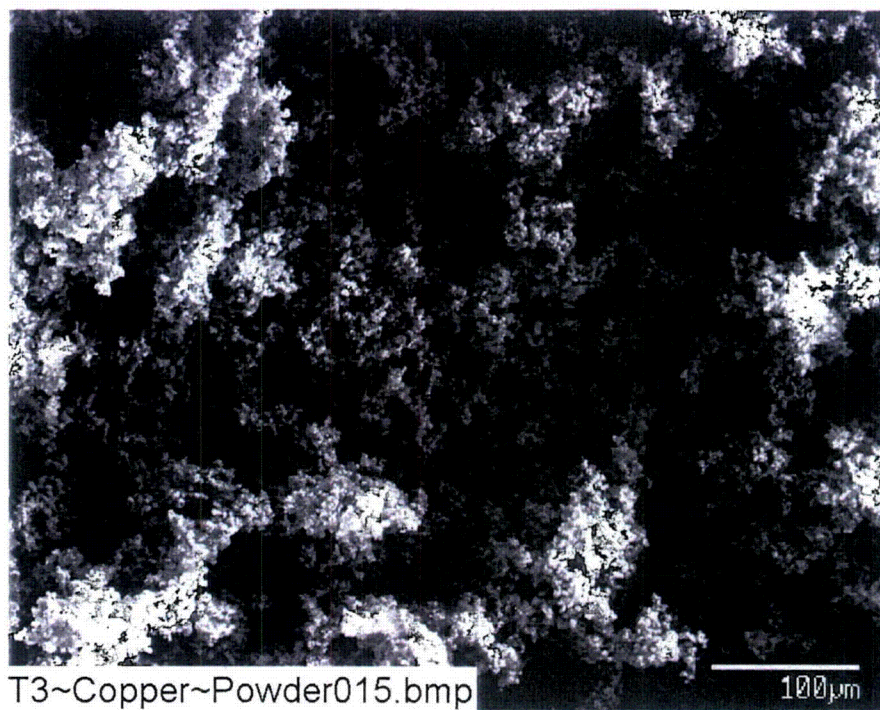
Figure D-6. SEM image magnified 500 times for a Test #3, Day-30 powder on a submerged copper coupon. (T3~Copper~Powder015)

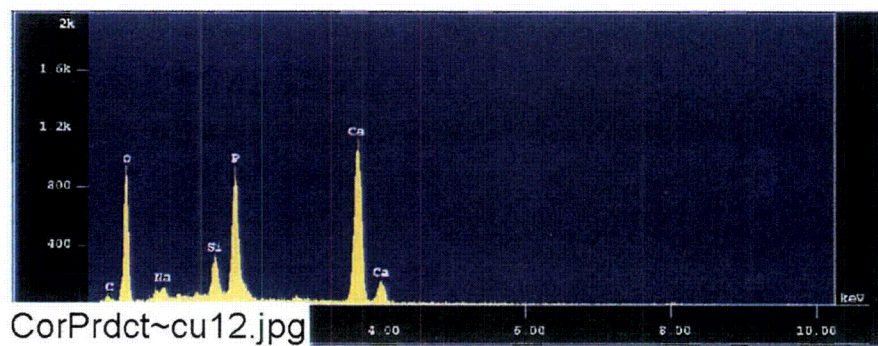
Figure D-7. EDS counting spectrum for the powder on copper shown in Figure D-6. (CorPrdct~cu12)

The results from the chemical composition analysis for CorPrdct~cu12 are given in Table D-3.

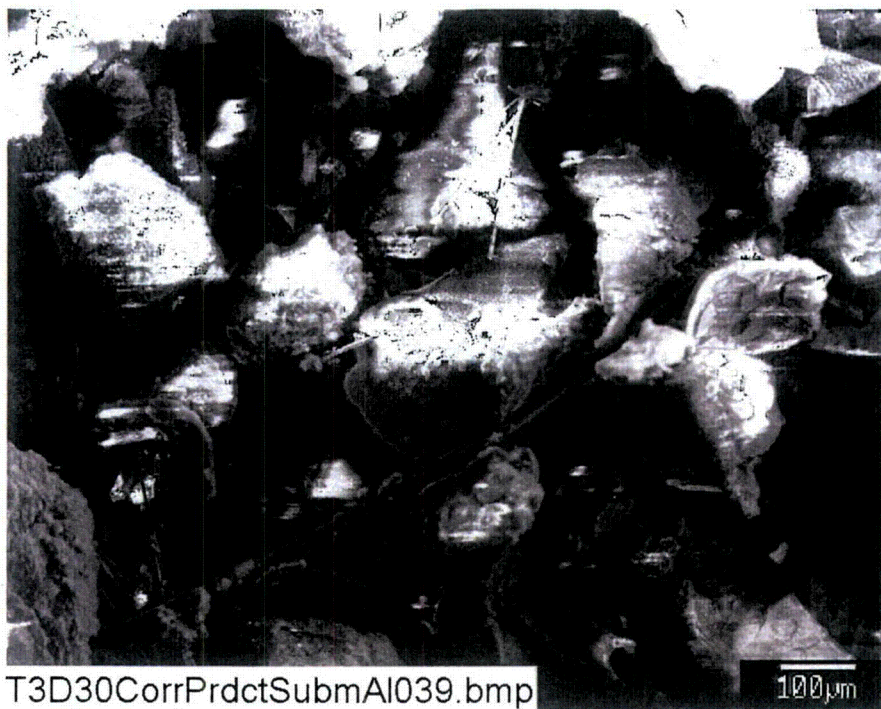
**Figure D-8.** SEM image magnified 100 times for Test #3, Day-30 corrosion products on a submerged aluminum coupon. (T3D30CorrPrdctSubmAl039)

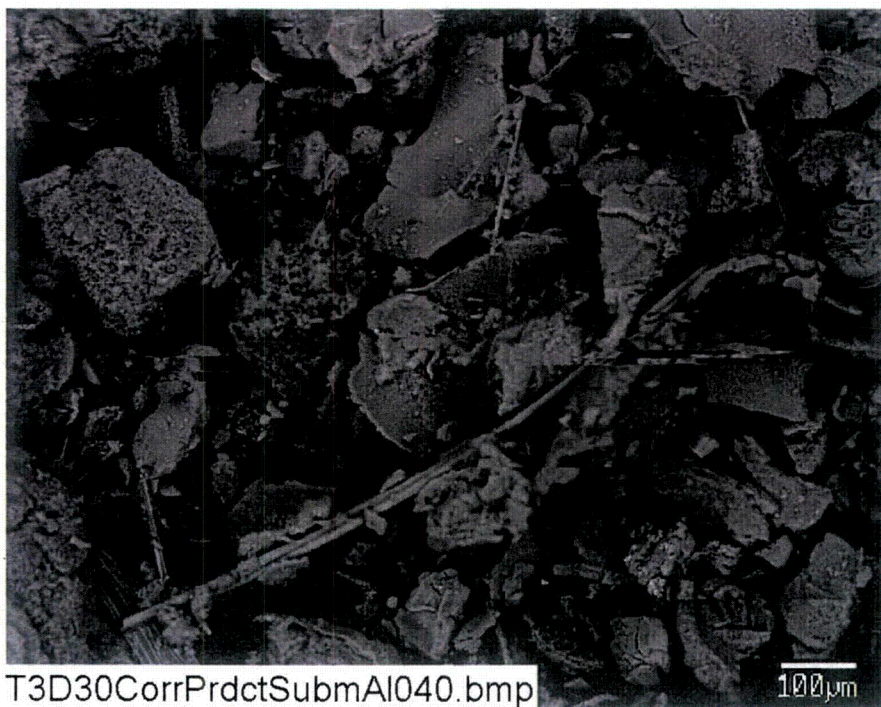
**Figure D-9.** Backscattered SEM image magnified 100 times for Test #3, Day-30 corrosion products on a submerged aluminum coupon. (T3D30CorrPrdct SubmAl040)

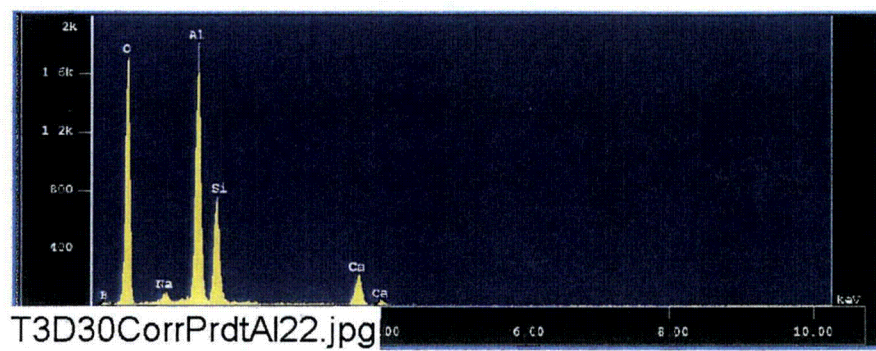
**Figure D-10.** EDS counting spectrum for the corrosion products (particles) shown in Figure D-9. (T3D30CorrPrdtAl22)

The results from the chemical composition analysis for T3D30CorrPrdtAl22 are given in Table D-4.

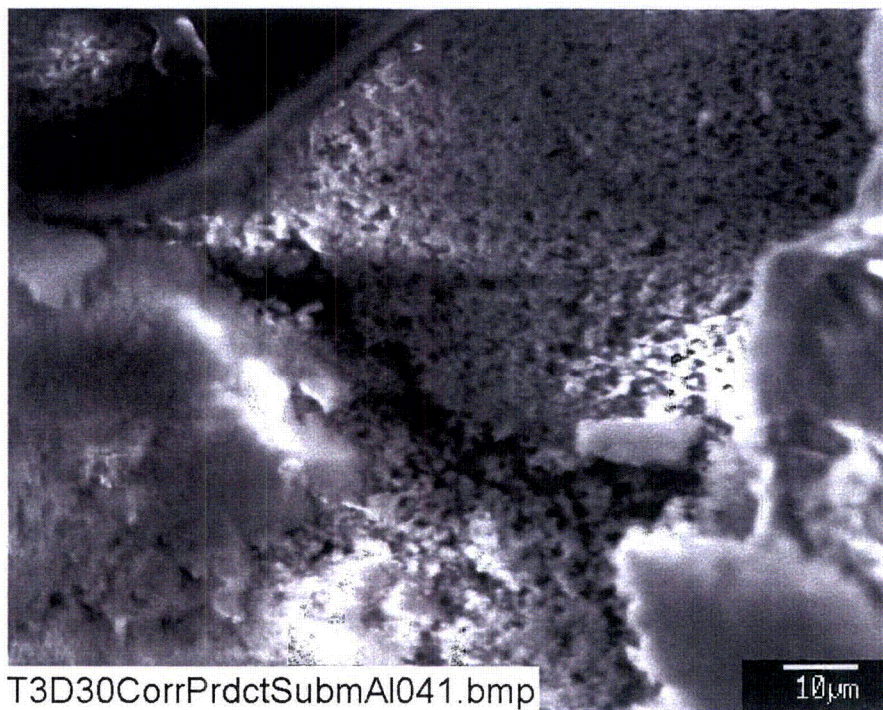
Figure D-11. SEM image magnified 1000 times for Test #3, Day-30 corrosion products on a submerged aluminum coupon. (T3D30CorrPrdctSubmAl041)

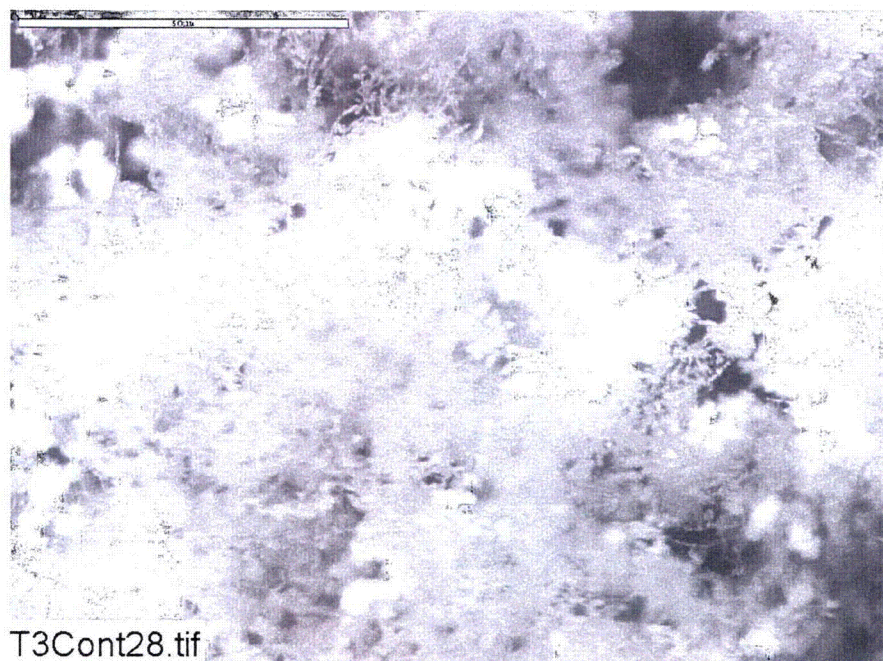
Figure D-12. ESEM image magnified 1000 times for Test #3, Day-30 corrosion products on a submerged concrete coupon. (T3cont28)

Image:	T3Cont28	1000 ×		Figure D-12
	t3cont29	100 ×		Figure D-13
EDS:	t3cont30		Particles on image 29	Figure D-14

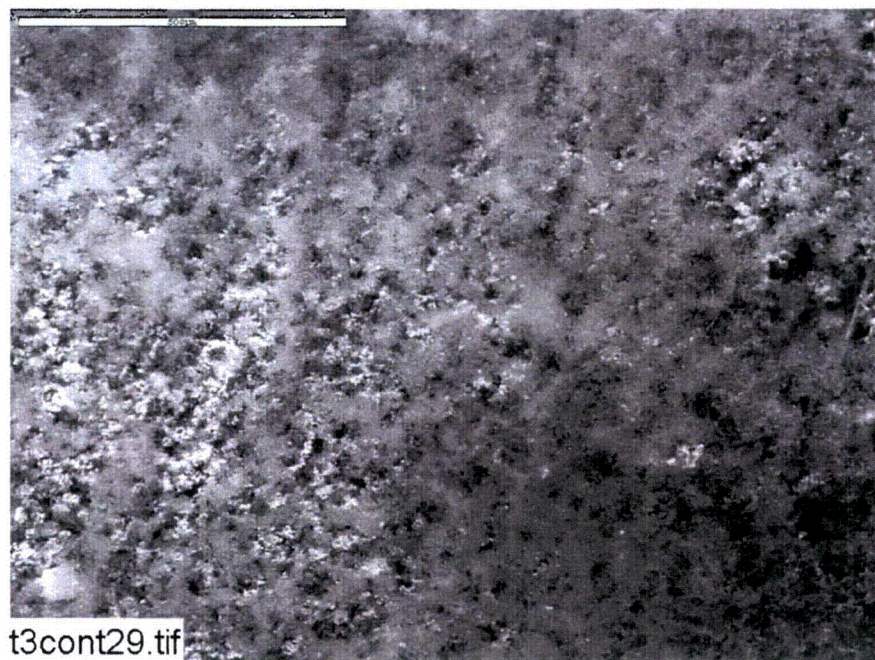
Figure D-13. ESEM image magnified 100 times for Test #3, Day-30 corrosion products on a submerged concrete coupon. (t3cont29)

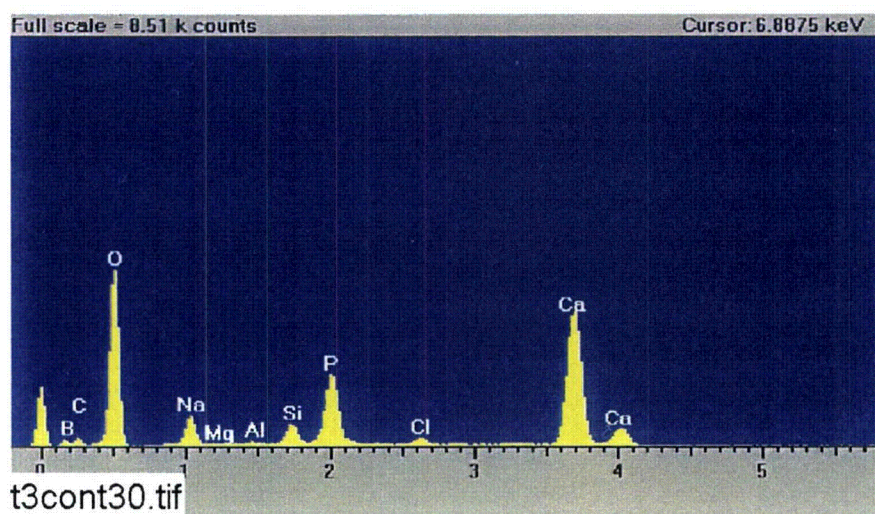
Figure D-14. EDS counting spectrum for the corrosion products (particles) shown in Figure D-13. (t3cont30)
