Enclosed please find, per your request today, a complete, redacted version of New England Coalition's July 16, 2007 filing, " Opposition to Entergy's Motion for Summary Disposition of NEC's Contention 4 (Flow-Accelerated Corrosion)." Please contact me if you need anything further.

## VY Piping FAC Inspection Program PP 7028 - 2007 Refueling Outage

VERMONT YANKEE PIPING EROSION-CORROSION INSPECTION PROGRAM

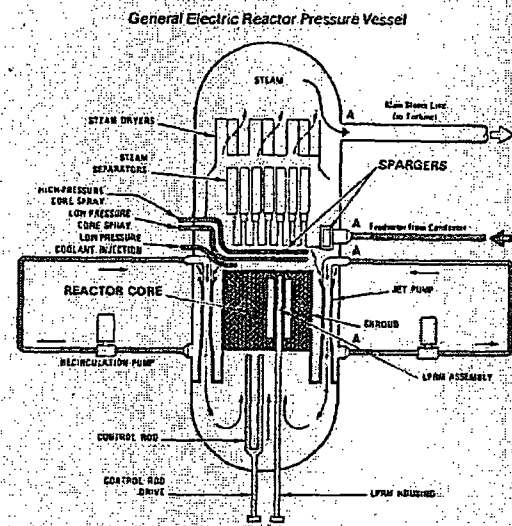
As shown in the graphic, control rods enter the BWR reactor core from below. The control rods function as brakes for the nuclear engine. Withdrawing control rods allows the nuclear reactor to increase power. Inserting control rods reduces the reactor's power and can stop it completely.

Each of the 137 control rods at Cooper is a hydraulic piston. Water pressure is used to move the control rod. Water is supplied below the control rod piston and vented from above it in order to insert the control rod into the reactor core. Conversely, water is supplied above the piston and vented from below in order to withdraw the control rod. Four directional control valves (numbered 120, 121, 122, and 123 in the schematic) sequence open and closed to insert and withdraw a control rod under normal operation. To rapidly shut down (called 'scram') the reactor, the scram inlet and scram outlet valves open to apply maximum differential pressure across the piston to cause it to fully insert within 5 seconds.

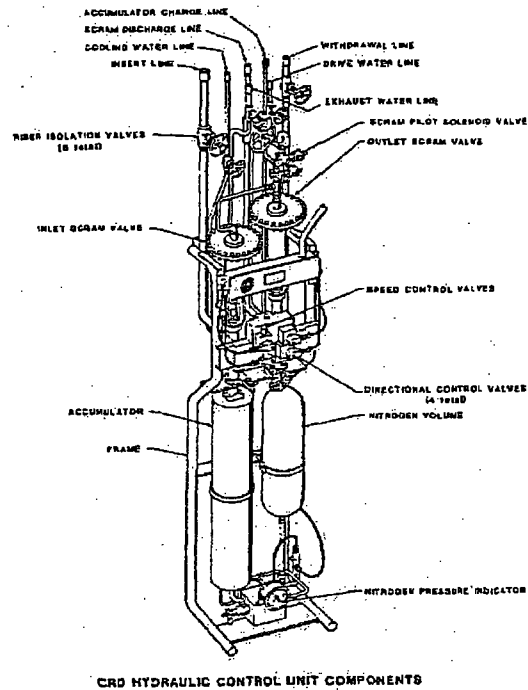
CRD HYDRAULIC CONTROL UNIT COMPONENTS

In order to safely replace the four directional control valves on each of the three control rods, workers fully inserted the control rods and then manually closed the isolation valves (shown as the vertical "bow-ties" in the schematic between the directional control valves and the control rod drive mechanism at bottom center). Workers reported a small amount of water leaking from the withdraw directional control valve (numbered 122) for control rod 26-27. The water was coming from the reactor vessel getting past the closed isolation valves and leaking from directional control valve 122. The four directional control valves, including 122, appear in the mid-section of the control rod drive hydraulic control unit shown on the right. The leak got bigger until a steam plume was visible. (The water inside the reactor vessel is maintained under nearly 1,000 pounds per square inch pressure. When it leaks into the atmospheric pressure of the reactor building, it flashes to steam like the plume from a teapot.) Reactor water leaking from the valve contained radioactivity and created an airborne radiation hazard. The control room supervisor ordered the reactor building to be evacuated as a precaution.
