NUREG-1841

U.S. Operating Experience With Thermally Treated Alloy 690 Steam Generator Tubes

**U.S. Nuclear Regulatory Commission
Office of Nuclear Reactor Regulation
Washington, DC 20555-0001**

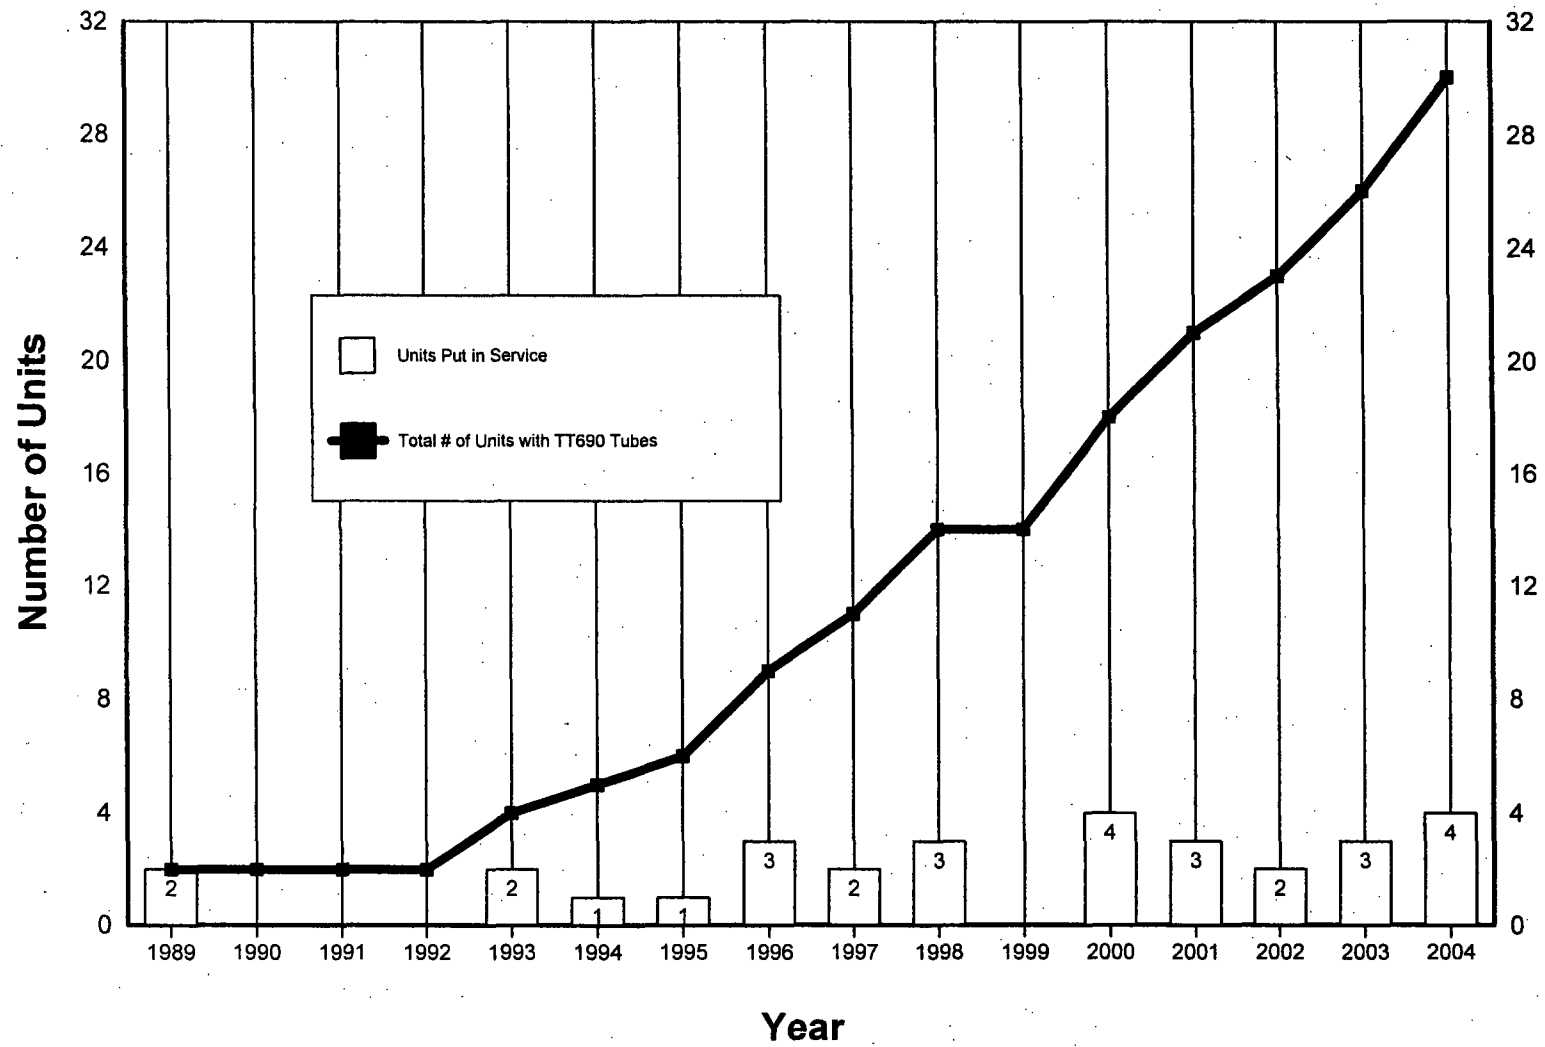
Figure 2-1: Number of Units with Thermally Treated Alloy 690 Tubes per Year

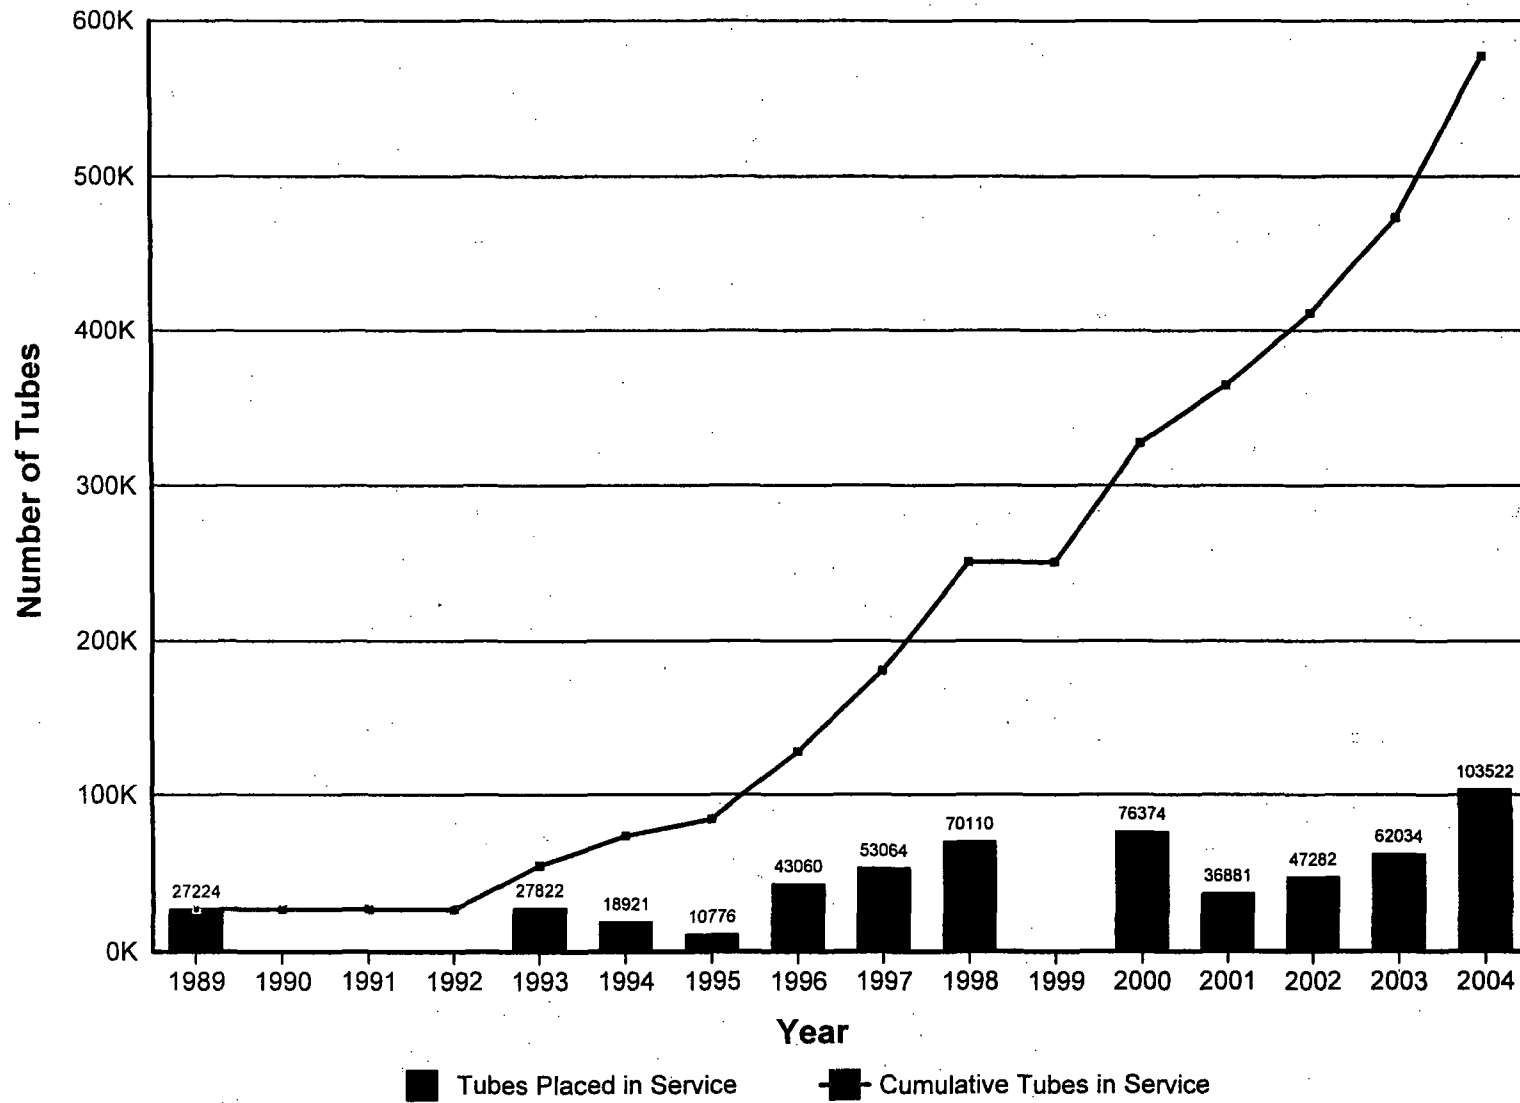
Figure 2-2: Number of Thermally Treated Alloy 690 Tubes in Service per Year

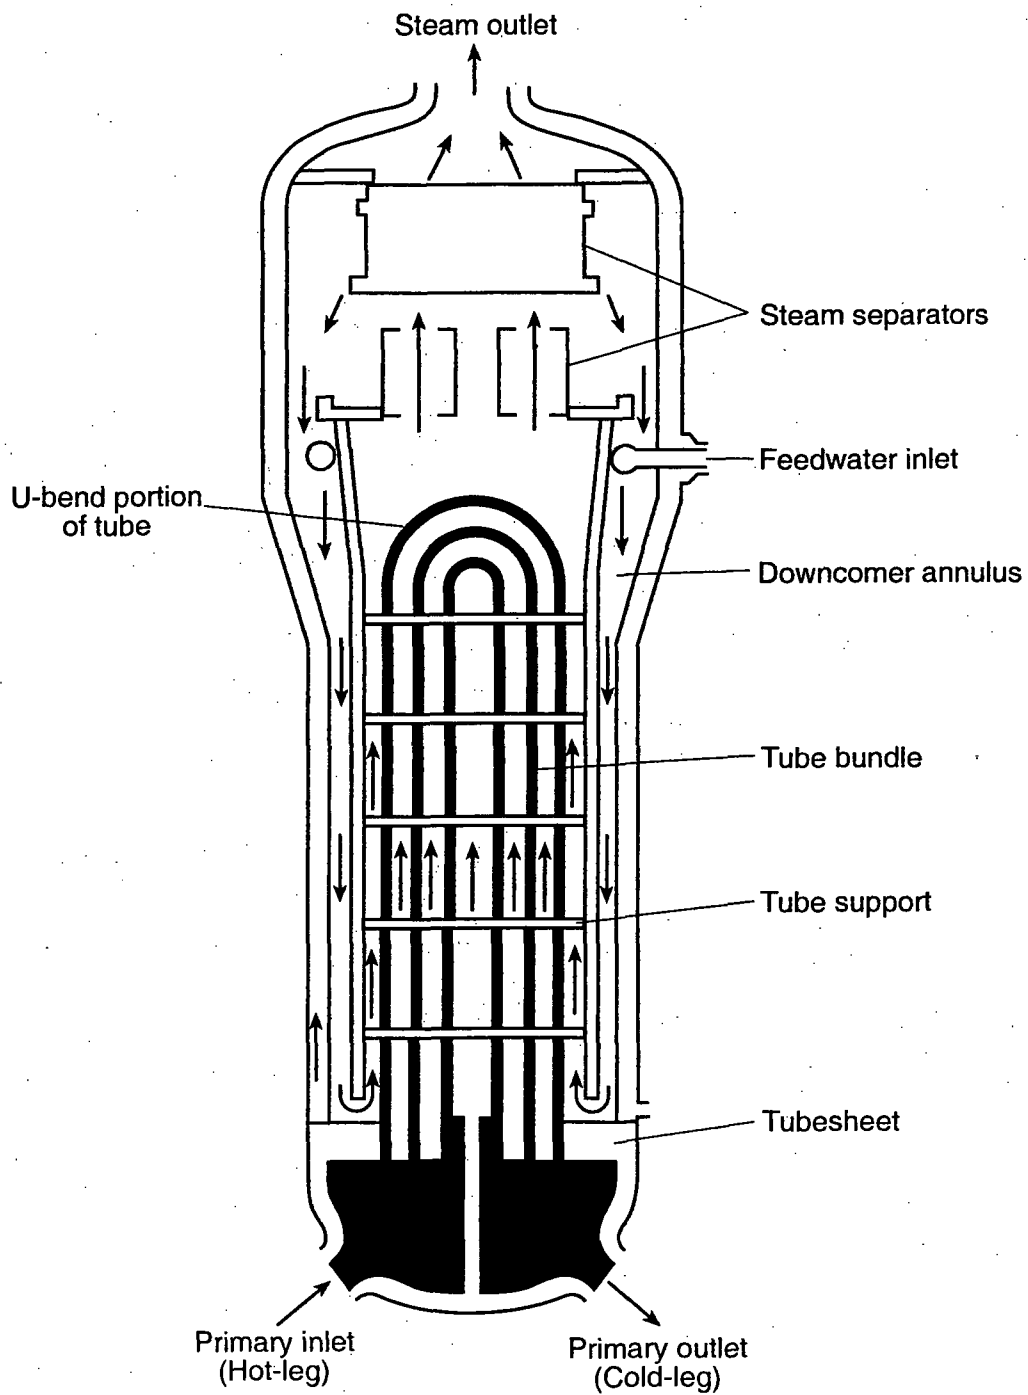
Figure 2-5: Pressurized-Water Reactor Recirculating Steam Generator

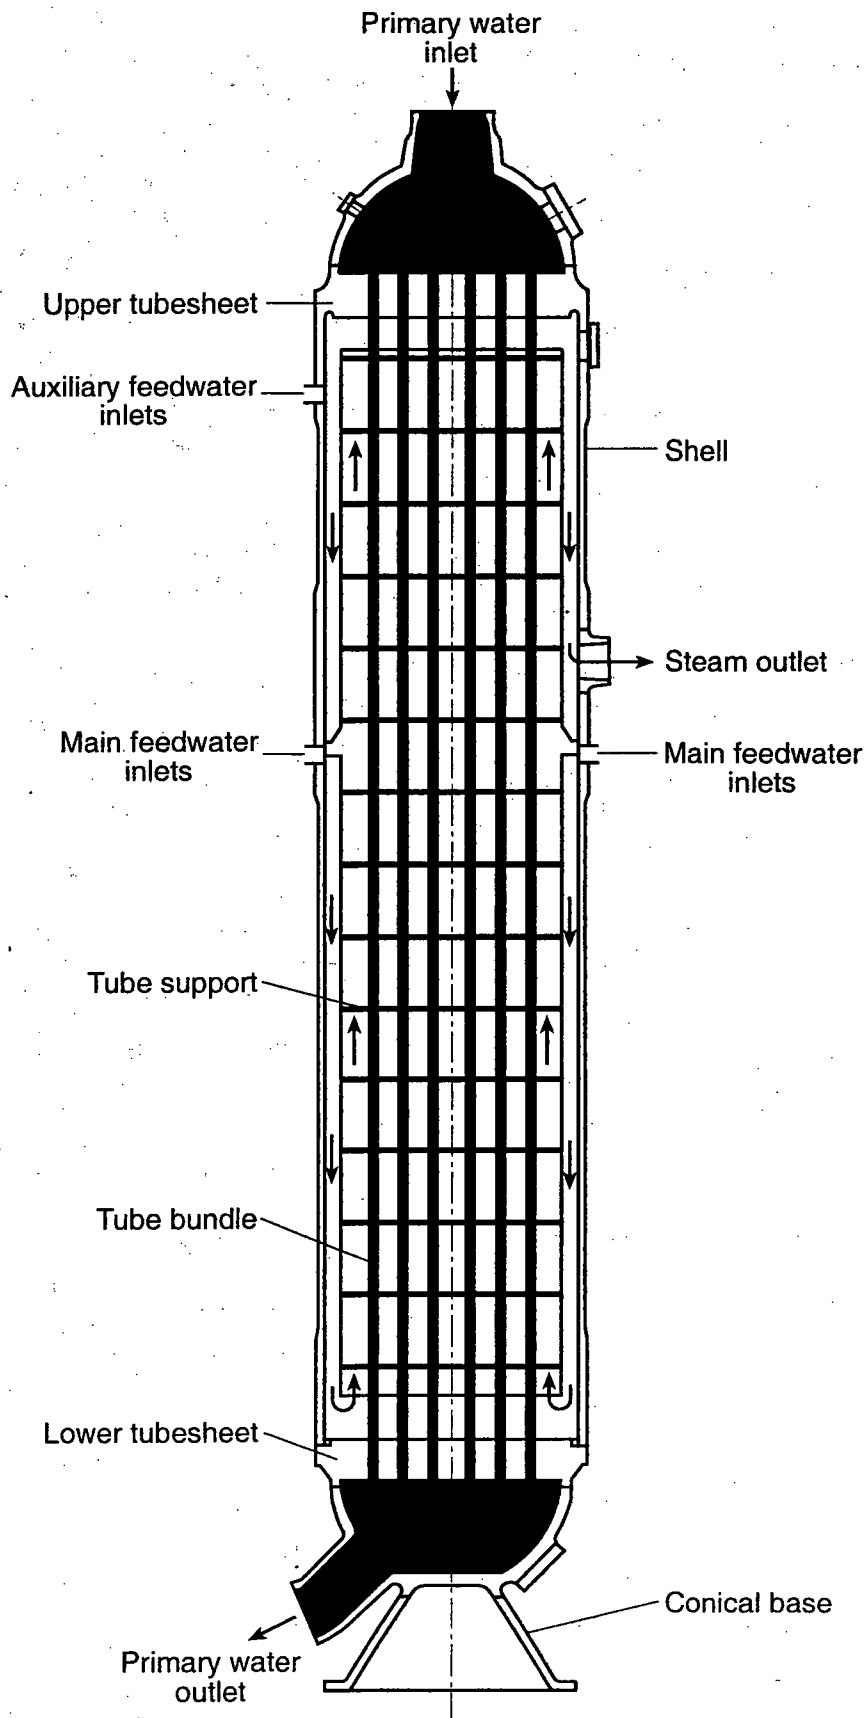
Figure 2-6: Pressurized-Water Reactor Once-Through Steam Generator

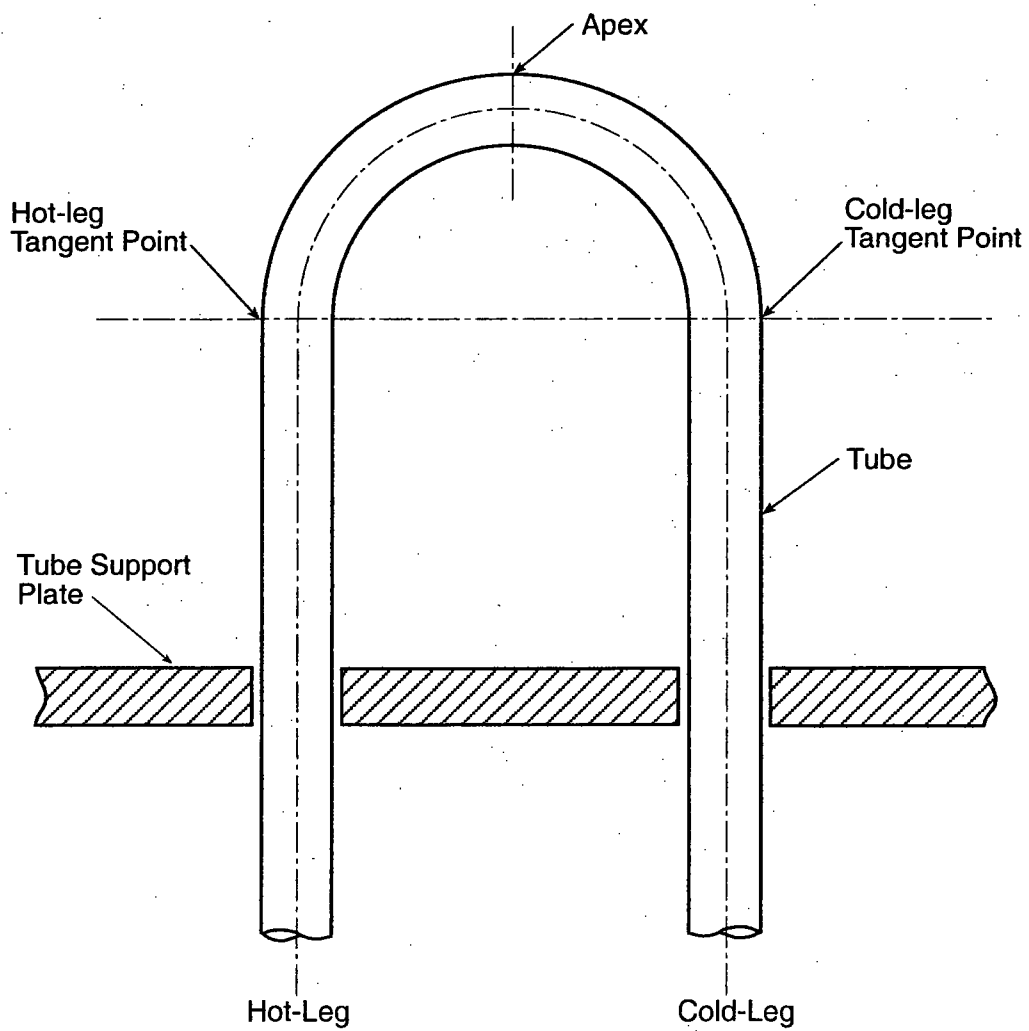
Figure 2-7: U-Bend Features

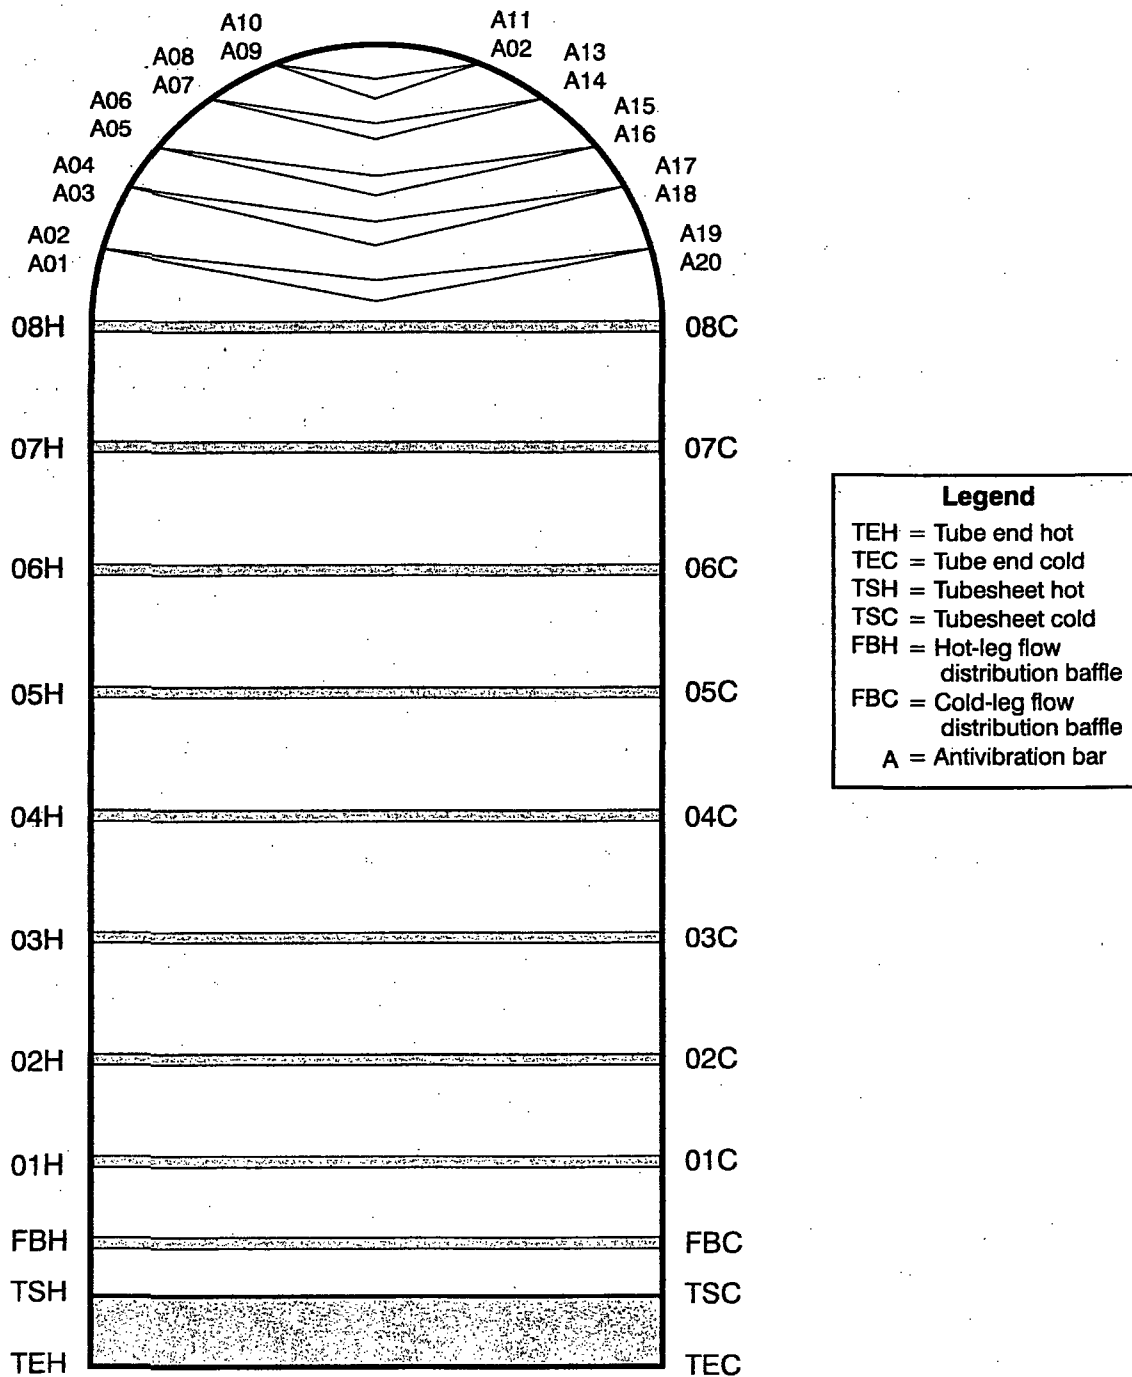
Figure 2-8: Tube Support Naming Convention at ANO Units 2

ANO 2 has two recirculating steam generators which were designed by Westinghouse and fabricated at ENSA. The steam generators went into service in 2000 during refueling outage (RFO) 14. The licensee numbers its tube supports as depicted in Figure 2-8.

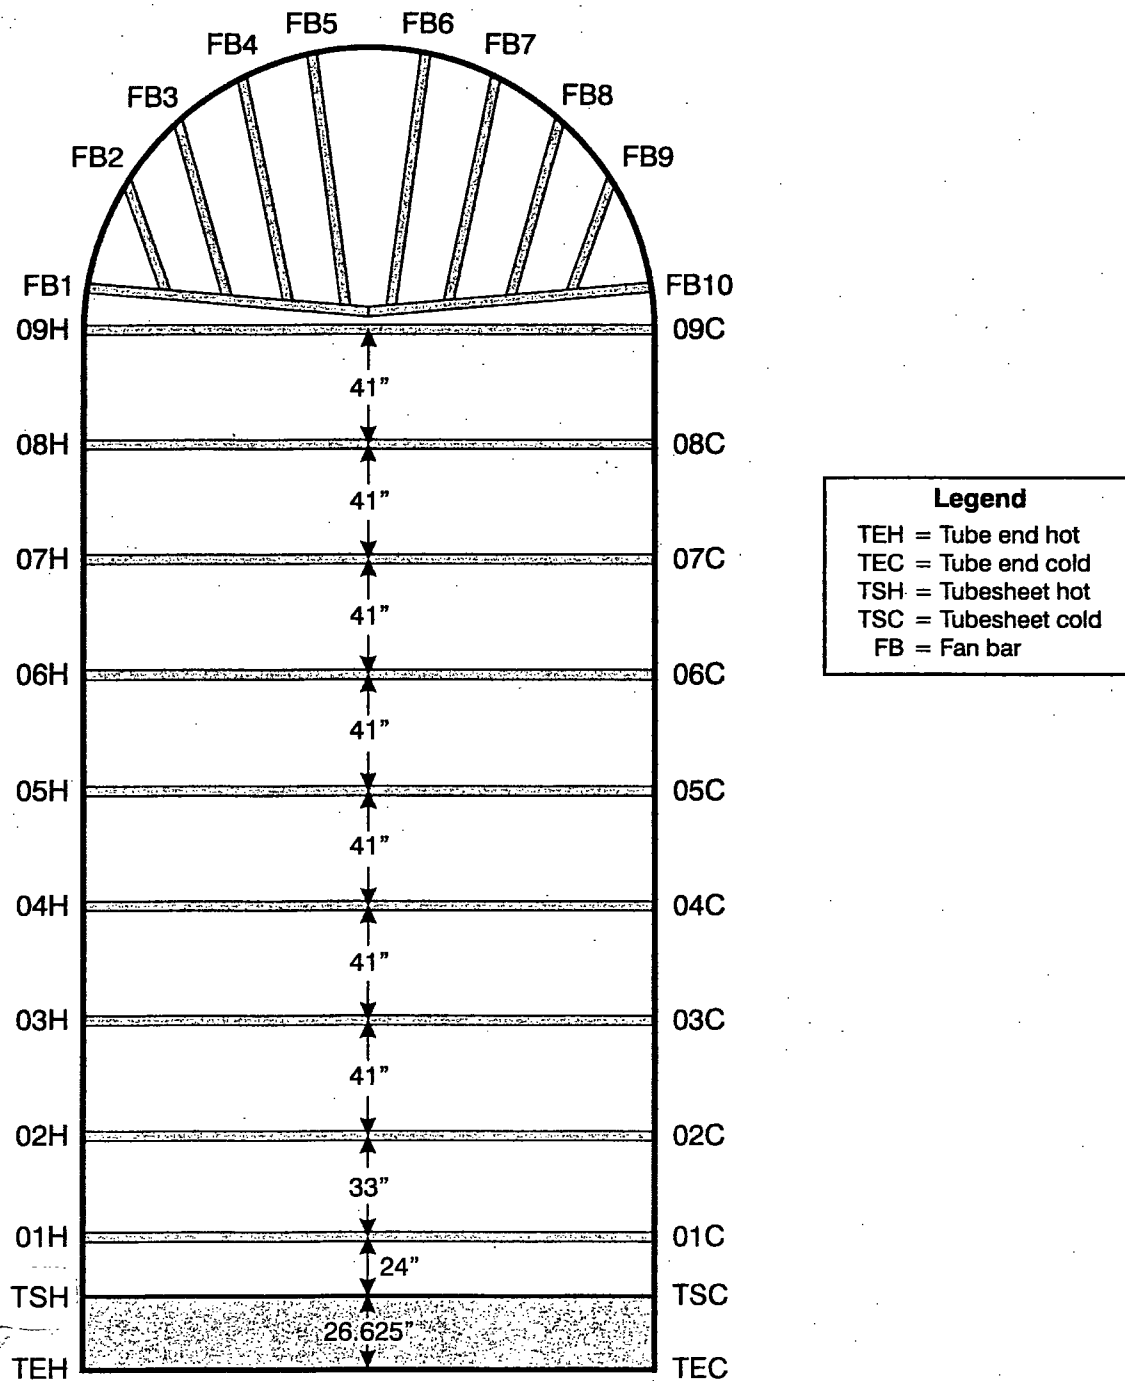
Figure 2-10: Tube Support Naming Convention at Braidwood Unit 1

Braidwood 1 has four recirculating steam generators designed and fabricated by Babcock and Wilcox International (BWI). The steam generators were put into service in 1998 during RFO 7. The licensee numbers its tube supports as depicted in Figure 2-10.

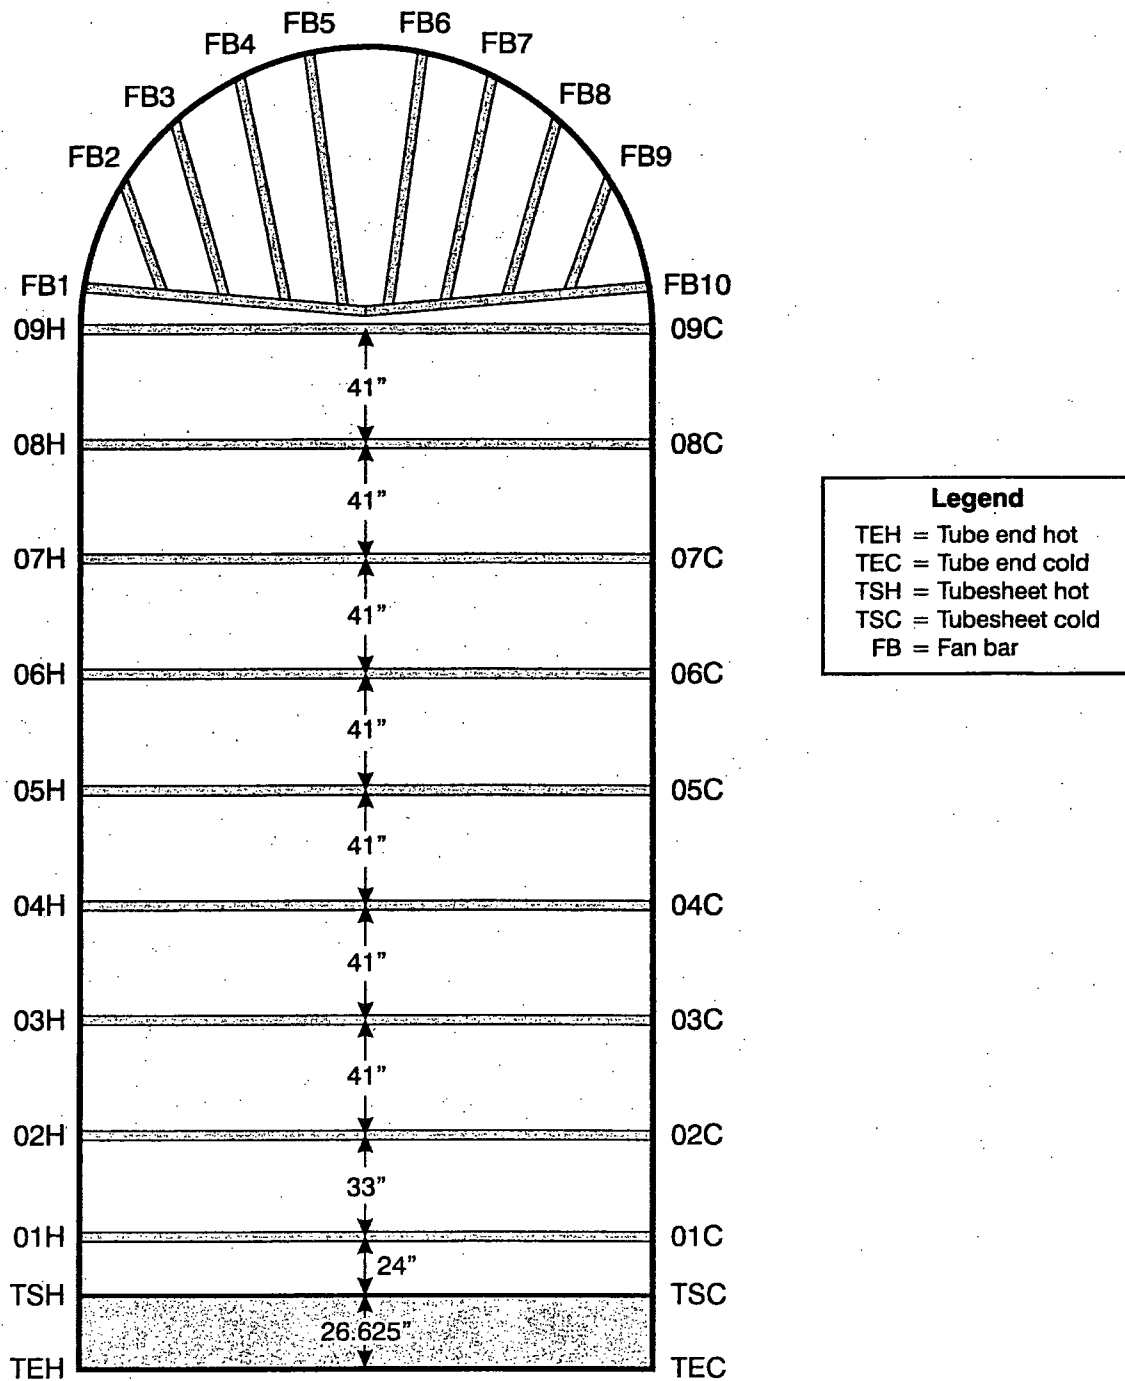
Figure 2-12: Tube Support Naming Convention at Byron Unit 1

Byron 1 has four recirculating steam generators designed and fabricated by BWI. The steam generators were put into service in 1998 during RFO 8. The licensee numbers its tube supports as depicted in Figure 2-12.

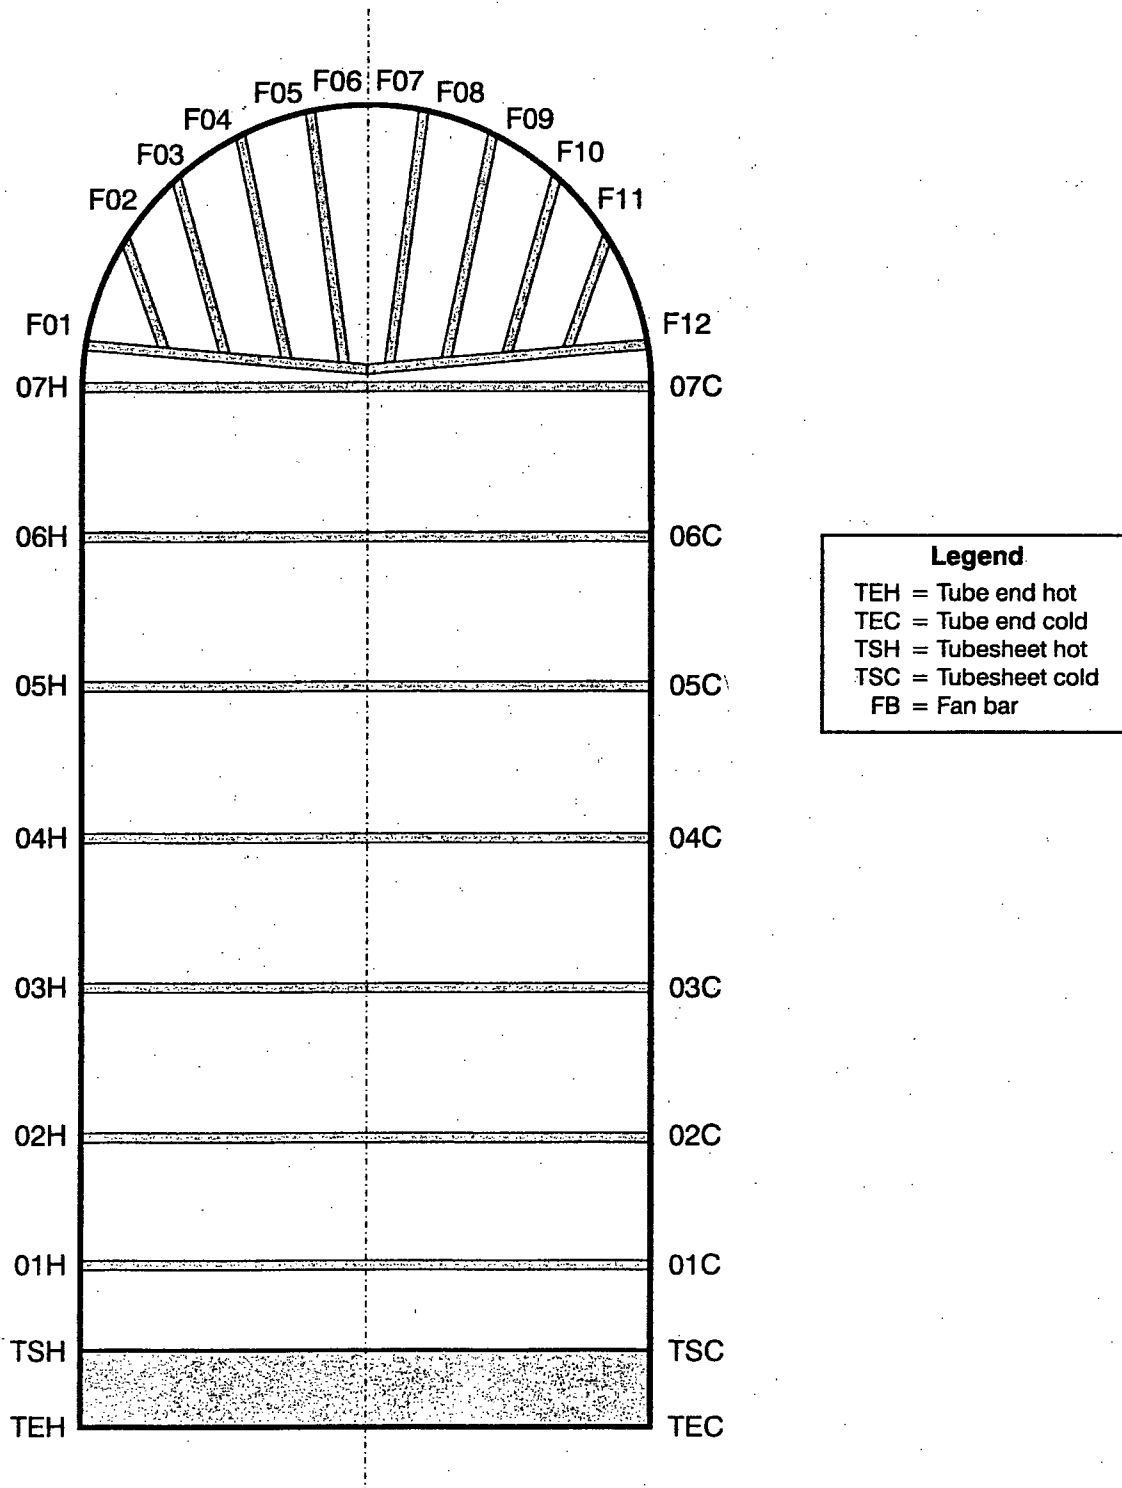
Figure 2-14: Tube Support Naming Convention at Calvert Cliffs 1 and 2

Calvert Cliffs 1 has two recirculating steam generators which were designed and fabricated by BWI. The steam generators were put into service in 2002 during RFO 15. The licensee numbers its tube supports as depicted in Figure 2-14.

Calvert Cliffs 2 has two recirculating steam generators which were designed and fabricated by BWI. The steam generators were put into service in 2003 during RFO 14. The licensee numbers its tube supports as depicted in Figure 2-14.

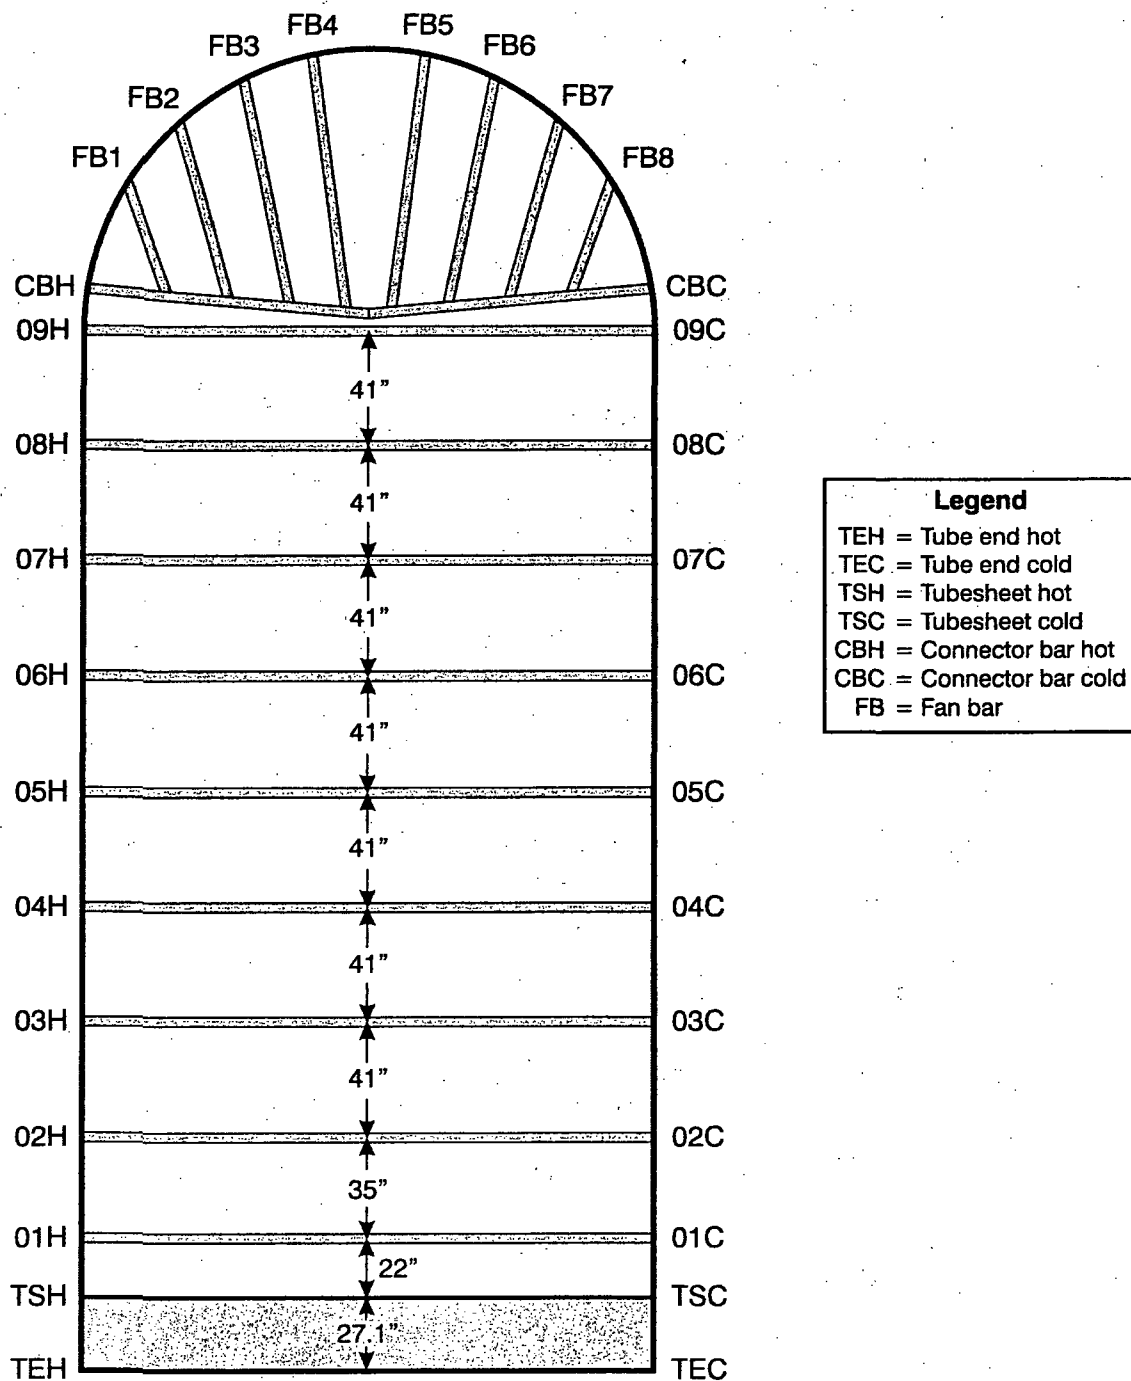
Figure 2-16: Tube Support Naming Convention at Catawba Unit 1

Catawba 1 has four recirculating steam generators which were designed and fabricated by BWI. The steam generators were put into service in 1996 during RFO 9. The licensee numbers its tube supports as depicted in Figure 2-16.

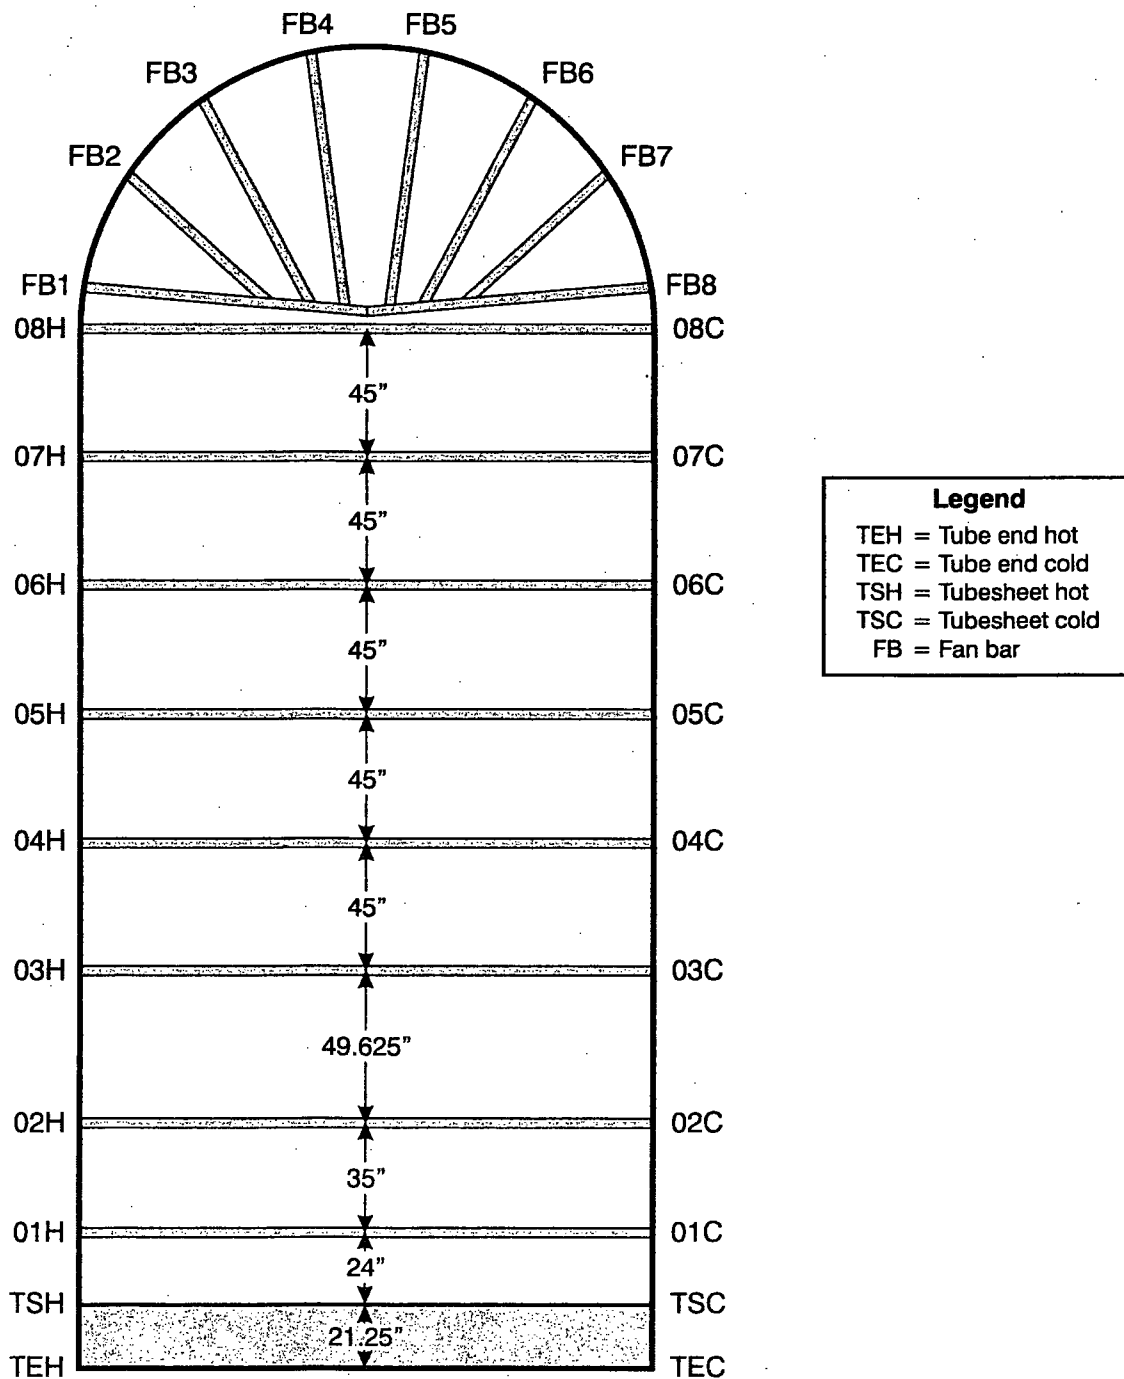
Figure 2-18: Tube Support Naming Convention at Cook Unit 1

Cook 1 has four recirculating steam generators which were designed and fabricated by BWI. The steam generators were put into service in 2000 during RFO 17. The licensee numbers its tube supports as depicted in Figure 2-18.

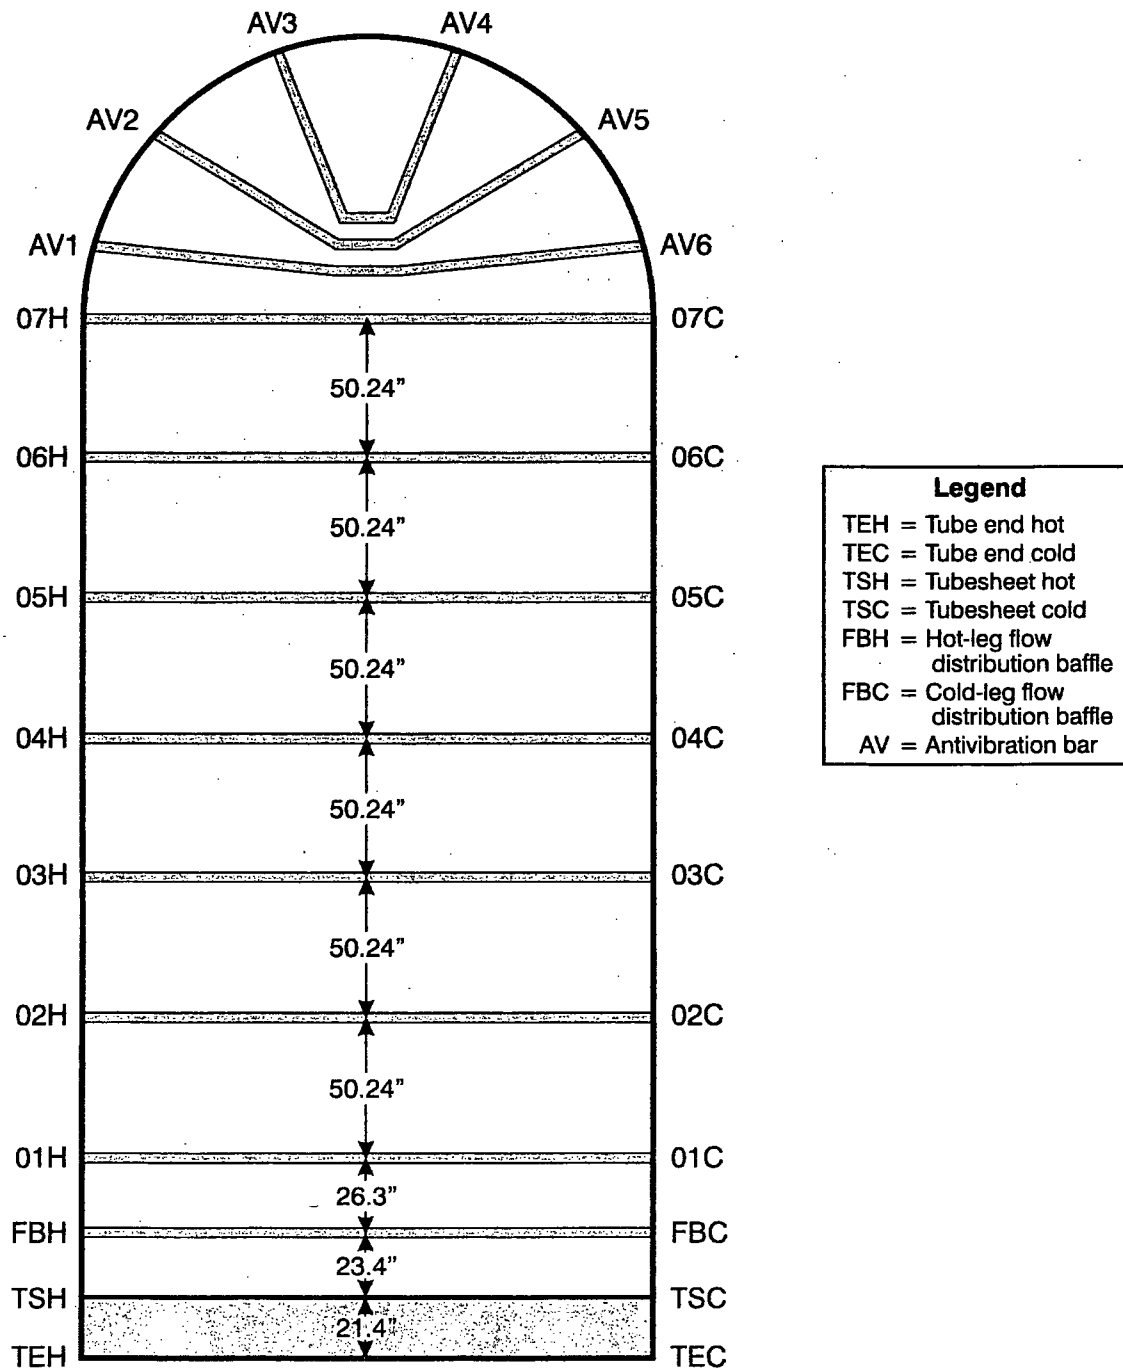
Figure 2-20: Tube Support Naming Convention at Cook Unit 2

Cook 2 has four recirculating steam generators which were designed and fabricated by Westinghouse. The steam generators were put into service in 1989 during RFO 6. The licensee numbers its tube supports as depicted in Figure 2-20.

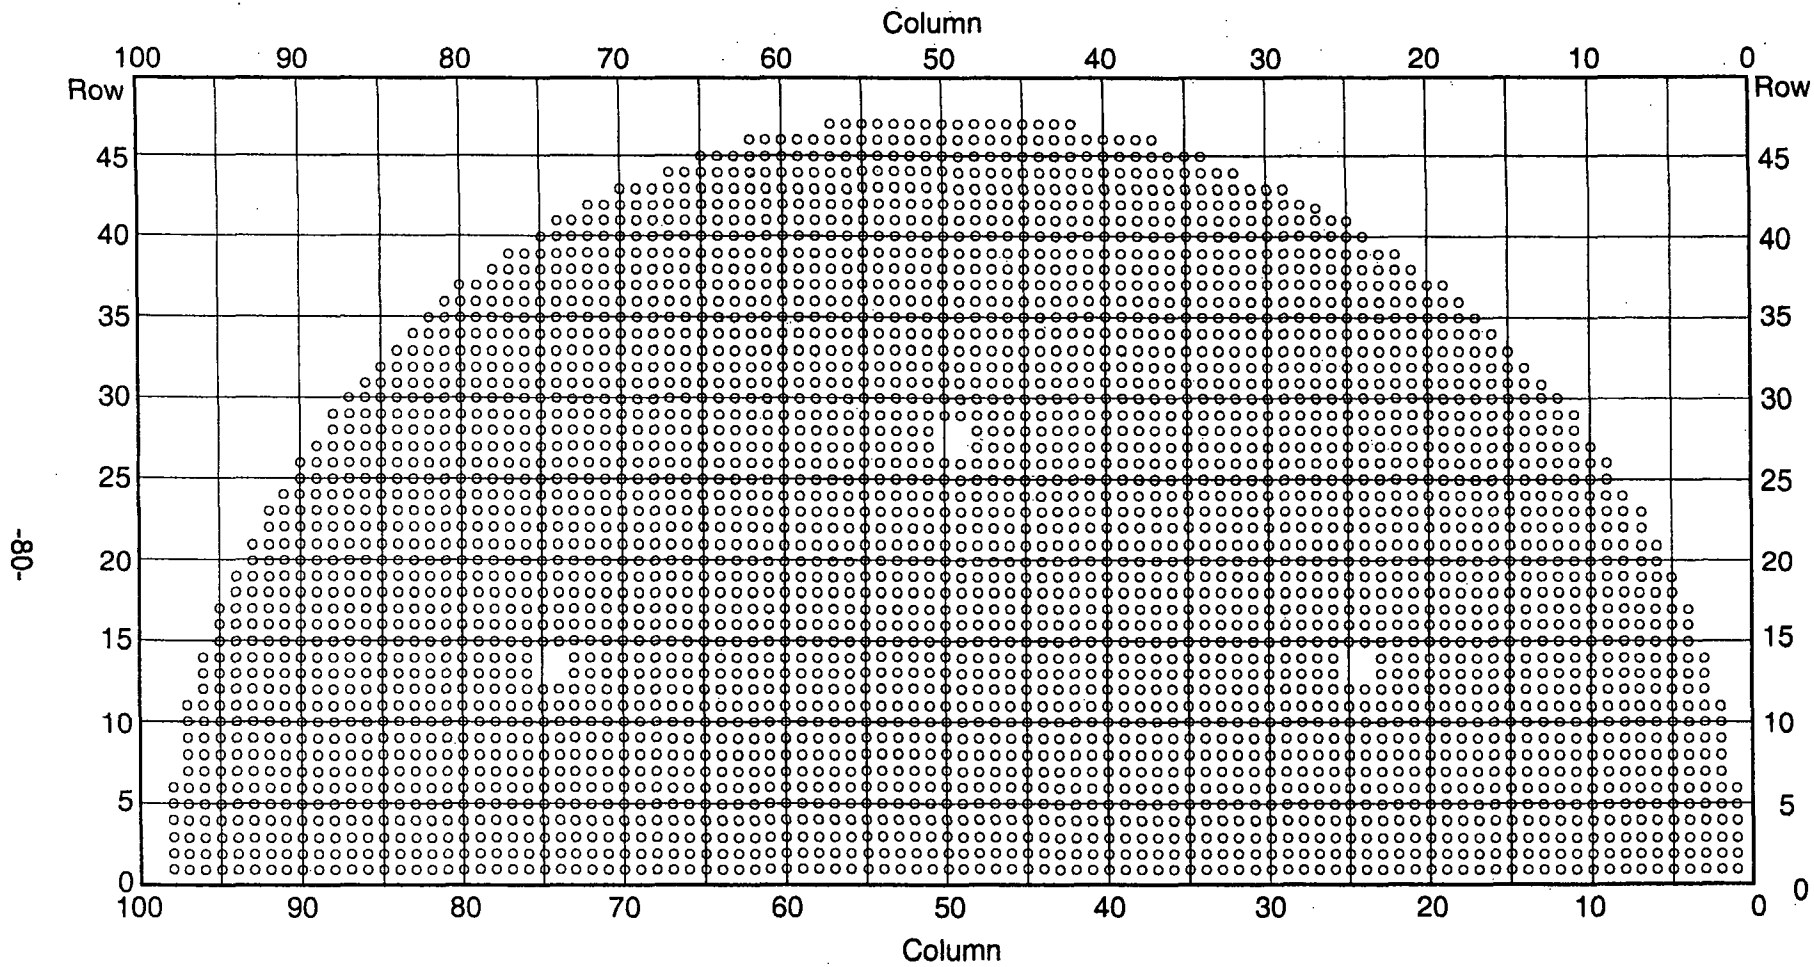
Figure 2-35: Tubesheet Map for North Anna Units 1 and 2

manufactured by Sandvik and are arranged in a square pattern as illustrated in Figure 2-35 with a spacing of approximately 1.225 inches. The heat transfer surface area in each steam generator is 54,500 ft².

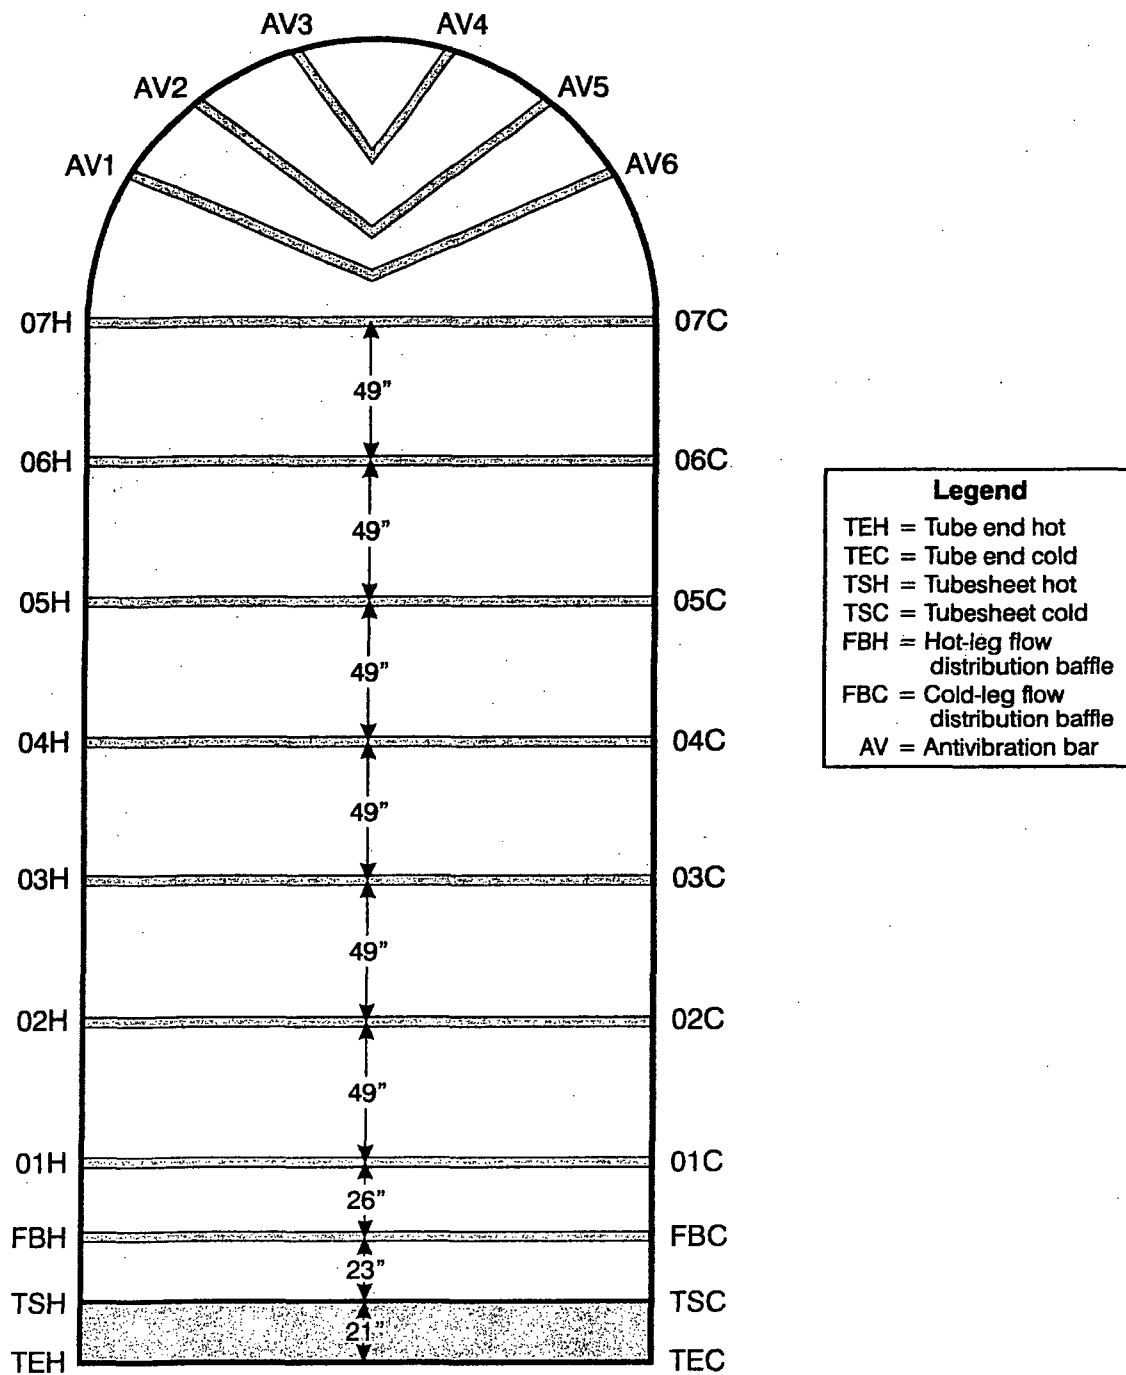
Figure 2-36: Tube Support Naming Convention at North Anna Units 1 and 2

The tubes were hydraulically expanded at each end for the full depth of the tubesheet. The tubes are supported by a flow distribution baffle, support plates, and AVBs. All supports are constructed from Type 405 stainless steel. The flow distribution baffle is 0.75 inch thick, and has octafoil-shaped holes through which the tubes pass (with the exception of the row 1 tubes, most of which have pentafoil shaped holes). The tube support plates are 1.125 inches thick and have quatrefoil-shaped holes through which the tubes pass. The AVBs are arranged in a "V" shape and penetrate the tube bundle through row 8. Figure 2-36 illustrates the tube support configuration and numbering.

The tubes were hydraulically expanded at each end for the full depth of the tubesheet. The tubes are supported by a flow distribution baffle, support plates, and AVBs. All supports are constructed from Type 405 stainless steel. The flow distribution baffle is 0.75 inch thick, and has octafoil-shaped holes through which the tubes pass (with the exception of the row 1 tubes, most of which have pentafoil-shaped holes). The tube support plates are 1.125 inches thick and have quatrefoil-shaped holes through which the tubes pass. The AVBs are arranged in a "V" shape and penetrate the tube bundle through row 8. Figure 2-36 illustrates the tube support configuration and numbering.
